St John's Tower and Tower Roof – Condition photographs of rain water ingress and penetration

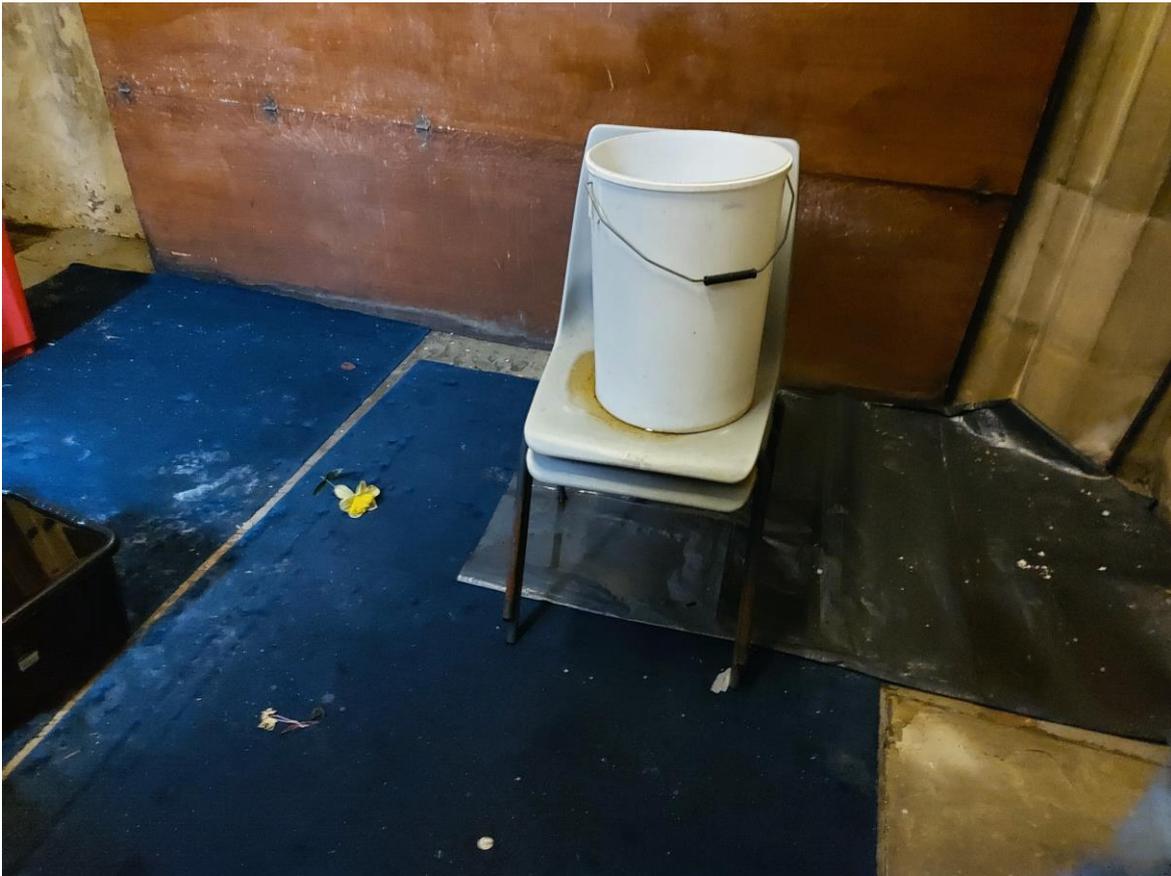
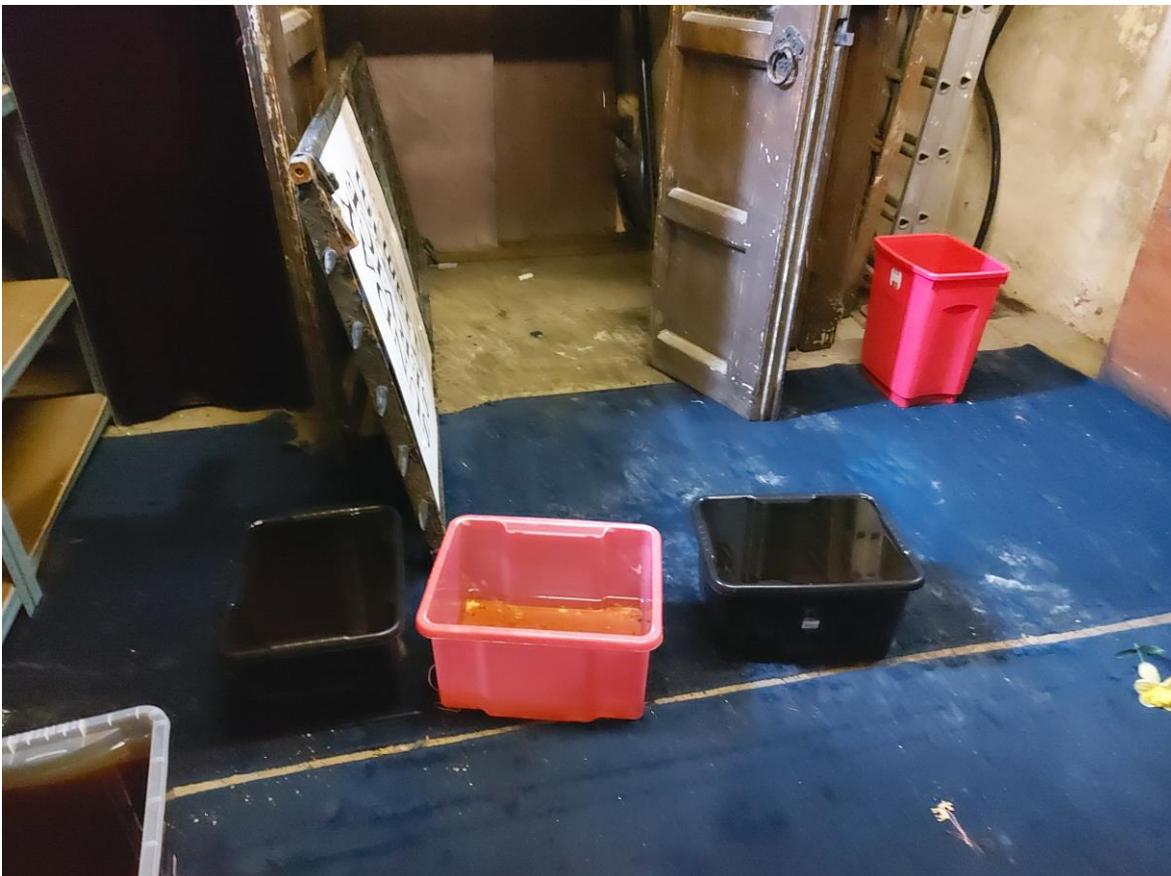
**Ground floor:** (stone floor - saturated carpets since removed)

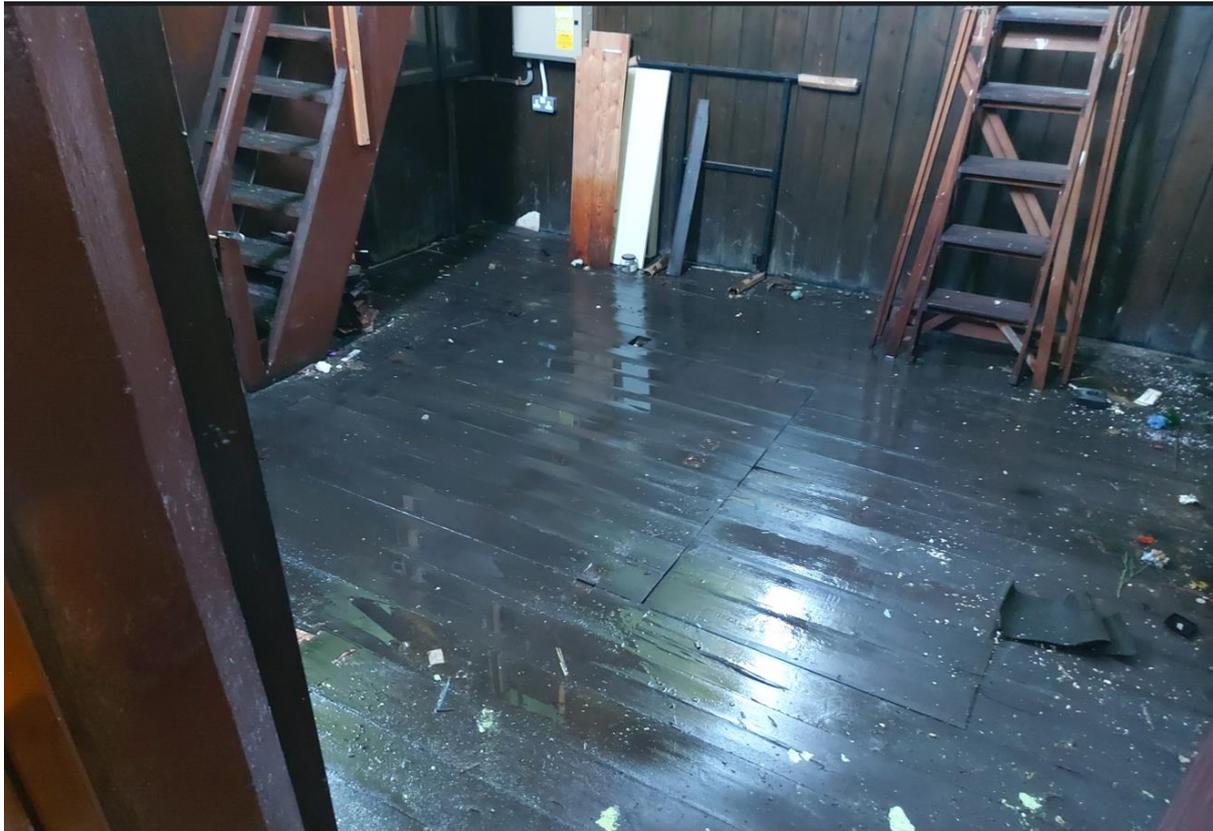
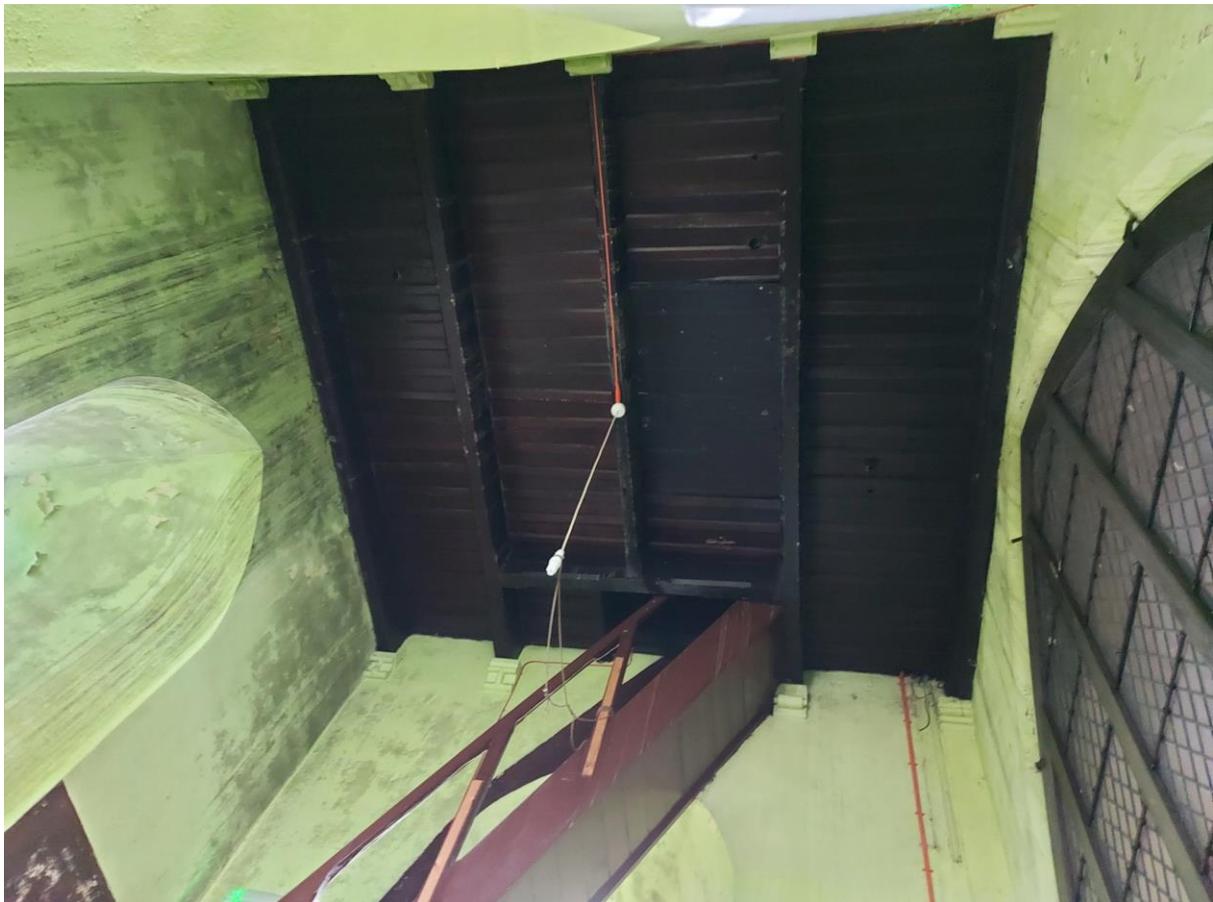
**Tower First Floor - timber floor and bell trapdoor saturated and in unsafe condition:**

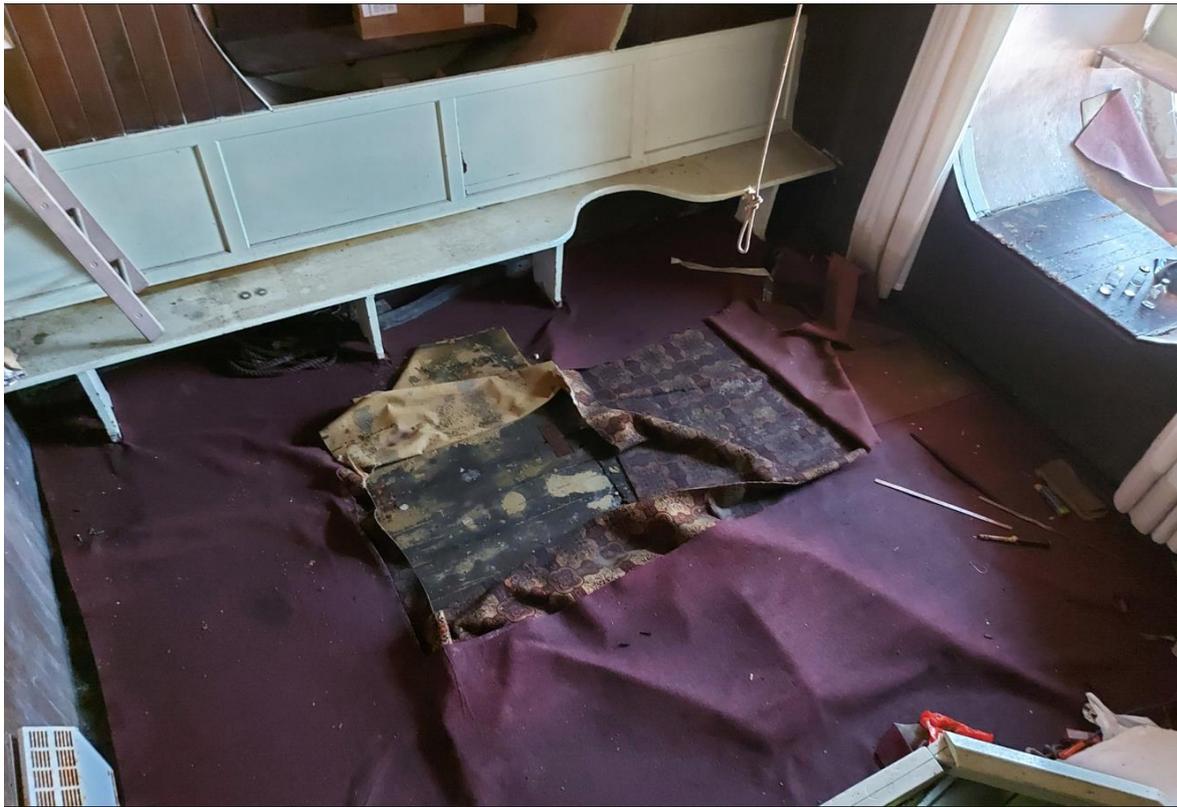
**2nd floor (bell ringing floor) timber floor and bell trapdoor saturated and in unsafe condition**

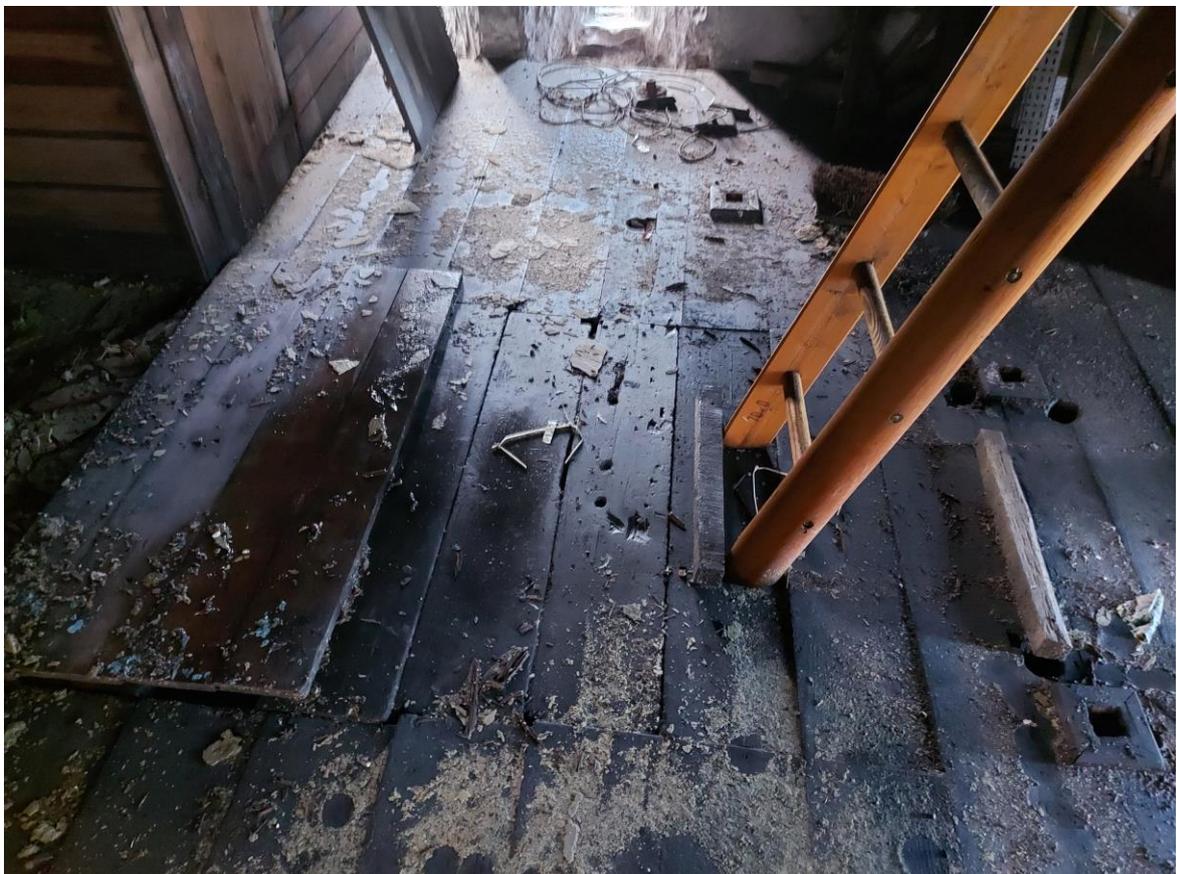
**3rd Floor: timber floor and bell trapdoor – saturated, sunken and in very unsafe condition**

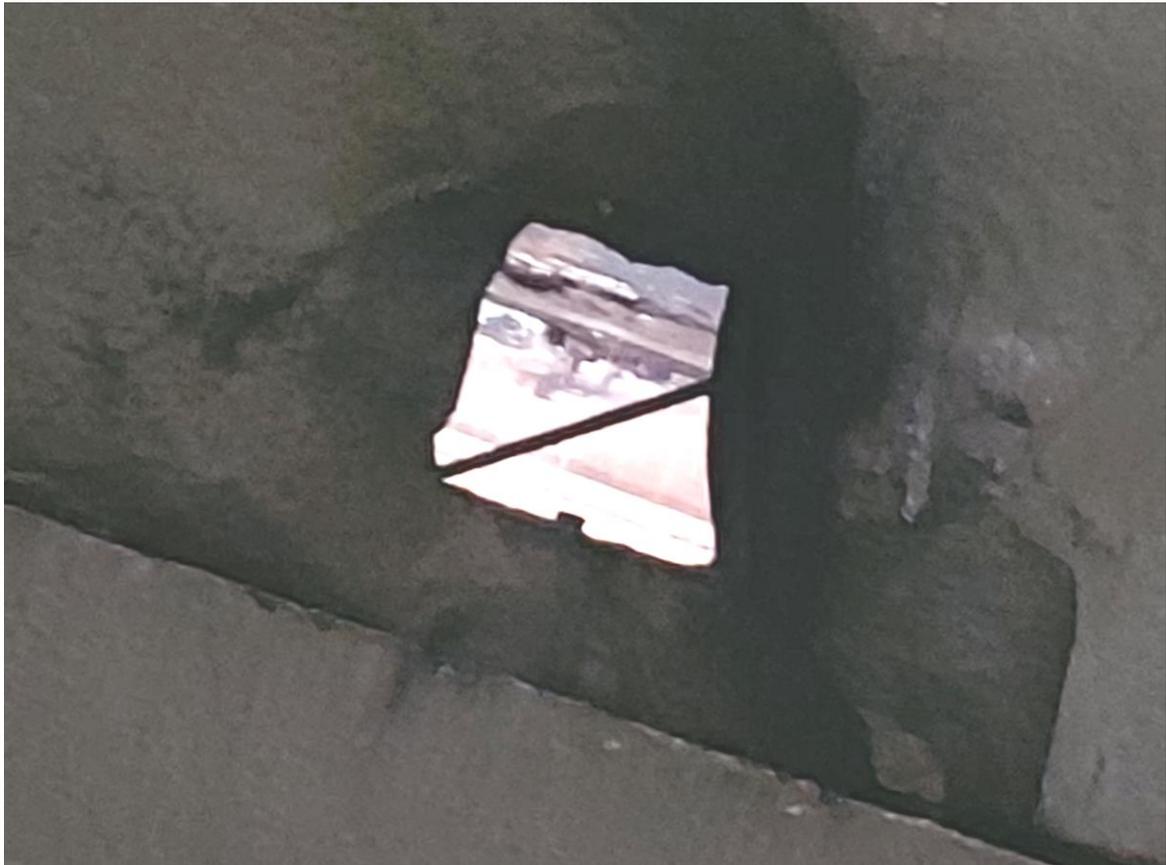
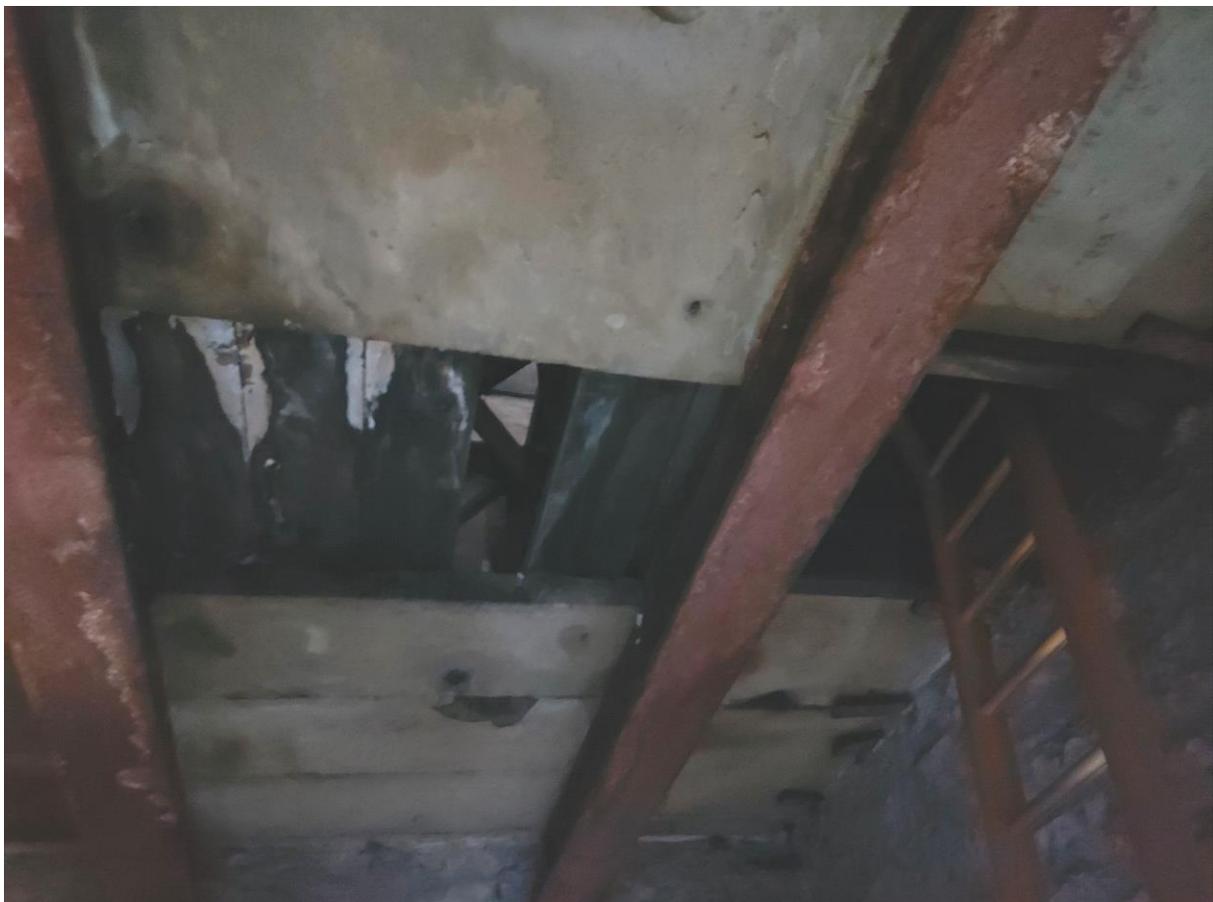
**4<sup>th</sup> Floor** (belfry sandstone slabs on steel beam) – localised saturation

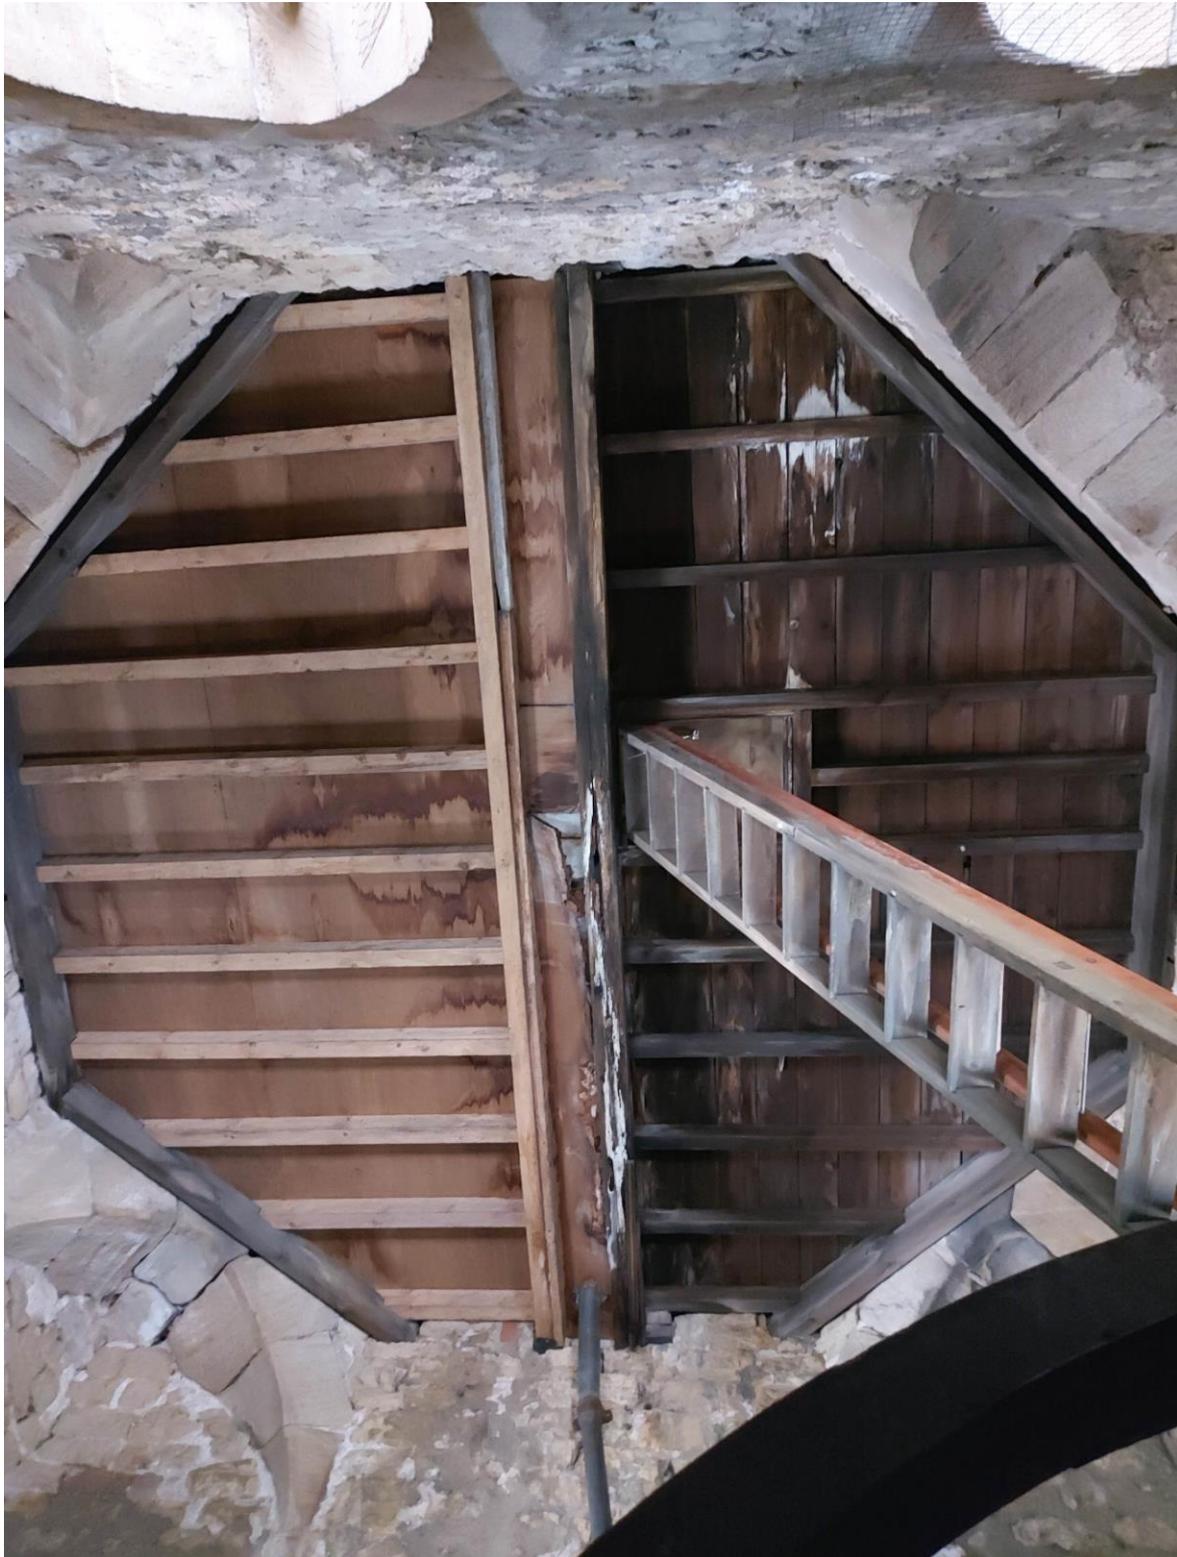
**Underside of roof deck:** Failing gutter is draining centrally through the building. Rotten gutter joists and flat roof joist trimmer in danger of failure/collapse.

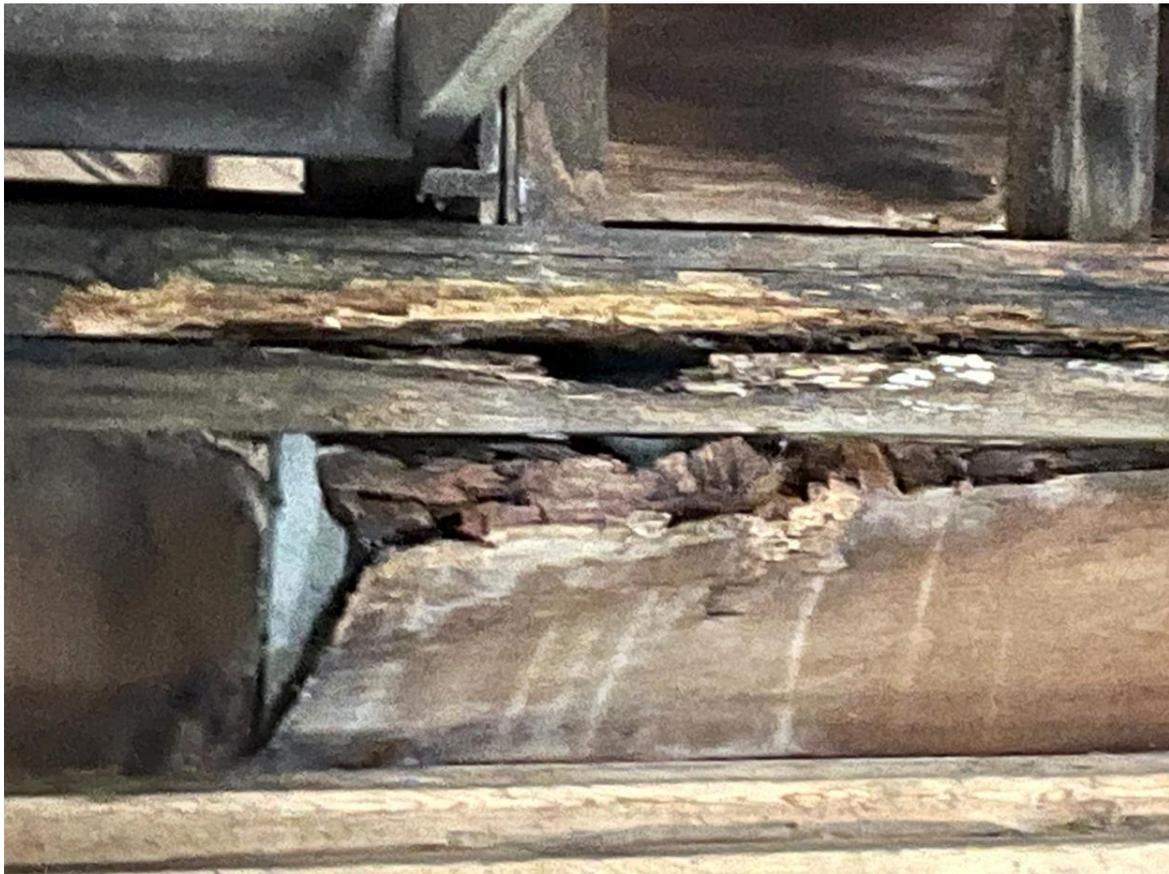
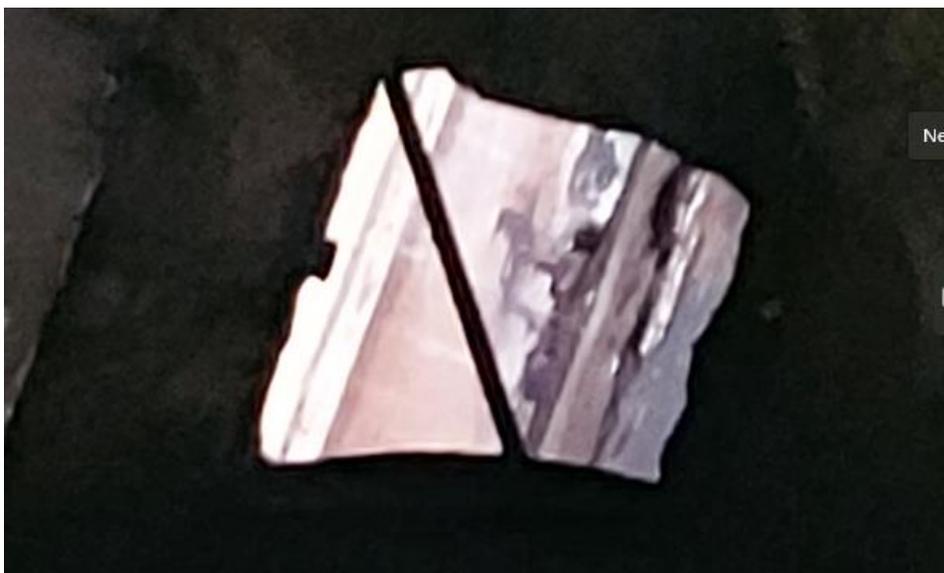
**Roof gutter/timber trimmer joist rot detail:**
