Diocese of Durham

## Belmont, St. Mary Magdalene

### Quinquennial Report

**25<sup>th</sup> March 2025**

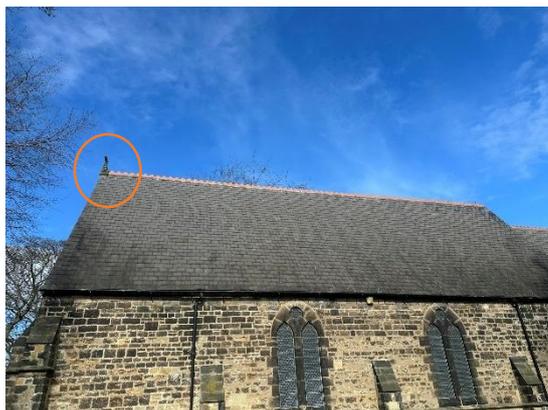
Figure 1 - South Nave

- 7.1.1 Ridge – Ornamental ridge cresting ok, the tiles adjacent to the ridge are slightly lifted and uneven.
- 7.1.2 West abutment – Pointed verge ok, the finial has a slight lean to the west, there is a little cracking evident to the top of the west gable (discussed in section 9.12). It is believed that the finial still appears to have a good seating as seen from ground level and the mortar to the rear and base is not cracked, though it would be best to be checked at close proximity.
- 7.1.3 East abutment – Pointed verge ok, although the overhang of the slate is slightly too short on both gables, causing pointing to be slightly messy.
- 7.1.4 General roofing – two or three slipped and cracked slates. Two missing to the top right-hand side.

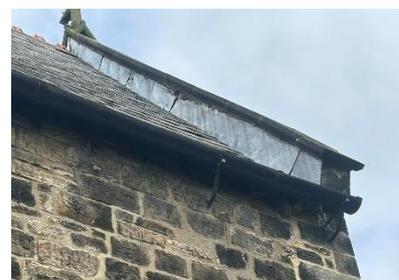
Figure 3 - Chancel East Abutment

- 7.2.1 Ridge – Slightly more ornate ridge cresting, all ok.
- 7.2.2 West abutment to the Nave– Pointed over in cement with lead soakers and flashing, some slight cracking half way down.
- 7.2.3 East abutment to gable water table – large step with lead flashing, one piece is lifting slightly and the pointing to the underside of the water table is breaking up. Finial appears ok.
- 7.2.4 General roofing – slating has some chips and an area close to the nave has had silicone repairs in in the past, believed to be more than 20 years ago.

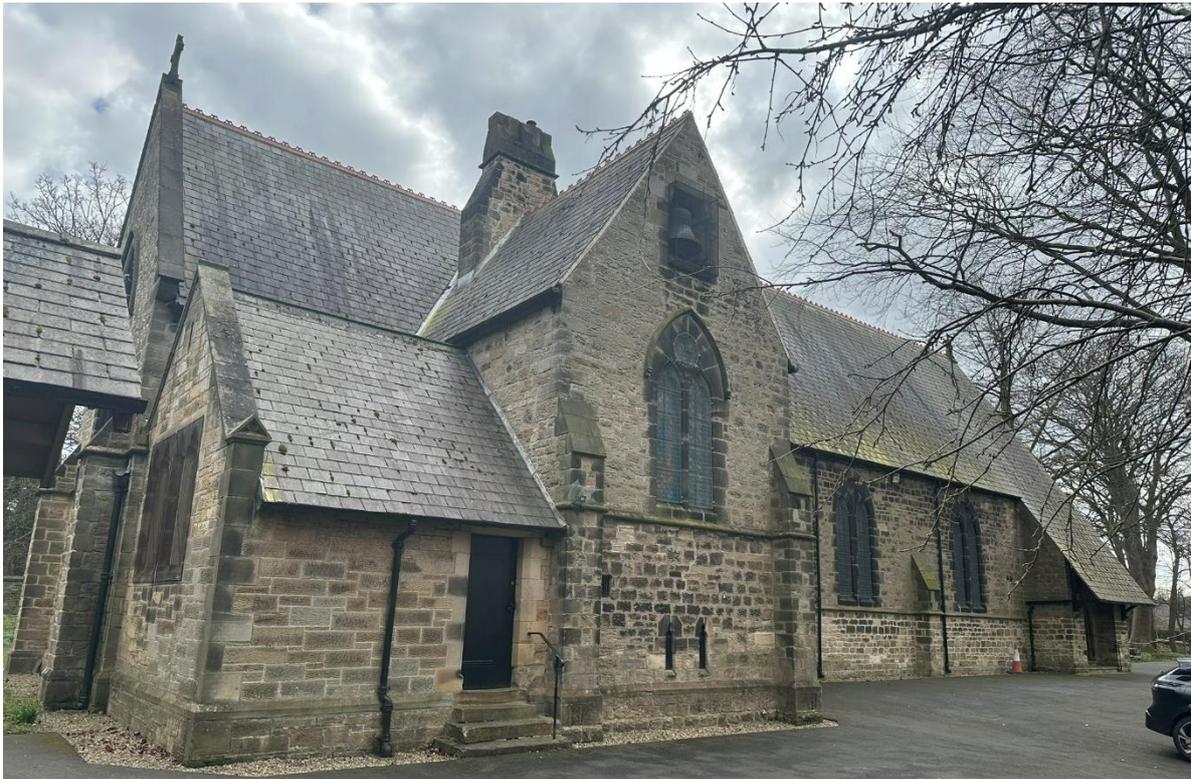
Figure 4 - Northern roofs (vestry in foreground)

- 7.3 **Chancel** – As per the south, limited view however there appears to be some slipped slates behind the chimney. Valley to the transept, all needs inspecting from high level.
- 7.4 **Choir Vestry (North Slope):**
- 7.4.1 Ridge – Roll top ridge tiles look bedded ok, gaps between but very difficult to fill.
- 7.4.2 East abutment into water table – lead flashing appears ok.
- 7.4.3 West abutment – into transept with lead flashing and all appears ok.
- 7.4.4 General roofing – Slating looks generally ok, some moss to surface.

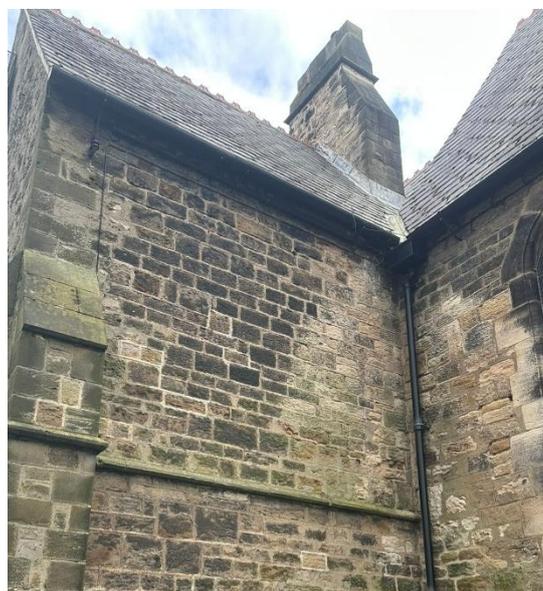
*Figure 5 - West Transept downpipe and hip*

8.6 The **gutter brackets** mostly look original and some are broken, leaving only a horizontal element, these appear to still be supporting the gutters.

8.7 **Downpipes** have anti-splash shoes and all appear ok, some require lead wedging to bottom joints as they are currently loose.

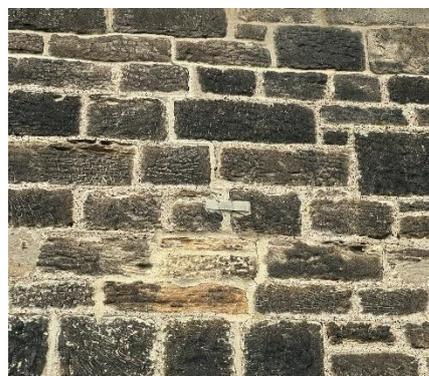
*Figure 6 - Crack monitor at S Nave*

9.2 **South Nave** has a 2mm crack to the west end, there is a cement tell-tale here and has not changed since the last inspection. If this area was re-pointed in lime it would greatly aid monitoring any future movement. There are three holes in a stone to the base, which looks to be for ventilation, this is mirrored on the north side. The tracery of the easternmost window has a crack at the shoulder radiating upwards and at the cill. Another minor crack to the right of this window above the buttress. All appear historic but should be monitored.

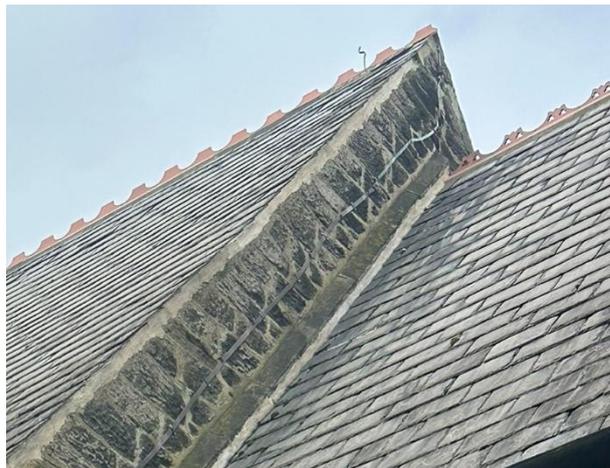
Figure 7 – E Nave pointing at verge

9.3 **East end of Nave** (above chancel) – Just below the apex the verge pointing has come away. The lightning conductor tape runs down this elevation. The gutter may be falling back to this corner as the walling at lower level is a little green.

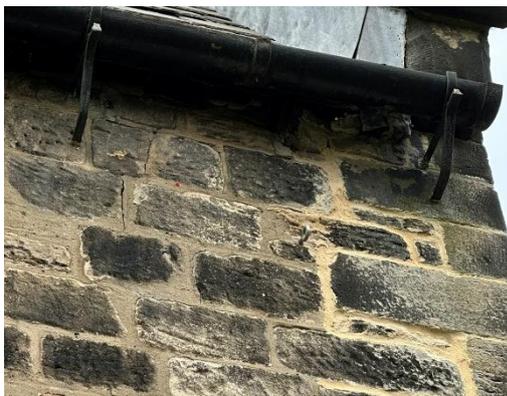
Figure 8 - South Chancel crack near wall plug & new pointing

9.4 **South Chancel** – Slight open joint on the tracery but no change since the last inspection. There is slight erosion to some of the stones, but not requiring any action currently. There is a slight crack to the upper east end near an old red wall plug, this requires monitoring. There are two former cracks on this elevation which have been re-pointed in the past but don't appear to have any additional movement.

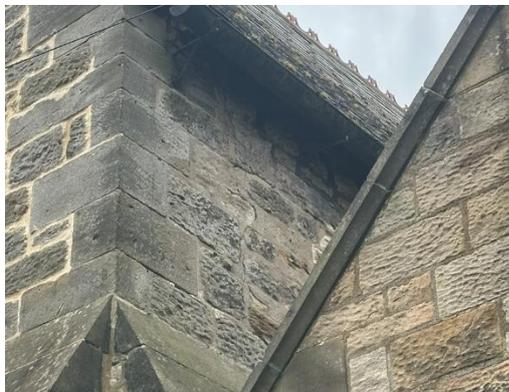
Figure 9 – North Chancel crack

9.8 **Chancel North (high level)** – Very little visibility, however there is a crack to the east end which appears historic but should be inspected closely when the gutter is, and would benefit from re-pointing to allow movement to be more readily monitored.

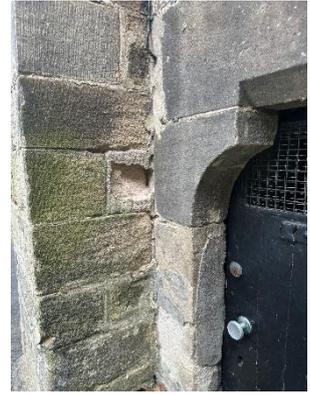
*Figure 10 - W Transept area for repair*

- 9.9.3 **Westside** - Some wear to the stonework in the corner where there was a leaking downpipe, no replacement needed just yet, but it should be re-pointed behind the downpipe. There is one eroded stone to the right of the door to the boiler room which would benefit from a plastic repair with lime mortar.

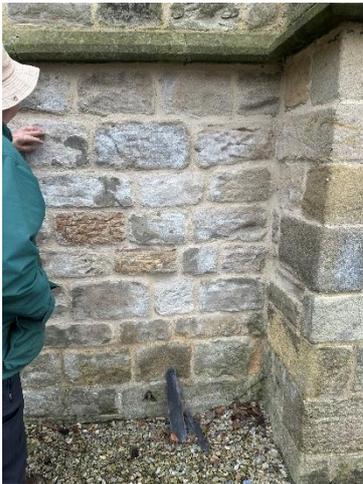
*Figure 9 - Salts on stones*

- 9.10 **Nave** – There is a large area of cement pointing here above the string course, and the string course itself has some open joints and is stained green. The lime pointing below the string course has slightly over-hardened and the salts appear to be showing through the stonework.

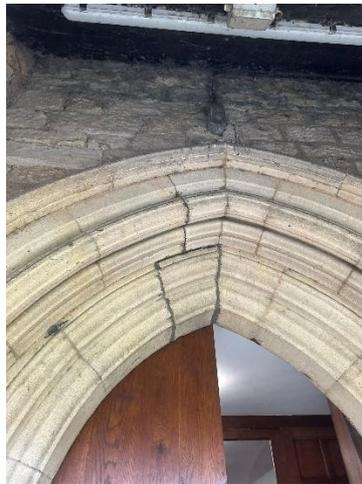
*Figure 12 - movement to porch arch*

- 9.11 **Porch** - The lower levels of this have been repointed, upper levels look ok. The arch moulding at low level has had some indented stone repairs in the past. There has been past repointing of the apex of the entrance arch where it has dropped in the past, now stained black but ok other than the aesthetics.

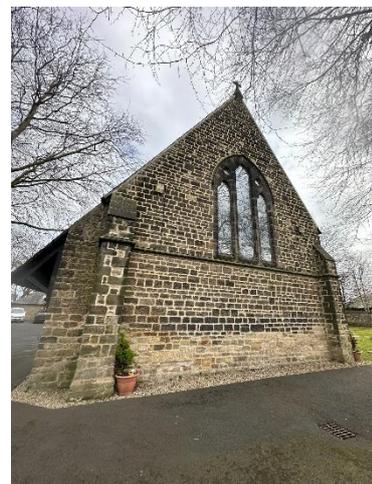
*Figure 13 - west gable*

- 9.12 **West Nave** - This whole elevation was repointed and all looks ok. Monitor any movement at apex as per item 7.1.2.

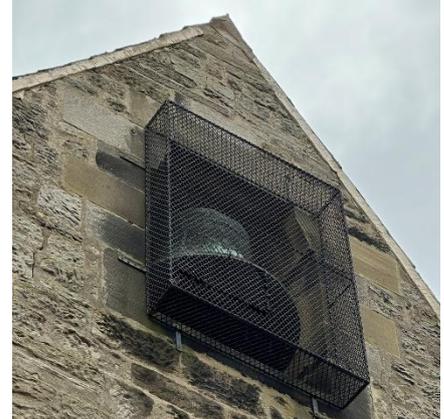
Figure 14 - bell & wire cage

11.1 **Bells:** One bell, part recessed within the north transept within an opening in the upper vestry. It is tolled for services and housed within a wire cage guarding. No recent checks have been carried out and therefore recommended within the next 12 months that the bell, headstock and mechanism is closely inspected.

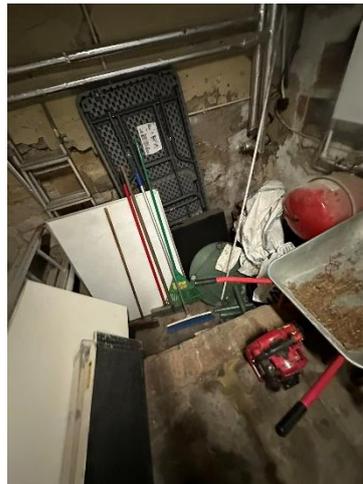
Figure 16 – dropped floor level

12.3 **Floor** – Cracked stone but all sound, there is a sunken pit to the south side, the base of which could not be inspected.

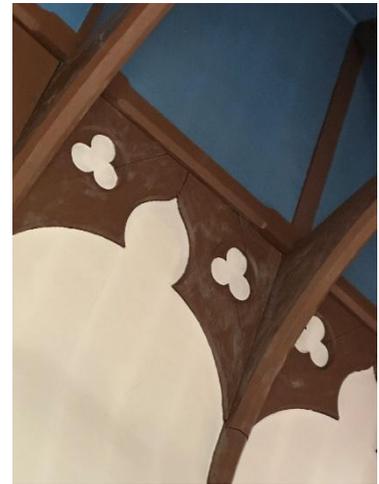
Figure 19 – Chancel Bloom

13.2 **Chancel** - Trussed roof, similar to the nave but without the tie rods. Additionally, the upper section is painted in dark blue. The lower section in white is also showing some ghosting on the decoration. Additional decorative detail over the sanctuary, where there is slightly more bloom on the decorative timbers.

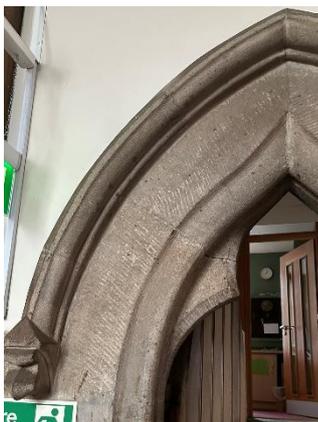
Figure 20 – arched doorway

14.1 **Office** – Slight crack to the lancet arched doorway from chancel to lobby but no changes to report here.

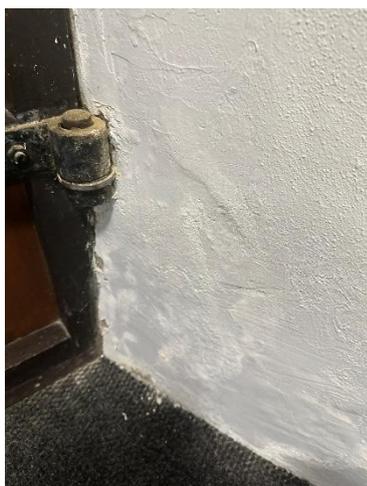
Figure 21 – Porch

15.1 **Porch** - Redecorated porch that used to have damp at low level, has an Artex type of coating now, which seems to have covered issues. There are salts showing back through at low level near the entrance doors.

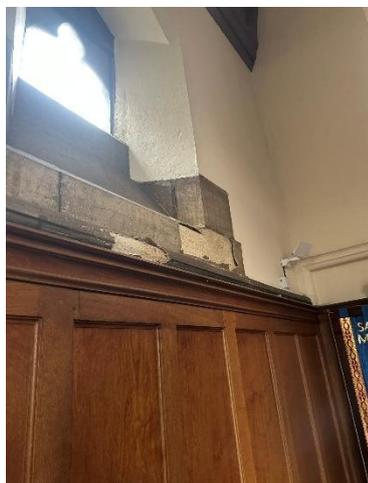
Figure 22 – Chancel stone damage

15.4 **Chancel** - reportedly redecorated, but there are two areas of water staining to either side of the chancel arch at high level, this could be from condensation. A large organ recess masks the arch behind the pipes, but seemingly ok. The lower sections are covered with timber panelling.

15.4.1 There is an area to the north side, below the lancet where the face of the stone has delaminated and there is some severe stone erosion which has appeared since the last inspection. This is thought to be due to a leak in the box valley behind, which has reportedly now been fixed but this should be checked by a professional heritage roofer as it is believed the fix may be temporary.
