## St Andrew, Southchurch, Bishop Aukland

### Quinquennial Report

On the architect's inspection of

**23<sup>rd</sup> April 2025**

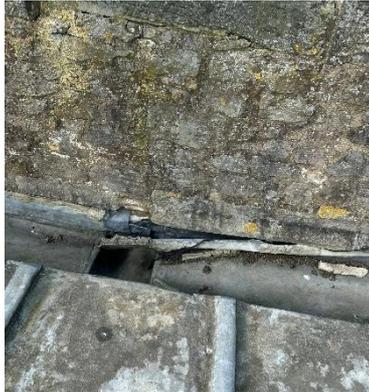
*Figure 1- NE corner*

- 6.1 **The tower:** Lead roof covering and gutters, generally the main roof falls to the east and west, in 9 bays with central cover bays. All of the lead roof and gutters were replaced by Norman and Underwood in 1991. Minor repairs and new gutter bottoms were also installed at the same time.
- 6.1.1 Lead lined gutters fall to outlets on the north and west sides. The lead above the outlet to the west side has an area of flashing which is separated from the wall, following the crack to pointing noted in the last QI completely breaking away. The gutter has a little build-up of silt to the northeast corner.

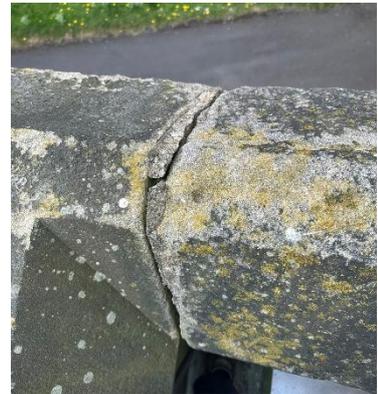
Figure 6 – Open joint to SW corner

- 6.2.1 The flashings up to the clerestory walls are in lead and painted over with bitumen, these are generally in good condition but there are some movement cracks. In several places there are gaps between the flashings and the clerestory wall, that need re-pointing.
- 6.2.2 The box gutter to the south is also in stainless steel and in need of cleaning out, there is a great deal of vegetation growth and even pieces of the polycarbonate window protection in there. The parapet flashings are lead. The flashing to the west end is also in lead and appears sound
- 6.2.3 The parapet walls and copings on the inner side are in fair condition. There are however several joints to point, especially at the SW corner and at the chimney stack. Additionally, there are a large number of open joints between the coping stones.

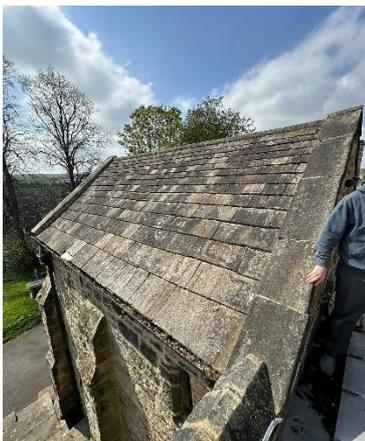
Figure 7- South Porch roof, East

6.3 **South Porch Roof:** covered with sandstone slates in diminishing courses and random widths. All re-laid in 1991 and in fair condition but on the west side, one slate near the ridge has slipped and at the base of the east side there is a poor repair on the bottom course. There may also be a slate missing at the ridge at the north end.

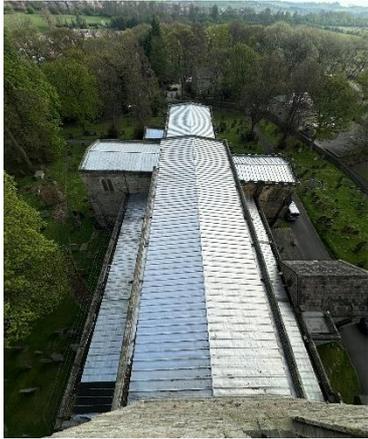
Figure 8 – Roofs from Tower

**6.5 Nave Roof:** Recovered in stainless steel with batten roll seams and lead gutters and outlets. All generally seem to be in good condition when viewed from available vantage points but some of the flashings are over long and have expansion tears on them. Some also seem very loose and not clipped down very effectively. There are also some recent non-lead flashing replacements to the east parapet on the north side. Access should be provided to the Nave roof so these flashings can be checked at close proximity.

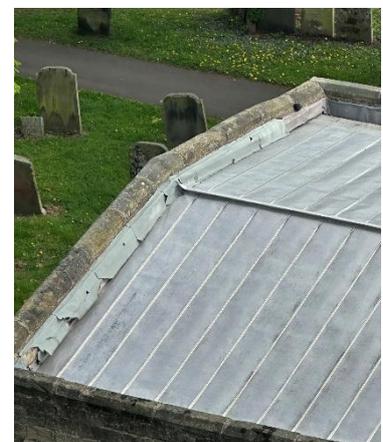
Figure 9 – N Transept parapet flashing

6.8.1 The missing or stolen sections of lead to the north and east parapet walls have been replaced with non-lead flashings. These are breaking down, the material has become brittle and appears to be perishing in areas, replacement is required. There is a gap between flashing and stainless-steel sheet at the west end, it appears as if the material has lifted at the joints, they should be refixed or replaced as soon as possible.

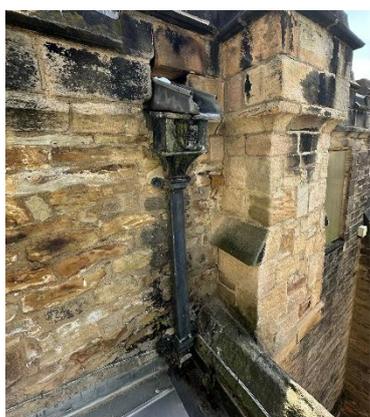
Figure 10 – S Transept W Hopper

7.2 South Transept – the outlet to the west discharges onto the south aisle below and the stone is in such poor condition behind that the fixings are loose; it looks as though this hopper overflows regularly.

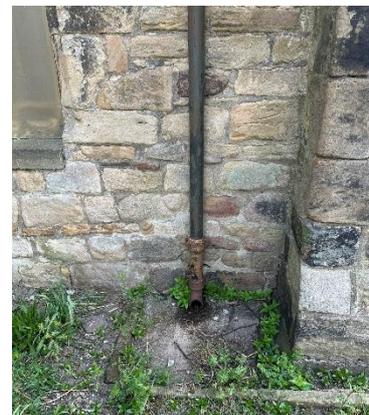
Figure 11 – Porch W downpipe

7.4 Porch - The gutters to east and west are cast iron ogee sections in good condition although but the east gutter needs clearing out as the gulley is completely blocked. The south chancel and west porch require re-decoration and to the porch the hopper head is out of alignment. The rainwater pipe discharges here to an area of concrete that then drains to the south, it is vital this is kept clear to avoid water building up adjacent to the porch. The rainwater pipe is part aluminium but mainly cast iron and requires painting.

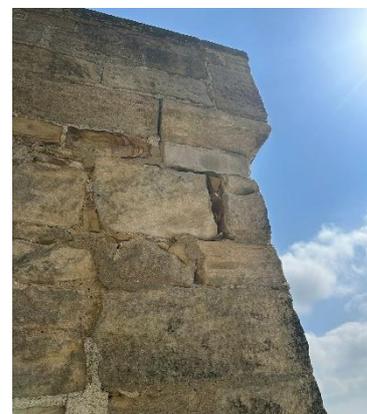
Figure 14 – Clerestory West

- 8.5.1 Rubble work generally in good condition but there are several open joints at parapet coping level.
- 8.5.2 The windows here are bulging and may require replacement (see interior notes). They have been protected recently with 'Lexan' sheeting.
- 8.5.3 Return face to Nave south clerestory has some open joints to point. There is a slight fracture in the stonework from the head of the just to the east of the rainwater pipe to the parapet.
- 8.5.4 To the West end of the clerestory, where the nave stonework returns to the tower, there is a very large gap in the stone that requires pointing, the inspector needs to monitor this area closely after re-pointing to ensure there is no movement here.

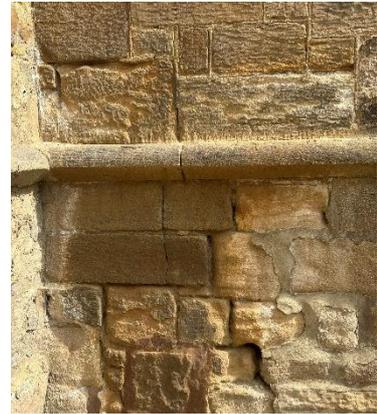
Figure 19 – Crack below string course

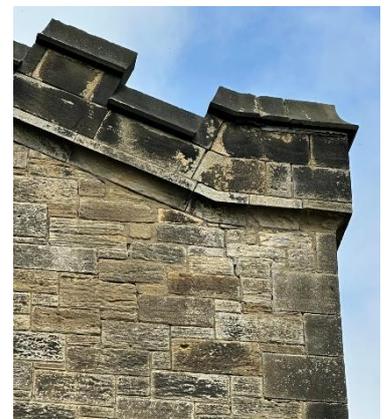
Figure 20 – SE corner movement

- The top eastern corner looks to have some movement outwards, not reported in the last QI, it is unknown if this movement is recent. Re-pointing should be carried out as a priority in order for the new inspector to monitor as closely as possible.
- There is also a hairline crack below the string course on the west side, again not previously reported and currently only around 0.5mm to the broken stone and emanating upwards to around 1mm, monitor closely.

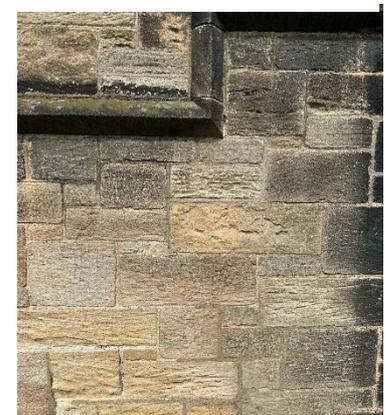
Figure 21 – Crack South elev

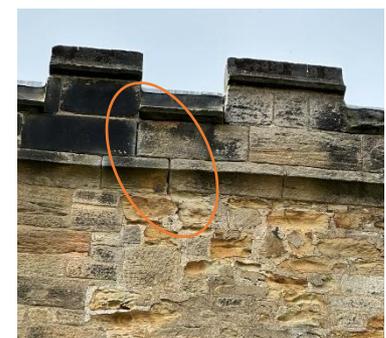
Figure 22 – E Transept open joint

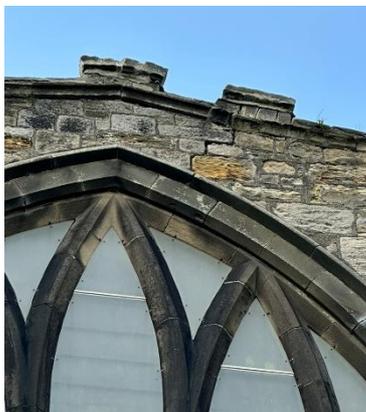
Figure 24 – E crack at window head

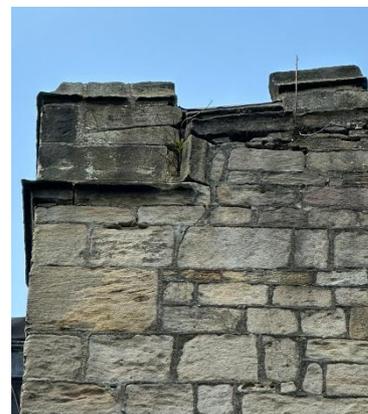
Figure 25 – SE crack

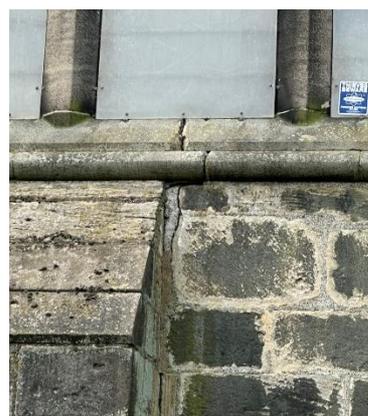
Figure 26 – E gable cill cracking

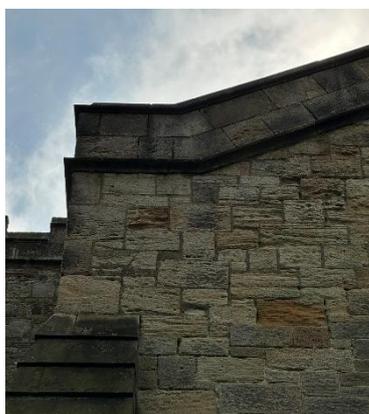
Figure 27 – N gable open joints

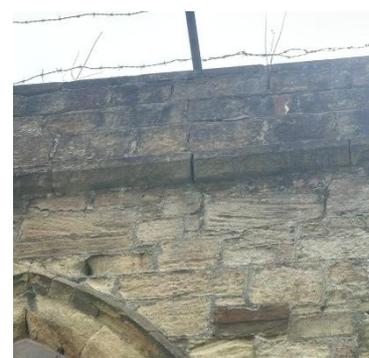
Figure 29 – N parapet open joints

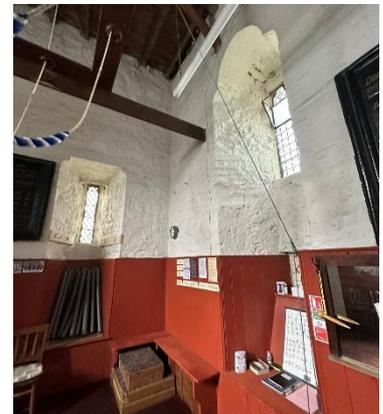
10.4.2 The upper walls are painted rubble masonry and generally in reasonable condition. However, on the south side, a hairline crack is visible above the lancet window, extending from the ceiling to the arch head. This is likely related to structural weakening caused by the deep recess formed for the window opening below.

Figure 39 - crack to lintel (10.4.3)

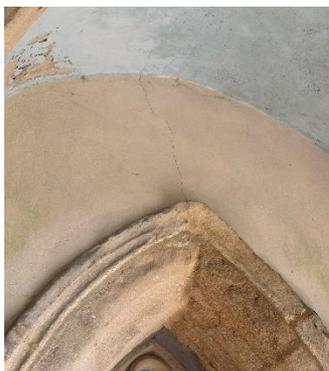
Figure 45 – crack above se

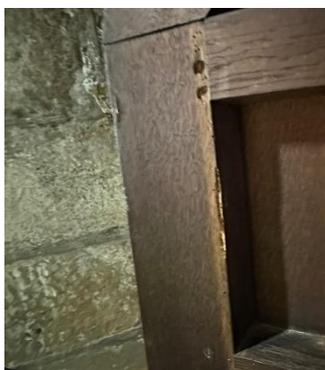
Figure 49 – door woodworm

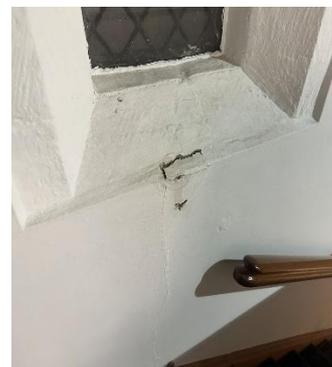
Figure 55 – N cill

18.4 The Early English style window on the north wall is covered with polycarbonate but the leadwork behind is buckled and in need of attention. The cill has damage and there is what appears to be a historic crack radiation downwards from this, not currently of concern.

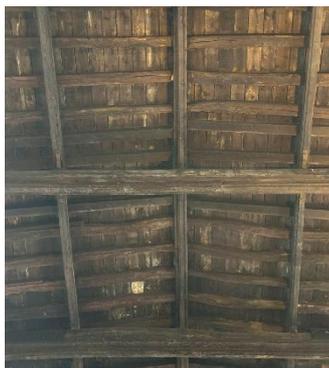
*Figure 59 – stained boards*

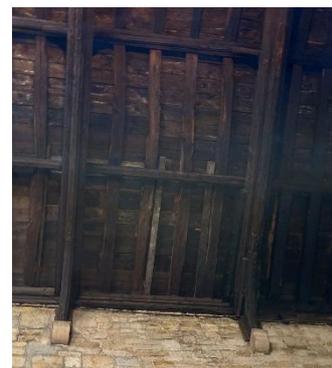
*Figure 60 – additional timbers*

20.3 Additional timbers have been introduced to reinforce the structure in the second bay from the chancel and in the third bay from the west, indicating past efforts to bolster the structure. The beams also do not sit centrally on the corbels, thought to be due to historic movement. Although the roof was inspected during previous re-covering works many years

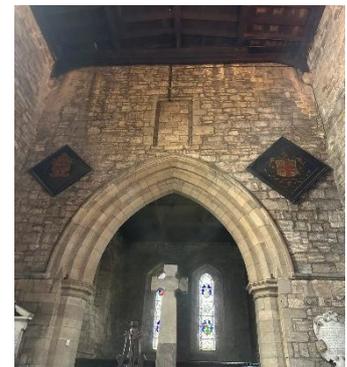
Figure 63 – W wall staining

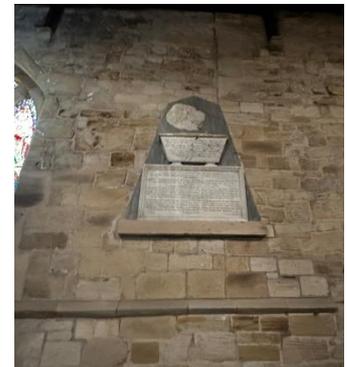
Figure 65 – W wall staining

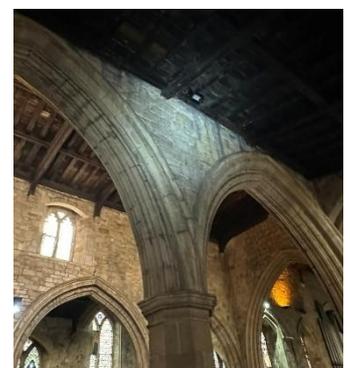
Figure 66 – arcade staining

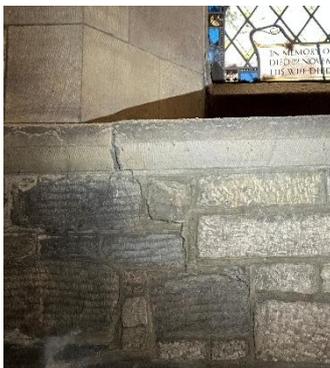
Figure 70 – West wall cill crack

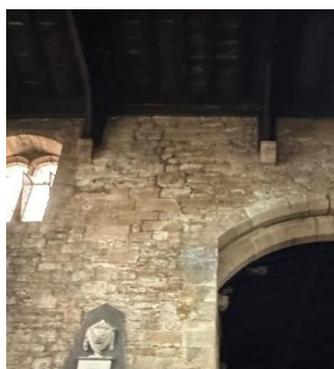
Figure 71 – W wall staining

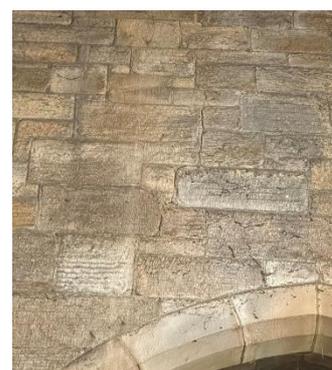
Figure 72 – crack to E wall above window

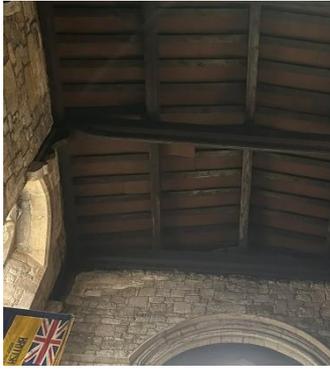
Figure 73 – ceiling board loose

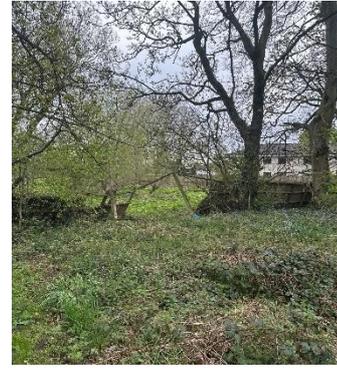
Figure 84 – fence missing S boundary
