St Peter, Bishopton

Quinquennial Report

18th January 2024

HARRISON ARCHITECTS STUDIO LTD

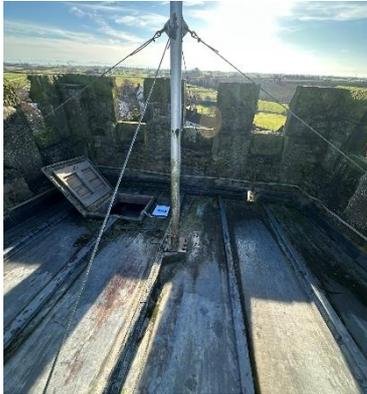
Figure 1- Tower roof

6.1.1 C19th crenellated tower with single pitch lead roof falling to a southern box gutter, outlet through the S parapet into a hopper. Hatch to the southeast corner and flagpole centrally. 6 bays of lead with rolls between each, all in single sheets apart from the area adjacent to the hatch, there is no step in level at this joint and the pitch is not steep enough to rule out water tracking back here.

6.1.2 The crenulations are generally ok, though the backings to the merlons are in brickwork with cement render, the corner nearest the hatch has a crack to the southern joint. The stonework to the back of the merlons have a few minor open joints that would benefit from re-pointing. The stability of these top stones should be checked regularly. There is a significant amount of vegetation growth at lower level, particularly above the box gutter which may suggest this area is permanently damp.

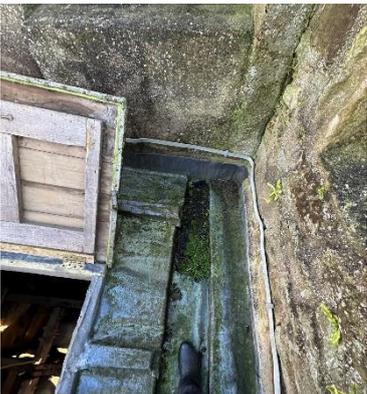
Figure 2 – hatch and E box gutter

6.1.3 The lead appears ok and there are no obvious splits or defects, however the condition to the underside of the box gutter to the east suggests there is a leak here. Dirt and moss were cleared from one area but present throughout, one step half way along the gutter doesn't appear to have an appropriate fall.

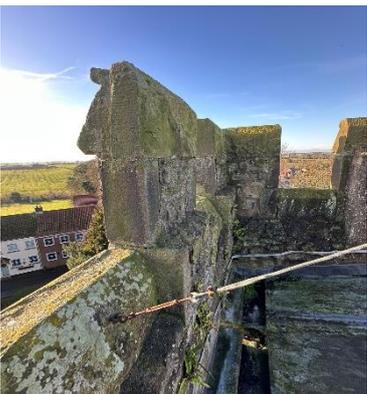
Figure 3 – cable stays

6.1.4 Glass fibre flagpole intact, the cable stays are ok but the connecting hooks are all rusted. The bolts at the base plate also look a little rusted. There is a loose rope attached to the base. The fixings into the stonework are ok but the shackle on the Northside is beginning to open up slightly, as reported in the last QI.

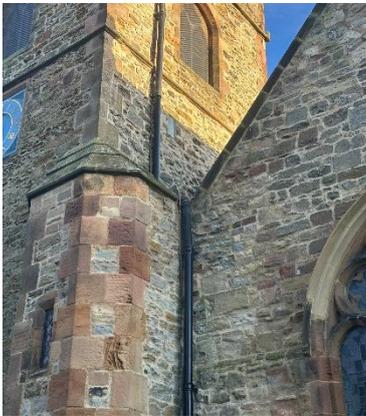
Figure 4 – Tower downpipe

7.1 **Tower** - Downpipe leading down the S side of the tower, over the west end of the nave and down between the stair tower and W gable

7.2 **Westside** – The rainwater pipe from the tower leads down to this elevation, there is a change in direction above the lead valley between the nave and the tower and a joint at the top of the downpipe, leading to a hopper. It is unknown if this is all working as it should, the condition of the west wall internally raises concern therefore further inspection should be carried out with testing in wet conditions.

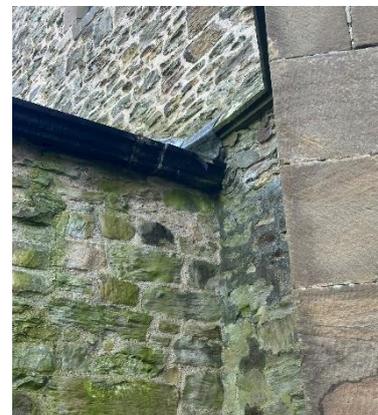
Figure 5 – W end of N aisle

7.4.3 **North Aisle:** Gutter brackets rather rusty here, downpipe looks ok but the gully appears to be silted up. Persistent green staining of the wall to the west end suggests there could be a leak here, it is a long run and therefore may not drain properly, this should be checked.

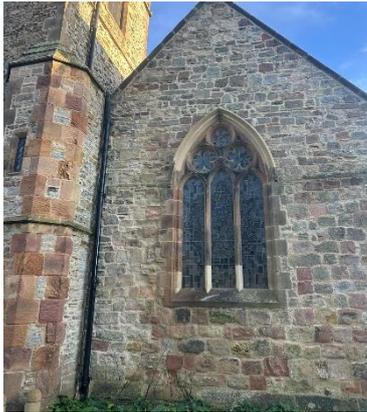
Figure 6 – W gable

8.1.1 **Westside** –The wall has been fully re-pointed with lime mortar and sections of the hoodmould replaced. Internally this wall is still damp, which does not

reflect its renewed external condition – more investigation required. There are very minor open joints at the base of the plinth course.

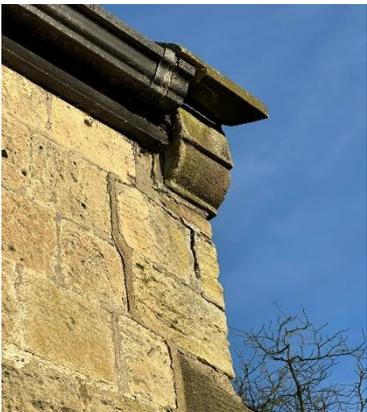
Figure 8 – SE corner of Chancel

8.2.1 **Southside** – It is a mixture of squared limestone at the Eastern most end sandstone at the other. There are areas of cement over-pointing particularly in the corner to the Nave. Buttresses are slightly cracking, worst on the South East corner, which is dropping, it is unclear if this is historic or progressive. There is pocket erosion to the sandstone cill, a mortar repair would be acceptable, rather than indent of new stone.

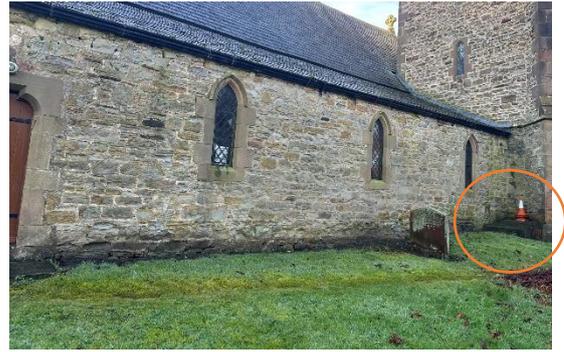
- 8.4.2 **Northside** – Near the rainwater downpipes there is significant erosion and green wall staining at either end, as per section 7, this needs to be checked. A large hole with penetrating pipework needs to be closed off. This elevation would benefit from the same full re-pointing as the west, as many holes, open joints and stone erosion prevails. Concrete at the base to the west end may encourage water inside due to its high level and no fall away, see further discussion at item 15.3.

Figure 9 – N Aisle, concrete step circled

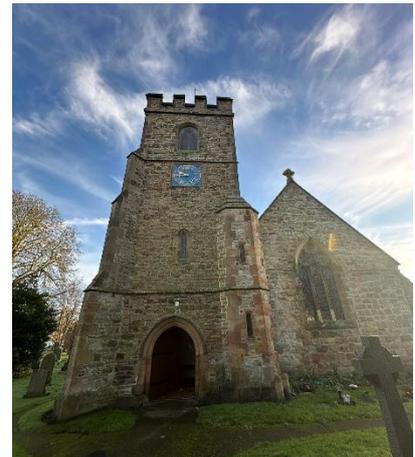
Figure 10 – West tower elevation

- 9.2.1 **West Elevation** – Slight easing of the door head has caused an open joint, no progression here, this elevation has some minor erosion, which is worst just beneath the clock and at either side of the door, though not currently cause for concern, the stone to the bottom left of the door should plan to be replaced. It appears like the top stage has been re-pointed.

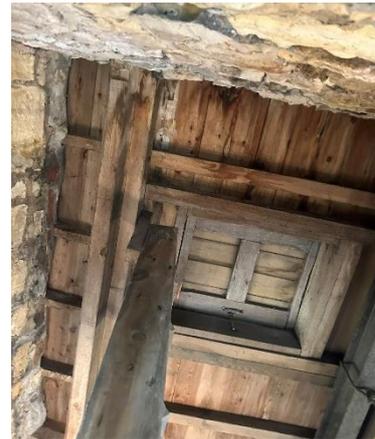
Figure 12 – Belfry ceiling

9.3.1 **Ceiling** – The ceiling (forming the deck of the lead roof above) is boards over joists, with larger perpendicular support beams below. The beam below the box gutter looks to have been strengthened in the past but still has rot to the eastern end. The ceiling boards have damp staining to both the west and east sides, though notably worse to the east with signs of rot. The lifting beam for the bells is rusting and would benefit from decoration so as not to deteriorate. The support beam for the clock weights looks ok, with slight staining. The base of the flagpole penetrates through the boarding and the bolts are rusting, these would be best replaced in stainless steel.

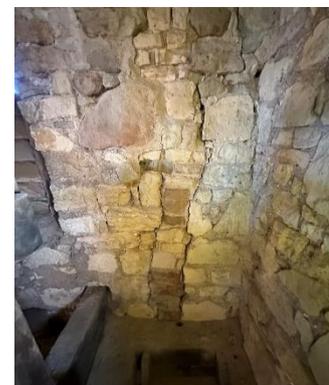
9.3.2 **Walls** – Random rubble, some open joints, particularly at high level. Cracks in the South East and to a lesser extent, South West corners as noted in the last inspection report, only the southeast was pictured, which shows little to no progression as far as I can see. A crack radiates from the top of the western lancet, not noted in the last report. These need to be pointed as soon as possible to allow any movement to be monitored. The sandstone quatrefoil belfry louvres are in very poor condition, these appear to have deteriorated since the last inspection, many louvres are dislodged. The tracery is also in need of repair, many cracks with some areas at risk of falling. There is external expanded metal mesh sheeting that looks in acceptable condition but should not be relied on to stop falling stone. The louvres and tracery need repairs urgently.

Figure 13 – Crack to E side belfry

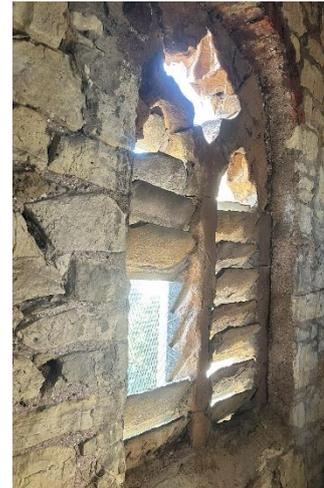
Figure 14 – Lancets to belfry

9.3.4 **General** – The timber bell frame is difficult to inspect safely, there was a report of some woodworm in the frame but it is unknown if this has been treated. The ladder access up to the Tower roof is quite dangerous, the ladder is at the wrong angle for the type, so the treads slope down, making securing oneself to open the hatch very difficult. The ladder itself has woodworm and signs of historic rot. This should therefore be completely replaced with a more suitable alternative.

11.4 The louvres to all of the high level tower lancets are in very poor condition, as well as having many cracks in the tracery, as discussed in section 9.3.2, these require immediate and urgent attention.

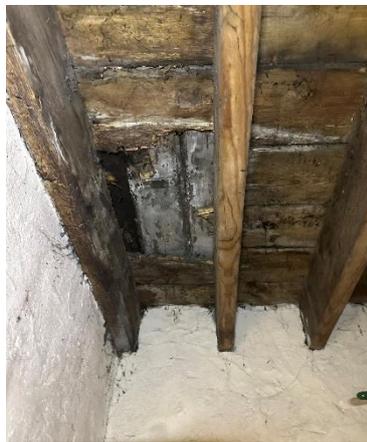
Figure 15 – Clock Chamber ceiling

9.4.1 **Ceiling** – Floorboards above with joists and perpendicular beam below. The rot in the southwest corner persists, with the loss of the floorboards here. The southernmost joist looks in poor condition. There are several other damp patches, and the beam below is also very damp to touch at the south side. Some floorboards above are missing. One floor joist cut away for the clock mechanism. Once the floor above is cleared (safely) further inspection is recommended, possibly with an experienced joiner who can assist with determining which timbers require replacement.

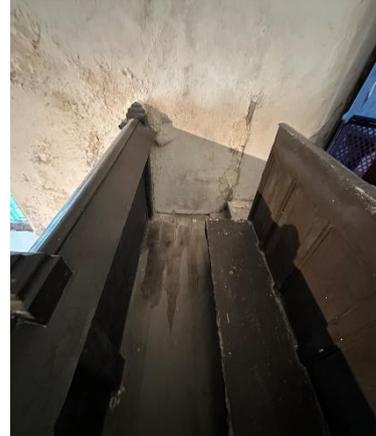
Figure 16 – Gallery floor and W wall

- 9.6.1 As per the last report, this has rot to the floor on the West side, which remains unchanged and is notably still wet. Previously thought to be associated with the poor walling conditions externally, now re-pointed. Therefore thought to be linked to the rainwater arrangement, see item 7.1 though the wall is not green externally. The area remains cordoned off and should stay this way until the water issue is resolved and the timber structure can be fully inspected and repaired as necessary.
- 9.6.2 Once the above issue is resolved the area would benefit from re-decoration.
- 9.6.3 The extension cable runs across this area and should be removed prior to allowing access.

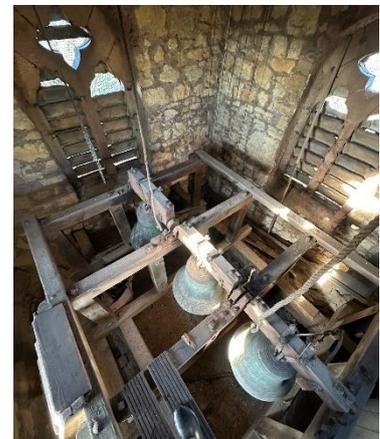
Figure 17 – bells

- 9.8 **Bells** - Three bells hung on a softwood frame by C & G Meres of London dated 1847. The bells are a treble, II and tenor. Previous QI's have reported woodworm holes to the timber frame and ladders, which does not look to have been addressed. It is unknown if the bells are rang regularly, nonetheless a maintenance scheme should be in place. The access around the headstocks and frame was restricted but there was some rust to areas, therefore it is recommended that a specialist inspection is carried out at regular intervals.

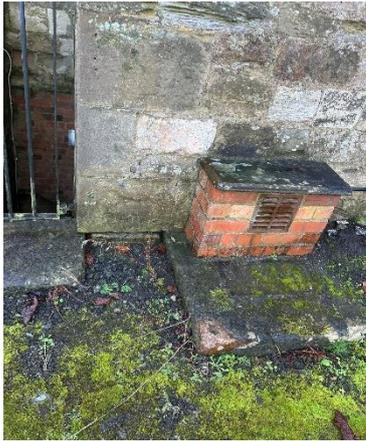
Figure 18 – Former Coal Chute

10.2 The room is relatively dry for a subterranean space, some spalling of brickwork, lime wash is coming away, particularly on the Northern side, and some open joints. There is a former coal chute which is letting more damp in (probably due to broken top as noted in section 8.3.2), part of the barrel is held up by a lintel here that is eroding and should be assessed for adequacy.

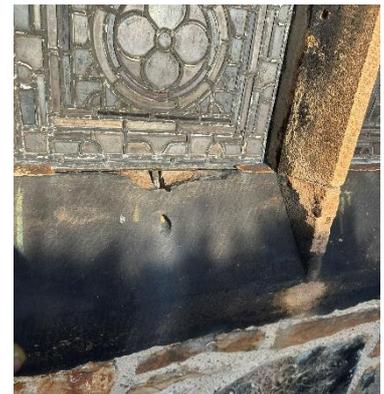
Figure 19 – South Nave W 3

- W1 – crack to the mullion on the left hand side
- W2 – erosion to mullion and tracery
- W3 – cracks at head and cill
- W4 – ok, some minor erosion
- W5 - losing its pointing and has broken glass

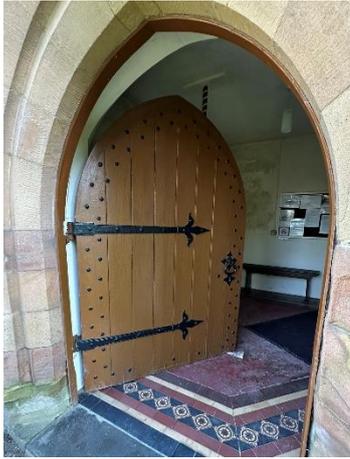
Figure 21- Main door

12.1 Main entrance door is a large timber door with decorative band and gudgeon hinges, it is studded to all sides. Average condition, the door needs re-decoration to protect the base.

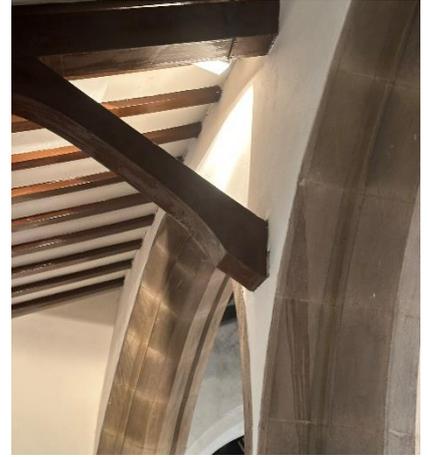
13.2 **North Aisle:** Exposed common rafters, primary rafter and purlin with a strut to the arcade. The lightweight vestry partition has settled slightly creating a gap, as noted in the last report. However there also appears to be some movement at the abutment of the strut to the arcade, this should be monitored.

Figure 23 – Strut to Arcade in N Aisle

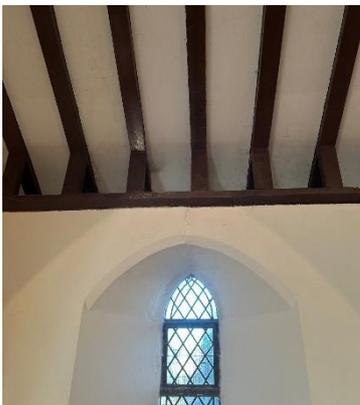
14.2 There are hairline cracks above each of the windows to the **North Aisle**. Due to the recent re-decoration scheme, these have become easier to monitor.

Figure 24- N Aisle slight easing

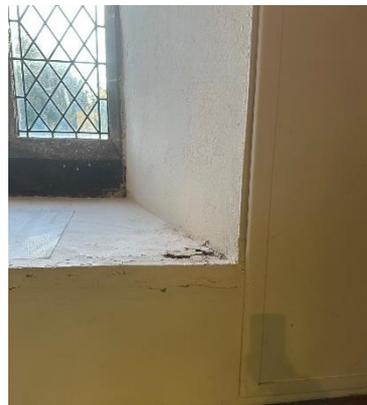
Figure 25- S window cill

14.3 To the south side of the **Nave** the western most window cill is breaking up. There is a minor hairline crack in the plaster at the centre point of this wall, another small hairline crack is visible on the westernmost double lancet from the apex up to the

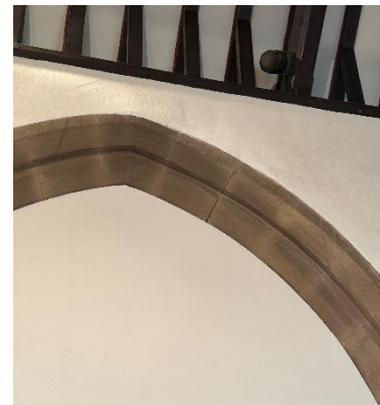
Figure 26 – Arcade open joint

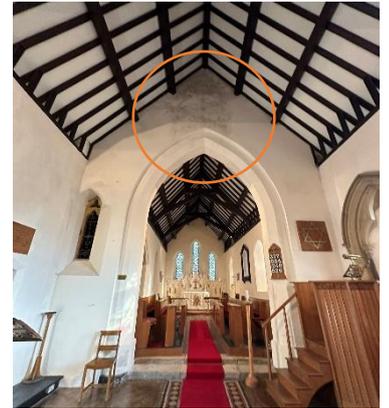
15.1 There appears to be an area of damp above the **Chancel Arch** on both the chancel and nave sides. Given the recent decoration, it would lead me to believe this is a current issue and the water table above should be checked. Slight damp to the base of the chancel arch is to be expected.

Figure 27- Damp to Chancel Arch

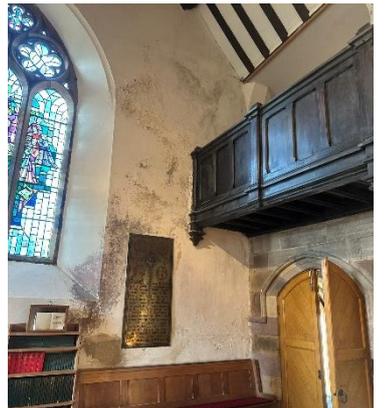
15.2.1 The west wall by the gallery floor beam remains very damp, this is thought to be linked to the downpipe from the tower overflowing wetting the wall, however there is also another distinct area of staining at high level. It may be that the high-level area was a past issue and is still drying out which has affected the recent decoration. Nonetheless this area needs further inspection either in heavy rain conditions or other replicated test conditions.

Figure 28- Damp to W gable

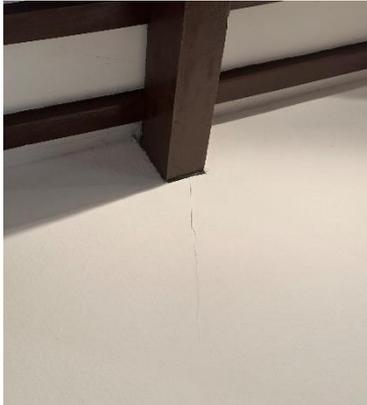
Figure 27- easing to vestry partition

16.1 Within the Choir Vestry it is cup boarded out, containing robes etc. This is formed from the North Aisle by a glazed screen into the Nave and painted partition to the north aisle, which is all in good condition. There is a hairline crack to the North Aisle side beneath the purlin, but as this is simply a partition and likely to move differentially to the other walls, not of concern.

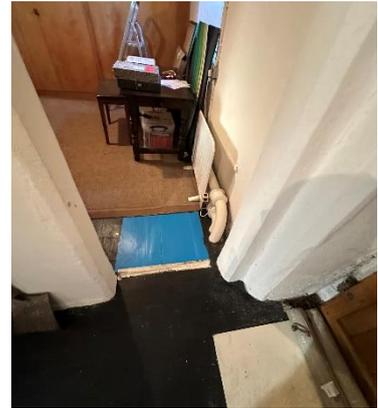
Figure 28- Vestry floor

19.3 **Vestry & Choir Vestry**: One step up from the main nave, timber boarded suspended floor painted black with a rough finish, there are various temporary boards and an area of blue protective sheet placed over uneven floor boards. The floor fall away to the North. The last report noted it required opening up to investigate, the PCC should report back if this was carried out and the findings, or undertake the recommended inspection.

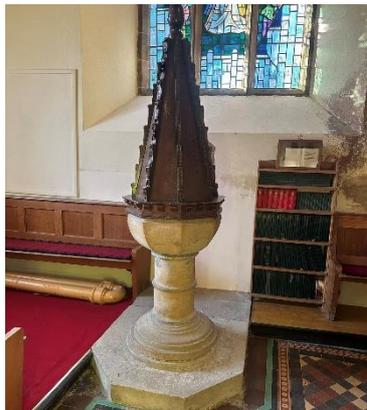
Figure 29- Font

20.1 **Font**: Stone octagonal bowl with no lining and mounted on pedestal with 17th Century timber spired & crocketed lid. In good condition except for a loose moulding to bottom edge and general wear and tear.

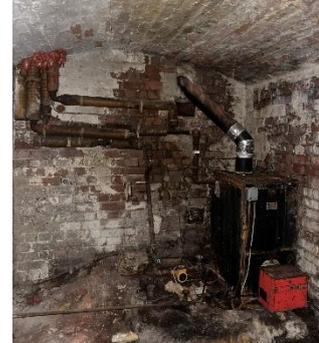
Figure 30- Boiler

21.2 It has an annual inspection but is generally only fired up only for services. No test certificate or servicing information available. The PCC noted the system was recently fixed but the engineer noted that it would be difficult to repair if it was to break again, therefore a new heating system should be planned into future expenditure.
