MAYA POLENZ ARB AABC

St Nicholas, Bishopwearmouth Quinquennial Inspection Report

April 2025

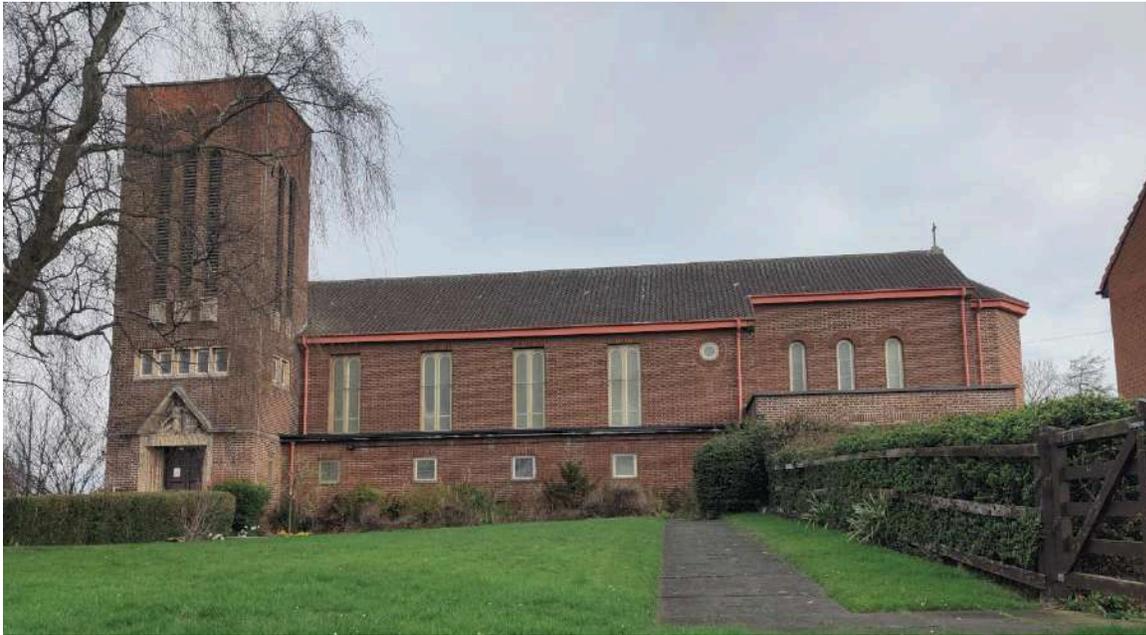
1 (top). View from S

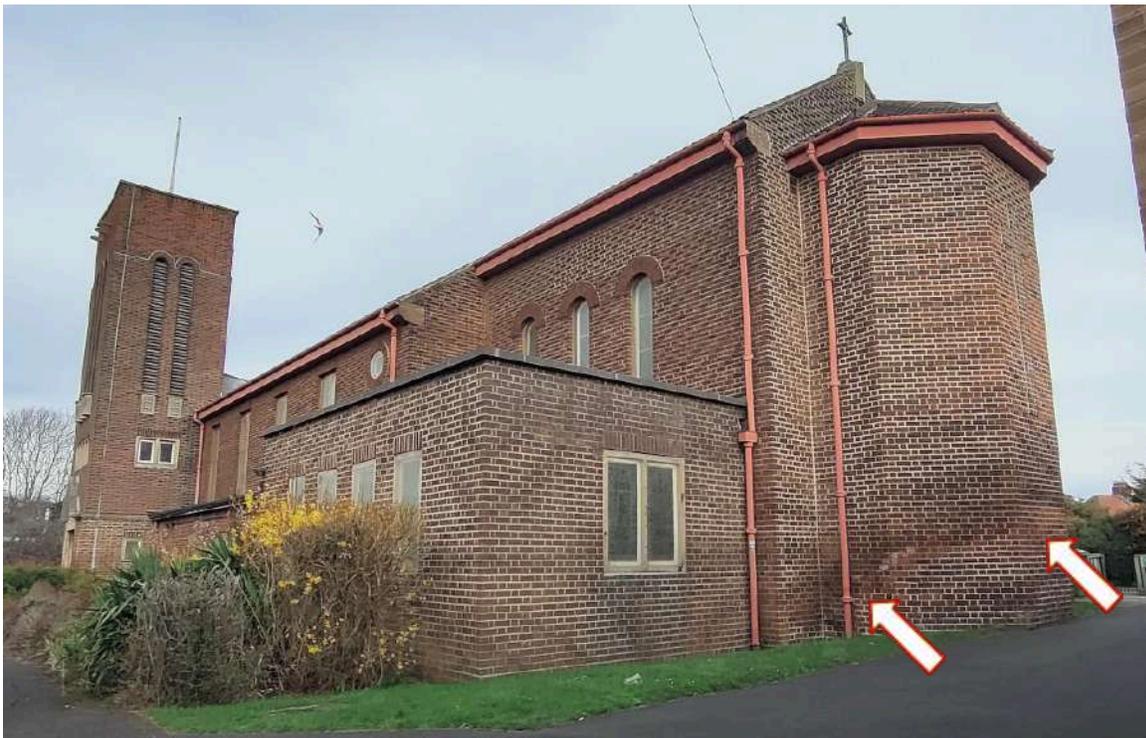
2 (bottom). View from SE. Dark areas indicate water ingress (arrows)

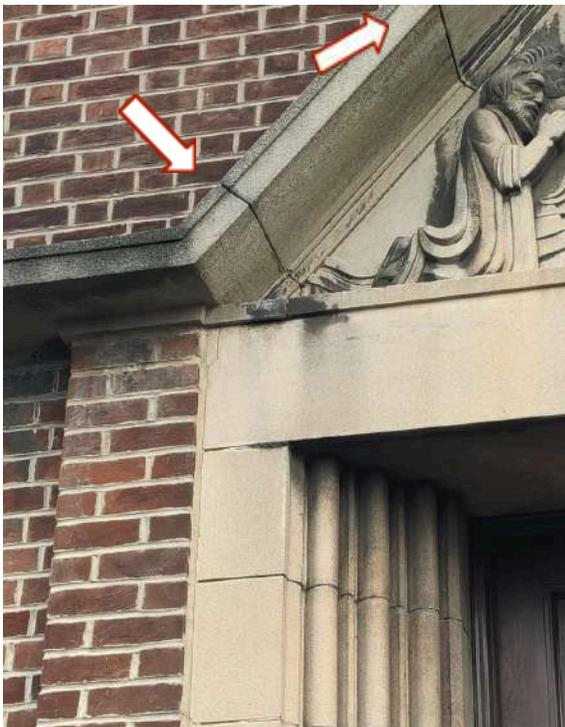
Open joints in the tympanum and string course to the south entrance need pointing. The timber louvres are in fair condition but one is missing on the west elevation, as reported in QIR 2021.

5. Open joints in Tympanum

No.	Repair required	Priority
2.1	South Entrance. Repoint all open joints to string course and tympanum to prevent further water ingress and stone decay.	B

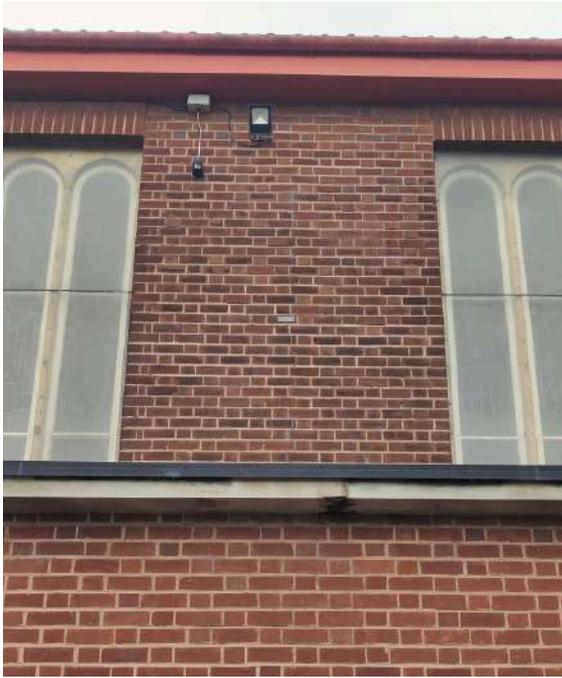
The brickwork is laid in Flemish bond, renowned for its structural durability as well as distinctive pattern and refined look. The alternating header/stretcher pattern is particularly well visible in areas of slightly recessed pointing. No DPC was visible, which is unusual for a building of its age - is it possible that the DPC has been bridged by pointing? The brickwork encases structural steelwork situated between each of the Nave windows. The structure suffered from considerable initial settlement which caused cracking in the north wall and Nave floor.

11. Condition of vertical cracking in N wall

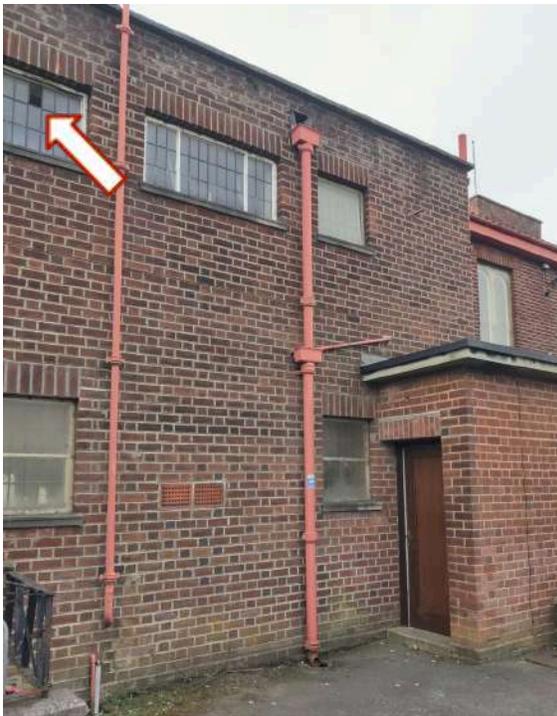
There is some rusting of the metal framed casement windows in the Tower first stage, and considerable rusting to those on both floors of the Vestry. The Vestry first floor north-facing window misses a glazing pane.

13. Vestry N wall; missing glazing pane (arrow)

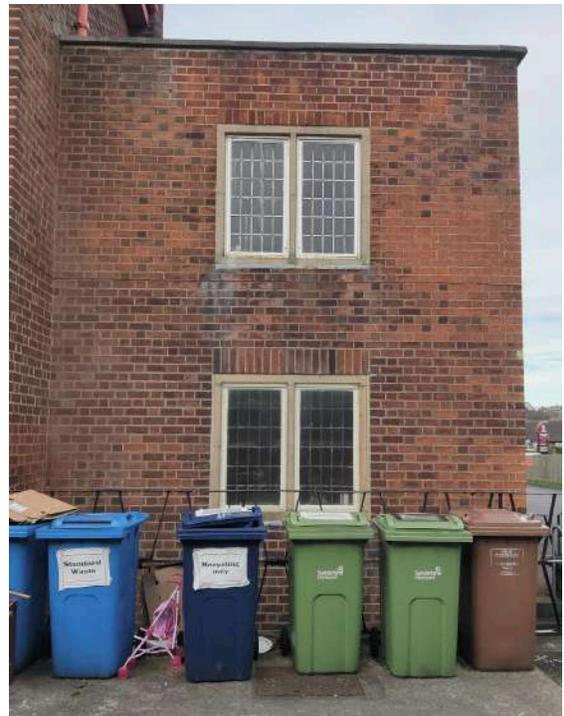
The Lady Chapel is somewhat affected by the above mentioned water run off. Its east elevation displays friable brickwork throughout, similar to the Vestry. The upper third of the brickwork is coated, according to QIR 2021 with silicone. The coating is peeling. It is unclear whether the water ingress is ongoing or whether the roof replacement addressed it fully. Eroding joints to the east wall were superficially repointed in the past and this poor workmanship is now failing. The coating and loose mortar should be removed, the wall repointed where needed and the situation monitored.

14. Vestry E wall

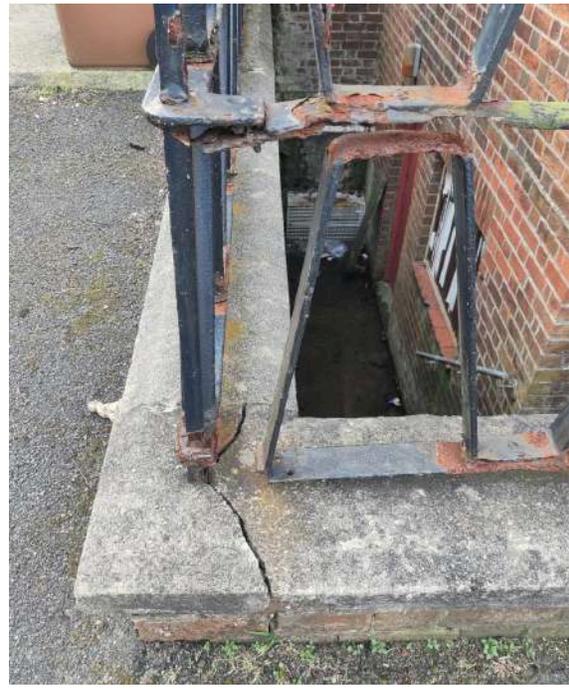
The open joints in the basement retaining wall reported in QIR 2021 have not been addressed. Its west end has also shifted, potentially some time ago. The railings are starting to disintegrate and might lose their structural integrity within the quinquennium. The copings are now severely rustjacked and broken.

16. Railing and copings in poor condition

2.4	Boiler Room retaining wall. Rake out and repoint the brickwork, re-bed copings and replace where broken beyond repair. Liaise with the local conservation officer to decide on the repair or replacement of the rusting and disintegrating railing.	C

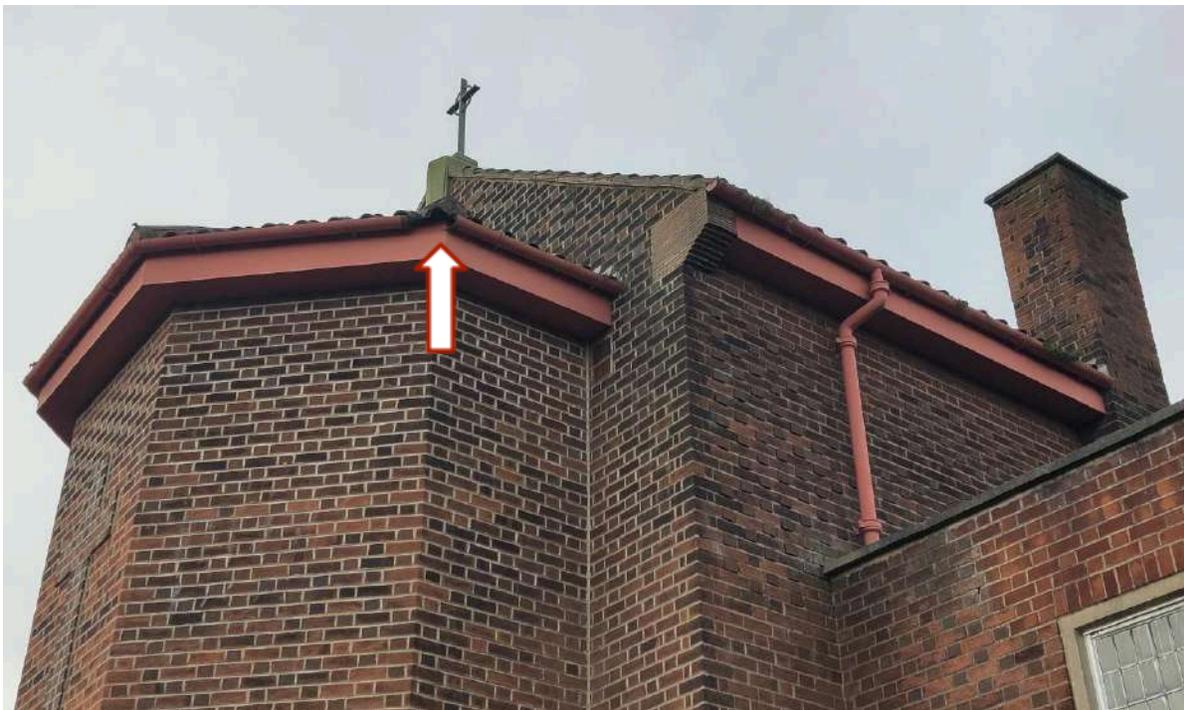
17. Missing gutter to Chancel (arrow); top of chimney needs pointing repairs

No.	Repair required	Priority
1.1	Rainwater disposal. Replace missing section of gutter to Chancel Roof. Re-align and clear the remaining gutter and downpipe to ensure swift disposal of rainwater. Ask the roofer to take photos and confirm the condition of the Chancel roof.	B

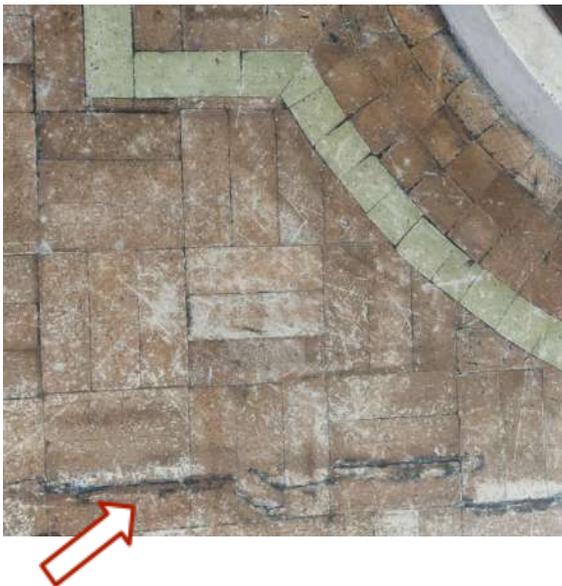
The Nave floor has several cracks running north - south, largely in line with the embedded steelwork in the walls. QIR 2021 states that these were investigated in 2016 and appear stable since. This is still the case. Small cracks in Nave walls appear no worse than stated in QIR 2021. The aisle walls show crazing and peeling of decorations to match that in South Lobby and Tower stairs. The south aisle is in particularly poor decorative condition due to water ingress prior to reroofing. The ceiling access panels in the aisles are very thin and bowing.

24. Floor in need of refinishing. Note the poorly sealed settlement crack (arrow)

4.5	Baptistry. Consider cleaning the light fitting and ceiling.	D
4.6	Nave, Baptistry & Chancel. Consider sanding and re-varnishing the floor, which should include raking out floor cracks and refilling to match floor colour. Consider full internal redecorations.	D/C+

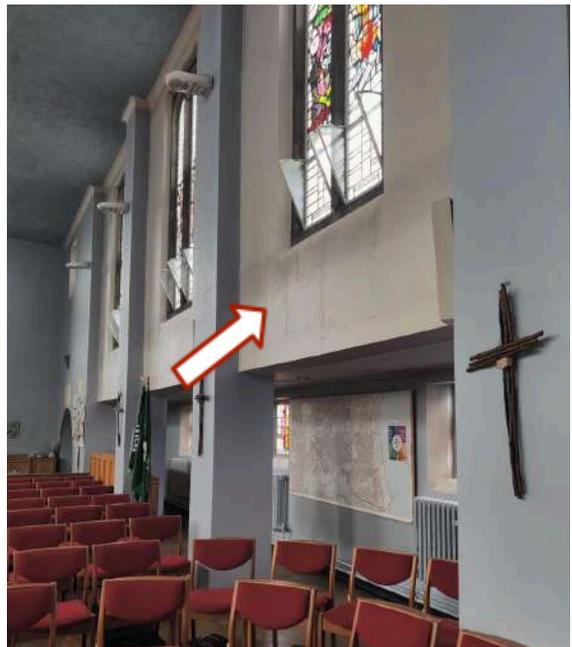
25. N Nave wall. Arrow shows plastered-over original heating outlet positions under windows

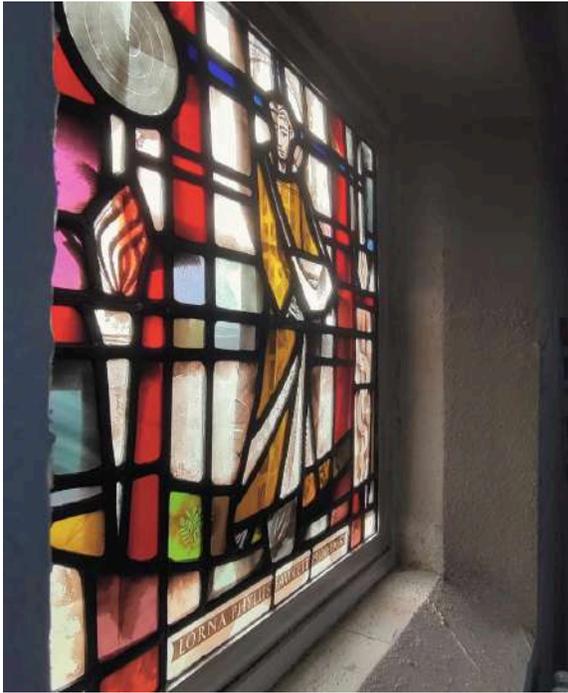
All windows are in good condition. The bowing in the Fawcett memorial window in the South Aisle remains as reported in QIR 2021. The top panel of the second-most western window in the N Nave wall is bowing slightly; this should be monitored. Smaller damages noted: one cracked and one shattered glass pane in the upper glazing of the southernmost west window; one small damaged pane in the second-most eastern window in the S Nave wall; two fine cracked bottom panes to easternmost window in N Nave wall; three of the glass hopper wings on each side of the Nave are cracked or shattered, which is more than the one mentioned in QIR 2021.

26. Bowing in the Fawcett memorial window

3.4	Monitor the condition of the following glass damages: <ul style="list-style-type: none"> - Bowing in the Fawcett memorial window in the South Aisle; - Bowing of top panel of second-most western window in N Nave wall; - 1No. cracked & 1No. shattered top pane in southernmost W window; - 1No. damaged pane in the second-most eastern window in S Nave wall; - 2No. fine cracked bottom panes to easternmost window in N Nave wall; - 3No. cracked or shattered glass hopper wings to each side of Nave. 	O

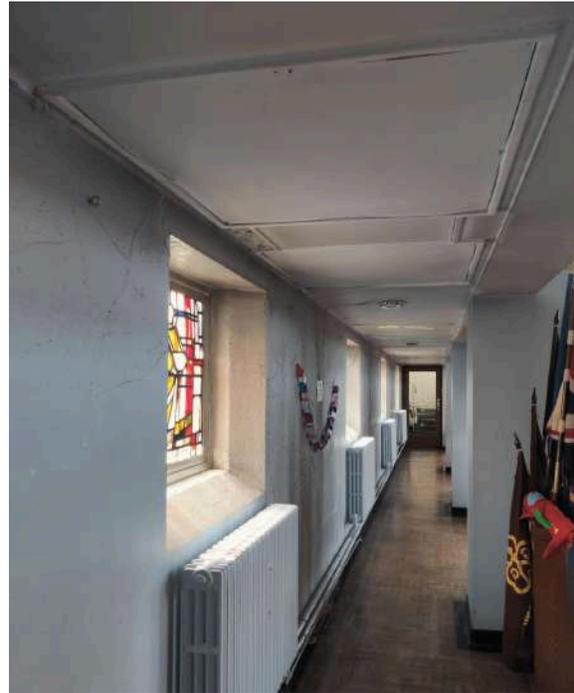
Historic cracking in Nave floors and walls appears to be stable and internal redecoration could be considered, funding permitting. The South Aisle walls are now dry following the reroofing; they should be repaired and redecorated. Water damage to Lady Chapel and Vestry need to be investigated and stopped prior to repairing the internal damage.

27. South Aisle in need of redecoration

4.2	Sacristy & Choir Vestry. The ongoing water ingress to the east elevation should be investigated, starting at roof level.	B
4.3	South Aisle. Repair and redecorate water-damaged wall plaster.	C

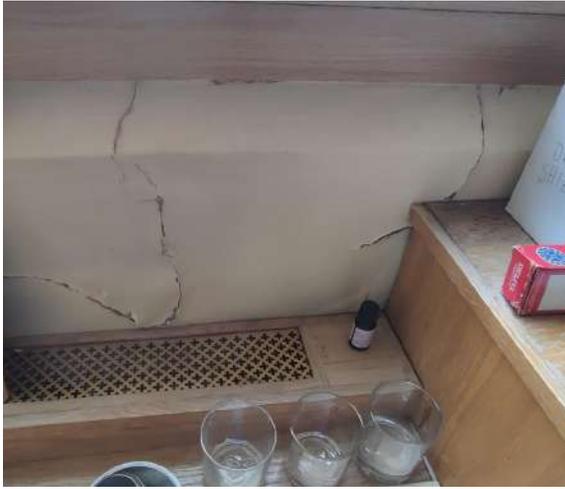
Two stories. East-facing Sacristy with adjacent toilet on the ground floor. Flat plastered ceiling and walls, floor with carpet tiles. All doors timber-grained. Built-in wardrobe towards organ. Evidence of blistering paint to external walls and reports of water ingress through east window lintel, although no external defects visible. Carpet tiles stained and loose in toilet. The latter in fair condition but would benefit from redecoration and removal of redundant services.

34. Blistering plaster in Sacristy

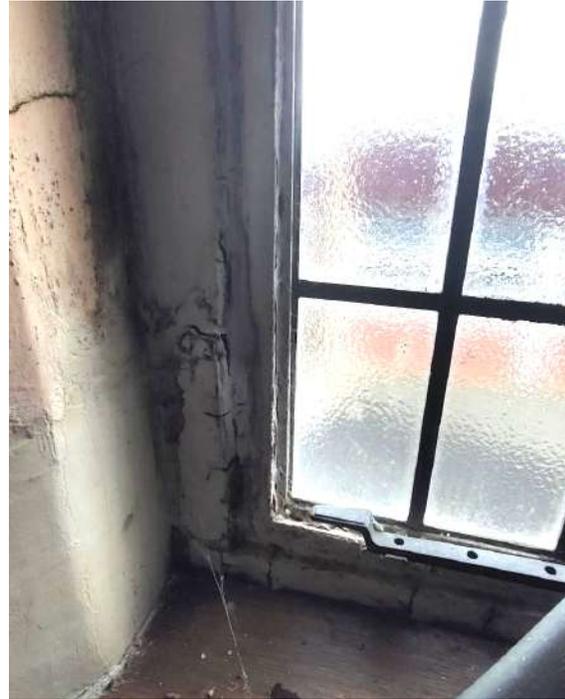
Stairs to first floor lead to east-facing choir vestry, upper organ room and a west-facing toilet. Choir Vestry: Flaking paint and cracks in the wall plaster and ceiling as QIR 2021. Metal window casements rusting severely. Original oak built-in furniture in need of resaturation. Room no longer in regular use. Paint in toilet peeling but underlying plaster appears sound.

39. Details of rusted window frame
