Diocese of Durham
Quinquennial Inspection Report 2025
St John the Evangelist Church
Brandon

Inspection of Churches Measure 1955

Inspected 23rd April 2025

Leanne Pratt BA (Hons), MArch, RIBA Advanced Dip PPA

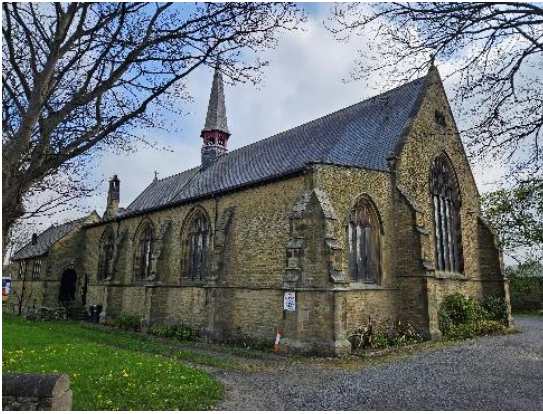
5.1 **Nave and Chancel:** Steep pitched, slate roofs on the north and south sides. The previous quinquennial inspection suggested that the blue Welsh slates could be the originals and if this is the case they appear in remarkable condition. photo

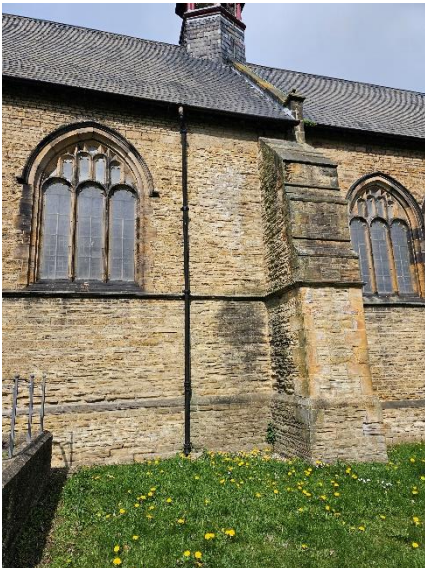
- 6.2 The performance of the rainwater goods could not be assessed on the day of inspection as it was dry, however the staining and salting of the stone walling adjacent to the downpipe at the Nave/Chancel intersection might suggest the gutter, downpipe and/or gulley is defective. The previous 2020 quinquennial reported of potential defects here, so the water damage may be historic and drying out. photo

Firstly 6.12 - 6.14 should be actioned to ensure the routes are clear, then the rainwater goods should be observed in wet weather to see if any defect is obvious. The findings should be reported to the Church Architect for further discussion/advice. 2

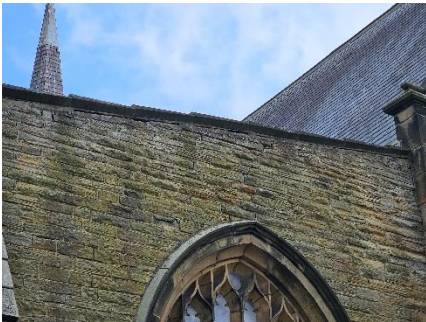
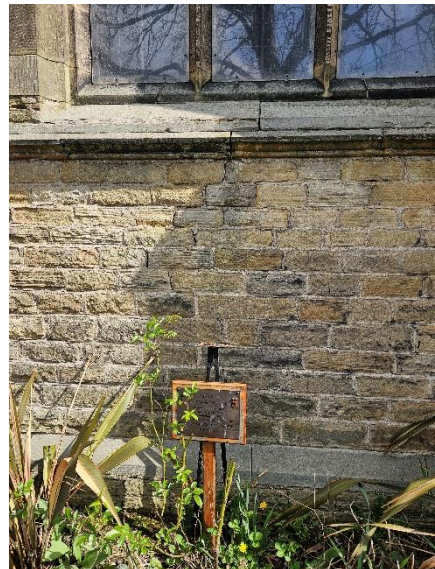
- 7.10 The previous quinquennial reported of external cracking to the west end of the north Aisle, "running from the plinth to the top of the lancet arch". This was particularly evident and a concern, as the plaster internally, to the top of the lancet arch, is bulging off. Father Carl did not think he had noticed this before and therefore it could be a sign of new movement and/or a more significant defect. photo

Firstly 5.12 should be actioned to see if any external defect in the roof/roof structure is obvious. The findings should be reported to the Church Architect for further discussion/advice. Secondly, the verge should be repointed as much of the mortar is missing and water ingress is a likely cause. Repointing should be with NHL lime:sand mortar. 2

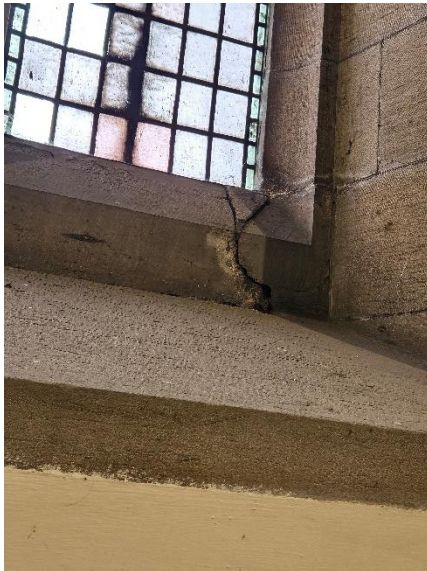
9.3 There is a significant crack to the cill piece at the right hand side corner. This does not seem to have been mentioned in the previous quinquennial report. Monitor closely over the next few months/quinquennial period.

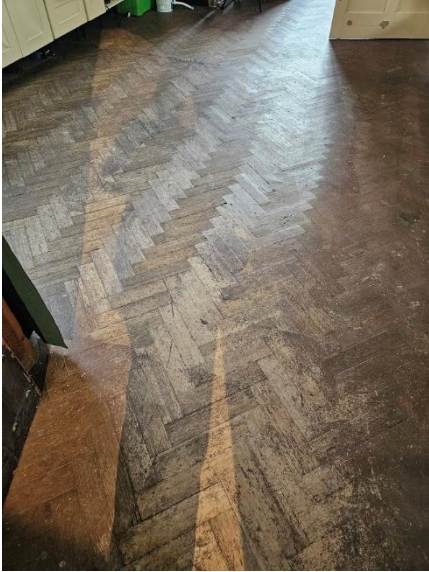
12.6 **Choir Vestry:** Timber parquet floor. Beautiful original floor but its photo
looking worn.

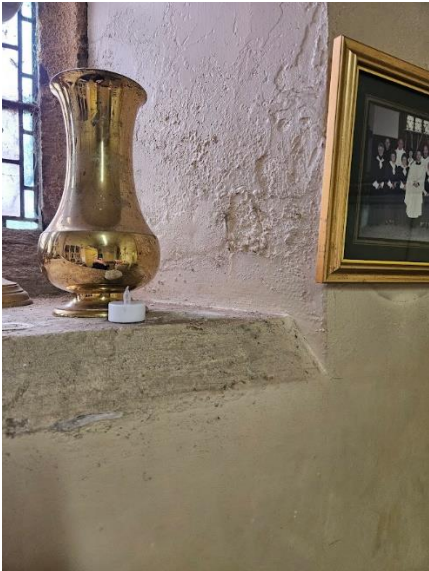
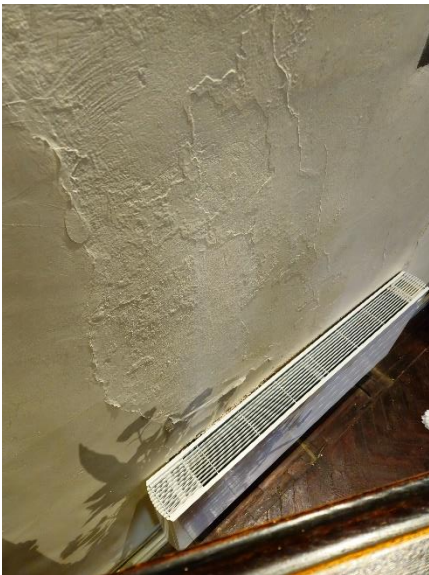
13.2

The condition of the wall finish in the main body of the Church is good. photo
There is some minor plaster cracking/missing
plaster/staining/salting/blistering, but generally not over and above
what is the norm for plastered Church interiors. The good wall
condition is likely due to the Church being heated and well used.

These areas have been referenced elsewhere in the report, and in most photo
cases the poor wall finish is likely to be the consequence of the various
'damp' issues discussed. There is little point in repairing/redecorating
the wall finishes until it can be ascertained that the problem has ceased
in the various locations and then there needs to be a period of drying
out.

The eaves level of the east end of the north Aisle, where it abuts the 3
Vestry, should be monitored closely over the quinquennial period. The
deterioration of the wall finish here does not seem to be mentioned in
the previous report and could suggest there is a high level water ingress

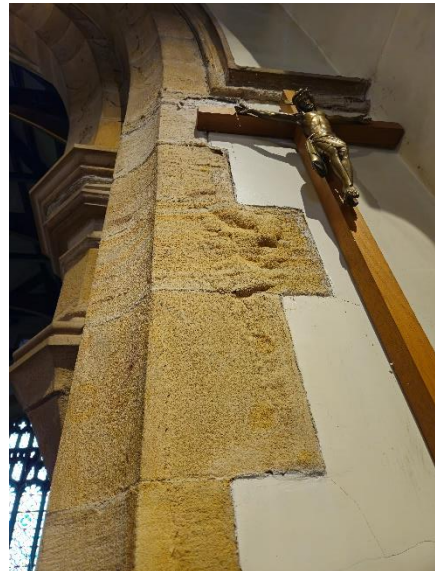
- 13.3 Chancel Arch: significant deterioration of the wall finish and dressed stone to the south side. Action as discussed in 6.0 and verify in the roof inspection that all leadwork in that area of the roof is properly fitted and water tight. Monitor condition over the next quinquennial period. photo 3

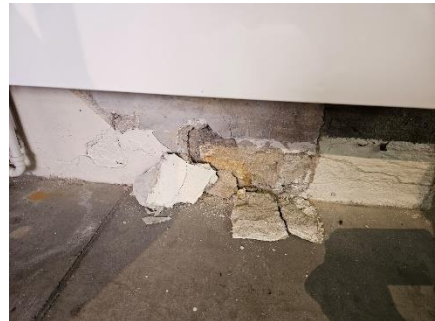
- 13.4 Organ Arch: the previous quinquennial reported cracking, but this had not changed. Monitor over the next quinquennial period. 3

There is an area of plaster, between the organ Arch and the clergy Vestry door, beneath the radiator, that has blown off. There is obviously some excess rising moisture in this area. Hack of the loose plaster and allow the walling to dry out over the next quinquennial period. photo 2
