## QUINQUENNIAL REPORT

*For the Parish Church of*  
Church of the Holy Spirit, Crawcrook

***Report Date: 14<sup>th</sup> July 2026***

Inspecting Architect:  
Becky Smith BA(Hons), MArch, ARB, RIBA

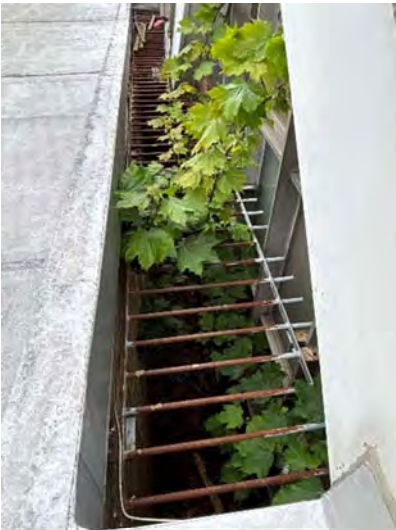
| Image & Location | Description | Condition | Repair Needs | Category |
|---|---|---|---|---|
| <p><u>Light well Void between Church &amp; Hall</u></p> | <p>Full height voids forming light wells between the main church and the later single ply flat roof extension building. The opening has protective steel safety grilles at flat roof level spanning the voids to prevent falls whilst maintaining light penetration.</p> | <p>There are significant mature self seeded saplings and invasive weeds growing aggressively from within the light well voids. There are no photos included within the previous QI (undertaken by others) to ascertain whether this vegetation was growing at the time of the previous QI. The expanding root system and moisture retaining vegetation present a risk to the building fabric and structure.</p> | <p>Remove protective safety grilles to access the light well voids to clear out all vegetation, ensuring roots are completely eradicated. (Alternatively could access be obtained via the window)</p> | 2 |
| | | <p>There appears to be significant quantities of debris (leaves etc) within the void. There are several pieces of timber on top of the grilles and within the void which have likely been left from previous repair works.</p> | <p>Ensure all soil, leaves and debris are cleared from the base of the light well voids. Once area is completely clear a close inspection of the condition of the building fabric to this area should be undertaken.</p> | 2 then M. |
| | | <p>The protective steel safety grilles are showing signs of significant rust and corrosion of the protective coating.</p> | <p>Brush back corroded steel grilles and treat with rust-inhibiting primer and apply durable topcoat.</p> | 3 |

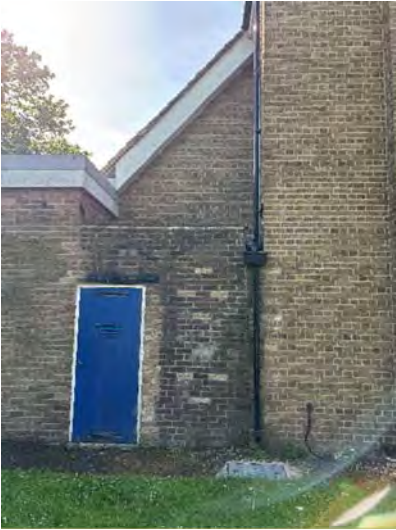
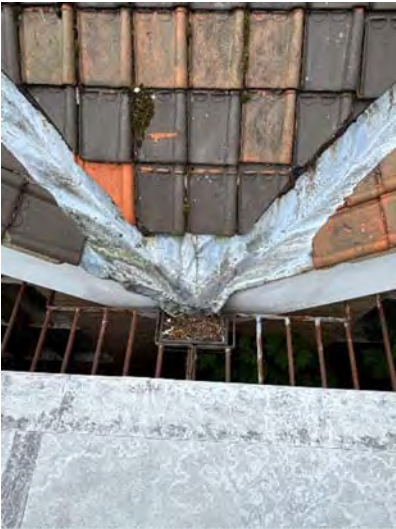
| Image & Location | Description | Condition | Repair Needs | Category |
|---|---|---|---|---|
| <u>Rainwater Goods and Drainage</u><br><br><br><br> | Church:<br>Cast iron gutters, downpipes and hoppers. | Due to the dry conditions on the day of inspection it is unknown whether there are any leaks in the gutters.<br><br>Evidence of flaking paint and surface rust across the downpipe sections, particularly noticeable at low level. This is applicable to most downpipes to the church. | Remove all loose, flaking paint and rust. Apply rust inhibiting primer and repaint with exterior grade paint. | 3 |
| | Hall Block:<br>U-PVC gutters and downpipes. | East Elevation:<br>The eaves gutters visible on the east elevation (hall) at the time of the survey are significantly blocked with organic debris. This accumulation is exacerbated by overhanging branches from trees in the adjacent park leading to heavy leaf fall. During this inspection, active wildlife nesting was observed, with birds actively clearing and retrieving debris from the gutter channels for nesting materials. The previous QI report (undertaken by others) highlighted that the gutters and downpipes were undersized for the roof area and are resulting in overspill. | Clear all vegetation and debris from the gutters. Ensure gullies are clear of debris. | 1/M |
| | | North Elevation:<br>The downpipe terminates abruptly at ground level with no drainage outlet, gully or connection to the surface water system. Discharge pours directly onto the ground which causes a water ponding hazard against the buildings footing. | Monitor issues with overspill and consider replacement for larger sized gutters and downpipes. | 5 |

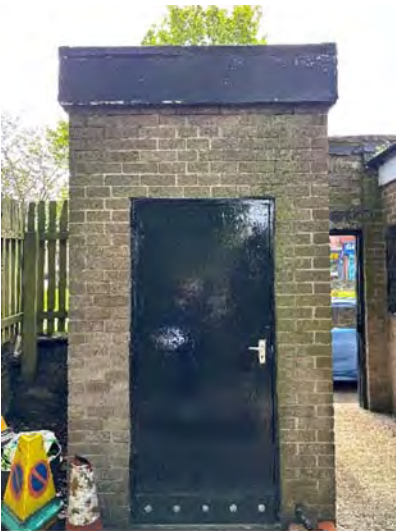
| Image & Location | Description | Condition | Repair Needs | Category |
|---|---|---|---|---|
| <u>External Store:</u><br> | Brick built with mineral felt roof. | Brickwork:<br>There is some missing pointing and open joints to the upper courses of brickwork below the fascia. Some green staining across the face. | Rake out loose and failing mortar joints and repoint with a lime based mortar mix to prevent future water ingress. | 4 |
| | | Roof Fascia:<br>Timber is showing signs of weathering with localised areas of flaking paint across the fascia and bottom edge. | Inspect fascia and scrape back failing coatings, cut out sections of rotten timber, piece in new treated softwood where necessary and recoat to match existing. | 3 |
| | | Immediate Context:<br>There has been localised collapse of the stone retaining wall section adjacent to the store. Loose, displaced stones and exposed soil is clearly visible. Currently blocked off with warning cones. | Investigate area to identify cause and identify repair need and carry out repairs. | 2 |

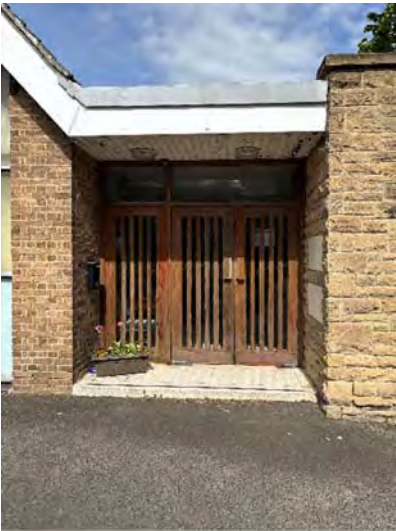
| Image & Location | Description | Condition | Repair Needs | Category |
|---|---|---|---|---|
| <p><u>Doors</u></p> | <p>Entrance Doors (South Elevation): Hardwood doors with glazed panels.</p> | <p>Overview:<br/>There are 3 doors which provide access/escape from the church. There is currently a lack of level access entrance to the building which means the building does not currently meet accessibility standards under the Equality Act 2010 or Building Regulations Part M.</p> | <p>Until a permanent solution is sought review the management of the temporary ramp. Ensure it is clearly signposted, regularly inspected for slip resistance and that a formal management plan is in place for staff to deploy it safely and quickly if necessary.</p> | M |
| | | <p>There is one temporary ramp located within the storage area which appears to be for the entrance (however this could not be confirmed on the day of inspection). However, relying on temporary ramps presents a barrier to independent access for wheelchair users and those with limited mobility as the main entrance is directly off a vehicle access route any temporary ramp is unlikely to be able to be left out when required while anyone in a wheelchair is in the building.</p> | <p>Consider a long term solution to have at least one permanent, compliant, gently sloping ramp installed. The preparation of plans would be required for a permanent access solution and would be required to be submitted for DAC Consent. This should be considered within the programme of works the church are intending to undertake to the entrance elevation.</p> | 5 (ideally 3) |
| | | <p>Doors appear ok. The surface coating to the doors is failing.</p> | <p>Strip doors, sand frame and apply exterior wood stain.</p> | 4 |

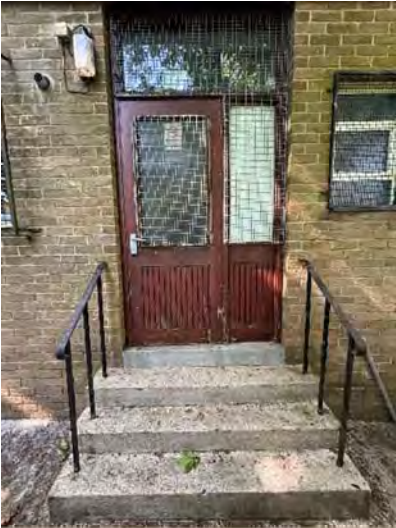
| Image & Location | Description | Condition | Repair Needs | Category |
|---|---|---|---|---|
| | Door leading from Kitchen / WC's<br>(East Elevation)<br>Hardwood Door with Side Panel and Glazed Panels to door and side panel. | Deterioration and flaking paint is evident to the doors. | Strip all loose, flaking finishes down to a sound, clean timber substrate. Any areas of localised rot should be cut out and repaired with timber splice repairs. Apply new wood stain. | 3 |
| | | The surface mounted security grilles are rusting which is causing staining to the timber. | Remove security wire mesh, treat rust and repaint with rust-inhibiting metal paint and re-fix using non-ferrous fixings. | 3 |

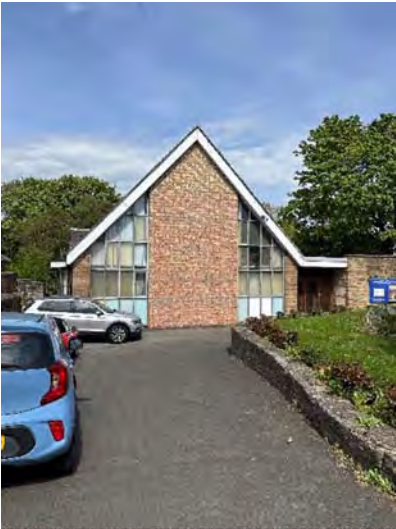
| Image & Location | Description | Condition | Repair Needs | Category |
|---|---|---|---|---|
| <u>Windows - South Elevation:</u><br> | Anodized aluminium curtain walling with single glazing in mixture of opaque and clear glass. | The large multi-light aluminium window is generally tired and weathered. The metal framing displays widespread dulling, loss of paint finish and surface wear. These windows are entirely single-glazed which creates a large area of high heat loss and poor acoustic insulation from external traffic noise. The lack of thermal performance across the large surface area acts as a major energy drain. | These windows form part of a package of works the church are intending to undertake to re-clad the central brickwork and replace the windows. Therefore as part of this package significant improvements to thermal efficiency values should be sought. | 2 |

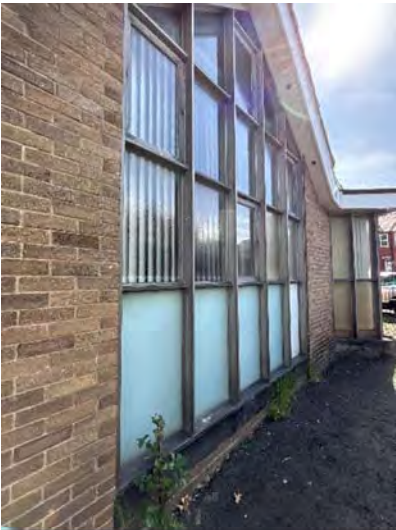
| Image & Location | Description | Condition | Repair Needs | Category |
|---|---|---|---|---|
| <u>Windows – West Elevation:</u><br> | Anodized aluminium curtain walling with single glazing in mixture of opaque and clear glass.<br><br>WW1<br>WW2<br>WW3<br>WW4<br>WW5<br>WW6 | To windows WW1, WW2, WW3, WW4, WW5, WW6:<br>The large multi-light aluminium window is generally tired and weathered. The metal framing displays widespread dulling, loss of paint finish and surface wear. Additionally, these window as many others within the nave are entirely single-glazed. This creates a large area of high heat loss and poor acoustic insulation from external traffic noise.<br><br>Large gap / loss of seal to right side of window<br><br>Cracked pane of glass. | Maintenance:<br>Carefully clean back metal frames and apply metal primer followed by high durability weather resistant external paint system. Rake out and replace perimeter mastic joints where necessary.<br><br>Replacement:<br>Consider future replacement which provide high-performing double/triple glazing. Solar-control glass would additionally assist with excessive overheating during summer months.<br><br>Replace cracked pane of glass. | 3<br><br><br><br><br><br><br>5<br><br><br><br>2 |

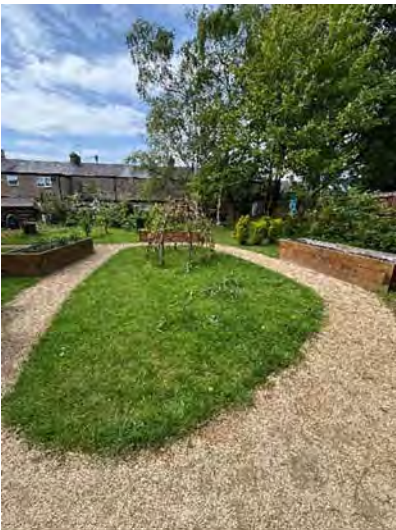
| Image & Location | Description | Condition | Repair Needs | Category |
|---|---|---|---|---|
| <u>Rear Churchyard / Garden</u><br> | Paved, gravel and grass areas. | <p>Main rear garden area is well cared for and utilised with planting beds / bench areas.</p> <p>Some mature trees in close proximity to boundary having an impact on boundary walls as covered in boundaries section.</p> <p>Some overgrown vegetation to rear of garden.</p> <p>Paved areas surrounding edge of church has significant moss / weed / vegetation growth which can create slippery surfaces.</p> | <p>See boundary walls section.</p> <p>Cut back vegetation.</p> <p>Remove moss / weeds and vegetation to pavement and clean paved areas if required.</p> | <p>M</p> <p>M</p> |

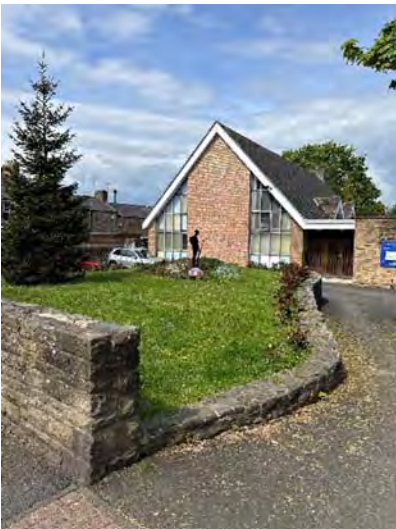
| Image & Location | Description | Condition | Repair Needs | Category |
|---|---|---|---|---|
| <u>Front Churchyard / Entrance</u><br> | <p>Sloped tarmac entrance towards church. Two access points creating a natural one way system for car access.</p> <p>Grass area to front with stone boundary walls and some mature trees.</p> <p>Grass area connects to park, shared ownership with Gateshead Council.</p> | <p>Stone Wall to Public Pavement Boundary: The top course of stones have missing and displaced stones which exposes the interior rubble core of the wall. The exposed void has become an area of collecting litter. The sharp edges and loose stones represent a hazard to pedestrians using the public path.</p> <p>Tarmac Road: Showing signs of age and wear with some pot holes and cracking forming with the surfaces becoming uneven.</p> <p>Stone Retaining Walls: Signs of mortar loss and open joints visible to all front churchyard walls with weed growth and vegetation growth visible. Central stone wall showing displacement of coping stones and upper course failure.</p> | <p>Clear out loose debris and litter. Re-bed sound existing stone using a matching traditional lime mortar. Fix new matching stone cappings to seal wall head.</p> <p>Patch localised potholes.</p> <p>Develop a programme of repair starting with the most urgent areas. Rake out loose, decayed mortar and repoint open joints using a lime mortar mix. Monitor walls annually for any signs of bulging or tree root induced displacement.</p> | <p>1-2</p> <p>2-3</p> <p>3-4</p> |

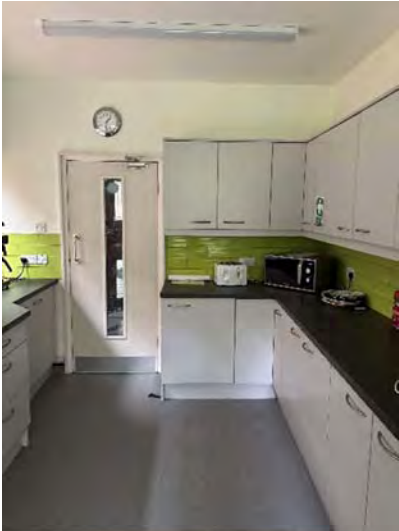
| Image & Location | Description | Condition | Repair Needs | Category |
|---|---|---|---|---|
| <u>Kitchen</u><br> | <p>Floor:<br/>Non-slip vinyl floor finish.</p> <p>Walls:<br/>Plaster painted walls with tiled splashback.</p> <p>Ceiling:<br/>Plaster painted ceiling.</p> <p>Facilities:<br/>Wall &amp; Base units, sink, drainage, separate inset hand wash, roller shutter to servery. Gas cooker and oven.</p> | <p>Generally well presented and modern.</p> <p>Crack to tile next to door / kitchen hatch.</p> <p>Internal Doors:<br/>Crack to vision panel in fire door between kitchen and access to hall an ad-hoc repair using a timber member across the face of the glazing. This could compromise the integrity of the fire compartmentation and is a health and safety issue.</p> <p>The door stop should be removed. Fire door must be kept shut at all times.</p> <p>The door leafs are showing some cosmetic wear and tear.</p> | <p>Replace with matching tile. Monitor and replace sooner if it becomes loose and a hazard.</p> <p>The entire vision panel requires replacement with certified fire-rated safety glass and intumescent bedding materials by a suitably accredited contractor.</p> <p>To be addressed during next period of decoration.</p> | <p>4</p> <p>1</p> <p>5</p> |

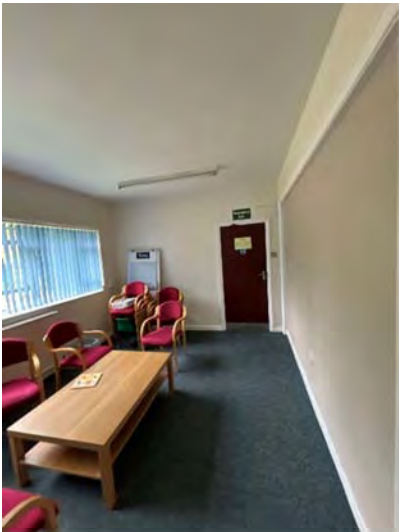
| Image & Location | Description | Condition | Repair Needs | Category |
|---|---|---|---|---|
| <u>Meeting Room</u><br> | <p>Floor:<br/>Carpeted.</p> <p>Walls:<br/>Plaster painted.</p> <p>Ceiling:<br/>Plaster painted.</p> | <p>Generally in satisfactory condition.</p> <p>Some minor blistering to cupboard doors.</p> <p>Internal Windows:<br/>Generally ok. One glazed panel yellow in colour – possible later replacement.</p> | <p>To be addressed in next period of decoration.</p> | <p>5</p> |

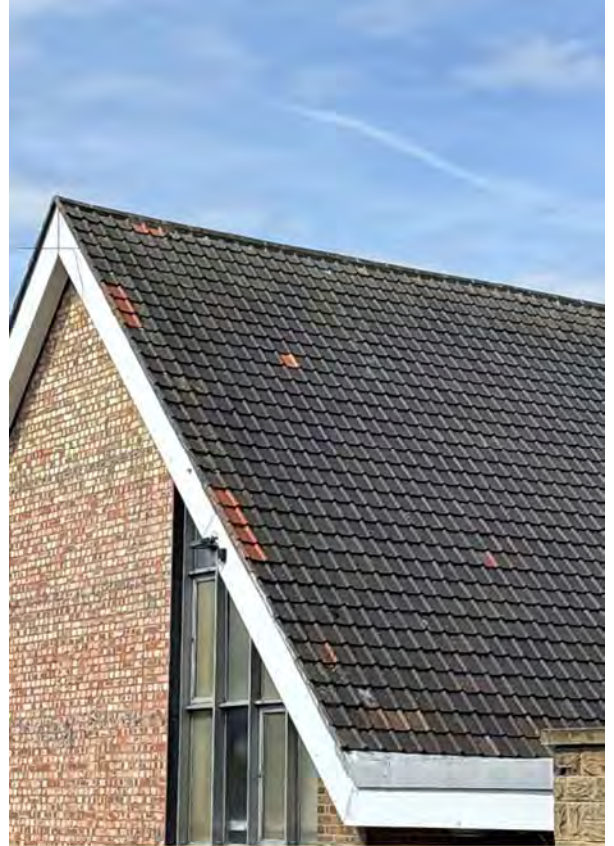
Evidence of replacement non matching slates.

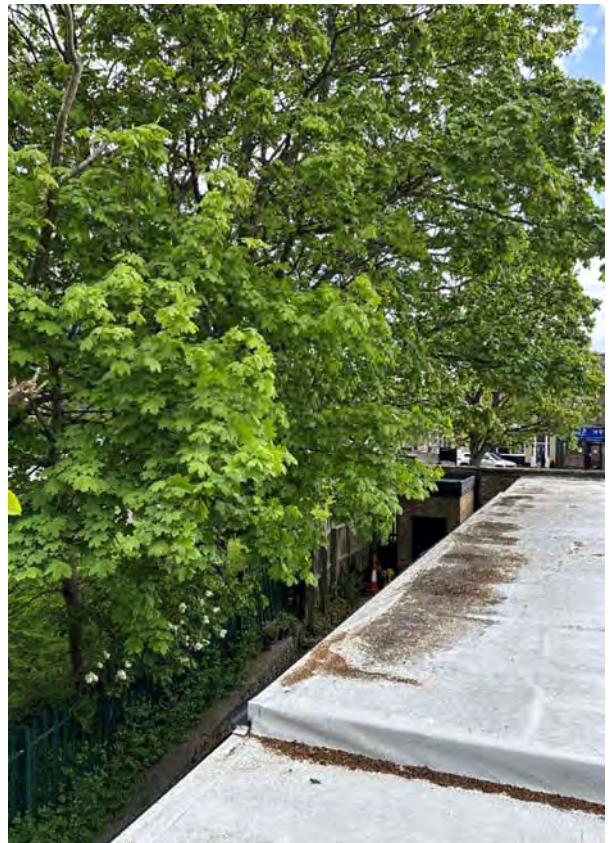
Debris and Staining to Roof from Overhanging Trees

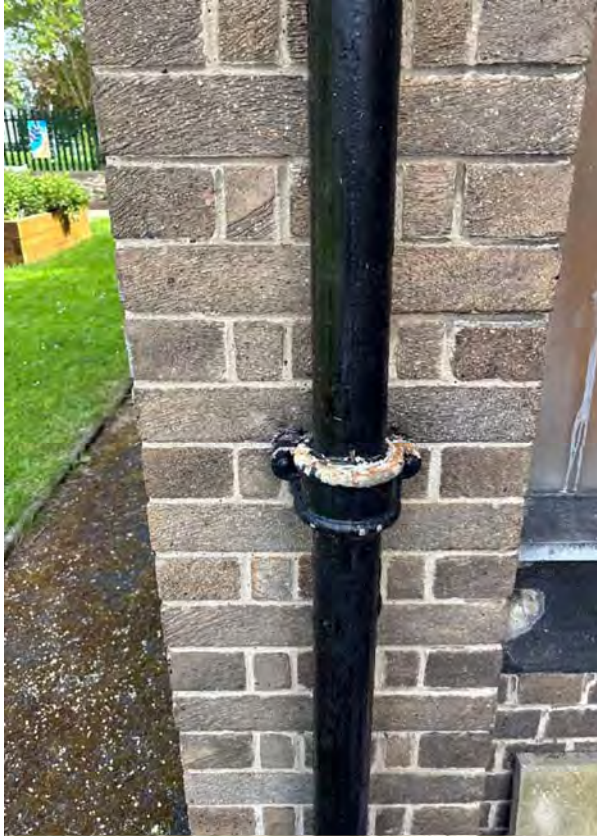
Example of flaking / rust to downpipe on West Elevation.

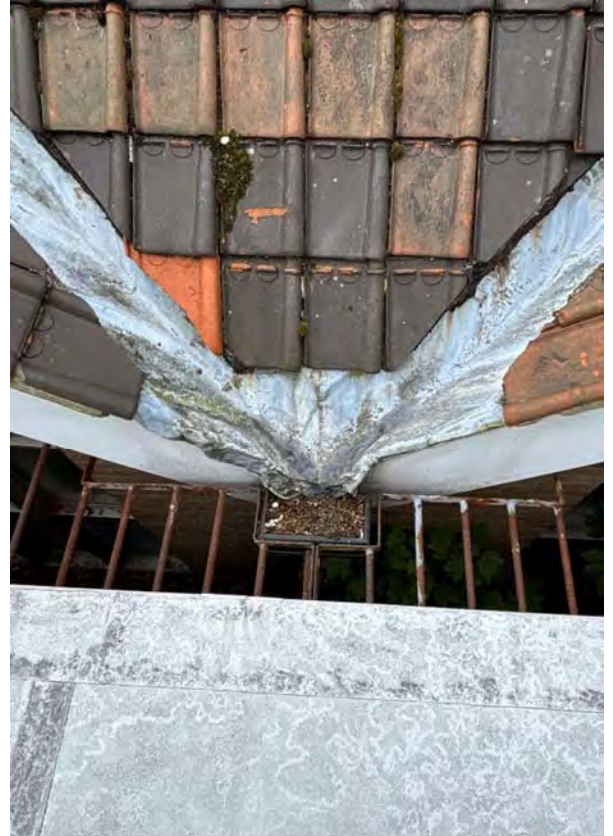
Blocked hopperhead to lightwell void

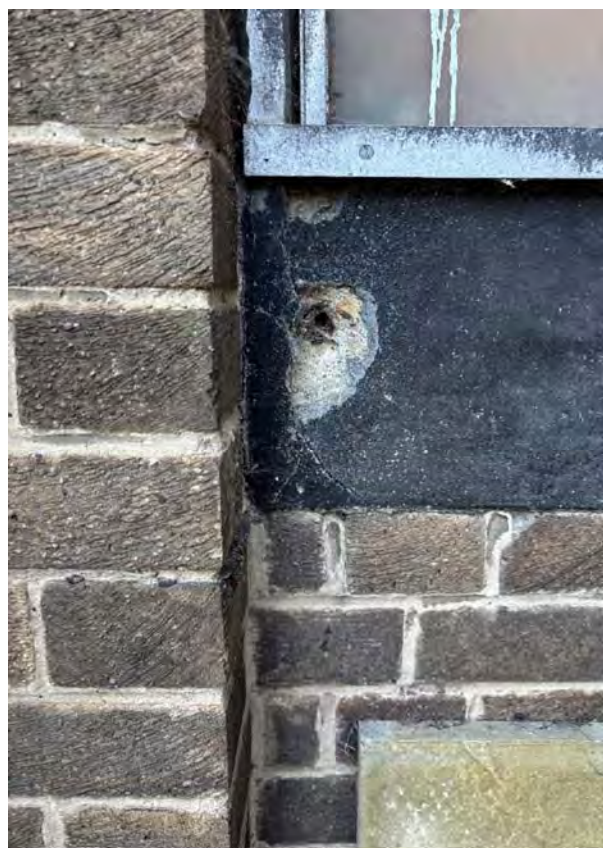
Evidence of spalling to concrete lintel.

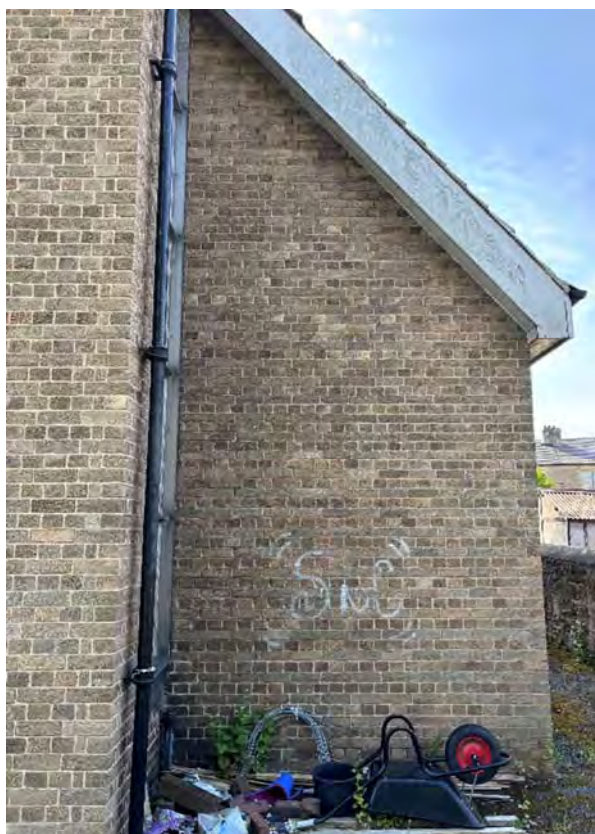
Overview of right area of elevation with graffiti shown to centre.

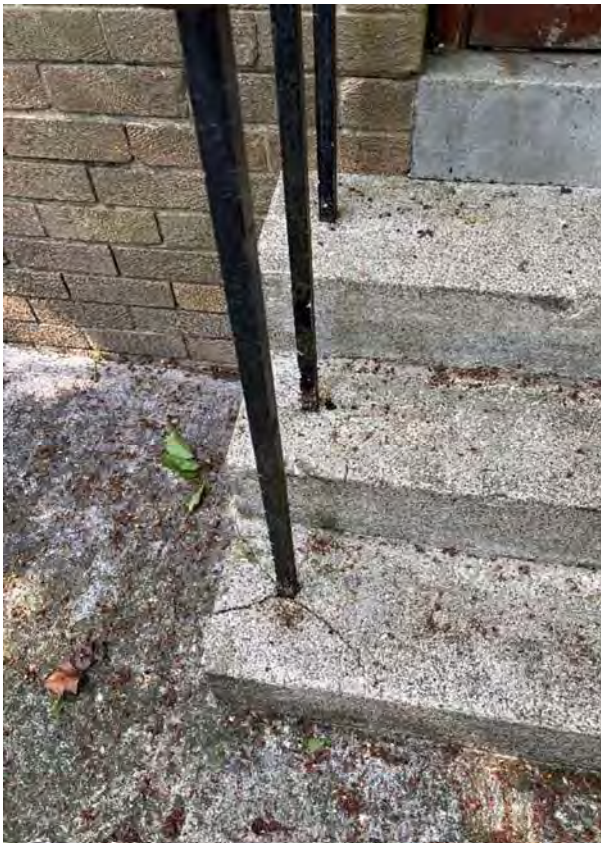
Evidence of cracking around handrail fixing.

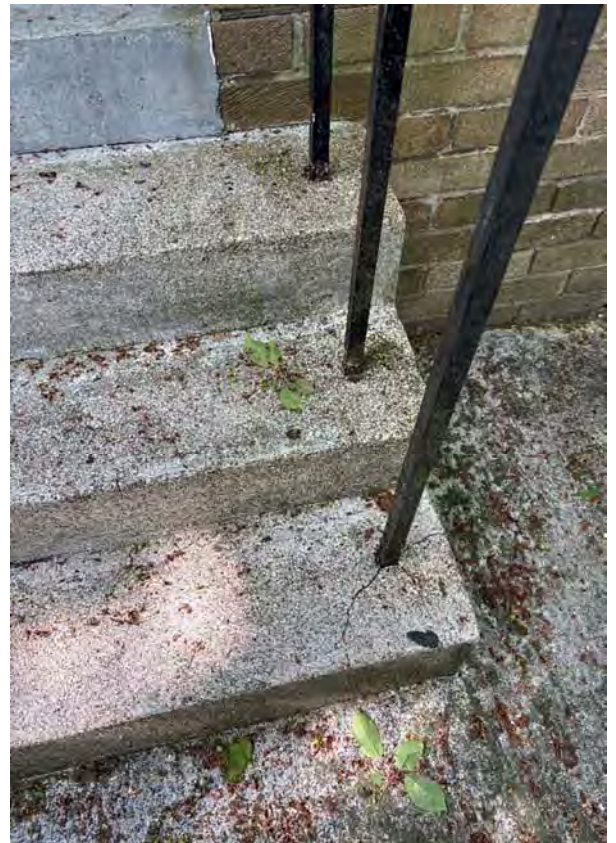
Evidence of cracking around handrail fixing.

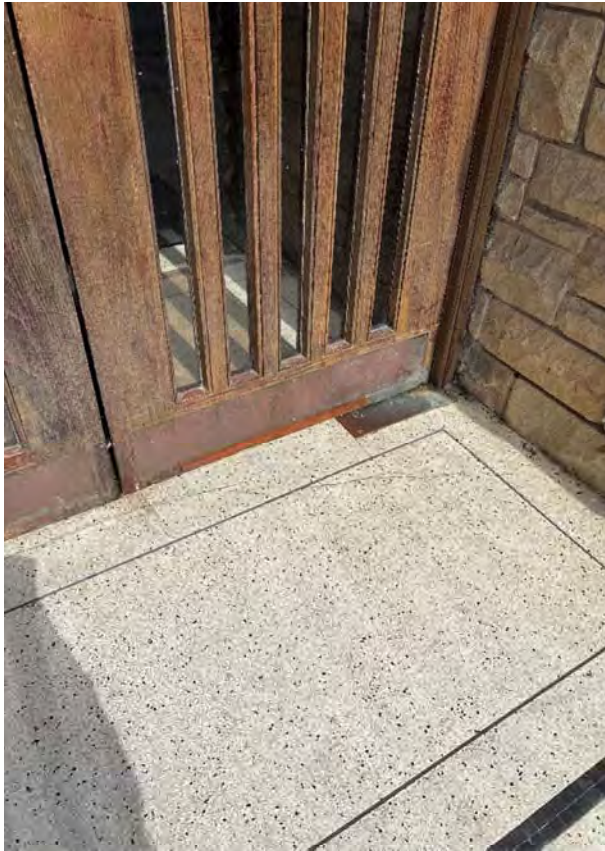
Cracking to terrazzo flooring

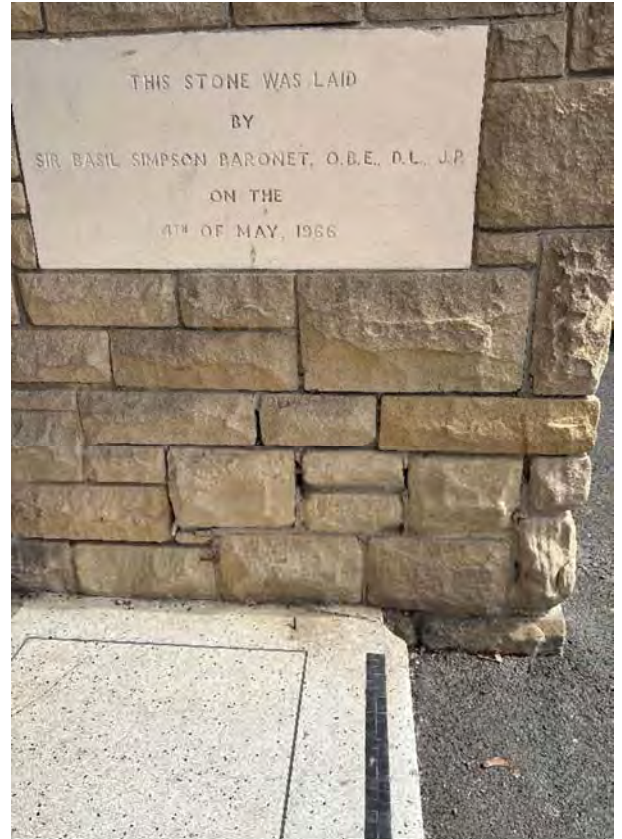
Loss of pointing to entrance area of stone wall.

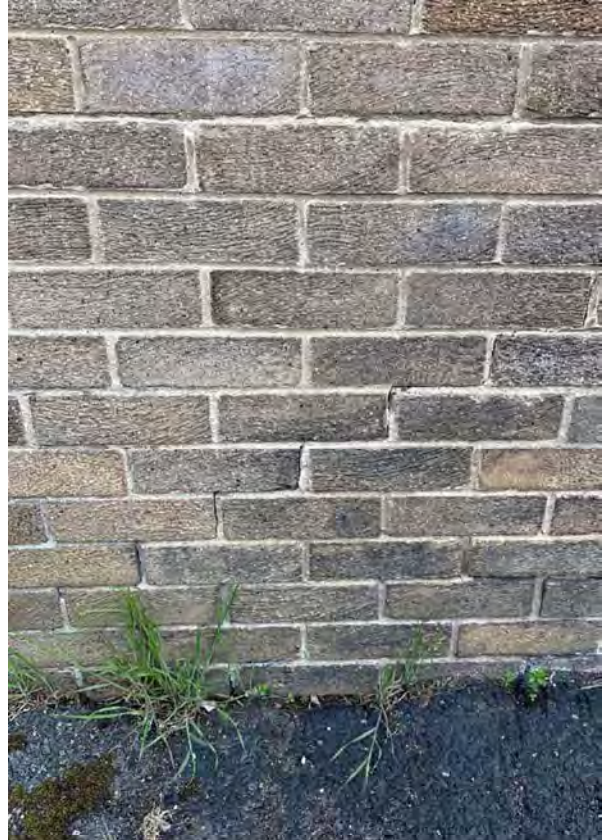
Area of stepped cracking

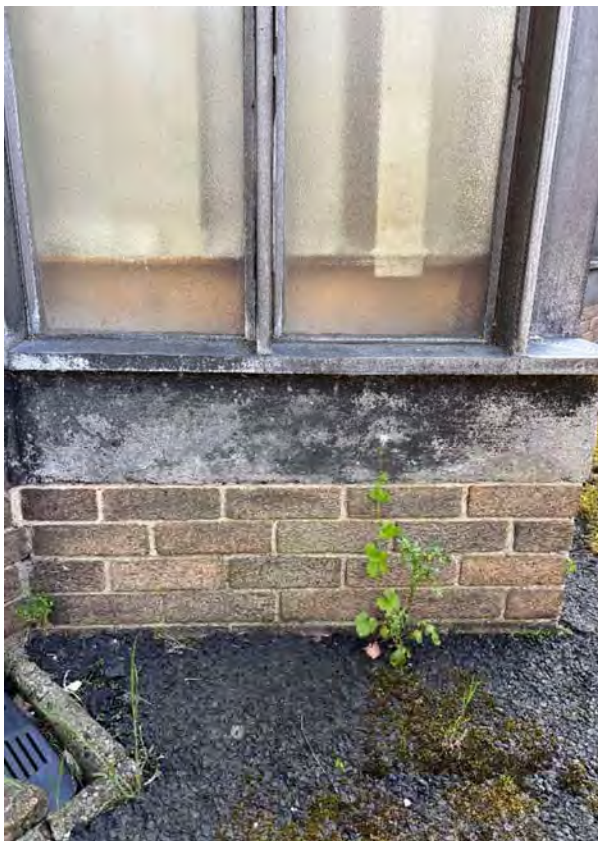
Deterioration of concrete cill

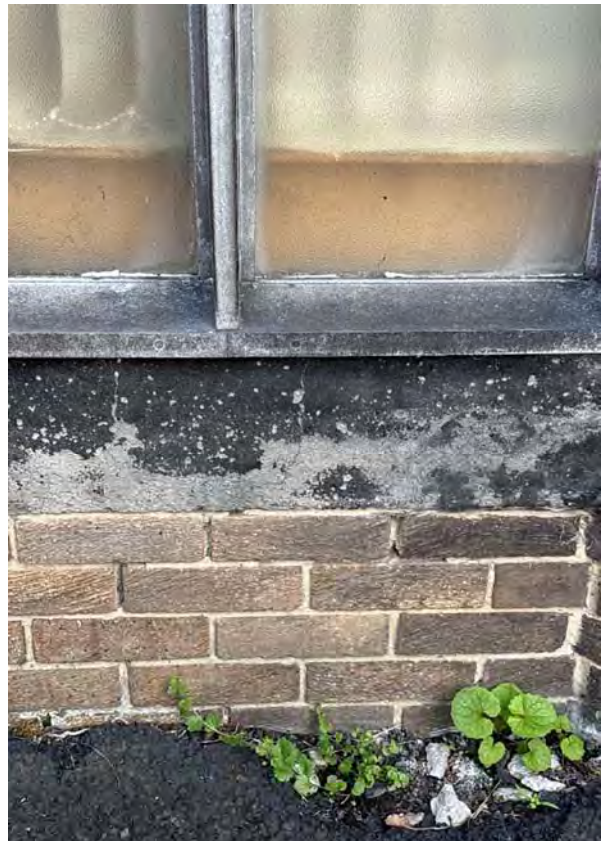
Other example area of deterioration of cill and loss of pointing.

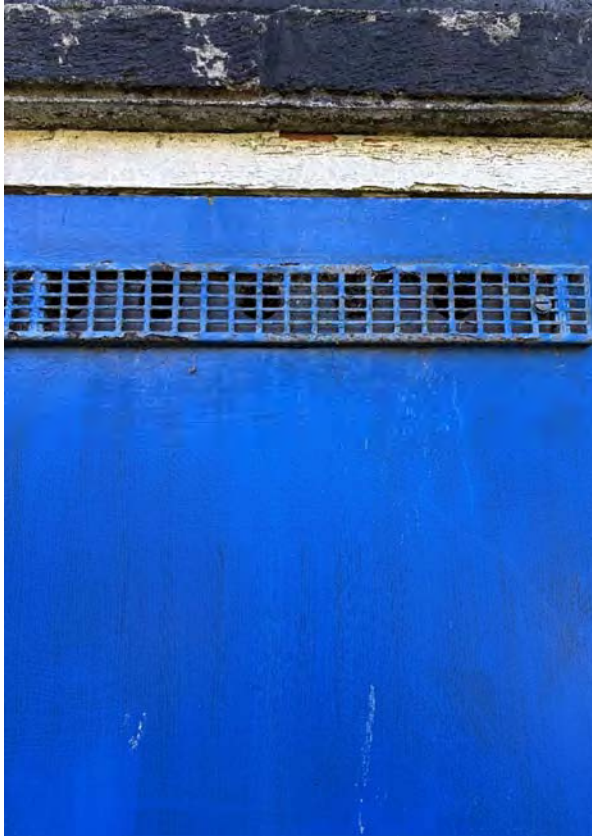
Rusting to grilles

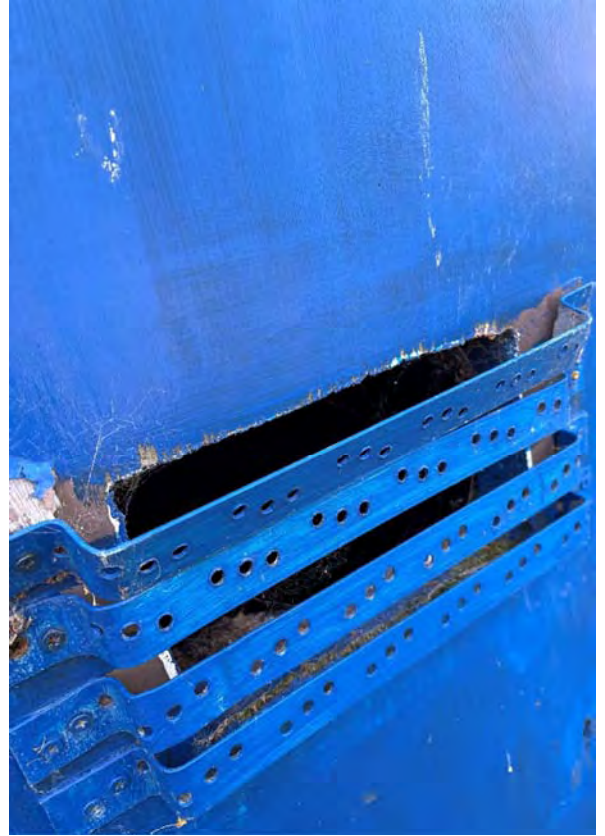
Open Vent Area

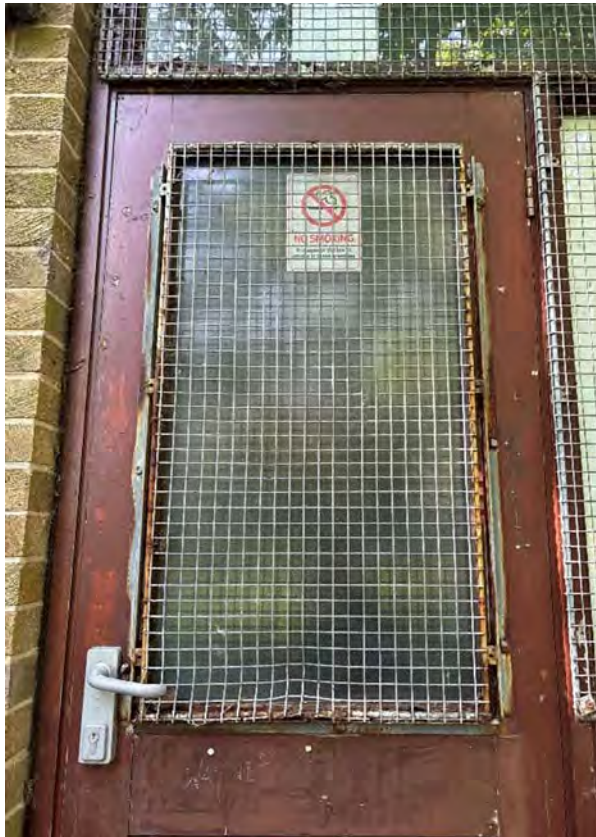
Rusting of metal security grilles

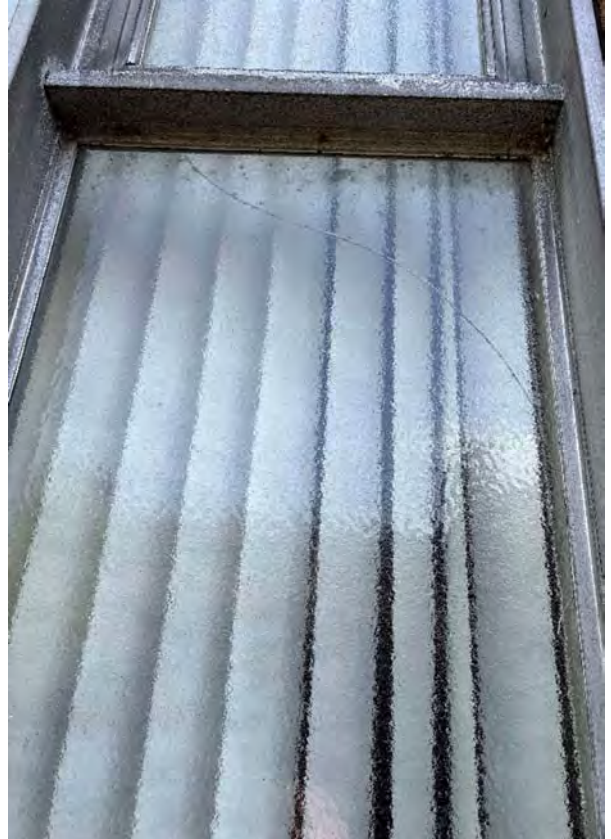
Cracked pane of glass.

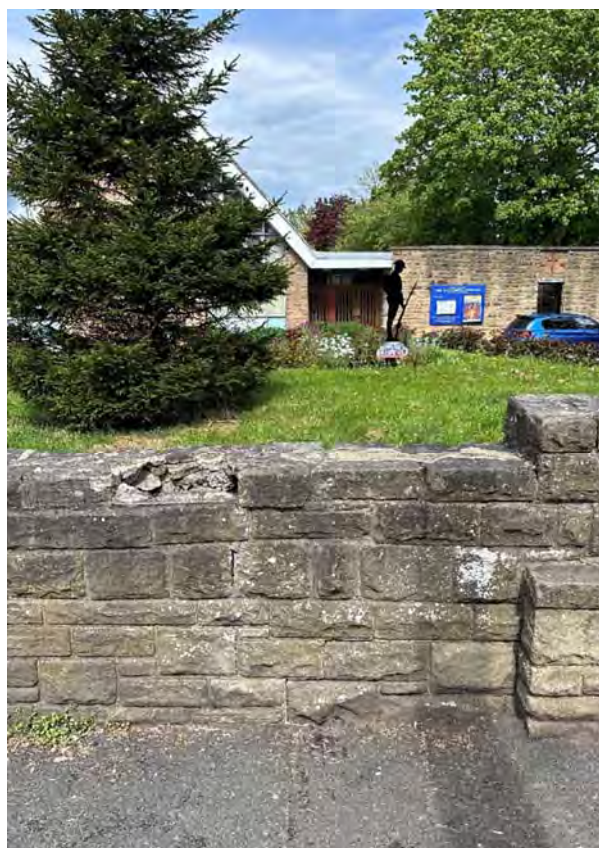
Area of missing stone to public pavement boundary wall.

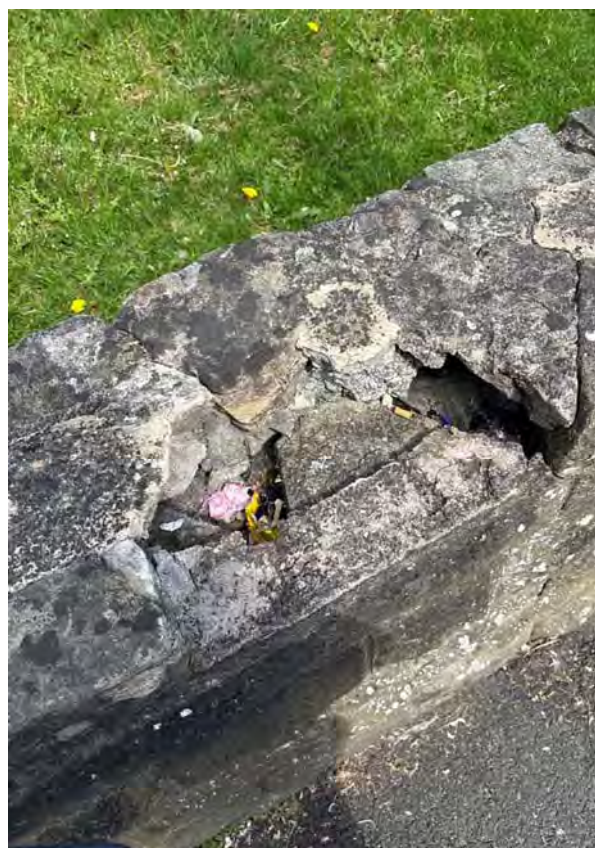
Close view of missing stone area.

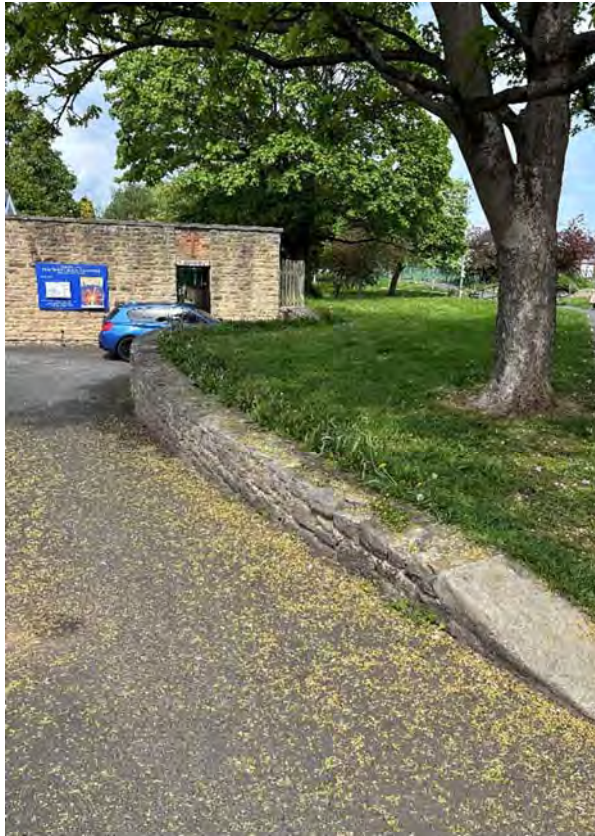
Areas of open joints to stone wall. Monitor to establish if any movements to wall.

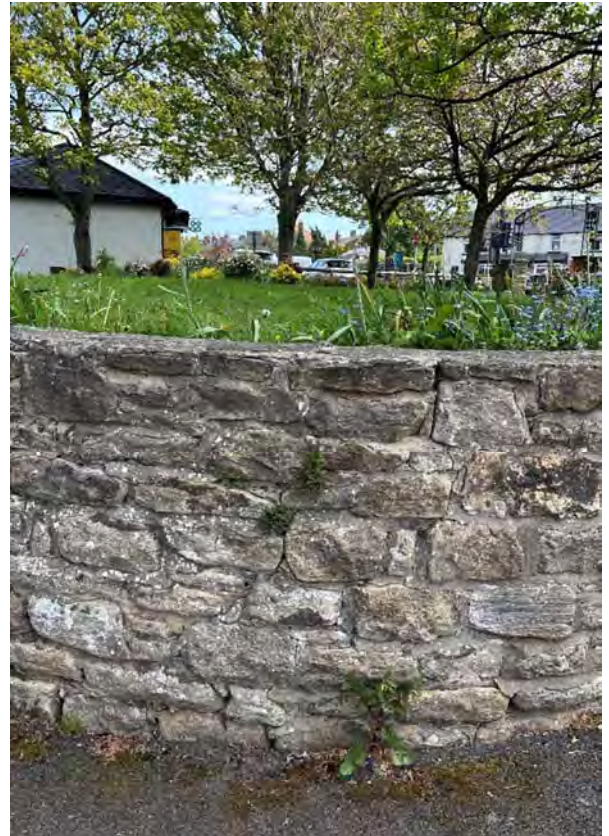
Areas of cracking and open joints visible to stone retaining walls.

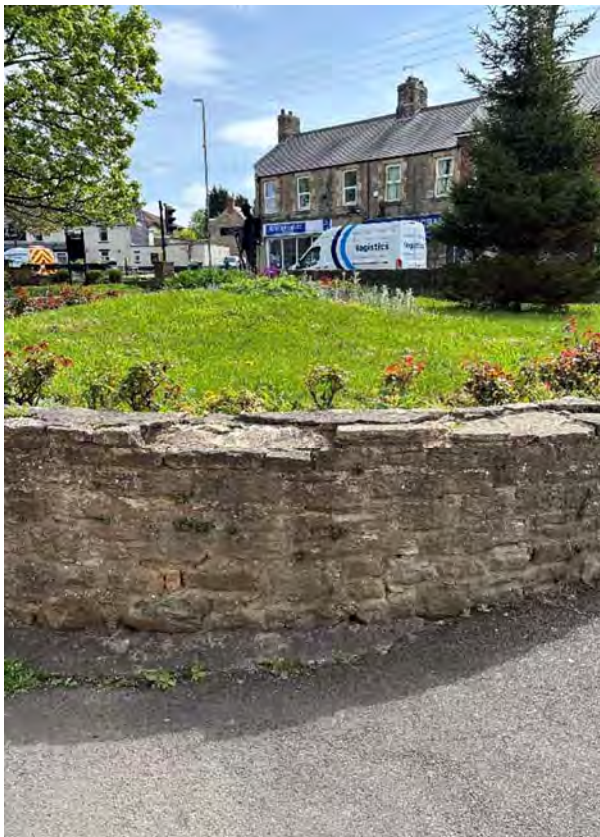
Poor condition of coping stones and upper courses.

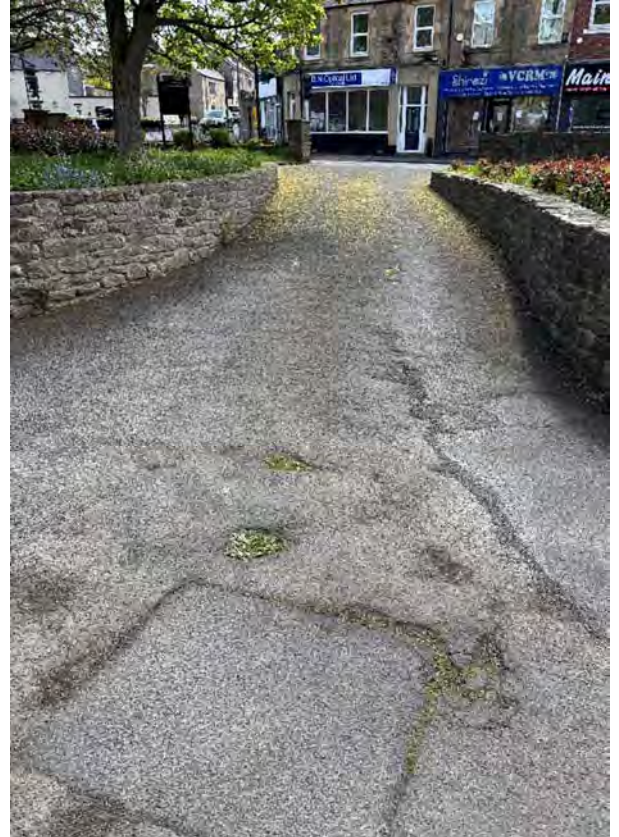
Potholes and vegetation growth to tarmac.

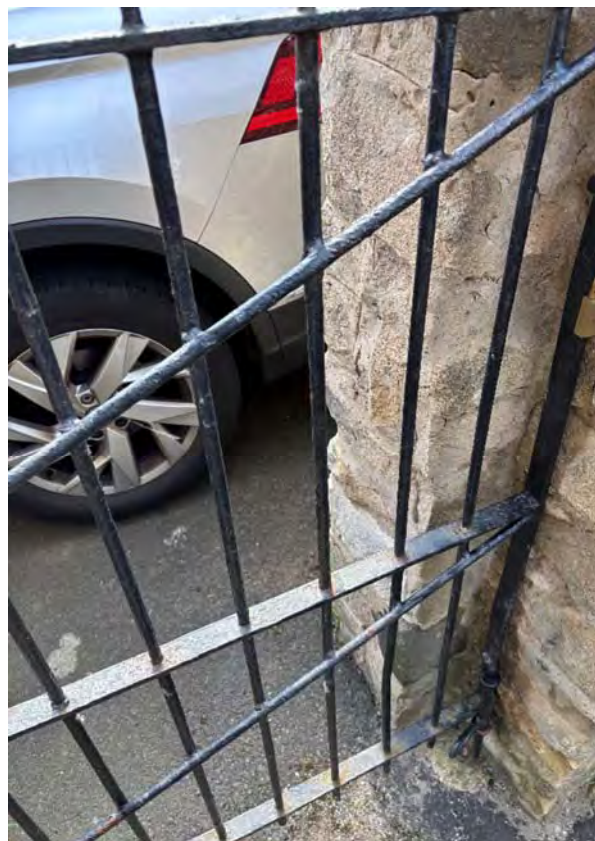
Evidence of flaking paint and rusting to gate.

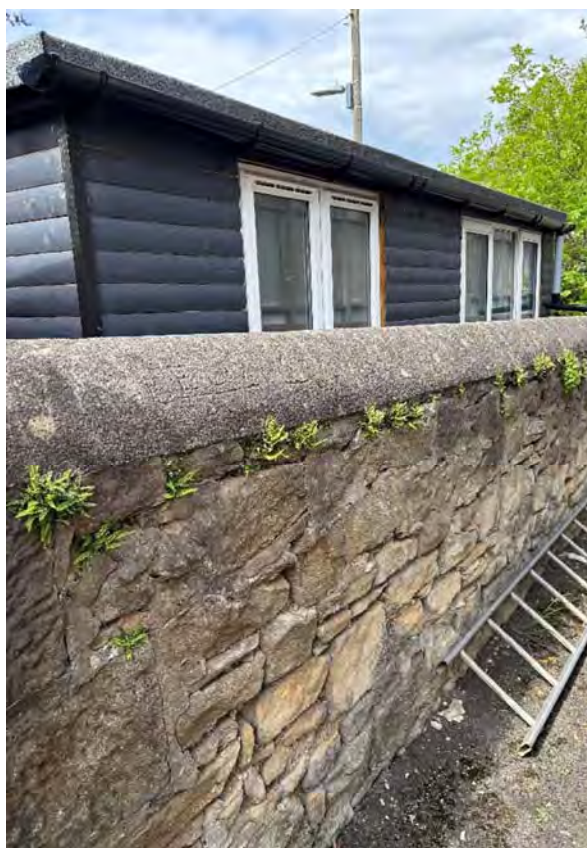
Deterioration of stone boundary wall.

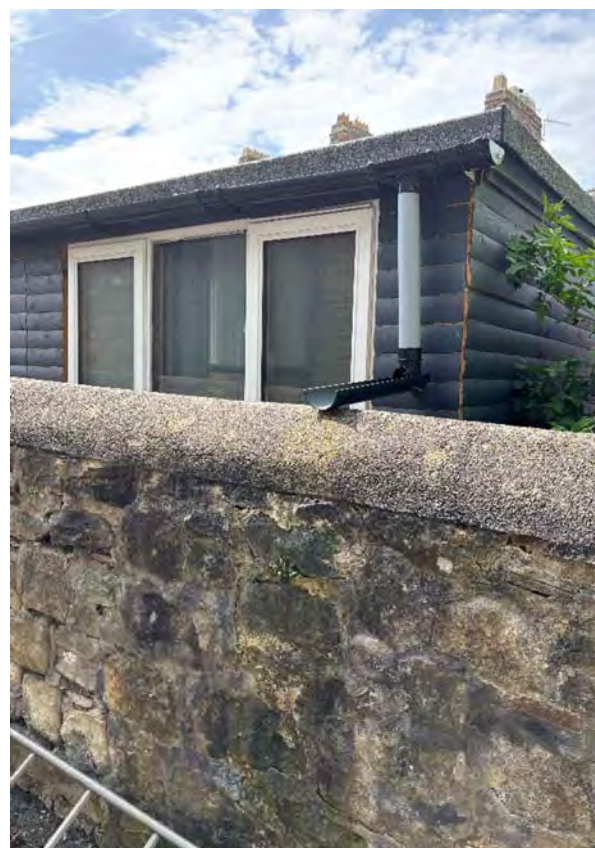
Neighbour draining rainwater over stone boundary wall.

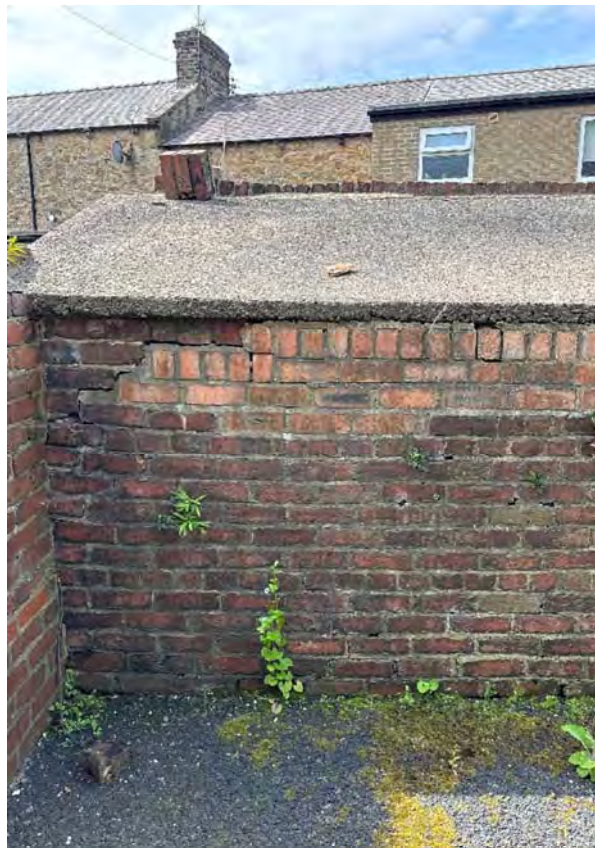
Significant cracking to brick wall

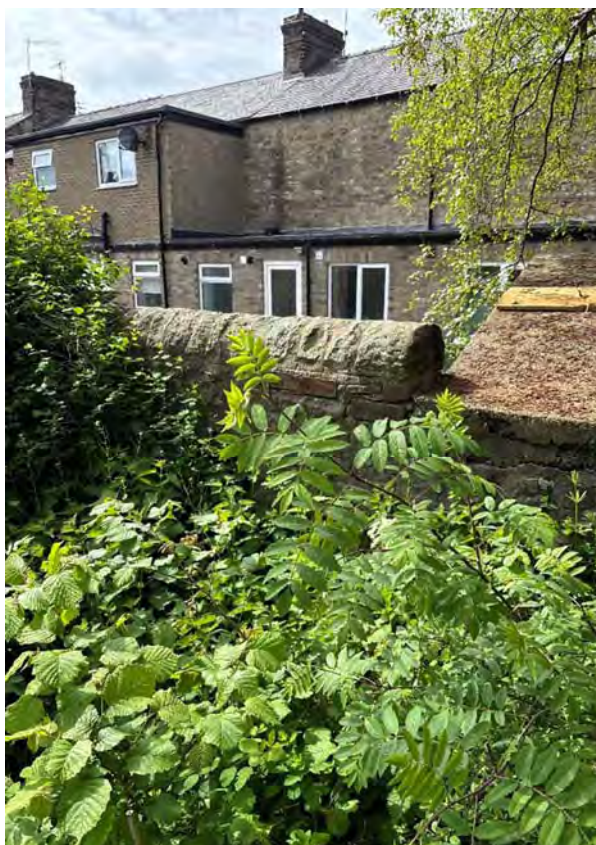
Areas of stone boundary not accessible due to vegetation overgrowth

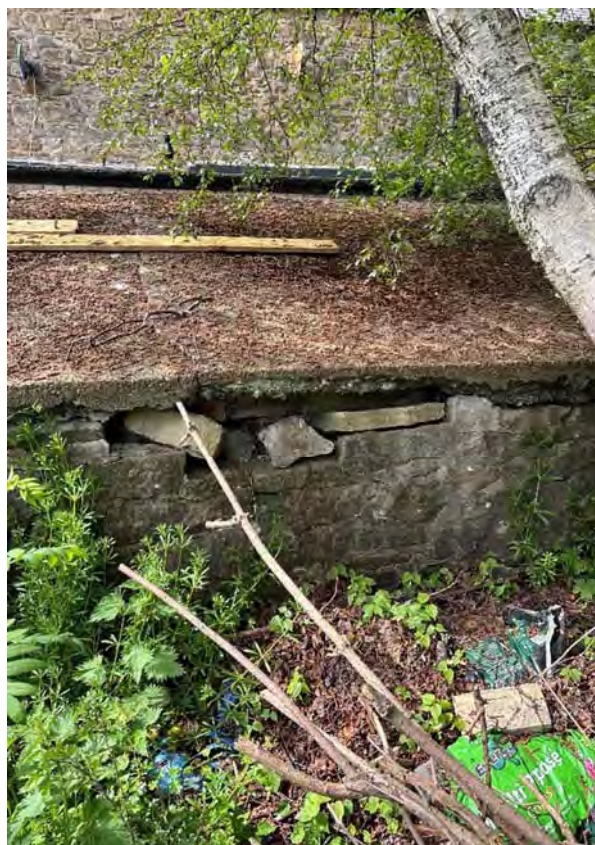
Significant deterioration to stone boundary wall.

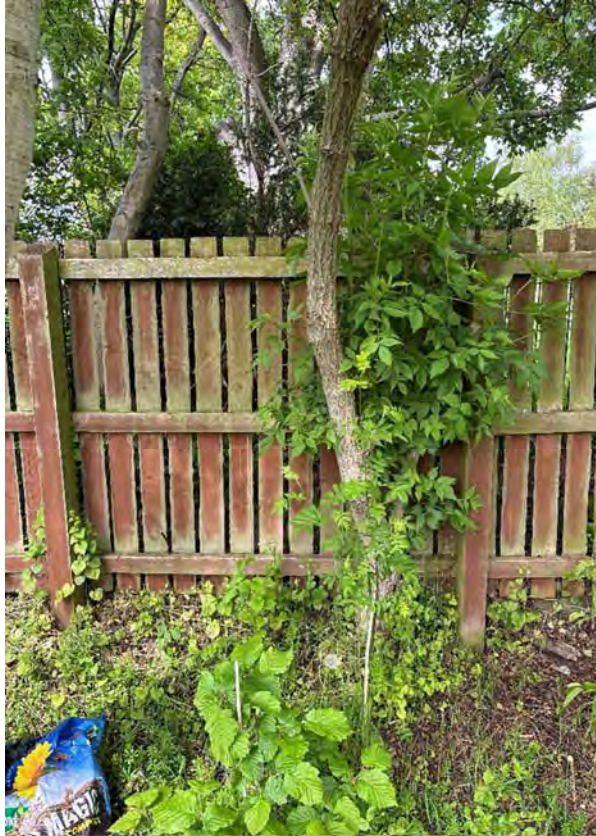
Example of tree in close proximity to fence boundary

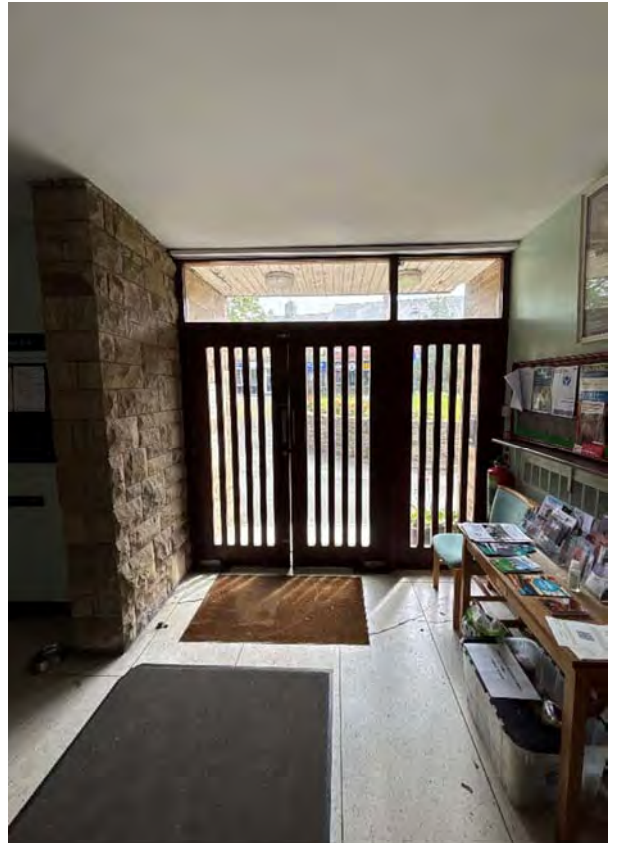
Entrance doors with cracking visible to floor area.

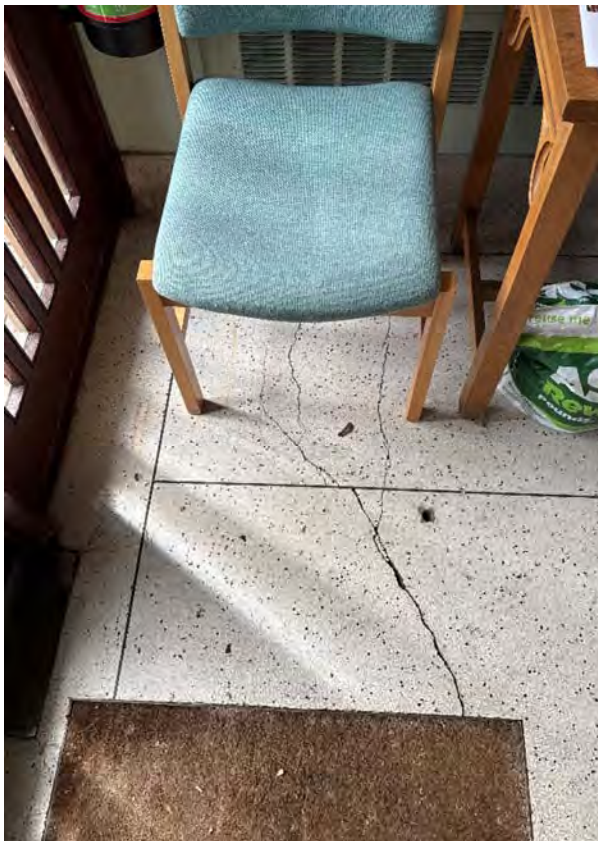
Cracking to right side of door.
