## QUINQUENNIAL REPORT

*For the Parish Church of*  
Church of the Holy Spirit, Crawcrook

***Report Date: 14<sup>th</sup> July 2026***

Inspecting Architect:  
Becky Smith BA(Hons), MArch, ARB, RIBA

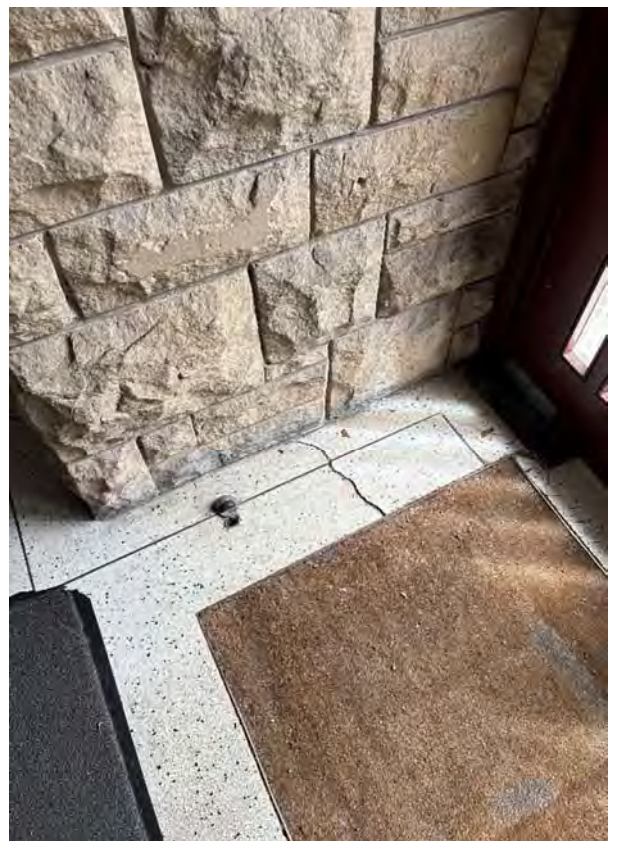
Cracking to left side of door.

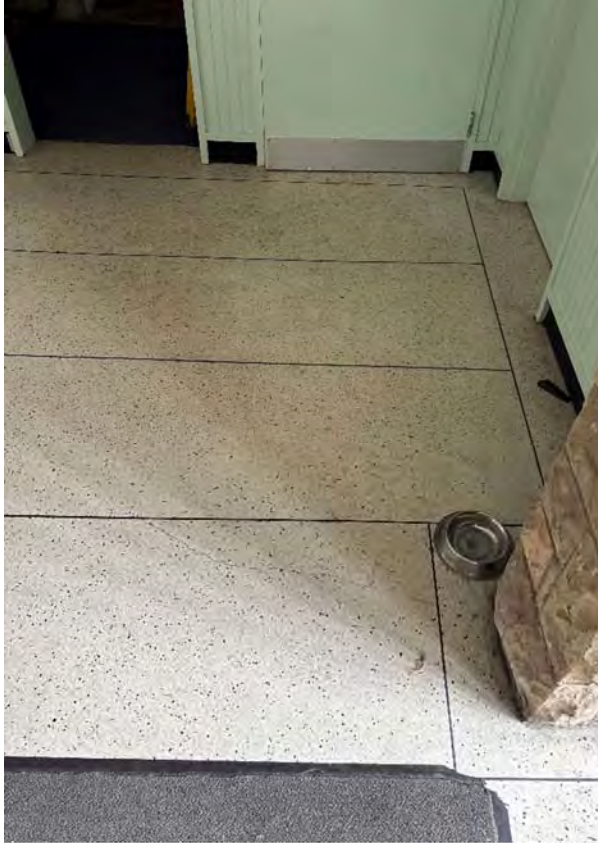
Hairline cracking continues beyond entrance doors

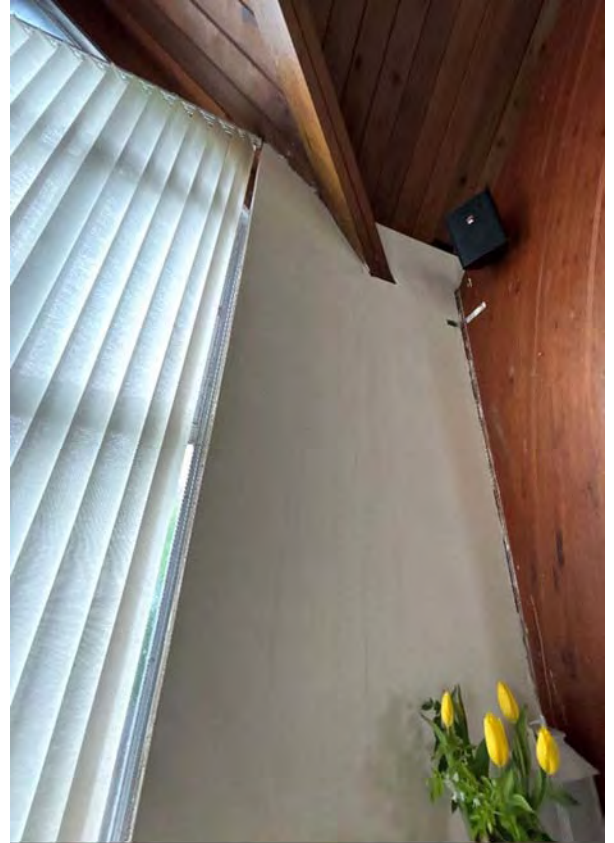
Evidence of Water Staining to **Window 15**

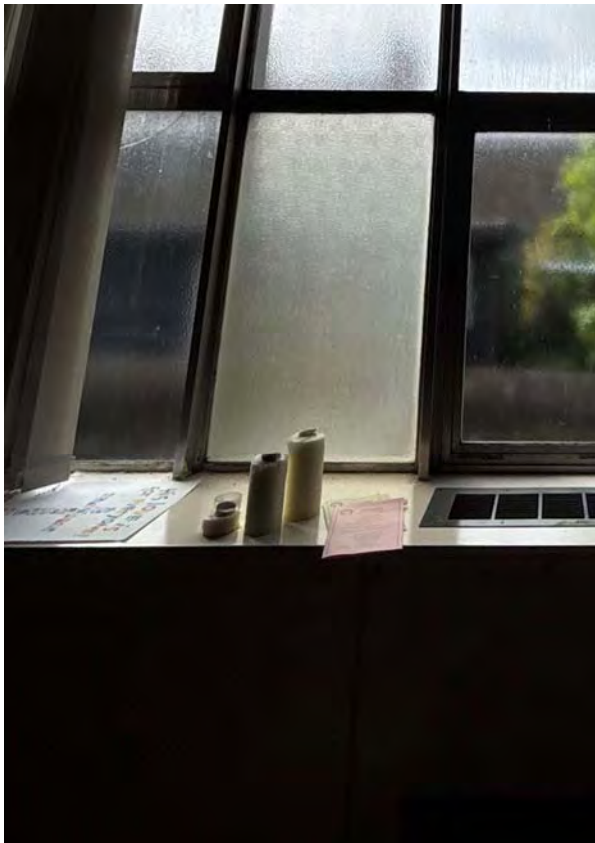
Cracked glass pane to lower left window

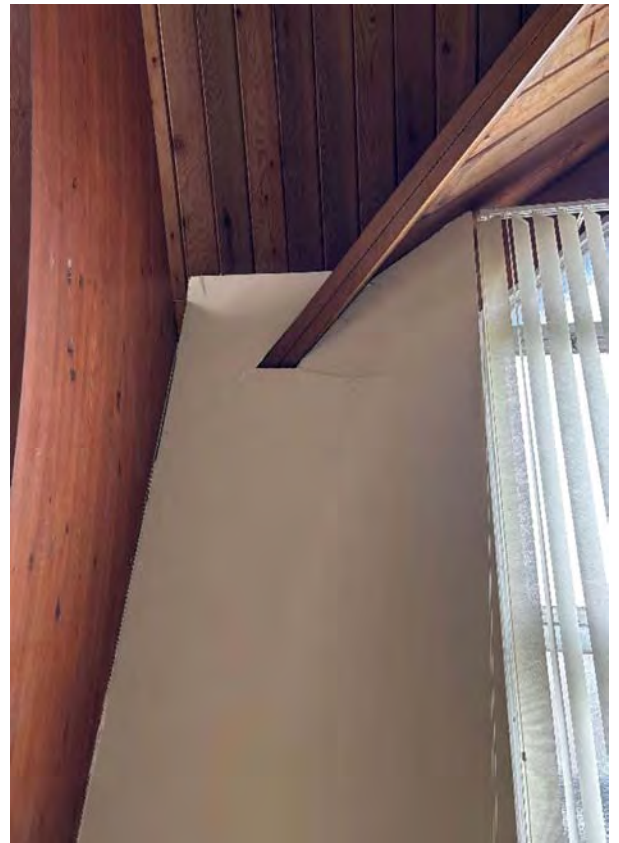
Some cracking to ceiling / window surround

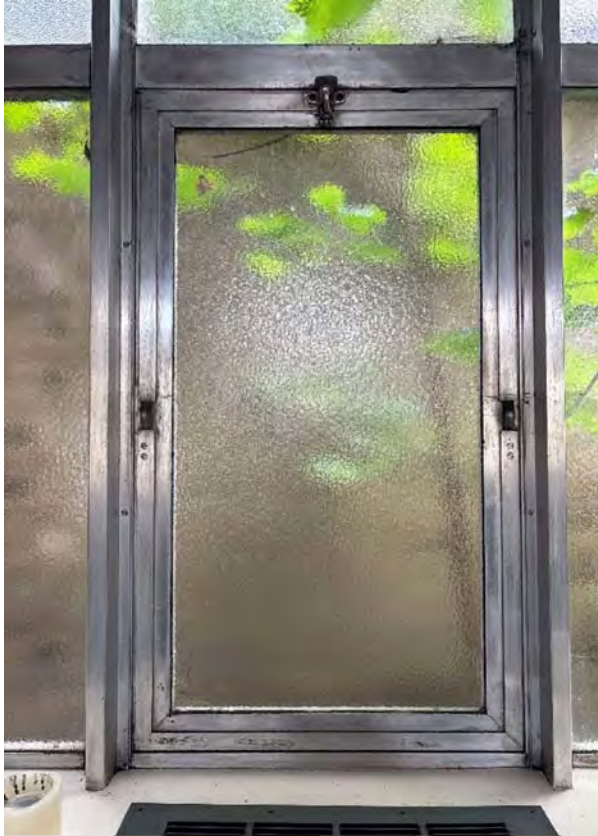
Example deterioration to frames

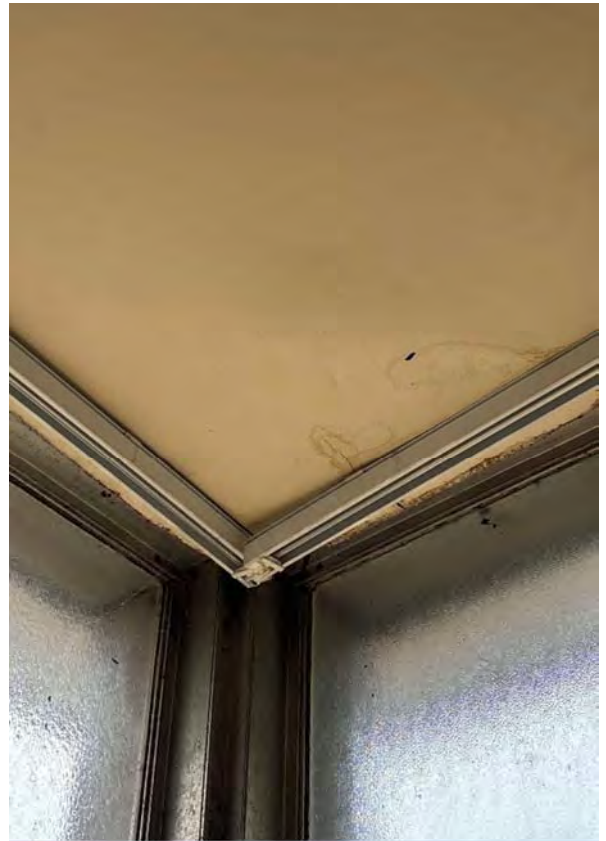
Areas of staining to ceiling of windows.

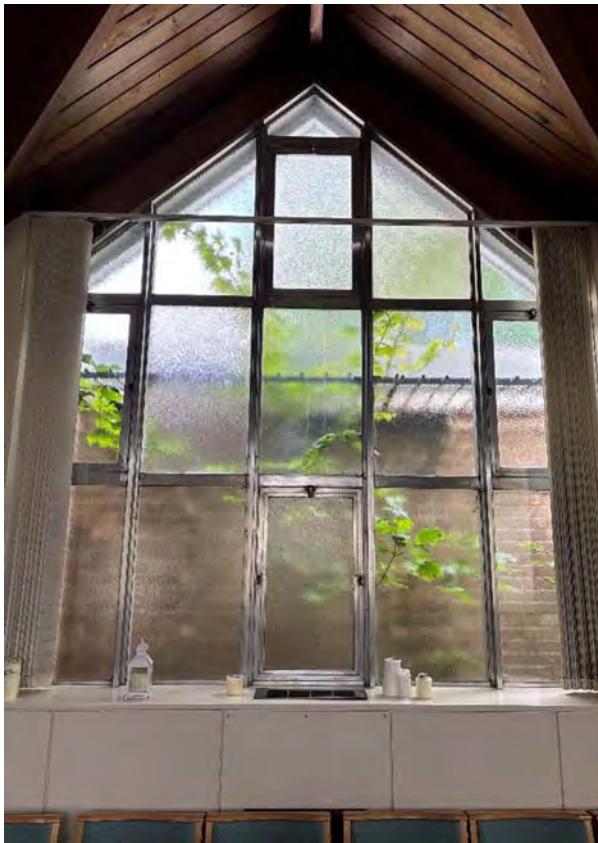
Vegetation growth visible to void in centre of church. Refer to Roof Coverings for info.

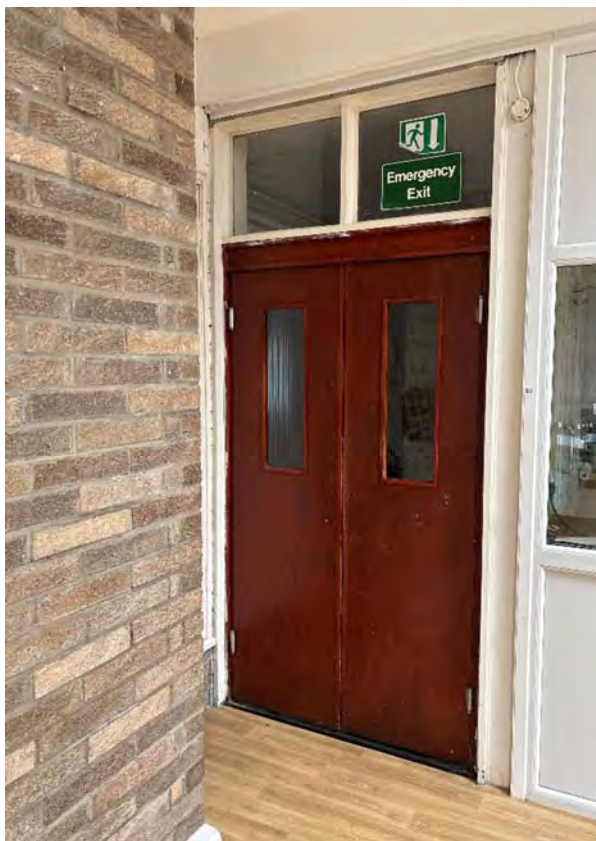
Clearance of double doors inadequate for fire escape doors.

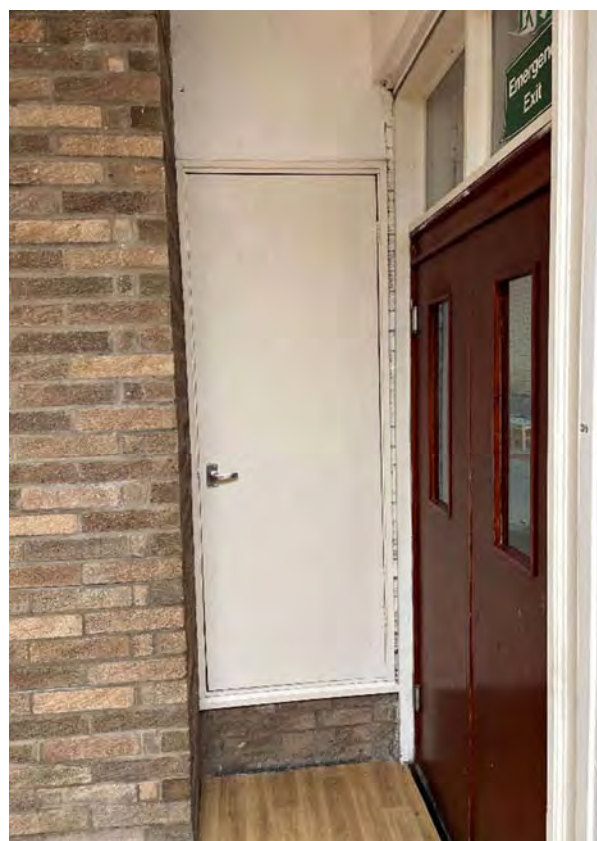
Inadequate clearance in front of fire escape doors.

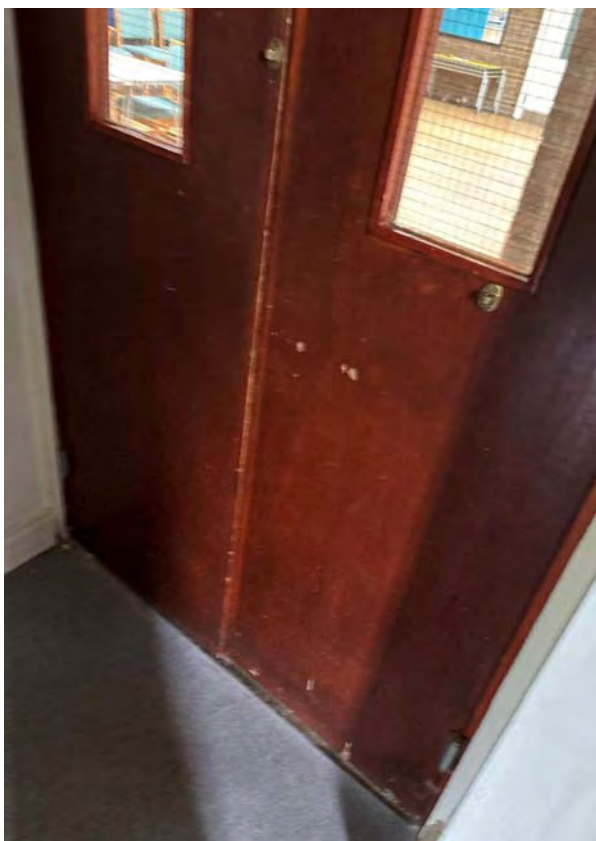
Example flaking paint / minor damage to doorset.

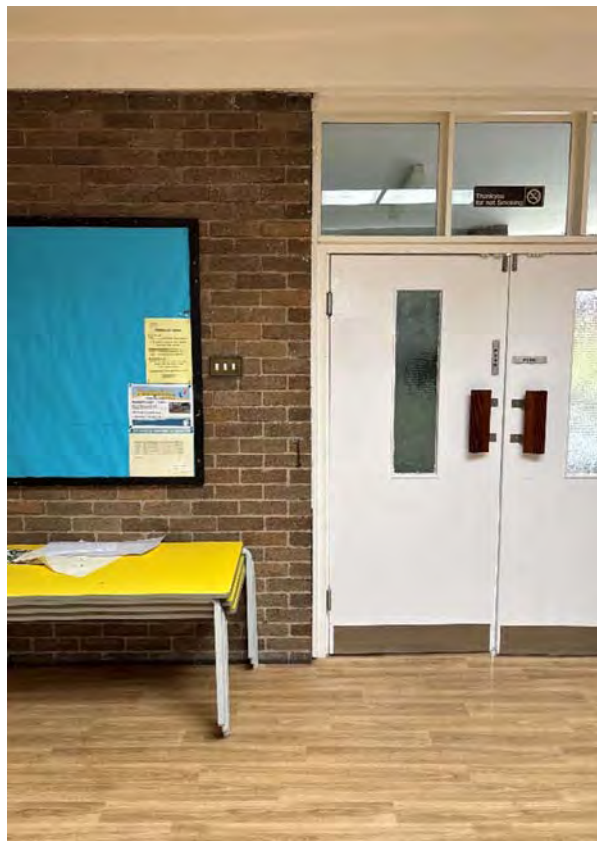
Example doors where fire escape strategy is unclear

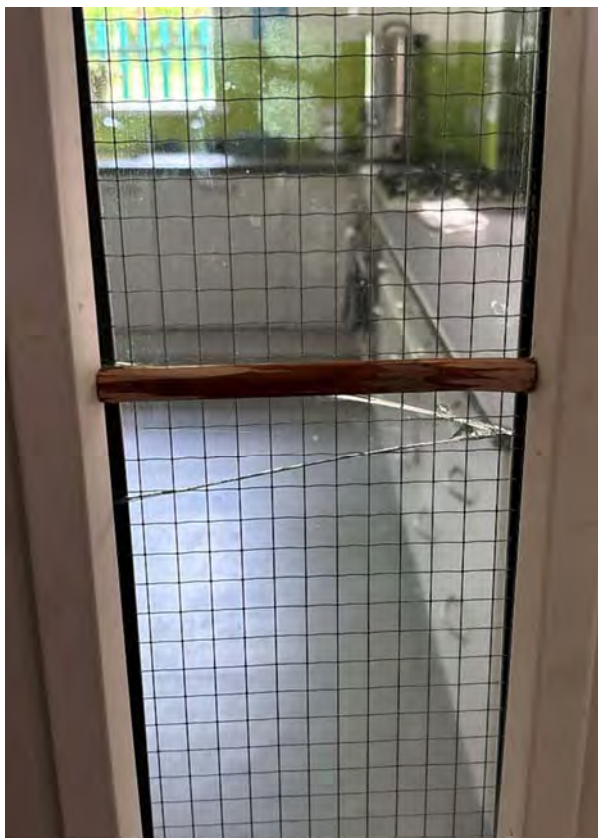
Crack to Fire Door vision panel with ad hoc repair.

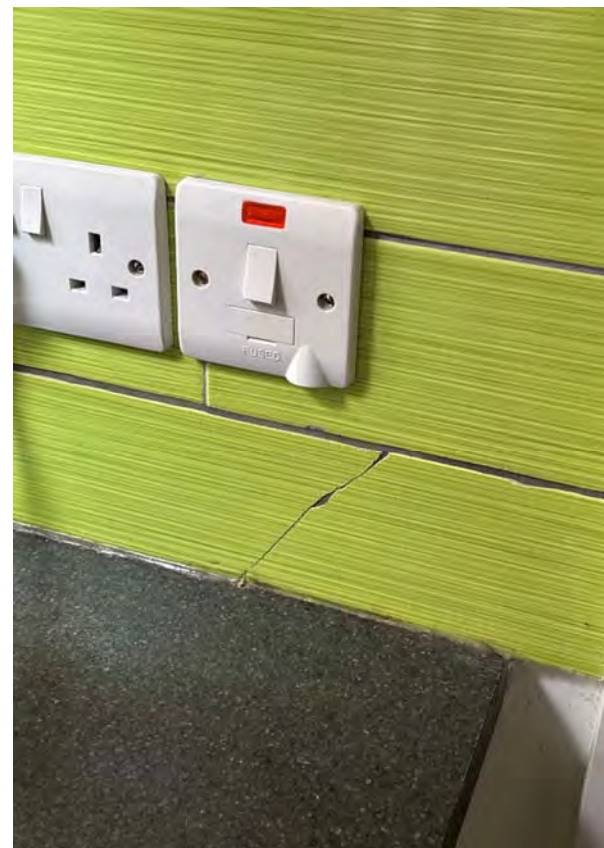
Cracked tile to kitchen splashback.
