St Oswald, Durham

QUINQUENNIAL INSPECTION REPORT 2023

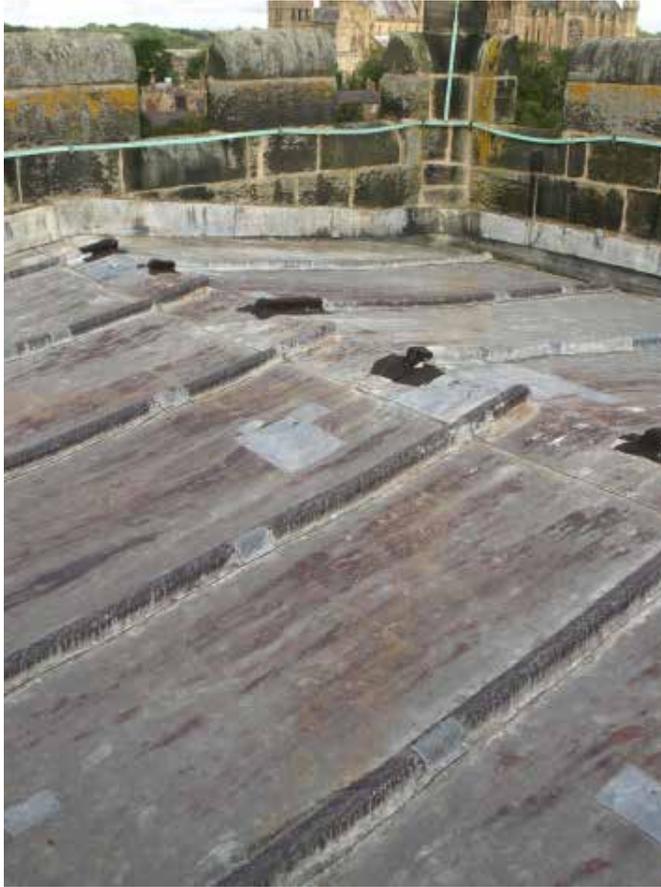
REF.	LOCATION / ITEM	DESCRIPTION	CONDITION/DEFECTS	RECOMMENDATIONS	PRIORITY
3.01 ROOF COVERINGS					
3.01.01	Tower Roof, roof coverings	Roof is dual pitch covered in lead with rolls. Deep flashings to perimeter. Gutters running east to west with outlets at the east.	Leadwork cracked and split in many locations, has previously been patch repaired over numerous phases and is now at the end of its service life. Leadwork over hatch access contains centuries of graffiti. Isolated graffiti also to sheets of main roof pitches.	Full replacement of the lead covering , to include all parapet flashings. Allow for repair of timber substrate. Cut out & retain historic graffiti.	C

Priority C		Works recommended to be carried out during the next 2 years	APPROX. £s excl. VAT
1)	3.01.01, 02, 03	Tower roof, roof coverings: Full replacement of the lead covering , to include all parapet flashings. Allow for repair of timber substrate. Replacement of lead-lined gutters, increase size of outlet from catchpits. Access hatch - minor patching to leadwork, ventilation holes to be added to timber door.	37,500

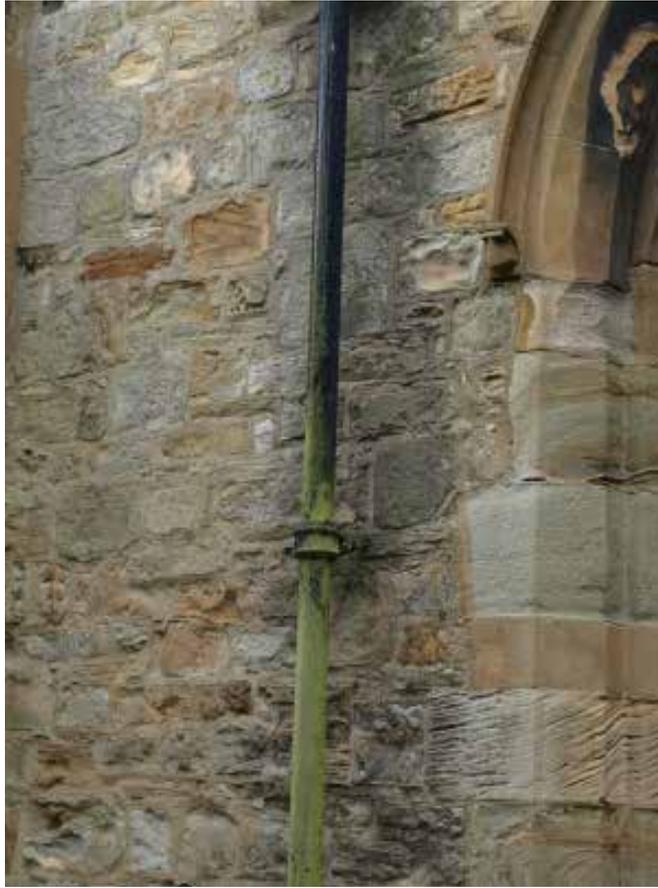
REF.	LOCATION / ITEM	DESCRIPTION	CONDITION/DEFECTS	RECOMMENDATIONS	PRIORITY
3.02.04	North Aisle rainwater pipes	Cast iron hoppers & pipes, round section.	Appear to be generally in good condition. West-most pipe shows signs of being blocked at mid height.	Clear blockage. Clean out hoppers and pipes periodically, ideally every 6 months & monitor for any blockage or leaks.	A

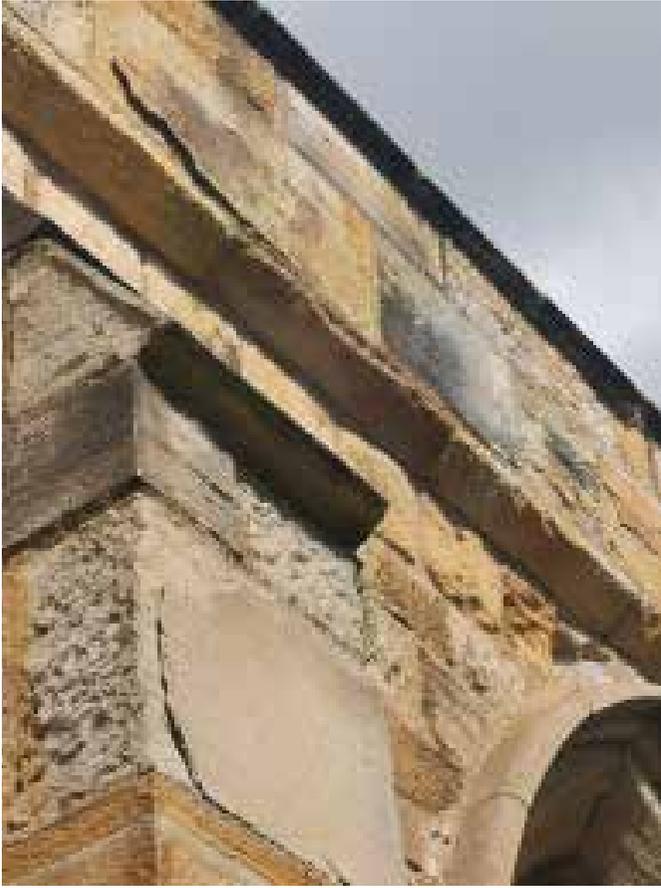
REF.	LOCATION / ITEM	DESCRIPTION	CONDITION/DEFECTS	RECOMMENDATIONS	PRIORITY
3.05.04	South Aisle, masonry	Coursed stonework with dressed ashlar reveals to openings and to buttresses. Projecting plain ashlar parapet to top. Decorative niche above south-west porch entrance. Projecting plinth at low level. Mixture of pointing phases, mostly in cementitious mixes or very hard hybrid lime-cement mixes.	Deteriorated masonry blocks, localised to particular soft stones. Grit stone appears to be faring better. West elevation notably worse than the south and east. The ashlar to the parapets is delaminating. Cement pointing is causing adverse and advanced decay to stonework. Cracking noted on east elevation to the south-east corner, copings slightly dislodged and deteriorated with open joints. Dressed ashlar to buttresses and parapet are delaminating and the face is sheeting away.	Phased approach to re-pointing and localised masonry repairs. Clean away algae from behind downpipes ensuring that hoppers are kept clear & free flowing.	D

Priority D		Works required to be carried out within the next five years	APPROX. £s excl. VAT
1)	3.05.04 3.05.12	North Aisle & South Aisle, masonry: re-pointing and localised masonry repairs. Clean away algae from behind downpipes ensuring that hoppers are kept clear & free flowing. Re-bed copings to west elevation on lead DPC.	25,000

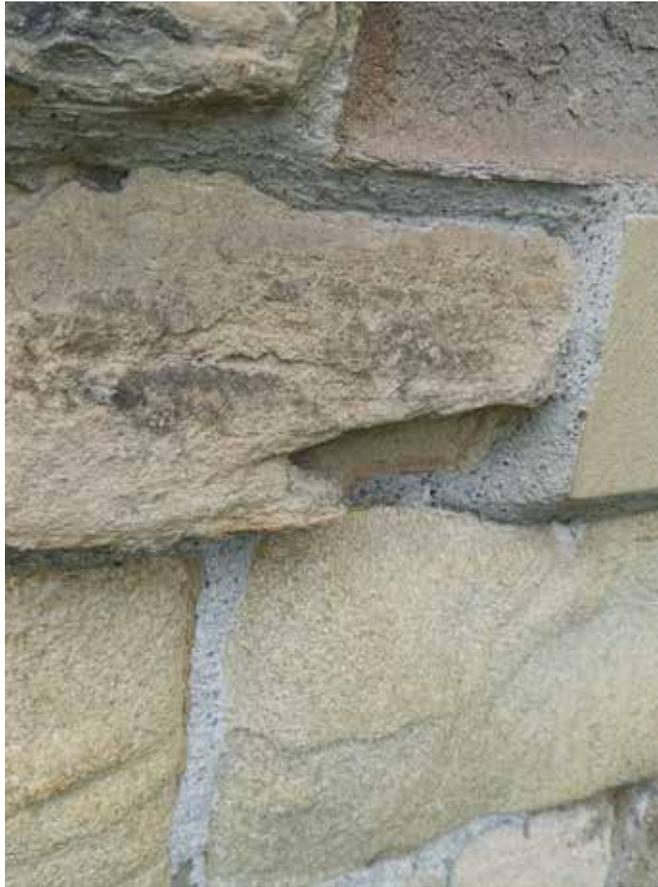
3.05.06	Chancel South Elevation, masonry	Coursed stonework with dressed ashlar reveals to openings and to buttresses. Projecting plain ashlar parapet to top. Decorative niche above south-west porch entrance. Projecting plinth at low level. Mixture of pointing phases, mostly in cementitious mixes or very hard hybrid lime cement mixes.	Main walling stone in fair condition with isolated deterioration to individual masonry units. Heavy stone replacement to eastern end. Ashlar to parapet delaminating and projecting cornice also delaminated and friable. Low level masonry deteriorated and weathered back. Mortar is of a cementitious or very hard lime mortar that is causing advanced deterioration of the masonry.	Defrass and repair ashlar masonry to parapet and buttress including isolated units in walling stone. Embark on programme of re-pointing, commencing with parapet and low level.	D

3)	3.05.06 3.05.07 3.05.08	Chancel North & South Elevation & East Elevation: defrass & repair masonry to parapet and buttress, re-pointing commencing with parapet and low level. Replace 1 no. coping stone, localised masonry repairs, removal of vegetation and packing all the open joints, open up crack below east window and re-point in lime to enable monitoring, ensure coping stone joints are filled	30,000

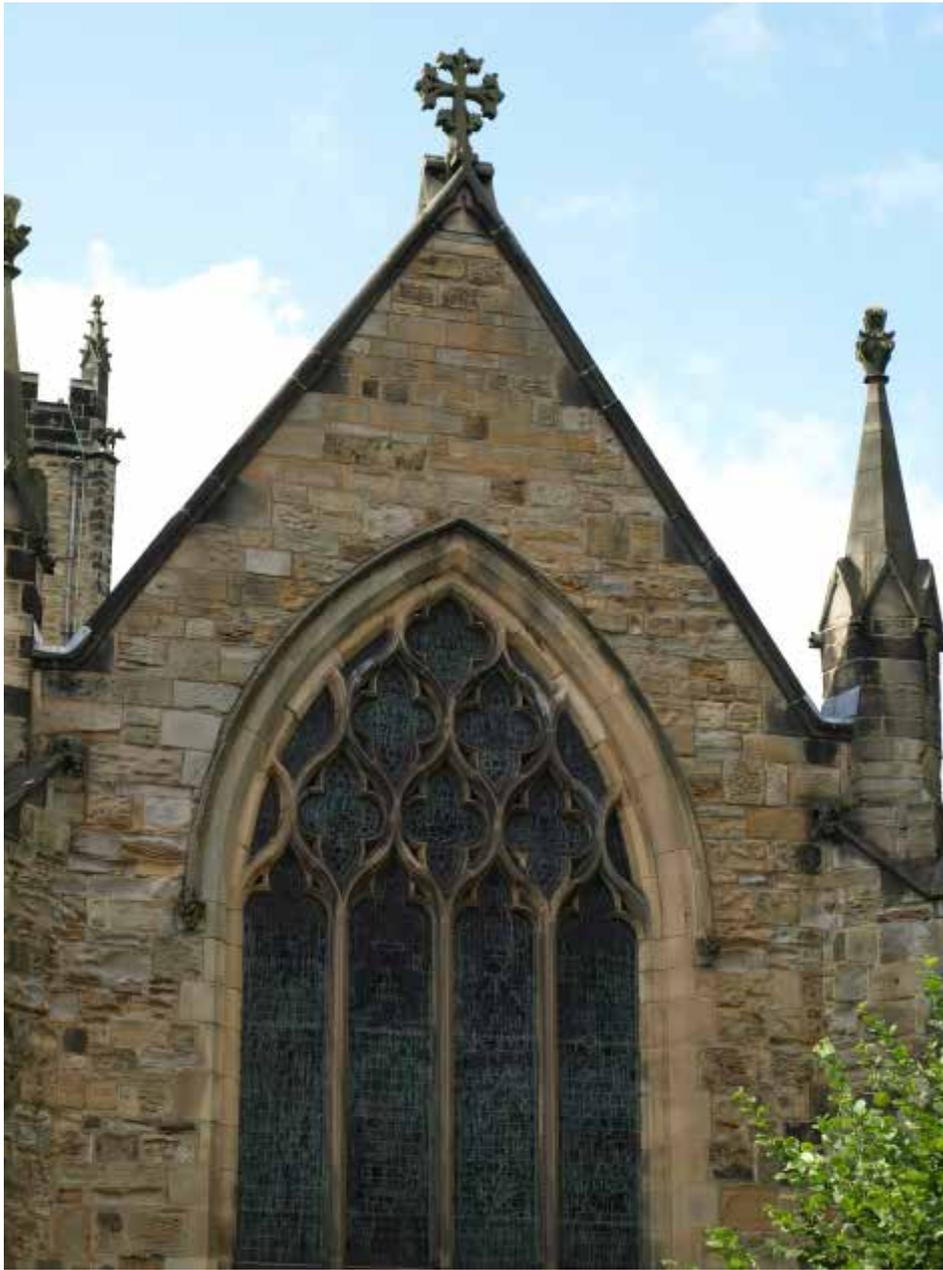
REF.	LOCATION / ITEM	DESCRIPTION	CONDITION/DEFECTS	RECOMMENDATIONS	PRIORITY
3.05.07	Chancel East Elevation, masonry	Coursed masonry of mixed stone types, gable with kneelers and copings, large buttresses to south and north-east corners with pinnacles and niches, finial to apex and large east window.	Walling masonry deteriorating behind heavy cementitious pointing. Opening joints at south-east buttress. Vegetation growth noted to top of north-east buttress indicating open joints and retained dampness. Central crack below principal window previously pointed and re-cracked. Apex stone not fully bedded. Coping stone joints partially open. Masonry at low level is particularly deteriorated due to hardstanding laid directly up to the base of the walls.	Phased re-pointing to masonry, including localised masonry repairs. Removal of vegetation, saplings and moss and packing all the open joints. Open up crack below east window and re-point in flexible lime to enable monitoring. Ensure coping stone joints are filled.	D

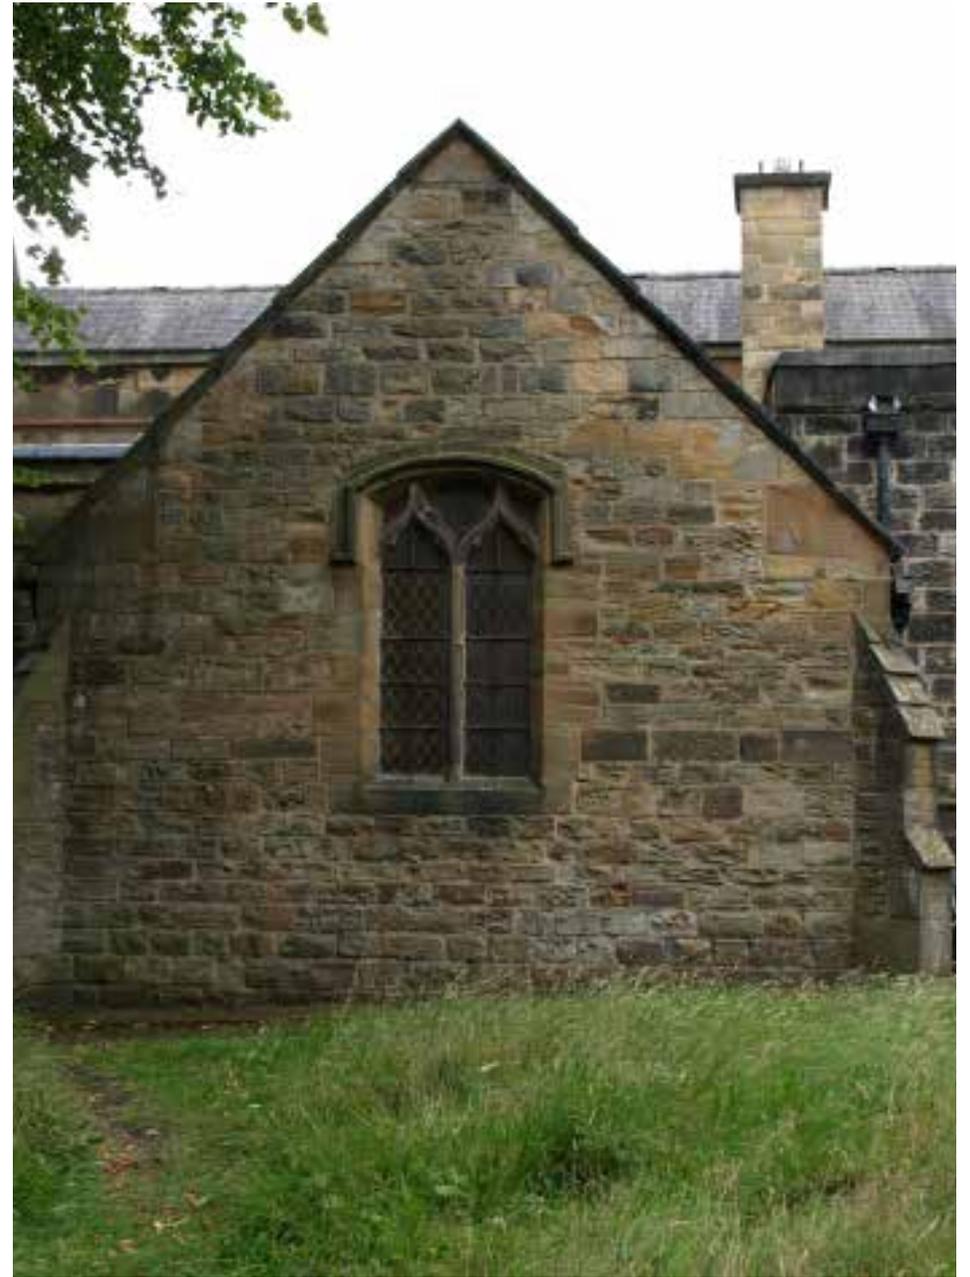
3.05.10	Main Vestry Elevation, masonry	Earlier vestry, coursed squared masonry with gable to north. Copings to gable and eaves to east and west. Buttresses to north-east and north-west corners.	Generally fair. Localised open mortar joints at low level, some stone delamination and weathering. Gritty hard mortar likely causing advanced deterioration as elsewhere.	Re-point isolated open joints, defrass delaminating masonry units.	D

4)	3.05.09 3.05.10	Clergy Vestry, Main Vestry, masonry: Localised re-pointing to remove damaging cementitious mortars. Isolated masonry repairs where required.	7,500

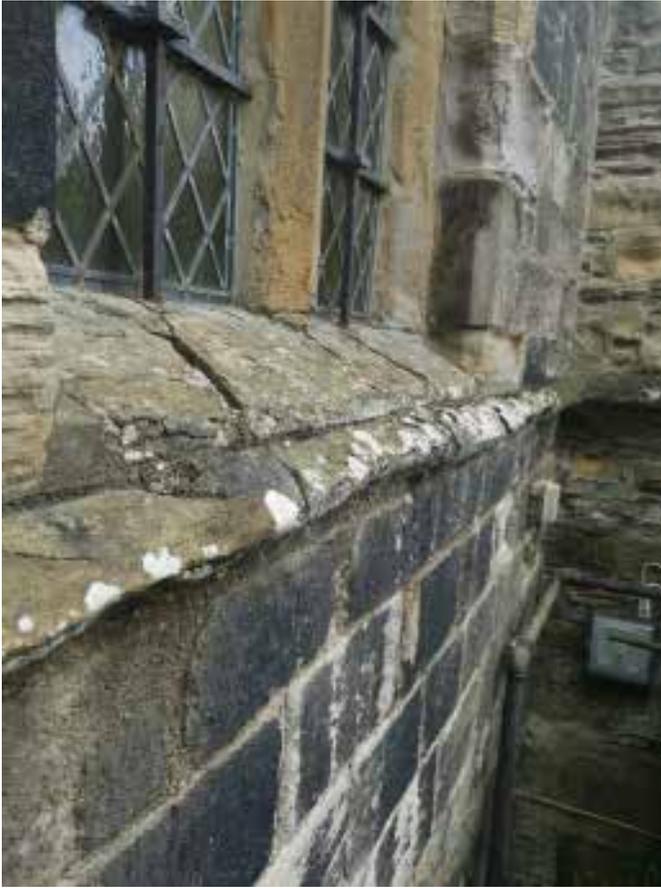
REF.	LOCATION / ITEM	DESCRIPTION	CONDITION/DEFECTS	RECOMMENDATIONS	PRIORITY
3.05.11	Former Organ Loft, masonry	Tooled squared coursed masonry up to projecting low parapet. Masonry blackened due to fire damage.	Masonry in fair condition with only minor localised deterioration of stonework around window reveal. String at window cill height heavily damaged and deteriorated. Cill to window also heavily damaged. Minor vegetation growth noted beside hopper. Masonry appears to be mostly gritstone which is surviving the hard mortar reasonably well, with the exception of dressed sandstone reveals to the window. Heavy algae growth at low boiler house basement level below ground.	Cill and stone string course below window to be locally repaired with stone indents. Remove algae from low level masonry and re-point. Ensure source of water is removed.	D

5)	3.05.11	Former Organ Loft, masonry: Stone string course to be locally repaired with stone indents.	3,000
6)	3.05.14	North Aisle, external doorway: masonry repairs to reveal and to hood mould.	2,000

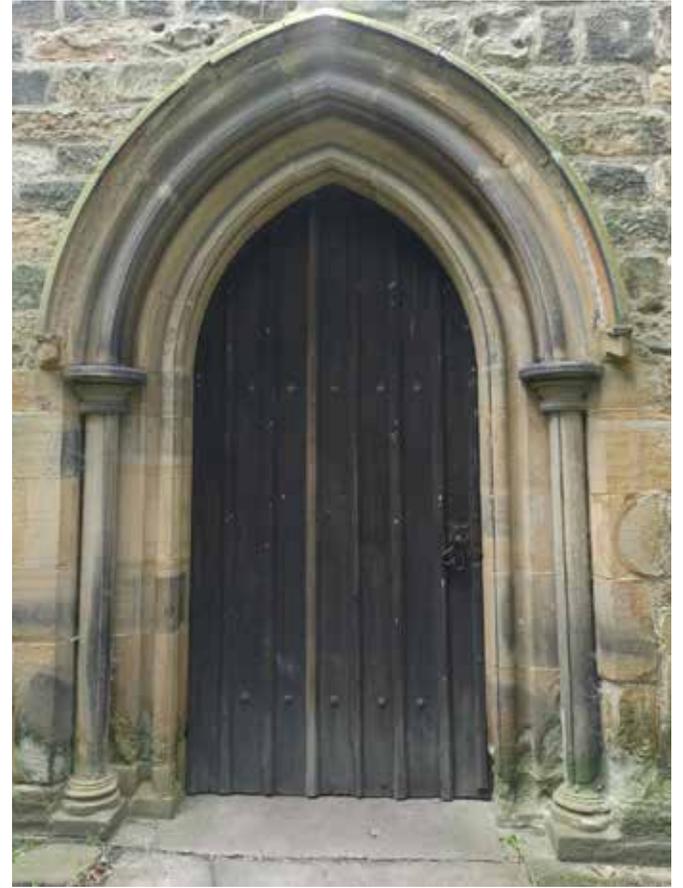
3.05.15	South Aisle doorway	Pointed arched opening with side pilasters, hood mould. Solid timber vertical boarded door.	Delamination and damage to hood mould. Masonry damage at low level.	Minor repairs to hood mould and low level masonry at jamb.	D

7)	3.05.15	South Aisle doorway: minor repairs to hood mould and low level masonry at jamb.	2,000
8)	3.07.0	South Aisle, Windows: replace mortar repair to mullion. Local repointing.	2,000

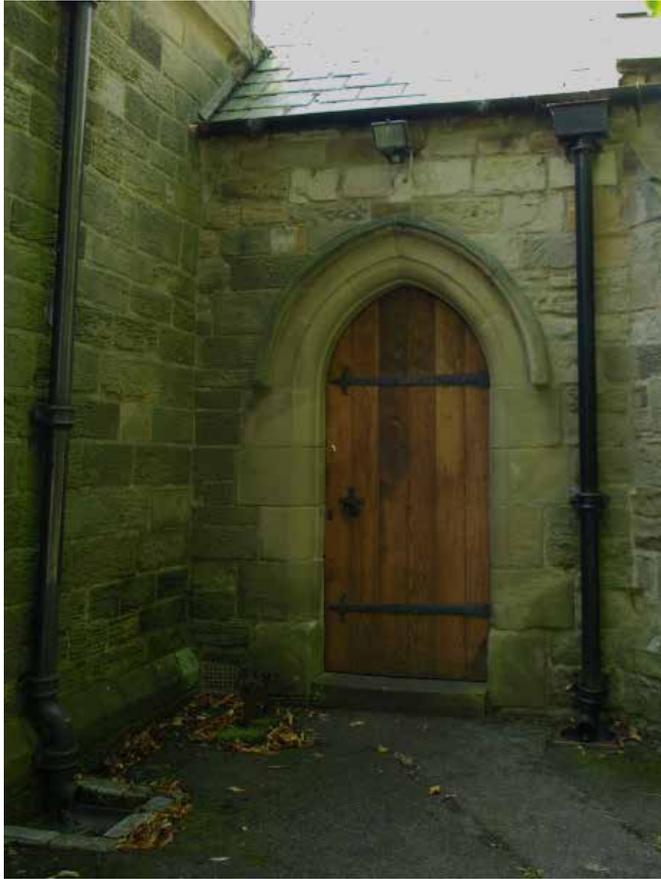
REF.	LOCATION / ITEM	DESCRIPTION	CONDITION/DEFECTS	RECOMMENDATIONS	PRIORITY
3.06 TIMBER PORCHES, DOORS, CANOPIES					
3.06.01	Main Vestry, door	Single leafed opening with pointed arched head, masonry hood mould and timber door leaf with iron strap hinges.	Good. Minor delamination to underside of hood mould. Timber door leaf condition good. Minor rusting to ironwork.	Rub back and redecorate ironwork to door leaf.	C

5)	3.06.01	Main Vestry, door: rub back and redecorate ironwork to door leaf.	1,000
6)	3.06.02	South aisle main door: de-rusting and redecoration of the ironmongery and lubrication of the hinges.	500

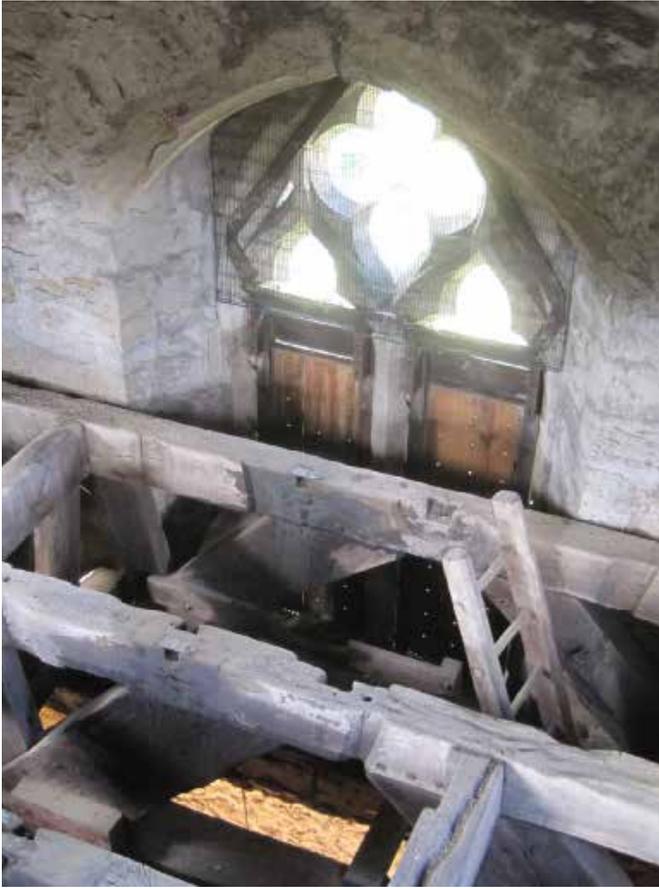
REF.	LOCATION / ITEM	DESCRIPTION	CONDITION/DEFECTS	RECOMMENDATIONS	PRIORITY
4.01 TOWERS, SPIRES					
4.01.01	Tower internal, Bell Chamber	Sandstone masonry walls, flush pointed with limewash, with patch repair cementitious slurry applied over in approx 60% of the areas.		Remove all damaging cementitious materials. Isolated consolidation and re-pointing where necessary. Ensure elimination of water ingress to north-east corner.	D

15)	3.07.09	Nave, North Elevation windows: Localised defrassing, re-pointing hood moulds. Localised masonry repairs.	3,000
16)	4.01.01	Tower internal, Bell Chamber: remove all cementitious materials. Isolated consolidation and re-pointing.	7,500

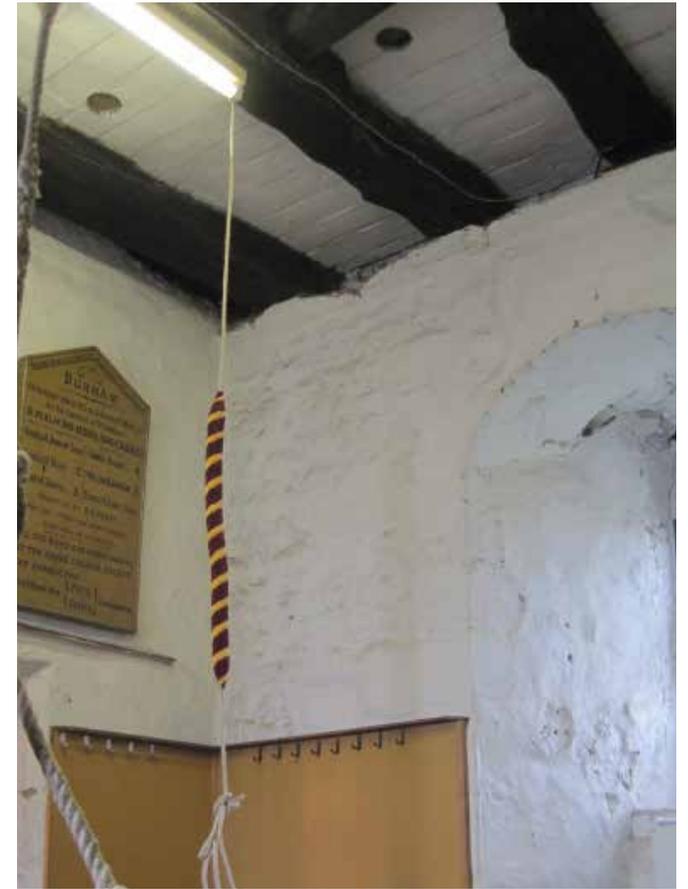
4.01.17	Ringing Chamber, ceiling	Heavy structural beams running north/south, stained dark, floorboards over seen from below, all likely 18 th century.	Appear sound. Minor areas of woodworm but likely historic.	Closer inspection of principal beams from ladder. Defrass where necessary.	D

19)	4.01.15 4.01.16 4.01.17	Ringing Chamber: scrape back loose plaster and paintwork to walls, localised patch repairs where necessary, redecorate. Lift carpet, level and re-secure boards. Inspection of principal ceiling beams from ladder - defrass where necessary.	5,000

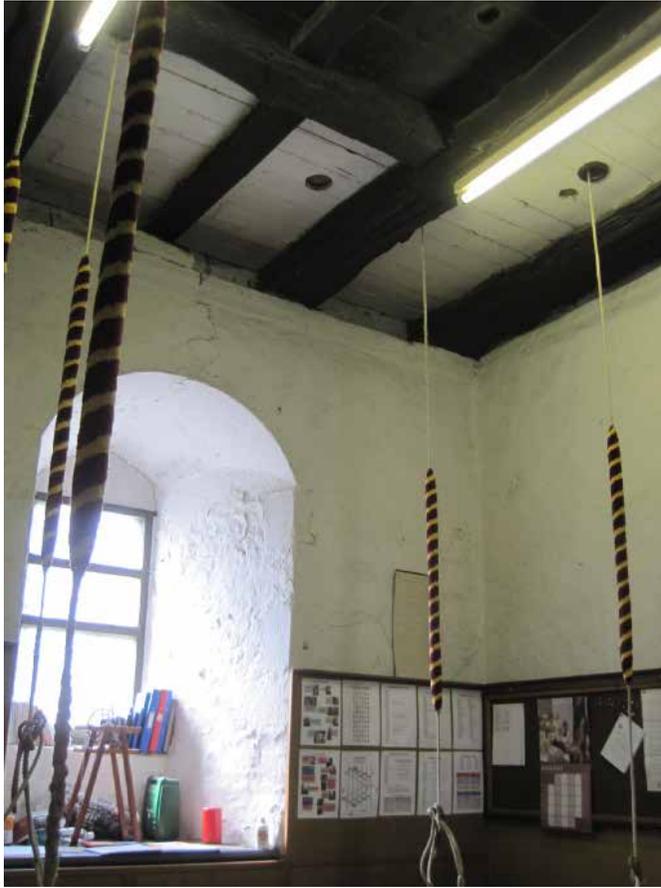
REF.	LOCATION / ITEM	DESCRIPTION	CONDITION/DEFECTS	RECOMMENDATIONS	PRIORITY
4.01.18	Ringing Chamber, windows	External diamond quarry leaded windows to exterior, with modern internal timber framed secondary window with Georgian wired glass, fully sealed.	Damp environment between the external and internal window panes evidenced by algae growth. Lack of ventilation to the Ringing Chamber is an issue.	Remove and discard modern internal timber window, repair original external windows, consider adding opening light or fixed vents to improve natural ventilation	C

9)	4.01.12	Former Ringing Chamber floor: re-fix loose or uneven boards to avoid trip hazards.	300
10)	4.01.18	Remove and discard modern internal timber window, repair original external windows, consider adding opening light or fixed vents.	1,000

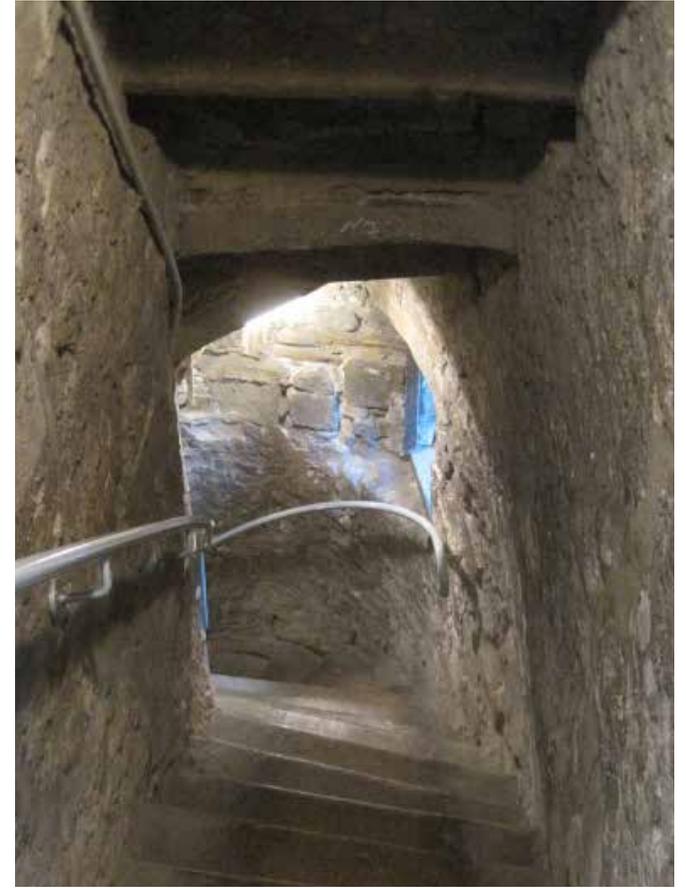
4.01.20	Tower internal, doors	Upper door into Ringing Chamber, modern, poor quality. Bottom door, timber boarded ledged to rear, good quality.	Upper door fair. Lower door good.	Upper door to be replaced in more appropriate material including draughtproofing. Lower door rub down and redecorate.	D

11)	4.01.20	Tower spiral stair from ground floor to Ringing Chamber: Localised consolidation of deteriorated masonry. Removal of areas of cementitious patching and covering of cracks, re-point in lime to enable monitoring of future movement.	10,000

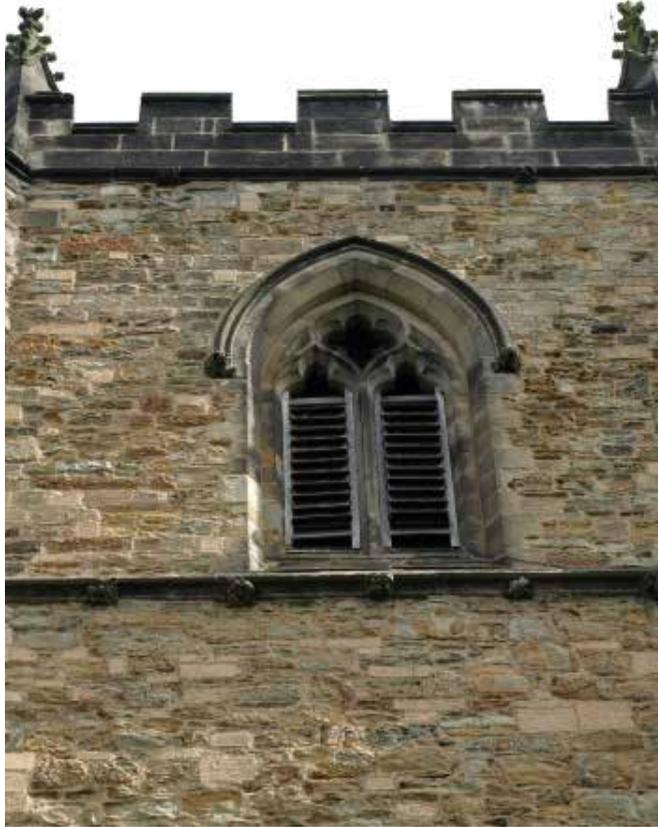
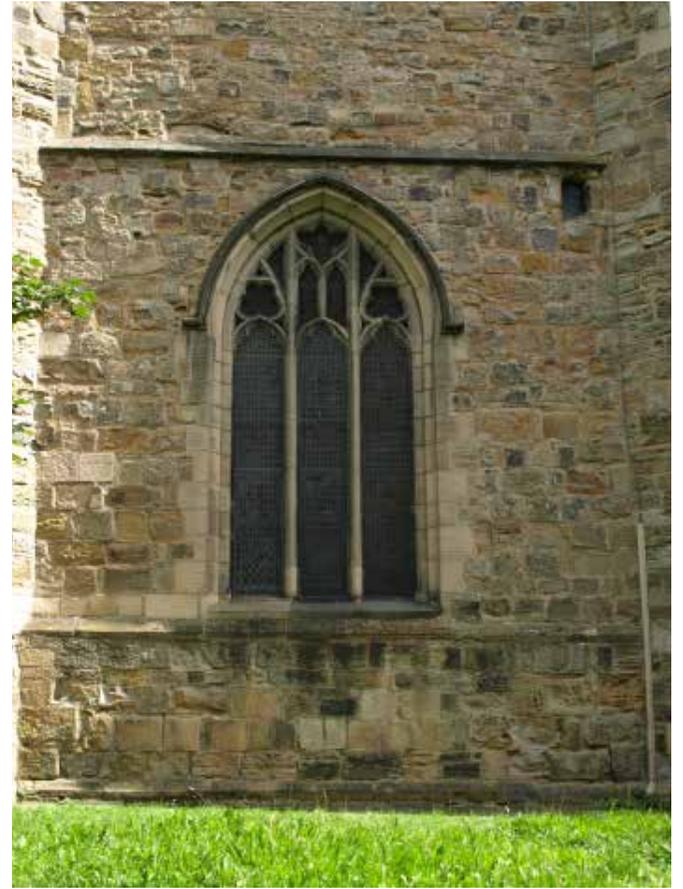
REF.	LOCATION / ITEM	DESCRIPTION	CONDITION/DEFECTS	RECOMMENDATIONS	PRIORITY
4.01.24	Tower external west elevation, openings	<p>Louvred opening to belfry with moulded hood mould and label stops and traceried opening. Oak timber louvres to exterior.</p> <p>Cusp headed window with plain leaded glazing at former bell ringing stage 2. Two small rectangular apertures to the tower stairwell and one large principal west window with hood mould over traceried tri-lancet window.</p>	<p>Louvred belfry opening generally in good condition. Deterioration to the stone sill. Timber louvres and frame in good condition.</p> <p>Cusped window in good condition, deterioration to more historic stonework at base of jamb and cill. Small windows to tower stairwell in fair condition. Cill stone to upper window in first stage is more severely weathered. Principal west window showing signs of minor stone damage at base of jambs, voussoirs to window head, and small sections within tracery. Open joints to hood mould.</p> <p>Condition of leaded panel to cusped opening is in fair condition, though slightly warped. Principal west window has metal wire security grilles fitted externally in good condition.</p>	<p>Localised re-pointing in with phased re-pointing works. To the cusped window, localised re-pointing and consolation of cill.</p> <p>To small stairwell windows, consolidation of stone replacement of cill of upper window.</p> <p>Principal west window, re-point open joints to hood mould, minor masonry repairs to window tracery and base of jambs.</p>	C

4)	3.05.01 4.01.20 4.01.22 4.01.23 4.01.24 4.01.25 4.01.26 4.01.27	Tower, external east elevation masonry: re-pointing including parapet, pinnacles and main walling stone, including localised stone repairs. Tower north elevation masonry: re-pointing including parapet, pinnacles and main walling stone, including localised stone repairs. Add lead caps to deteriorated string courses to aid water shedding. North elevation openings: localised re-pointing. Second stage window: repair glazing, localised re-pointing, particularly around historic stonework. West & south elevation masonry & openings: re-pointing including parapet, pinnacles and main walling stone, including localised stone repairs. Add lead caps to deteriorated string courses to aid water shedding. To the cusped window, localised re-pointing and consolidation of cill. To small stairwell windows, consolidation of stone replacement of cill of upper window. Principal west window: re-point open joints to hood mould, minor masonry repairs to window tracery and base of jambs.	70,000

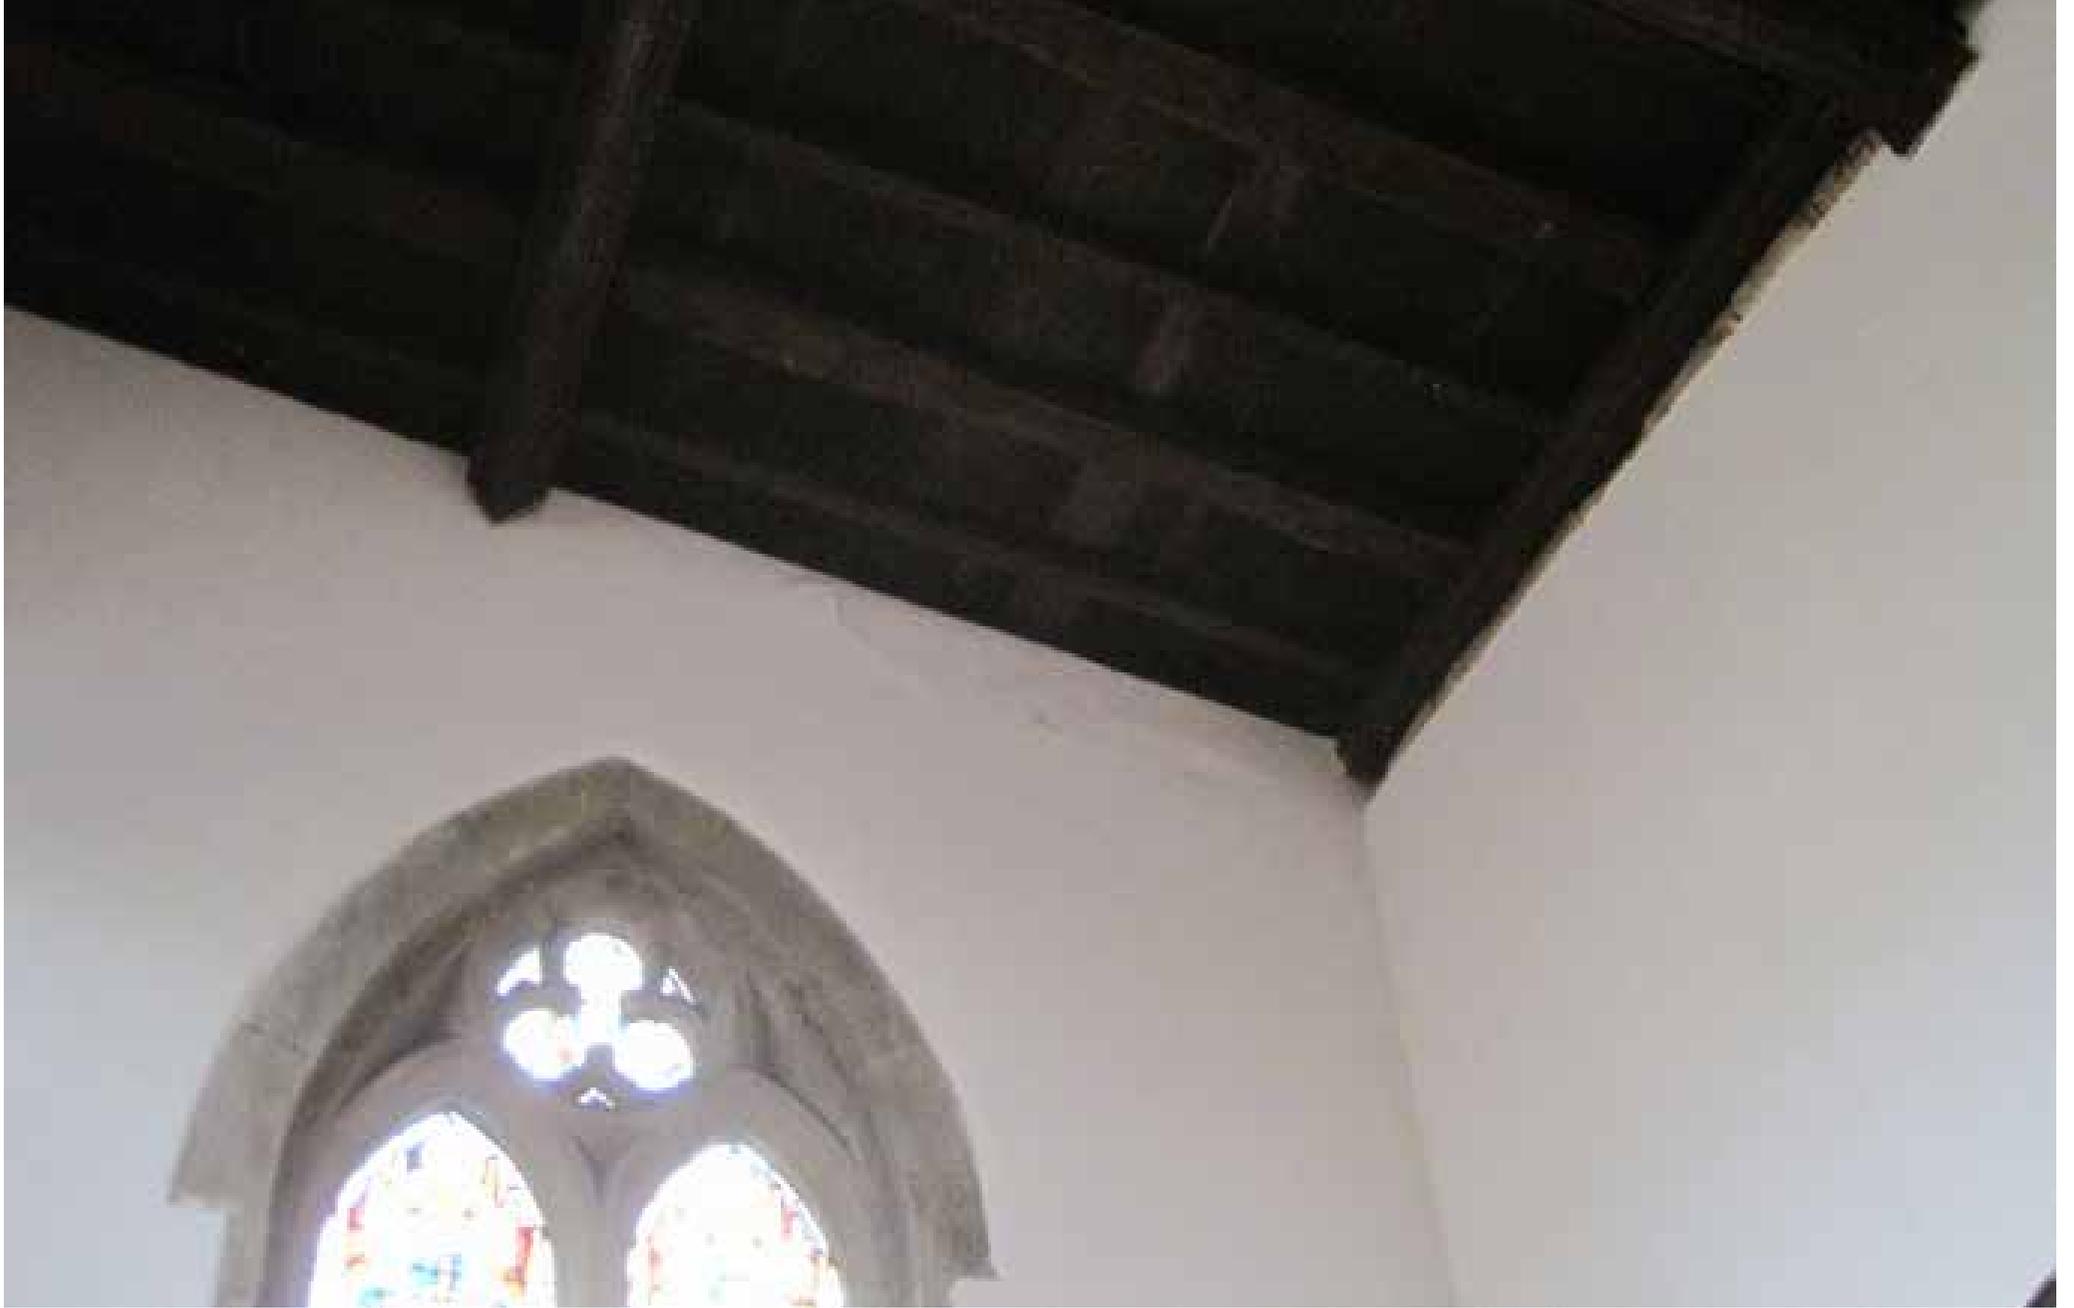
4.05.03	South aisle internal walls	Walls are panelled at low level, plastered and painted above.	Plasterwork and decoration appears to be in good order with the exception of a minor area of bubbling paint above the south door lobby at high level and a larger area of cracked plaster and evidence of water ingress to the east end of the south aisle at high level above the window. This corresponds to observed movement in the masonry of the aisle parapet in this location.	Make good external defects, allow area to dry out before re-decoration.	C

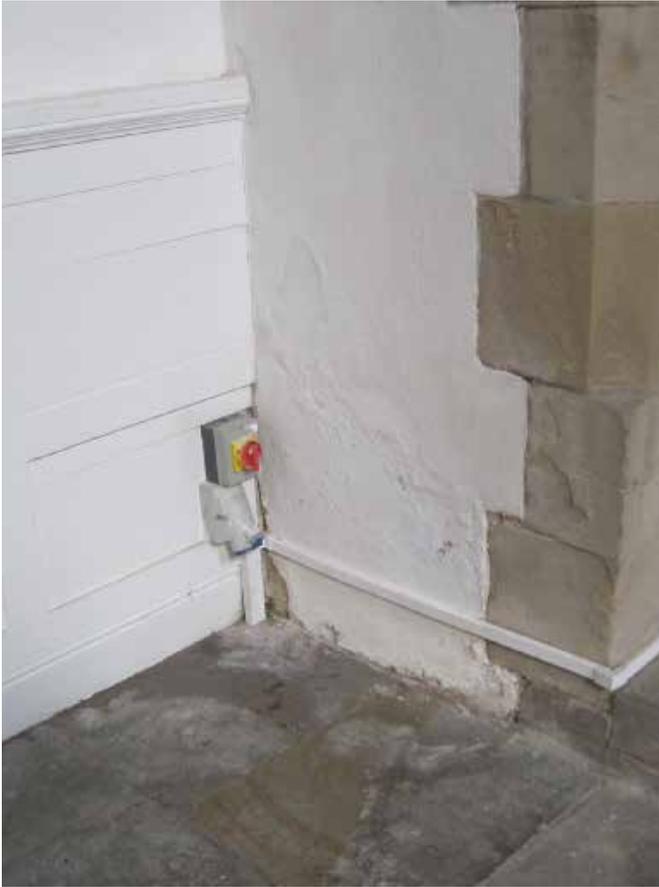
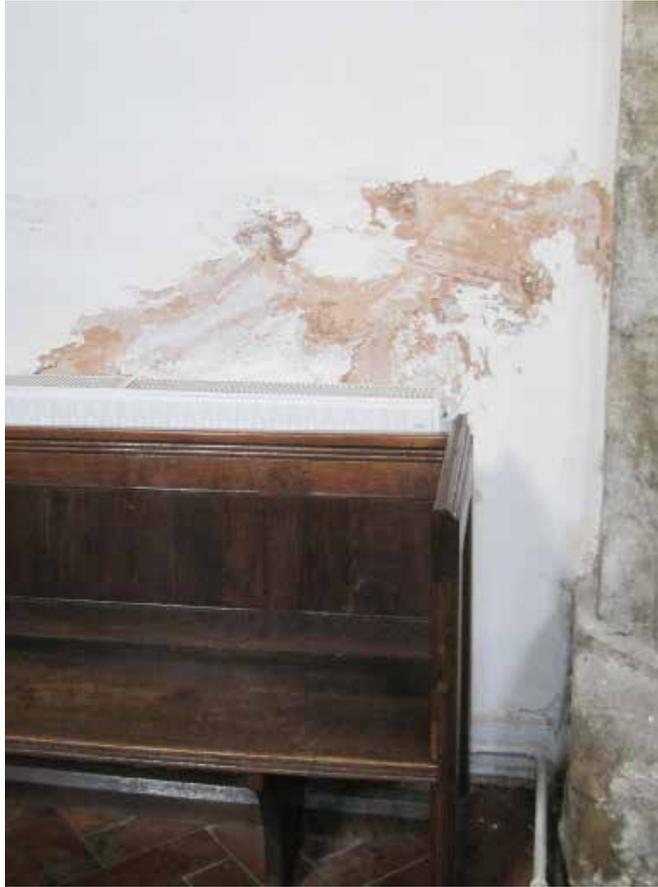
REF.	LOCATION / ITEM	DESCRIPTION	CONDITION/DEFECTS	RECOMMENDATIONS	PRIORITY
4.05.04	North aisle walls	Walls are panelled at low level, plastered and painted above and it would appear that in many places the plaster work has had a gypsum skim applied.	Generally good. Some minor loss of finish above the north door lobby and a more substantial area of damp affected plaster near the lobby steps and in the vicinity of the north aisle dividing arch. This is believed to correspond to the location of a blocked downpipe outside. To the east end of the north aisle there is suggestion of some historic water ingress at high level in the final bay of the aisle. This may relate to poor flashings above. There is a further sign of water ingress at low level at the corner of the former organ loft. This may relate to external drainage in this location. In the organ loft proper there is some evidence of water ingress at high level to the east wall above the coat of arms. Anecdotally this areas has leaked during heavy rain and this may be related to the condition of the copings and flashings to the roof in this location.	Make good external defects, allow area to dry out before re-decoration.	C

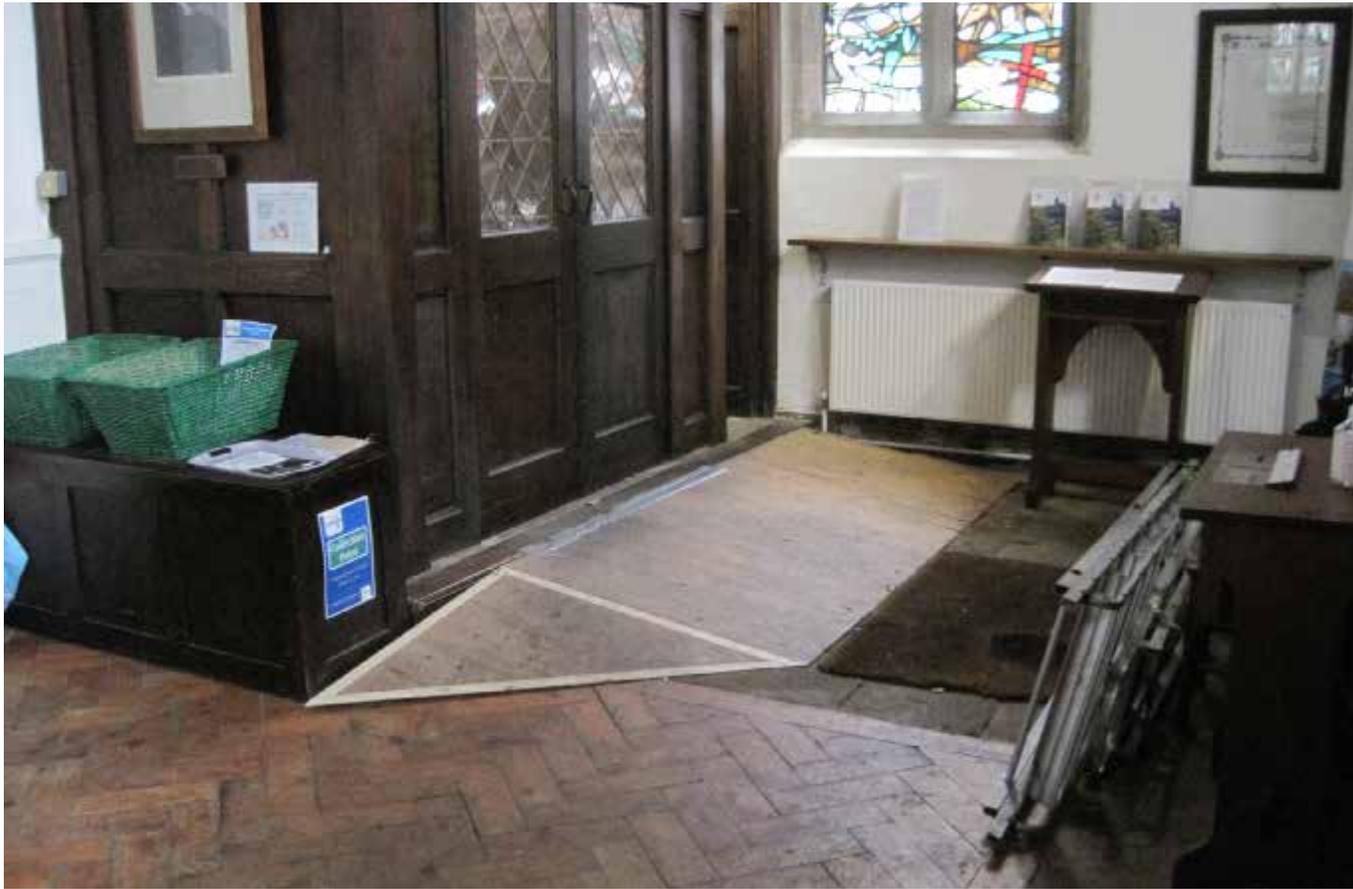
REF.	LOCATION / ITEM	DESCRIPTION	CONDITION/DEFECTS	RECOMMENDATIONS	PRIORITY
4.07.08	South Aisle floor structure	A combination of stone flags, cast iron heating grilles and the same timber herringbone parquet as elsewhere.	To the south door draft lobby a makeshift timber ramp has been fitted to effect wheelchair access. This ramp is very steep for a wheelchair user and creates a cross fall which would be difficult to negotiate in a self-propelled wheelchair. The intention is very good but the execution is not particularly successful.	Construct a new internal timber platform, flat and level to allow wheelchair users to enter the south aisle fully before progressing on to a longer ramp running parallel with the axis of the aisle. For ambulant users, a marked step down with handrail should be provided.	C

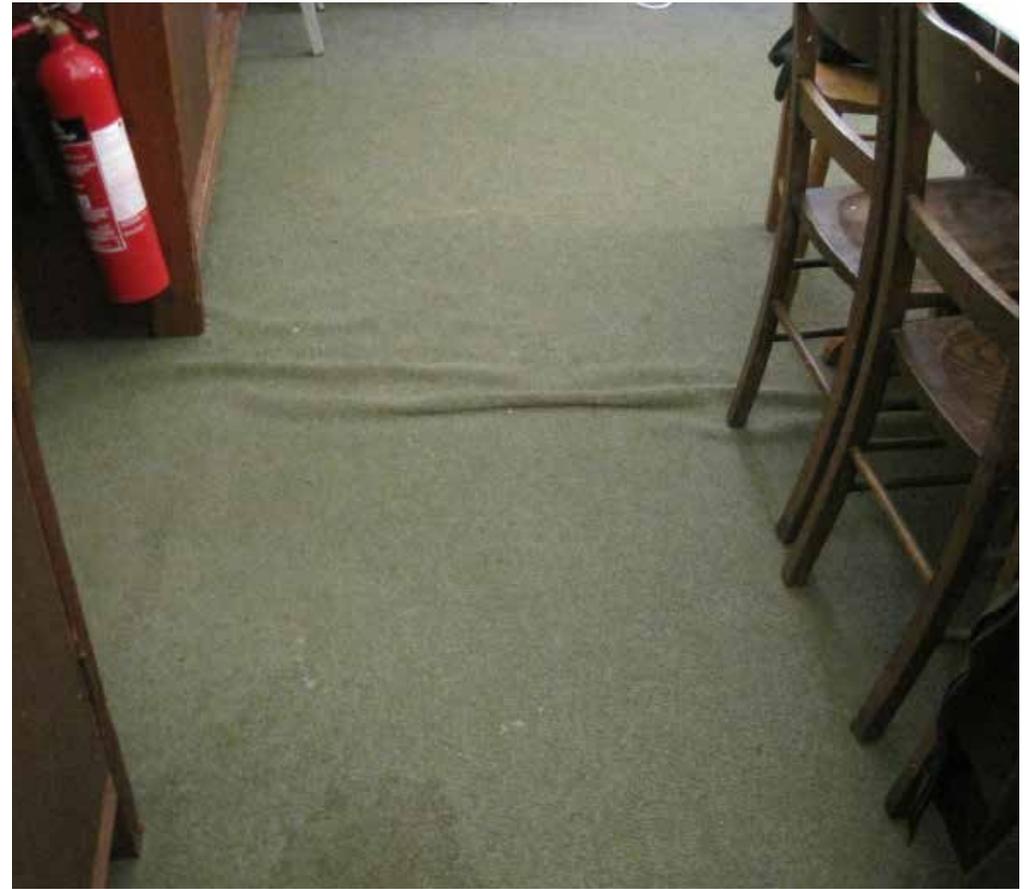
A rucked carpet in the Vestry is a trip hazard.

4.11.01	Vestry	A bright and functional space in a good state of decoration with plastered and painted ceilings and walls with timber panelling at low level. An area to the east has been enclosed to form a toilet and kitchenette equipped with sink. There are fixed cupboards providing storage for robes and a suspended timber floor.	Generally good throughout.	The Vestry carpet has become rucked in the middle. This is a trip hazard and the carpet should be re-stretched and re-fitted by a professional carpet layer to remove this rucking. If the carpet is stretched beyond repair then it should be replaced.	B

26)	4.10.05	Pulpit: secure the timber pulpit fully with discreet stainless steel brackets and fixings.	150
27)	4.11.01	Vestry carpet has become rucked in the middle. Re-stretch and re-fit by a professional.	150

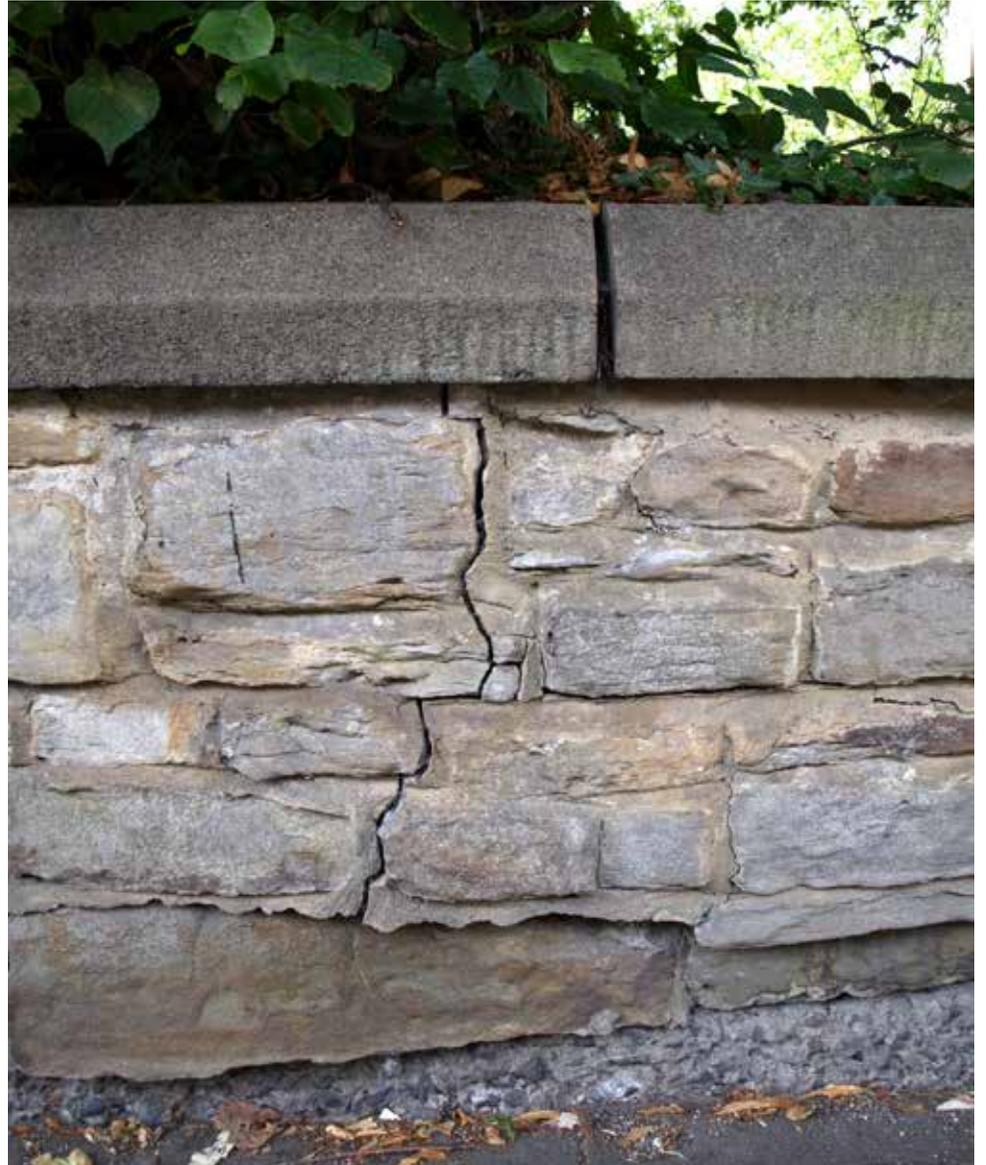
6.04.02, 6.04.03

6.04.02	Boundaries & gates	Church Street boundary retaining wall	Tree growth directly behind the wall will continue to cause damage to the masonry in the medium to long term.	A programme of tree removal should be planned, with roots grubbed out, the wall repaired, and a more appropriate form of planting developed e.g. meadow planting which allows a better view of the church from the road.	C
