# QUINQUENNIAL INSPECTION REPORT - MARCH 2026

## THE PARISH CHURCH OF **SAINT MICHAEL AND ALL ANGELS**

FRONT STREET, ESH, CO. DURHAM, DH7 9QY

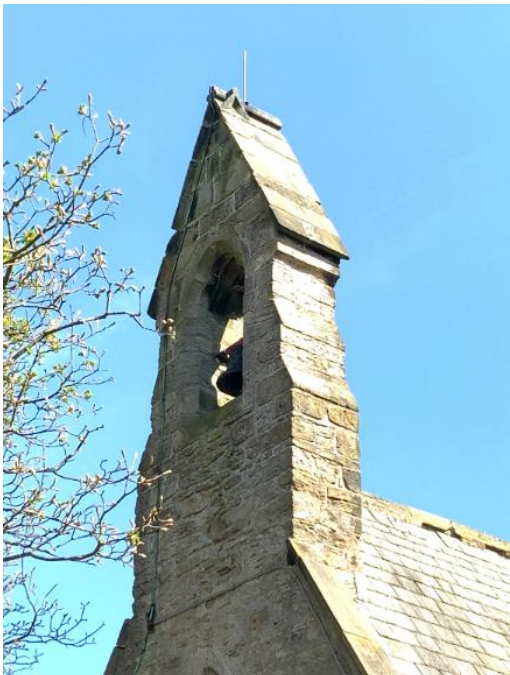
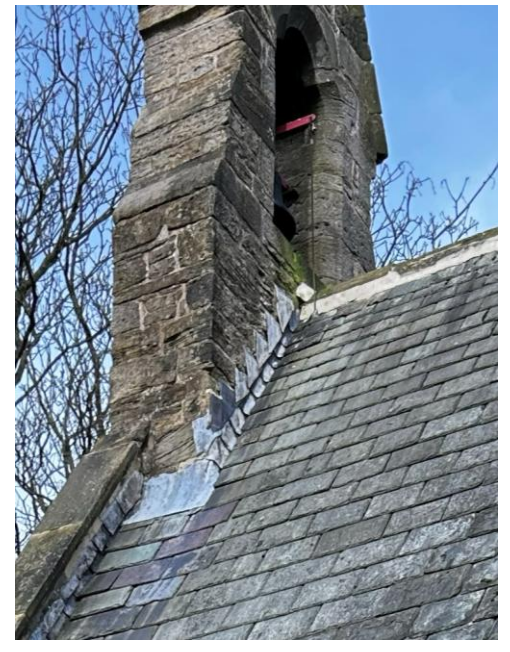
| | <b>Condition</b> <ul style="list-style-type: none"><li>• The 2009 report notes that the bell-cote was completely repointed between the 1994 and 2000 inspections, and the bell being remounted with new fittings, bearings, etc.</li><li>• Pointing remains in a sound condition.</li><li>• There are some large chips of stone missing from the projecting edge of the water tabling.</li><li>• Lightning conductor tape appears to be secure.</li><li>• The lead flashing has been re-fixed and stone joints have been re-pointed, during the 2024 roof works. Cover flashings and mortar bedding appear sound.</li><li>• There is a missing stepped cover flashing on the North East side of the bell-cote, but this has been replaced with a mortar fillet at some point in the past, and this remains stable.</li></ul> | |

| | <b>Repair Needs</b> <ul style="list-style-type: none"> <li>None required</li> </ul> | |

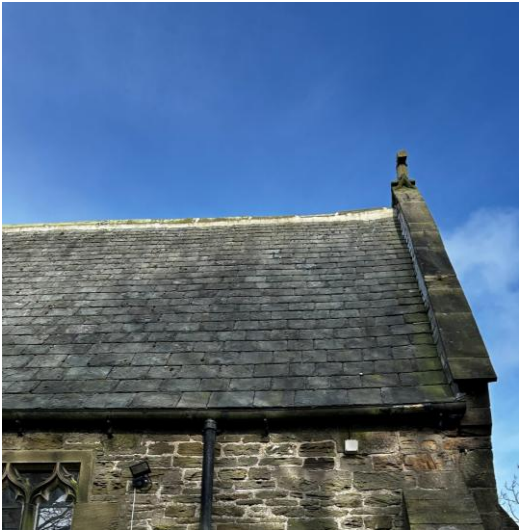
| | <b>Condition</b> <ul style="list-style-type: none"> <li>Some minor delamination of slates, but generally in sound condition.</li> <li>Extensive moss was removed during the 2024 roof works, however there is a small area of moss growth present.</li> <li>Flashings in sound condition.</li> <li>Ridge tiles have been re-bedded and a number were replaced where required during the 2024 roof works. Ridge tiles and bedding remain sound.</li> </ul> | |

| | <b>Repair Needs</b> <ul style="list-style-type: none"> <li>Monitor moss growth.</li> </ul> | M |

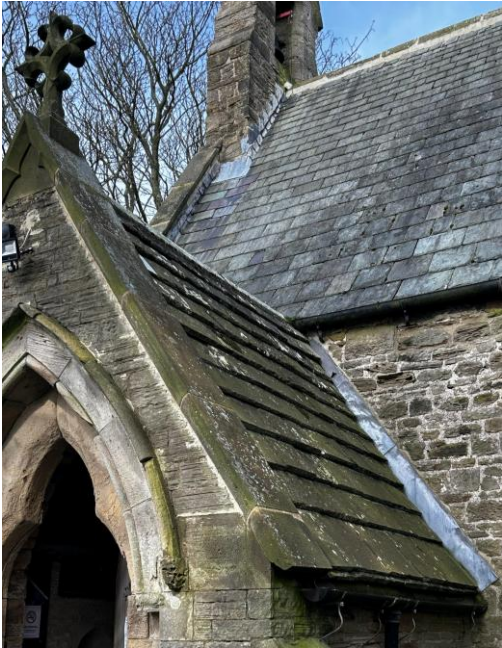
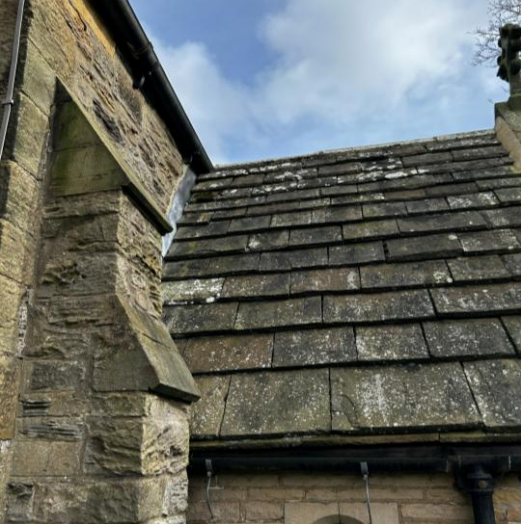
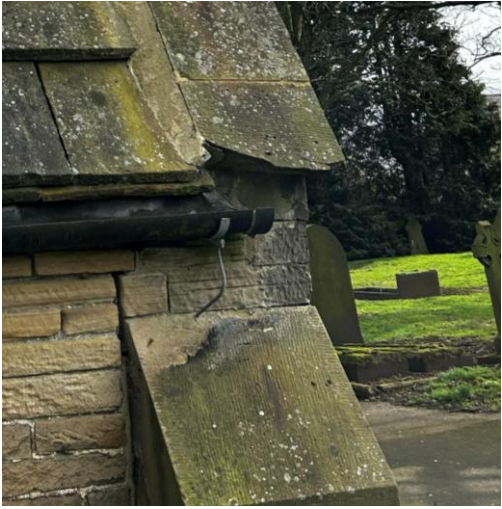
| | <b>Condition</b> <ul style="list-style-type: none"><li>• The roof remains in good condition.</li><li>• The mortar fillet to the South gable was replaced during the roof works in 2024 and remains sound.</li><li>• The bottom coping stone on the west hand pitch has chipped.</li></ul><br><b>Repair Needs</b> <ul style="list-style-type: none"><li>• Monitor coping stone for further degradation. This will need to be replaced in future as further weathering will start to affect its ability to shed water.</li></ul> | M |

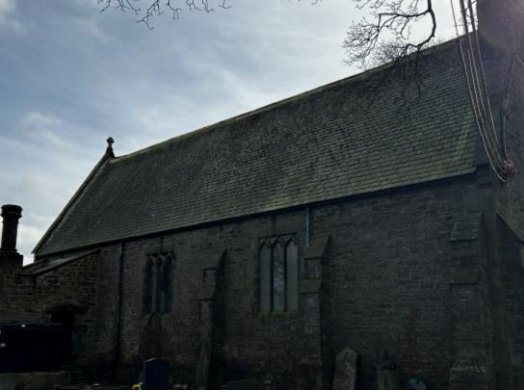
| | <b>Condition</b> <ul style="list-style-type: none"> <li>Some minor delamination of slates, but generally in sound condition.</li> <li>Flashings in sound condition.</li> <li>Ridge tiles were re-bedded in the 2024 roof works. Bedding and pointing remain sound.</li> </ul> | |

| | <b>Repair Needs</b> <ul style="list-style-type: none"> <li>None</li> </ul> | |

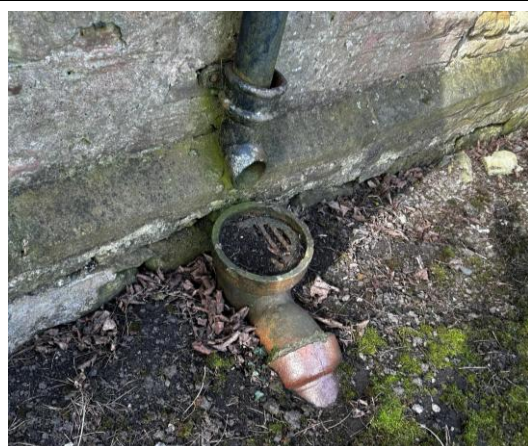
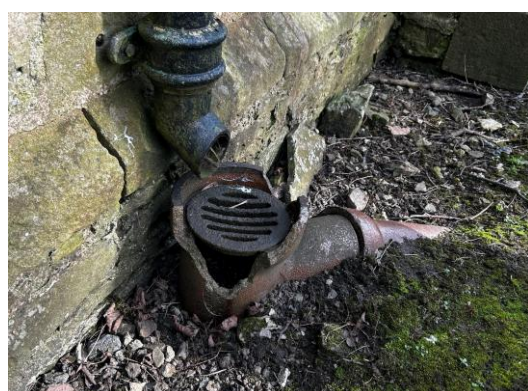
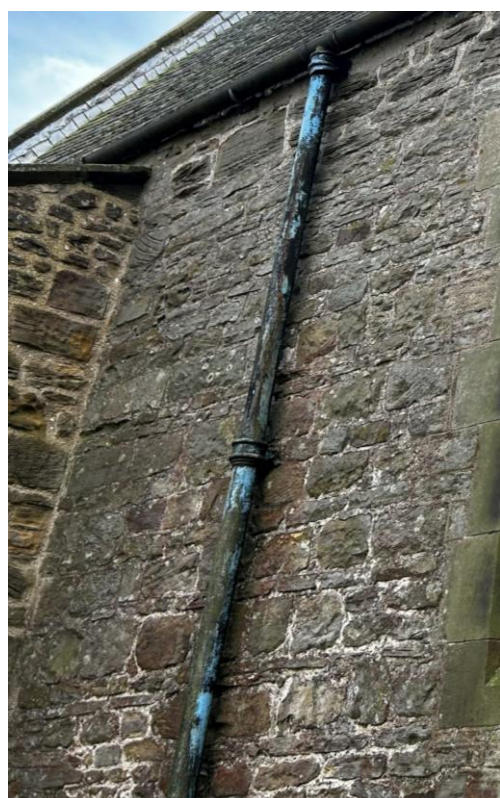
- Generally, the rainwater goods are in sound condition. It should be noted that this inspection was made on a dry day, so the opportunities for checking for leaks were greatly reduced.

- There is some leaf debris backed up in the gutter between the Porch roof and the western buttress.
- The clay pipe from the gully on the West side of the Transept appears to be broken.

- The gully on the South side of the Chancel has broken. It appears to be discharging normally.
- The gully on the East side of the Transept appears to be full of soil debris. This will limit its ability to function correctly.

- The gutter on the South side of the Chancel has been repaired, possibly a weld/solder. The repair is functioning.
- The downpipe on the North side of the Chancel offsets at the plinth. Previously blockages have been reported. Due to the dry weather, it has not been possible to say if this is still an issue.

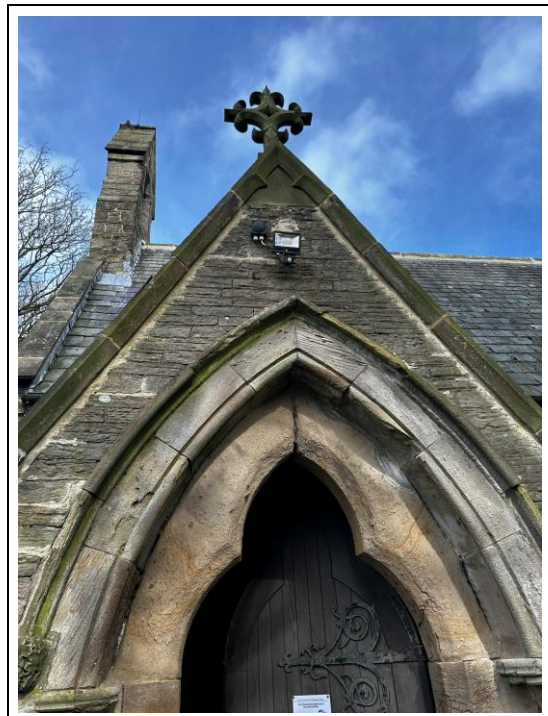
| | <p><b>Condition</b></p> <ul style="list-style-type: none"> <li>Copings to the porch were repointed and re-bedded in the 2024 roof works, and remains sound.</li> <li>There is some delamination occurring to the top surface of the Porch coping stones. This is a result of natural weathering. At some point, the top surface will debond, and this may have an impact on the stones ability to shed water.</li> <li>The lowest coping stone on the West side of the Porch has broken corners at its lowest point. Although unsightly, this is probably not resulting in water ingress.</li> <li>The cross above the Porch gable is sound and is not exhibiting any undue weathering.</li> <li>The coping stones to the Transept gable are sound.</li> <li>The apex stone at the Transept gable is weathering far faster than the adjacent coping stones because its stone 'bed' is exposed on one side. This weathering will continue slowly.</li> <li>The chimney stack at the Transept gable is sound and remains in reasonable condition. It appears to have been haunched with mortar on its top surface.</li> </ul> | |

| | <p>This haunching was out of sight and couldn't be inspected.</p> <ul style="list-style-type: none"> <li>The coping stones at the Chancel gable have been displaced in the past, and some iron cramps have been installed in the South slope to address this. There is displacement in the North slope too. The cramps have caused some copings to crack. The copings were re-pointed in the 2024 roof works and remain sound.</li> <li>The cruciform finial at the apex of the Chancel Gable is showing signs of heavy weathering. It appears to be leaning slightly to the West, although this could be an optical illusion due to the movement in the coping stones.</li> <li>The coping stones to the Vestry are soundly bedded and pointing is in reasonable condition.</li> <li>The chimney stack in the corner of the Vestry has been repointed in small area at top during 2024 roof works and remains sound.</li> <li>The coping stones at the West Gable are themselves sound and have been re-pointed and re-bedded during 2024 roof works and remain sound.</li> </ul> | |

| | <p><b>Repair Needs</b></p> <ul style="list-style-type: none"> <li>The upper surface of the coping stones to the Porch gable should be monitored for further delamination.</li> <li>The apex stone on the Transept gable will benefit from replacement in the longer term.</li> </ul> | <p>M</p> <p>E</p> |

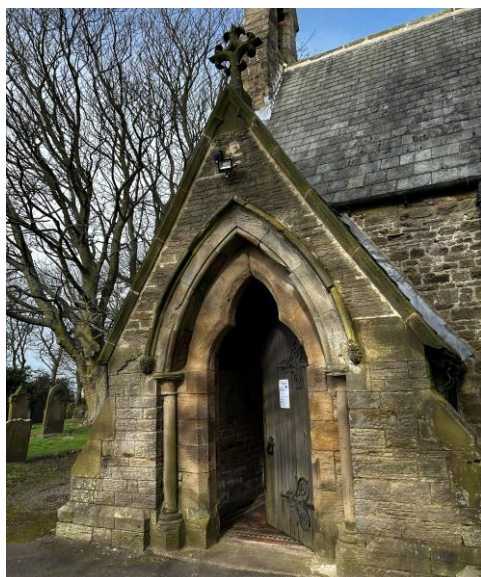
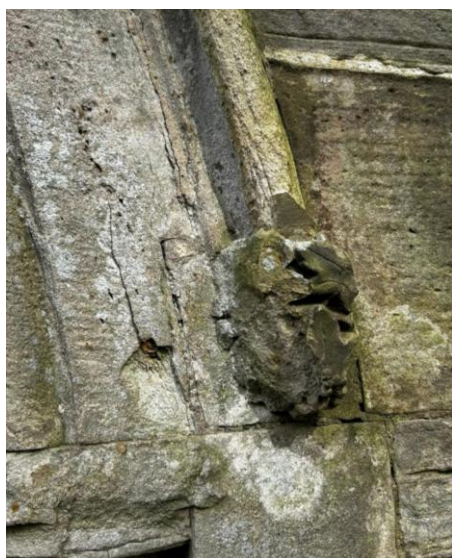
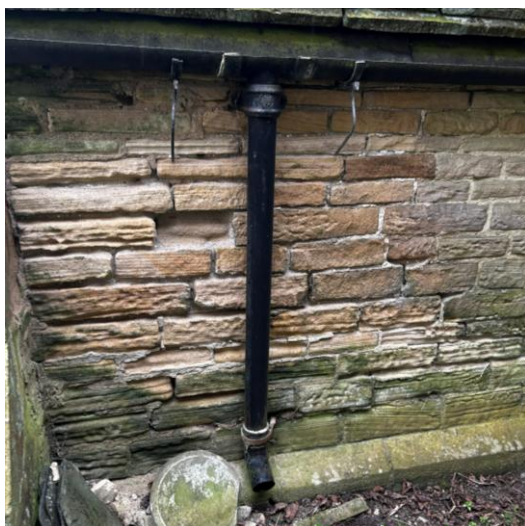
- There is delamination of the ashlar stone which is integral with the lowest coping stone, on the left hand side.
- There is pronounced weathering of the roll-mould above the arch including chips and cracks, and also a loss of clarity in the features of the leaf-stops at each side, probably caused by excessive dampness in the wall.

- There are some areas of stonework at low level which should be repointed using lime mortar.
- The gable will continue to weather slowly, and at some point some replacement stonework will be required.

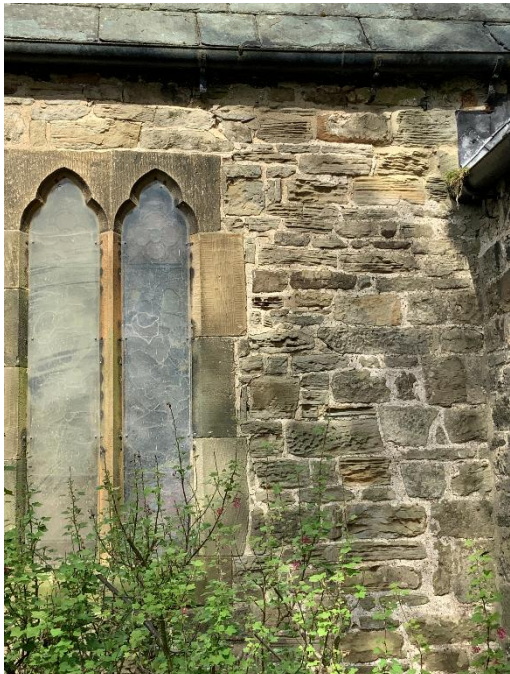
| | <b>Condition</b> <ul style="list-style-type: none"> <li>Pointing is in reasonable condition. Some low level pointing has weathered out that will require repointing.</li> <li>There is pronounced weathering to one or two stones. There will be a need for isolated stone replacement at some point in the future.</li> </ul> | |

| | <b>Repair Needs</b> <ul style="list-style-type: none"> <li>Repoint mortar joints at low level with suitable lime mortar.</li> </ul> | D |

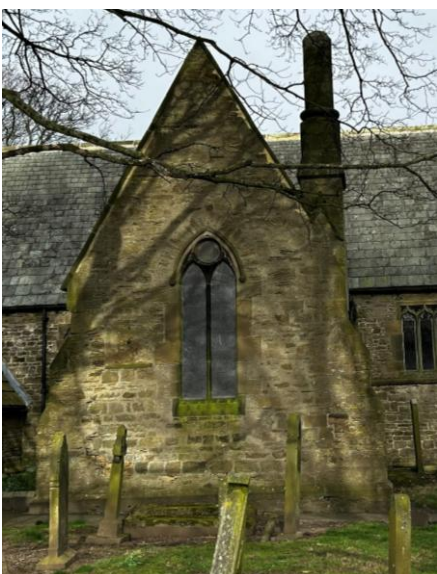
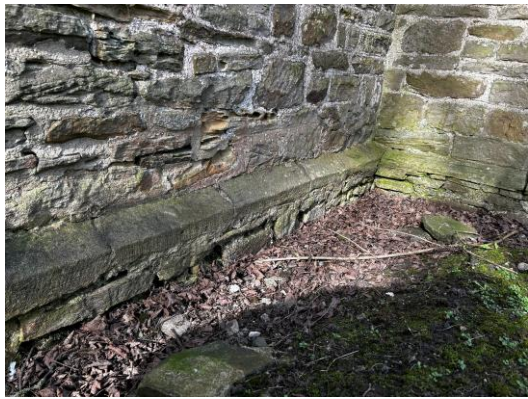
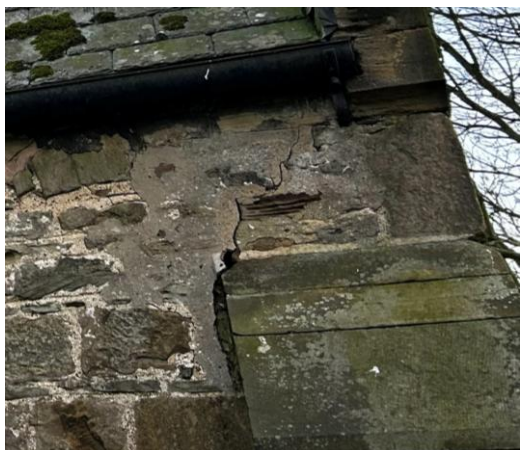
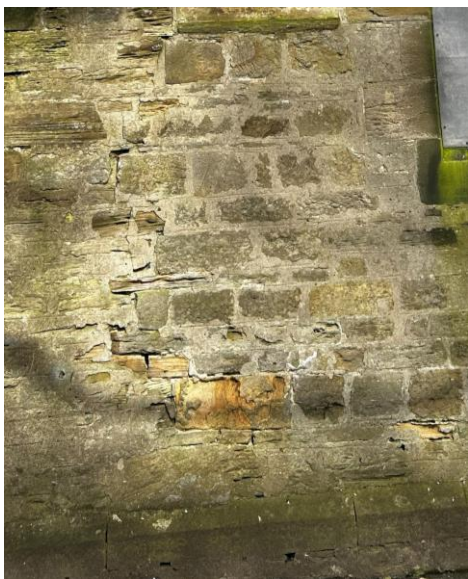
| | <b>Condition</b> <ul style="list-style-type: none"> <li>Walling is generally sound, although with some pronounced weathering to isolated stones, as elsewhere. There is a need for repointing at low level below the plinth line.</li> </ul> | |

| | <ul style="list-style-type: none"> <li>Some areas have been repointed poorly with cement-based mortar and this is exacerbating the stone degradation.</li> <li>The cracking in the wall at the head of the Western buttress, noted in the last report, which had been patched with cement mortar, does not seem to have worsened since the last inspection. However this should be repointed to limit any water ingress.</li> <li>The area of stonework to the Western side of the gable window still needs repointing. The stonework continues to weather badly here, exacerbated by previous use of cement mortar.</li> <li>The remains of an inset sundial can be seen to the left of the gable window, although it is badly eroded.</li> <li>An area of stonework to the left of the window on the East side of the Transept is in need of repointing.</li> </ul> | |

| | <p><b>Repair Needs</b></p> <ul style="list-style-type: none"> <li>Repoint the crack at the head of the buttress on the left-hand side of the gable.</li> <li>Carry out localised repointing to areas identified, using suitable lime-based mortar.</li> </ul> | <p>D</p> <p>D</p> |

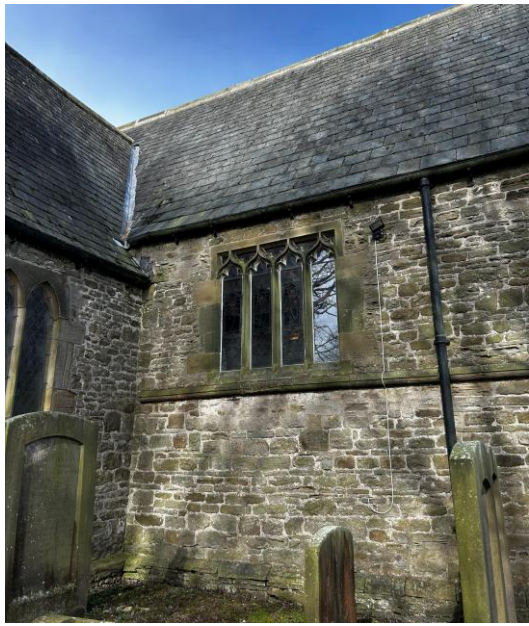
| | <b>Condition</b> <ul style="list-style-type: none"> <li>Walling is generally sound, although with some pronounced weathering to isolated stones, as elsewhere.</li> <li>Some areas have been repointing poorly with cement-based mortar and this is exacerbating the stone degradation.</li> <li>Some of the lower parts of the wall around the plinth are in need of repointing.</li> </ul> | |

| | <b>Repair Needs</b> <ul style="list-style-type: none"> <li>Carry out localised repointing to areas identified, using a suitable lime based mortar.</li> </ul> | D |

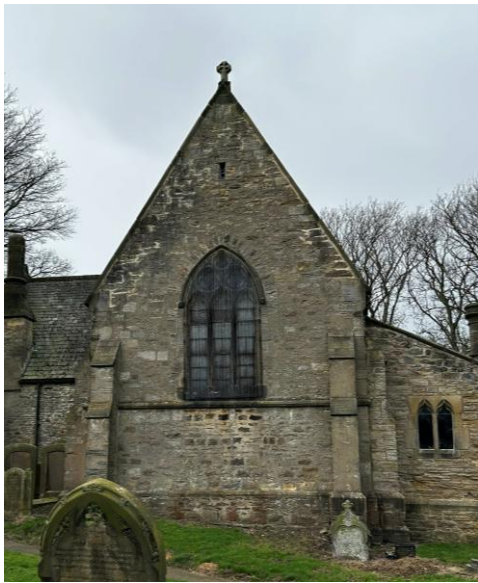
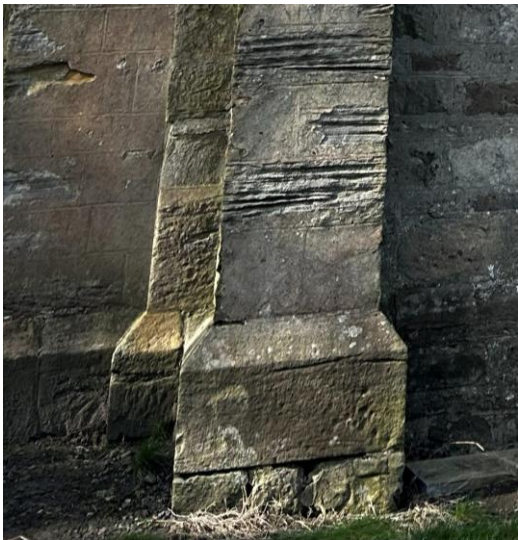
| | <p><b>Condition</b></p> <ul style="list-style-type: none"> <li>• Walling is generally sound, although with some pronounced weathering to isolated stones, as elsewhere.</li> <li>• Some areas have been repointed poorly with cement-based mortar and this is exacerbating the stone degradation.</li> <li>• There has been some recent repointing to stonework at high level beneath the copings, this has been done in a suitable lime mortar. All remains sound.</li> <li>• Some of the lower parts of the wall around the plinth are in need of repointing.</li> <li>• There is some staining beneath the window caused by runoff from the window grille.</li> <li>• There is some cracking in the mortar fillets where the buttresses at the North East corner meet the main wall, perhaps indicative of some movement.</li> </ul> | |

| | <p><b>Repair Needs</b></p> <ul style="list-style-type: none"> <li>• Carry out localised repointing to areas identified, using a suitable lime based mortar.</li> </ul> | D |

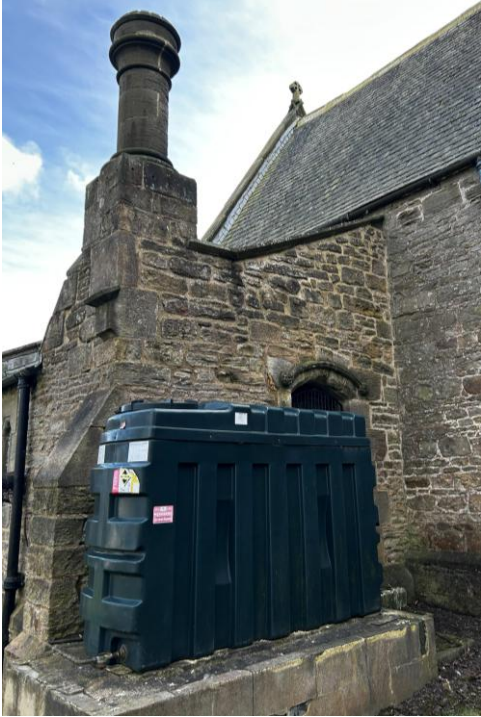
| | <p><b>Condition</b></p> <ul style="list-style-type: none"> <li>• Walling is generally sound, although with some pronounced weathering to isolated stones, as elsewhere.</li> <li>• Pointing appears sound, although it is not clear whether it is lime or cement.</li> <li>• The oil tank plinth is unsympathetic to the church and would benefit from being faced with stone or screened from view.</li> <li>• There is some dampness to the west side wall behind the oil tank and around the vestry door.</li> <li>• The stone steps up to the vestry door are covered in moss.</li> </ul> | |

| | <p><b>Repair Needs</b></p> <ul style="list-style-type: none"> <li>• Face the oil tank plinth with stone, or screen it.</li> <li>• Remove moss from stone steps</li> </ul> | <p>E<br/>M</p> |

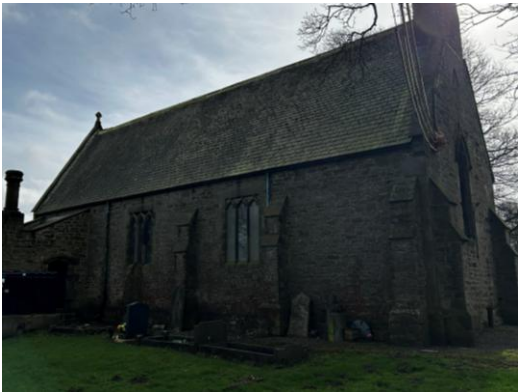
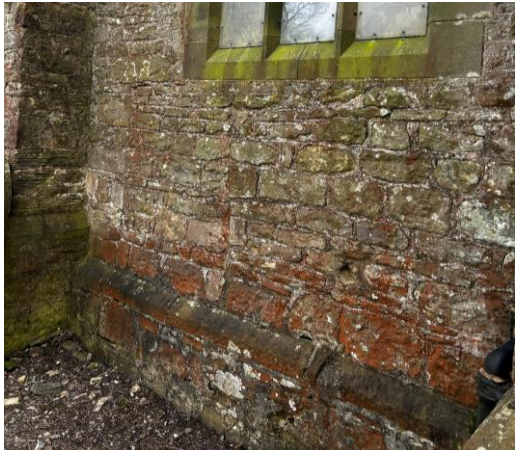
| | <p><b>Condition</b></p> <ul style="list-style-type: none"> <li>• Walling is generally sound, although with some pronounced weathering to isolated stones, as elsewhere.</li> </ul> | |

| | <ul style="list-style-type: none"> <li>Some areas have been repointing poorly with cement-based mortar and this is exacerbating the stone degradation.</li> <li>Stonework at plinth high level would benefit from repointing.</li> <li>There is some rust coloured residue on the stone at low level across the elevation. Most likely an algae / lichen growth.</li> </ul> | |

| | <p><b>Repair Needs</b></p> <ul style="list-style-type: none"> <li>Carry out localised repointing to areas identified.</li> <li>Monitor the rust algae / lichen growth for condition worsening.</li> </ul> | <p>D<br/>M</p> |

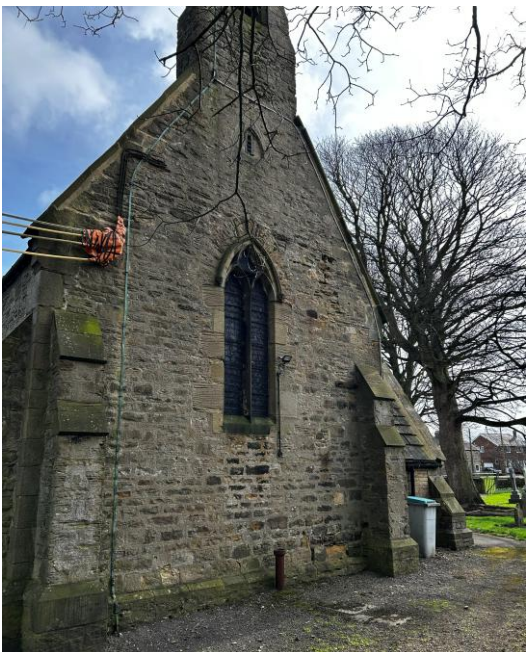
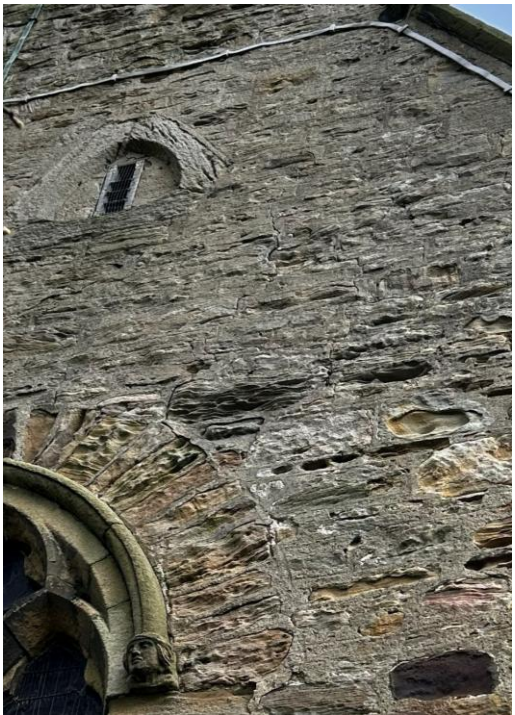
| | <p><b>Condition</b></p> <ul style="list-style-type: none"> <li>The walling is sound, but there is considerable weathering of the surface, resulting in pitting and hollowing of the stone face. This stone loss is pronounced in some places, notably the head of the arch over the window and an area to the right of this. There are a couple of stones at knee level which are also weathering poorly. See photo.</li> <li>This is being exacerbated by the hard cement pointing which has been applied at some point in the past. Removal of the pointing will cause further</li> </ul> | |

| | <p>damage to the stone face so it should be left to weather away. Isolated stone replacements will be required at some point in the future.</p> <ul style="list-style-type: none"> <li>The long crack in the walling running from the window head upwards for about six feet does not appear to have propagated further since the last report. However this should continue to be monitored.</li> <li>The cables and lightning cable attached the elevation appear soundly fixed.</li> </ul> | |

| | <p><b>Repair Needs</b></p> <ul style="list-style-type: none"> <li>Carry out isolated areas of repointing, using lime mortar.</li> <li>Monitor the cracking in the wall above the window head.</li> </ul> | <p>D</p> <p>M</p> |

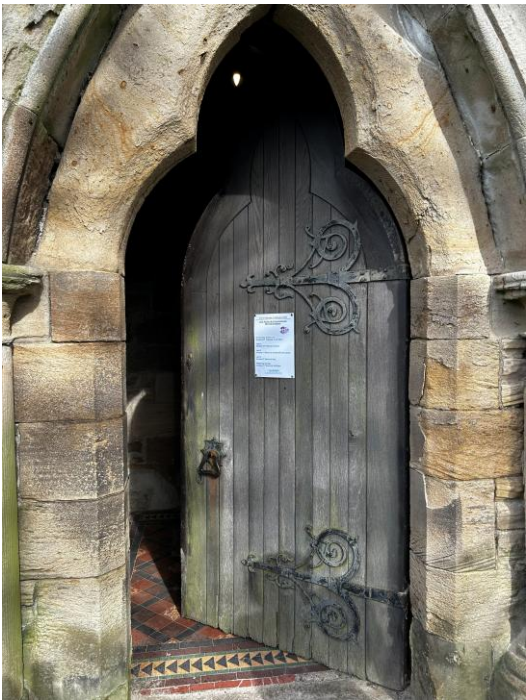
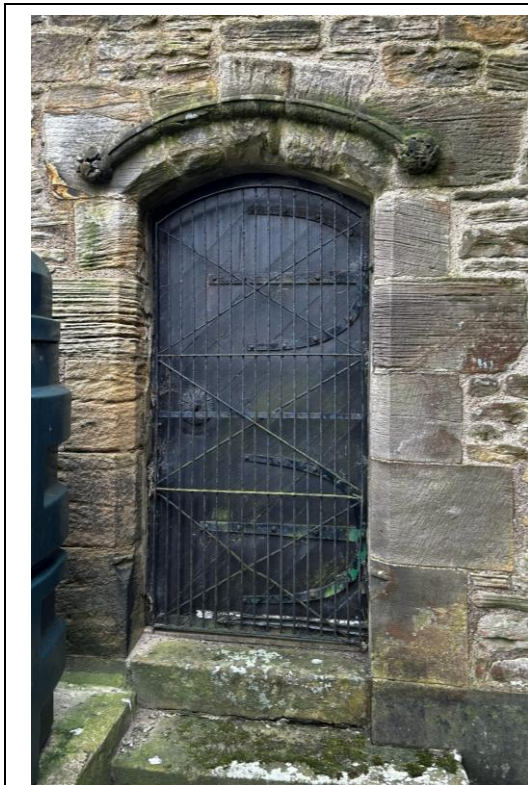
- The exterior door to the vestry (D2) is in sound condition. There is pronounced weathering to the stone arch, particularly around the keystone, although no remedial action is needed now. There is an outer iron security gate which doesn't latch to the stonework and so moves freely. The timber door has preservative woodstain which is failing at the base of the door and it would benefit from replacement. The weatherbar at the base of the door has completely come away and needs to be replaced.

- Glue the large splinter at the top of the front door with a suitable exterior grade wood glue.
- Repaint the front door with preservative woodstain.
- Repaint the rear vestry door with preservative woodstain, and replace the weatherbar at the base.

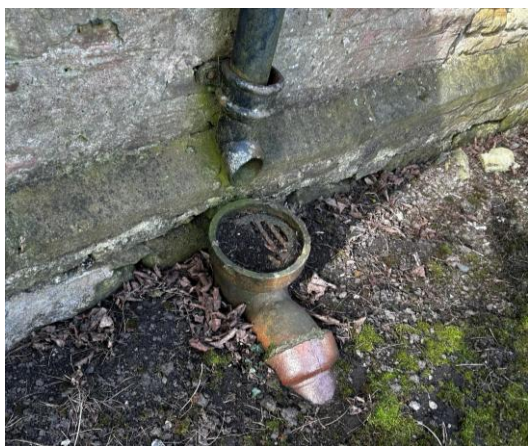
| | <p><b>Condition</b></p> <ul style="list-style-type: none"> <li>• The state of the surface water drainage system can't be assessed, except to say that all gullies appear to be emptying. Except the gully on the East side of the Transept which appears to be full of soil debris. This will limit its ability to function correctly and should be cleared.</li> </ul> | |

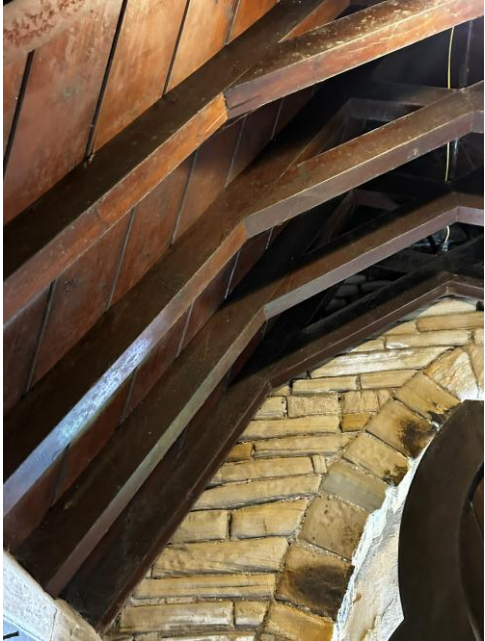
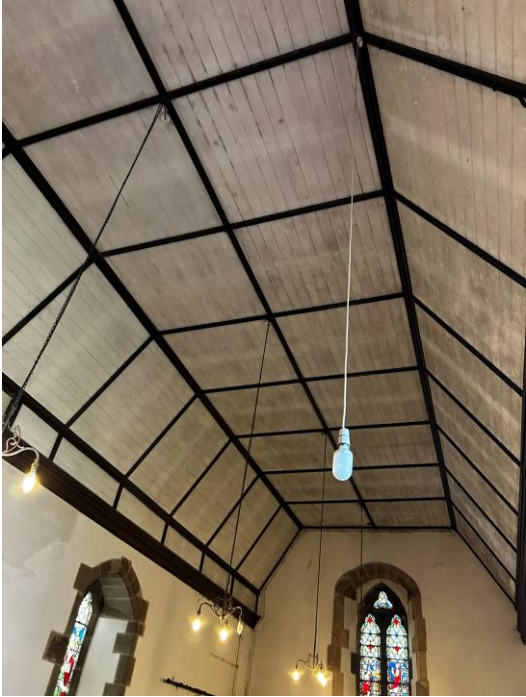
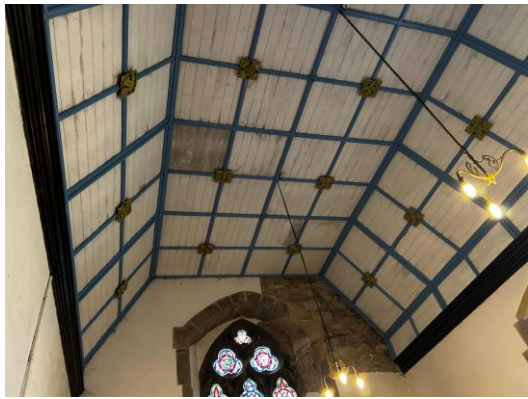
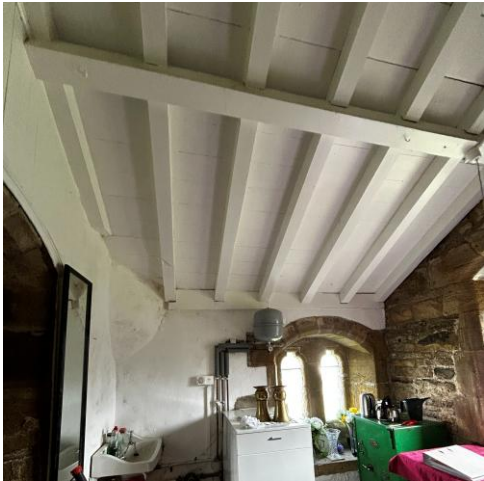
| | <p><b>Condition</b></p> <ul style="list-style-type: none"> <li>• The roof structure and ceiling in the porch is in good condition.</li> <li>• The ceilings in the Nave and Chancel have considerable discolouration and mould growth due to condensation. There are some areas with pronounced discolouration, but the reason could not be ascertained. There are some areas of pronounced colour variation which are unsightly.</li> </ul> | |

| | <ul style="list-style-type: none"> <li>The ceiling in the Transept is discoloured and is showing some mould growth too.</li> <li>The roof structure above the Vestry is sound.</li> </ul> | |

| | <p><b>Repair Needs</b></p> <ul style="list-style-type: none"> <li>The ceilings in the Nave, Chancel and Transept need to be repainted. Care should be taken when specifying appropriate paints.</li> <li>Take note that <u>historic paintwork may contain lead</u>, and thus any work carried out should be done by experienced tradespeople using appropriate methods.</li> </ul> | E |

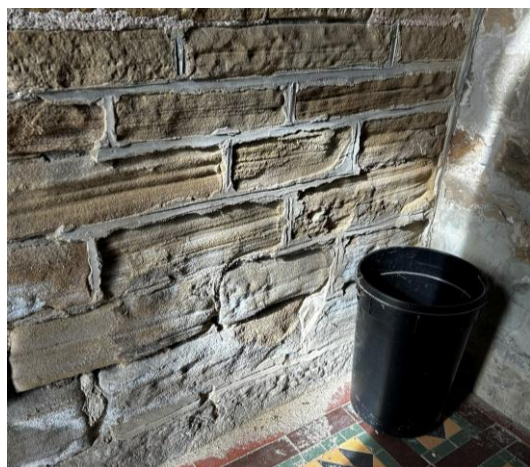
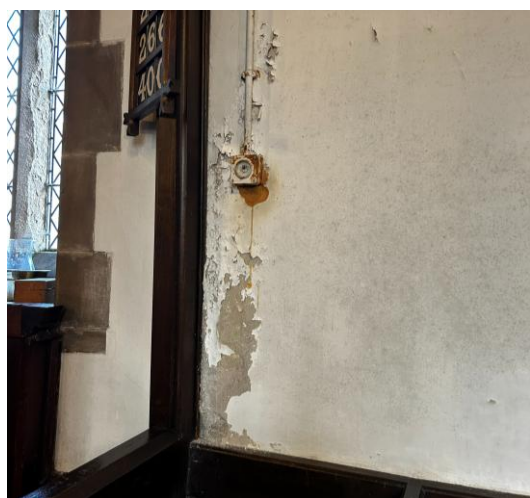
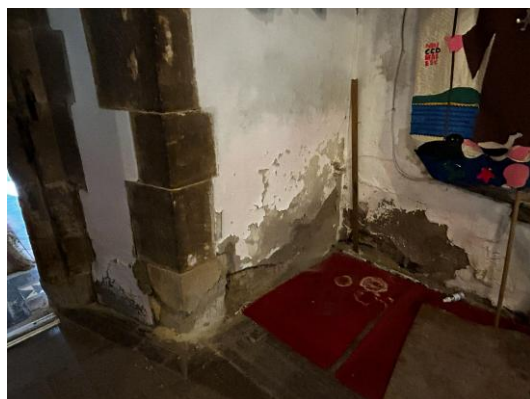
| | <p><b>Condition</b></p> <ul style="list-style-type: none"> <li>The porch walls are in fair condition, although there is some presence of dampness in the lower parts, and some areas of missing mortar which will be attributed to the dampness. On the west wall, the stone is suffering from erosion and is now set back</li> </ul> | |

from the mortar which was noted in the last report as being cement mortar, which will be exacerbating the problem. Rev. Peers noted that stone dust/debris is often found on the floor of the porch.

| | <p><b>Repair Needs</b></p> <ul style="list-style-type: none"> <li>• The Chancel, Nave, Transept and Vestry would benefit from being repainted, with some minor plaster repairs in advance of this, where damage has occurred to plaster.</li> <li>• Re-plaster the area above the chancel gable window.</li> <li>• Monitor the vertical crack in the SW corner of the Transept</li> <li>• Consider repointing internal porch walls with a suitable lime mortar to address the dampness.</li> </ul> <p>Any plaster repairs should be carried out with lime-based plasters rather than those containing cement or gypsum. Lime plaster will permit the masonry to breathe fully.</p> | <p>E</p> <p>E</p> <p>M</p> <p>E</p> |

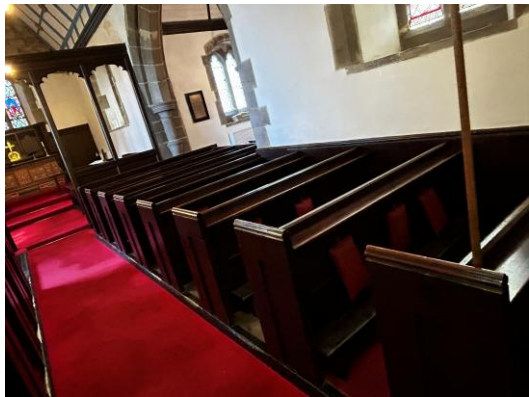
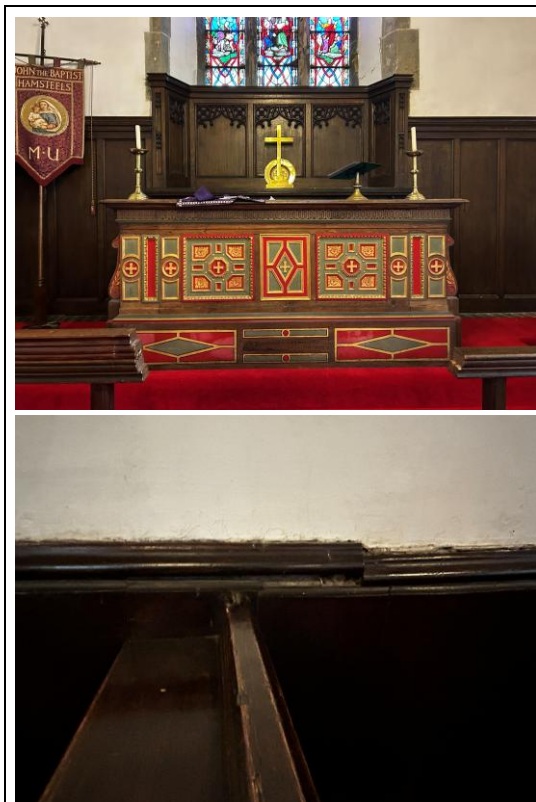
| | <p><b>Condition</b></p> <ul style="list-style-type: none"> <li>• There is some distortion of the paneling, perhaps due to structural movement in the church, or the result of dampness in the supporting timberwork. This should be monitored.</li> </ul> | |

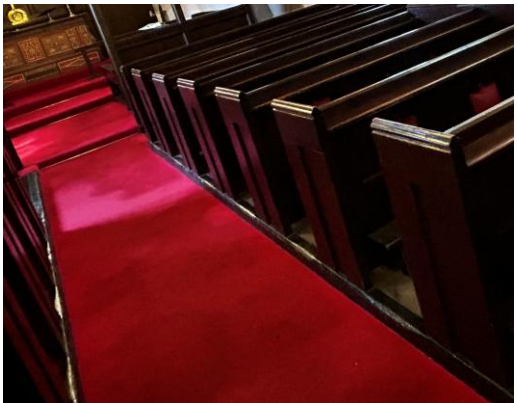
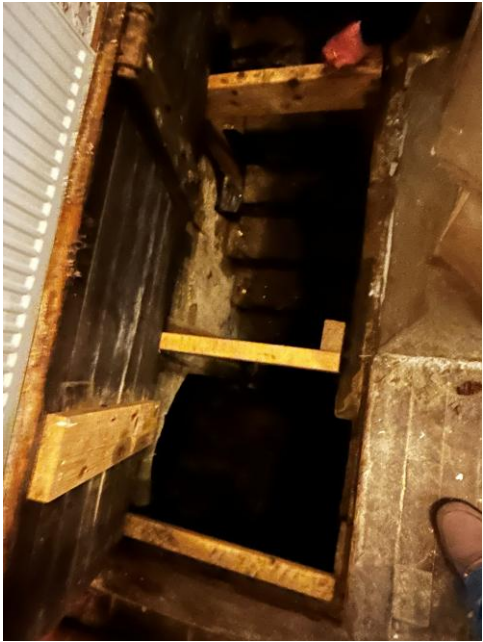
| | <p><b>Condition</b></p> <ul style="list-style-type: none"> <li>The tiled floor in the Porch is generally sound, although there is a loose triangular tile around the inset entrance matting.</li> <li>The raised timber flooring appears to be solid.</li> <li>The woodblock flooring in the Nave is very uneven, but not exceptionally so for a building of this age. The finish is wearing and it would benefit from being sanded back and re-varnished. The carpet runner is in good condition.</li> <li>The basement chamber access hatch is covered with carpet, however Rev Peers removed the carpet and opened the hatch for inspection. The hatch opens adequately and a supporting structure has been built below to support the hatch.</li> <li>The raised floor of the Chancel was covered by carpet and could not be inspected fully, but it appeared to be sound. The carpet is in good condition.</li> <li>The timber floor in the Vestry was covered by carpet and could not be inspected fully, but it appeared to be sound. The carpet was in good condition.</li> </ul> | |

| | <p><b>Repair Needs</b></p> <ul style="list-style-type: none"> <li>Refix the loose floor tile in the porch.</li> </ul> | C |

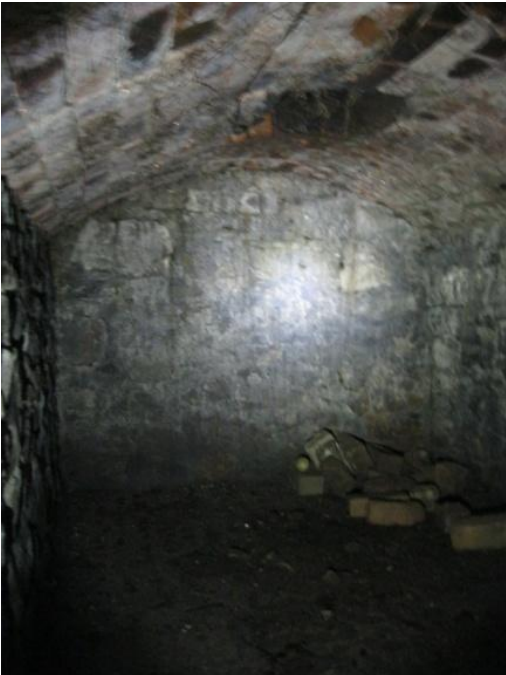
| | <p><b>Condition</b></p> <ul style="list-style-type: none"> <li>• The author did not access the basement. The notes and photos below are from the last report. It is noted in the next section that a lack of ventilation in the chamber is probably partly responsible for damage to the base of the font.</li> <li>• The masonry of the coal chamber and heating chamber would benefit from some repointing, particularly in the area under the nave where bricks have come loose. This will consolidate the structure.</li> <li>• The heating chamber does not appear to have much by way of ventilation, leading to potentially damaging conditions for the iron and timber. This was noted in previous reports. However, the conditions in the floor void do not appear to be causing imminent risk of rot.</li> <li>• The timber stored in this area, as noted in previous reports, appears to have been removed, as advised.</li> <li>• There is some severe corrosion to some steel beams which should be treated with rust inhibitor.</li> </ul> | |

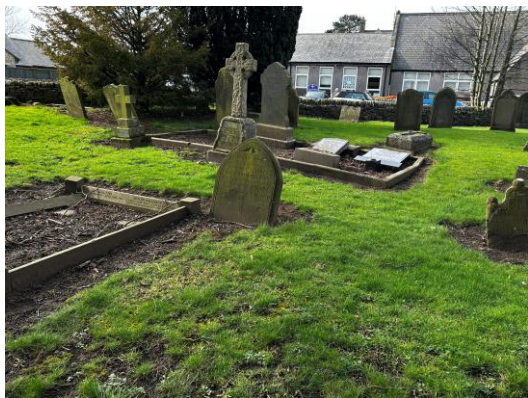
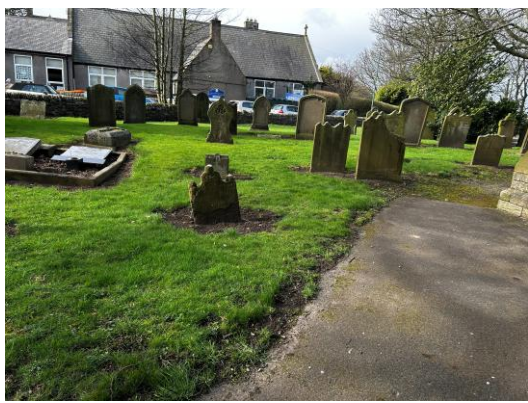
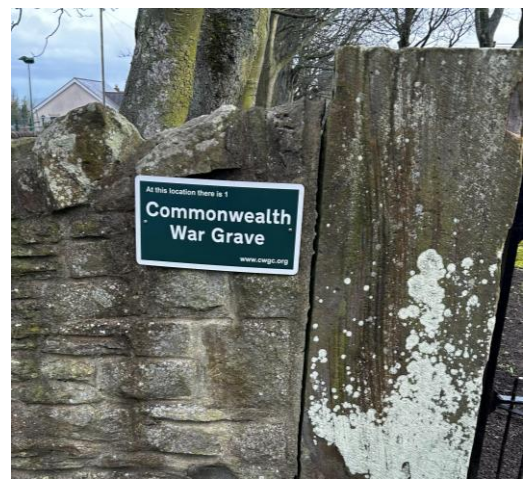
| | <b>Condition</b> <ul style="list-style-type: none"> <li>• The headstones vary in condition, and some have been laid flat to the ground and are degrading, whilst others are leaning apparently precariously. The previous report notes that the Local Authority had inspected these in recent years and that any found unsafe had been laid flat.</li> <li>• A number of gravestones have been laid flat and are being grown over by grass. They would benefit from being cleared, and if possible, lifted and laid flat on gravel, to prevent further damage.</li> </ul> | |

| | <b>Repair Needs</b> <ul style="list-style-type: none"> <li>• The Local Authority should be called on to inspect some of the leaning headstones for stability. It is preferable for unstable headstones to be repositioned vertically and secured in place with suitable foundations, rather than being laid flat which will hasten their degradation.</li> <li>• Clear back vegetation from graves which are laid flat.</li> </ul> | <div>B</div> <div>M</div> |

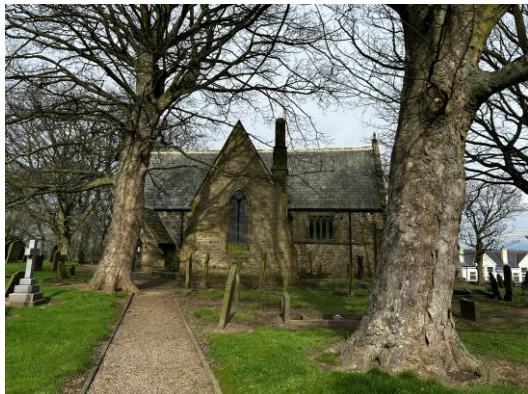
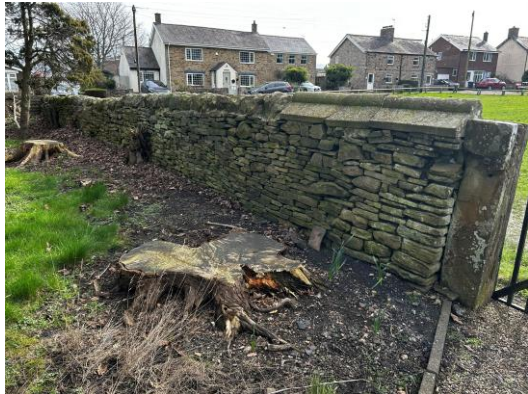
| | <p><b>Condition</b></p> <ul style="list-style-type: none"> <li>• The large trees to the South and West of the church are growing close to the Transept and the Nave, and in time may pose a risk. They may need to be pruned back in the future. They will be depositing leaves into the church gutters which must be kept clear at all times.</li> </ul> | |

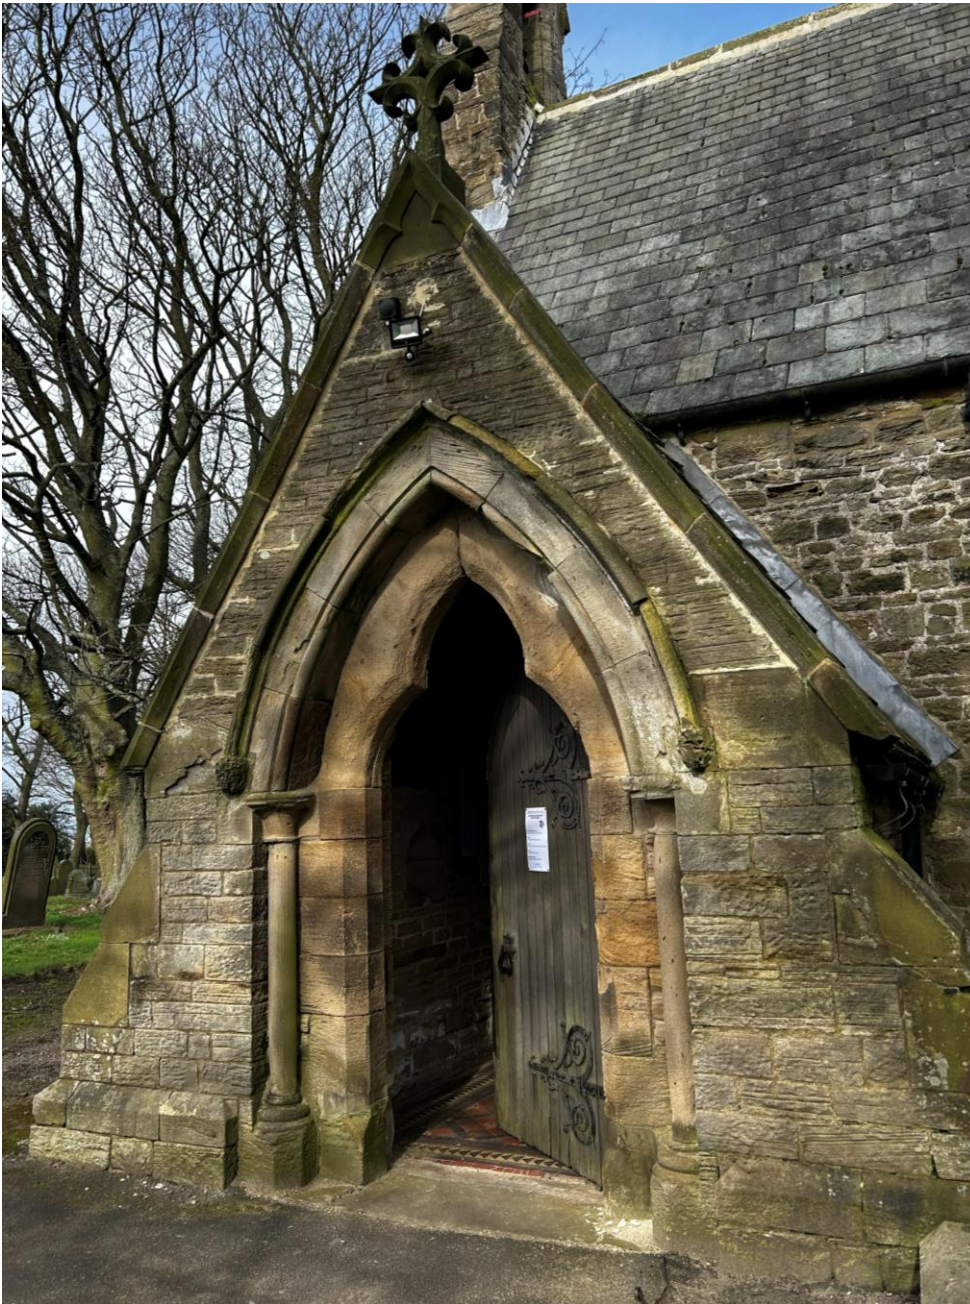
The photograph below was taken during this inspection in March 2026, and is included as a comparison to the 2014 photograph. The condition has worsened considerably, with much edges, features and stone facing.
