MAYA POLENZ ARB AABC

St Edmund's Chapel, Gateshead Quinquennial Inspection Report

March 2025

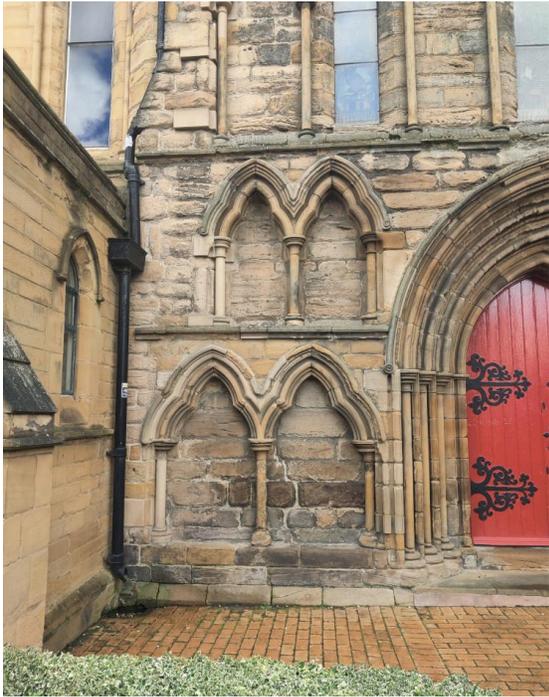
The **base of the west wall is wet**, most likely due to damaged below-ground drainage. Internally at the West door, the base of the wall is damp to both sides of the door. The problem is considerably worse to the north of the door with very high moisture content even at 1m above ground level, with internal plaster showing salt efflorescence, the electrical socket having failed due to moisture ingress and the floor below the carpet being wet to the touch. The base of the door frame showed elevated moisture readings of 18-22% equivalent moisture content (EMC) to both sides - a moisture content of 6-8% for timber inside a heated building is considered 'dry', extending to about 9-14% for external timbers. Timber is likely to decay if exposed to conditions of over 20% EMC for an extended period of time.

3. Water ingress at NW corner of W facade

2.1	External Stonework. Undertake repairs to west wall to stop water penetration and conserve friable stonework. Include immediate southwest return and consider extending the lead drip detail. Ball park figure of £100k tbc	B	Masons or Conservator	£100k

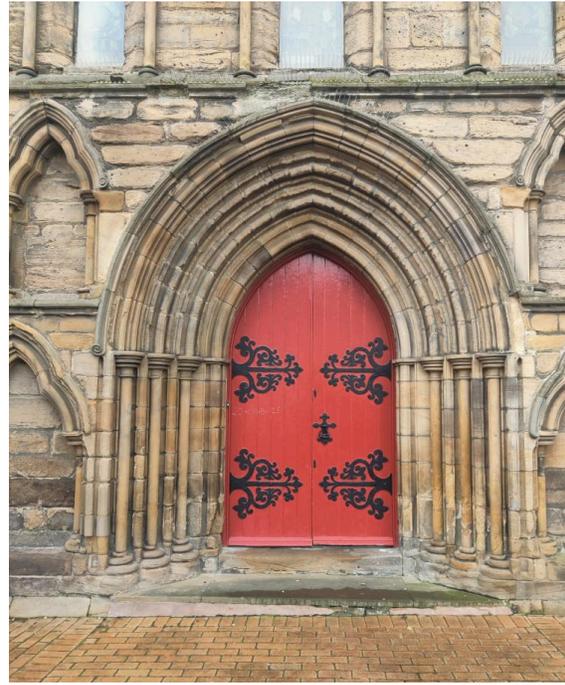
The **west front** suffers from water ingress from open joints and decayed sections in the string courses as well as rising damp (see next paragraph). The medieval stonework is friable and eroding, and some of the sky-facing C19 stonework replacements are also affected. Appendix B provides an overview of the current condition. The west front requires urgent conservation work, which should include:

4. W door stonework

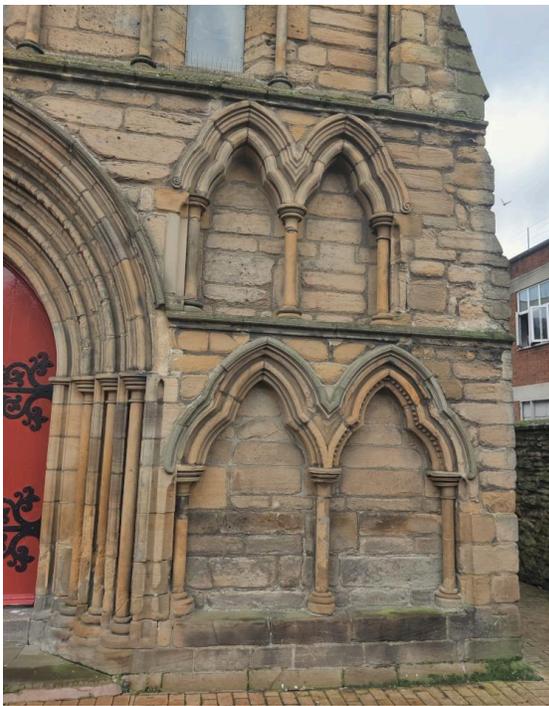
5. Wet base at SW corner of W facade

1.3	Below-ground rainwater disposal. Survey and repair the below-ground drainage system to stop water ingress into the base of the west wall. Not priced as drainage is owned jointly or adopted by the council, and survey and repairs are envisaged to be undertaken as part of Holy Trinity works.	B	Specialist	£0

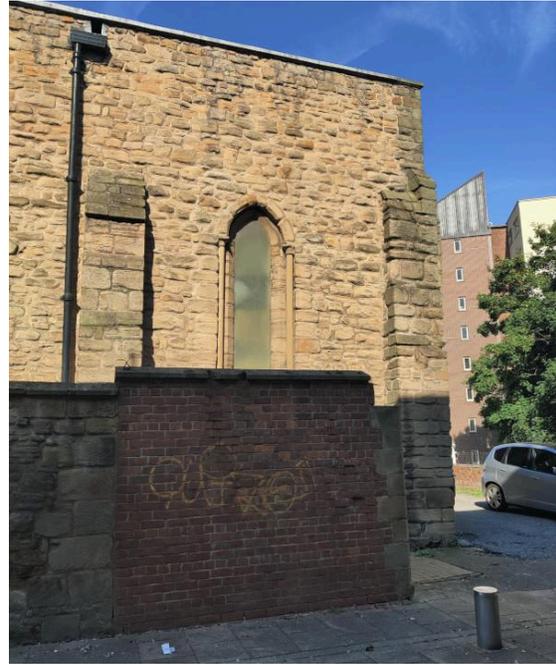
The stonework to the **south wall** is heavily eroded and friable but in reasonable condition. Most of the capitals over the nook shafts are cracked and starting to delaminate. The stonework at the west and east returns is covered by organic growth and the pointing is being washed out. The lead drip detail installed in 1999 (?) prevents this from happening along most of the south wall but it was stopped short of the gable copings to the east and west.

8. Lead drip to S gutter and SE corner without it, leading to water saturation and organic growth

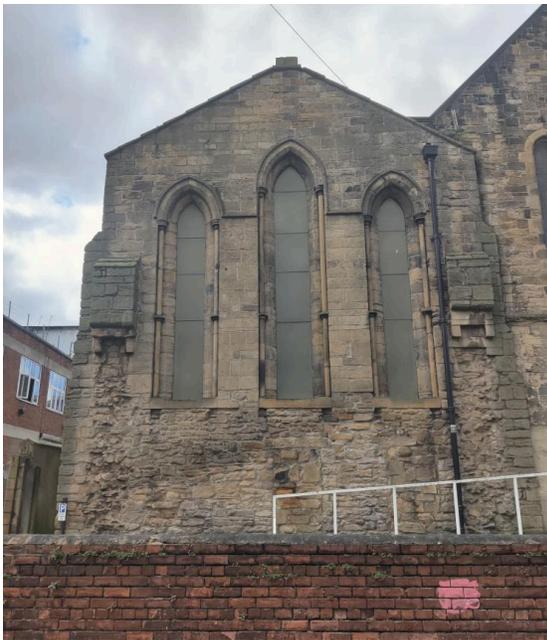
The condition of the **east wall** is similar to the south wall. The lower nookshafts have been partly replaced. As some are bowing, it is unclear if the repairs have been suitably secured or connected, or whether the sections are loose. The cross to the apex stone is missing.

9. E facade and E boundary brickwork wall

2.3	External Stonework. Consider replacing the missing cross to the east gable.	D	Mason	tbc
3	Doors & Windows			
3.1	Windows. A suitably experienced glazier should inspect the eastern windows and recommend repairs or further observation of the following: <ul style="list-style-type: none"> - middle window: lead corrosion within the central group; - middle window: 4th ferramenta from top not engaging with stonework surround. It requires extension to prevent movement and damage; 	C	Glazier	£500

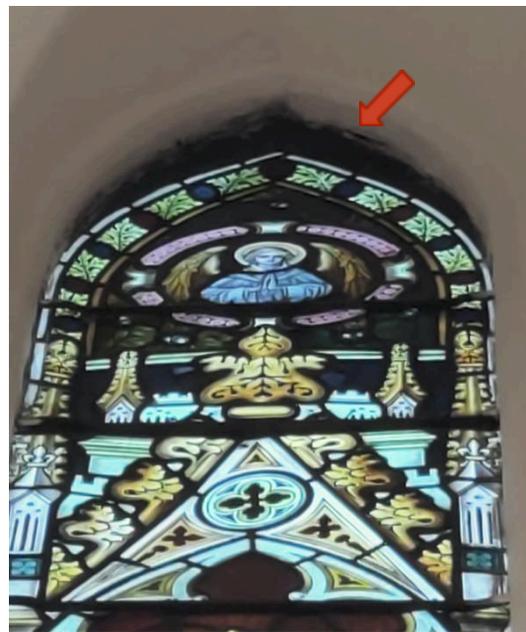
The glazing appears to be generally in good condition. There are some minor damages to the eastern windows. The top light of the northeastern window appears to have been installed in a contorted position, potentially to accommodate previous damage. There is wide-spread splashing of white wall paint onto the stained glass. This appears to have happened during the most recent redecoration works and **is unacceptable**.

17. Distorted NE light appears stable

3.3	Windows. The top light of the northeastern window appears to have been installed in a contorted position, potentially to accommodate previous damage. Arrange for inspection if there was any change.	O	PCC	£0

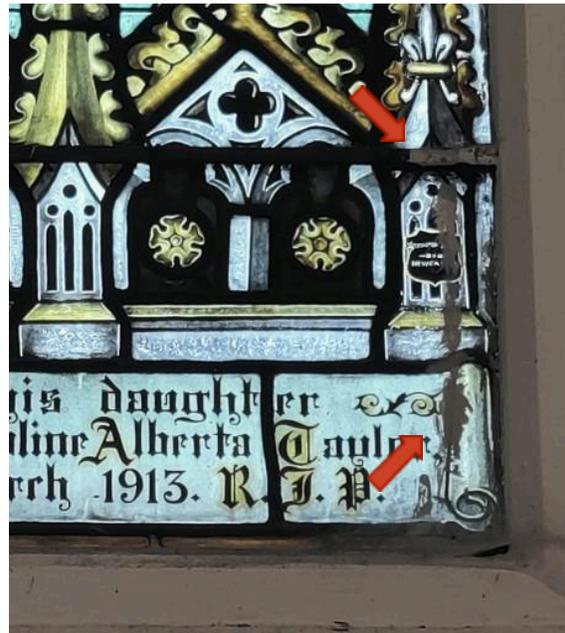
19. Wall paint smeared onto windows

3.4	Generally. Building contractors should be carefully chosen, suitable protection of the building fabric insisted upon and works closely supervised. The wide-spread splashing of wall paint over stained glass windows is not acceptable.	M	PCC	£0
4	Church Interiors

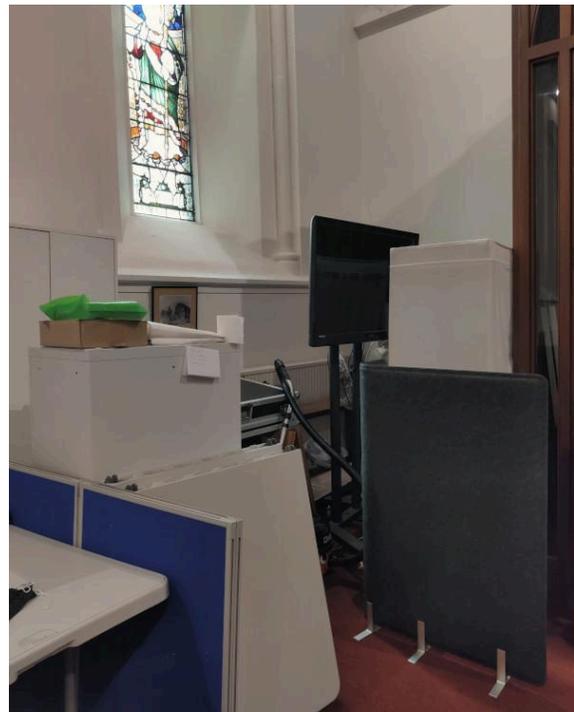
Storage should be reduced to the area south of the entrance lobby as it is unsightly and increases the fire loading near the main exit. As there is a history of water ingress, gutters and gullies should be cleaned twice per year, which is also an opportunity to check for leakages.

25. Storage accumulation at W lobby

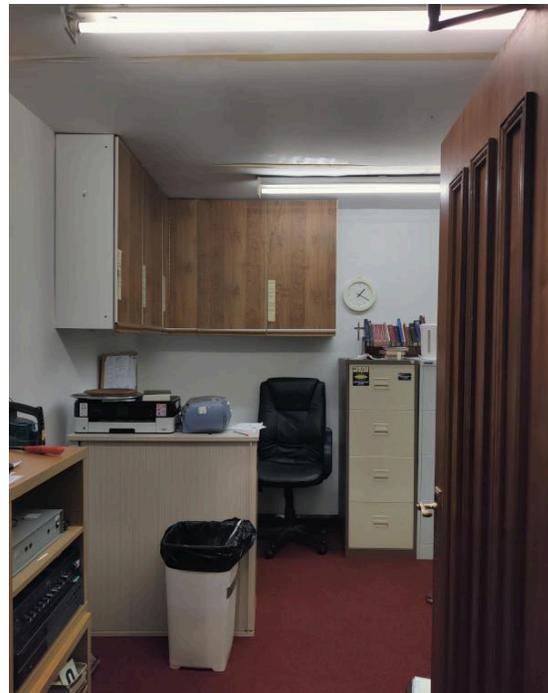
Cracks in the ceiling boards have been taped but the tapes are becoming loose, the cracking is increasing and the boards are sagging.

29. View into Vestry. Note taped and sagging ceiling boards

4.6	Interiors. The sagging and cracking vestry ceiling requires replacement. Whilst in reasonable condition, the room would benefit from redecoration at the same time. <i>I note that fire separation and building works are planned as part of the planned sale and conversion of Holy Trinity, which would likely include a replacement ceiling.</i>	C
4.7	Interiors. Toilet. Following external repairs, replace the salt-damaged internal plaster. Consider increasing ventilation to the toilet as well as rerouting a heating pipe along the base of the wall to reduce condensation.	C

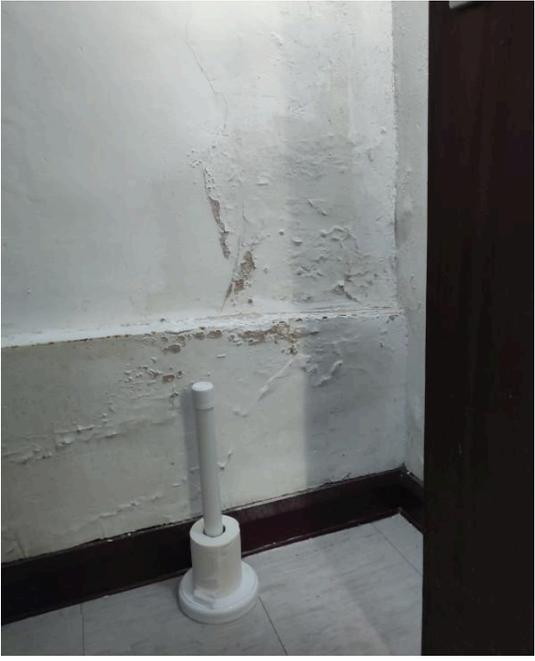
31. Salt efflorescence on external toilet wall
