**QUINQUENNIAL INSPECTION REPORT
OF
GRANGETOWN, SUNDERLAND, ST. AIDAN**

**DIOCESE OF DURHAM
ARCHDEACONRY OF SUNDERLAND
DEANERY OF WEARMOUTH**

QUINQUENNIAL INSPECTION AND REPORT

JUNE 2025

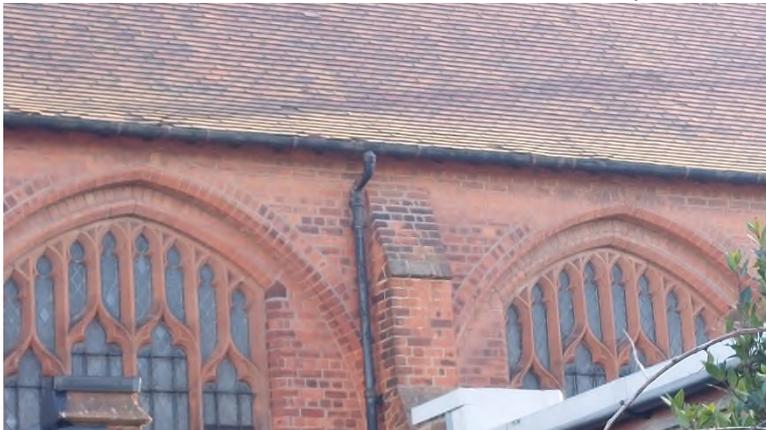
The north eaves of the nave has been relaid unevenly

Was this the consequence of the 2000 repairs to gutters and gutter hangers. There are missing and misaligned tiles. Both North and south side needs assessing for repairs.

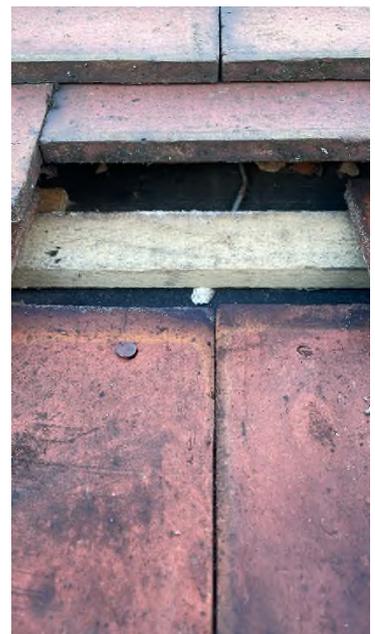
Following our visit to site yesterday (27th February 2025), I confirm below the information that we collected, and our ideas for possible future works. Tiling at north aisle

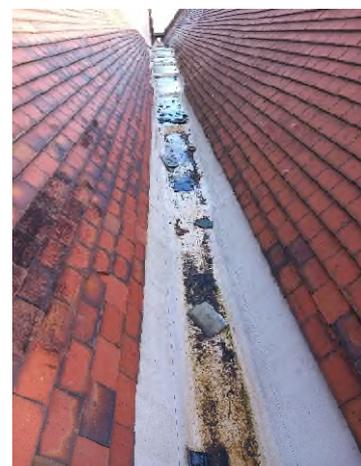
South gutter, west end, tiles and repairs in gutter

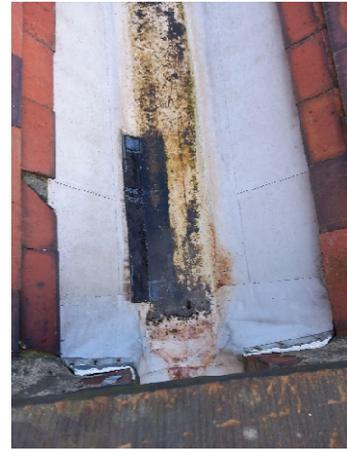
South Gutter, west end, repair in gutter lining

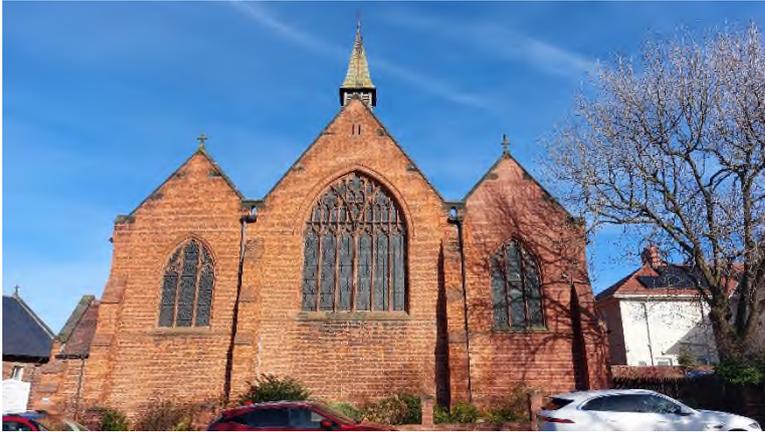
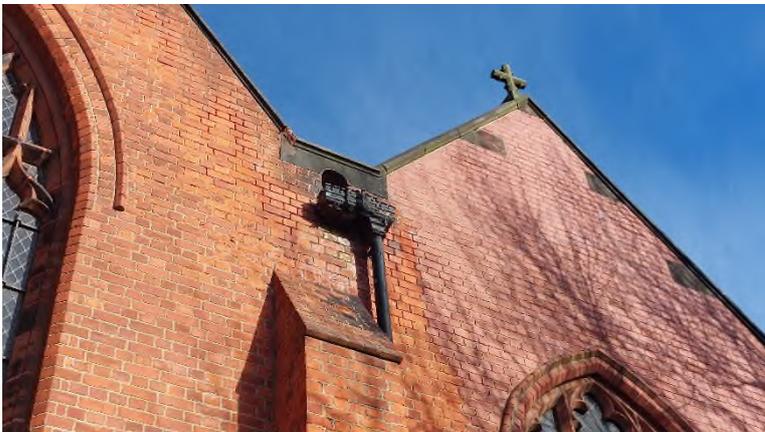
Some open joints to the stone watertables but no obvious marking down the walls.

At junction of south aisle and nave the hopper head is leaking and washing out the joints and staining up the brickwork and below this the buttress is eroded brickwork at the upper stage.

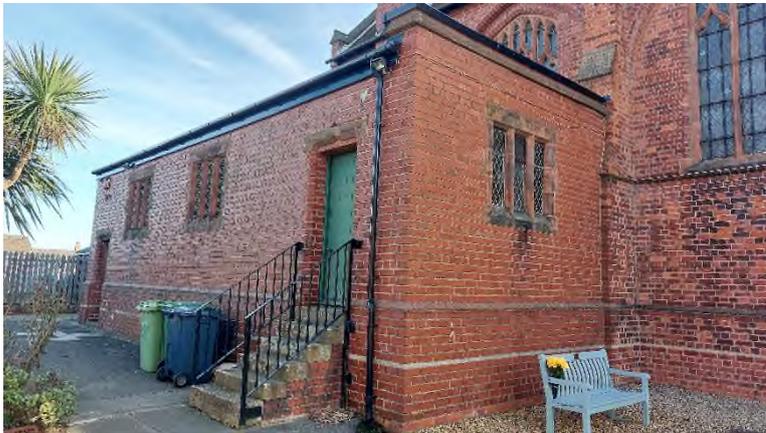
West side – Some pointing coming out at high level.

North side – OK but some cracking at the doorway from previous handrail fixings, this features a very fat mortar line above the ground level suggesting a slate damp proof course.

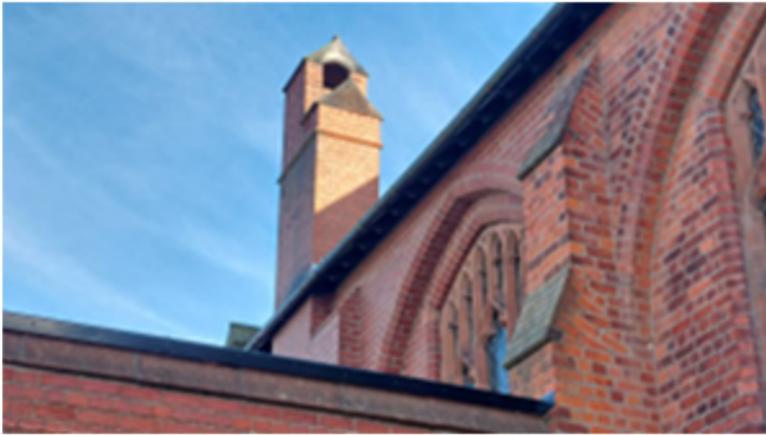
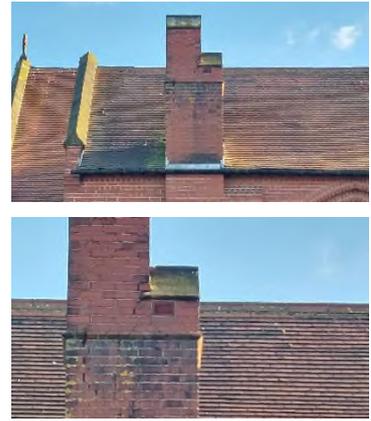
Chimney

- B** At north side at east end of nave. Crack to the ridged stone cap on east face, Possible cracking of brick inside the flue below this point, north face brickwork open joints.

Recommendation: have a closer inspection of the chimney during roof works

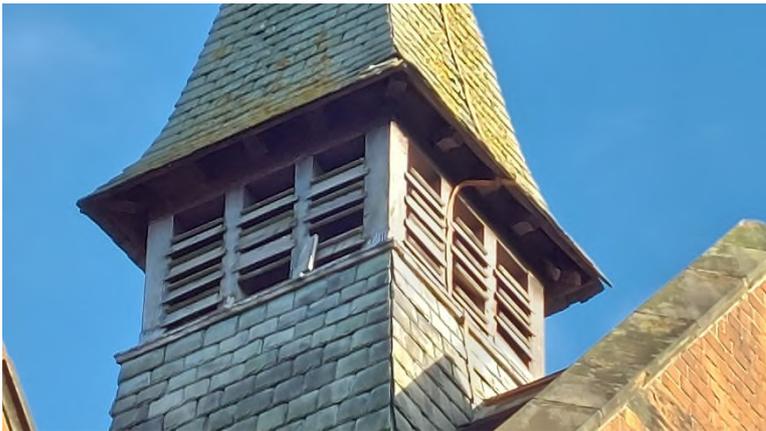
Timber framed fleche with square spire of Westmoreland slating with button capped lead finial top with rusty cross above and the lighting conductor comes down from the cross down on the western side. Hip slate missing at NW side and there are slates fallen into the parapet gutter, reports Ferguson.

Belfry louvre stage – Timber structure needs close examination. The wood louvres are coming away and there is a pigeon roosting above at higher level. The fleche roof and belfry base is slate covered with mitred corners, no obvious evidence of lead there and the flashings to the roof are not seen from the ground, it has its bell still within it though that is no longer rung and is now an electric sounder within. Concern that the bell may be coming away from its fixings.

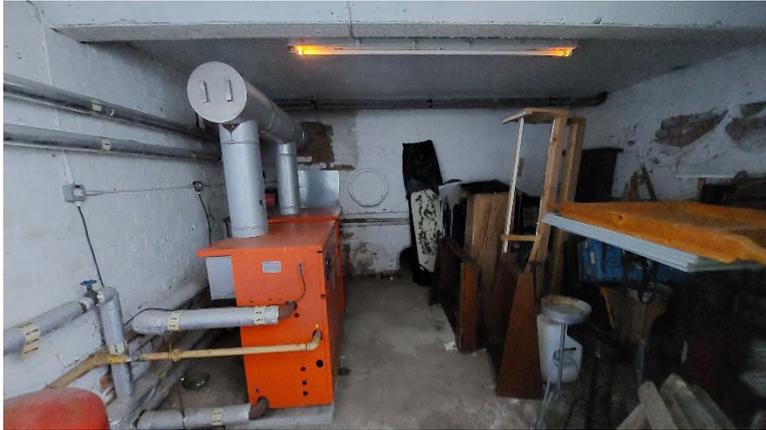
Painted concrete ceiling white painted brickwork walls peeling now with solid floor, housing the twin boilers and a lot of lumber that has built up over time, The light doesn't come on properly.

Recommendation: Replace lamp, remove lumber

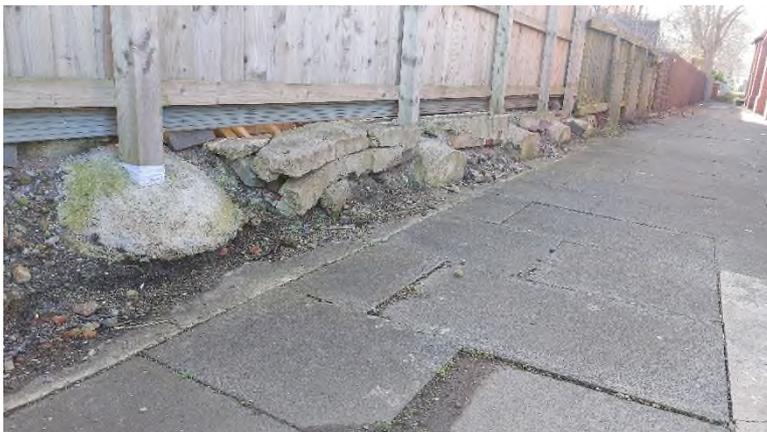
On the south side is paved strip and the paving is sinking in places, it has a kerb within the buttresses and a gravel area between that, some of the gravel from the Vicarage is coming through the timber fence and that boundary is made up of different fencing depending on which dwelling is up against it and some of the Vicarage fencing paleing is broken now, in the middle section where the road is, this is in pretty poor and these is barbed wire about the place.

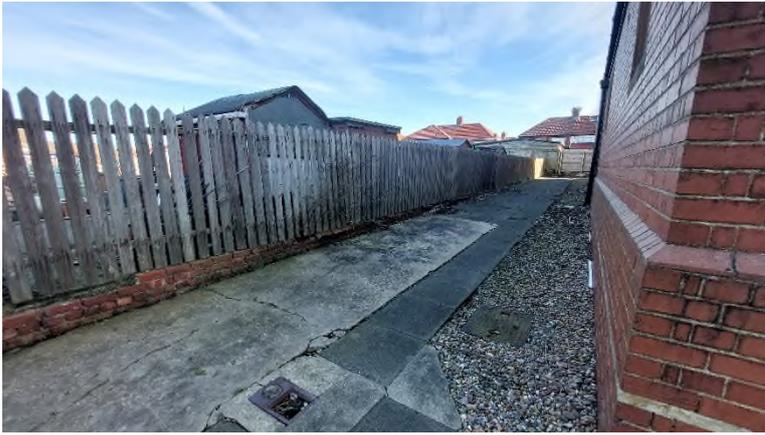
East boundary fencing is reasonably sturdy plank boarding with the allotments beyond, the centre panel is leaning out sitting on a brick plinth that doesn't look very good and the south boundary end also has paving slabs with rather wide gaps and they are not level inboard of that. Towards the church is a gravel margin made up of scraps and there is a lot of leaf litter and the like on the ground.

Recommendation: tidy up pathway, firm up leaning fence panel

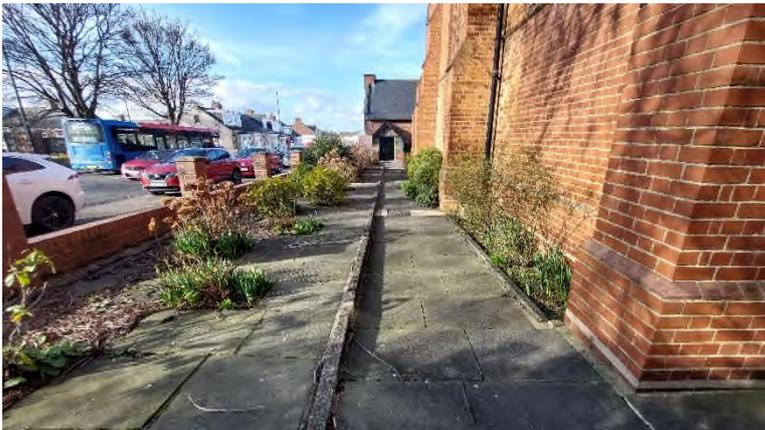
West boundary is next to a road. The boundary has a low brick wall with intermediate brick piers with precast concrete cap which used to feature a railing this was taken away and sold for scrap as it had rusted up so badly and was beyond economic repair, the brickwork itself is all ok. The paving is principally flagged with concrete kerbs to form a path against the church and the reinforcement within the kerbs is rusting and expanding and breaking them. Towards the church side, planting beds are created by enclosing them in the kerb. Towards the road side various slabs are omitted and they have low shrub planting in them. Some undulating paving in SW corner perhaps caused by the Vicarage tree roots.

Recommendation: none

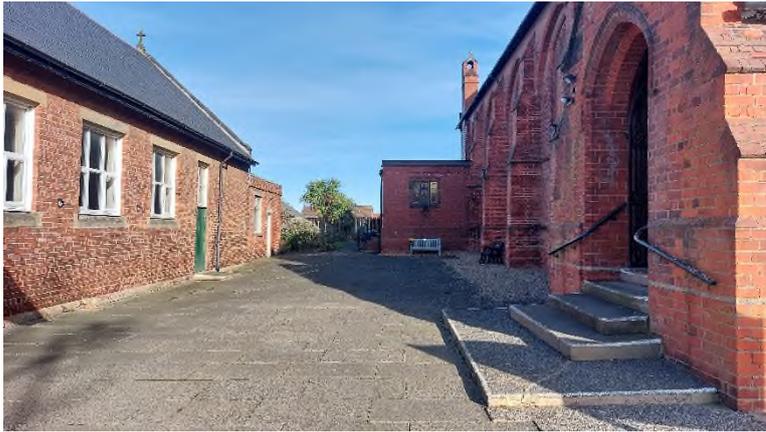
The north boundary is where the parish hall is. The area between the two buildings is paved again, slightly sloping towards the church hall with a gravel margin up against the north aisle. The stone steps leading up to the north door are sloping downwards slightly and the middle stone step is loose, and the bottom concrete margin is cracked causing a trip hazard.
