Quinquennial Inspection Report

Church of St John the Evangelist Greenside, Tyne and Wear

Date of inspection: 19th August 2024; weather conditions – cloudy with sunny intervals

Date of report: 31st August 2024

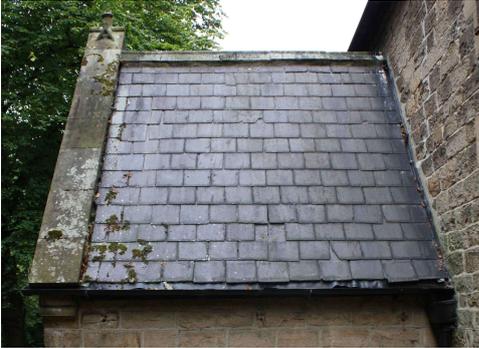
<p>Porch roof – east slope</p>

<p>Organ Chamber – east slope</p>	<p>There are number of defects which require attention:-</p> <p><u>Porch:</u> Ridge - open perpend joints. East slope – 1No slipped slate; 3 slates with broken corners; 1No missing slate (see photo opposite). West slope – 1No slipped slate by eaves; 3No rotated slates by gable.</p> <p><u>Nave:</u> South slope – 5No missing slates; 1No slipped slate; 6No rotated slates. North slope – view obscured by trees.</p> <p><u>Chancel:</u> Ridge – receding perpend joints South slope – 2No missing slates; 1No slipped slates; 1No rotated slate North slope - 2No missing slates (near eaves); 1No slate with broken corner; 1No rotated slate (near ridge).</p> <p><u>Organ chamber:</u> East slope – several missing and slipped slates exposing the rigid sarking boards to the elements (see photo opposite).</p> <p><u>Flat roof to Strong Room, Toilet and Kitchen:</u> The mineral felt appears sound but there is a build-up of moss in places. The rooflights appear satisfactory.</p> <p><u>Flat roof to Vestry and Corridor:</u> The flashings and pointing appear sound. Again there is a build-up of moss on the mineral felt.</p> <p><u>North Aisle:</u> Re-slatted in 2010. Assumed to be in good condition. Too high to access safely from ladders and view obscured from ground level due to shallow pitch and sloping ground.</p>

Repair needs	The east slope of the Organ Chamber needs urgent slating repairs where the sarking is exposed. Re-slating the full east slope would be a better option. I suspect the sarking boards are rotten and not providing a hold to the nails.	A
	In the short-term slating repairs are needed to all areas identified with missing, slipped and rotated slates. (Many of these were identified in the 2019 report).	B
	In the long term the Porch, Nave and Chancel roofs should be re-slating as they are suffering from nail fatigue and slating failures will continue until then.	D/E
	The moss needs to be removed from the flat roofs to allow the roofs to drain freely to the outlets (see also 2.2)	M

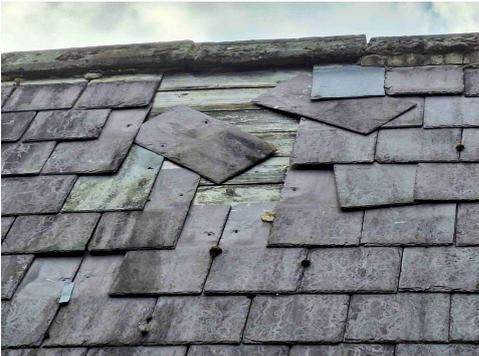
Several slates in a patch are missing on the east slope of the Organ Chamber leaving a section of the sarking boards exposed to the weather. Slating repairs are needed as a matter of urgency to prevent water ingress and potential damage to the organ below. Elsewhere the main concern is the condition of the pitched roofs where there are many missing, slipped and rotated slates. This indicates the roofs are suffering from nail sickness. In the short-term slating repairs are needed but in the long-term, the roofs need re-slating.

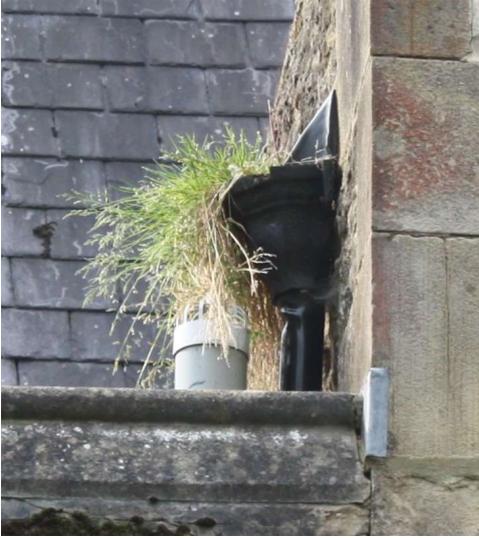
<p>Chute & hopper to Vestry</p>

The hopper and chute to the parapet wall on the NE corner of the Vestry is blocked with vegetation resulting in an overflow of water to the wall heads. This is likely to be the reason for the dampness, peeling wall paper over the kitchen door opening. The North Aisle gutter is blocked at the west end and needs clearing to prevent overflow to the wall heads and internal dampness. Clearing the gutters twice a year is recommended. The parapet gutter to the flat roof over the strong room/ kitchen/ toilet are blocked with moss preventing water discharging freely to the outlet point. Removal of moss is needed.

<p>North Aisle gutter</p>	<p>The chute and hopper on the NE corner of the Vestry block roof is blocked with vegetation (see photo left). This is resulting in water overflowing and soaking the wall. This is thought to be the cause of the dampness and peeling wall paper to the kitchen door opening. Removing the vegetation is needed ASAP.</p> <p>There is also some vegetation in the North Aisle gutter (see photo lower left). This needs clearing to prevent overflow to the wall heads.</p> <p>There is moss blocking the parapet gutter to the flat over the Strong Room/ Kitchen/ Toilet. The moss needs to be removed to allow water to flow freely to the outlet.</p>	A

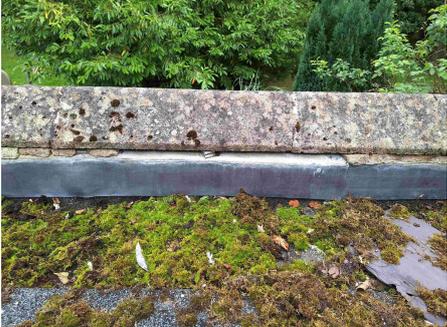
<p>Flat roof – moss blocking parapet gutter</p>	<p>The gullies, gutters and hoppers should be cleared of vegetation, leaves and silt etc. twice a year.</p>	B
			M
			M

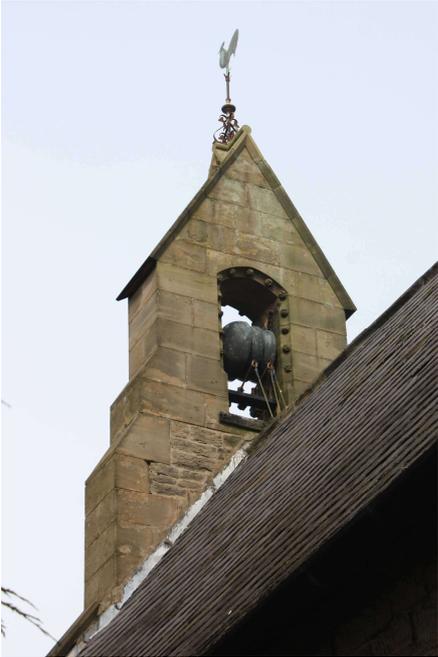
<p>The masonry and pointing appear in fair condition. The copper cockerel weathervane is tarnished and would benefit from cleaning; the metal supports would benefit from redecoration.</p> <p>There are some receding joints to the water tabling – this should be monitored.</p> <p>The bells comprise 3No dishes mounted vertically and chimed from hammers operated from bell ropes at the rear of the Nave. The bells are working but have limited volume.</p>	<p>E</p>

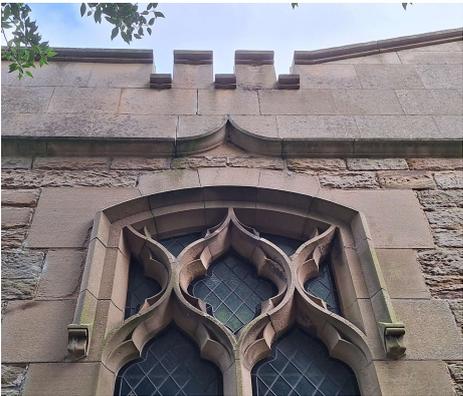
<p>North Aisle west gable parapet</p>	<p><u>Parapets:</u> The bedding is breaking away from the rear of the parapet above the toilet/ kitchen/strong room block. The flashing is out of alignment in places. The parapet flashing and pointing needs repair to prevent water ingress to the wall heads and ceilings.</p> <p>There is a vertical stepped crack emanating from the west parapet of the North Aisle down to the LH of window nVII. This should be raked out and repointed (see photo opposite).</p> <p><u>Upstand walls:</u> Generally the water tabling appears solidly bedded and pointed. However there are open perpend joints and poor bedding to the water tabling of the Porch on the western slope; to the east gable of the Chancel; the and the roof side of Organ Chamber gable. The water tabling should be raked out and repointed in these areas to prevent water penetration. The lead flashings all appear to be securely fixed.</p> <p><u>Crosses:</u> The apex cross to the Nave east gable is in good condition.</p> <p><u>Chimneys:</u> The chimney appears to be solidly pointed.</p>	<p>B</p> <p>B</p> <p>C</p>

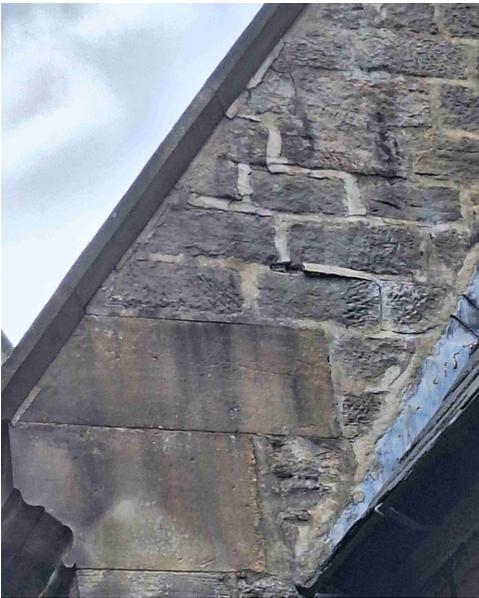
<p>The masonry and pointing are generally in sound condition. The walls have been repointed in places over the years and are of varying degrees of quality. However defects were noted as follows:-</p> <p><u>Porch</u>: Crack to LH hood mould over the door – needs repair to prevent water ingress and further cracking.</p> <p><u>Nave</u>: Loose mortar to the Nave east gable wall near the kneeler on the south side (see photo opposite). Some loose ribbon pointing to the plinth on the west gable. These areas should be raked out and repointed.</p> <p><u>Chancel</u>: Some open joints in chamfered plinth course. Raking out and repointing is needed.</p> <p><u>North Aisle</u>: Stepped crack from LH quoin of middle window nVI through the plinth to the air vent below. This should be raked out and repointed.</p> <p><u>Note</u>: See section 2.7 for window masonry.</p>	 C C C C

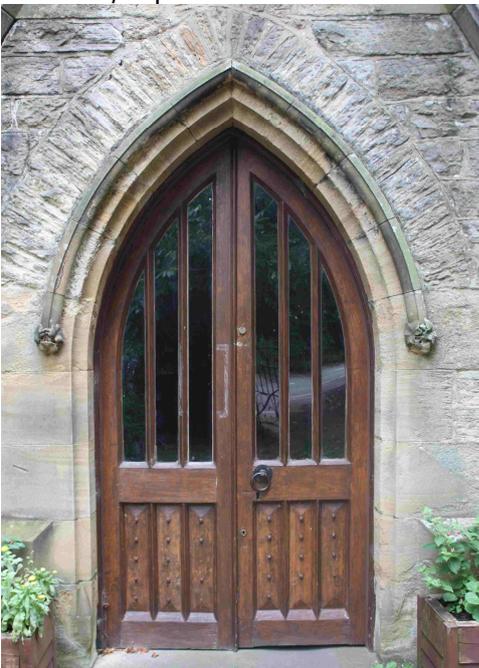
<p><u>Porch</u>: The door would benefit from re-varnishing (photo left).</p> <p><u>Nave</u>: The door is in fair condition.</p> <p><u>Chancel</u>: The priest's door has been blocked up internally. The door needs re-oiling externally to prevent drying out and cracking of the timber. The mastic caulking between the door and frame is perishing and should be replaced. The ring pull is rusty and should be cleaned and redecorated.</p> <p><u>Organ Chamber</u>: The door is in fair condition but redecoration is recommended during the quinquennium.</p> <p><u>Boiler Room</u>: The door needs decoration.</p> <p><u>Generally</u>: All external doors have robust and appropriate ironmongery. Locks are of the five-lever roller mortice deadlock type. The Organ Chamber external door is left unbolted during services for ease of emergency egress.</p>	 C C D C

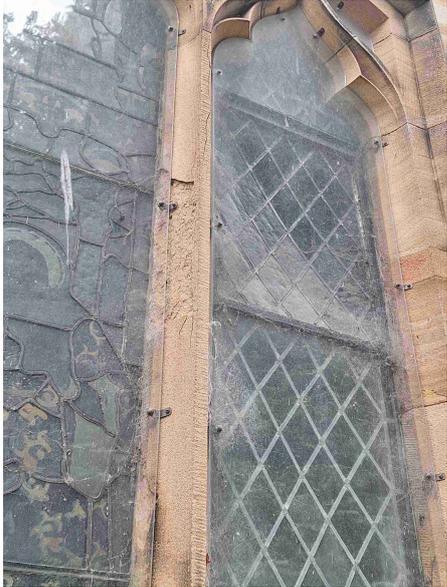
<p>Nave window sVI</p>

<p>North Aisle west gable nVIII</p>	<p><u>Chancel east:</u> Some erosion of the external masonry to the underside of the arched head stones. This should be monitored. There are open perpend and bed joints to the cill to LH and RH sides. The joints need raking out and repointing. Some bowing of stained-glass panels due to thermal expansion of the leading. This should be monitored. Copper mesh grille in fair condition.</p> <p><u>Chancel south:</u> Windows sII and sIII: some movement between head stone and jambs/mullion below – bed joints need repointing internally and externally. Window sIV: stained glass and mesh grille in fair condition.</p> <p><u>Nave south:</u> Window sV: some cracks in mullion – should be monitored. Window sVI: RH mullion cracked & decayed – repairs needed</p> <p><u>Nave west window nVIII:</u> External masonry eroding to the underside of the arched head stones and to LH jambs – this should be monitored. Vertical crack in LH mullion – this needs repair. Open joint in external cill – need repointing. Open internal joints to apex of lintel & cill – need repointing</p> <p><u>Chancel north:</u> Window nII: some movement between head stone and jambs/mullion below – the bed joints need repointing internally.</p> <p><u>Toilet:</u> Window nIII: timber frame – some rot appearing on lower member and peeling paint. Timber repair and redecoration are needed. Slate cill starting to de-laminate – should be monitored.</p> <p><u>Organ Chamber:</u> Window nIV upper: some bulging of the leading – should be monitored.</p> <p><u>Basement:</u> Window nIV lower: the timber vertical sliding sashes need redecoration and checked for movement. Star crack to lower RH pane – ideally replace.</p> <p><u>North Aisle north:</u> Window nV: glass bulging to RH light - monitor. Hopper vent doesn't close square in frame – needs realigning. Window nVI: glass bulging to LH light – monitor. Window nVII: in fair condition.</p> <p><u>North Aisle west:</u> Window nVIII: masonry to tracery slightly out of alignment due to settlement of this wall (see 2.4 regarding crack in masonry from parapet to this window). The tracery should be raked out and repointed.</p>	<p>D</p> <p>D</p> <p>D</p> <p>D</p> <p>D</p> <p>D</p> <p>D</p> <p>D</p> <p>D</p> <p>C</p> <p>C</p> <p>C</p> <p>C</p> <p>C</p>

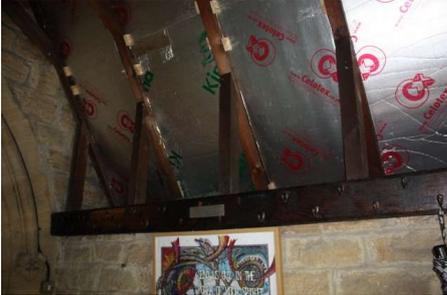
<p>Porch - unsightly exposed insulation</p>	<p><u>Porch</u>: the roof timbers are obscured by insulation bats. These are fitted hard up against the tiling battens with no air space for ventilation and no ceiling to conceal the foil covering making it unsightly. As the Porch is an unheated space the insulation is considered unnecessary and will have little impact on the heat losses through the church roofs as a whole. It is recommended that the insulation boards are removed the original ceiling be fitted between the rafters is re-instated.</p> <p><u>Nave, North Aisle and Chancel</u>: the exposed timber roof structure appears in sound condition from a purely visual inspection from floor level.</p> <p><u>Organ Chamber</u>: the boarded ceiling has some discoloured boards. This could be due to roof leaks from the missing slates. See 2.1 for action on the slates.</p> <p><u>Basement Meeting Room</u>: the painted boarded ceiling would benefit from redecoration.</p> <p><u>Boiler House</u>: it is recommended that the ceiling be tested for asbestos and any recommendations implemented should asbestos materials be found.</p> <p><u>Vestry, Strong Room, Toilet, Kitchen and adjacent passage</u>: The painted plasterboard ceilings and sloping soffits to the roof light have mould patches due to water leaks from the upstand walls above. Once the leaks are cured and the ceilings are dry, redecoration is recommended.</p>	<p>C</p> <p>D</p> <p>B</p> <p>D</p>

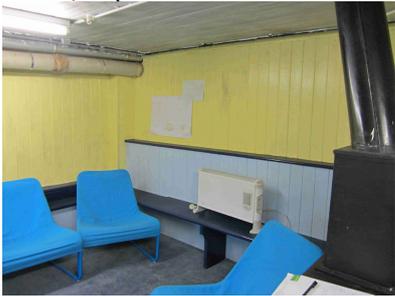
<p>Basement Meeting Room panelling</p>	<p><u>Partitions</u>: the partition between the Vestry and adjacent corridor and between the Toilet and Kitchen are in fair condition structurally and decoratively.</p> <p><u>Timber screen and door</u>: between the North Aisle and Organ Chamber does not close properly. Adjustment is needed.</p> <p><u>Panelling</u>: the varnished timber panelling to the Organ Chamber is in fair structural and decorative condition. However the painted panelling to the Basement Meeting Room is discoloured and in need of redecoration.</p>	<p>C</p> <p>D</p>

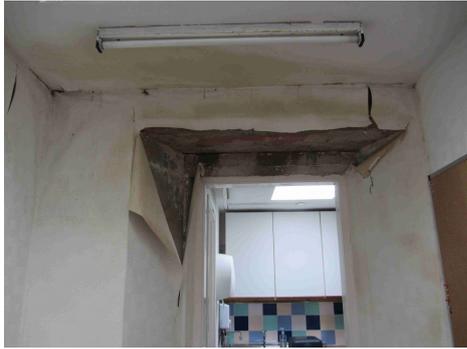
Peeling wallpaper by opening into kitchen

Vestry and Passage: peeling wall paper near door opening into kitchen caused by water ingress from the parapet wall and blocked hopper above. (see 2.2 for action on water ingress).

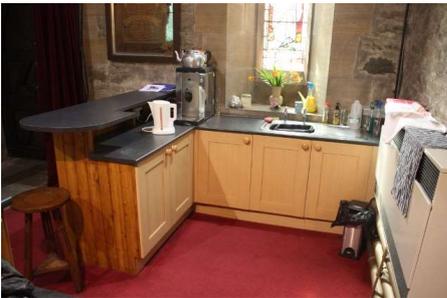
<p><u>Vestry</u>: fairly basic space, no fitted cupboard for vestments.</p> <p><u>Kitchen</u>: small and functional but remote from Nave; no cooking facilities; no extract ventilation. Some unit doors missing and need replacement.</p> <p><u>Servery</u>: (see photo opposite) ideal for serving hot drinks etc. at rear of Nave.</p> <p><u>Toilet</u>: functional but remote from Nave. See section 2.8 regarding facilities for wheelchair users.</p>	M

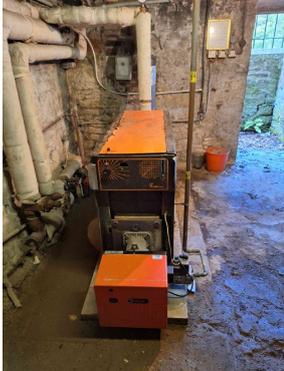
<p>It is understood that it can take several hours for the heating system to reach adequate temperatures for services. The boiler is over 40 years old and well past its expected service life. Given the age of the boiler and the inefficiency of the system it is strongly recommended that the heating system is replaced. Consideration should be given to emitters using a zero-carbon heat source. Perhaps electric infra-red, heaters or electric radiators.</p> <p>There is some dampness of the floor slab in the Boiler Room. The adjacent pipework should be checked for leaks.</p>	<p>E</p> <p>B</p>
<p>4.2 Electrical</p>	<p><i><u>Supply:</u> Overhead supply on the west gable of the Nave. The meters and distribution board are located in a cupboard adjacent. A secondary distribution board is located adjacent to the organ.</i></p> <p><i><u>Lighting:</u> Comprises the following:-</i></p> <p><i>Porch – 1No pendant light; 1No exterior light</i></p> <p><i>Nave – 8No metal halide floods; 2No PAR spot lights by Chancel steps; pendant light over sound desk.</i></p> <p><i>Crèche/ North Aisle – 3No metal halide floods</i></p> <p><i>Chancel - 5No metal halide floods; 2No incandescent lights; 2No reflector spot lights; 2No lamp holders by rood screen.</i></p> <p><i>Organ Chamber passage – 1No fluorescent light</i></p> <p><i>Basement meeting room – 2No fluorescent lights</i></p> <p><i>WC/ kitchen – ceiling mounted/ fluorescent light</i></p> <p><i>Kitchen corridor - fluorescent light</i></p> <p><i>Vestry/ strong room - fluorescent lights</i></p> <p><i>Boiler Room – fluorescent light</i></p>

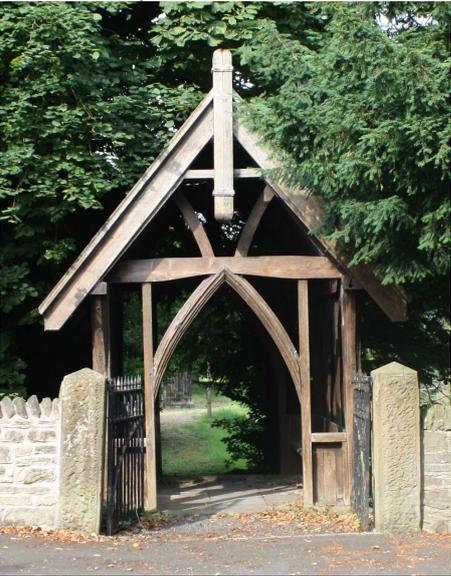
<p><u>South gate</u>: in fair condition.</p> <p><u>East gate</u>: the metal gates by the lych-gate structure are out of alignment and don't close properly. Also the gates are rusting in places. Realignment, removal of rust and redecoration is recommended.</p> <p><u>Lych-gate structure</u>: the felt shingles are covered in moss – this should be removed to reduce weight and prevent damp penetration. It is recommended that the timber structure and particle-board ceiling is re-decorated within the next five years to prevent water penetration and rot.</p> <p><u>Railings to Boiler House steps and Organ Chamber door</u>: the railings are showing signs of rust in places. Removal of rust followed by redecoration is needed.</p>	D D D

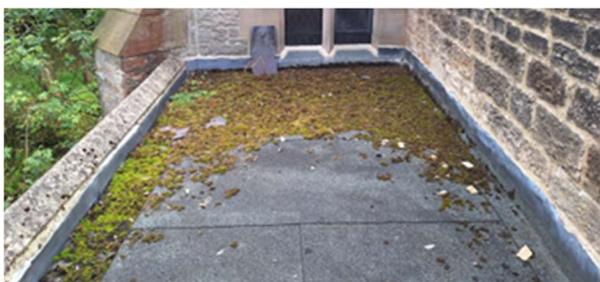
Moss to flat roof over Strong Room, Kitchen & Toilet

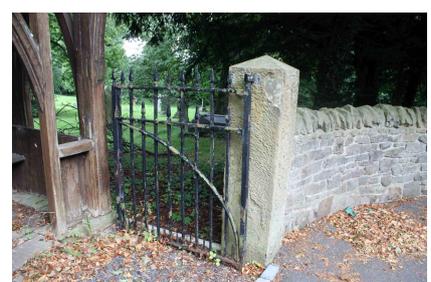
East gate - rusty
