**QUINQUENNIAL REPORT on the  
THE CHURCH OF ST THOMAS**

**HARELAW**

**Inspected by Bryony Roff BSc. BArch. MA, RIBA, AABC**

Date of inspection and weather conditions: 1<sup>st</sup> April 2026    Weather was cool and overcast, becoming sunnier later  
Date of report: 12<sup>th</sup> August 2026  
Date of previous report: January 2020

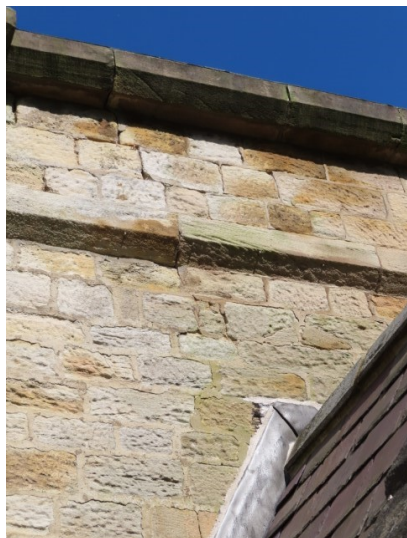
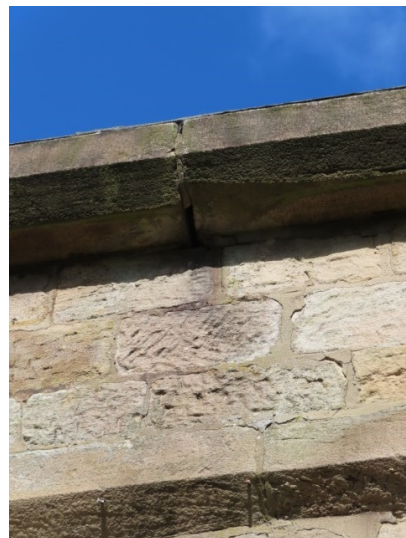
Cracking and open joints to South Nave

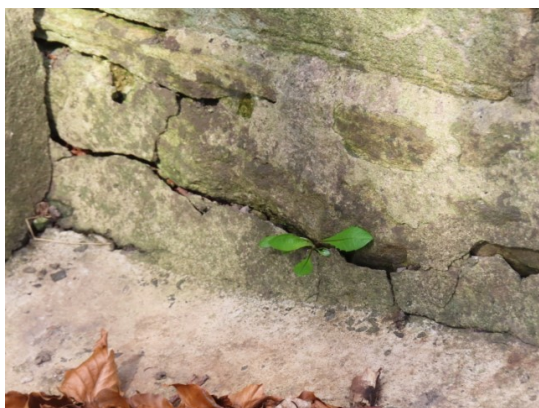
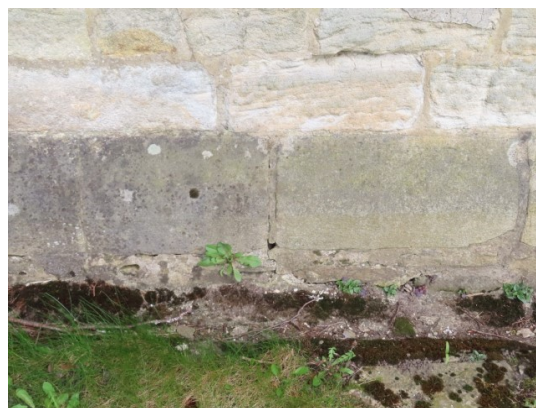
Cracking and vegetation growth to South Nave (left) and South Chancel (right)

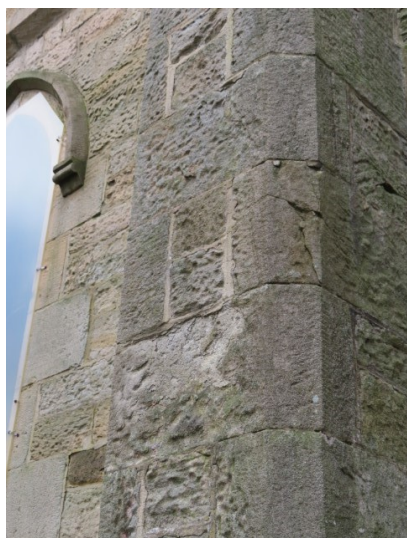
Cracked stone to South East corner of the Nave

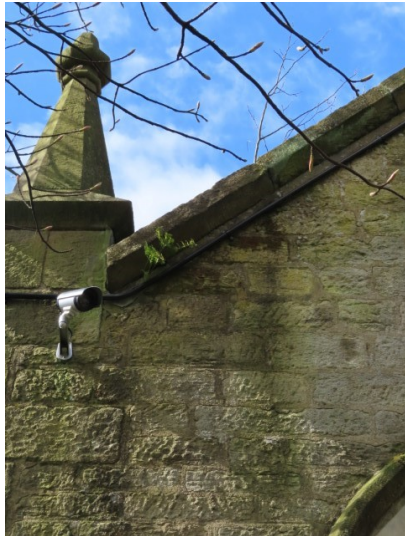
Vegetation & open joints to water table & Pinnacle to East Elevation of the Chancel

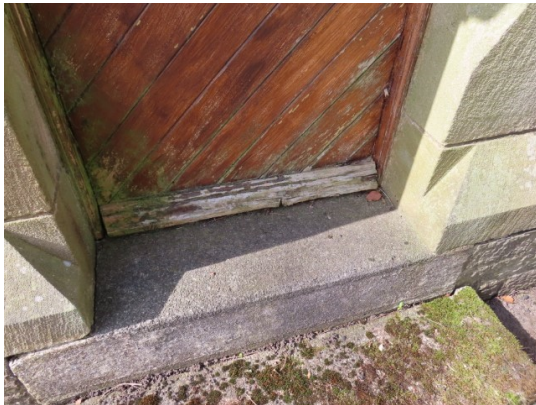
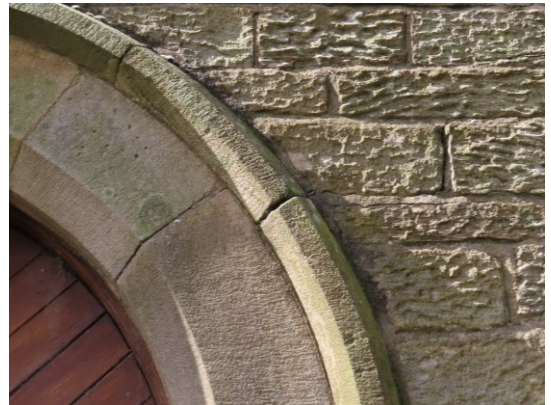
Failing finish to East Vicars Vestry door (left) and open joints and cracking above the door (right)

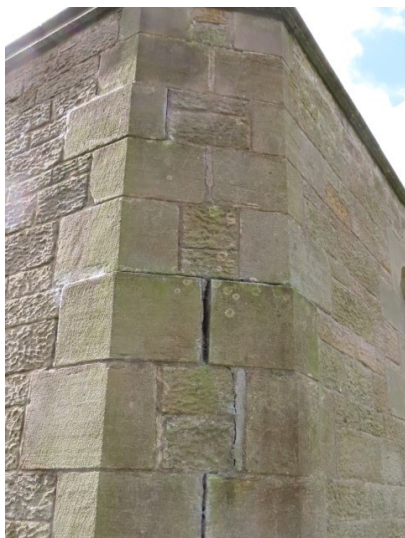
Cracking to North East corner of the Vicars vestry

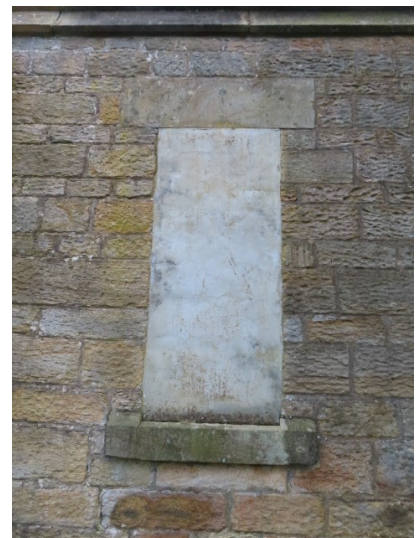
| 8. North Elevation of the Organ Chamber | Semi coursed squared sandstone | <p>Ply covering to the windows is failing and needs to be replaced. It would be sensible to consider more permanent options for replacement if possible.</p> <p>There are a number of open joints and loss of bedding to the water table and these need fairly urgent attention. Staining below joints indicates that water has been running down the wall in area where mortar has been lost for a while.</p> <p>Cementitious mortar is starting to fail in multiple locations (some is strap pointing and in many areas the joint appears well filled behind) and there are a number of open joints to the circular window and at low level. There are isolated weathered stones and the corbel is showing signs of deterioration to the upper edge.</p> | Rake out and repoint open and hungry joints to the water table and bed joint under. | 2 |

Failing ply finish to Organ Chamber window openings

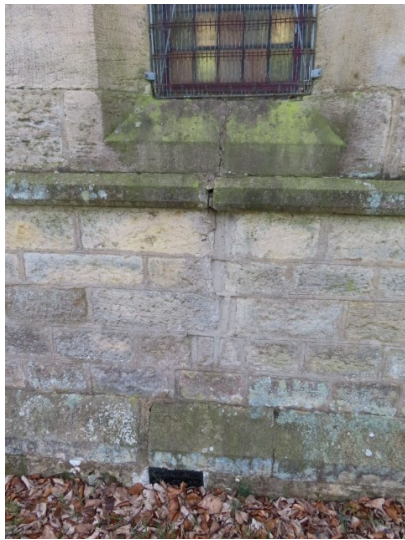
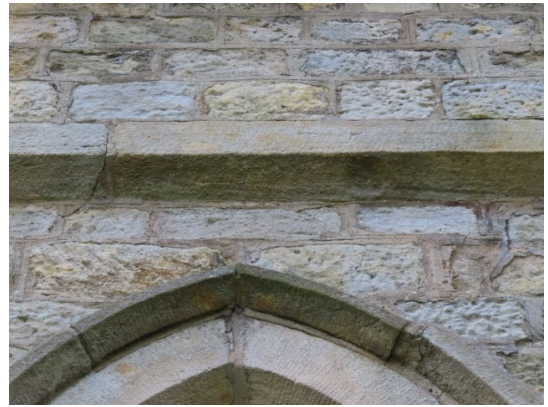
Open joints and cracking to sill of window Nv (left) and cracking and weathered stone over the same window (right)

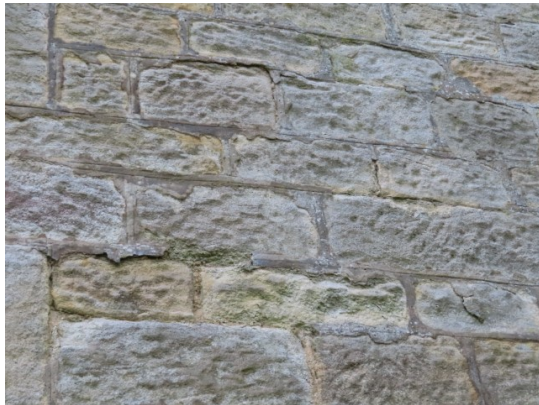
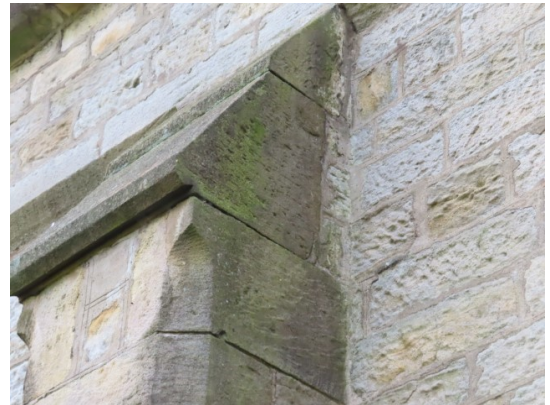
Failing mortar and open joints to the North Nave and buttress

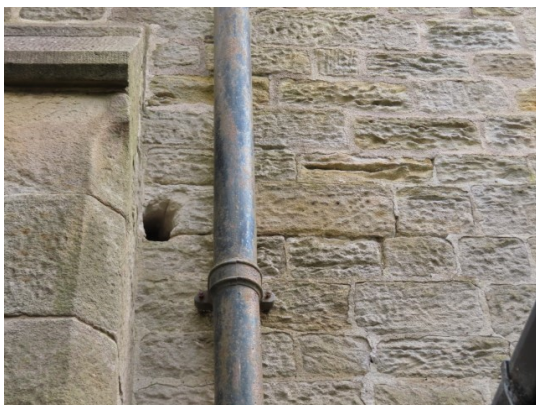
Hole to West elevation of the Nave the parish room

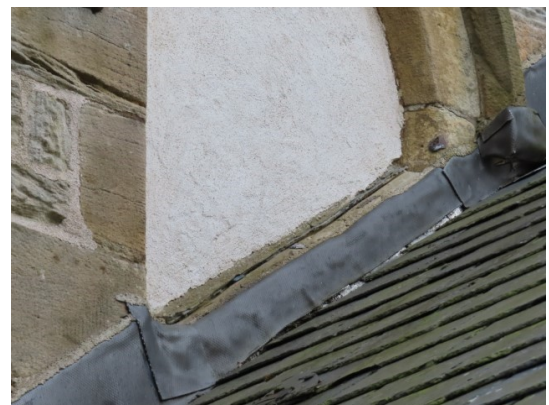
Failed pointing over flashings over link roof

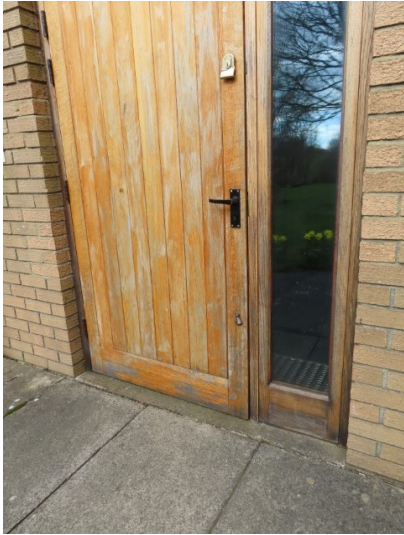
Failing finish to parish room door

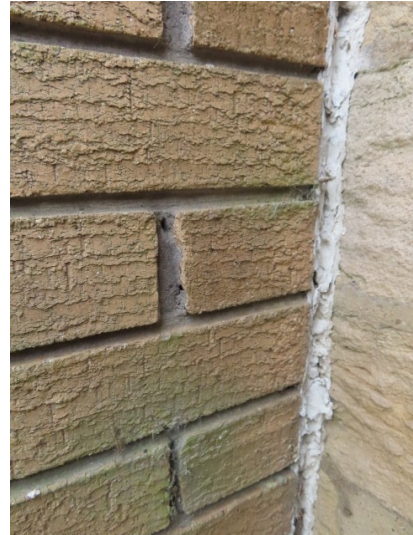
Failing mastic to junction between Parish room/link and the Nave

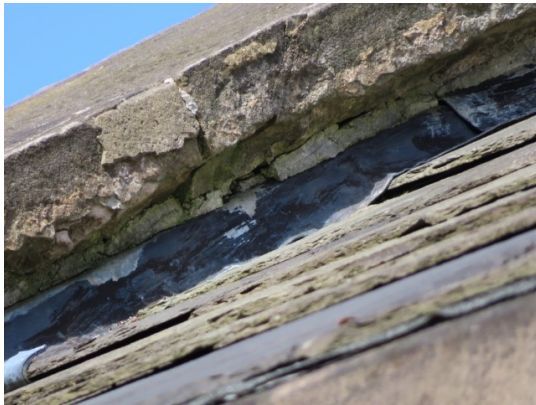
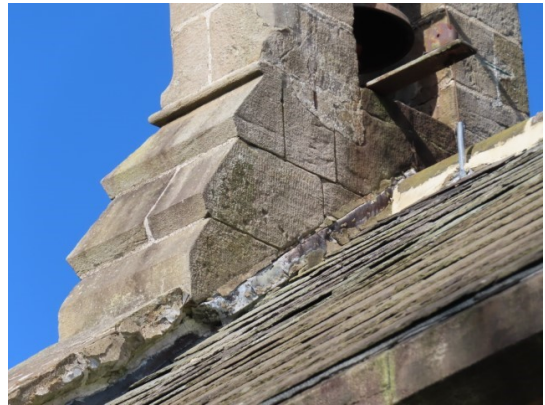
Failing mortar to chase over flashings to South West of the Nave (left) and bellcote (right)

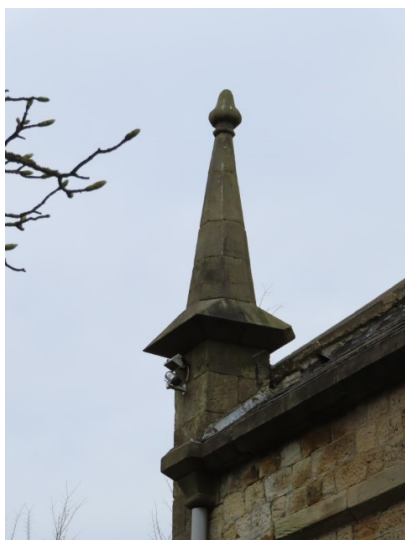
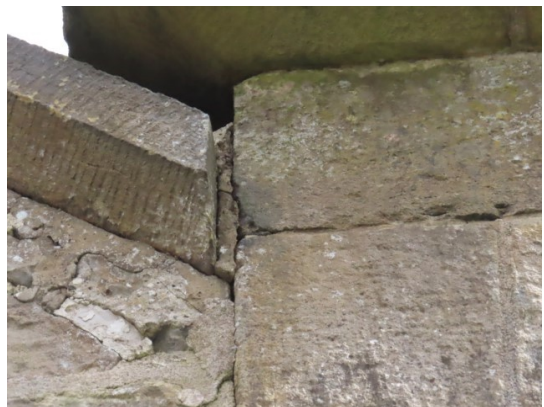
Open/hungry joints to West pinnacle on the south side of the Nave

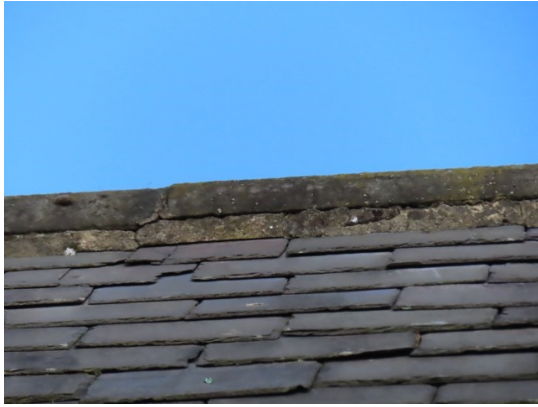
Failing mortar bed to the Chancel roof

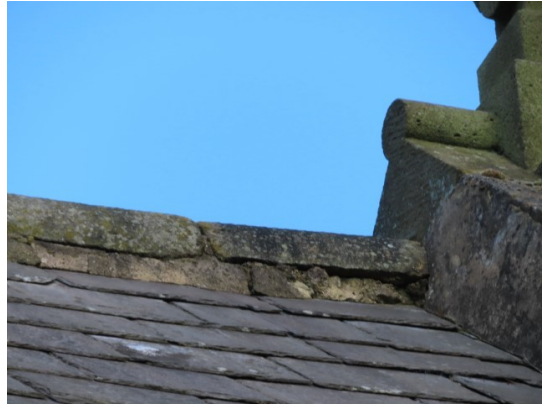
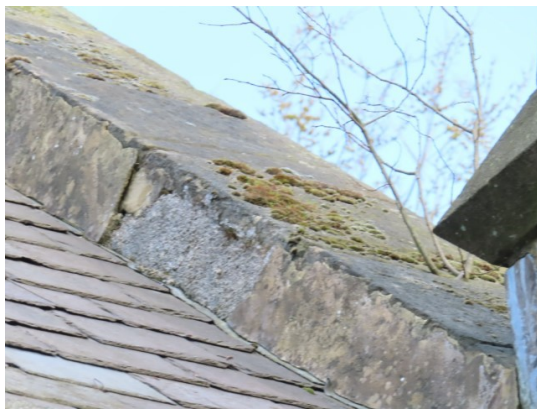
Sapling and failing mortar fillet to the Chancel

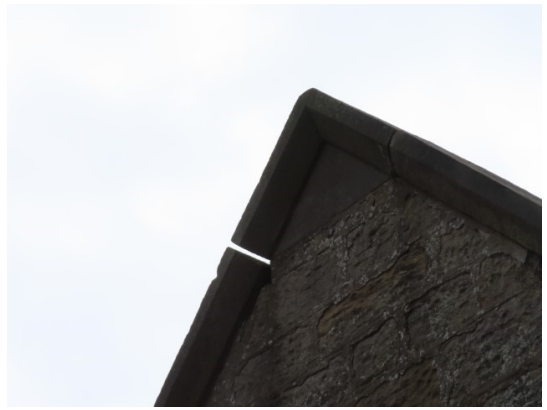
Open joints to the water table on the organ chamber

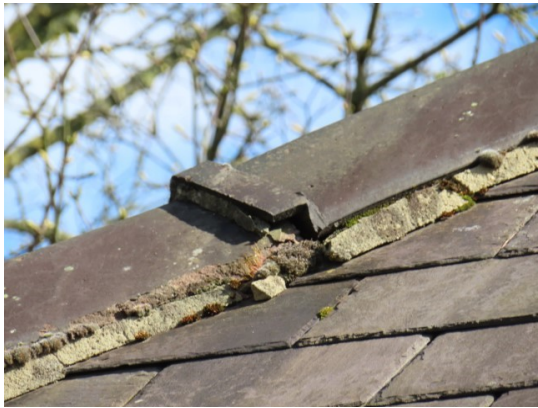
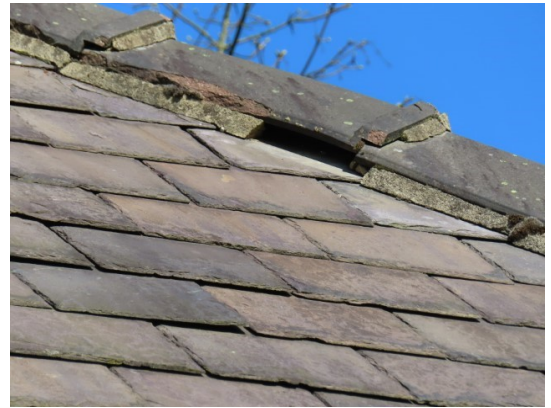
Failing and missing mortar bedding to the hops of the parish room

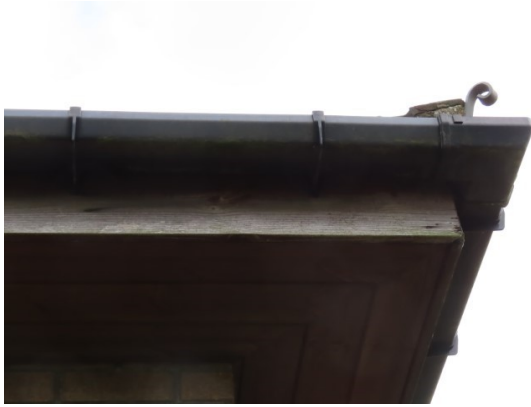
Failing stain finish to Parish room fascia and overhanging eaves

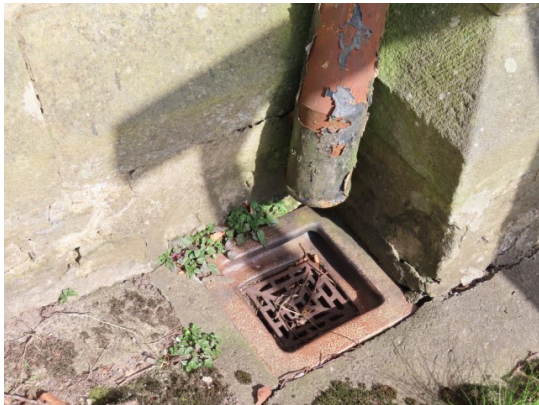
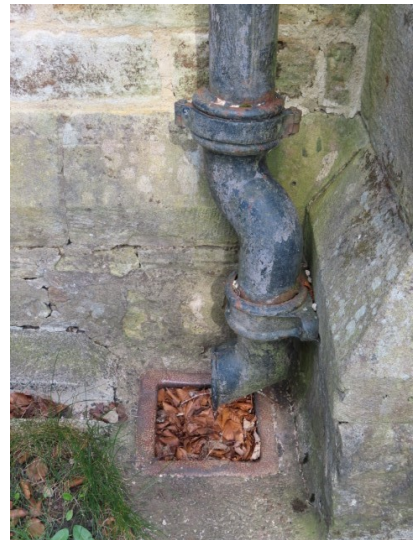
Rusting downpipes, vegetation growth, leaf build up (above and below left) and to the top left, downpipe not fully discharging over gully

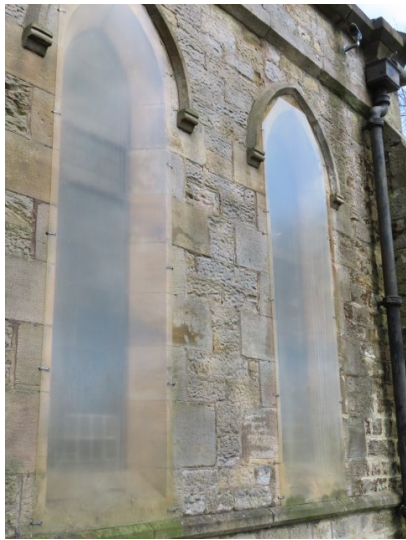
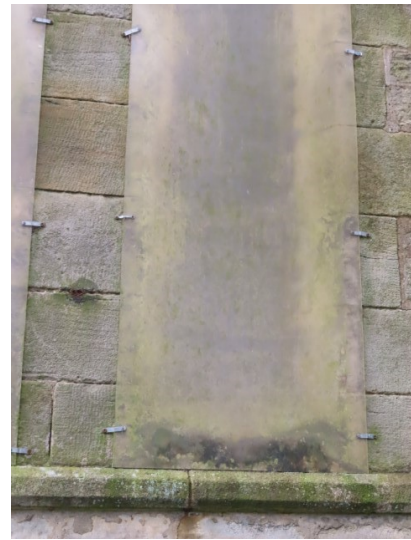
Aging protection is becoming discoloured with some algal growth further obscuring the protection

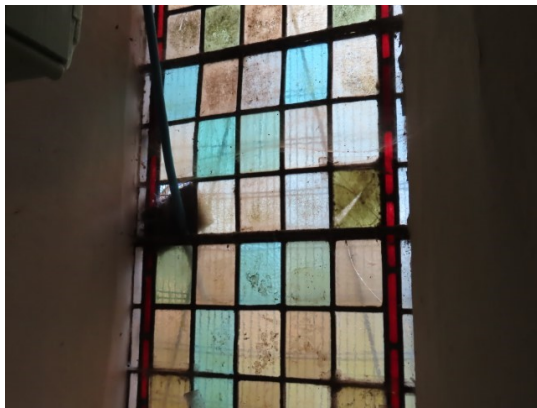
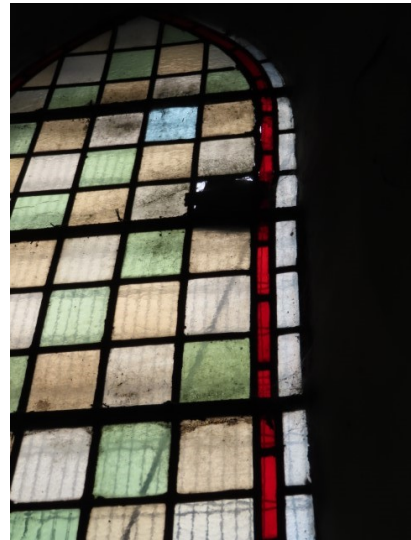
| 14. Windows | Leaded lights with the majority having plain coloured glazing with the exception of the Chancel. UPVC windows to meeting room | Nvi – Rusting saddlebars with a few cracked panes, with some missing fragments. One replaced glass pane and one slightly open around a hose (what it is connected to was unclear). The window needs repair, and if the pipe is redundant, it would be better to remove it and make the window weathertight. If not then options to find a better solution should be considered. | Carry out more urgent repairs to windows with more obvious defects namely the saddlebar to Sii and glazing which is no longer weathertight. | 2 |

Hose passing through window and damaged panes to window Nvi

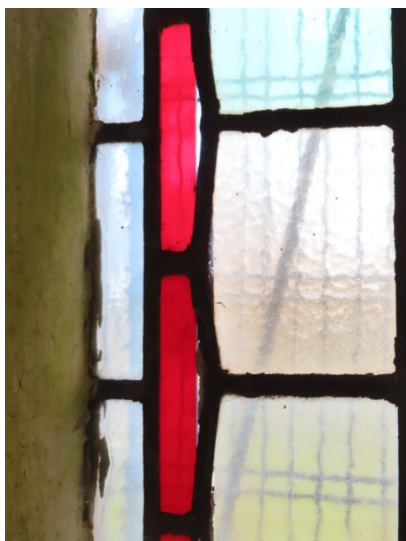
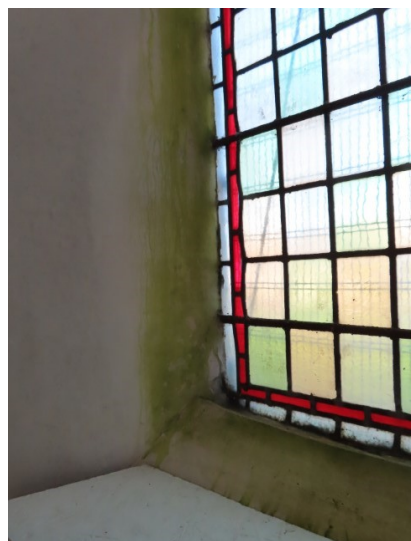
Gaps around panes where lead has distorted Nvi

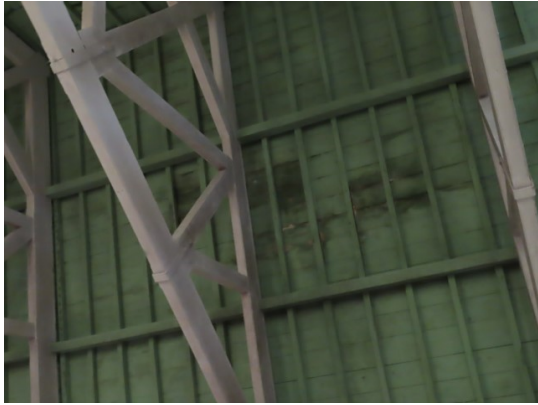
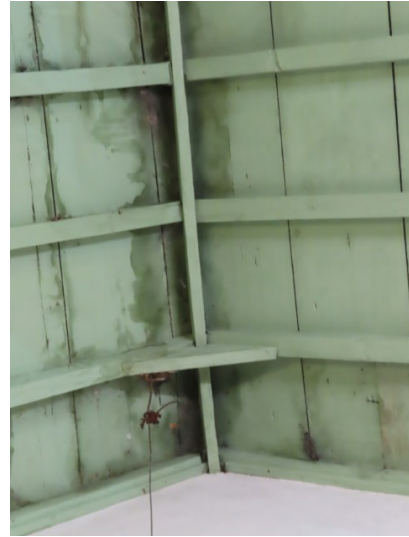
Damp staining to sarking boards of the Nave including near the bell rope (right)

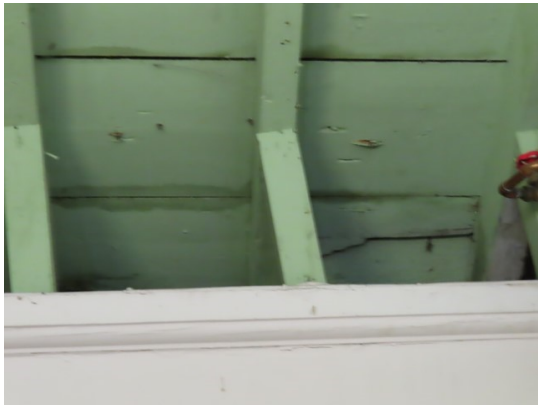
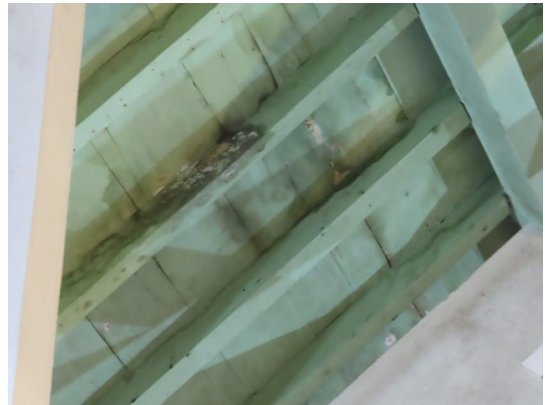
Split sarking board to the South West of the gallery

Dampness and possible rot to the side of one rafter

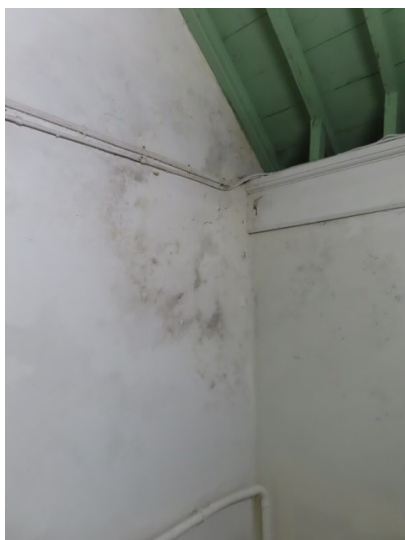
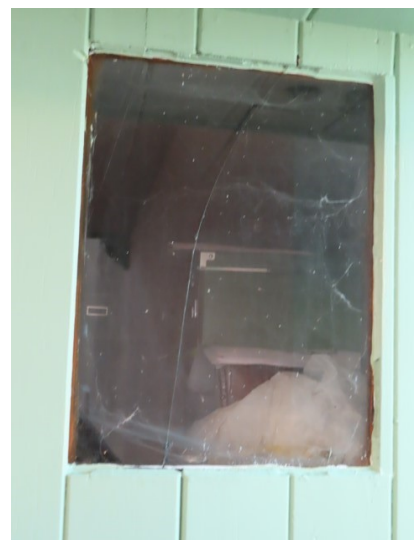
Dampness and blistering to plaster near the gallery stairs

Cracked pane to understairs cupboard

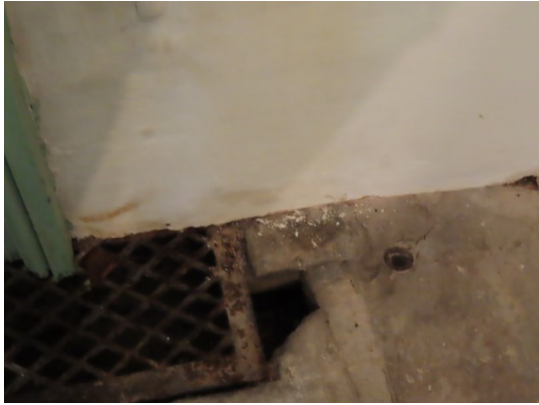
Damaged flag to the side of the grating near the porch

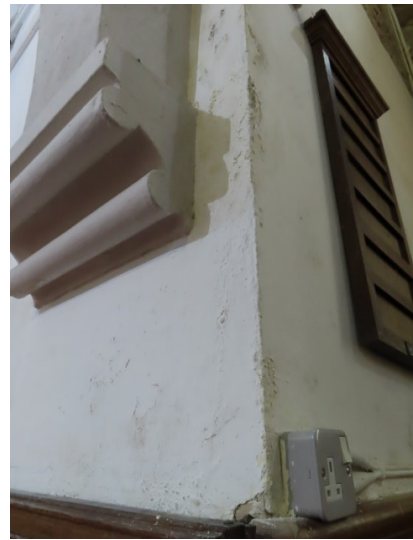
Blistering of paint/plaster to junction between the Nave and Chancel

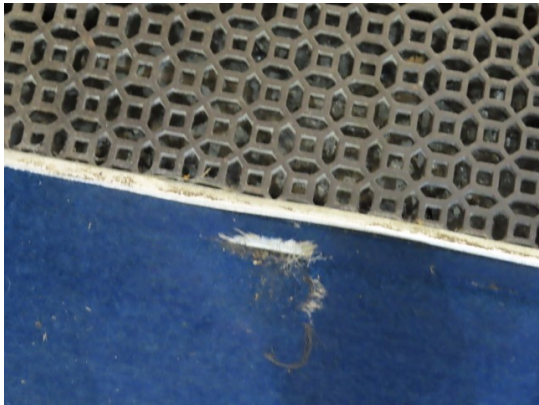
Damage to carpet (possibly due to defect below)

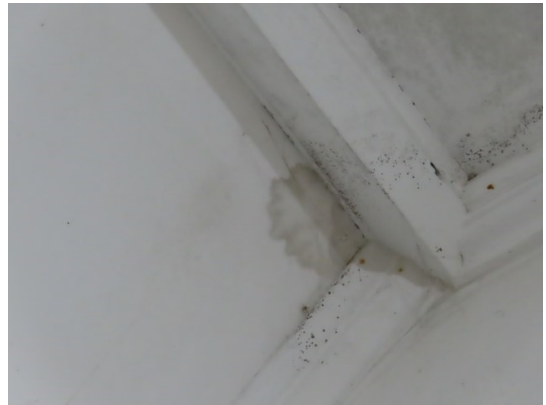
Damp patch to East Chancel ceiling To Chancel

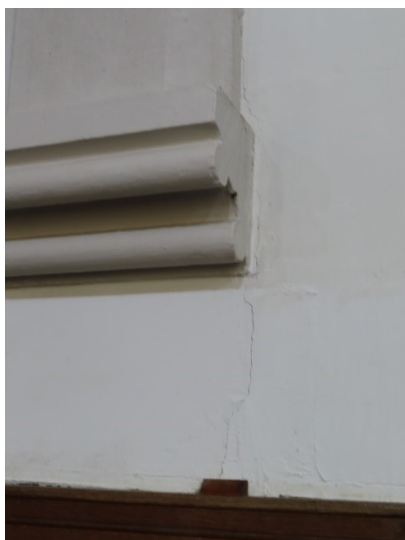
Crack to Chancel wall

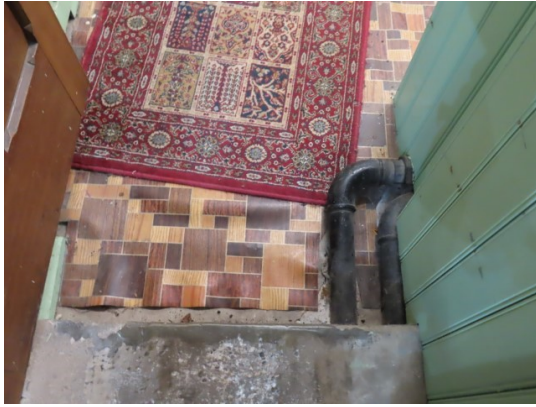
Poorly defined step and projecting pipework to Choir Vestry

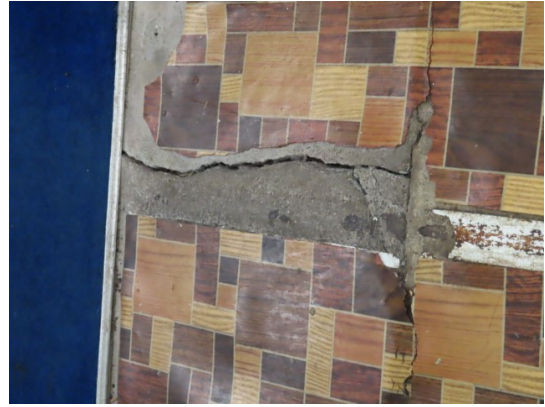
Significant cracking to Choir Vestry floor

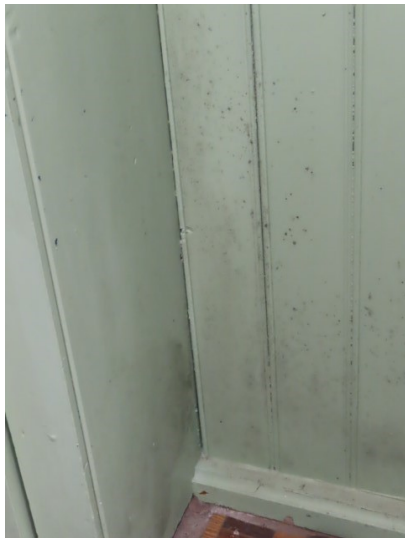
Mildew to Choir Vestry panelling

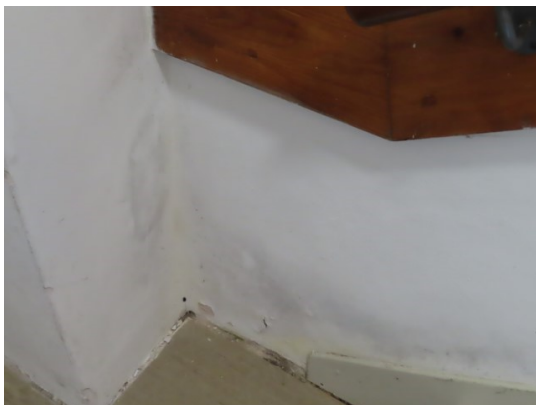
Dampness and deterioration to plaster by steps Parish room

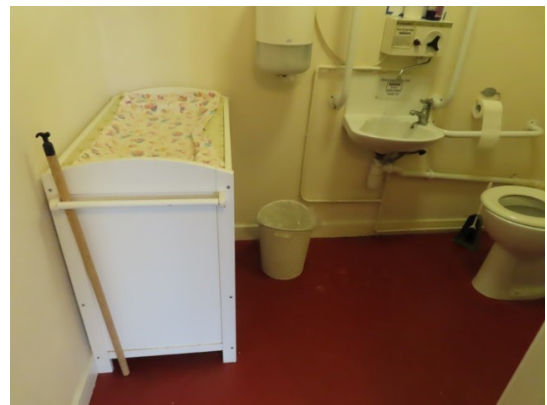
Bulky changing table taking up to floorspace in the Accessible WC

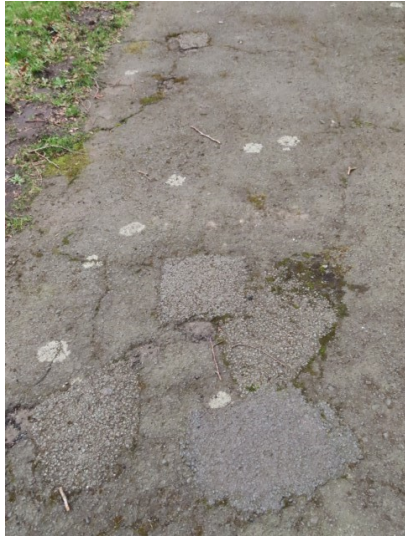
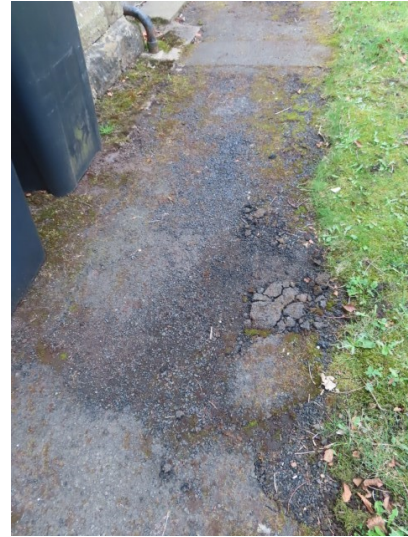
Damage to tarmac paths and to the right-hand image encroaching grass is reducing the width of the path

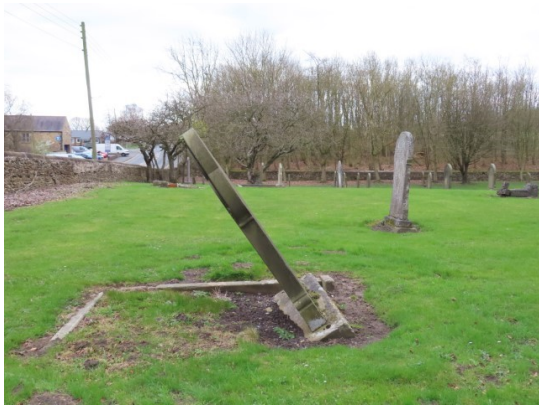
Significantly leaning gravestone

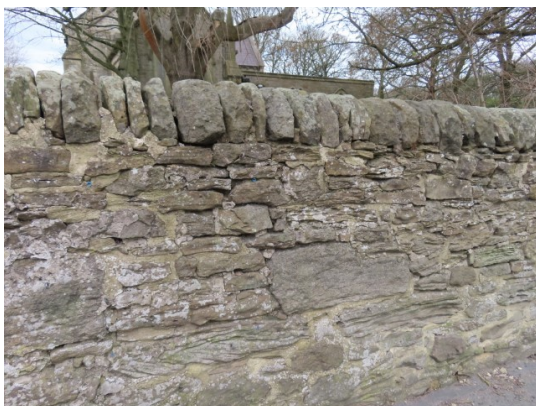
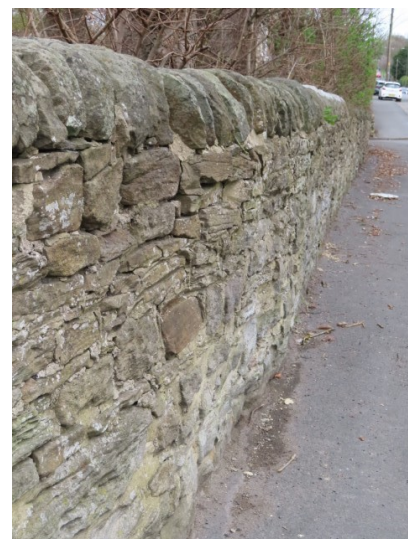
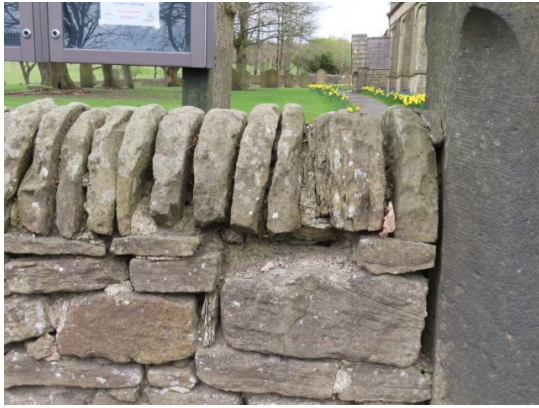
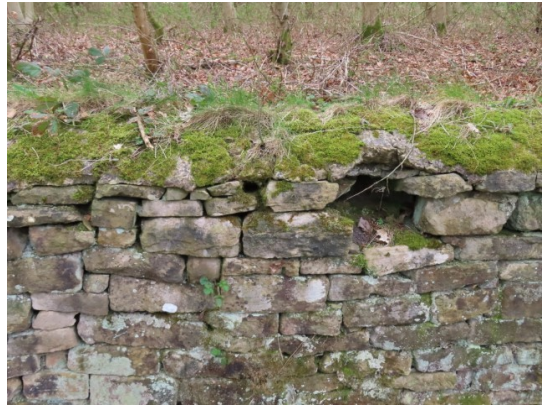
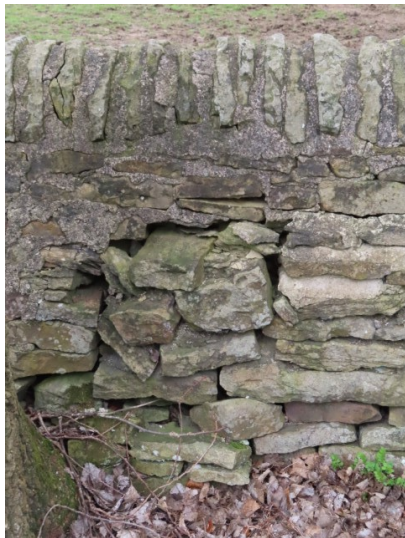
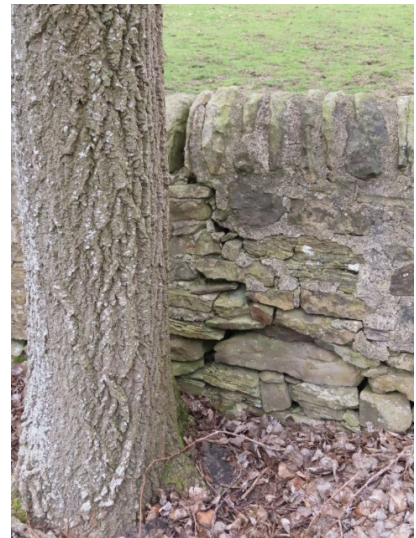
| Churchyard<br>cont'd | | Western Boundary – a stone wall with stone copings with higher field behind. Vegetation growth is present in a number of areas and isolated weathered stones. Condition is better than the South boundary but there is cracking/movement around trees and a number of sections need attention, with some of the worst impacted sections liable to fall. | | |

The following photos show defects to the East, South and West boundary walls including bowing (and other damage around mature trees), loss of stones, open joints, vegetation growth and cracking:
