Quinquennial Inspection Report

**Church of St John
Hebburn
Diocese - Durham
Archdeaconry – Sunderland
Deanery - Jarrow**

Date of report: 18th September 2024

Ref: 24025/5

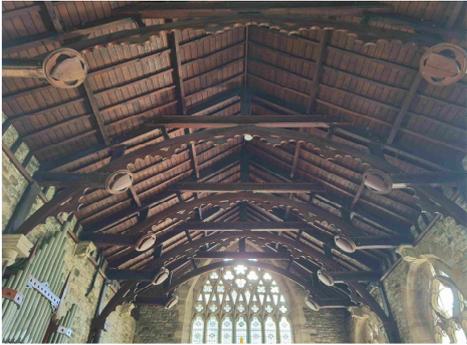
<p>Chancel ceiling structure</p> <p><u>Chancel and Nave:</u> Exposed hammerbeam trusses, purlins, rafters and boarded ceilings in good condition. <u>Vestry:</u> fibre board ceiling and laths in fair condition apart from some minor staining in one location. <u>Transept (upper):</u> new suspended ceiling in good condition. <u>Transept (lower):</u> new plastered ceilings in good condition. <u>Toilets and kitchen:</u> plastered ceilings in good condition. <u>Void over kitchen/toilets:</u> small chink of daylight showing in profiled metal deck indicating a potential for leakage. See 1.1 for action on repairing the hole. <u>Prayer room/store area:</u> some stained and damaged ceiling tiles due to roof leaks. See section 1.1 and 1.5 for actions on leaks. <u>Hall:</u> some staining of suspended ceilings in store due to past roof leaks. See 1.5 for actions.</p>

Repair needs	It is recommended that the stained and damaged ceiling tiles in the Creche/Store and Hall/Store are replaced.	D

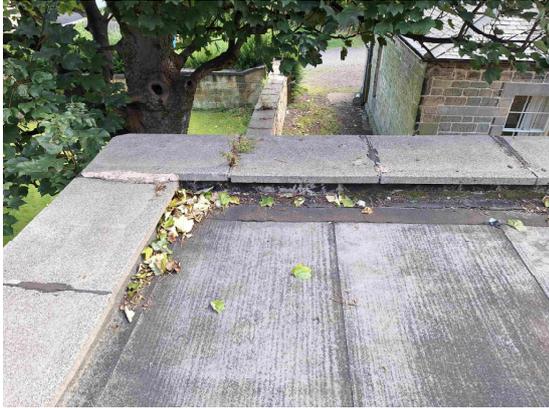
Hall parapet copings need repointing

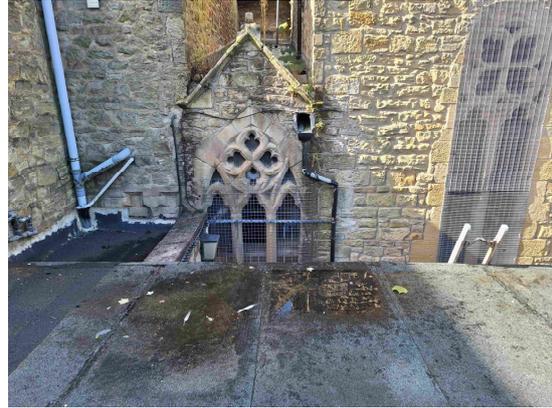
Hall flat roof ponding/ vegetation to gable beyond

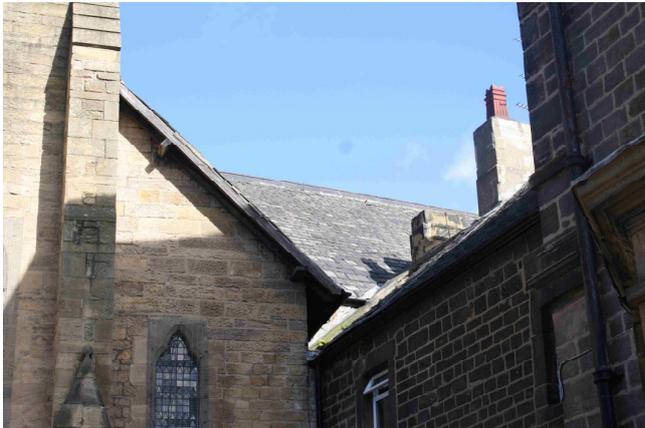
Nave gable with missing pointing to verge

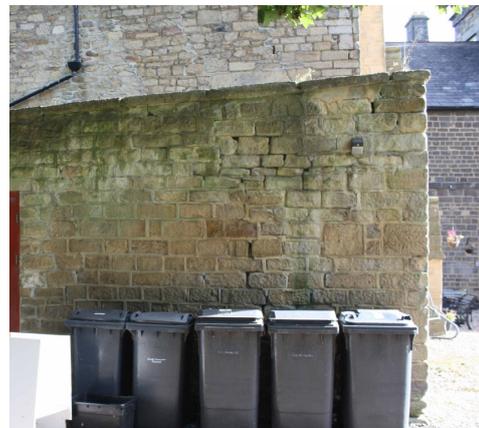
Prayer Room north wall with open joints

Repair needs	Raking out of cracks, open and receding joints in the areas identified above followed by repointing in lime mortar.	C
--------------	---	---

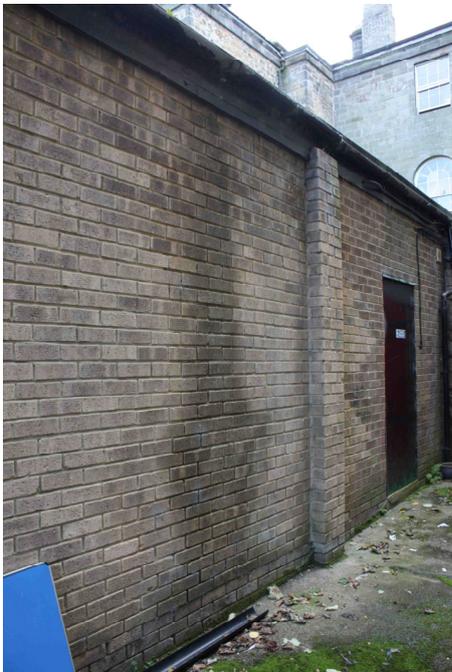
Damp patch to Hall wall due to leaking gutter

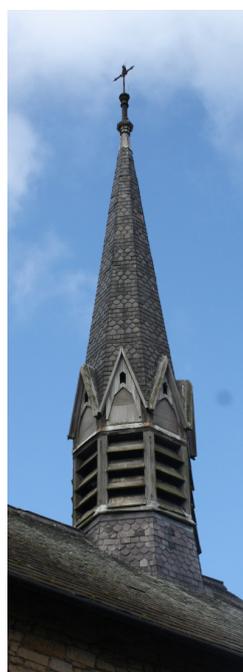
1.3 Fleche		
Condition	The external timberwork (e.g. louvres, gablet panels etc) is badly in need of redecoration and there is some timber decay to some of the gable features which needs repair or replacement. The mesh bird protection is missing on the NW facet which will allow pigeons to nest in the spire. The missing netting should be replaced.	
Repair needs	As above	B

Fleche – missing mesh to louvred openings

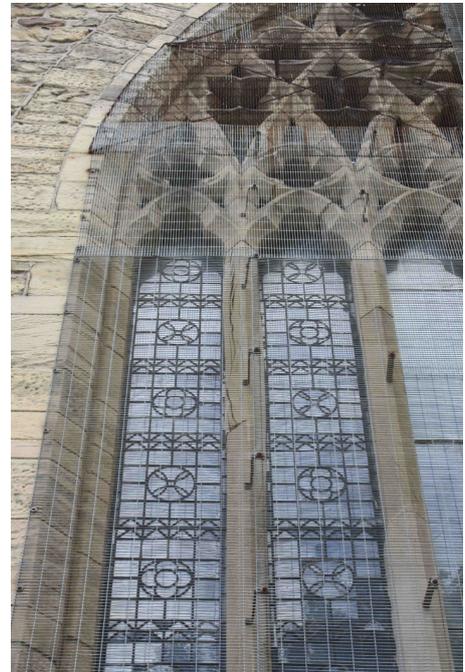
1.8 Windows and window masonry		
Condition	<p><u>Chancel east window:</u> 2No mullion sections are badly delaminating and need replacement. There is a crack in the window cill. The mesh is a patchwork and has rusting upper members (see photo).</p> <p><u>Vestry, Transept, Nave and Chancel:</u> Stained glass, clear glass, leadwork generally all in fair condition apart from one or two cracked panes. The mesh grilles are in sound condition but crudely fixed.</p> <p><u>Hall:</u> Timber windows single glazed; metal mesh grilles. The paintwork is flaking and some of the cill sections are rotten.</p> <p><u>Prayer Room:</u> bronze framed window in good condition.</p>	
Repair needs	<p><u>Chancel east window:</u> The two delaminating mullion sections need replacement. This will entail removing the stained-glass panels and external mesh. It is strongly recommended that the mesh grilles are replaced in polycarbonate fitted closely around the window profiles. The window cill joints need repointing.</p> <p><u>Vestry, Transept, Nave and Chancel:</u> It is recommended that the mesh grilles are replaced in polycarbonate fitted closely to the profiles of the glass openings. Cracked panes should ideally be replaced.</p> <p><u>Hall:</u> Repair of rotten cills followed by redecoration</p>	<p>C</p> <p>E</p> <p>E</p> <p>C</p>

Chancel east window - delaminating mullions
