**QUINQUENNIAL INSPECTION REPORT  
OF  
ST. MARY, BLACKHILLS ROAD, HORDEN, SR8 4LJ**

**DIOCESE OF DURHAM, ARCHDEACONRY OF SUNDERLAND, DEANERY OF EASINGTON**

**DATE October 2025**

**David Beaumont BA (Hons) Grad Dip, RIBA, AABC**

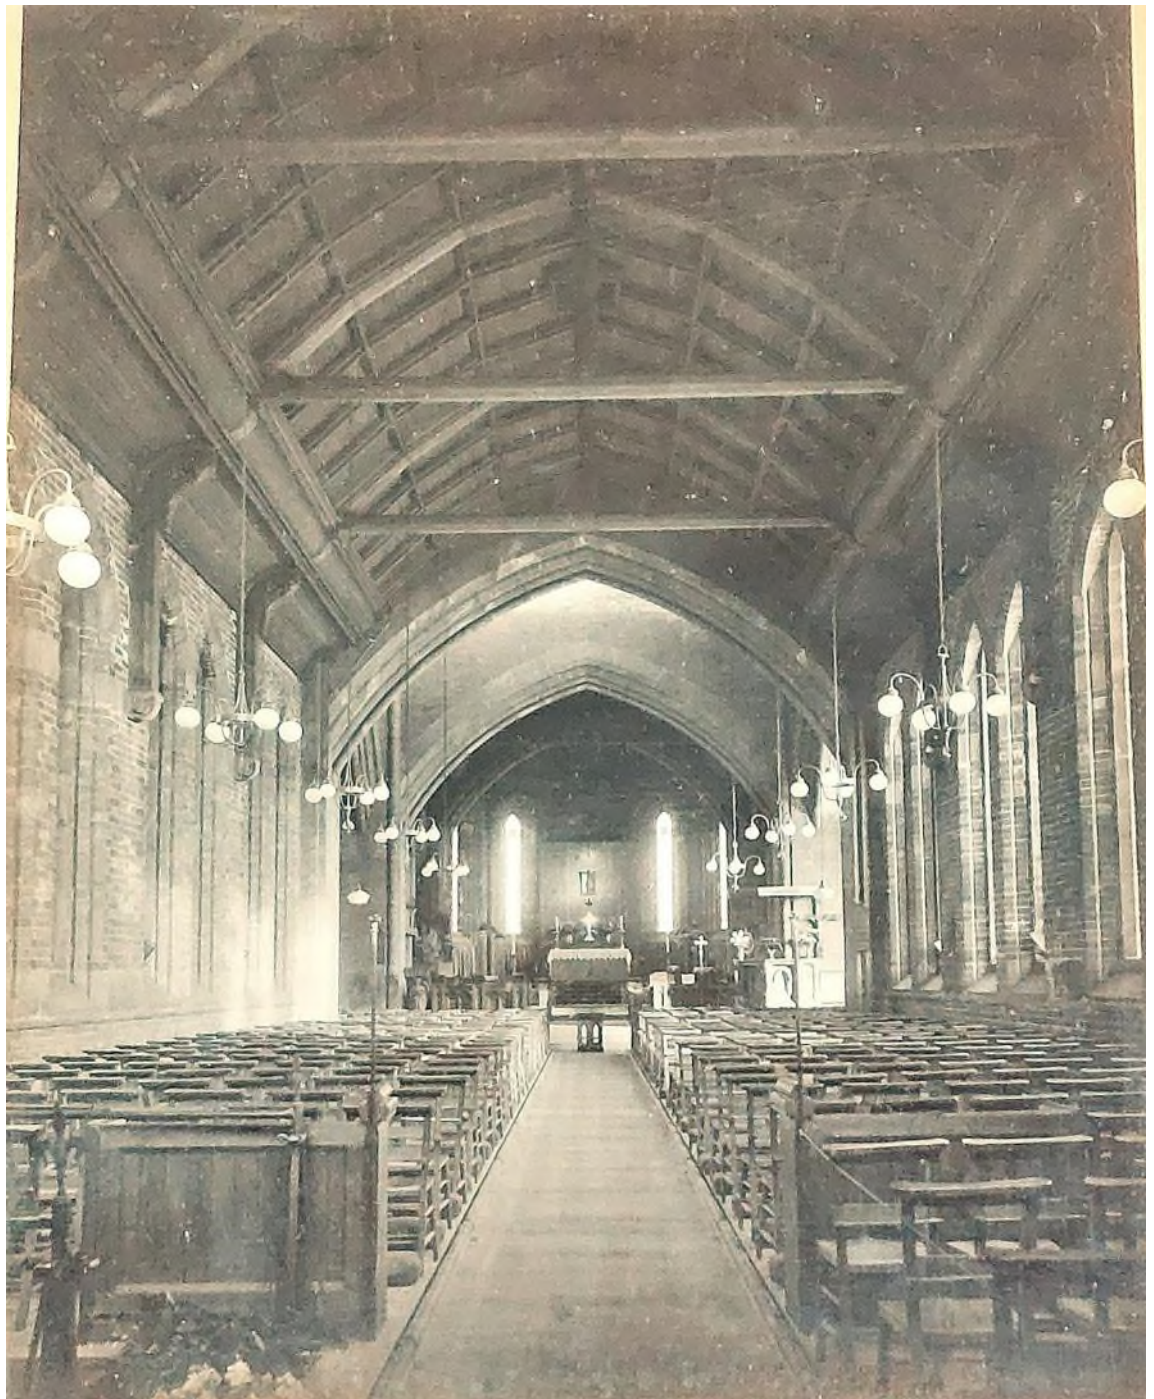
*Undated image held within the church. Note rush seats, not pews, suspended lamps, now replaced and the markings on the tower arch that are evident today.*

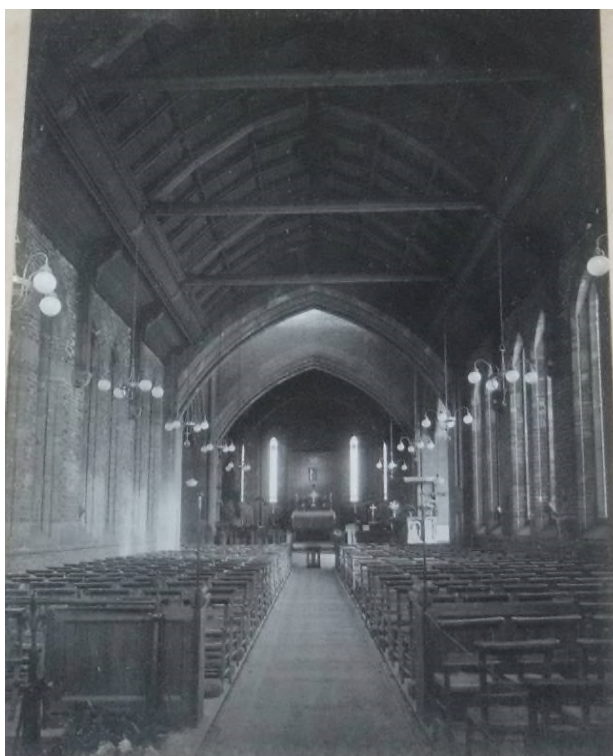
The undated image below shows that there is staining at the tower crossing on the nave arch, brickwork and cast stone. So it has been there for some time.

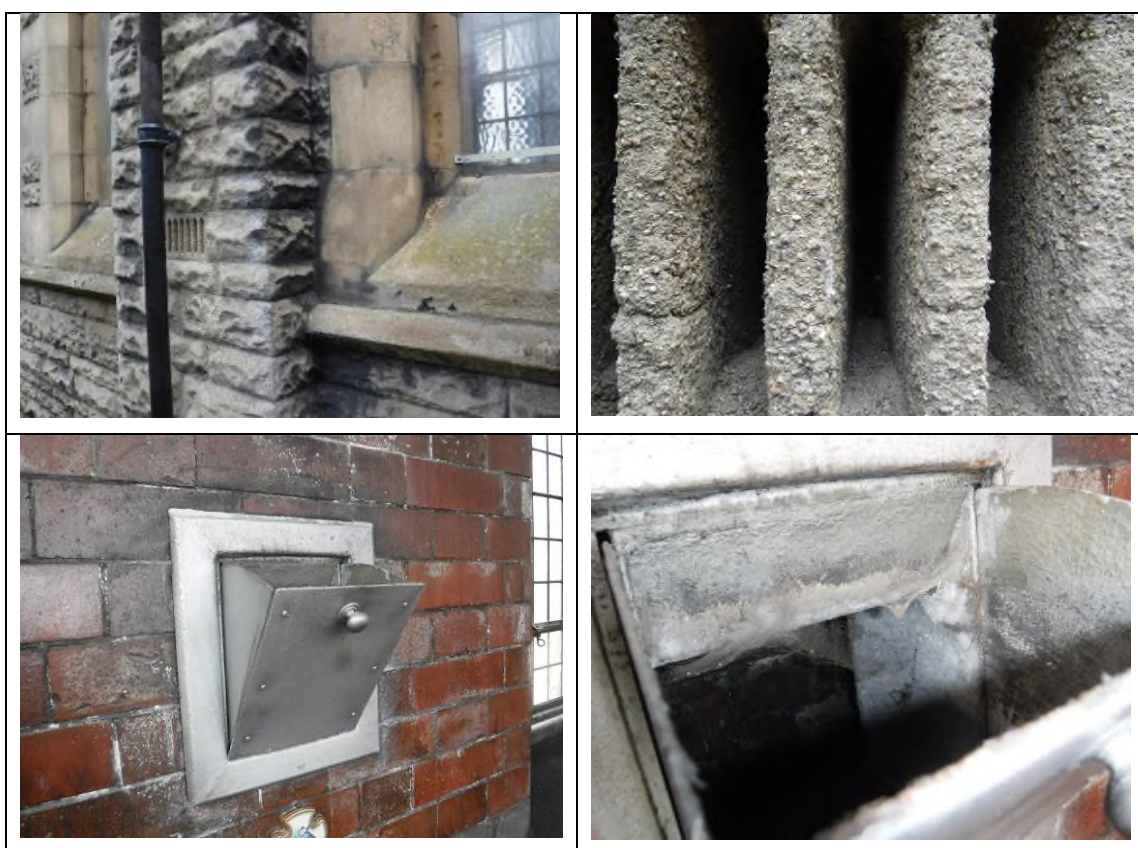
The church has a rapid ventilation system. It looks like it has an inner skin of 100mm brick and then a cavity of 150mm then there is a further brick face creating a lined flue. One would expect high level air bricks but none can be seen. Perhaps its purpose is to allow air in at low level and use convection to let it rise in the nave and disperse through the glazing vents. The vents are rusted shut.

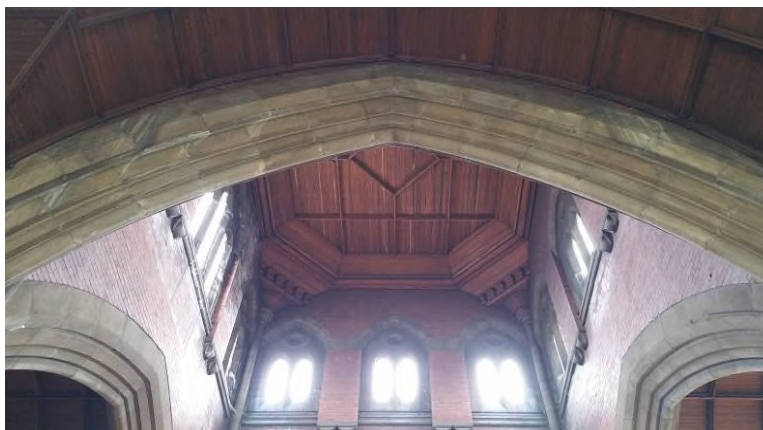
The arches are all sound, there is water staining at the springing points in all corners but less so in the N W corner, and down to the ground they are all ok.

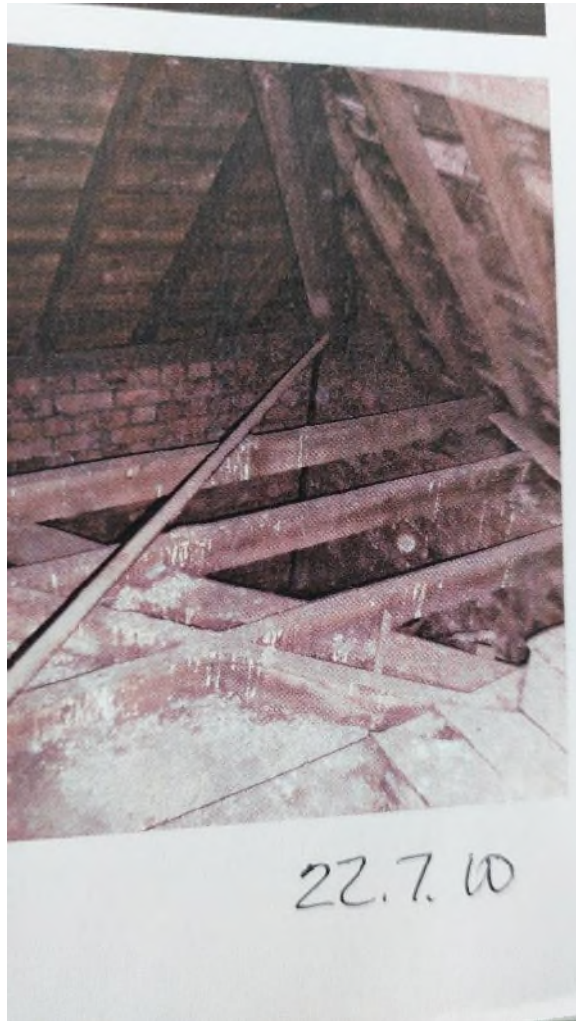
Access to the roof attic is available externally, it was inspected when the cross was replaced in 2010. And it would be wise to inspect again.

There's no ceiling hatch and when there is next scaffold inside one should be created. There is an external access at the east end, but this always requires scaffold to access.

**Recommendation:** create attic access, investigate wall construction, repoint exterior, repair glass, remove inside salts and staining

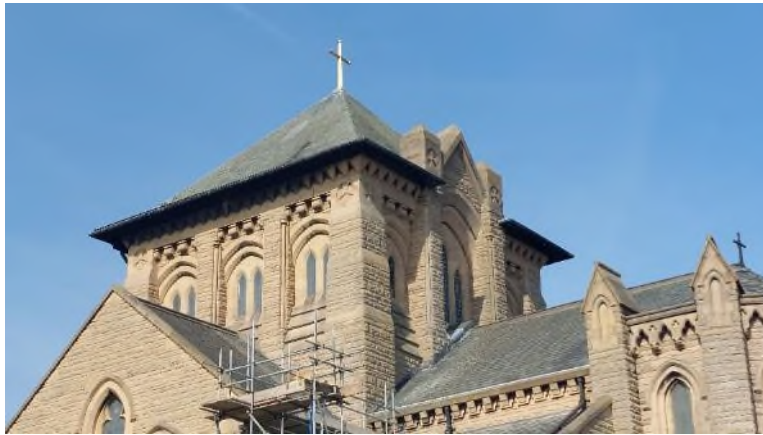
Hipped slated roof which has problems with its mitred hips occasionally and last repaired in 2020. It had its gold cross replaced 2010. The gold leaf is coming away.

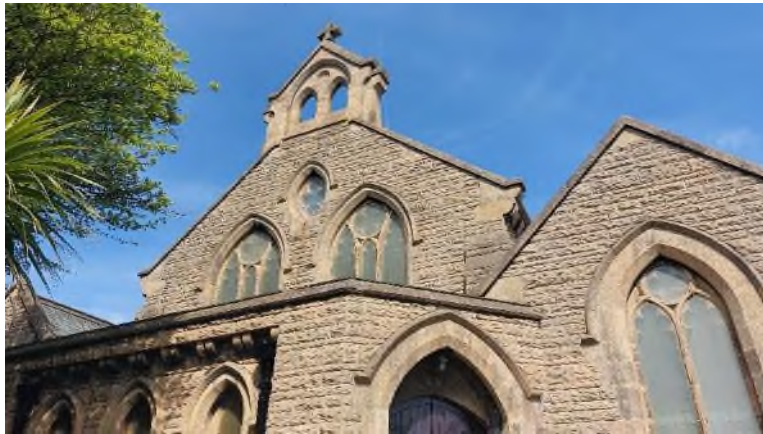
#### Bellcote:

No obvious defect.

**Recommendation:** none

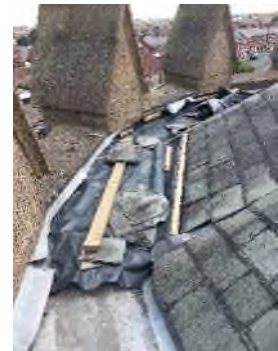
Missing lead gutter at apse

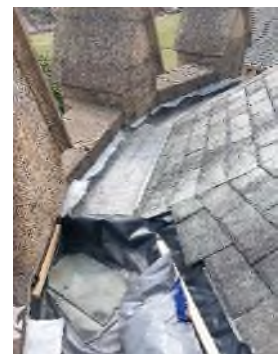
Damaged flashings

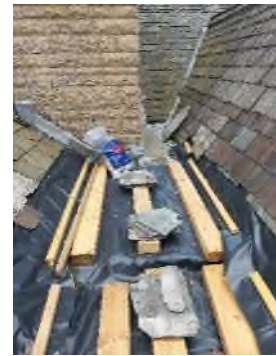
Missing lead gutter

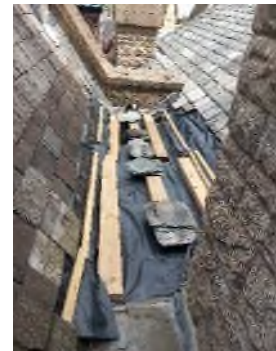
Missing flashings

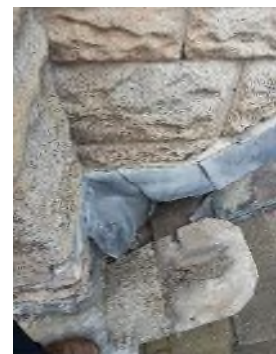
Damaged gutter

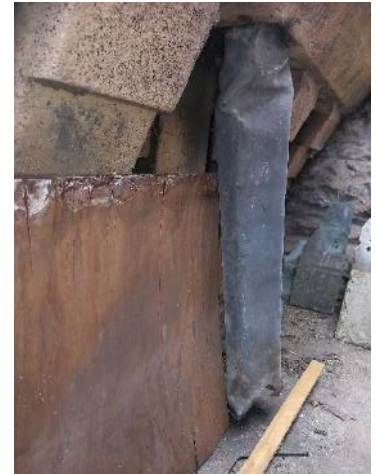
Damaged downpipe

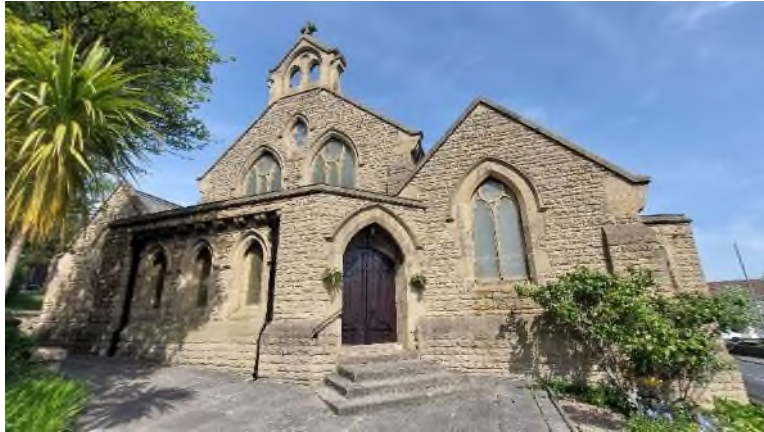
##### - Nave and Porch:

Gable and windows appear ok, below that is the entrance porch. All ok.

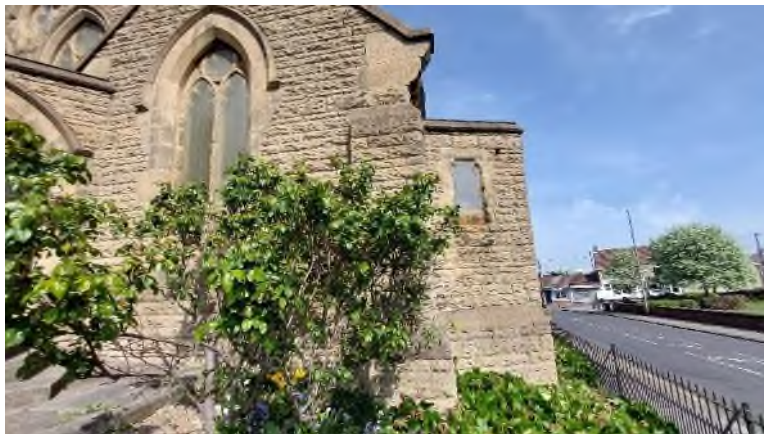
##### C Female Vestry:

No change to open joints reported in last QI:

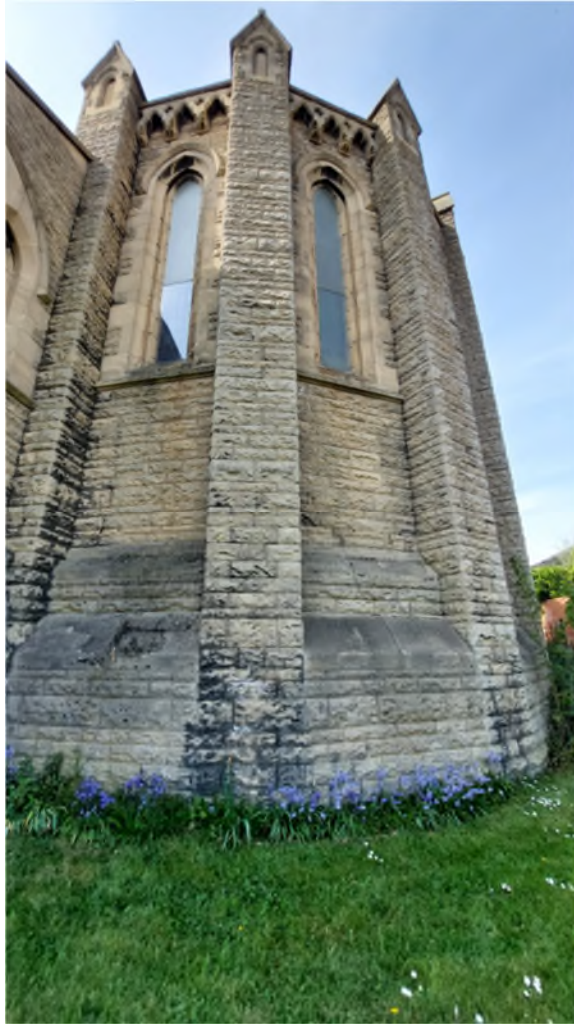
**Apse:**

The same as the QI. We know there is some efflorescence showing on S side at high level so there might be a problem here with the parapet gutters. They are undergoing repair after lead theft.

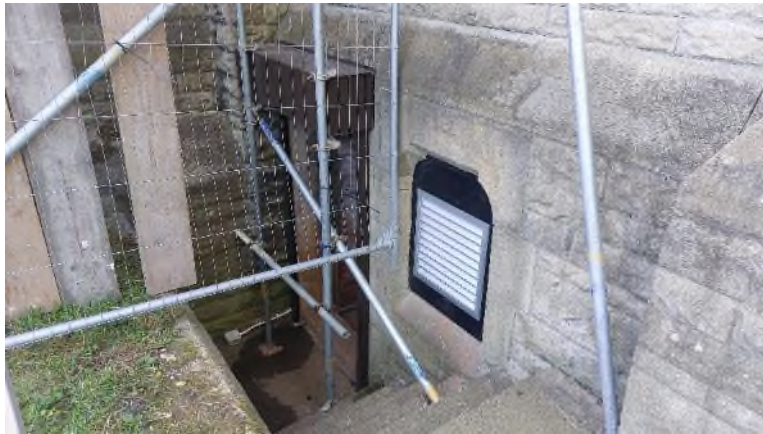
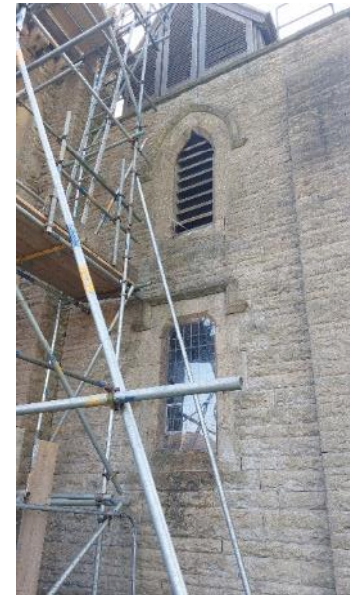
### Vestry Corner:

Basement boiler house (see separate entry below). Air vent now replaced. But needs further protection against intruders. Header tank overflow pipe extended so it doesn't drip on the walling now. Polycarbonate renewed. A little bit of open jointing on south side of mid-level louvre (probably not noticed last time- I don't think it's new)

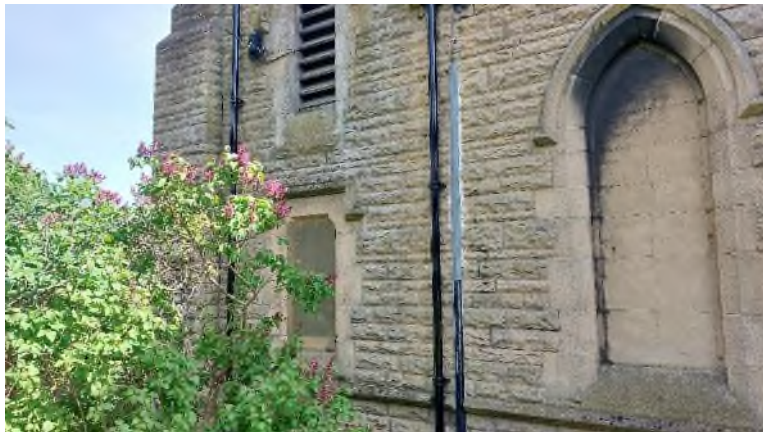
### Organ Chamber:

The organ has a blanked window opening and the plaster is cracking on it but not really needing attention yet. There is an old bit of cracking just to the left of the downpipe linking the louvre window and the ground floor window at the Sacristy.

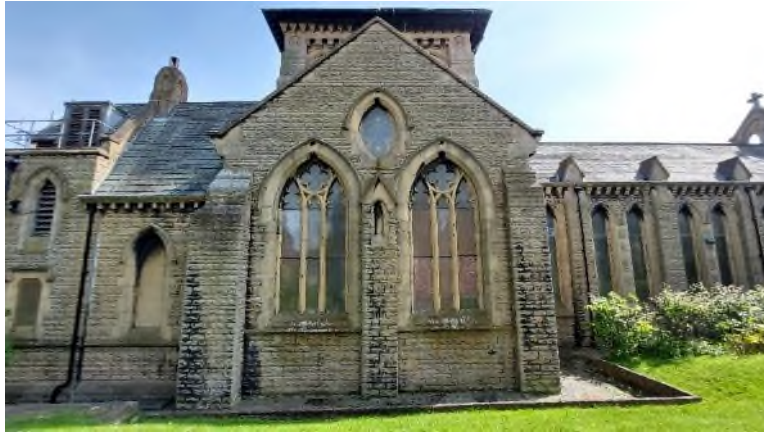
### North Transept:

Water table joints look a bit open on the E side, bit of an open joint above the vesica window but the condition looks much as before, polycarbonate has been replaced. Door has been repainted

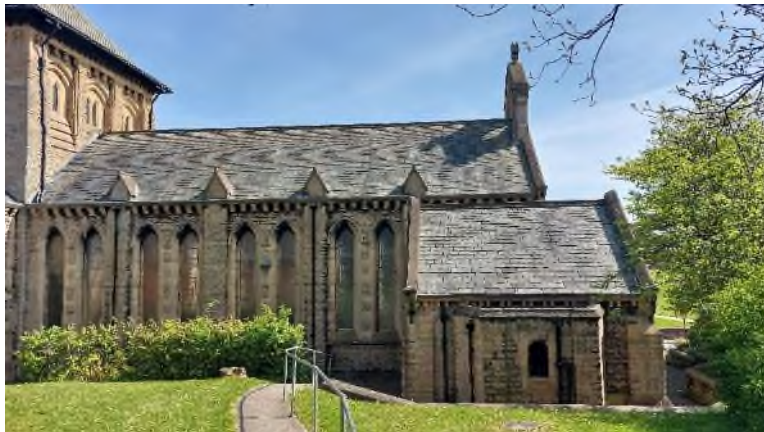
### Nave:

The gutter here over sails with corbels so what created the (historic) staining inside on the eaves woodwork? It must have leaked back into the wall head. See comment about box gutter in rainwater goods section.

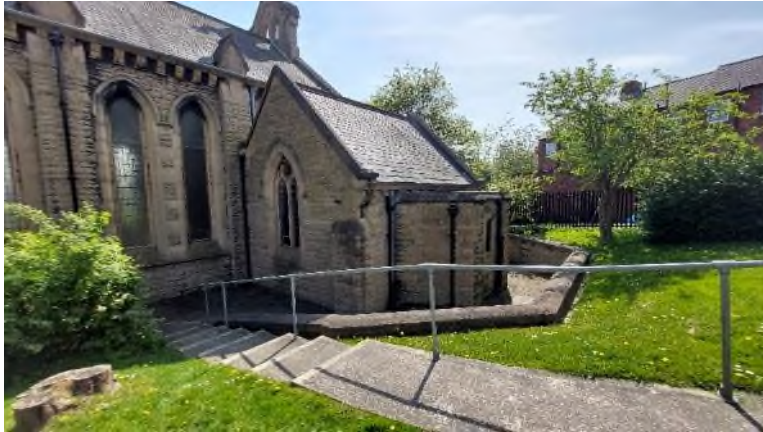
- **North Vestry:**

Has undergone repairs and is ok

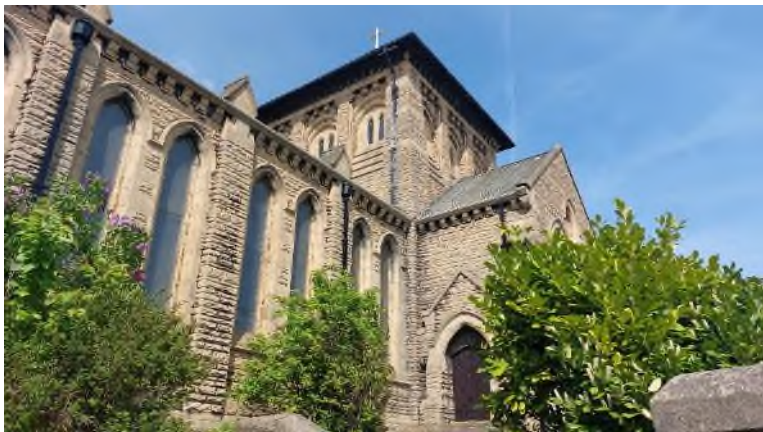
- **Nave:**

The S side of the nave looks generally ok, polycarbonate is clean on this side.

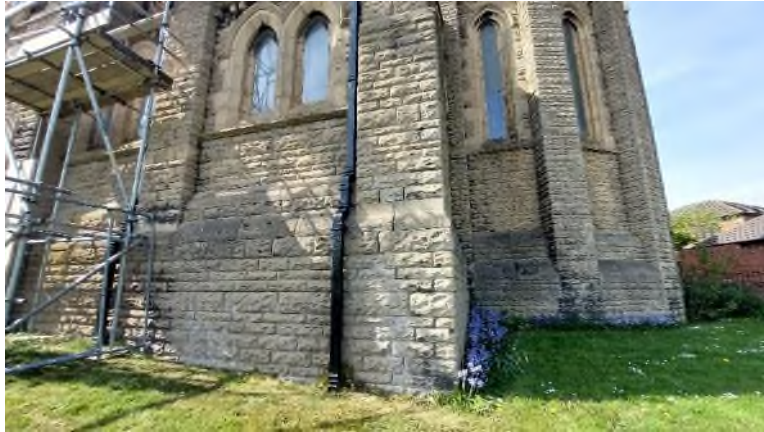
### Lady Chapel:

You can see here easily that wherever there is a sloping surface the pointing is coming out.

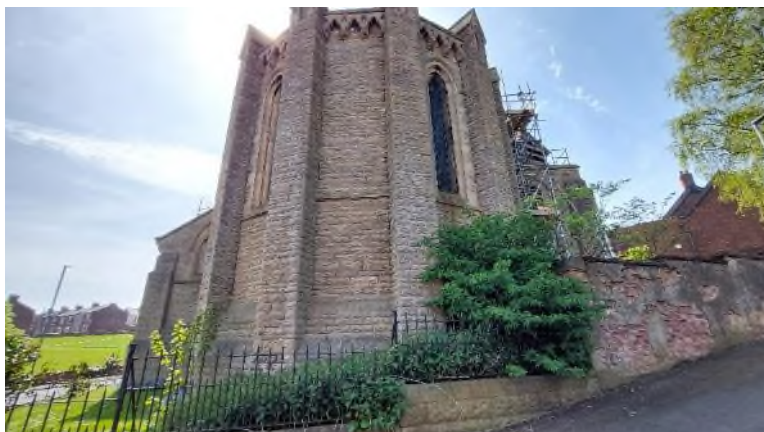
**East Boundary:**

Rusty railings on the low cast stone walls. Further up is a masonry wall that has a crack induced by the tree within the church grounds.in fair condition.

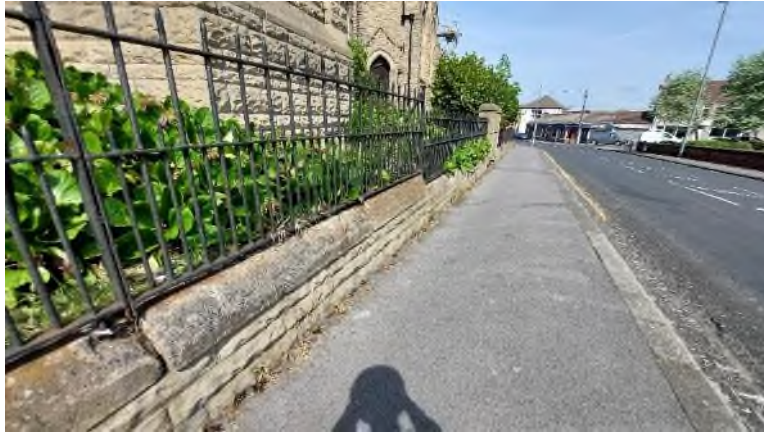
**South Boundary:**

Low retaining wall (same cast stone as church) with metal railings rusting in places and the decoration is breaking down and some of the fixings are rusting and breaking the stonework. The top course is being pushed out.

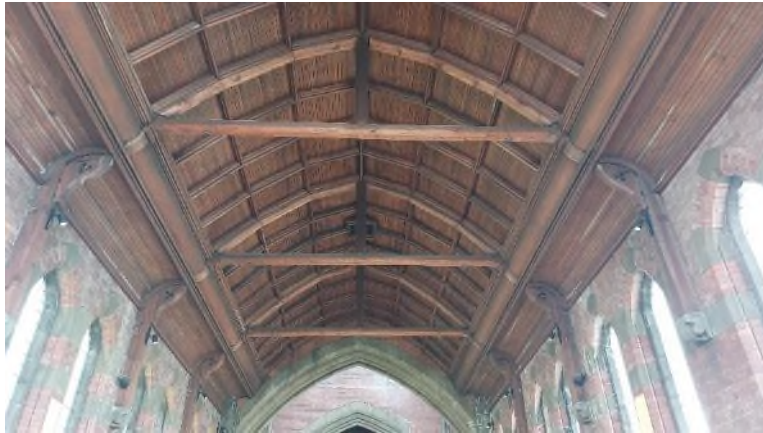
### C Nave:

- **Ceiling** – open rafter roof, boarding is in good condition, some water marking at eaves at tower and west gable ends Clear finish has darkened with age.

Up at the eaves the major damp item in the nave is at the further most truss on the N W side which is historic.

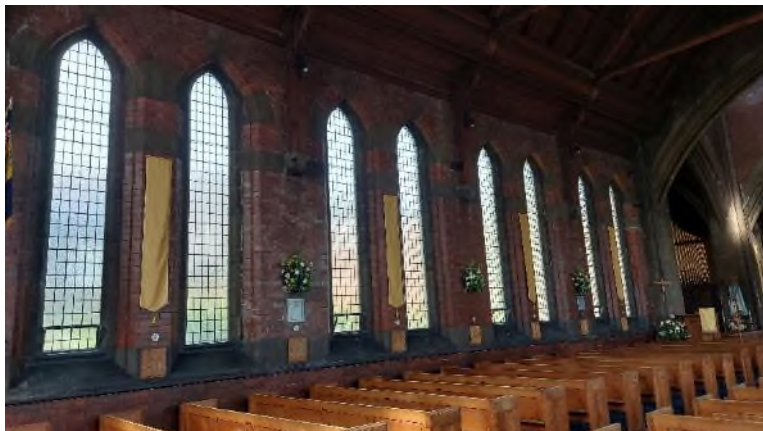
- **Walls** – Walls are fair faced engineering brick and look severe compared to the lighter 'stone' colour of the outside.
- There are salts to them. Damp showing at low level particularly to the South side (oddly, as it is higher out of the ground on the south).
- The window reveals are in cast stone and dark with pollution, also has water staining and should be cleaned

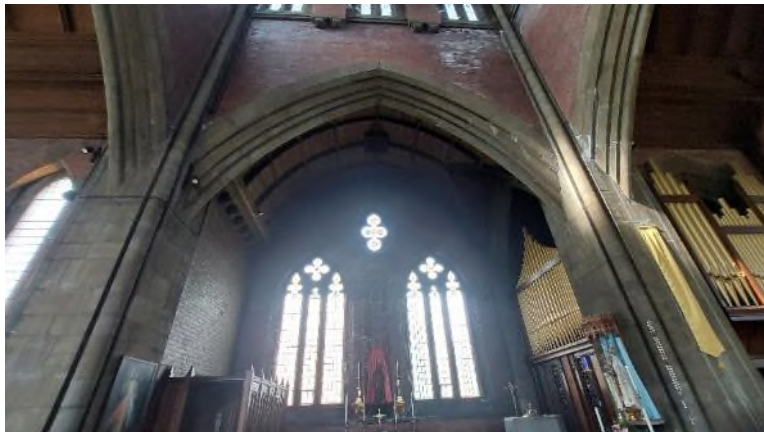
### Transepts:

- **Ceiling** - The Transepts and Lady Chapel ceilings have exposed rafters and purlins with boarding and these appear to be in good condition.
- **Walls** – Same as the nave. Salts at the window reveals
- **Floors** – Same as the nave.
- **Doors** – The external doors to the transepts are no longer used for general access. They are within lobbies that are used for storage and can no longer function as exits. They have been forced in the past by intruders and are now heavily guarded. They are draughty and could do with draught sealing.

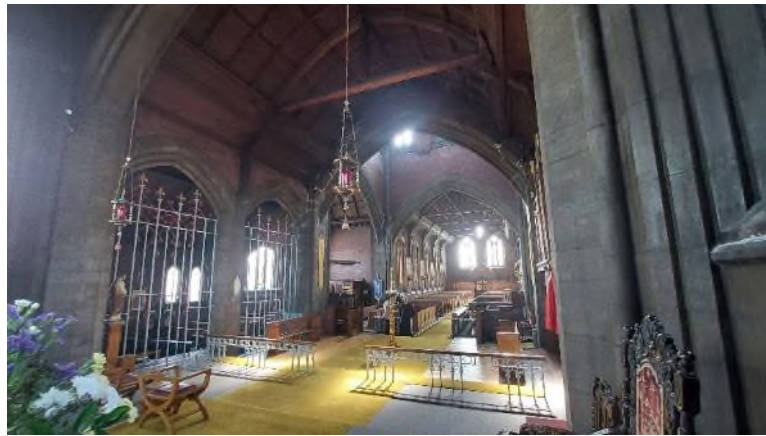
#### Chancel:

- **Ceiling** – Boarded and there is a void over that hasn't been inspected since 1993. The 1995 QI identifies periodic leakages through this roof up to a time when the roof was recovered and that there were no reports of leakage since then. But there are some salts outside at high level so the parapet gutters need checking.
- **Walls** – Same as the nave. Arcade arches are ok. The cast stone elements have been treated with a wax finish and there is more water staining to them at this inspection.
- High level of salts on the N E corner reveal still and there is also one area which has loss of facing.

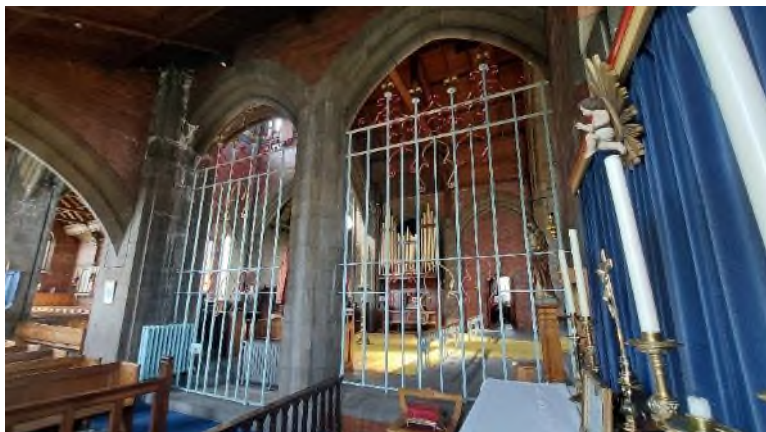
**Lady Chapel:**

- **Ceiling** – exposed rafters and purlins with boarding and these appear to be in good condition.
- **Walls** – Same as the nave. Vet attractive painted metal parclose screen and gate. Good condition. Salting same as chancel to window masonry (behind curtain- rather dusty).
- **Floor** – herringbone wood block and carpet. Uneven towards altar.

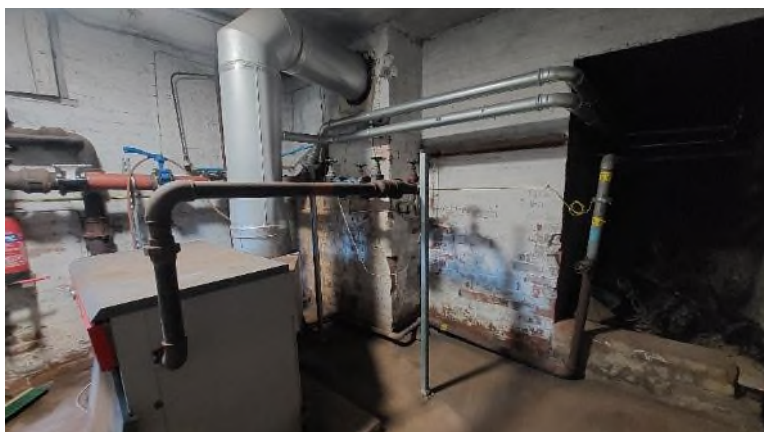
**E Boiler room:**

- **Ceiling** - Cracking to the concrete ceiling at steel beam mid span position, with some holes in it. But not troublesome.
- **Walls** – Painted brickwork, the paint is coming off.
- **Floor** – Concrete floor is ok.
- **General** –Improved vent window needs more work at the bottom edge as it has a gap that could be used to prise it off. Much tidier now but with old light fittings and flower stands to remove. The door frame looks rather worn- does it need replacing? The sacristy waste is plumber through the room to discharge onto the entrance area where it falls to the gully. Not ideal but will do for the present.
- **Recommendation:** tidy up, check door frame for firmness.
