Confidential to:

**IRJ/EC/S2046/Quin**

## 1. PREMISES IDENTIFICATION

- 1.1. The property is a Grade II listed, mid-19<sup>th</sup> century parish church occupying a large churchyard to the south of Front Street (B6279) in the centre of the village.

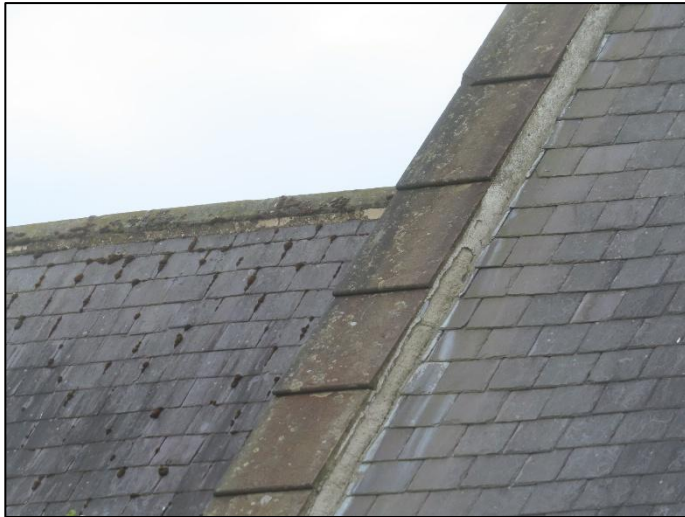
**Photograph 7**

- 5.1.6. Mortar filleting to the copings has been undertaken to a poor standard I anticipate to have been during unsuitable weather conditions and is consequently breaking down, requiring replacement.

8.2.10. Replace mortar filleting to main gable copings.

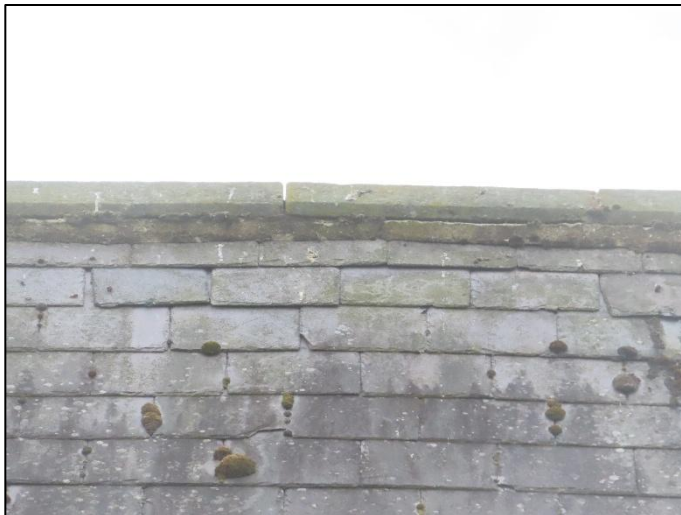
**Photograph 11**

- 5.1.7. Pointing to the ridges is becoming cracked and loose to some areas, requiring replacement.

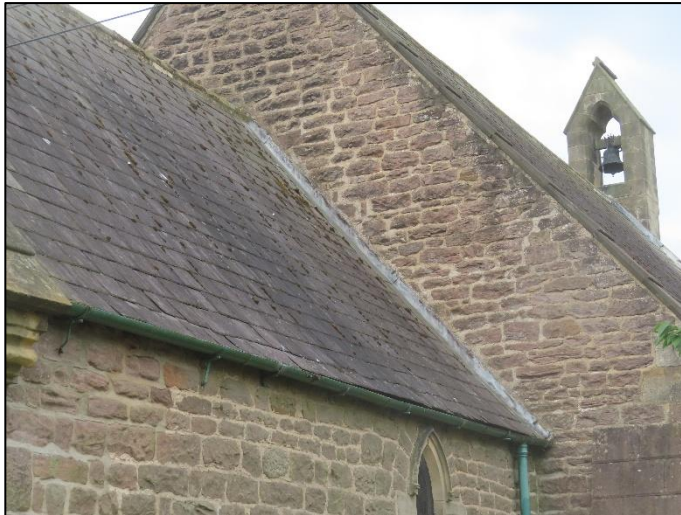
**Photograph 13**

- 5.1.8. At the abutment of the chancel roof with the nave, there are lead flashings which are in reasonable condition for their age.

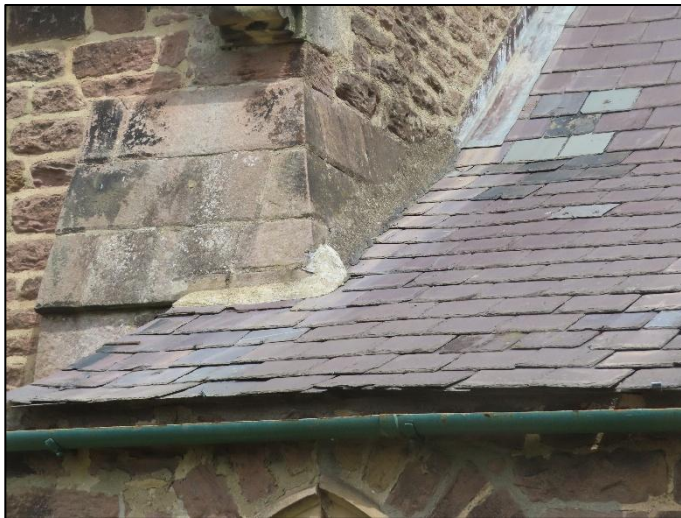
**Photograph 16**

- 5.1.12. To the vestry roof abutment, there is mortar filleting, some of which has been repaired.

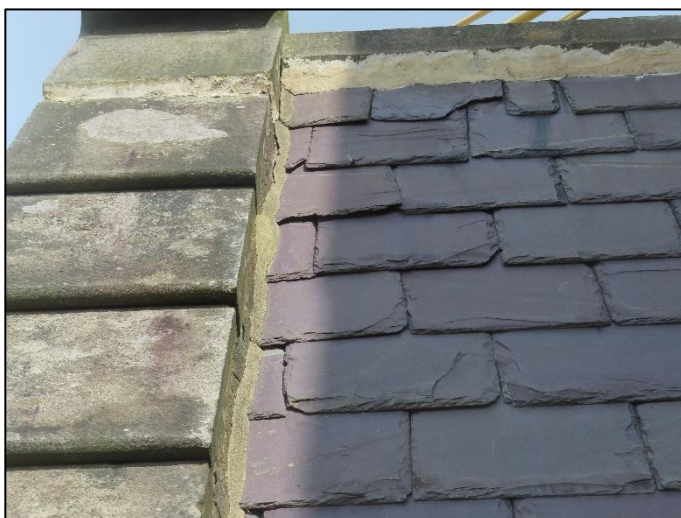
**Photograph 19**

- 5.1.17. However, a small area on the south slope is cracked and loose requiring replacement.

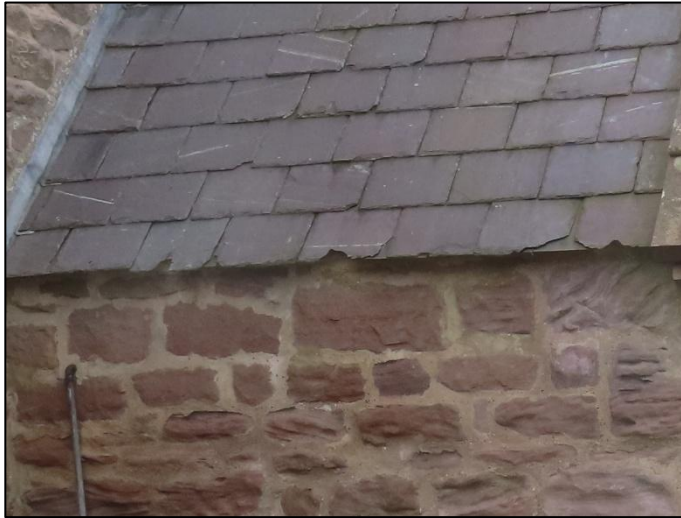
**Photograph 20**

- 5.1.19. There are broken slates at eaves level which would likely allow water to run down the face of the walls and which I would recommend are replaced.

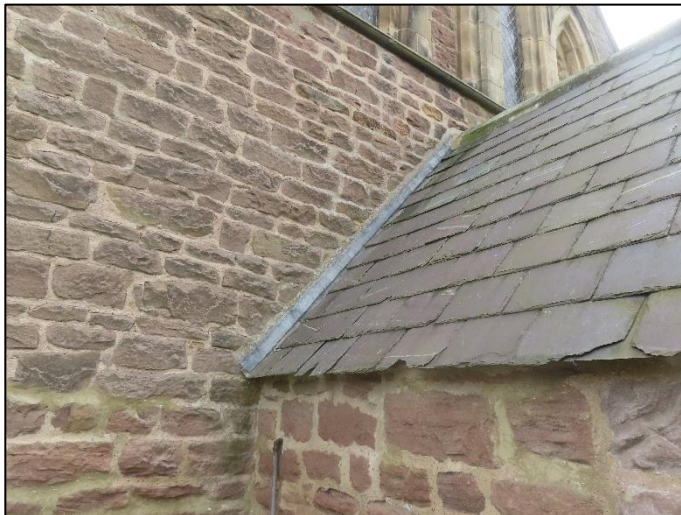
**Photograph 21**

- 5.1.20. There are lead soakers and flashings at the abutment of the porch roof which are seen to be in reasonably good condition for their age.

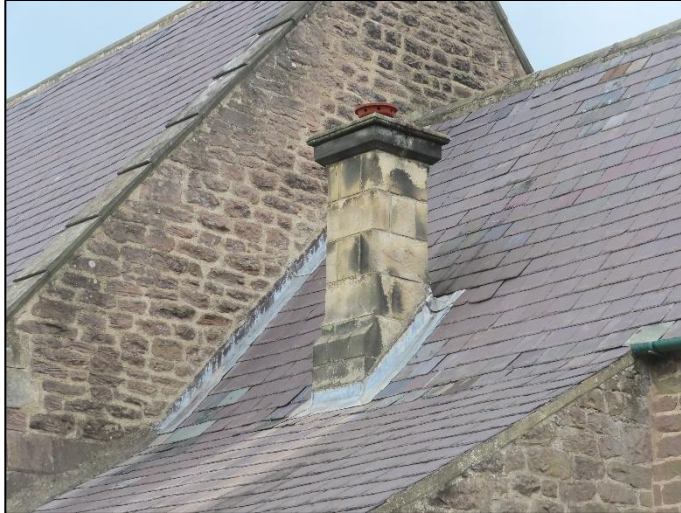
**Photograph 23**

- 5.2.1. There is a stone-built chimney stack serving a previous boiler. The stack is of ashlar stone construction terminating with a clay pot which has a ventilated cap.

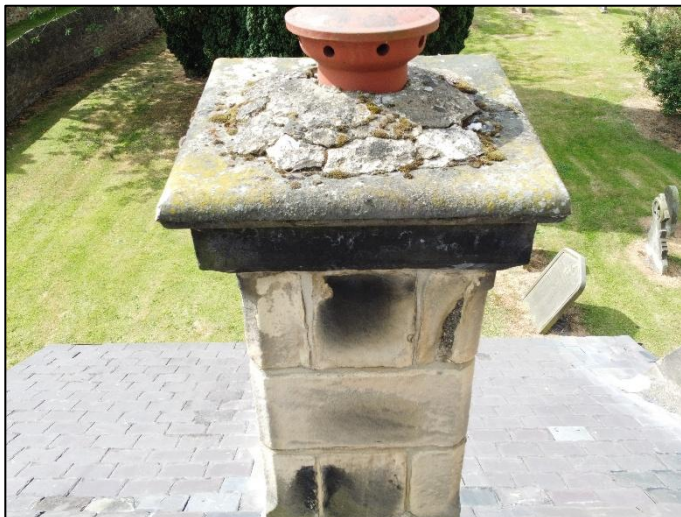
**Photograph 24**

- 5.2.2. The pot is mortar bedded and flaunching.
- 5.2.3. The flaunchings are deteriorating and cracked, requiring replacement.

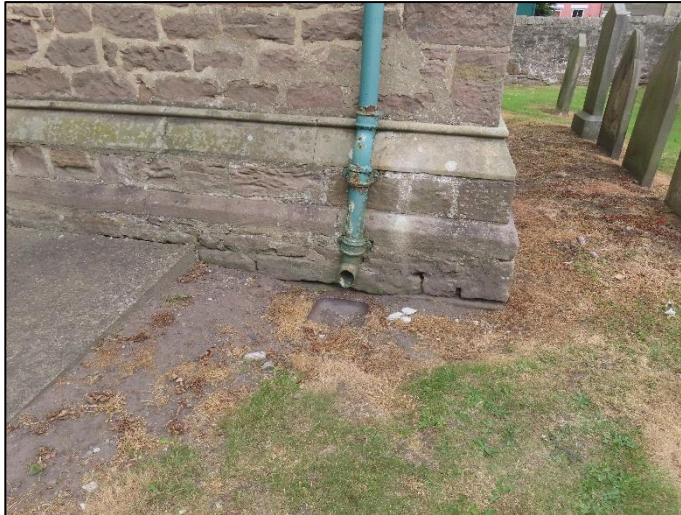
**Photograph 25**

- 5.3.3. There is staining around some of the gutter joints indicative of leakage although this can only be confirmed by observation during periods of rainfall.
- 5.3.4. A new section of gutter has been provided to the south-east corner of the nave.
- 5.3.5. There is general flaking of paintwork and surface corrosion evident. The rainwater goods are in need of re-decoration and potential sealing of some of the gutter joints.

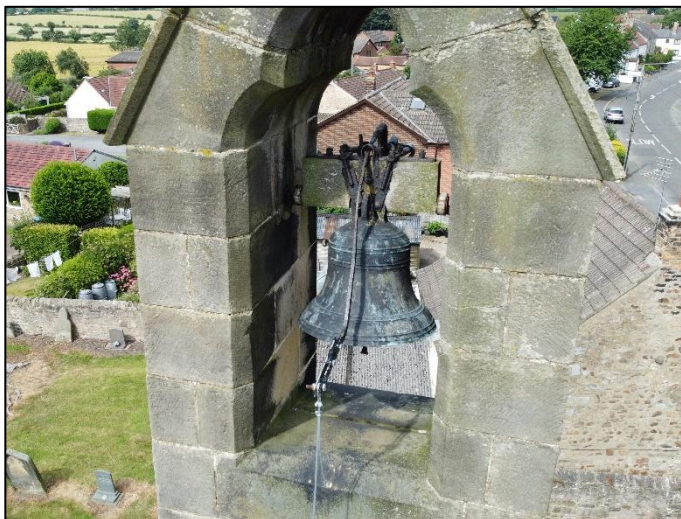
**Photograph 28**

- 5.4.3. I understand that a recent inspection of the bell has been undertaken while scaffold was up for maintenance works and the bell and stock considered to be in reasonably good condition.

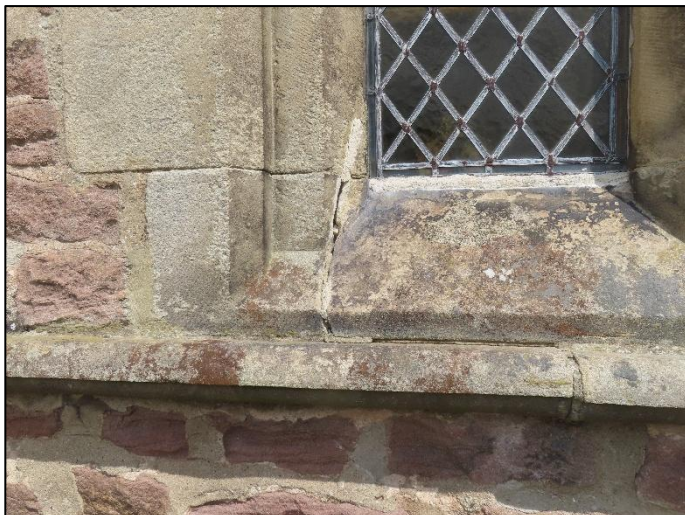
**Photograph 33**

- 5.5.8. There is a cracked cill to the south-west nave window which has been previously pointed up, however, the pointing has eroded and daylight can be seen through the crack from inside. The crack should be cleaned out and pointed up.

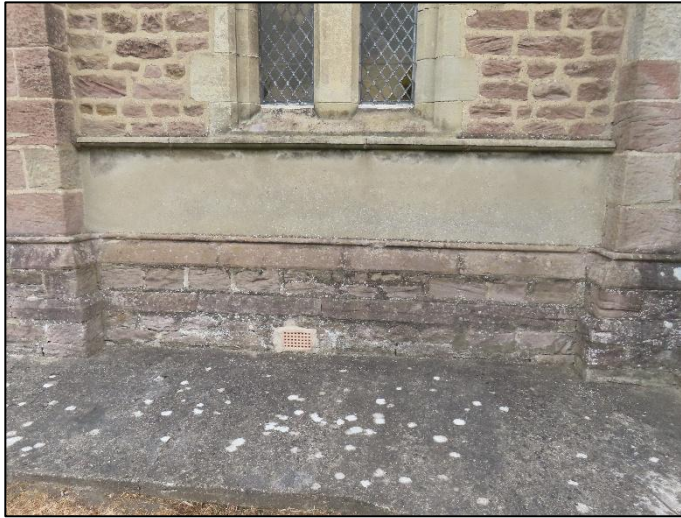
**Photograph 34**

- 5.5.9. To the south elevation, one of the bays has a panel of cement mortar render and another approximately 50% of the panel rendered between the plinth and string course stone beneath the windows.

- 5.5.10. The cement mortar pointing and render panels will contribute towards dampness issues and deterioration of plaster and paint finishes internally.
- 5.5.11. Removal of the render is however likely to cause damage to the stone.
- 5.5.12. Cement mortar re-pointing should be programmed for replacement with lime mortar.
- 5.5.13. There are significant areas of eroded/open mortar joints at low level to the walls generally which should be re-pointed.

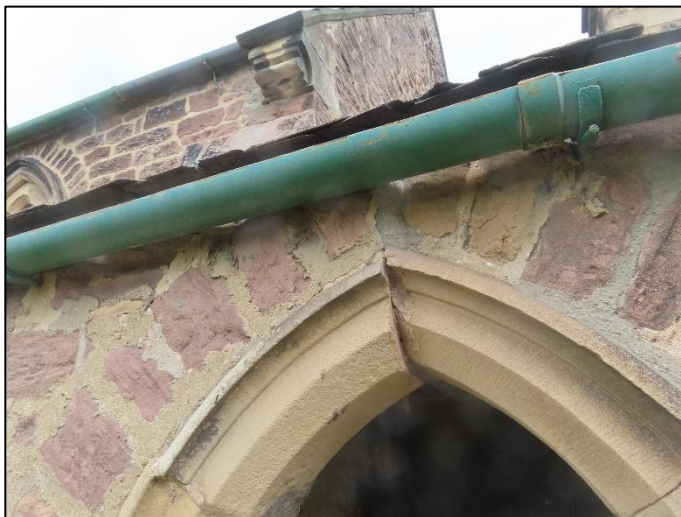
**Photograph 46**

- 5.5.15. There has been structural movement to the south-west corner of the boiler room causing outward movement of the arched head above the door, but which appears to be historic, there being no evidence of there presently being a progressive nature to the movement.

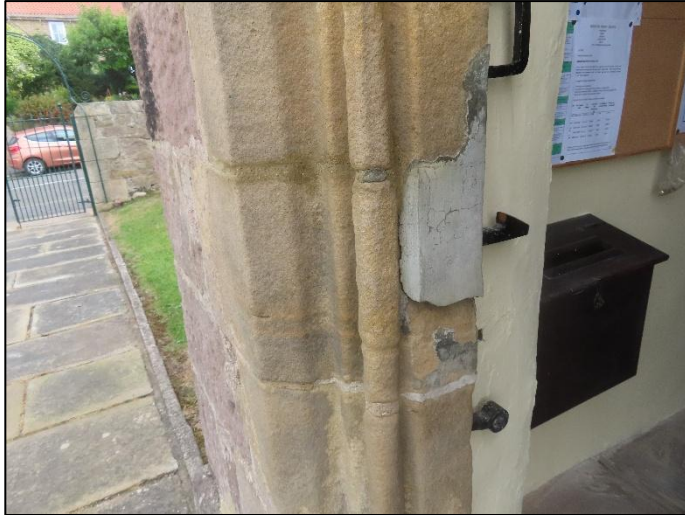
**Photograph 47**

- 5.5.16. Ashlar stonework to the front porch door, boiler house door and vestry door reveals have had areas of “repair” using cement mortar. This is unsuitable and will exacerbate erosion of the surrounding masonry (which is evident) and I would recommend that either an indent repair is undertaken or a lime mortar repair by a suitably experienced stonemason.

8.4.3. Replace cement mortar repairs to porch, vestry and boiler house door reveals.

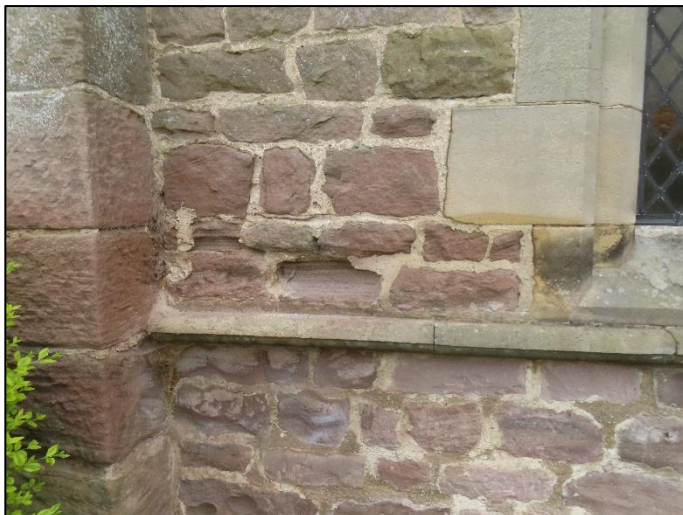
**Photograph 52**

- 5.5.17. There are areas of significant erosion of stonework evident which are to a degree exacerbated by previous cement mortar pointing and to these areas in particular, the cement mortar should be removed and replaced with lime mortar.

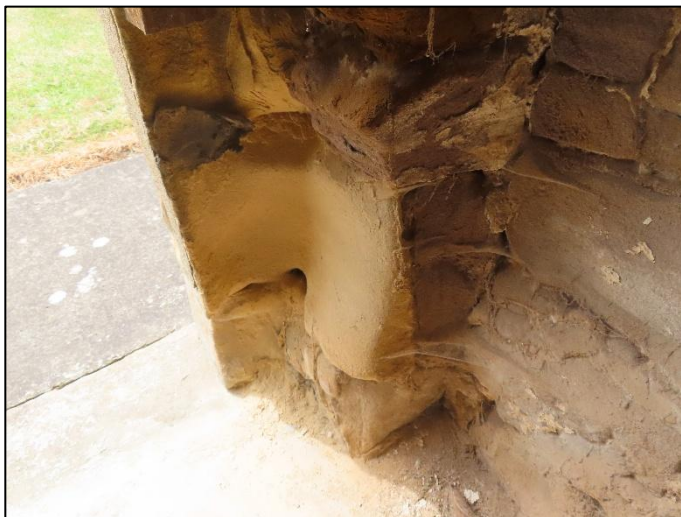
**Photograph 54**

- 5.5.18. There is significant erosion of stonework to the east side internally of the boiler house door which is not yet threatening the structural integrity of the wall. This will continue to deteriorate over time and in the very long term, repairs will be required.

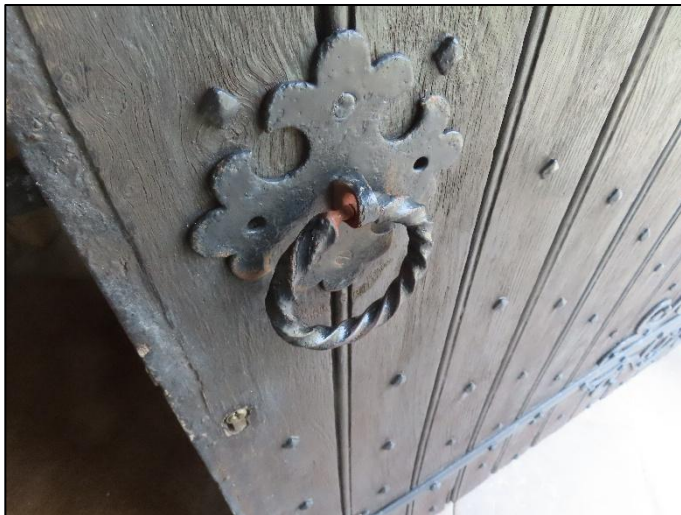
**Photograph 56**

- 5.6.2. There is an iron ring pull which is significantly worn but still operational.

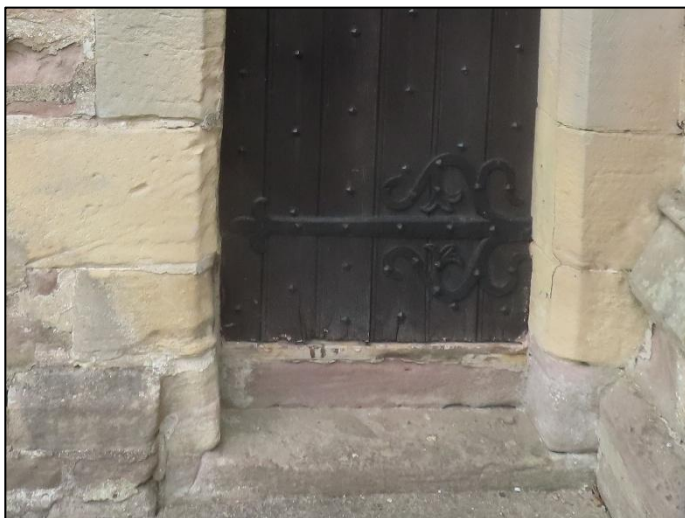
**Photograph 59**

5.6.5. The vestry has a weathered lower face.

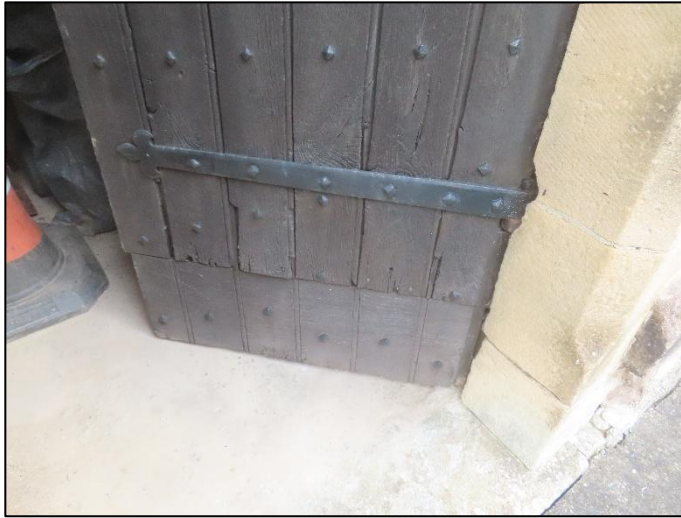
**Photograph 60**

- 5.6.6. The bottom of the boiler room door has been extended, likely due to the floor having been lowered. There is weathering to the lower section of the door.

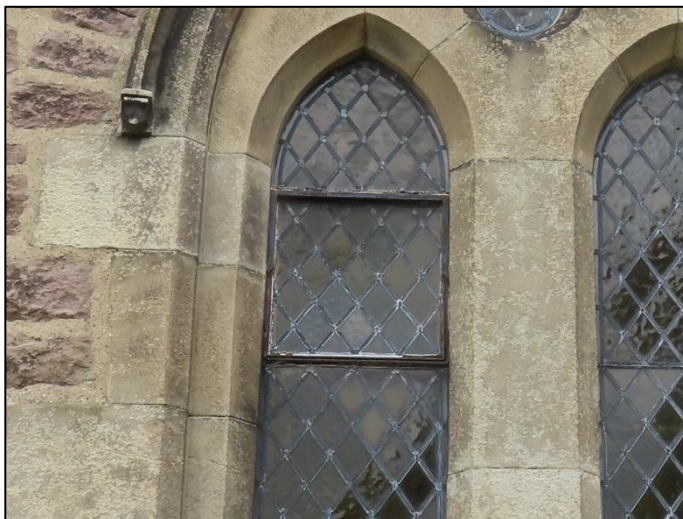
**Photograph 62**

- 5.6.14. To the south-east window, there is an opening vent which is distorted and the metalwork corroding, requiring cleaning down and re-decoration.

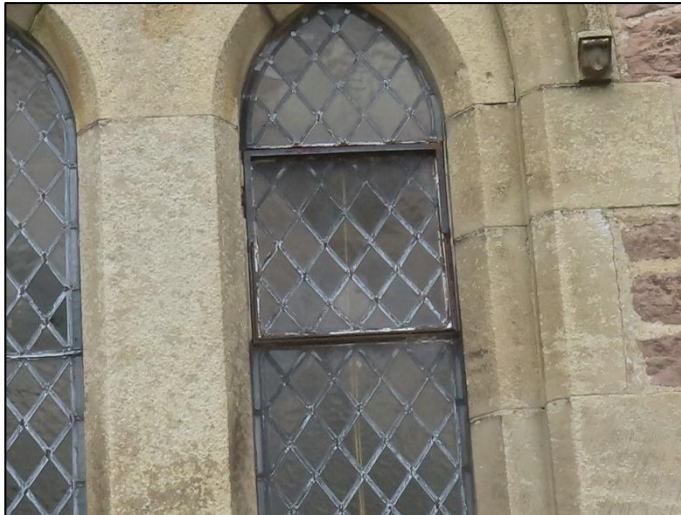
**Photograph 63**

- 5.6.15. There are four panes of cracked glass.
- 5.6.16. To the south-west window, there is an opening vent which is distorted and the metalwork corroding, requiring cleaning down and re-decoration. There is one pane of chipped glass.

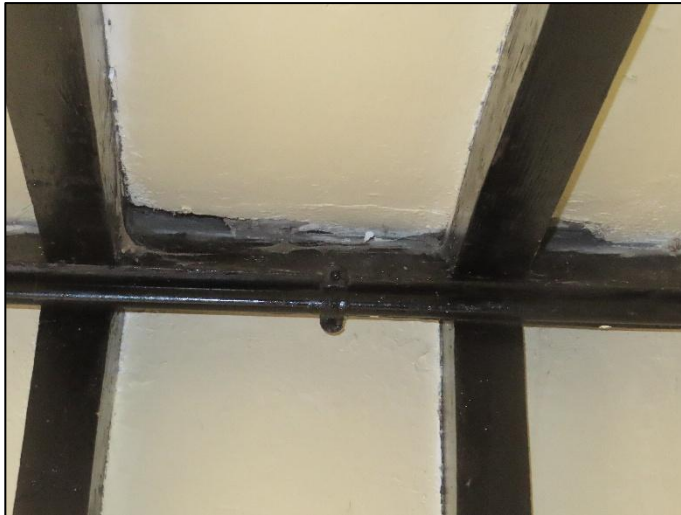
**Photograph 71**

- 5.10. **Ceilings**
  - 5.10.1. There is pine boarding to the ceilings between the trusses and above the truss ties in the chancel and nave.
  - 5.10.2. To the porch, there is a lath and plaster ceiling between the rafters.
  - 5.10.3. There are areas of damaged and missing plaster as a result of previous water penetration which should be patch repaired.

8.4.5. Repairs to porch ceiling.

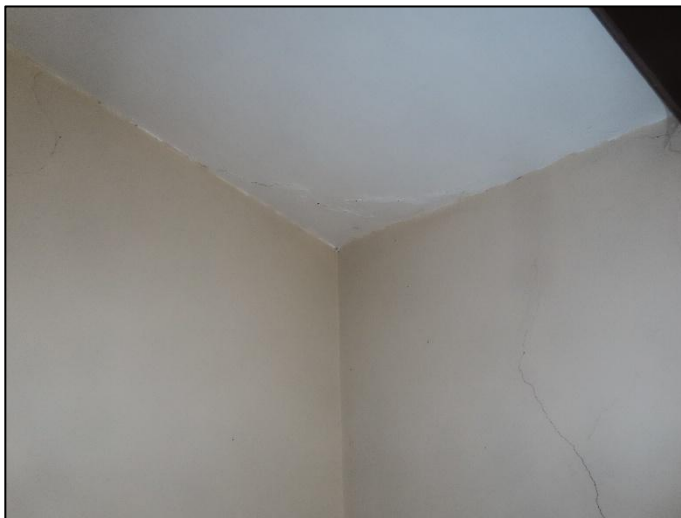
**Photograph 72**

- 5.10.4. Within the vestry, there is a lath and plaster ceiling on the underside of the rafters.
- 5.10.5. Cracking is evident to the north-east corner, but which appears old standing.

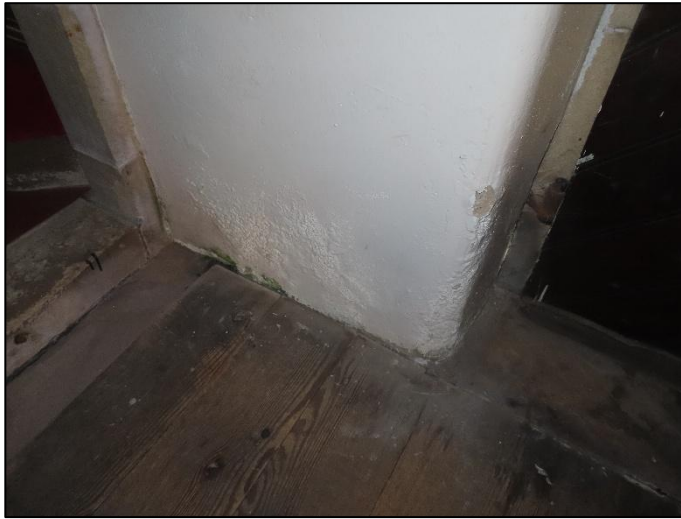
**Photograph 75**

- 5.11.6. There is blistering and deterioration of paintwork and plaster at lower level to each side of the external door and south wall which I would recommend is patch repaired with lime plaster. Any decorative finish should be vapour permeable.

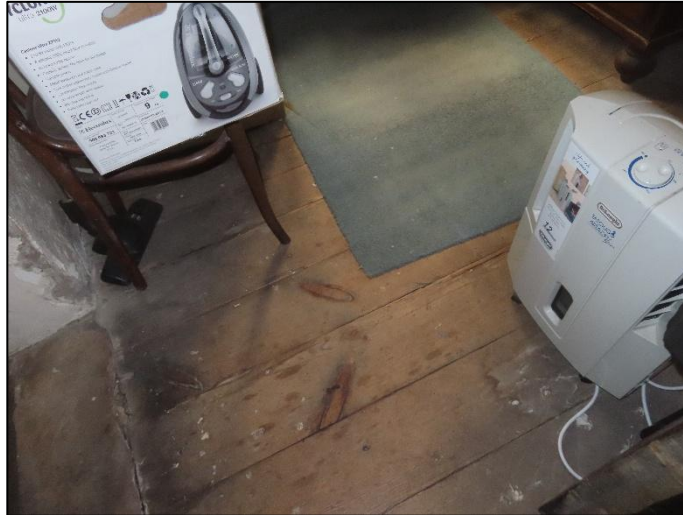
**Photograph 83**

- 5.12.8. The vestry has a pine, boarded floor which is uneven and slopes down towards the south, there is slight springiness indicative of shrinkage or decay to the supporting joists. It is noted that there are no air bricks providing sub-floor ventilation which increases the risk of decay. I would recommend a sub-floor inspection to determine the condition of the floor structure with a view to any necessary repairs.

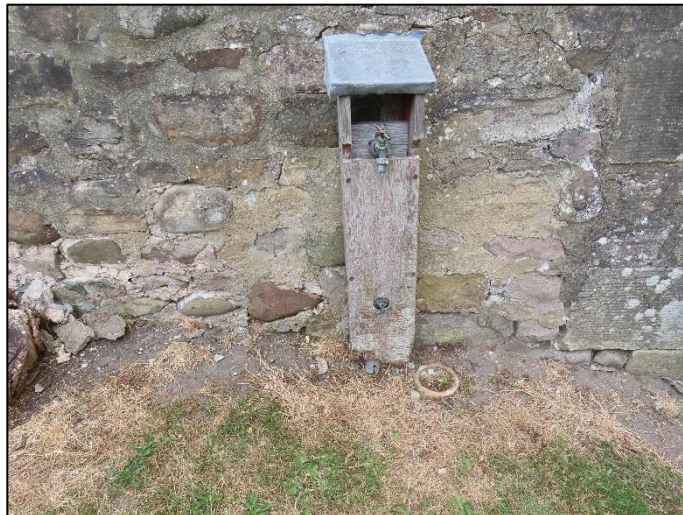
**Photograph 85**

- 5.23.2. The pipework is insulated. The timber boxing is beginning to deteriorate to lower sections.
- 5.23.3. There is no water supply within the church.

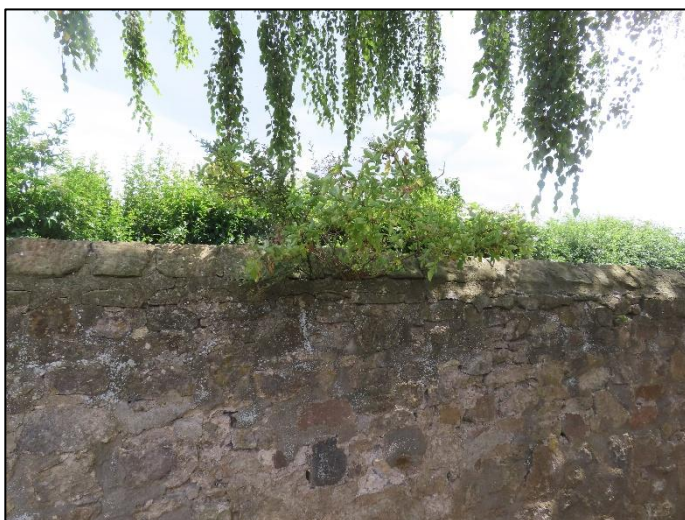
**Photograph 89**

- 5.28.4. There are isolated tree saplings growing out of the east-boundary wall which should be removed to prevent future damage to the wall.

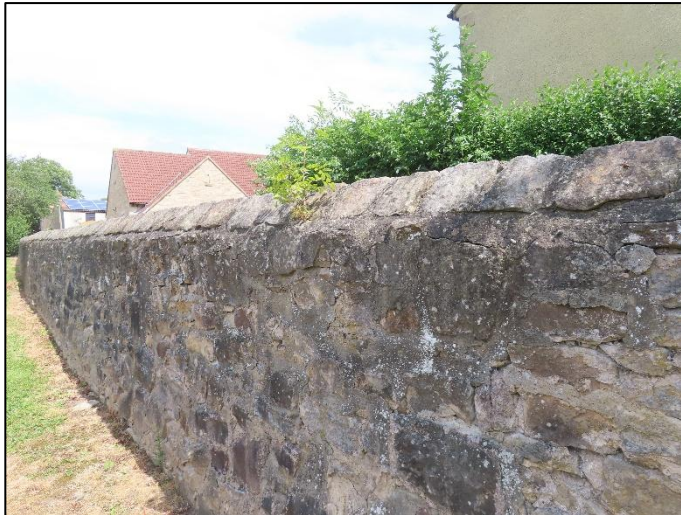
**Photograph 90**

- 5.28.5. Mortar joints are eroding, cracked and loose to many areas and there is deterioration of stonework to the north end of the east boundary wall.
- 5.28.6. I would recommend a programme of re-pointing be put into place.
- 5.28.7. Within the north wall, there is a pair of steel gates with a wrought iron arch above within which there is a light fitting.

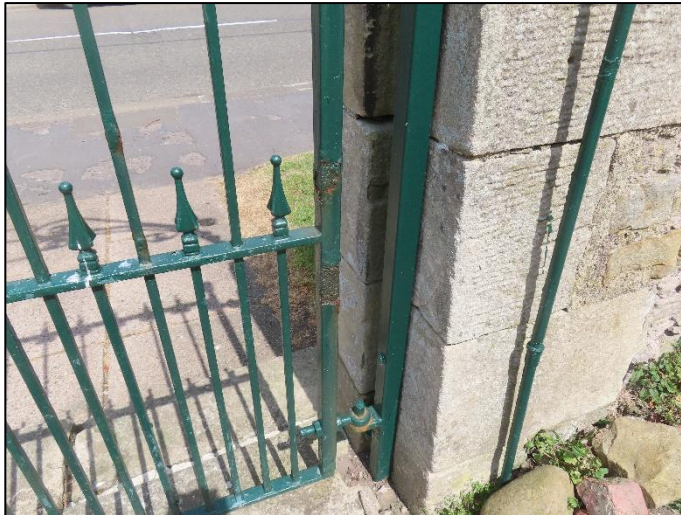
**Photograph 92**

- 5.28.8. Although the gates have been recently decorated, preparation has not been properly undertaken, and areas of corrosion are again visible.
