**ST HELEN'S KELLOE**  
**QUINQUENNIAL INSPECTION REPORT 2025**

Prepared by: Andrew Bodenham AssocRICS, MCIAT Architectural Technologist

Date: March 2025

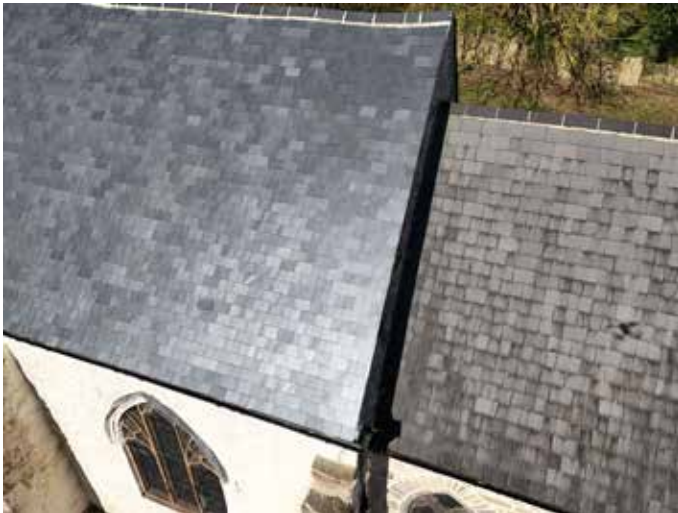
Since the last QI the nave roof has been re-slatted, but not to the specification provided by the architect. The slates are Spanish grey rather than Welsh heather, and the clay ridges with roll tops have been replaced with plain grey ridges. The slating is of very poor quality - already with some slates damaged, displaced, or missing in a number of areas. The verges are made up with narrow slips of slate, and in most cases do not adequately cover the verges below. A very strong cement mortar has been used to point up below the slates to the verge wall head, which will be detrimental to the masonry. The north pitch of the nave was seen to be holding water between the slate joints, and slates are stained by mineral leaching. The hard pointing to the ridges is seen to be failing by cracking and detachment on the south slope, and the pointing has been lost from at least one location.

South roof slopes: contrast between new Spanish slate on nave (left) and Welsh slate on chancel (right)

*Recommendation: re-roof the nave entirely with the correct slate, installed to relevant standards and architect's details. **B***

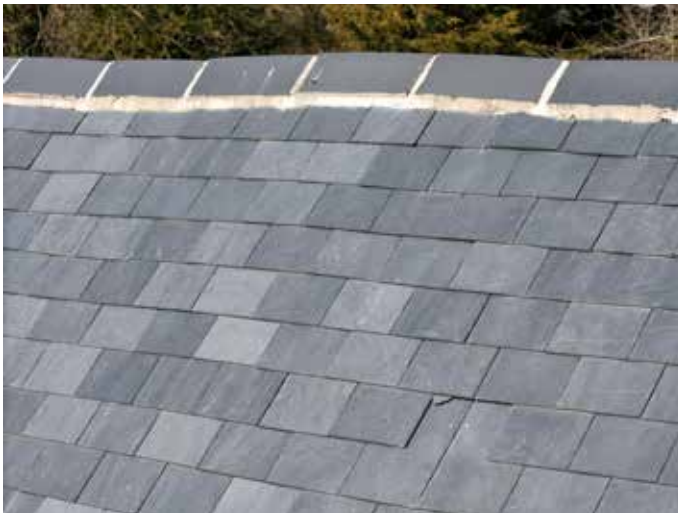
Nave south slope: missing slate, ridge pointing poor

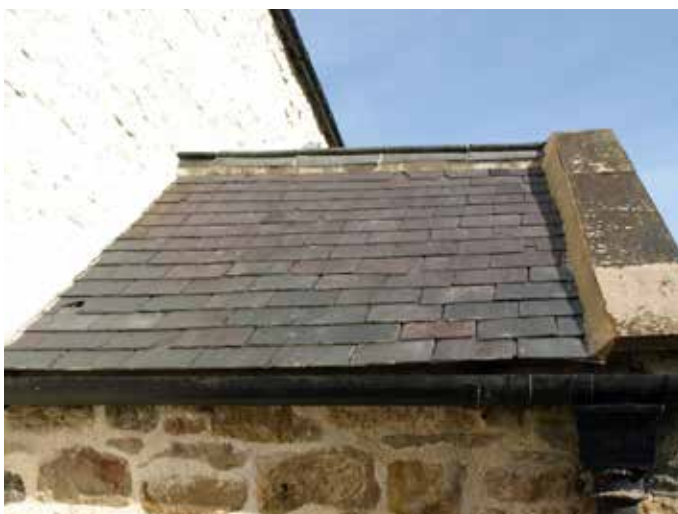
The south porch roof is in poor condition has several slipped or broken slates, including one obvious holes which will be admitting water. The mortar fillet to the back of the copings is detached. The abutment to the nave wall is made with a mortar fillet which is cracked and failing.

Porch roof, west slope: broken, damaged & displaced slates

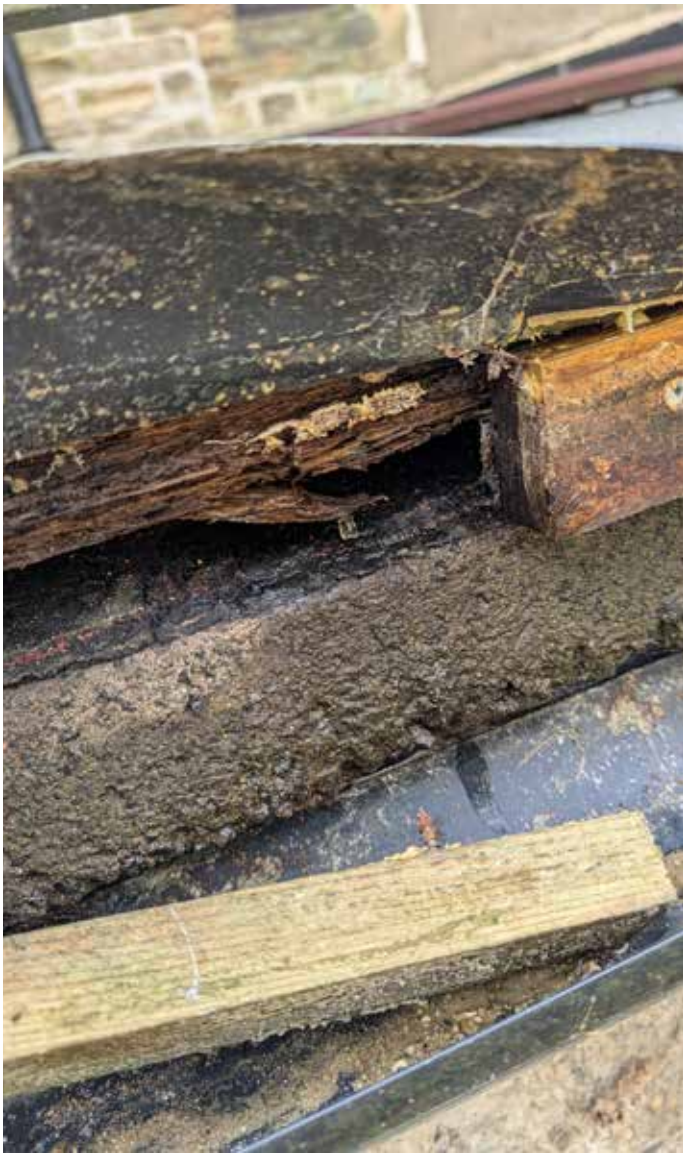
Decay to timber detail of boiler-room roof

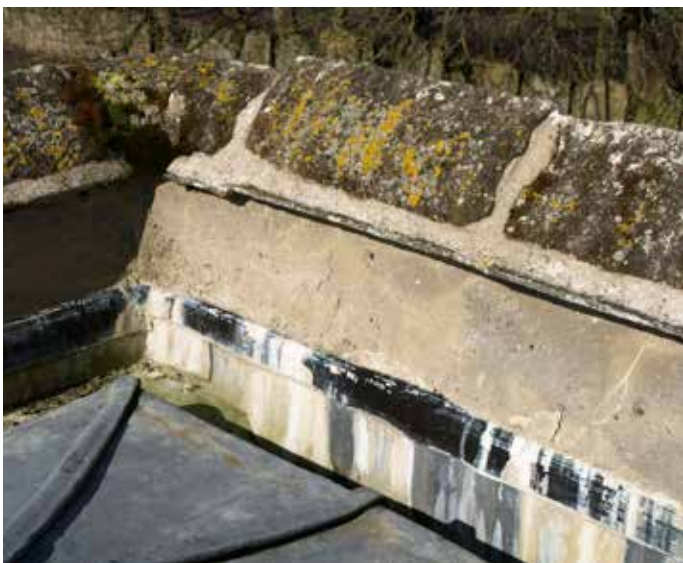
Frost-damaged render to the inside face of the tower parapet

*Remove loose material and carry out localised repointing of cracks to parapets. Clean out gutters and outlets. B*

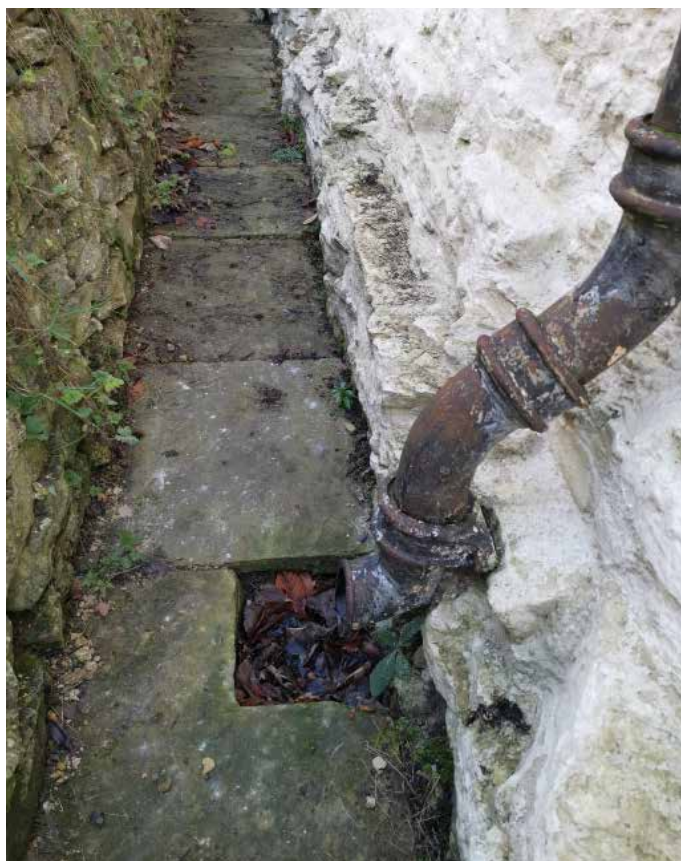
Gullies restricted by leaves, downpipe rusting

At the time of inspection, many gullies were blocked with leaves, sludge and earth. Most have wire mesh over the outlets, but these were also holding leaves. It is essential that all gullies are regularly cleared of leaves/debris to allow water to flow freely away and not back up and saturate the masonry wall.

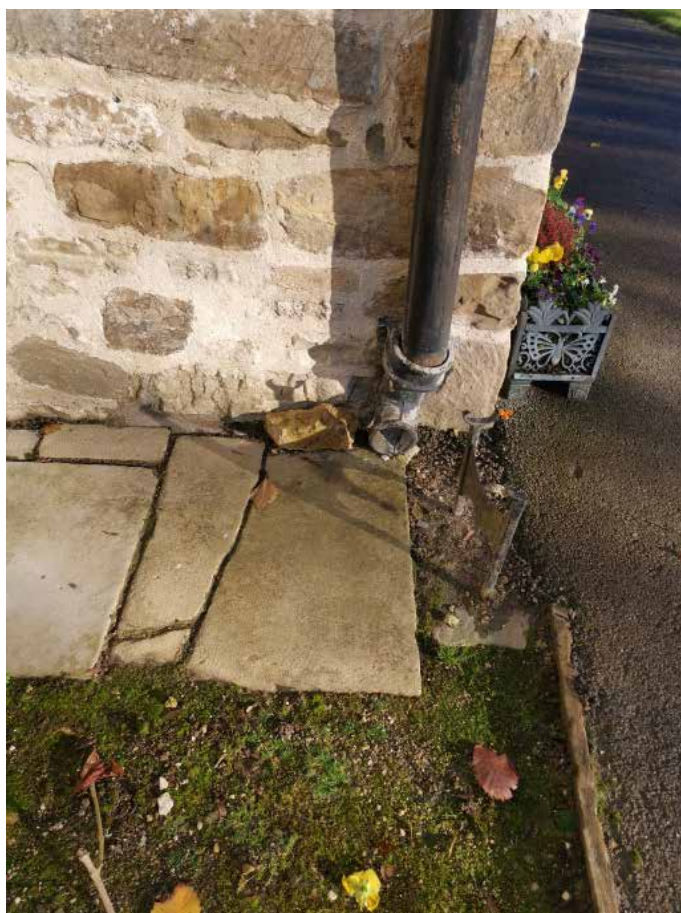
All downpipes to the main roofs discharge into gullies at ground level. The south porch downpipes do not discharge into gullies but discharge on to the hard standing at the side of the porch. This arrangement will be holding water at ground level beneath the paving and thus contributing to any localised soft ground conditions. The western porch downpipe shoe is dislodged and should be straightened.

Porch downpipes discharge over ground

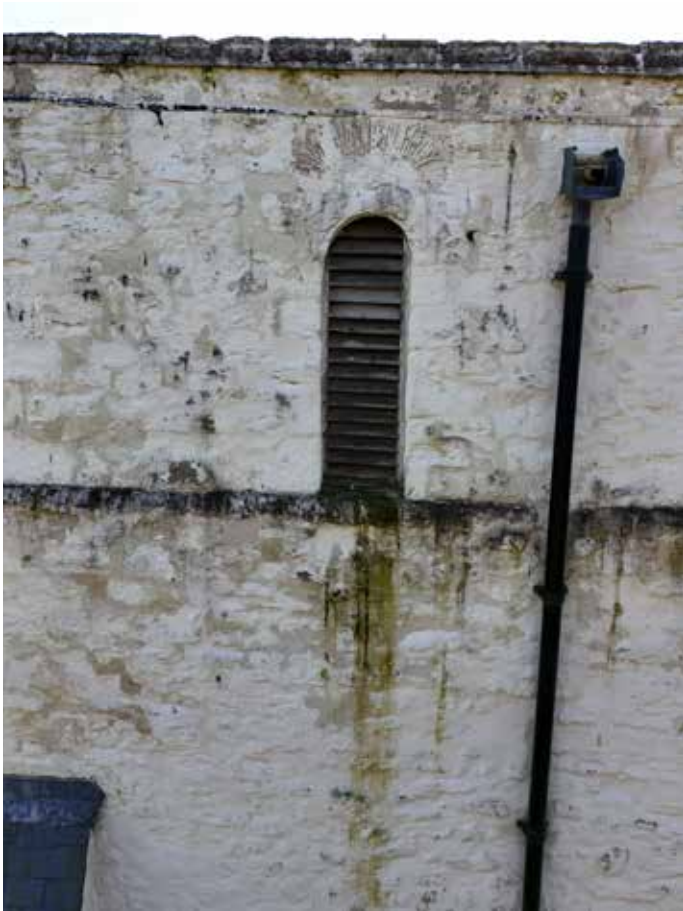
Wear and algae staining to tower limewash

| 2.02 | PRIORITY B: Works recommended to be carried out within 12 months | Approximate £ |
|---|---|---|
| c) | Tower - carry out localised repairs and re-limewash the tower, from MEWP or by rope access. (p.14) | 5,000 |

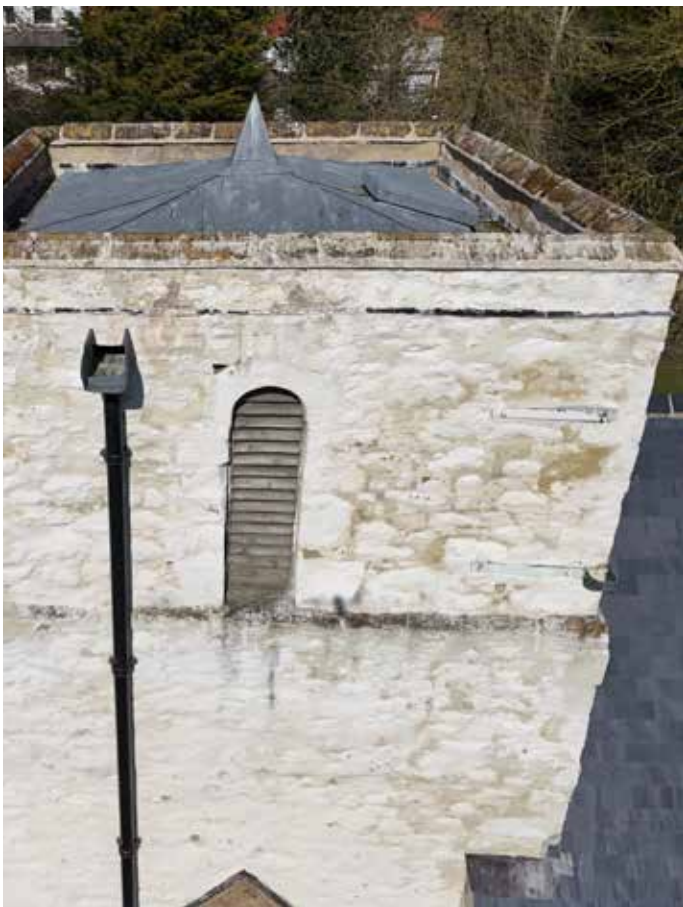
Wear and weathering of limewash finish

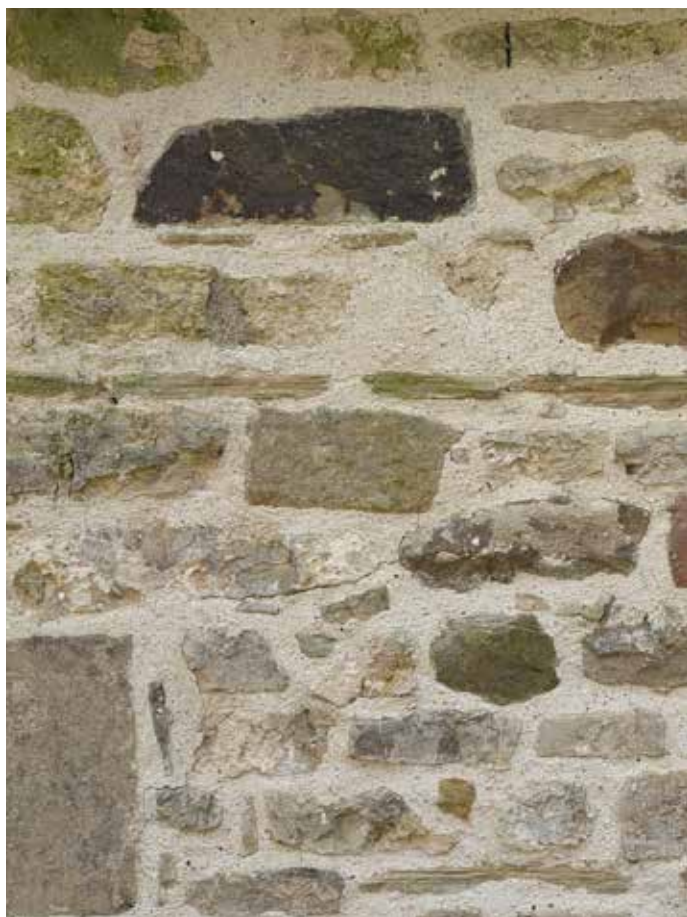
External crack to Thornley Porch

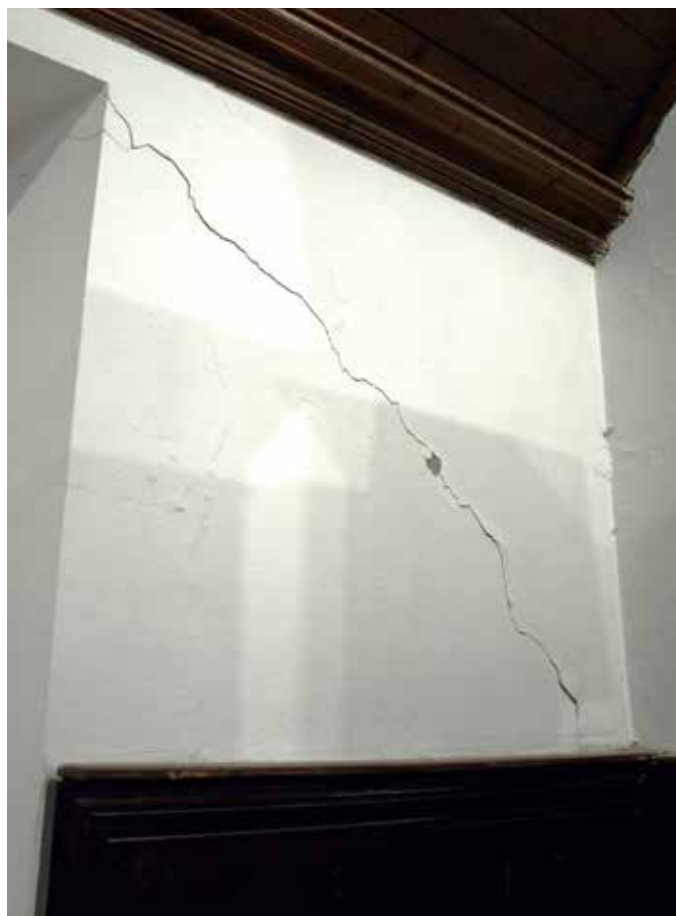
Cracking in the Thornley Chapel should be investigated

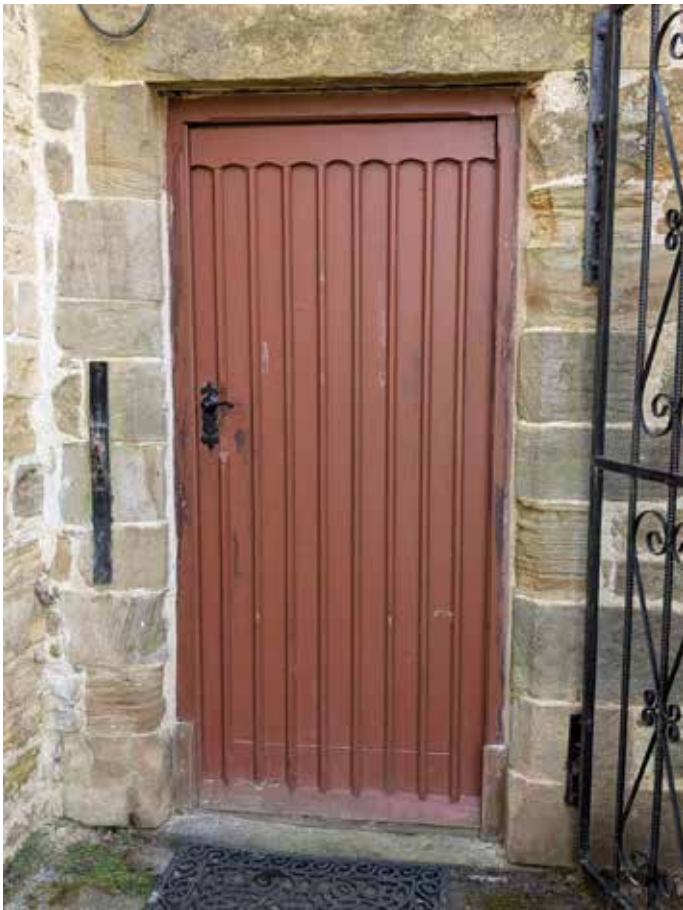
All external doors would benefit from re-painting

| 2.03 | PRIORITY C: Works recommended to be carried out within 2 years | Approximate £ |
|---|---|---|
| h) | Repair and redecorate timber doors, lubricate ironmongery (p.16) | 750 |

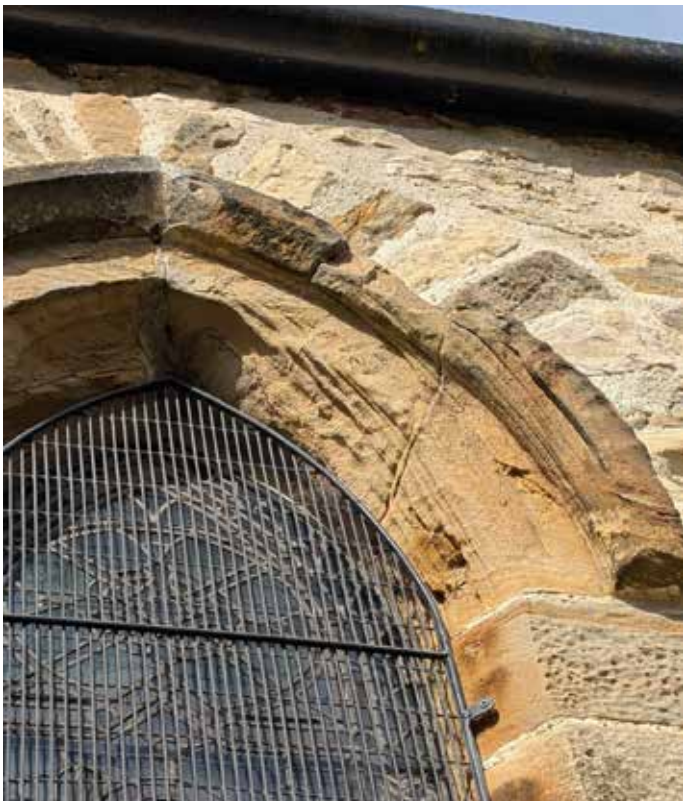
Hoodmould cracking has led to loss of section - the adjacent section is also at risk of failing

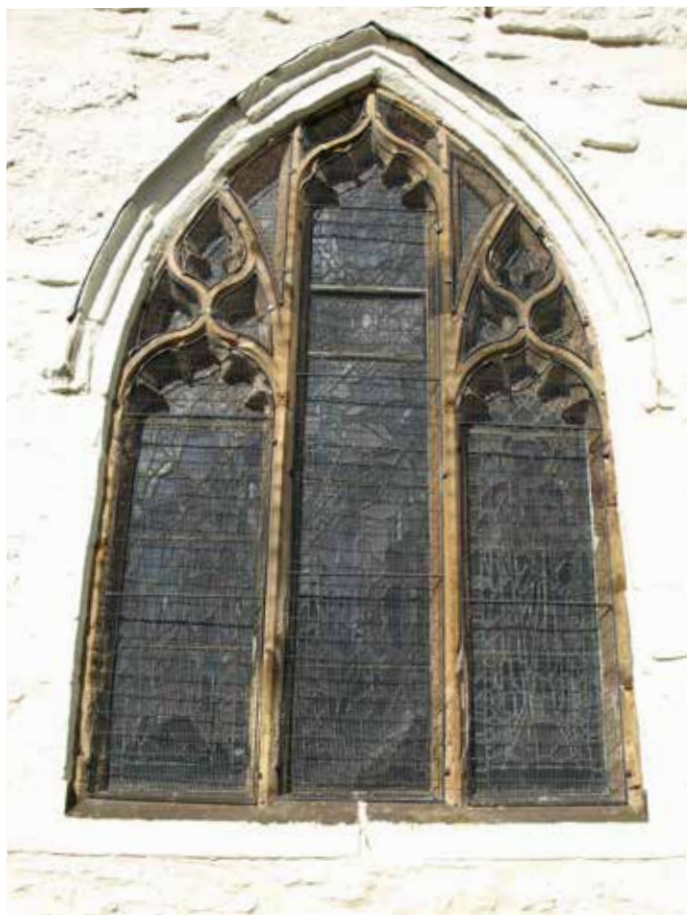
Window on south nave - stonework surrounds heavily deteriorated. Hoodmoulds now protected with lead

which are showing severe signs of deterioration, as well as to the jambs and mullions at lower level. Mortar repairs to the hoods have been carried out and lead caps have been added, which adds protection from above. The jambs and mullions still require repair.

Of these two windows on the nave, the western most window appears to be suffering worst, with the right hand jamb visibly delaminating. The hood mould has been repaired and capped in lead.

| 2.05 | PRIORITY E: Works in the long-term, or desirable works | Approximate £ |
|---|---|---|
| a) | Window masonry - in the long-term the jambs and hood mould should be repaired with stone indents. | 10,000 |

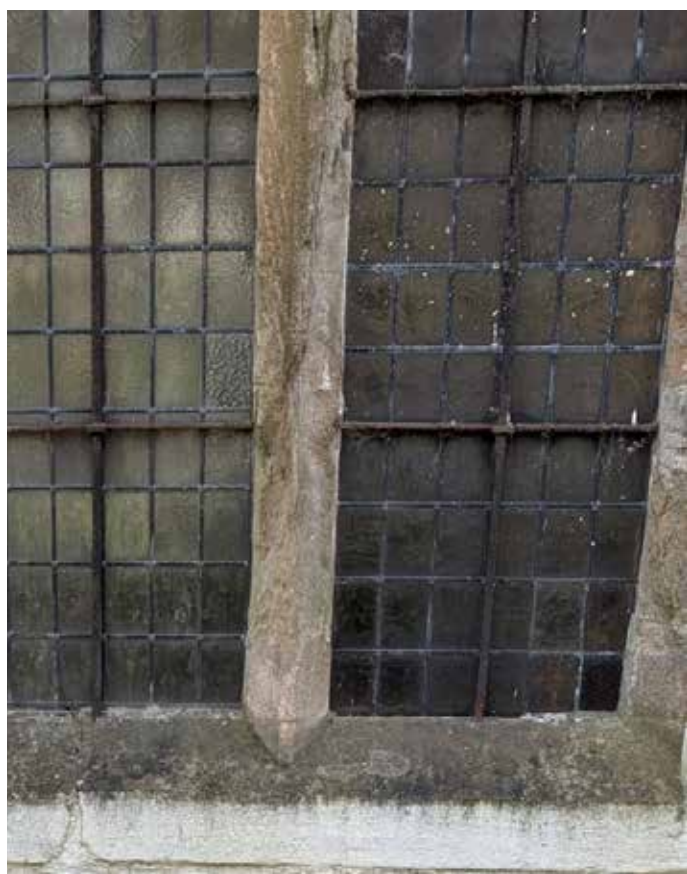
Rusting ferramenta to window

There were several cracks through the tracery masonry, now repointed. This window has iron ferramenta to the windows which has caused damage to the stonework and would benefit from treatment.

#### *De-rust ferramenta and re-paint. C*

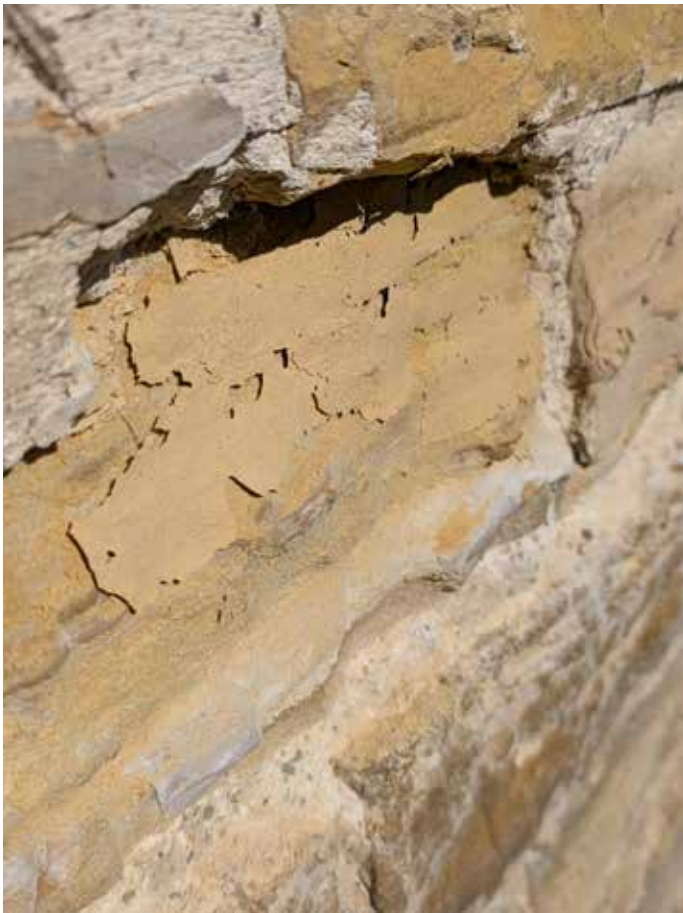
Stone decay is widespread across the building, exacerbated by over-hard pointing in many places.

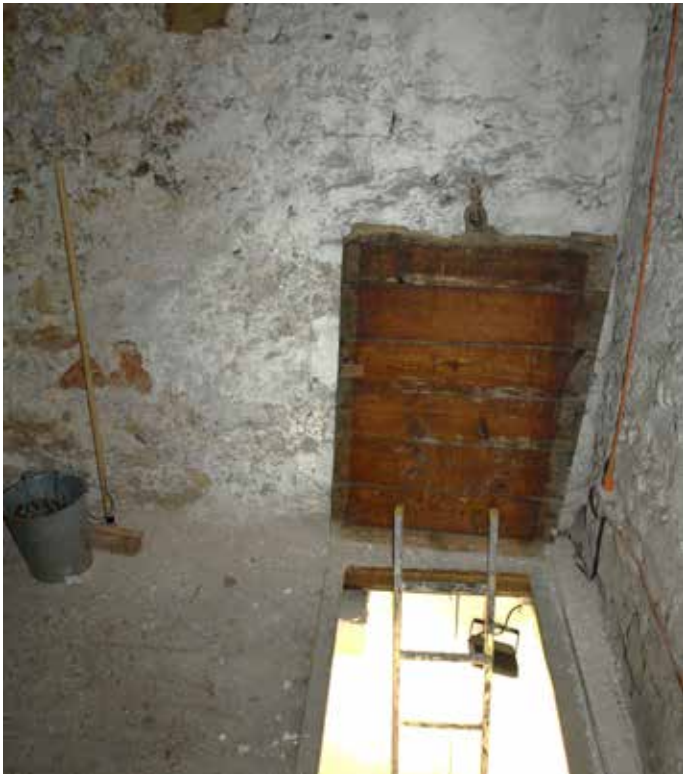
Peeling of impervious paintwork in tower - north wall, assumed drying out. Cement render internally in stage above requires removal

brickwork over. The majority of the walls have been rendered in a cementitious render which is now cracking and will be holding water within the wall. The north wall, particularly in the north west corner, is evidently damp with salts visible.

*Remove all cementitious pointing from tower internal walls, particularly the north. Clean off all walls and apply limewash D*

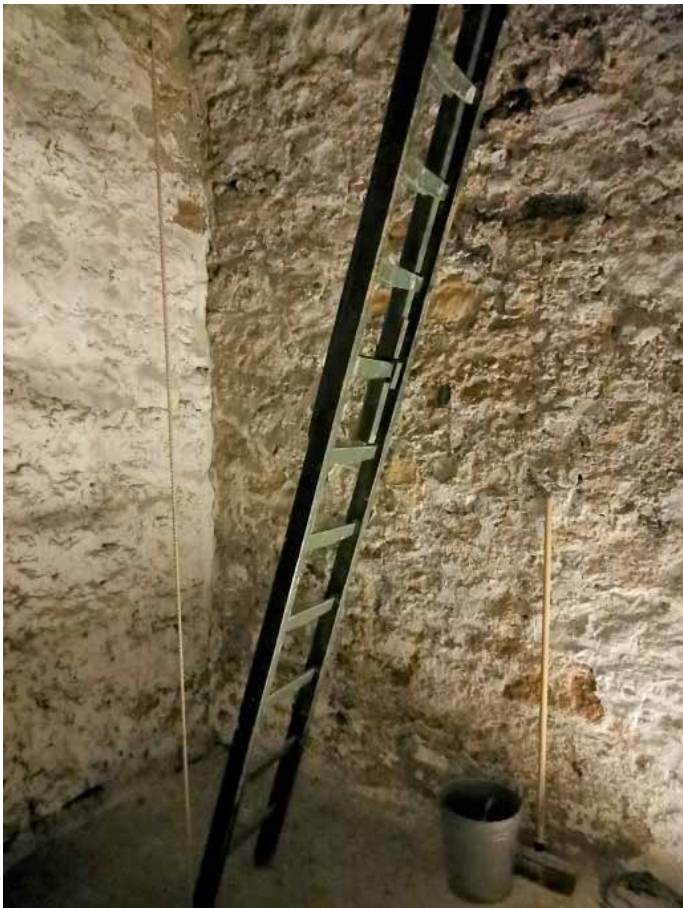
Historic timber ladder should be replaced with alloy or galvanised steel equivalent

| 2.01 | PRIORITY A: Urgent works requiring immediate attention | Approximate £ |
|---|---|---|
| d) | Tower - set aside the historic ladder and replace with a new galvanized steel or alloy ladder (p.20) | 500 |

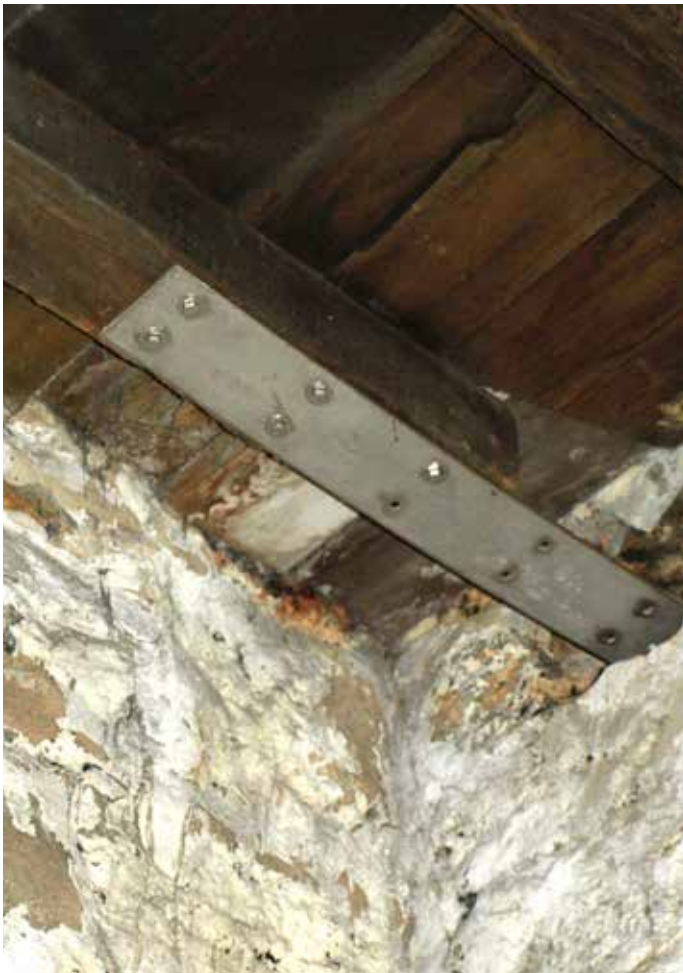
Strap repairs to the embedded timbers are structurally poor and should be re-worked to a Structural Engineer's design

| 2.01 | PRIORITY A: Urgent works requiring immediate attention | Approximate £ |
|---|---|---|
| c) | Tower - Structural Engineer to assess all the built-in beams and specify proper designed repairs using steel angles or a fabricated bearing shoes (p.20) | 1,000 |

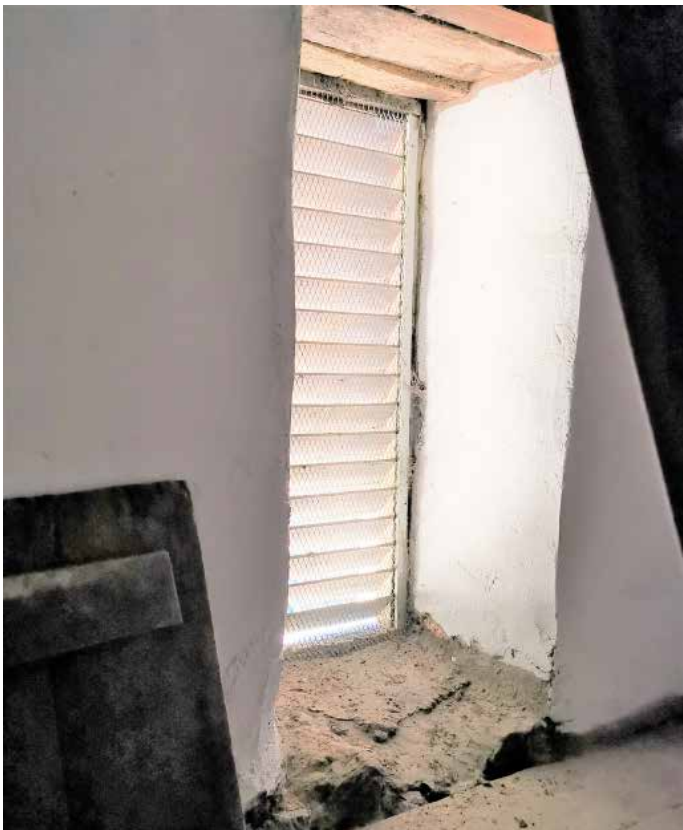
Lintels to south louvre still timber, in good condition. All others concrete. Metal grills in good condition, fixed securely

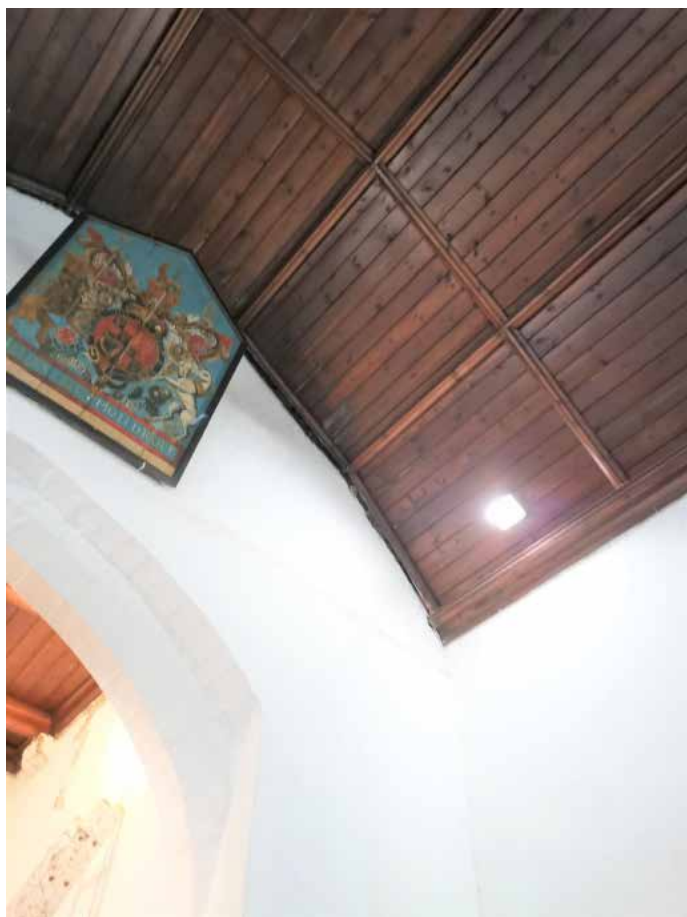
Nave ceiling boarded. Gap between ceiling and tower wall would benefit from clearing of debris and filling

Within the nave the timbers are moulded faceted ribs with horizontal panelling between, all stained in a dark timber stain. There are various areas that appear to indicate water ingress, particularly at the west end, but these are possibly historic. There is debris in the gap between the ceiling and the wall of the tower which would benefit from clearing out and the gap filling/plugging.

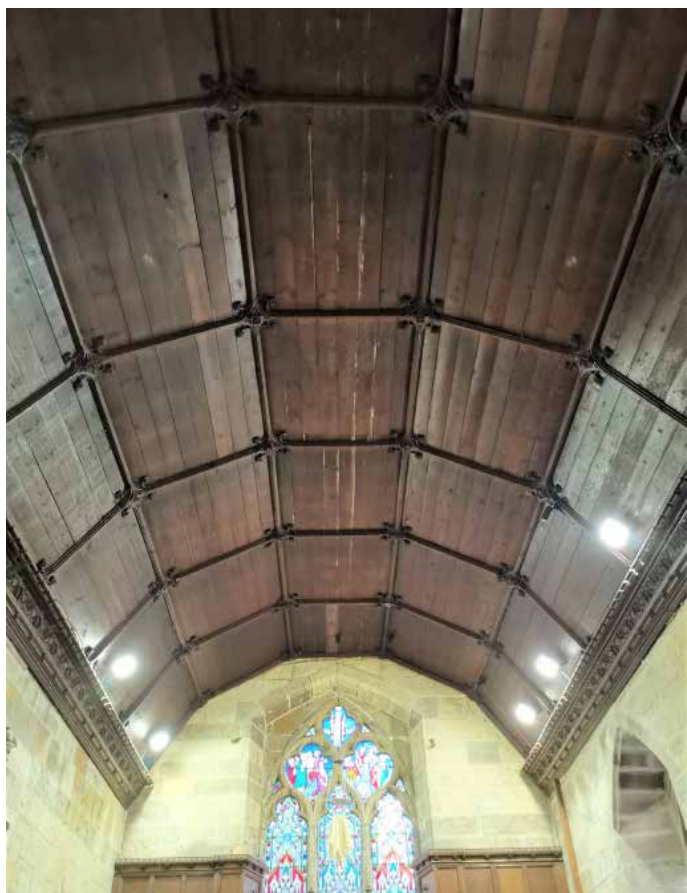
Chancel ceiling, water staining historic

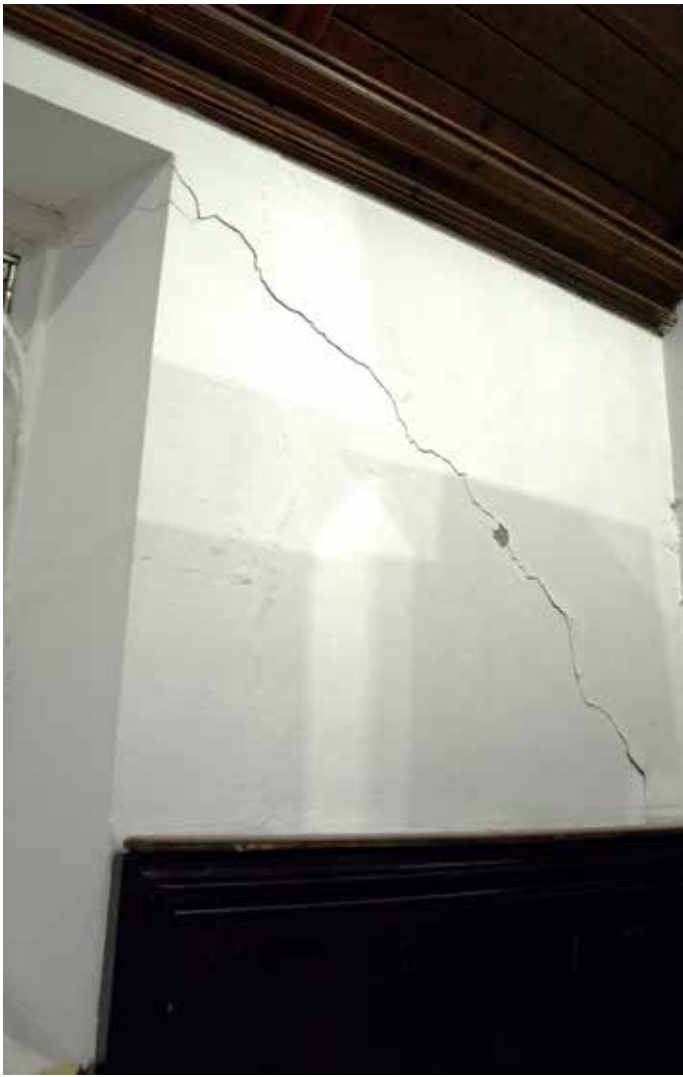
Crack to right hand of window in Thornley Porch

*Fill the internal crack with a proprietary filler e.g. Toupret, discretely record the date of filling, and continue to monitor in the future for any further movement. A*

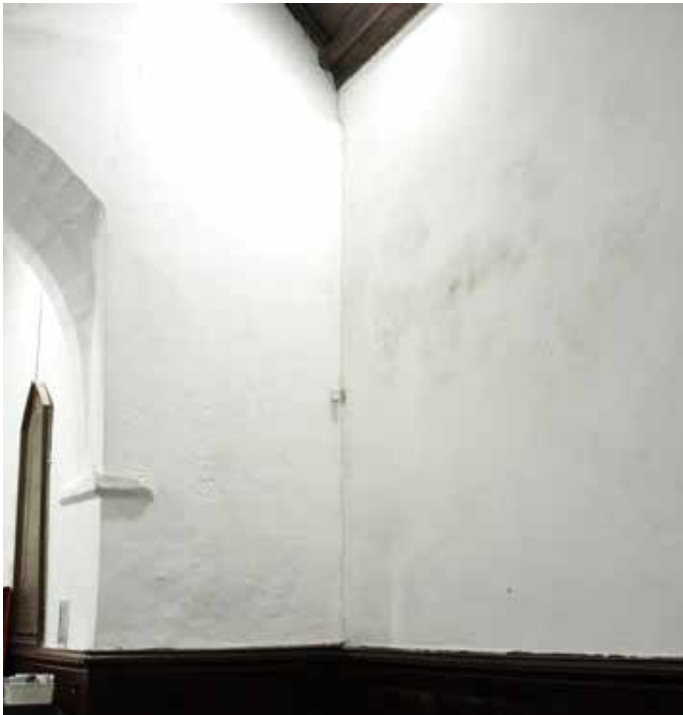
Damp staining and minor mould to nave north wall, to be monitored

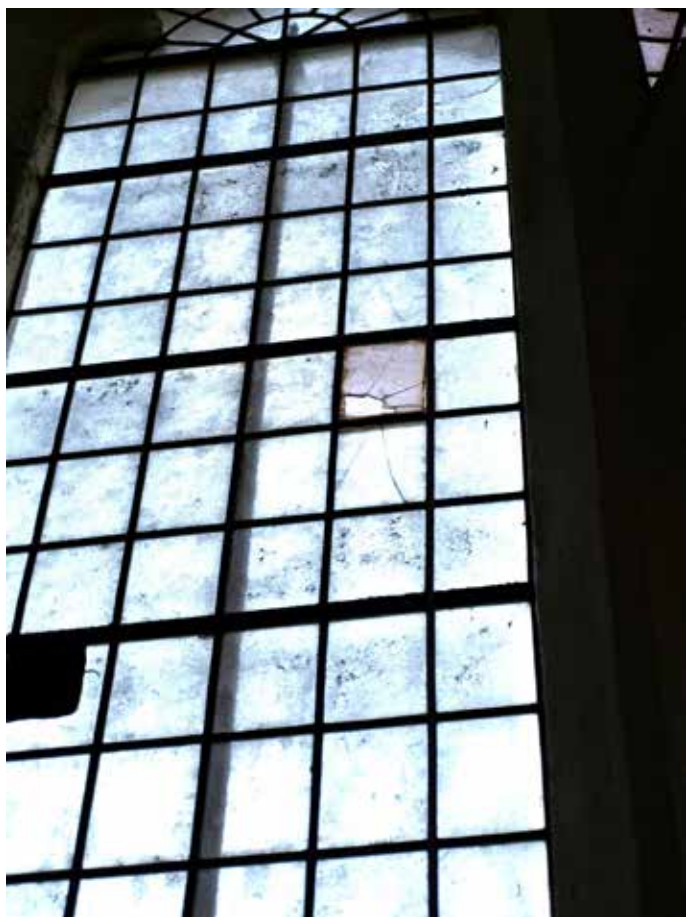
Window in north of nave has several broken square quarries and some leadwork distorted

| 2.04 | PRIORITY D: Works recommended to be carried out within 5 years | Approximate £ |
|---|---|---|
| d) | Specialist glazier to assess all windows, repair the leadwork and replace the broken glazing (p.23) | 2,000 |

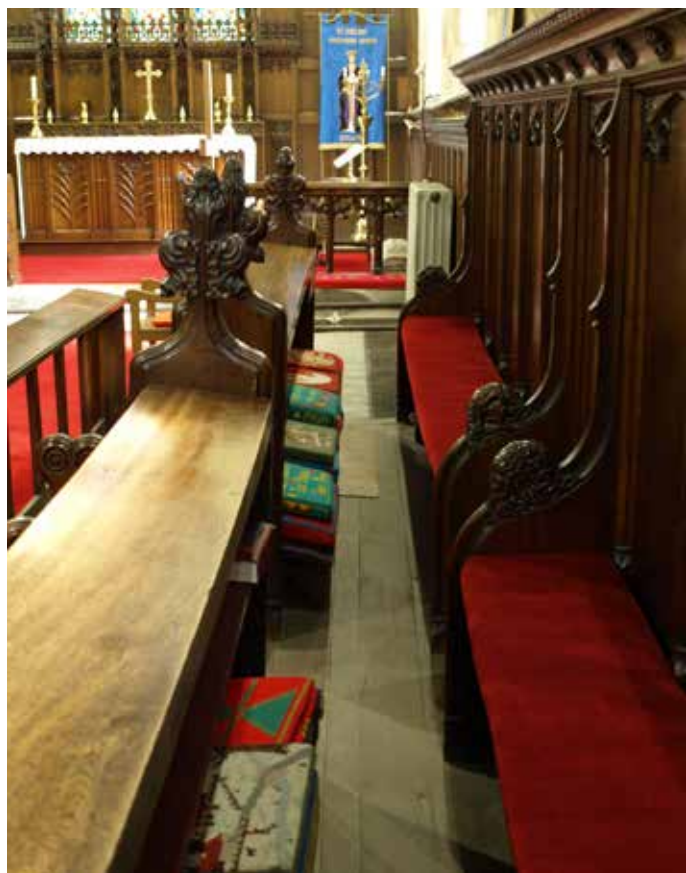
Choir pews on timber platforms - distortion of floor should be investigated.

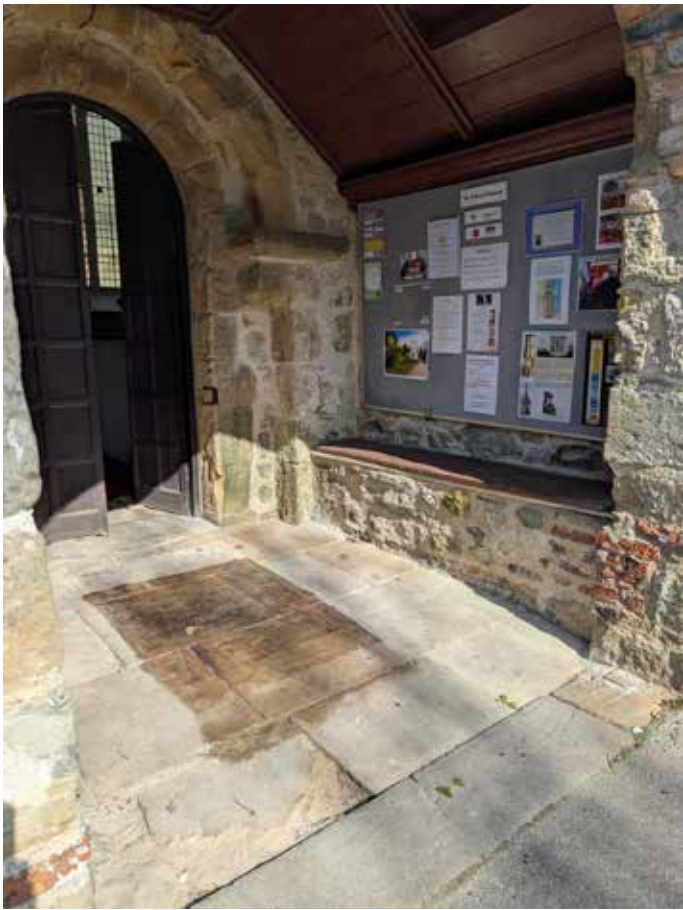
Lifting the rubber-backed matting in the Porch reveals trapped moisture - seen here as a dark damp patch

| 2.02 | PRIORITY B: Works recommended to be carried out within 12 months | Approximate £ |
|---|---|---|
| g) | Porch - remove matting from the porch. Replace the badly worn flagstone. (p. 26) | 500 |

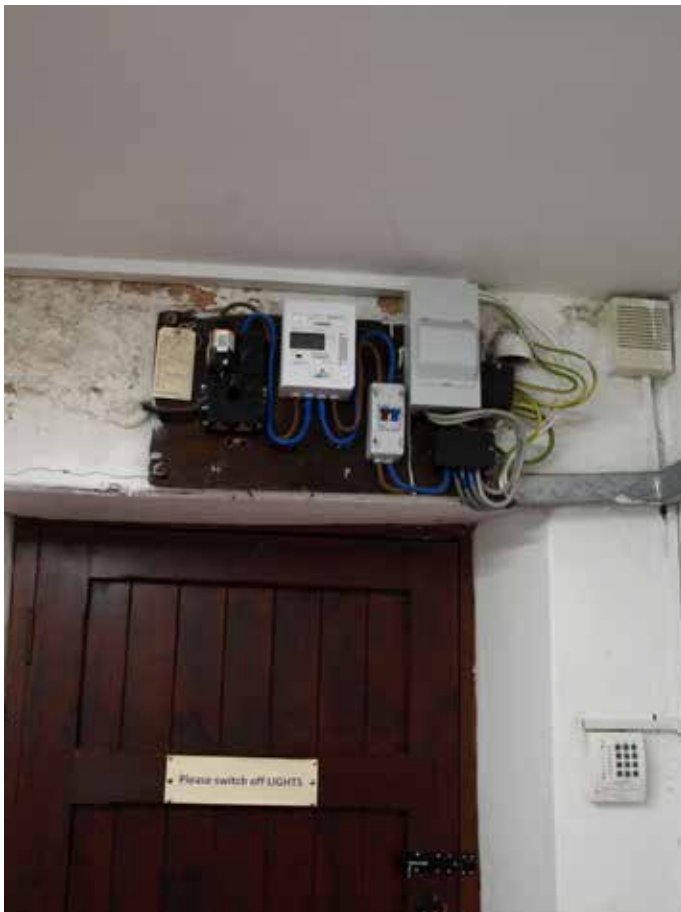
Damp around electrical installation, possibly due to leaks from verge coping stones above.

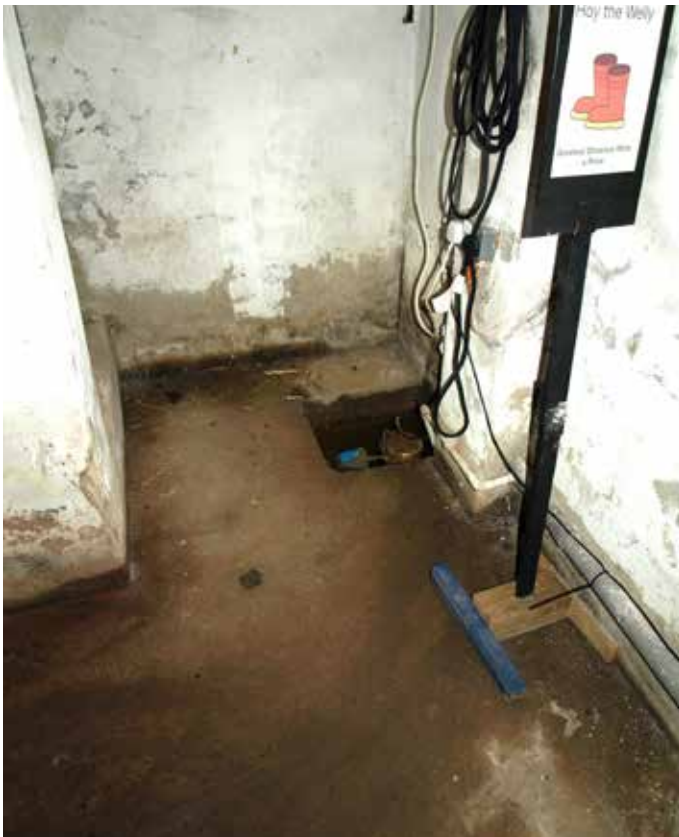
The boiler-room is particularly wet, and roof and abutment details should be checked

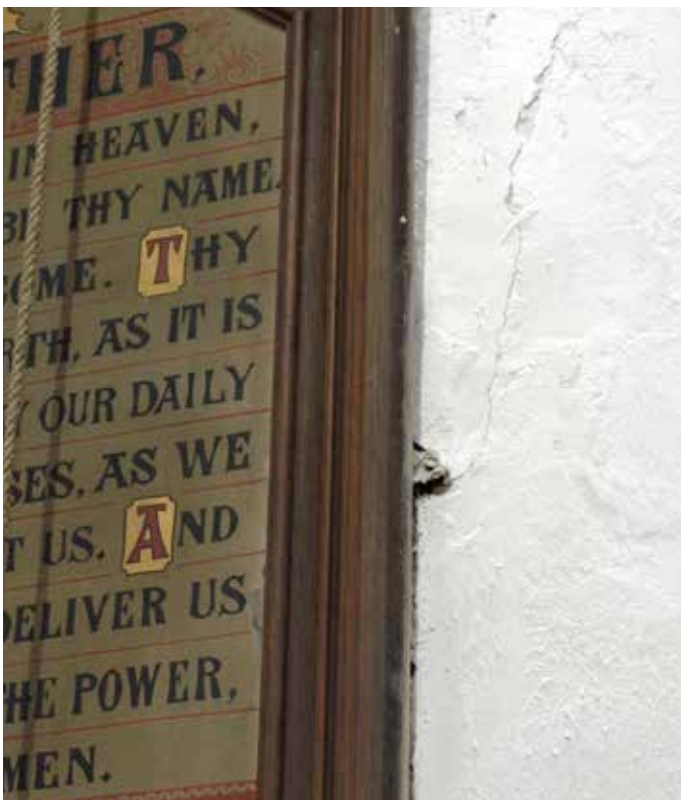
Loose fixings to Lords' Prayer board

| 2.02 | PRIORITY B: Works recommended to be carried out within 12 months | Approximate £ |
|---|---|---|
| h) | Replace the prayer board fixings with new brass or bronze screws into nylon plugs. (p.27) | 50 |

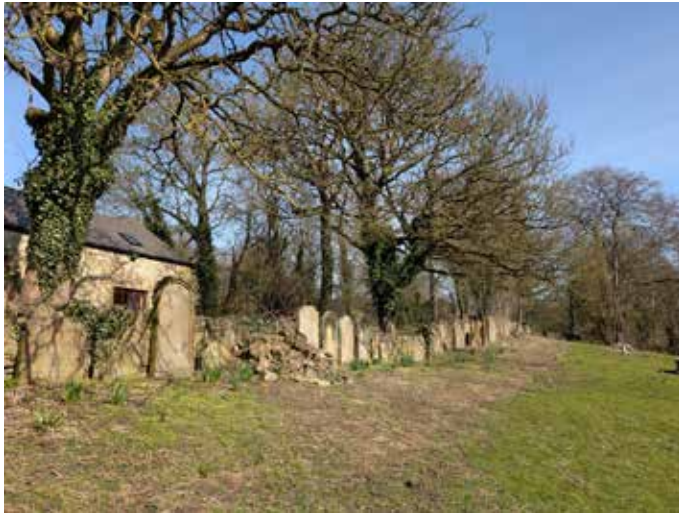
Headstones fixed along the north boundary wall. Area of collapsed wall

| 2.05 | PRIORITY E: Works in the long-term, or desirable works | Approximate £ |
|---|---|---|
| c) | Boundary walls - rebuild areas of damage to match the style of the adjacent walls | 1,500 |

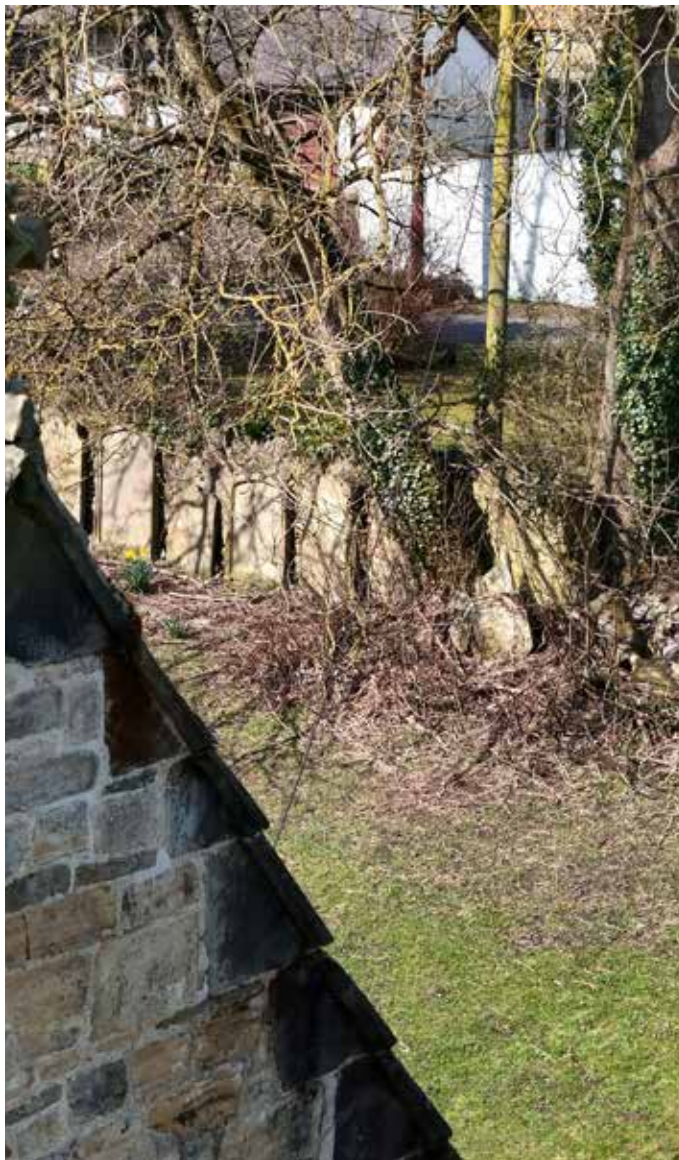
Leaning tree on the north boundary

*Review churchyard trees annually and after high winds for signs of damage or distress. Review trees on neighbouring land at the same time for risk from overhang or falling. M*

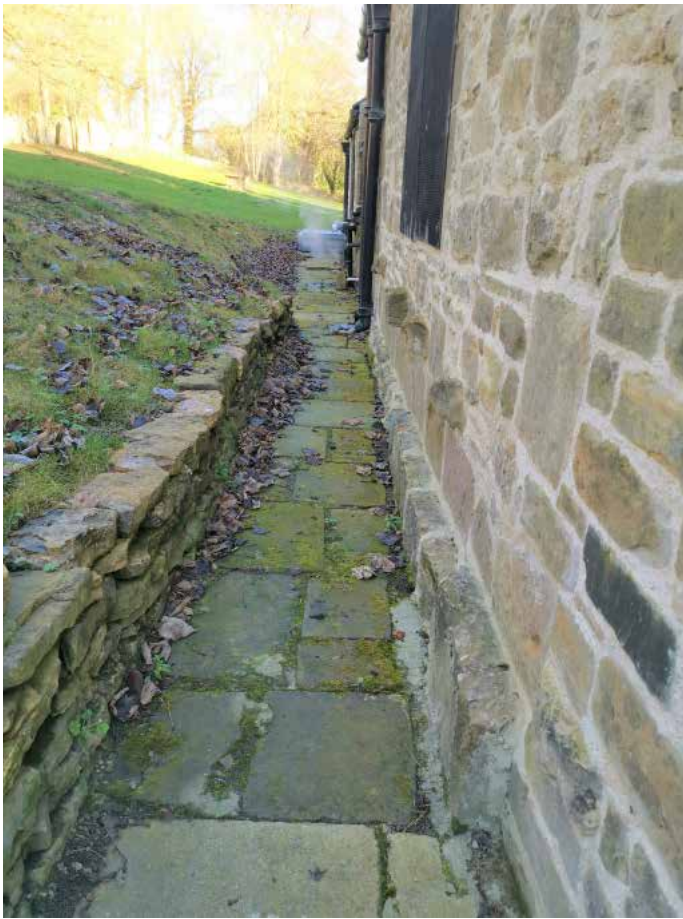
Hardstanding against base of wall will be trapping moisture - consider removal and laying grass directly up to base of walls
