**QUINQUENNIAL INSPECTION REPORT - MAY 2026**

# **ALL SAINTS CHURCH**

**LOW MOOR ROAD, LANGLEY PARK, CO. DURHAM, DH7 9TZ**

**ADAM VAUGHAN**

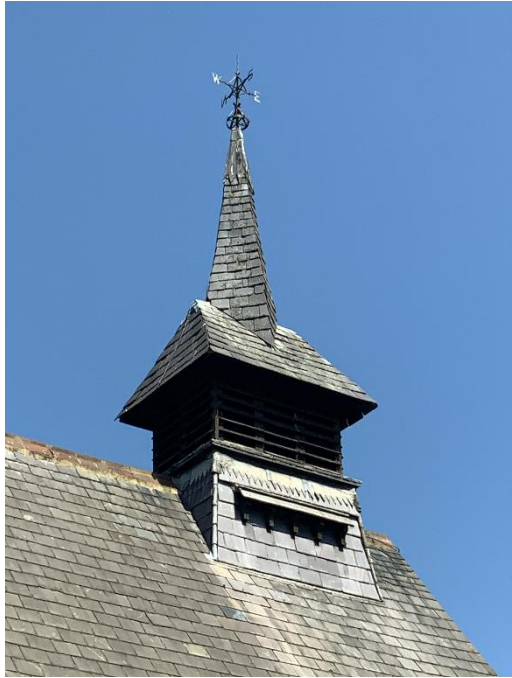
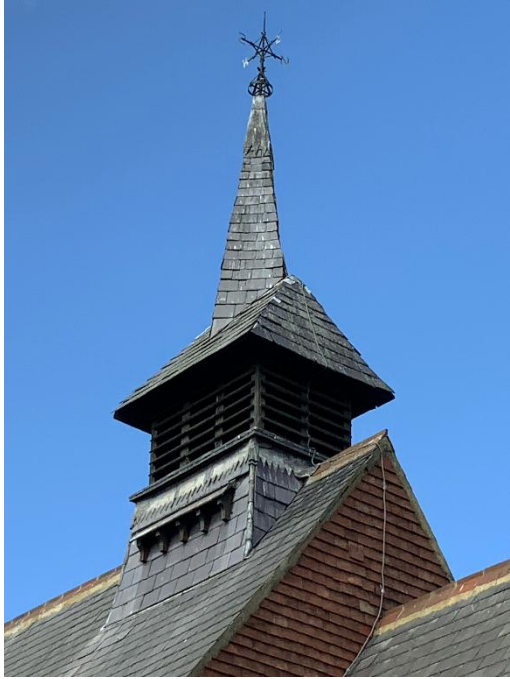
## Bell-cote

| | <p><b>Condition</b></p> <ul style="list-style-type: none"> <li>• The 2004 report indicated that the bell-cote and spirelet were overhauled in 1992 including the replacement of the original shingles with Welsh slate.</li> <li>• As far as can be seen from ground level, the structure is in sound condition</li> <li>• Exposed timber is showing signs of distortion, and would benefit from coating with timber preservative to prolong its lifespan. However, no loose timbers are visible.</li> </ul> | |

| | <p><b>Repair Needs</b></p> <ul style="list-style-type: none"> <li>• When roof repair works are next carried out, it is suggested that the contractor inspect the timberwork for any loose elements</li> <li>• Exterior timber work is due for treatment with timber preservative.</li> </ul> | <p>E</p> <p>E</p> |

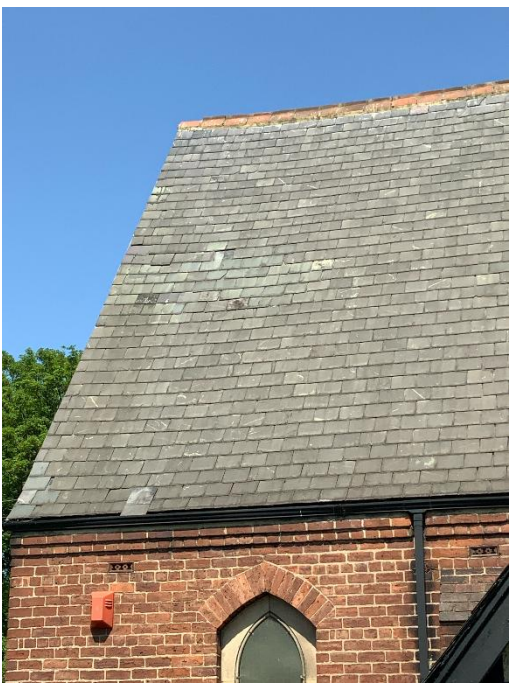
### Southern Pitch of the Nave Roof

| | <p><b>Condition</b></p> <ul style="list-style-type: none"> <li>• Generally in good condition. There is one missing slate to the left of the porch and it is sitting in the gutter.</li> <li>• Mortar pointing and bedding to the ridge tiles appears sound. Westernmost ridge tile does not match the others.</li> <li>• Pointing to the western verge is complete and appears to be stable.</li> </ul> | |

| | <b>Repair Needs</b> <ul style="list-style-type: none"> <li>• Refix slipped slate.</li> <li>• Monitor slates and refix any which continue to slip, or are blown off.</li> <li>• Replace westernmost ridge tile with a closer match to the others.</li> </ul> | B<br>M<br>E |

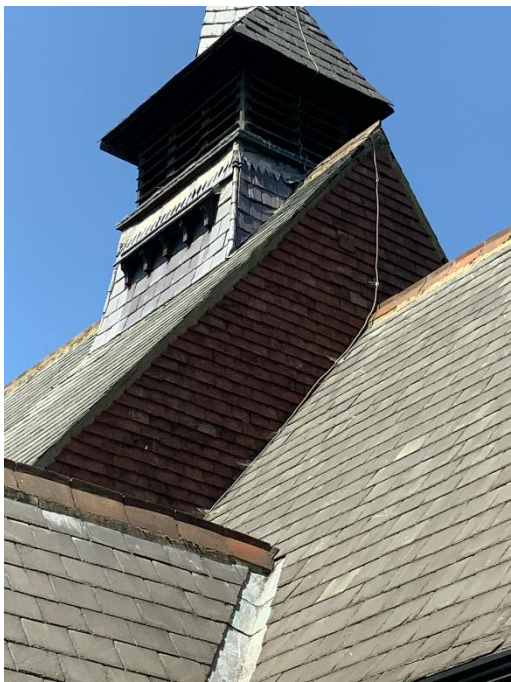
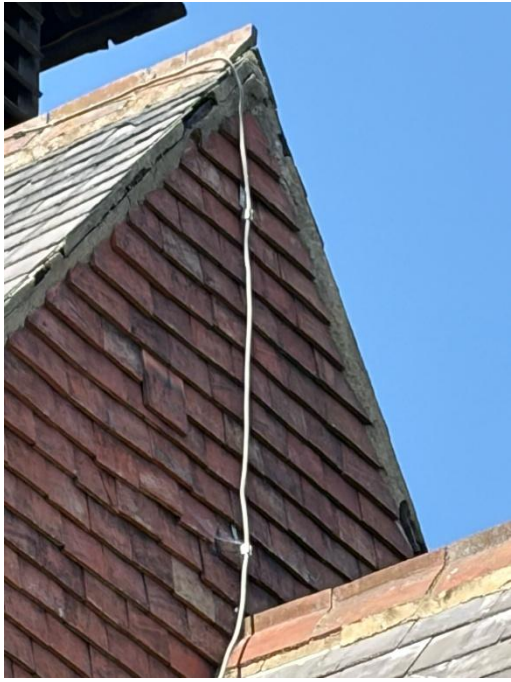
## Tiled East Gable to Nave

| | <p><b>Condition</b></p> <ul style="list-style-type: none"> <li>• All tiles appear sound although one or two have broken corners.</li> <li>• One tile has slipped noticeably and should be monitored. It doesn't appear to have moved since the last report. Any further slippage will warrant a repair.</li> <li>• Mortar pointing to the verge continues to crack and the ends of the roof sparring boards are visible. It is time for this to be repaired.</li> </ul> | |

| | <p><b>Repair Needs</b></p> <ul style="list-style-type: none"> <li>• Repoint the mortar verge and fix the tile that has slipped.</li> <li>• Continue to monitor other tiles for slippage.</li> </ul> | <p>C</p> <p>M</p> |

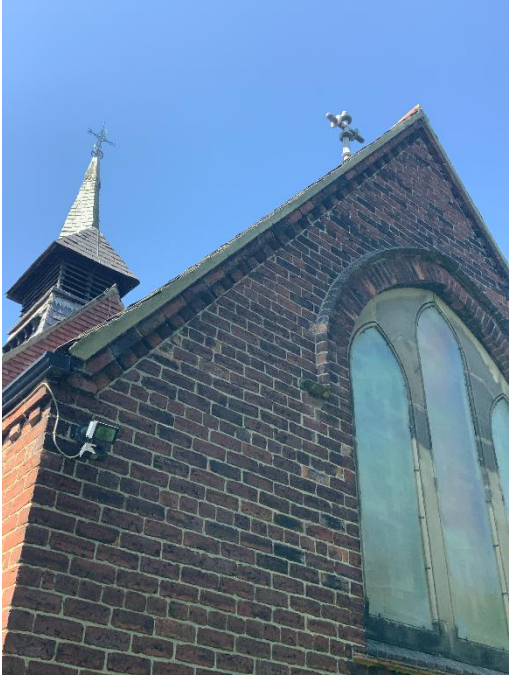
## Roof over the Chancel

| | <b>Condition</b> <ul style="list-style-type: none"> <li>• Generally in good condition. No missing slates, although one or two have chipped corners.</li> <li>• Mortar pointing between ridge tiles is weathering out in some areas.</li> <li>• Ridge tile bedding has cracked away at the East gable.</li> <li>• Minor cracking to the mortar verge at the East gable.</li> </ul> | |

| | <b>Repair Needs</b> <ul style="list-style-type: none"> <li>• Monitor slates and ridge tiles and refix any which continue to slip or are blown off.</li> <li>• Monitor cracks in mortar verge and carry out repairs should any fall out before the next inspection.</li> </ul> | M<br><br>M |

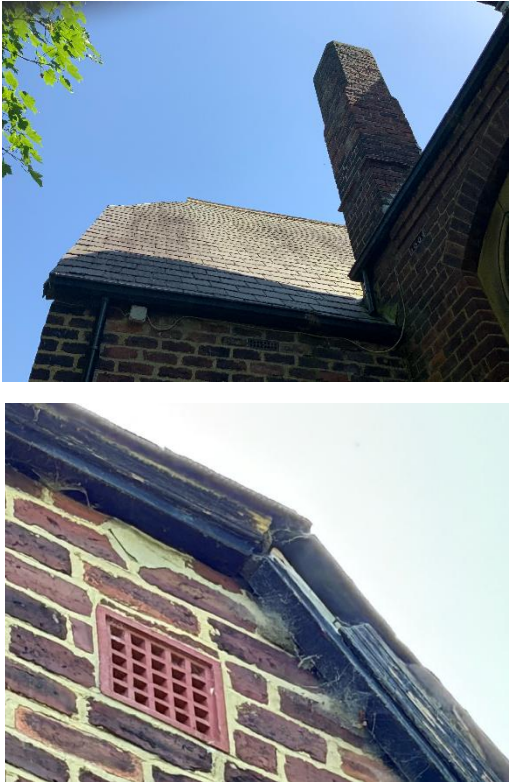
## Roof over the North Vestry

| | <b>Condition</b> <ul style="list-style-type: none"> <li>• Generally in good condition. No missing slates, although one or two have chipped corners.</li> <li>• Mortar pointing between ridge tiles is weathering out in some areas.</li> <li>• The vicar reports that the flashings to the rear of the stub chimney on East slope have been cleared out since the last inspection, with plant growth removed.</li> <li>• A short length of timber moulding is still missing at the verge leaving roof timber exposed to driving rain.</li> </ul> | |

| | <b>Repair Needs</b> <ul style="list-style-type: none"> <li>• Timber moulding on verge should be completed.</li> </ul> | C |

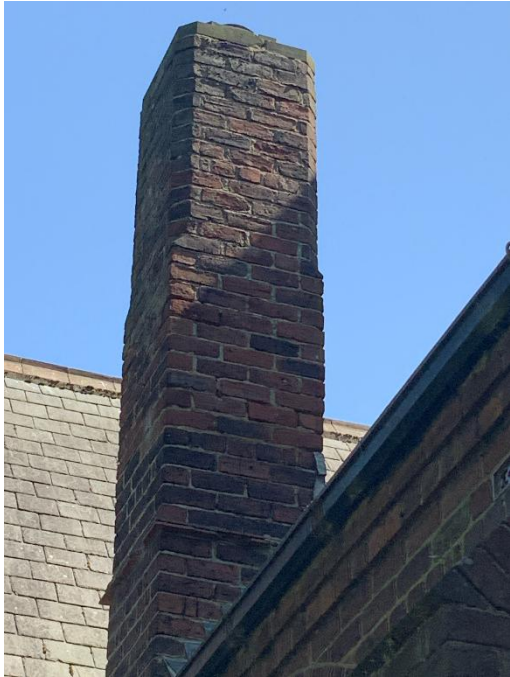
## North Pitch of the Nave Roof

| | <b>Condition</b> <ul style="list-style-type: none"> <li>• Generally in good condition. No missing slates, although one or two have chipped corners.</li> <li>• Mortar pointing between ridge tiles is weathering out in some areas.</li> <li>• Pointing has weathered out of the chimney in some areas. This now warrants attention to prevent any water damage or dislocation.</li> </ul> | |

| | <b>Repair Needs</b> <ul style="list-style-type: none"> <li>• Repoint the chimney and check that capping is sound.</li> </ul> | D |

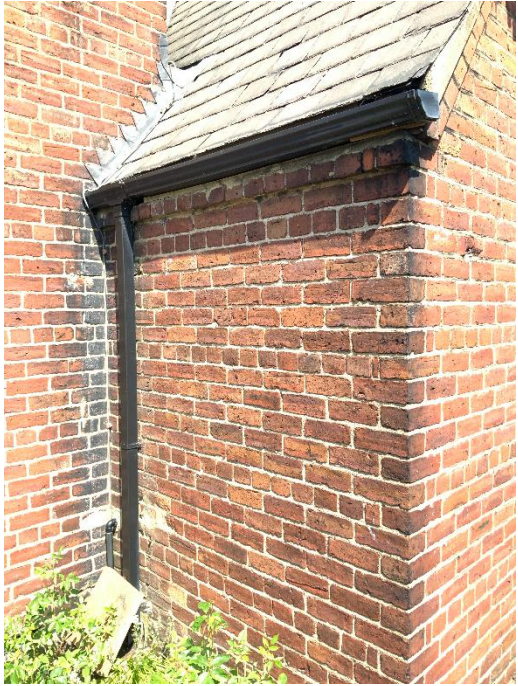
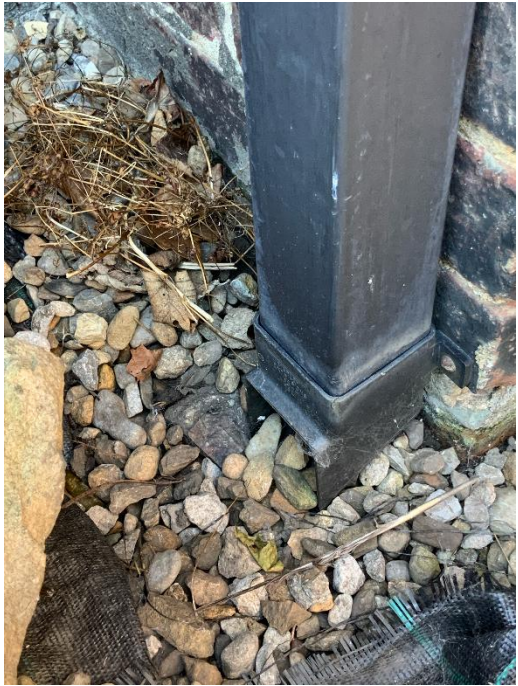
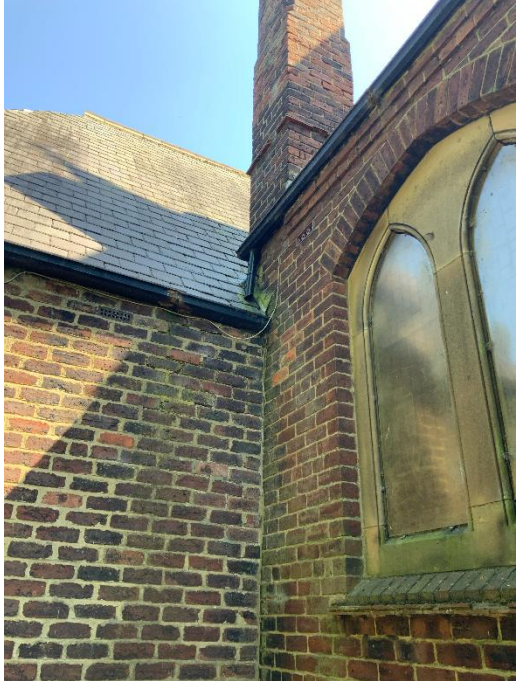
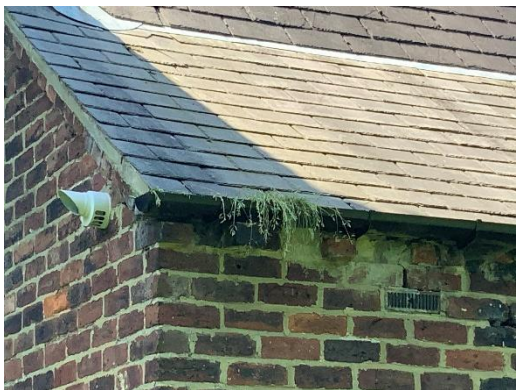
## 10.2. RAINWATER GOODS AND DISPOSAL SYSTEMS

| | <p><b>Condition</b></p> <ul style="list-style-type: none"> <li>• The inspection was carried out after several dry sunny days, so it was not possible to see the signs of overflowing gutters. Efflorescence on some areas of brickwork would suggest that there is (or has been) some leakage from the system.</li> <li>• The downpipe from the East gutter on the Porch does not appear to be discharging to a gulley at ground level.</li> <li>• Half of the water from the North pitch of the Nave roof discharges onto the roof of the North Vestry at the base of the chimney stack. This is a risky detail, and it's causing considerable algal growth. The area of roof discharging to the single downpipe on the West elevation of the North vestry will almost certainly overload the gutter and pipe during heavy rain causing spillage onto the wall beneath.</li> <li>• Plant growth was observed in some gutters.</li> </ul> | |

| | <b>Repair Needs</b> <ul style="list-style-type: none"> <li>• All leaking gutter joints should be repaired, and all plant growth removed.</li> <li>• Cast iron gutters, such as those on the North wall of the Nave, should be recaulked and repainted.</li> <li>• Longer term, the PCC should consider complete renewal of guttering and downpipes. At this time, it will be worth considering the following: <ul style="list-style-type: none"> <li>○ Introduce a second line of defence such as a high performance felt or DPC between the gutter and the top of the corbel.</li> <li>○ Use continuous seamless aluminium guttering will avoid the risks of leaky joints.</li> <li>○ Downpipes should be reintroduced where they have been removed so that all guttering is adequately drained.</li> <li>○ Introduce a downpipe to the guttering on the North of the Nave to remove water currently being discharged to the North Vestry roof.</li> </ul> </li> </ul> | C |

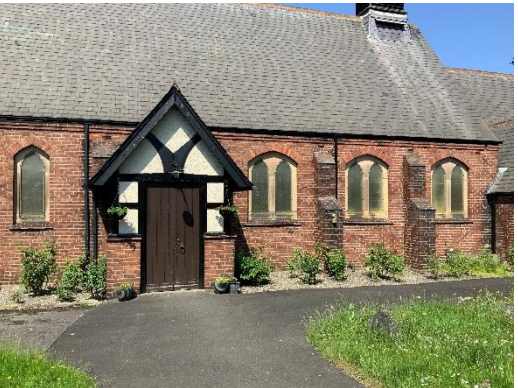
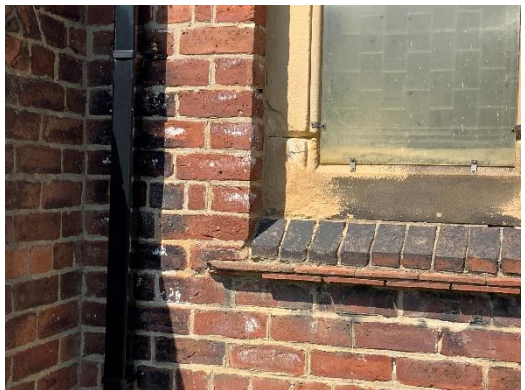
#### South Elevation of the Nave

| | <b>Condition</b> <ul style="list-style-type: none"> <li>The saturation and efflorescent noted in the previous reports is still noticeable, suggesting that the brickwork is continues to dry out.</li> <li>Pointing is generally in good condition, although there are some small areas needing attention in the longer term.</li> </ul> | |

| | <b>Repair Needs</b> <ul style="list-style-type: none"> <li>Brush off the worst of any remaining efflorescence.</li> </ul> | M |

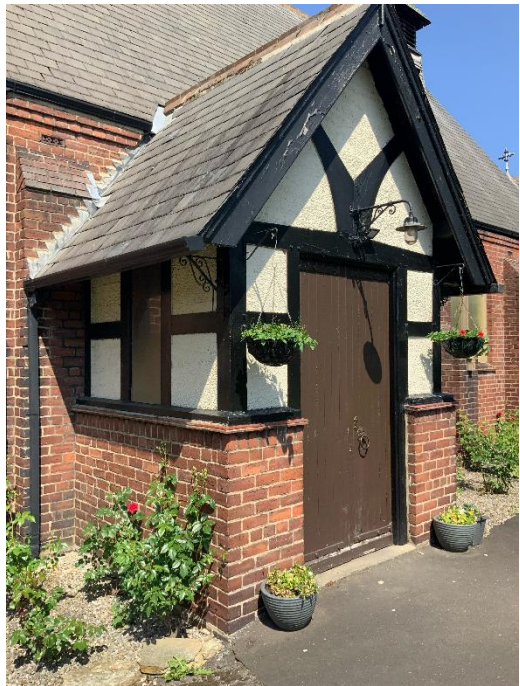
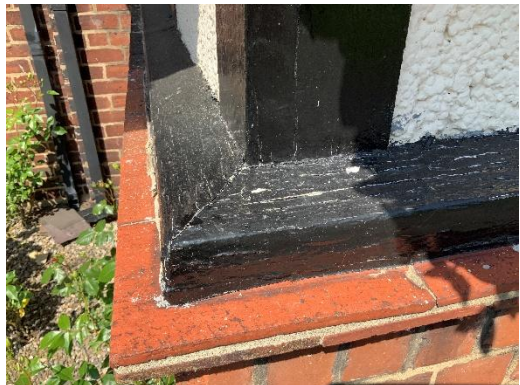
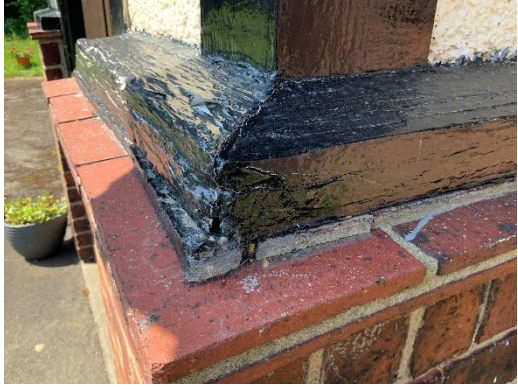
### Porch

| | <b>Condition</b> <ul style="list-style-type: none"> <li>The timber soleplate at half height is exposed to the elements in some locations due to flaking paint, despite being repainted in recent years.</li> <li>The mortar fillet below this sole plate is cracked and pulling away in places, missing in others. This should be replaced.</li> </ul> | |

| | <b>Repair Needs</b> <ul style="list-style-type: none"> <li>Strip the paint from the timber sole plate to each side of the doorway and repaint using a microporous paint. This will be more breathable and should prevent blistering.</li> <li>Repair the mortar fillet beneath the sole plate where cracked or missing.</li> </ul> | <p>C</p> <p>C</p> |

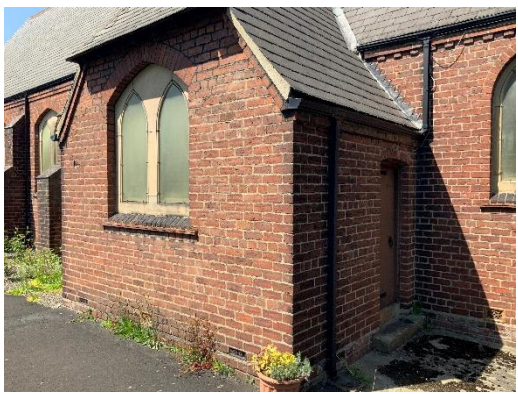
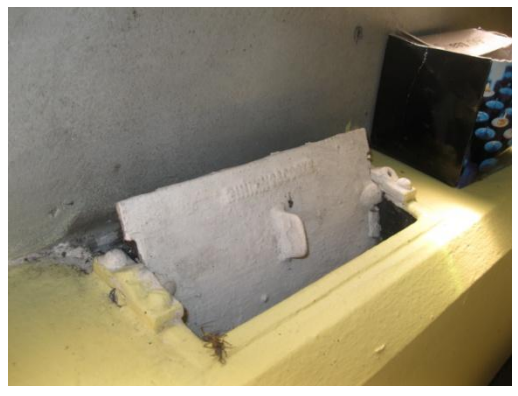
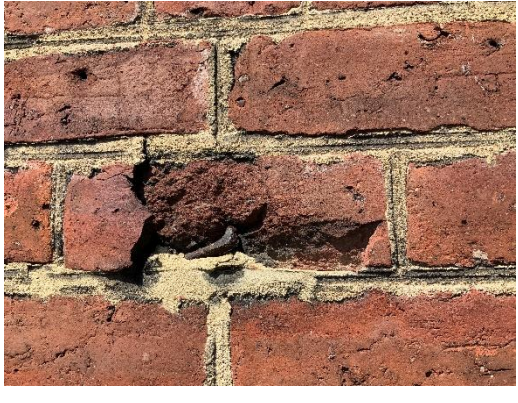
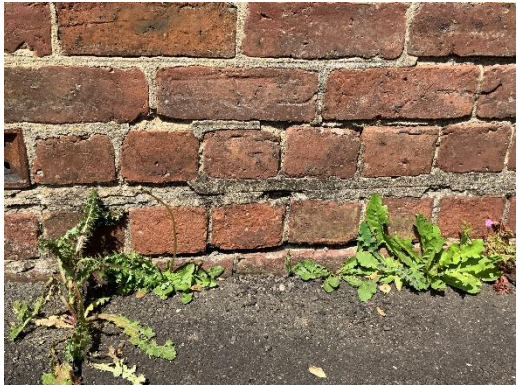
### South Vestry

| | <b>Condition</b> <ul style="list-style-type: none"> <li>The pointing has weathered out in some locations at low level, below the DPC line.</li> <li>The brick damaged by a corroding iron nail on the South Elevation has not deteriorated further since the last report, and no remedial action is warranted unless it degrades significantly.</li> </ul> | |

| | <b>Repair Needs</b> <ul style="list-style-type: none"> <li>• Repoint at low level, using suitable lime mortar.</li> </ul> | D |

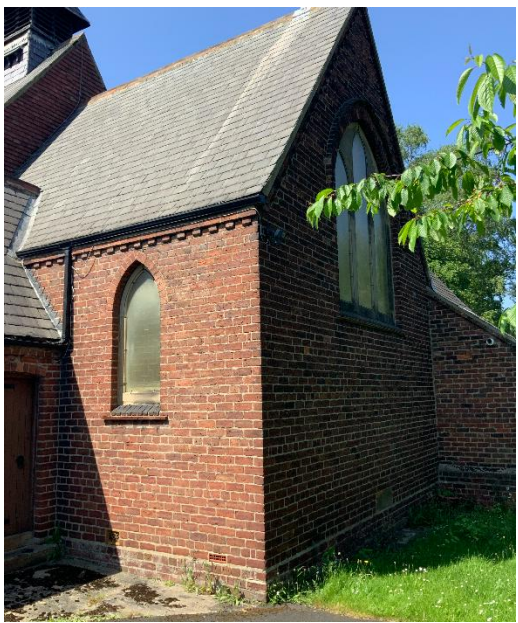
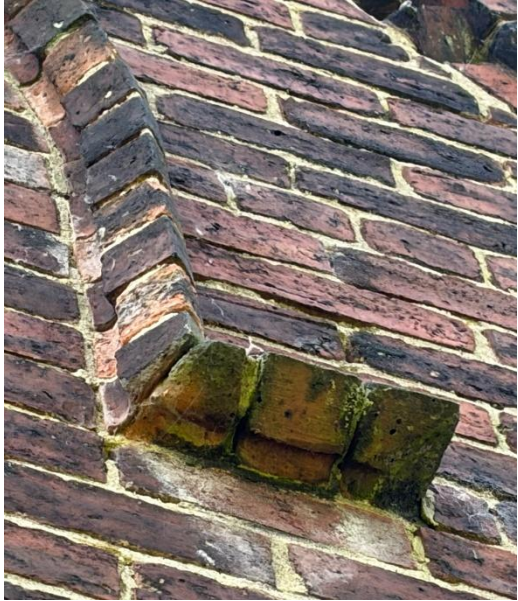
### Chancel

| | <b>Condition</b> <ul style="list-style-type: none"> <li>• Pointing is weathering out of the window arch on the gable end.</li> </ul> | |

| | <b>Repair Needs</b> <ul style="list-style-type: none"> <li>Bricks at the arch should be repointed using lime mortar.</li> </ul> | D |

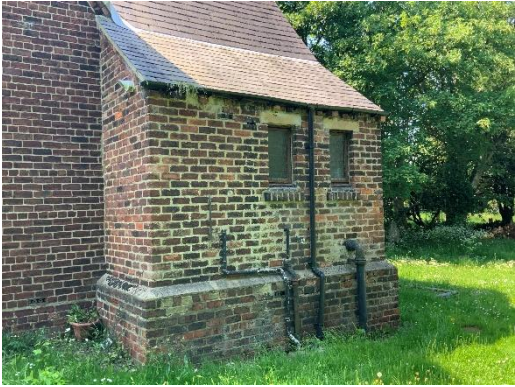
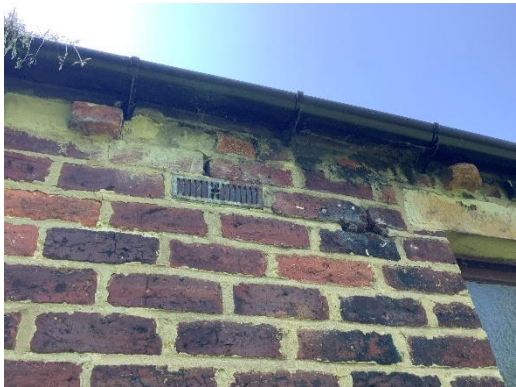
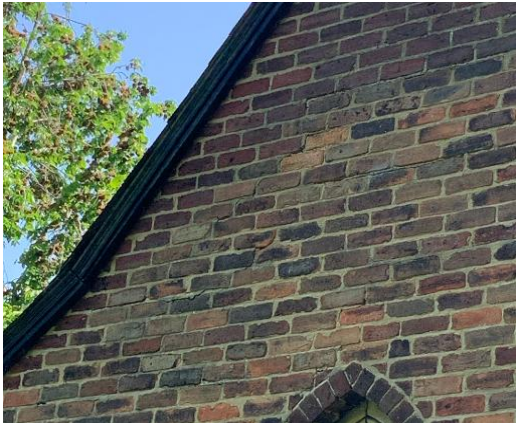
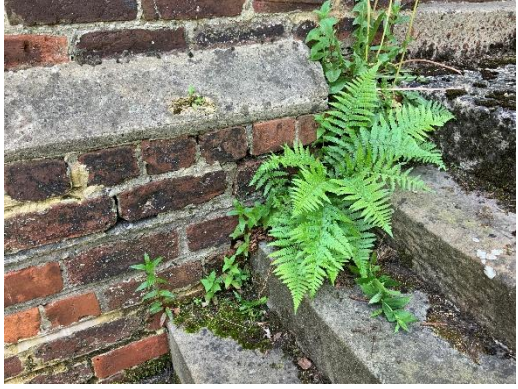
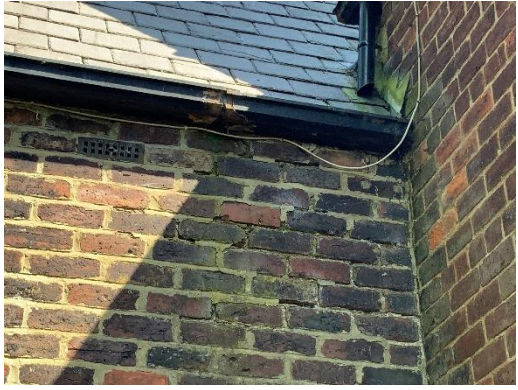
### North Vestry

| <br> | <b>Condition</b> <ul style="list-style-type: none"> <li>The North Vestry has been poorly repointed some time before the previous report. The buff cement-based pointing is degrading quickly, but there is plenty of the original lime mortar left in the joints.</li> <li>The structural cracks in the North elevation, reported in 2009, are still noticeable close to the eaves, and also above the arched window. They do not appear to be getting any worse.</li> <li>The stone stair up to the Vestry door has some open mortar joints here which would benefit from repointing. They are now supporting plant growth which needs to be removed.</li> <li>There are some other localised areas where pointing has weathered out.</li> </ul> | |

| | <p><b>Repair Needs</b></p> <ul style="list-style-type: none"> <li>• Remove all plant growth</li> <li>• Loose or missing pointing should be replaced, using lime mortar, in the following locations to prevent water ingress: <ul style="list-style-type: none"> <li>○ East elevation around plinth level close to the downpipes, and at high level.</li> <li>○ Open joints close to the eaves on the North Elevation, particularly around the cracking.</li> <li>○ Walling beside the stone steps, and at the steps down to the basement.</li> <li>○ Inside corner of the North Vestry and the North wall of the Nave.</li> </ul> </li> </ul> | <p>M<br/>D</p> |

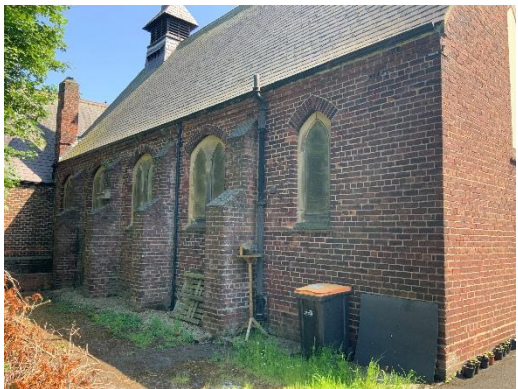
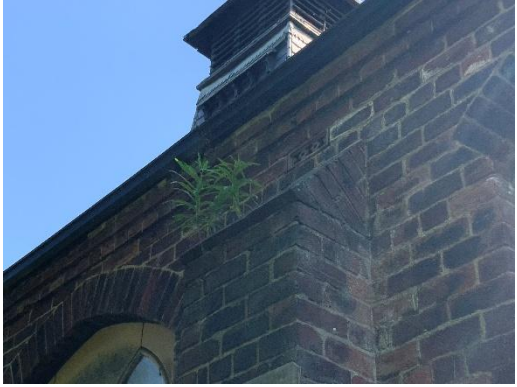
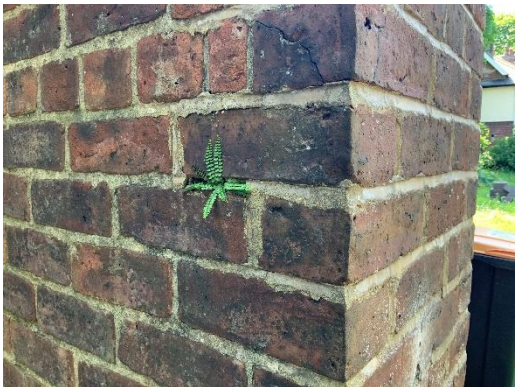
### North Elevation of the Nave

| | <p><b>Condition</b></p> <ul style="list-style-type: none"> <li>Some large areas of efflorescence are visible on this elevation, suggesting that dampness in the masonry is still a problem, but also perhaps because of a long dry spell without rain to wash it away.</li> <li>One or two locations are in need of repointing, including in the region of the rainwater downpipe. This allows plant growth to take hold.</li> <li>One sloped top to buttress has plant growth which should be cleared.</li> </ul> | |

| | <p><b>Repair Needs</b></p> <ul style="list-style-type: none"> <li>Loose or missing pointing should be replaced using lime mortar. This is needed: <ul style="list-style-type: none"> <li>Walling to the left of window W.06.</li> <li>Buttresses, in several locations</li> <li>At plinth level in several locations.</li> </ul> </li> <li>Keep the top surfaces of the buttresses clear of plant growth.</li> </ul> | <p>D</p> <p>M</p> |

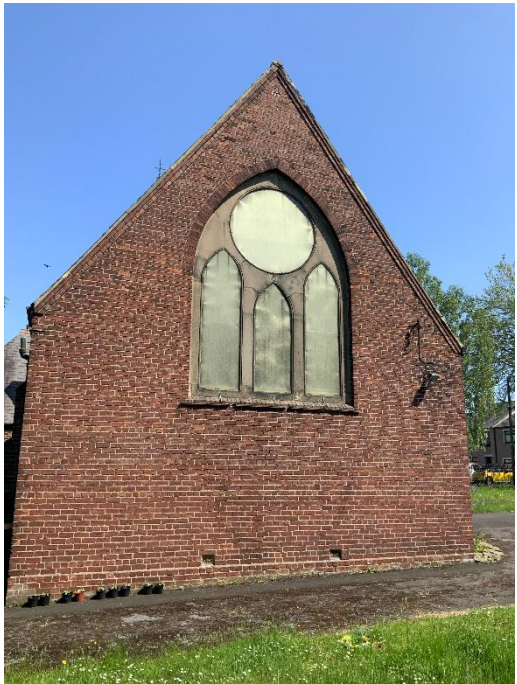
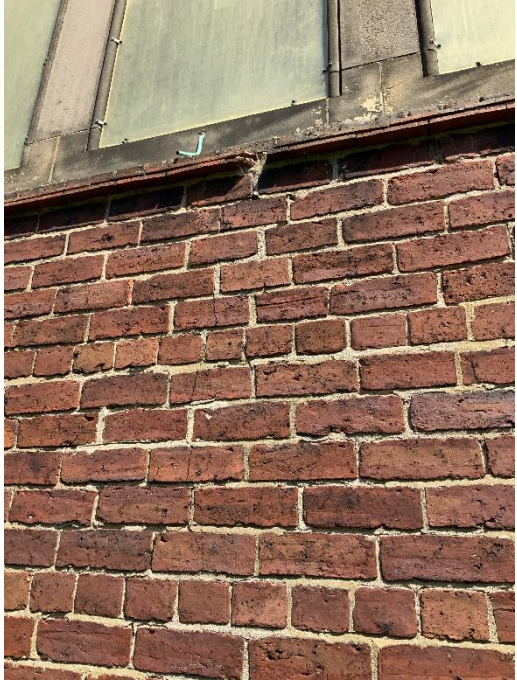
### West Gable of the Nave

| | <p><b>Condition</b></p> <ul style="list-style-type: none"> <li>The wall is generally in good condition except the vertical structural crack reported at the 2009 inspection. The crack does not appear to be getting any worse, but should be monitored.</li> <li>The creasing tiles at the sill to the West window have been damaged in three locations. This will result in some runoff onto the walls below but isn't considered to be a significant risk.</li> </ul> | |

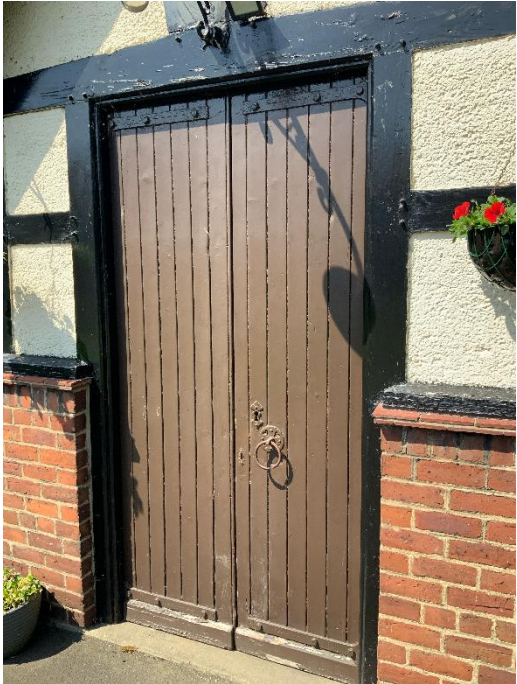
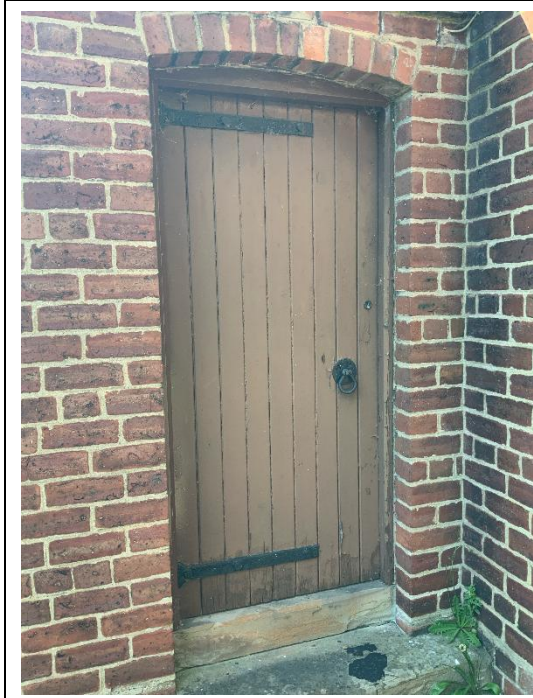
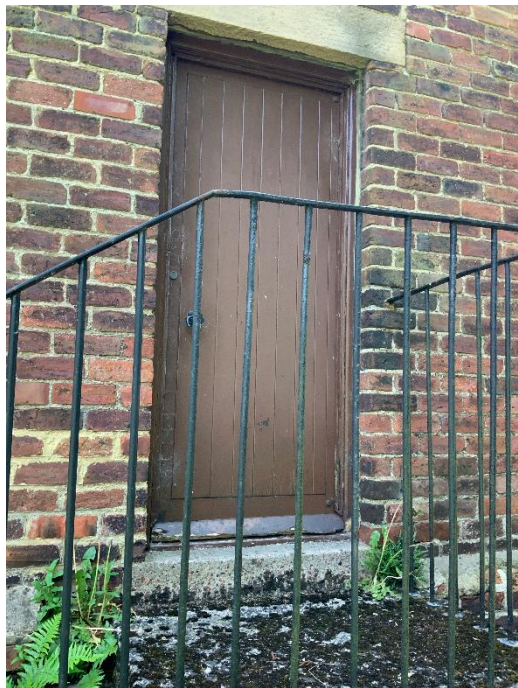
##### Exterior Doors

- All doors are in reasonable condition although the paintwork and timber is deteriorating in the splash zone (bottom 20-30cm), and the timber frames are degrading slowly at low level.
- The main entrance door to the Nave has been repainted since the last inspection. When it is repainted in the future, it would be best to paint the ironwork separately in black gloss paint to highlight its character.
- The North Vestry door in particular is degrading at its base, particularly around the weatherbar, and it would benefit from repair.
- Latch, mortice locks and bolts are in working order.

- Weatherbar to the North Vestry door should be replaced and the door repainted.
- Exterior doors would benefit from regular repainting to prolong their lifespan. Flaking paint, particularly at low level, should be removed first.
- At some point in the future, the timber frames will require a splice repair to the bottom 30cm of door frame.

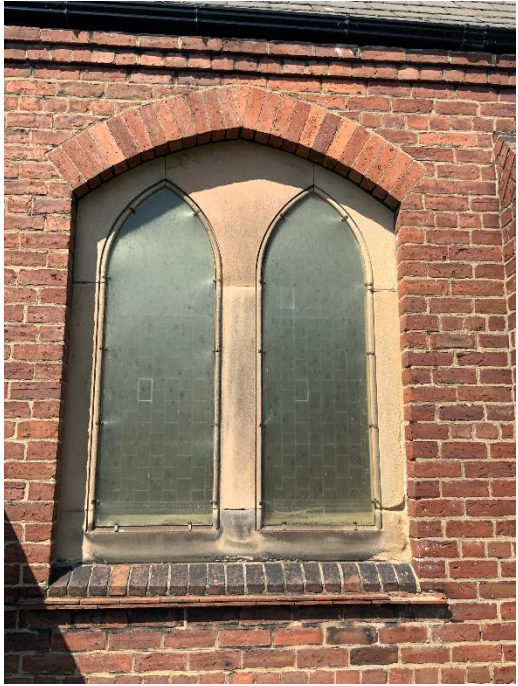
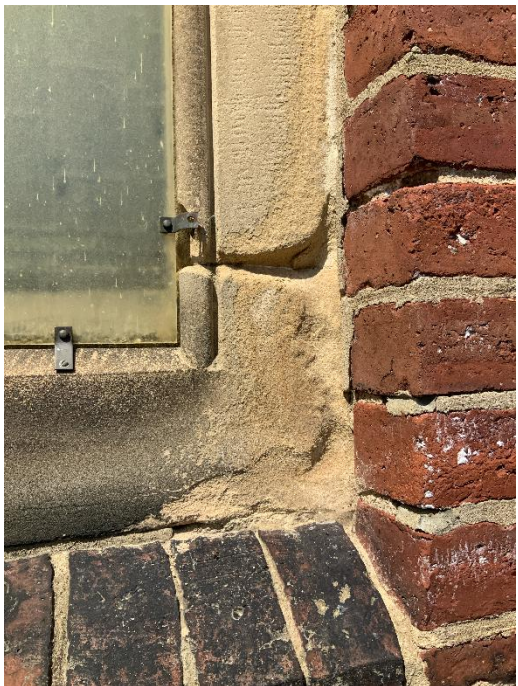
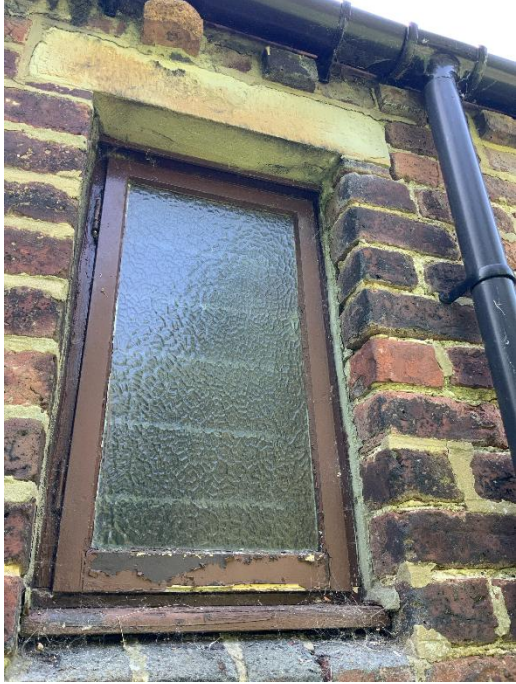
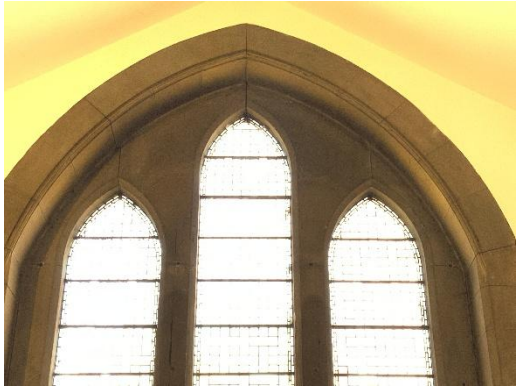
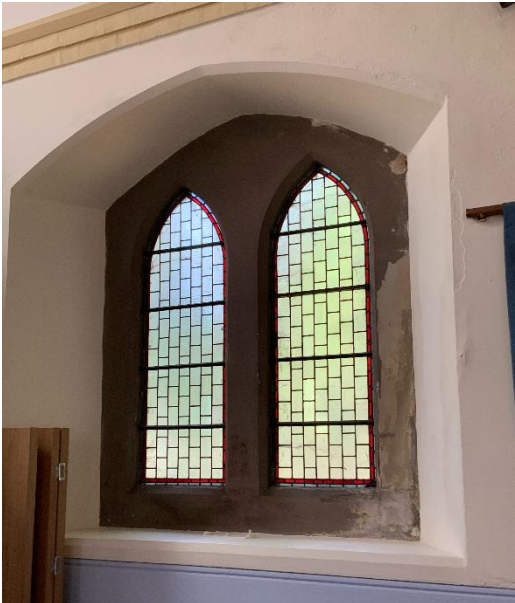
## Windows

| | <p><b>Condition</b></p> <ul style="list-style-type: none"> <li>• Many of the stone surrounds are exhibiting delamination of the stone and some blistering caused by dampness in the stone. Externally, this has caused some minor opening up at joints. which would benefit from limited pointing. Internally, although unattractive, I would not recommend painting to conceal this because it may retard the stone drying out process.</li> <li>• The delamination has resulted in a continued build up of stone dust between the window and the polycarbonate protection in several locations, notably windows W.15 and W.16. Clearing this will help stonework to dry out.</li> <li>• There is some opening up of the joint at the head of the stone arches of window W.14 in the South Vestry. Nothing is required other than monitoring.</li> <li>• The tripartite East window in the Chancel, W.12, continues to show an opening up of joints in the stone arches at the head. Nothing is required other than monitoring.</li> <li>• The timber frames to the windows of the North Vestry would benefit from repainting, particularly</li> </ul> | |

| | <p>the timber sills to W.10 and W.11, to prolong their life.</p> <ul style="list-style-type: none"> <li>As reported previously, a sizeable piece of the stone surround to the North Vestry window W.09 has come away. Although unsightly, no repair work is proposed.</li> </ul> | |

| | <p><b>Repair Needs</b></p> <ul style="list-style-type: none"> <li>Some very small areas of exterior pointing are required to stone surrounds, particular at the windows on the South elevation of the Nave and Chancel, where stone delamination has occurred unevenly at mortar joints. Use a colour-matched soft lime mortar only. This fiddly work will require a skilled craftsman.</li> <li>Clear out the stone dust held behind polycarbonate window protection. I was able to dislodge some using a credit card run around the side, but to clear it properly will require the temporary loosening of the polycarbonate.</li> <li>Repaint the timber frames to the windows of the North Vestry.</li> </ul> | <p>D</p> <p>C</p> <p>D</p> |

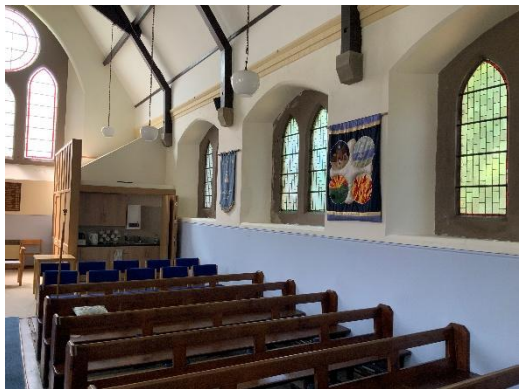
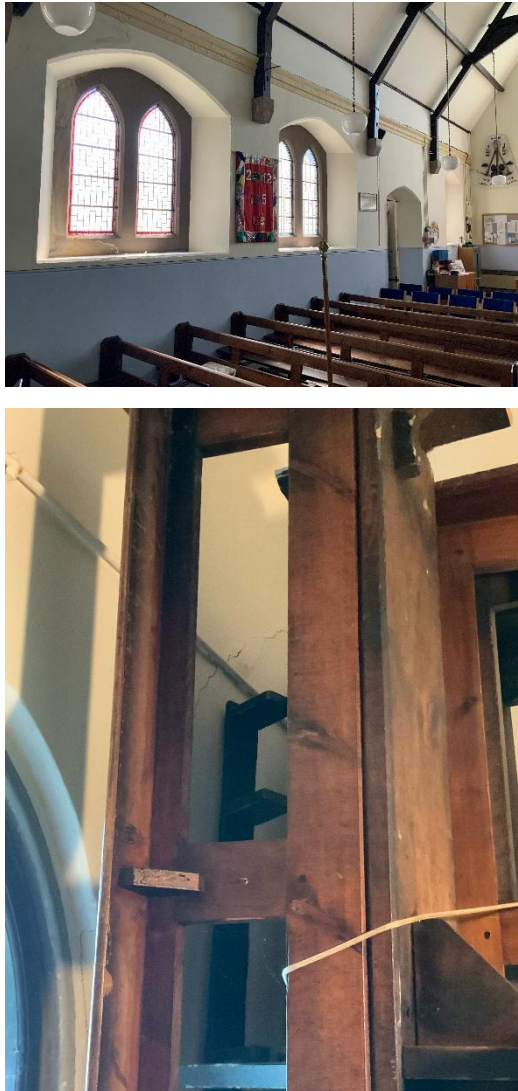
## 11.3 INTERNAL WALLS

| | <p><b>Condition</b></p> <ul style="list-style-type: none"> <li>• The walls were all redecorated as part of the community space contract in 2019 are still looking fresh.</li> <li>• The replastering around window W.16 which was suffering from dampness has had no reoccurrence of plaster failure.</li> <li>• The cracking in the wall of the North Vestry towards the North East corner is still evident. It looks much better following redecoration, but the hairline crack has reappeared. It does not appear to be getting any worse, but engaging a structural engineer to install telltales would be prudent because a slow worsening of the cracks over time may not be apparent.</li> </ul> | |

| | <p><b>Repair Needs</b></p> <p>Engage a structural engineer to install telltales in the North Vestry.</p> | D |

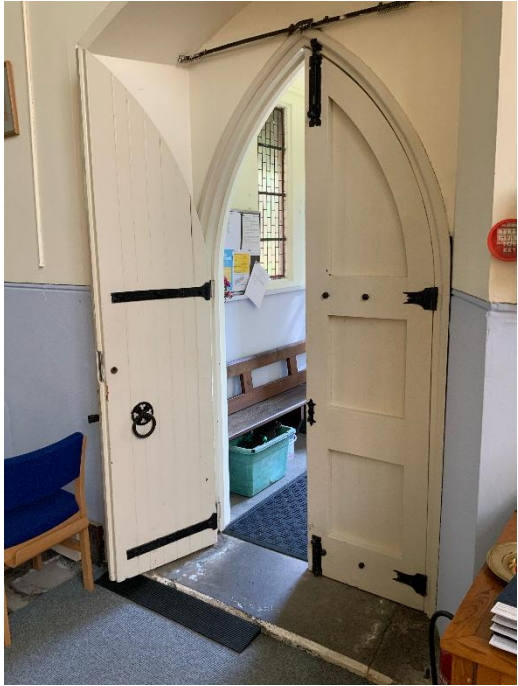
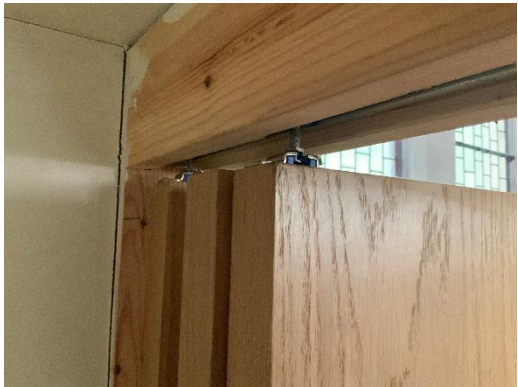
## Interior Doors

| | <p><b>Condition</b></p> <ul style="list-style-type: none"> <li>• Doors generally in sound condition.</li> <li>• The new bi-fold doors to the kitchenette are not running smoothly and the leading edge is scraping the floor. The screw hanger needs adjustment and this should be a simple repair n</li> </ul> | |

| | <p><b>Repair Needs</b></p> <ul style="list-style-type: none"> <li>• Adjust folding door hanger. Any competent joiner should be able to carry out this adjustment.</li> </ul> | B |

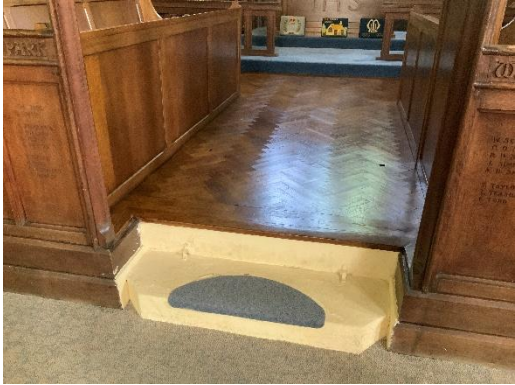
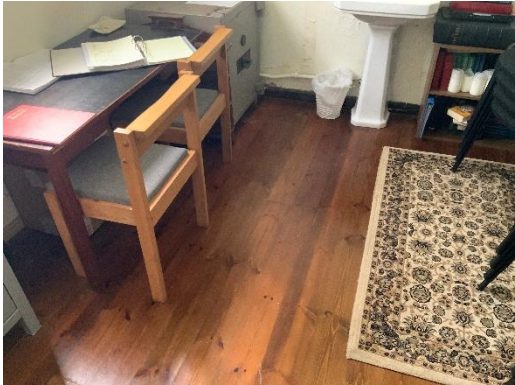
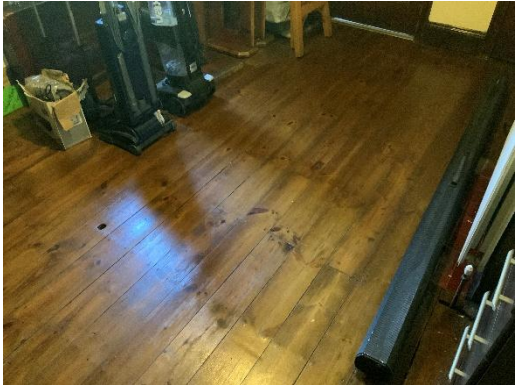
## 11.5 FLOORS AND PLATFORMS

| <br><br> | <p><b>Condition</b></p> <ul style="list-style-type: none"> <li>• The West end of the Nave and area around the pulpit have been carpeted as part of the community space contract. The original runner up the aisle has been modified to suit. There is new barrier matting inside the lobby door, and vinyl around the kitchenette and WC.</li> <li>• Two further rows of pews have been removed on a trial basis, being replaced with loose seating. If this is to be made permanent then timber infills should be installed to tidy up the floor.</li> <li>• One or two cracks in the concrete floor of the Nave are evident, but these are no doubt historical and aren't of any concern.</li> <li>• The previous QQ reports highlighted some rocking in the grill behind the altar and this has been partially dealt with using wedges.</li> <li>• No floor boards were lifted in the North and South vestries, and it was not been possible to inspect the sub-floor void.</li> <li>• In the North Vestry, the floor beside the WC was previously reported as being soft. This is no longer apparent so it is assumed that a repair has been carried out.</li> </ul> | |

| | <b>Repair Needs</b> <ul style="list-style-type: none"> <li>If the additional rows of pews are to be removed permanently, then timber infills should be installed to tidy up the floor.</li> </ul> | C |

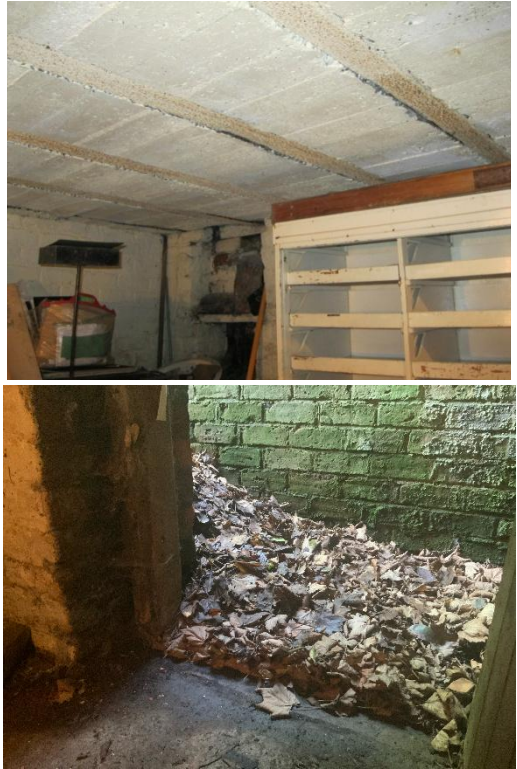
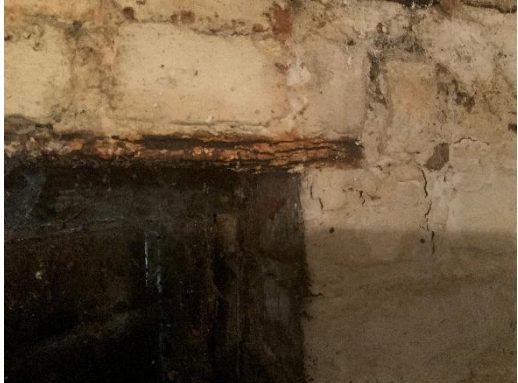
## 11.6 BASEMENT HEATING CHAMBER

| | <b>Condition</b> <ul style="list-style-type: none"> <li>The fireproof plasterboard ceiling continues to show dampness and flaking paint, particularly above the door, but this does not appear to be getting worse and the board remains sound.</li> <li>The concrete floor is damp, although no standing water was observed.</li> <li>The steel RSJ's framing the lowered ceiling below the organ and the RSJ door lintol are all rusting due to the damp environment, and anti-corrosion painting is required.</li> <li>The door lintel (RSJ) is starting to fail at its bearing with a split, and there is some distortion in the beam. This doesn't show in photos taken in earlier inspections, so it warrants an inspection by a structural engineer in the near future</li> </ul> | |

| | <ul style="list-style-type: none"> <li>The exposed heating pipework will benefit from having all joints in the insulation taped up to minimise thermal bypass, helping efficiency.</li> <li>There is a considerable build up of leaves on the steps which could be a safety risk.</li> </ul> | |

| | <b>Repair Needs</b> <ul style="list-style-type: none"> <li>The steel RSJ's need to be wirebrushed and then repainted with a high quality metal primer and paint.</li> <li>Engage a structural engineer to check the door lintel.</li> <li>The joints in the insulation on the heating pipework should be taped up.</li> <li>Remove the leaves covering the steps to the heating chamber.</li> </ul> | C<br><br>A<br><br>D<br><br>B |

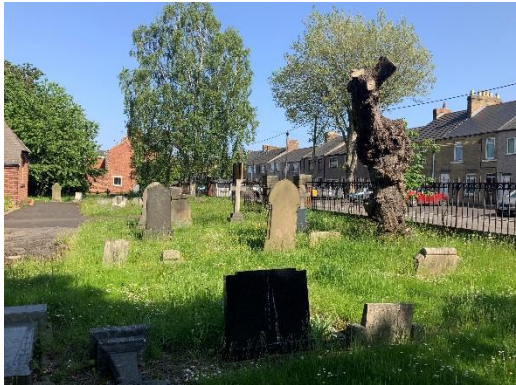
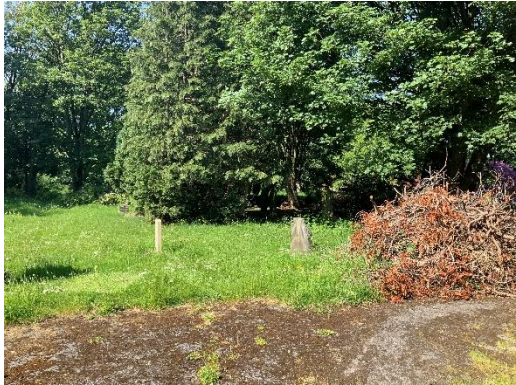
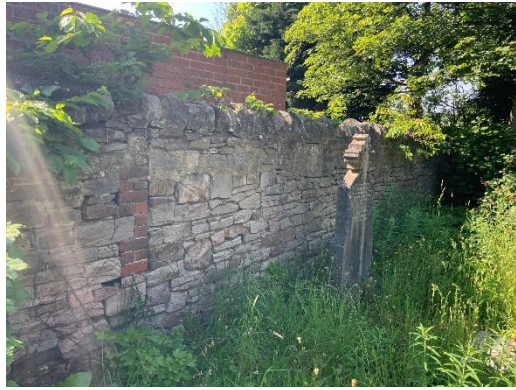
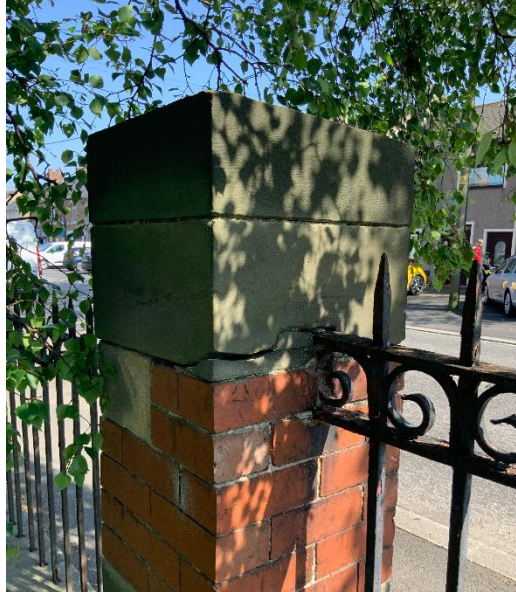
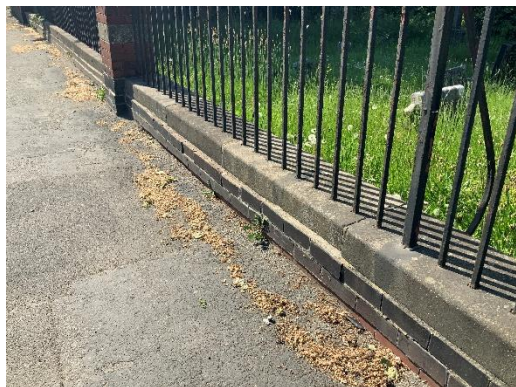
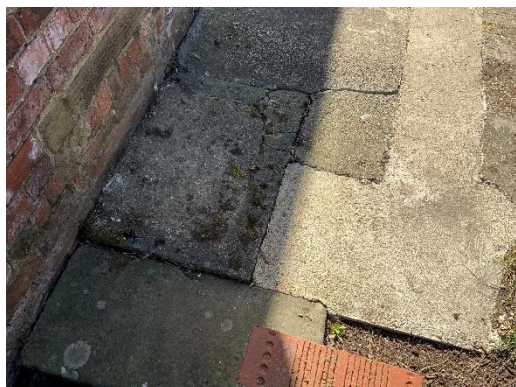
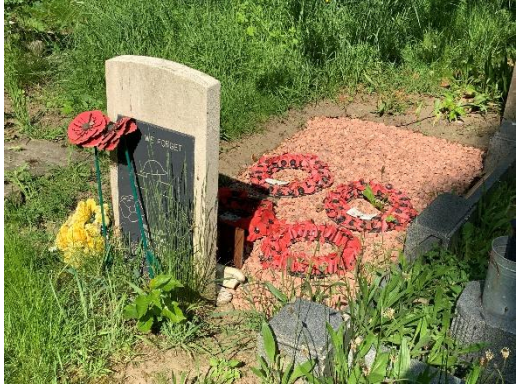
## 12. CHURCHYARD AND ENVIRONS

- The churchyard grass is being left to grow to support wildlife. Volunteers have cleared away some shrubbery which was getting out of hand.
- Plant growth continues to damage stone walls, particularly at the copings. See photo as an example of damage being caused.

- The Northern and Eastern boundaries are in reasonably sound condition, although plant growth needs to be attended to.
- At the Southern boundary to the road, one pier has a badly cracked coping, probably caused by rusting of the ironwork. There doesn't appear to have been any worsening of this since the last inspection so it should just be monitored.

- The tarmac surfaces are reasonably clear of moss and plant growth.
- Concrete flagstones / surfacing at the top of the basement stair needs to be reset – they're currently a trip hazard, although this is by no means a high traffic area.

| | <p><b>Repair Needs</b></p> <ul style="list-style-type: none"> <li>Remove all plant growth from stone boundary walls, particularly copings. This is relatively easy to do, and will have a big benefit in the long run. Ideally, holes should be pointed up.</li> <li>Reset concrete flagstones beside basement stair.</li> <li>Monitor movement in the Southern boundary where the wall is bulging.</li> </ul> | <p>M</p> <p>B</p> <p>M</p> |
