**QUINQUENNIAL INSPECTION REPORT - MAY 2026**

# **ALL SAINTS CHURCH**

**LOW MOOR ROAD, LANGLEY PARK, CO. DURHAM, DH7 9TZ**

**ADAM VAUGHAN**

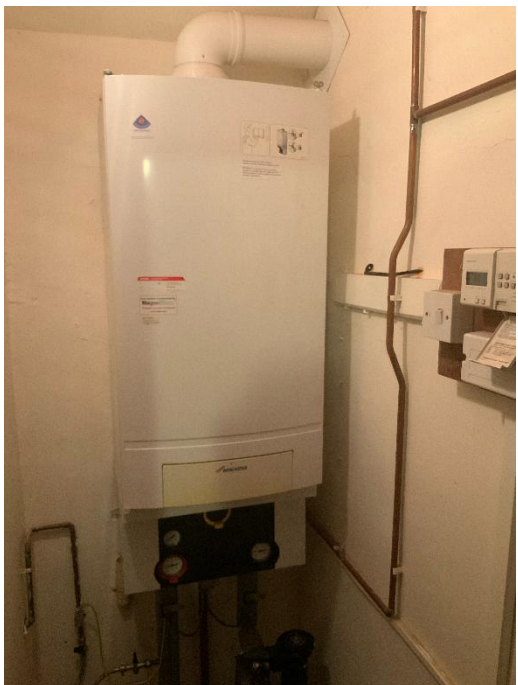
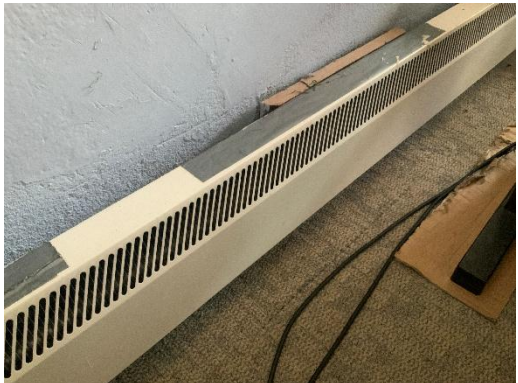
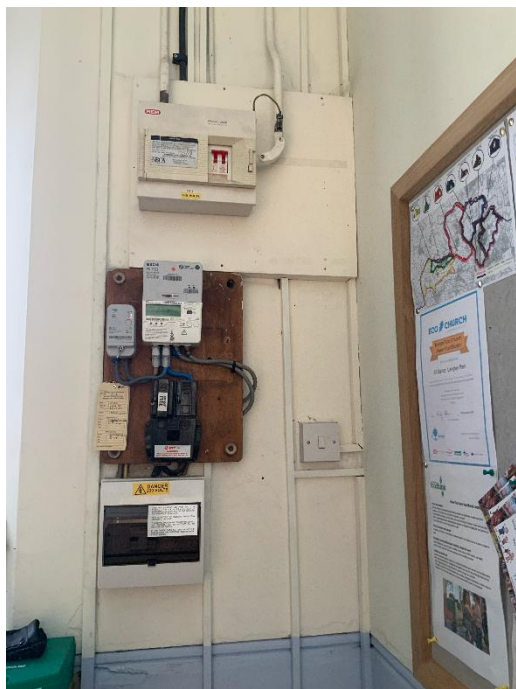
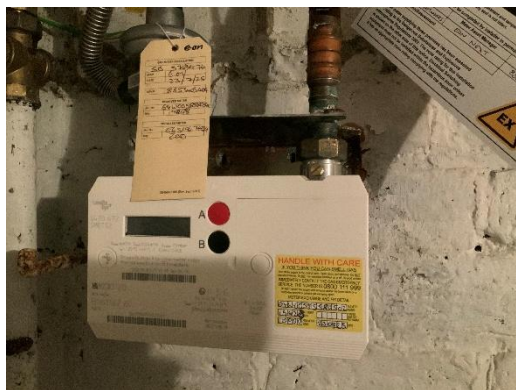
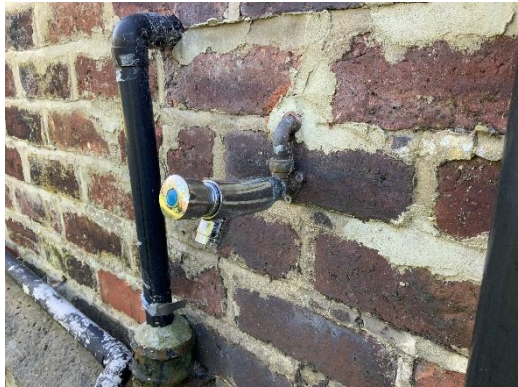
### 13. SERVICES

- The log book indicates that the boiler was last serviced in 2024. Ideally, it should be serviced once a year.
- Heating pipes in the basement have been insulated but still require the joints to be taped.
- The vicar says that electrical testing was carried out last year, but the certificate is outstanding.
- PAT testing doesn't appear to have been carried out recently. It should be done on an annual basis.
- Fire extinguishers are being serviced each year.
- Gas and electricity smart meters have been fitted since the last inspection.
- The lightening protection system was last tested in 2016 and an updated test is now overdue.
- The alarm in the accessible WC was checked and the sounder and warning light were operational.

| | <b>Repair Needs</b> <ul style="list-style-type: none"><li>• Boiler to be serviced annually. Tape joints to heating pipework insulation in basement.</li><li>• Obtain electrical testing certificate.</li><li>• Arrange annual PAT testing for electrical equipment.</li><li>• Arrange for testing of the lightening protection system.</li><li>• Maintain the ZIP water boiler in line with the manufacturer instructions.</li></ul> | <div>M</div> <div>M</div> <div>M</div> <div>M</div> <div>M</div> |
