## QUINQUENNIAL REPORT

### **A- DESCRIPTION OF THE CHURCH**

Church of St. Ives

### **Quinquennial Inspector's overview on the condition of the church:**

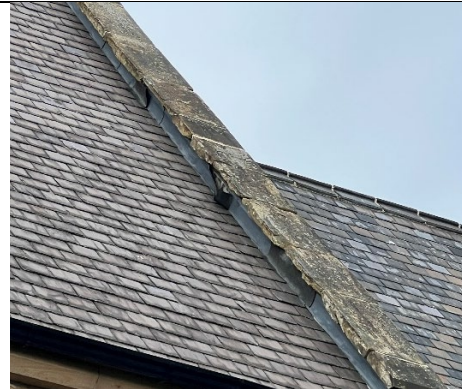
| No. | Defect | Recommended Repair | Cat.<br>/Cost | Photograph |
|---|---|---|---|---|
| 1.1.2 | Flashings to east/gable appear to be coming away | Inspect the flashings and refix/replace as necessary.<br>Carry out high level inspection of the water tabling and consider rebedding the tabling and/or replacing the tabling | B<br>£1750 | |

| 1.1.2 | Rebed water tabling the east gable to south nave pitch | 1750 |

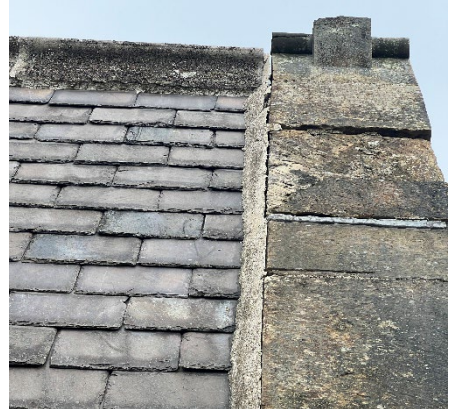
| 1.3.1 | 2 no. watertables to the west pitch and 1 no watertable to the east pitch showing signs of delamination (this was noted in the last QI but seems no worse)<br>Mortar fillets to Porch gable have lost adhesion to copings to both pitches | In association with general repairs, it is recommended defective tabling should be replaced and the tabling bedded on dpc. | B<br>£1000 | |

| 1.3.1 | Rebed water tabling to porch roof | 1000 |

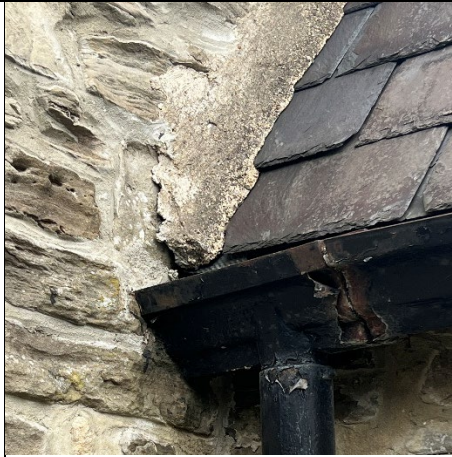
| 1.3.2 | Section of mortar fillet to wall abutment has lost adhesion | Break out the mortar fillet and replace in lime mortar. | B<br>£150 | |

| 1.3.2 | Renew lime mortar fillet to porch roof wall abutment | 150 |

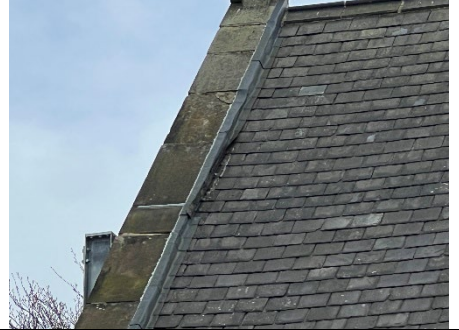
| 1.5.1 | The alternative material 'lead' flashing to the east gable appears to be coming away. | Inspect the flashings and refix/replace as necessary.<br>In association with general repairs recommended for tabling defective tabling should be replaced and tabling bedded on dpc. | B<br>£1750 | |

| 1.5.1 | Rebed east gable water tabling to north chancel pitch | 1750 |

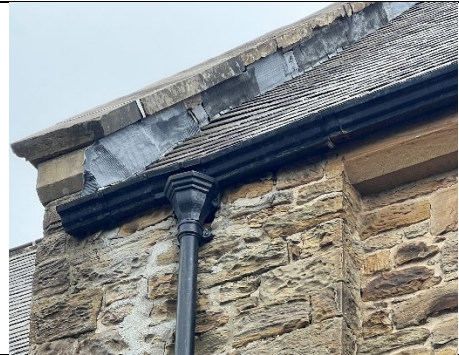
| 1.6.1 | The alternative material 'lead' flashing to the east gable appears to be coming away. | In association with general repairs recommended for tabling, any defective tabling should be replaced and the tabling bedded on dpc with an effective upstand flashing.. | B<br>£1750 | |

| 1.6.1 | Rebed water tabling to north nave pitch | 1750 |

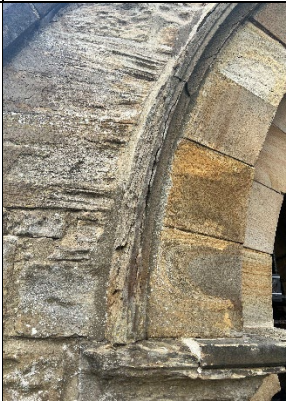
| 3.1.2 | 4 no. hood mould components suffering from significant delamination: not performing properly to shed surface water (as noted in previous QI: unable to comment if any worse) | Consider replacing with new sections to match original mould, or monitor during QI period. | E<br>£1000 | |

| 3.1.2 | Replace damaged sections of hood mould | 1000 |

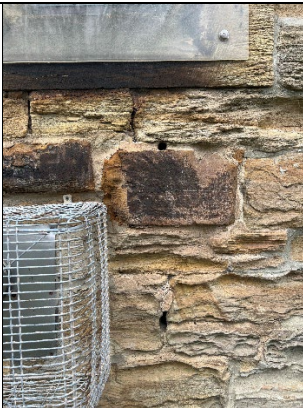
| 3.2.1 | This wall has largely been repointed since the last QI. There are isolated pockets/joints which need further attention.<br>There is minor cracking to stone joints to 4 no. window surrounds. | Cut out joints as necessary and repoint. | C<br>£500 | |

| 3.2.1 | Repoint isolated areas | 500 |

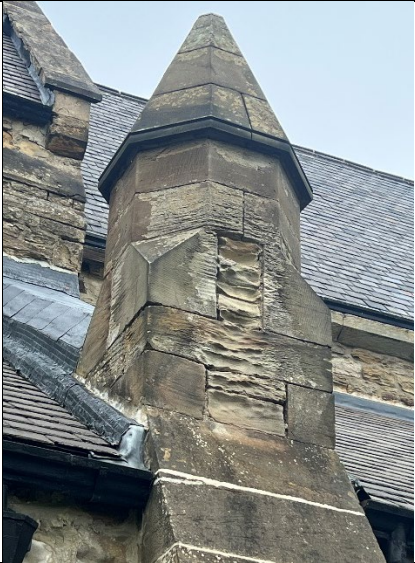
| 3.2.2 | Pinnacle to east buttress has lean joints | Cut out joints and repoint. | D<br>£1000 | |

| 3.2.2 | Repoint pinnacle buttress | 1000 |

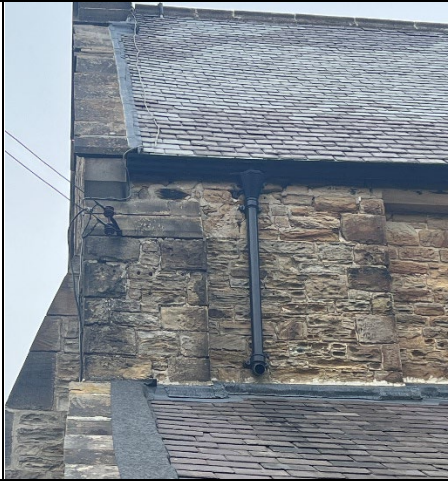
| 3.3.1 | The joints to the west end buttress and adjacent panel appear to be lean particularly to the eaves | Cut out joints and repoint. | D<br>£500 | |

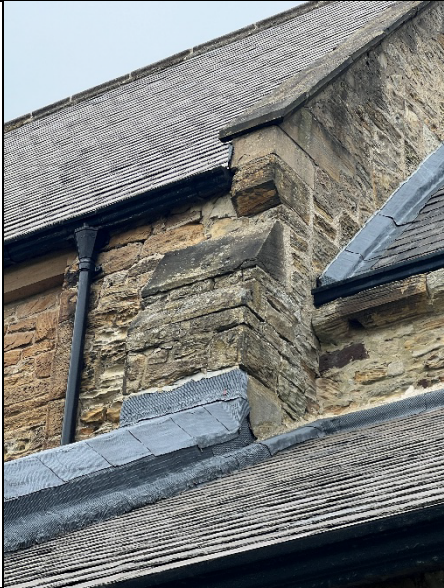
| 3.3.2 | The joints to the east end buttress and adjacent panel appear to be lean. Evidence of mass mortar filling from poor earlier repairs? | Cut out joints and repoint. Include for galletting and/or indenting stonework. | D<br>£500 | |

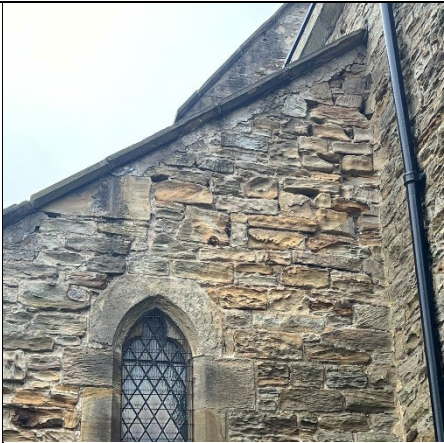
| 3.4.1 | Stonework and pointing in reasonable condition apart from the upper apex to the monopitch wall: deep erosion pockets and very hungry joints. Evidence of poor earlier repairs with mass mortar filling. Minor areas of pointing require attention to lower walling. | Deep tamping to joints required along with building up with replacement stonework at mass mortar filling. | C<br>£500 | |

| 3.4.1 | Repoint east elevation to organ chamber | 500 |

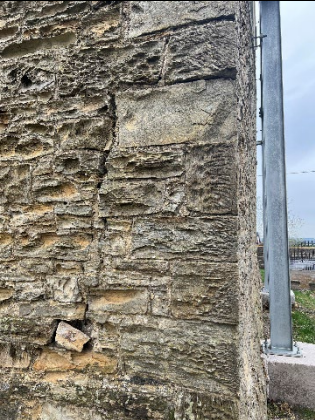
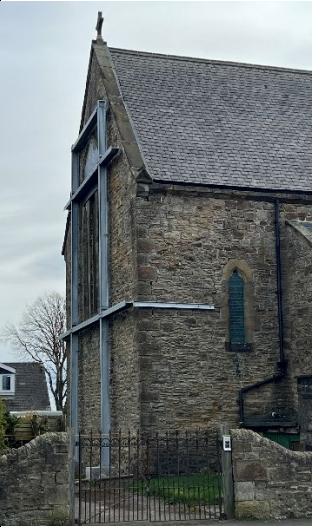
| | <p>The condition of the chancel east gable has caused problems since before the last QI. Apart from the temporary stabilising steel frame supporting the gable virtually no work has been carried out the chancel walls: north, south and east, since the last QI.</p> <p>The upper course of stone to the north aisle eaves shows evidence of displacement, which may be caused by the outward thrust of the roof rafters/wall plate.</p> <p>Some stonework repairs have been carried out since the last QI. This includes for knocking back projecting hard mortar and repointing using a lime mortar. It would appear the work includes indenting stone blocks at particularly deep erosion pockets.</p> <p>It is hoped general stonework repairs can continue in a phased manner. Repairs works to the east chancel gable wall will be significant. It is understandable why no works have been carried out to the adjacent north and south walls of the chancel. All three chancel walls should be repaired under a comprehensive repair scheme. A structural engineer should be appointed to develop a repair scheme in conjunction with an architect.</p> <p>It is noted (and mentioned in the previous QI) there are many minor cracks in the masonry throughout the external walls. Apart from the chancel these appear to be relatively minor and may be little different to that at observed in the last QI. It is advised a structural engineer should be invited to report on the general stability of the church walling to ensure there is no underlying issue.</p> <p>It is recommended a programme of phased masonry repairs is instigated. This will require schedules of work which should be prepared by a conservation architect detailing the scale and location of the repointing and/or indenting. The full repair of the chancel walls should be undertaken. Such work to historic masonry does require the skills of an experienced heritage masonry contractor. A mortar mix for repointing/rebuilding work will need to be agreed, and this should then be used for all other work to ensure a consistency of mortar if the works are undertaken over a period of time. A lime based mortar should be used, and consideration should be given to using a 'hot' mixed lime as these tend to have greater porosity, which aid in the drying out of damp walls.</p> <p>The Bellcote has been repointed since the last QI and appears to be sound.</p> |

| 3.5.1 | <p>A temporary steel frame has been installed since last QI to support the east chancel gable wall.</p> <p>Evidence of movement in gable to north, south and east. (all as noted in previous QI)</p> <p>The stonework generally shows deep erosion pocketing with hard mortar joints standing proud.</p> | <p>A structural engineer and architect should be appointed to develop a comprehensive scheme to stabilise/rebuild the east gable.</p> <p>Retained walling will require general repointing and indenting stonework to any deep erosion pockets.</p> | <p>C<br/>£250,000<br/>inclusive</p> | |

| 3.5.1 | Comprehensive rebuilding of east/north/south chancel walling | 250,000 |

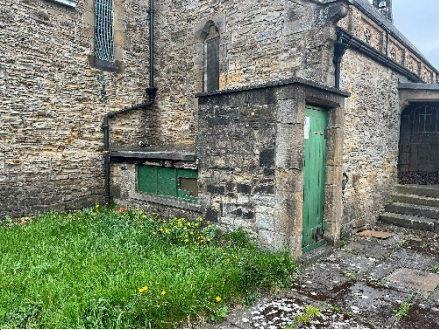
| 3.6.1 | <p>Pointing to vestry gable generally satisfactory apart from isolated minor lean pointing and weak/mass mortar beneath the watertabling.</p> <p>The undercroft stair is enclosed with walling and flat roof (relatively modern).</p> <p>The low level window is blocked with timber boarding, in poor condition. It appears to be in no worse a condition since the previous QI.</p> <p>The roof is finished in mineral felt</p> | <p>Repoint vestry gable using a lime mortar including for galletting to make up for mass mortar.</p><br><p>Repair the timber boarding to window opening.</p><br><p>Monitor the condition of the felt roof.</p> | <p>D<br/>£100</p><br><p>C<br/>£100</p><br><p>DIY</p> | |

| 3.6.1 | Repair blocked opening to undercroft window | 100 |

| 3.6.1 | Repoint east vestry wall | 100 |

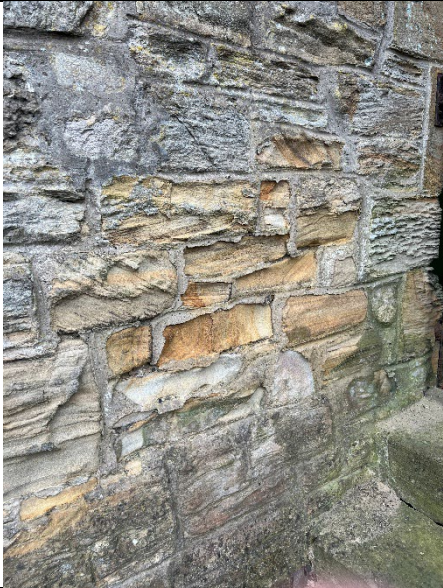
| 3.7.1 | <p>Some minor cracking.</p> <p>Pointing generally satisfactory apart from an area of eroded stone facing.</p> | Repoint locally. | <p>B<br/>£400</p> | |

| 3.7.1 | Isolated areas of repointing to the north vestry wall | 400 |

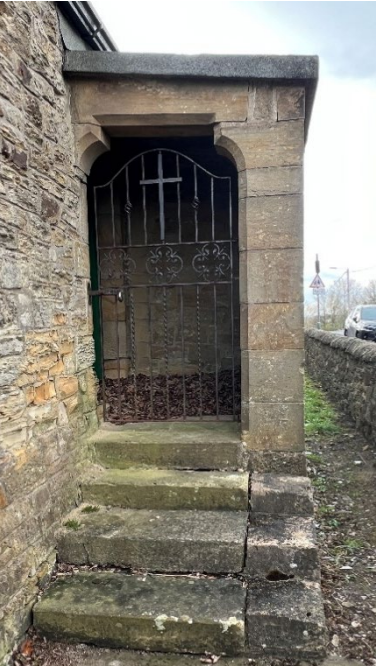
| 3.8.1 | The door lintol is displaced to the flanking corbel jambs, though no sign of settlement.<br>The external steps show signs of movement | Monitor.<br><br>Repoint the external steps | B<br>£150 | |

| 3.8.1 | Repoint external steps to north porch | 150 |

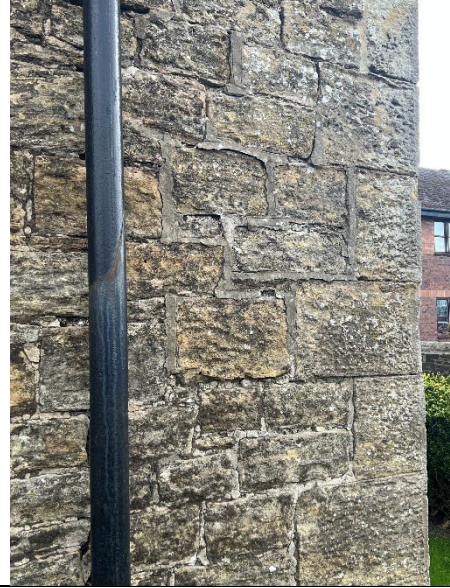
| 3.9.1 | <p>The stonework and general pointing is relatively sound (probably due to being constructed using a more durable stone).</p> <p>Isolated areas of pointing required, particularly at the west end with hard pointing almost falling out.</p> | Rake out joints and repoint | <p>D</p> <p>£300</p> | |

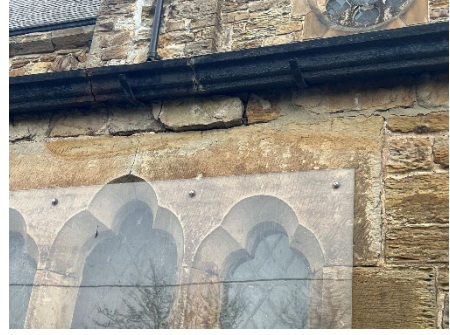
| 3.9.3 | Evidence of displaced stone to the eaves course, possibly caused by thrust from roof structure. | Investigate and pin back any displaced stones and repoint. | <p>B</p> <p>£500</p> | |

| 3.9.3 | Stabilise loose stonework to north aisle eaves | 500 |

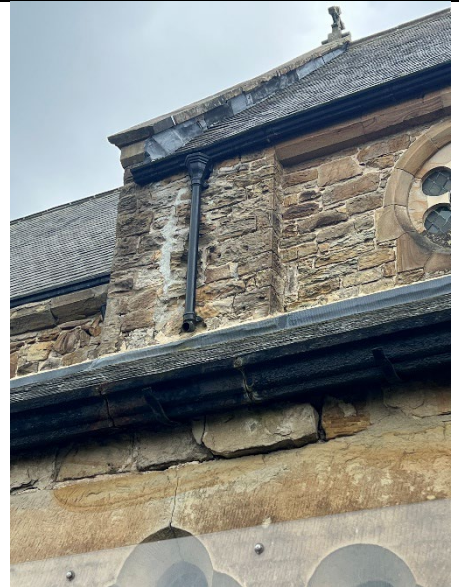
| 3.10.1 | Isolated areas of lean joints, particularly to pier at east end | Repoint stonework | D<br>£500 | |

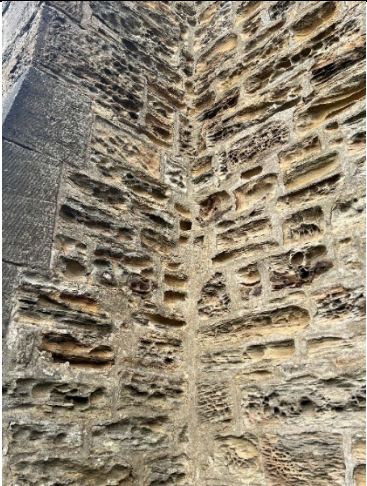
| 3.12.1 | <p>Apart from the bell cote (which has been repointed), no further works have been carried out since the last QI.</p> <p>The stonework generally is suffering from significant erosion and sanding, with hard mortar pointing standing proud.</p> | Investigate high level condition and prepare a scheme for breaking back hard mortar pointing, repointing and indenting in locations of deep erosion pockets. | <b>C</b><br><b>£12,000</b><br><b>inclusive</b> | |

| 3.12.1 | Repoint west elevation to nave | 12,000 |

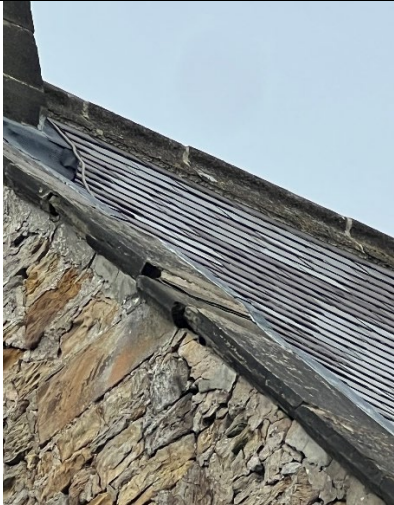
| 3.12.3 | <p>The north watertables are sound except 1 no which has a broken edge, but should be retained.</p> <p>The south watertables are sound apart from 1 no which is out of alignment to the others</p> | In association with general repairs recommended for tabling, any defective tabling should be replaced and the tabling rebbed on dpc with an effective upstand flashing.. | <b>B</b><br><b>£1750</b> | |

| 3.12.3 | Rebed water tabling to east end gable to west nave elevation | 1750 |

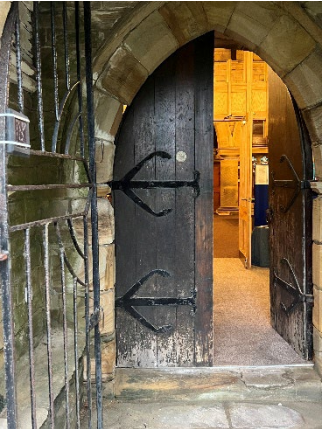
| 4.1.1 | Main entrance door:<br>Appears sound though needs redecorating.<br>Wrought iron gates need redecorating | Redecorate the church door and the lobby gates | C<br><b>£250</b> | |

| 4.1.1 | Redecorate entrance door | 250 |

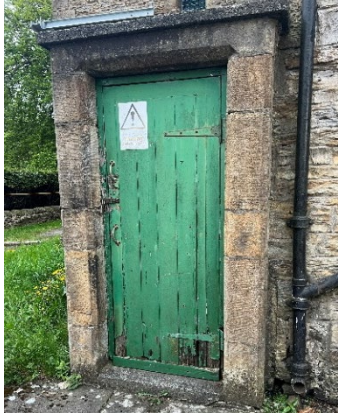
| 4.1.2 | The Undercroft door and frame are rotten | Replace the door and frame. | A<br>£400 | |

| 4.1.2 | Replace undercroft door and frame | 400 |

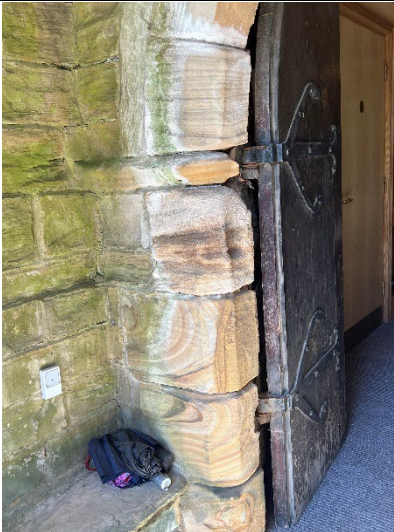
| | Exposed stone flagged floor. Open white painted boarded roof. The previous QI noted the internal stonework had been pointed with a hard mortar which was standing proud. There was significant weathering to the stonework surface. This was particularly noticeable with voids to the closed door leaf leaving gaps. Salt effervescence was also evident. There were isolated open joints to the stone flags. It was noted that whilst a temporary ramp was available a more permanent level access solution should be explored. The current QI reports the porch is in similar condition as reported in the previous QI summarised above. | Repoint internal stonework.<br><br>Repoint stone flags.<br><br>Explore options to provide level access into the church. | C<br>£100<br><br>B<br>£50<br><br>E<br>£1250 | |

| 5.1.0 | Repoint lobby flags | 50 |
| 5.1.0 | Repoint internal stonework to lobby | 100 |

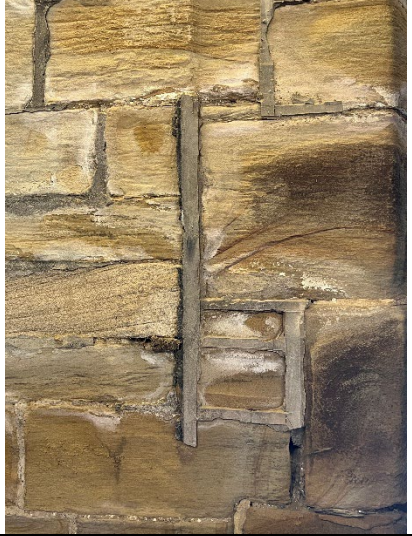
| 6.1.0 | <p>Formed with new timber/glazed screens to east and north. Carpeted floor.</p> <p>The previous QI noted daylight around the external door (as previous note above) with salt effervescence in the door reveal. There are remains of hard strap pointing and the stone face is sanding.</p> <p>Significant sanding to walls in utility cupboard.</p> <p>The current QI reports the inner porch is in similar condition as reported in the previous QI summarised above.</p> | <p>Remove the strap pointing, brush back sanding stone and repoint in isolated areas.</p> <p>Consider replacing the door jamb stones. (see 5.1.0 above)</p> | <p>C</p> <p>£150</p> | |

| 6.1.0 | Repoint at 'strap pointing to inner lobby | 150 |

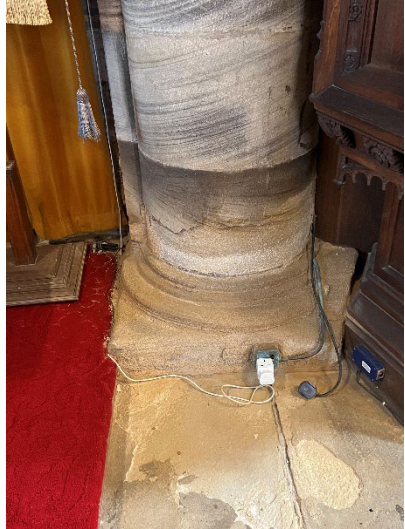
| 8.1.1 | Previous QI reported: indications of cracking in the north west corner, and sanding to base of columns particularly the east end column. The same issues were noted in this QI. | It is recommended a structural engineer is appointed to investigate the minor cracking throughout the church. Brush back the loose surface to stonework. | DIY | |

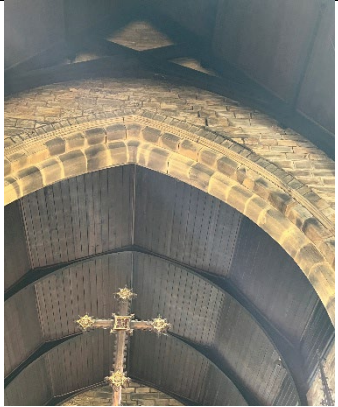
| 8.2.1 | <p>Previous QI reported: cracking noted in a number of areas including right hand side and over Chancel arch, with cracking to the left side of the arch.</p> <p>The same issues were noted in this QI</p> | <p>It is recommended a structural engineer is appointed to investigate the minor cracking throughout the church.</p> <p>Repoint open joints using lime mortar.</p> | <p>C<br/>£3500<br/>inclusive</p> | |

| 8.2.1 | Repoint to nave chancel arch | 3500 |

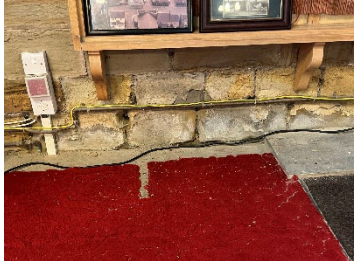
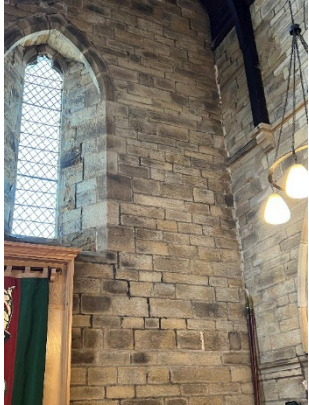
| 8.4.1 | <p>Previous QI reported significant sanding particularly to the base of the wall with associated lean pointing, along with suspected movement cracks.</p> <p>As with previous QI some 'black' pointing may be exaggerating the issue.</p> | <p>It is recommended a structural engineer is appointed to investigate the minor cracking throughout the church.</p> <p>Brush back the loose sanding and repoint stonework with a lime mortar.</p> | <p>C<br/>£12,000<br/>Inc scaffolding</p> | |

| 8.4.1 | Repoint the internal nave west wall | 12,000 |

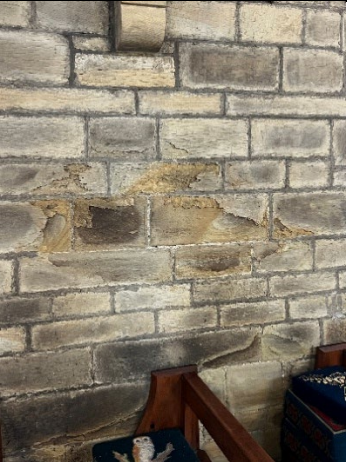
| 8.5.1 | <p>Evidence of isolated areas of sanding midway to south wall.</p> <p>Cracking to stonework in left hand reveal of western window.</p> <p>Cracking in reveals to second window from east repointed since last QI, leaving gap at head to complete.</p> <p>Cracking evident below eastern window.</p> <p>Dislodged stones above heaters (from installation of balanced flues?)</p> <p>There are 2 no flags with broken corners which may be trip hazards.</p> | <p>Brush back loose sanding.</p> <p>Repoint in window reveals.</p> <p>Rebed loose stones above heaters.</p><br><p>Rebed damaged/loose flags.</p> | <p>C<br/>£250</p><br><p>A<br/>£100</p> | |

| 8.5.1 | Rebed damaged uneven flags in south aisle | 100 |

| 8.5.1 | Repoint isolated areas of internal south aisle wall | 250 |

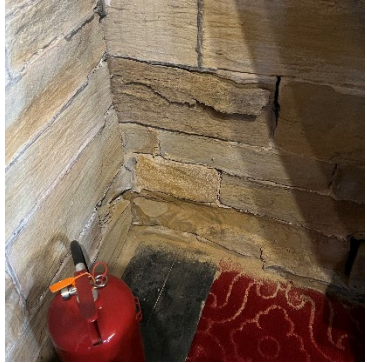
| | <p>Evidence of poor repointing to second window from east.<br/>Lean joints to right hand reveal to middle window.<br/>Sanding to upstand in east window.<br/>As with the previous QI: significant sanding to the east wall behind the fabric hanging, with cracking noted at higher level.</p> | <p>It is recommended a structural engineer is appointed to investigate the minor cracking throughout the church.</p> <p>Replace recent pointing with a lime mortar, along with repointing to window reveals and the east wall.</p> | <p>C<br/>£2500<br/>inclusive</p> | |

| 8.6.0 | Repoint internal east wall to north aisle | 2,500 |

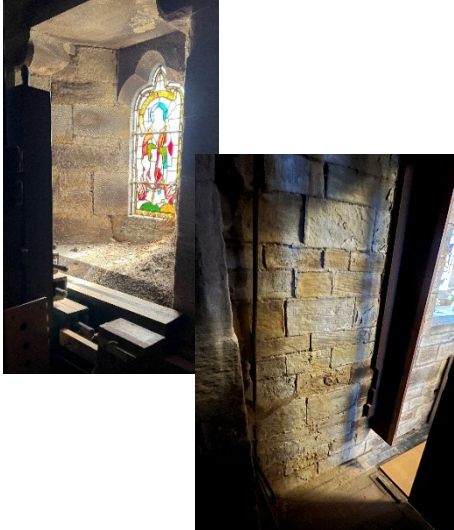
| 8.7.1 | <p>Significant build up of sanding debris in the window reveal. Evidence of movement crack in external walling.</p> | <p>It is recommended a structural engineer is appointed to investigate the minor cracking throughout the church.</p> <p>Brush off any loose material and remove the build up of sanding debris.</p> <p>Repoint to movement crack.</p> | <p>DIY</p> <p>C<br/>£250</p> | |

| 8.7.1 | Remove debris in organ chamber and repoint to crack in south wall | 250 |

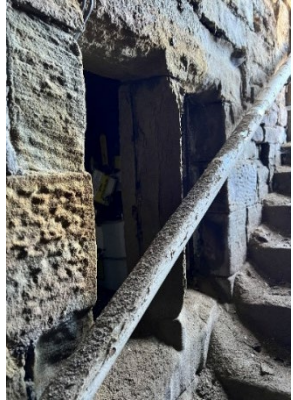
| | The undercroft is accessed via an original stone stairway. The stair was originally open to the elements, but subsequently covered in with a timber roof with felt finish. As the church now has gas heaters the undercroft is redundant other than housing the gas meter. The stone steps and walling are suffering from significant shaling. The existing 'window' opening has a central mullion which is has deteriorated and is now in danger of collapse. | Clear away heavy build up of sanding debris.<br>Check the handrail is firmly secured and if necessary make it so.<br><br>Consider remedial works to the defective mullion: replace mullion, block up opening to support the lintol. Consider relocating the gas meter. | DIY<br><br>A<br>£50<br><br>A<br>£500 | |

| 10.0.0 | Secure handrail in undercroft | 50 |
| 10.0.0 | Remedial works to failing mullion in undercroft | 500 |

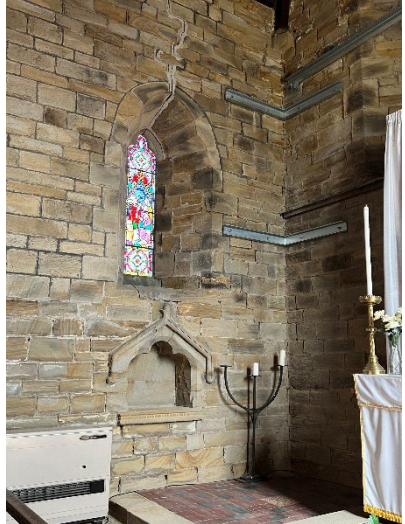
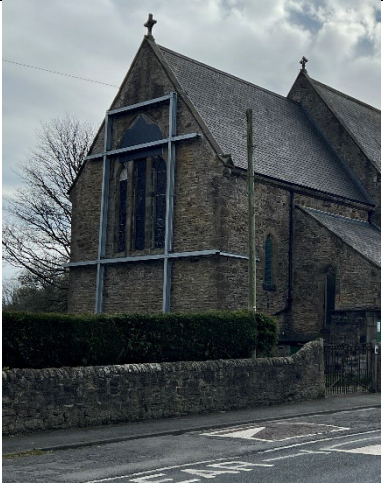
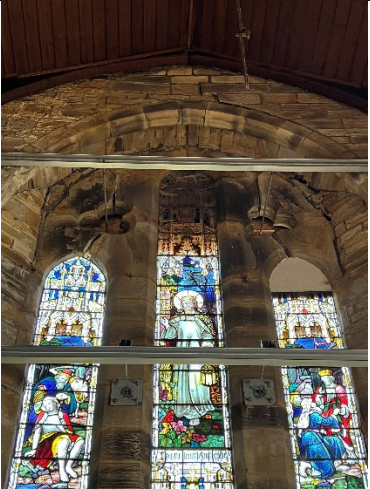
| 11.1.0 | <p>As reported in the previous QI there is significant movement evident with cracks in the masonry to the north, east and south walls. Since the last QI an external temporary steel support frame has been installed. There is evidence of areas of sanding to the stonework and lean pointing.</p> <p>There a number of cracked tiles to the floor.</p> | <p>It is recommended a structural engineer is appointed to investigate the movement in the chancel walling. The engineer and architect to prepare a scheme for the stabilisation/rebuilding of the walling, along with the repointing to any retained masonry.</p> <p>Relay loose floor tiles.</p> | <p>See 3.5.1 above</p> <p>A<br/>£150</p> | |

| 11.1.0 | Repair chancel floor tiles | 150 |

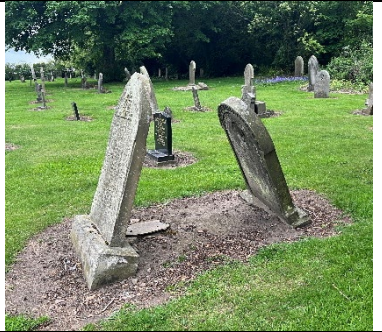
| | There are a large number of gravestones which are leaning precariously and present a health and safety issue. | | | |

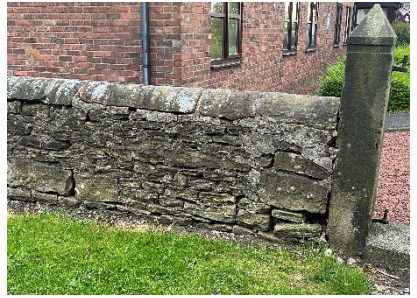
| | The west boundary wall requires attention/repointing. | | | |
