QUINQUENNIAL INSPECTION REPORT

CHURCH OF ST. MARY MAGDALENE
MANOR ROAD, MEDOMSLEY VILLAGE, DH8 6QN

Michael Atkinson Architecture + Heritage

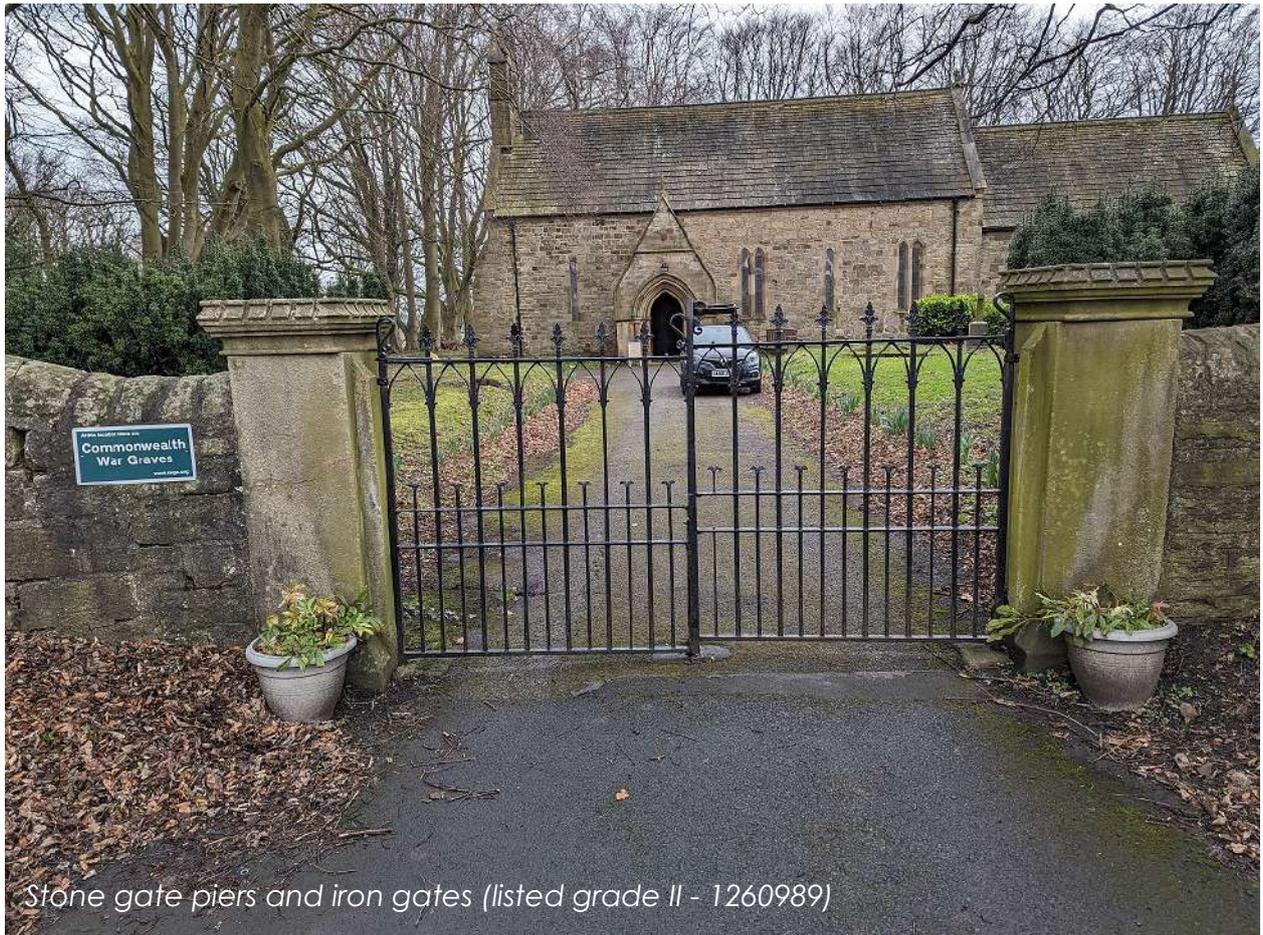
Stone gate piers and iron gates (listed grade II - 1260989)

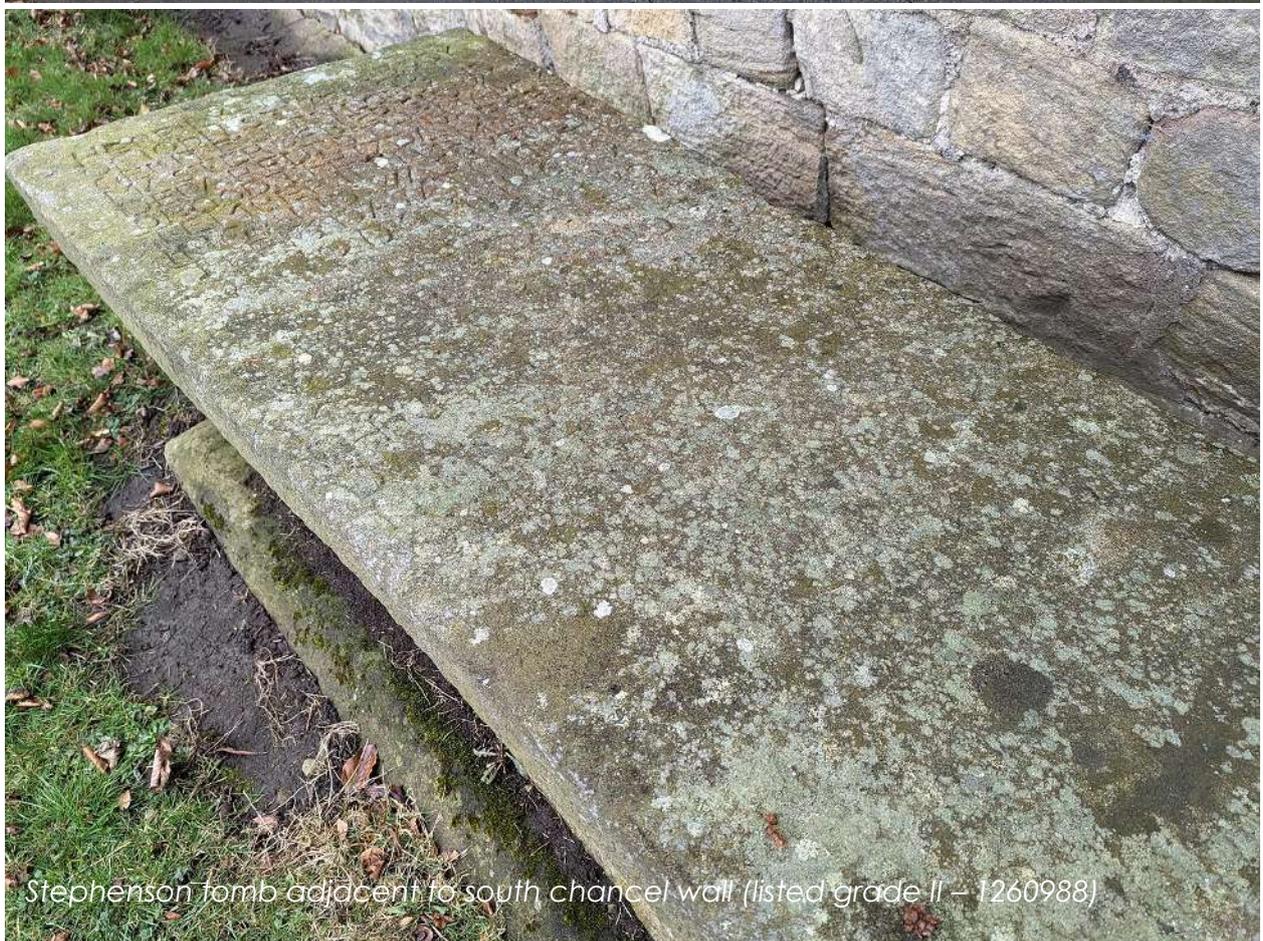
Stephenson tomb adjacent to south chancel wall (listed grade II - 1260988)
