St. Mary Magdalene Church, Millfield,
Bishopwearmouth

Diocese of Durham
Archdeaconry of Sunderland
Deanery of Wearmouth

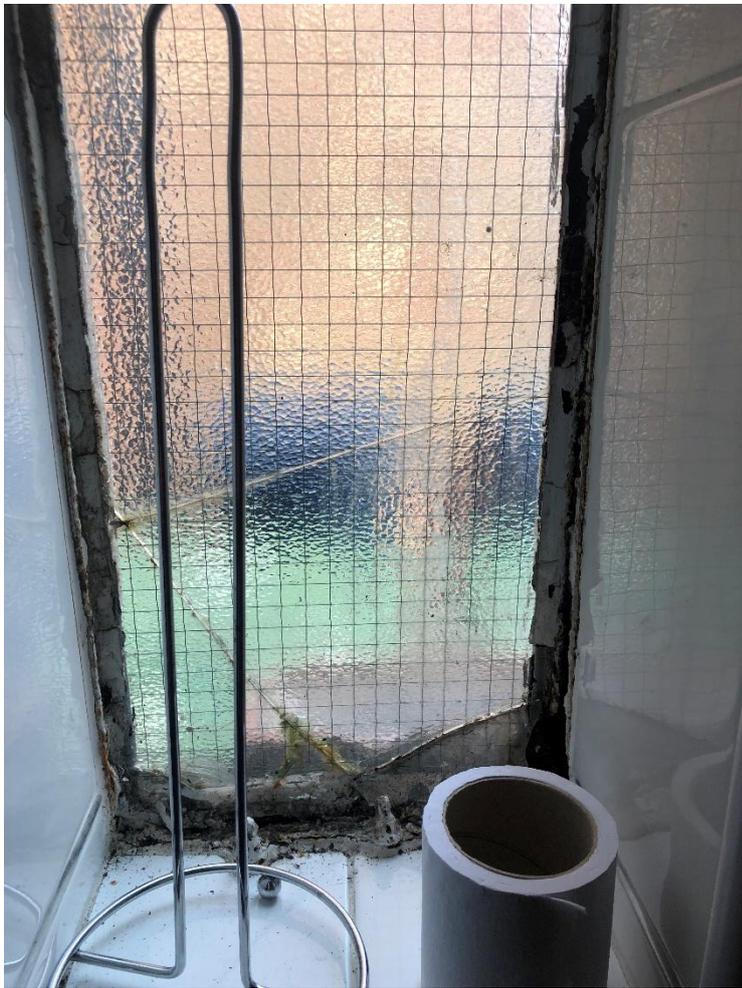
P7 (1104):
Metal window deterioration: Vestry WC

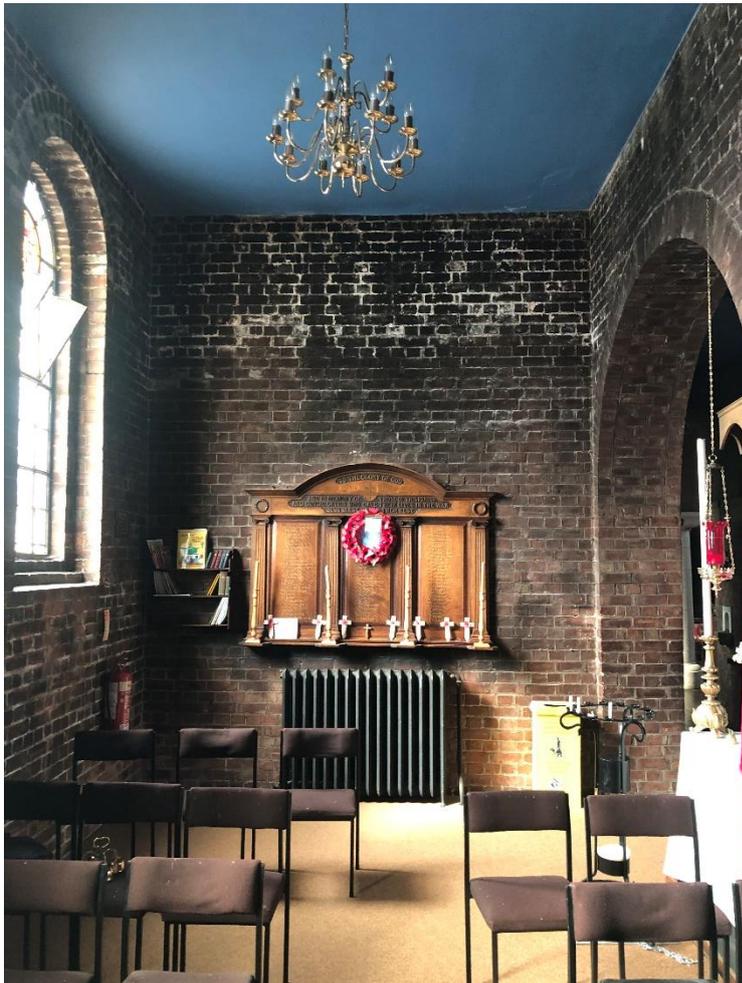
P8 (1111):
High level salts in brickwork
southern chapel, west end

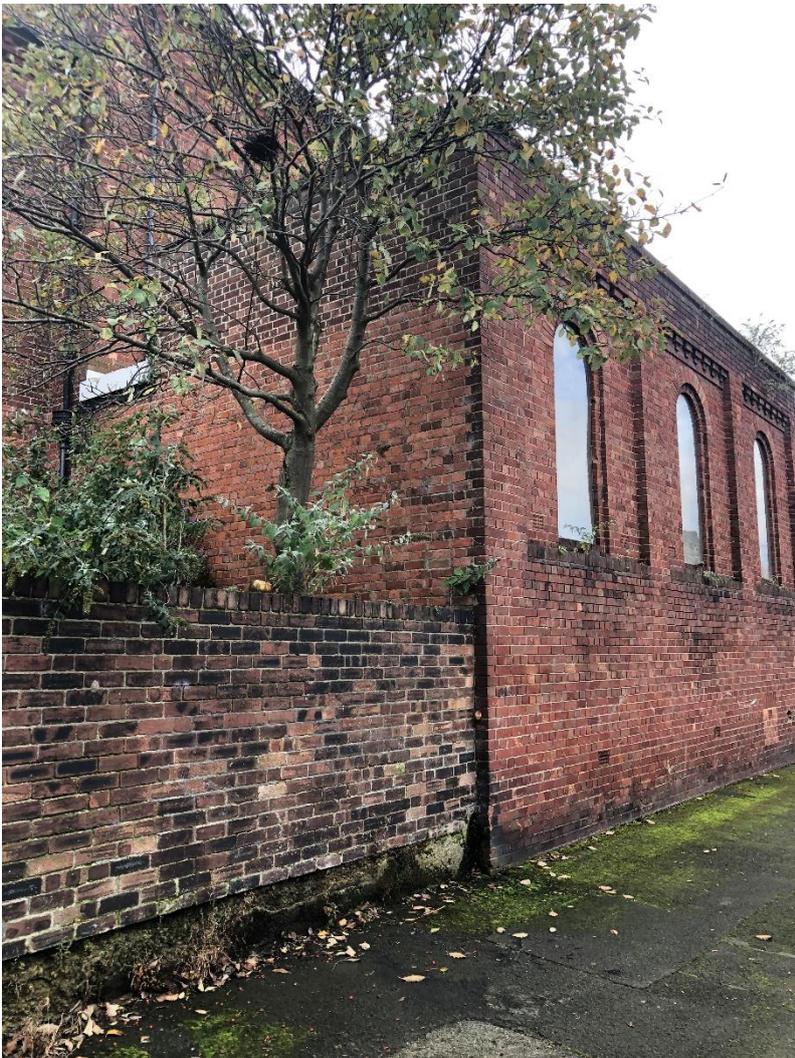
P17 (3208):
Vicarage garden: tree in close proximity to southern aisle, and deteriorated concrete foundation to Vicarage wall

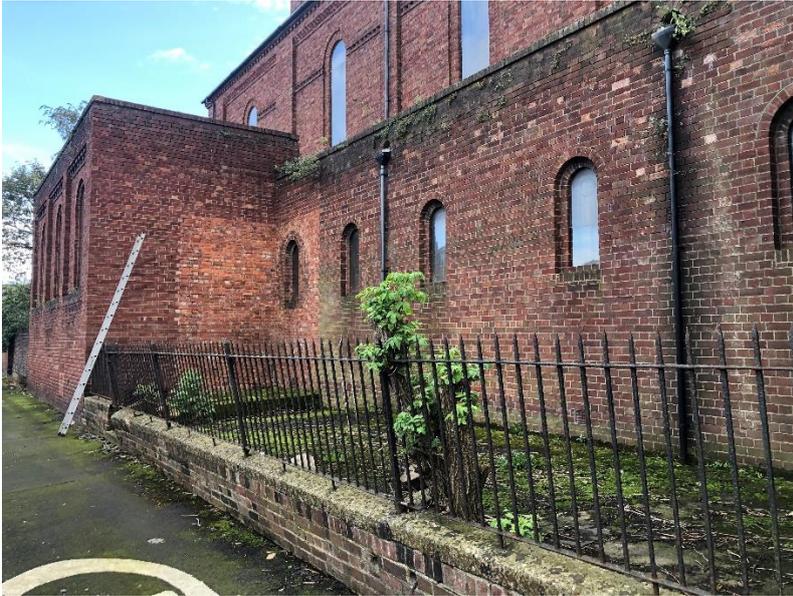
P18 (3201):
Part view, north elevation,
showing perimeter fencing
movement from vertical and
pruned shrubbery; also buddleia/
vegetation to uncapped parapet

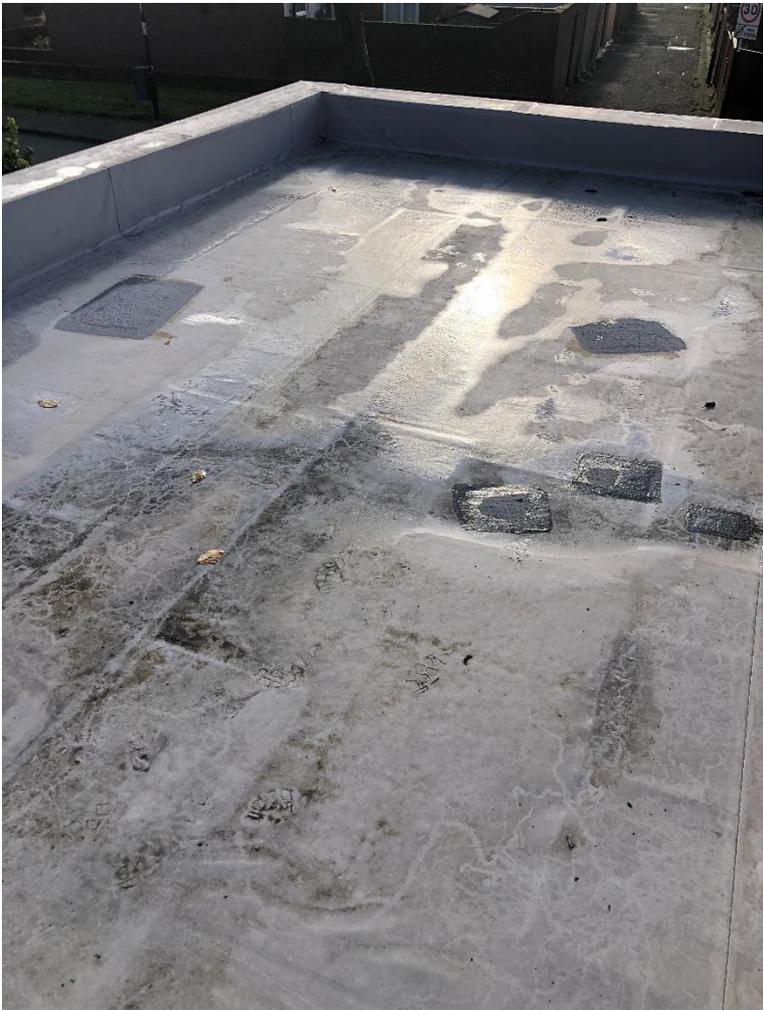
P20 (3168):
Patch repairs to Sarnafil flat roof
covering

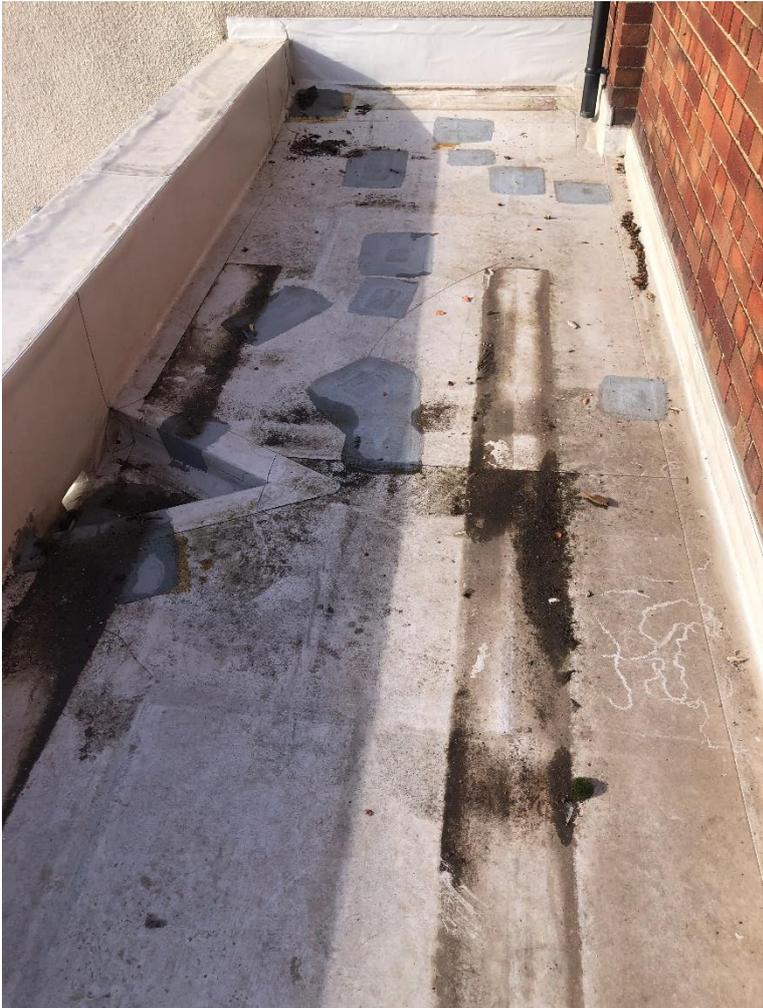
P21 (3168):
Additional area of patch repairs to
Sarnafil flat roof covering

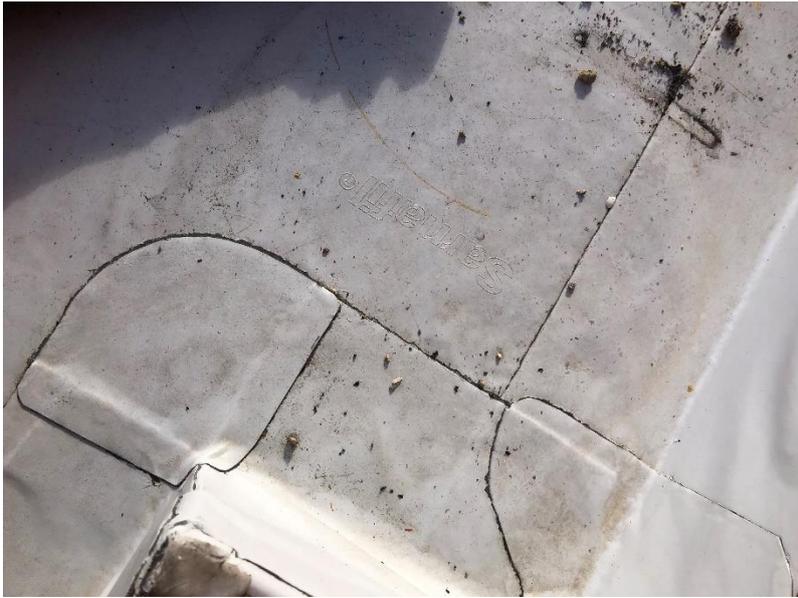
P22 (3179):
Details of material (Sarnafil)
identification
