Diocese of Durham  
Quinquennial Inspection Report  
October 2025  
St Catherine's Church  
New Brancepeth

Inspection of Churches Measure 1955

Inspected 15<sup>th</sup> October 2025

L Pratt BA (Hons), MArch RIBA Advanced Dip PPA

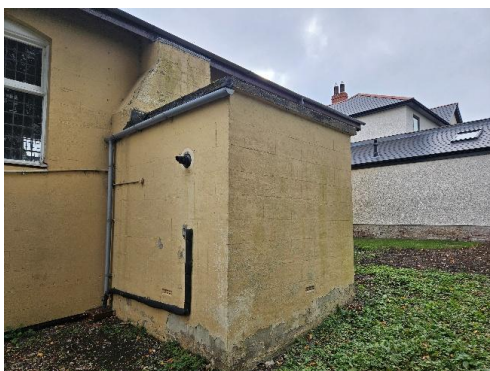
- 5.10 The boiler room is an extension off the main building to the west side. This has a mineral felt, uninsulated, flat roof. *photo*
- 5.11 The previous QI reports that this was probably coming towards the end of its lifespan but was in a sound condition with no signs of leaking. That is still the case.

- The condition/performance of this should be monitored over the course of this next quinquennium. The Church Architect should be consulted on any plans to replace this, so improvements can be considered. 3

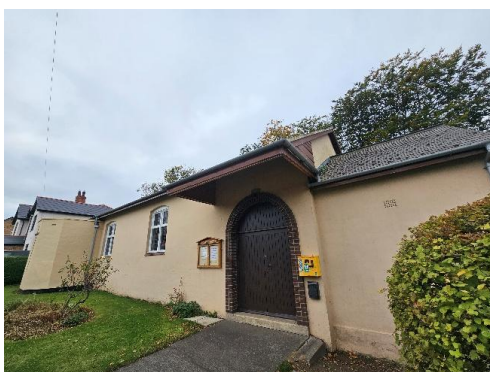
- 7.2 Externally, the rendered finish is not in good condition with cracking and blown areas. There is evidence of patch repairs and paint touch-ups.
- The frontage appears tidy on approach and is in the best condition; the decorated finish is reasonable considering the substrate. The reported works to the Organ Chamber facades, in the last quinquennial period, are evident; and the render stops short of ground level, as is advised. *photo*

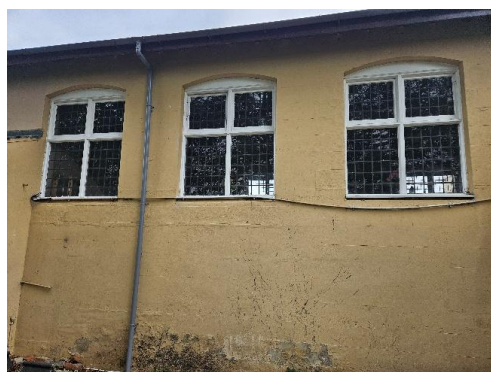
7.2

- The rear is in the worst condition; the extents of the adjacent tree canopy and its shading are probably to blame. Improvements have been made in this past quinquennium period, particularly with the removal of the vegetation/leaf litter against the façade. *photo*

- b) The render is not of a breathable specification; any moisture trapped in the brickwork is unable to dry out quickly.
- 7.5 The trapped moisture will account for the evident cracking and blown render across the façade, particularly that at low level.

- 7.8 The PCC should continue, as they are doing, to manage the damp issues. The long-term solution is to hack off the external render and replace with a breathable specific render that stops short of ground level, circa. 150mm, when funds permit. Although this would be a significant investment, it would eradicate the ongoing costs and time associated with maintaining the current state. 4

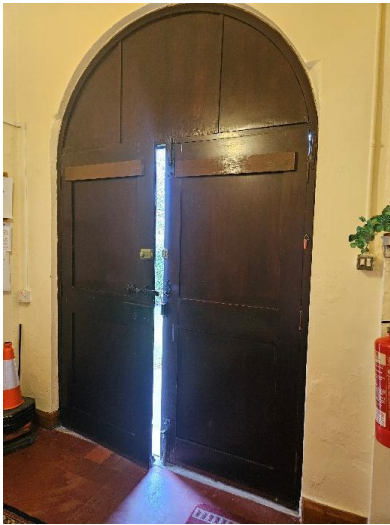
9.1

The doors have been decorated in this quinquennial period; whilst the finish of this is still ok, I think further redecoration will be required in the next quinquennium period. Monitor condition, particularly cills and low-level timbers for rot. 3

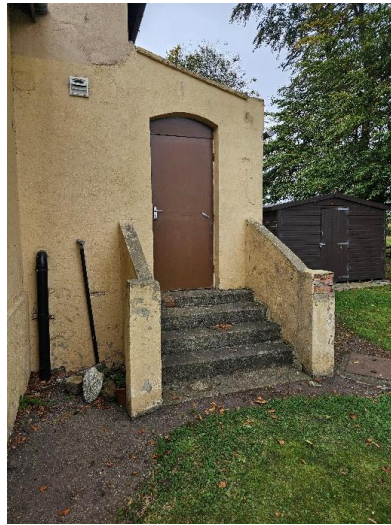
9.2

External ply face is rotting at the bottom as there is no cill. Door is rarely used and serves its purpose. Consider replacement when funds permit; particularly if this starts to present as a security issue. 3

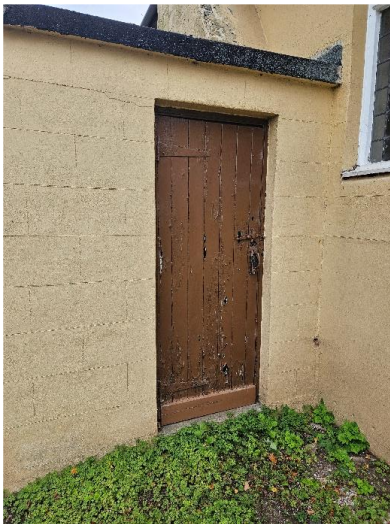
9.3

Door is in a poor state. Probably beyond reasonable repair but arguably, door is rarely used and serves its purpose. Consider replacement when funds permit. 3

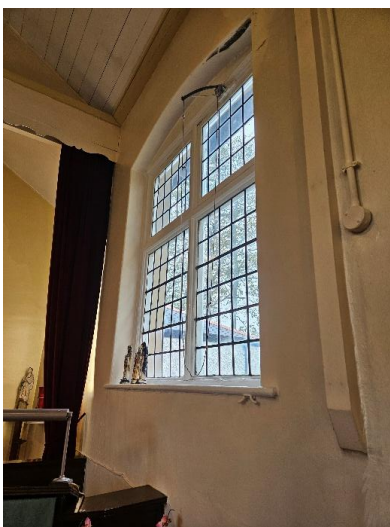
- 10.3 The window adjacent to the Pulpit has more significant defects. The lower glass panes are buckling, and the plaster is failing at the window head. These defects suggest movement in the window or surrounding structure, but were referenced in the previous QI report so are not products of a 'new' issue; perhaps remnants of the historic water ingress issues? *photo*

- Monitor movement/condition over this quinquennial period to ensure cause has ceased and discuss/consider necessary repairs with the Church Architect. 3

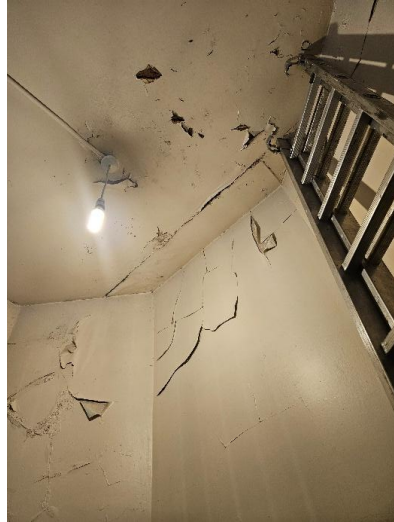
12.7 The Organ Chamber is also in a poor state. Again, the cause has likely been remediated with the recent repair/refurbishment works. *photo*

It is recommended that the wall be rubbed down/cleaned and all of the loose plaster/paint removed. That way, in a period of monitoring, any further defects can be more accurately observed. 2

Discuss/consider necessary repairs with the Church Architect. 3

It is also recommended that this area be kept as clear as possible to allow air to circulate, and the Church fabric and Organ to aerate.

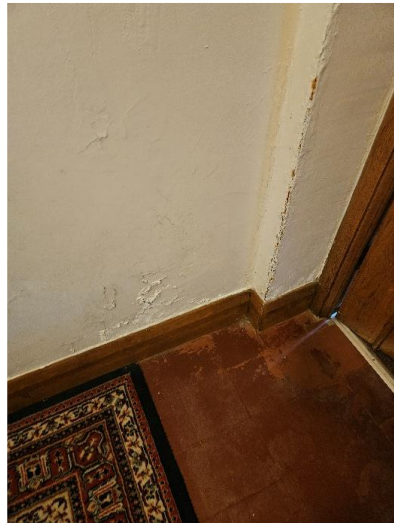
- 12.14 Floors –  
The main entrance lobby is 1no. step up from the outside, then level through with the main body of the Church. The flooring is square terracotta quarry tiles in generally good order. Trapped moisture in the floor would seem to be affecting the tile finish (or they may have been painted?) *photo*

- Their condition should be monitored over the next quinquennium. Lifting the entrance mat periodically would also assist in allowing the floor to airate. 3

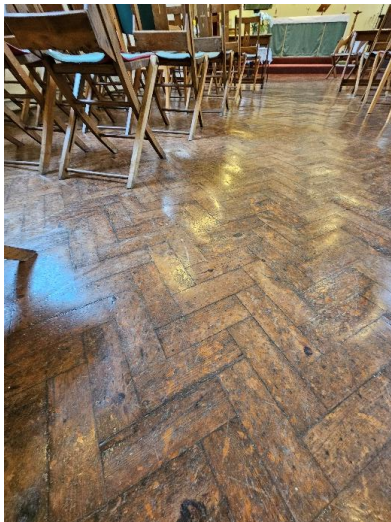
- 12.15 The flooring to the main body of the Church is timber parquet, and I would suggest it is the original; it has a varnished finish. The flooring is understandably worn but is, overall, in excellent condition. *photo*

Some areas do have loose or sunken planks which could be repaired; their condition should be monitored to ensure they do not present as a trip hazard.

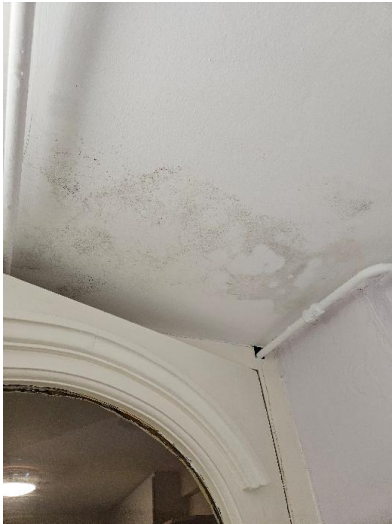
14.5 There is evidence of surface damp and mould in this lean-to extension, which is likely caused by construction/environmental condensation. Enabling the window to open and/or installing a mechanical extract unit will help ventilate this space and mitigate the issue. *photo*

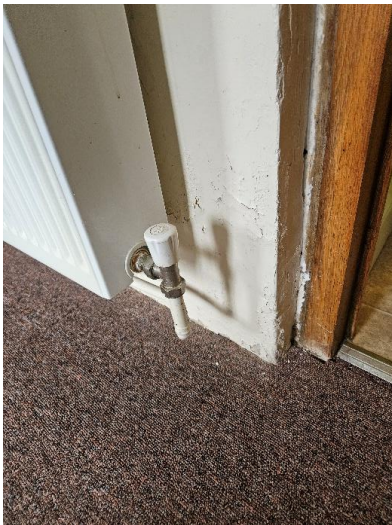
- 16.5 There is an area of damp beneath/behind the radiator that has caused the paint/plaster to blister and flake. This is reported in the previous QI and is therefore not a 'new' issue; this was formerly an external wall and could still have retained moisture. More likely, this is rising damp with no un-invasive solution. There is a similar problem in the porch, to the same wall, suggesting there is a consolidated issue. *photo*

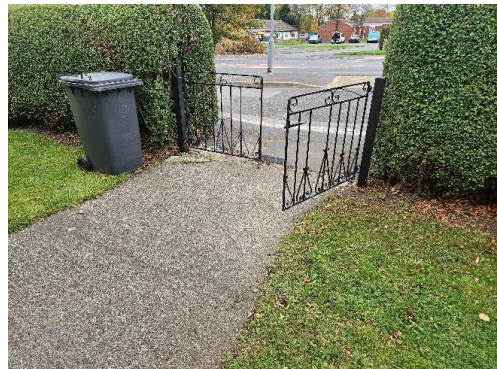
23.3  
23.4

- 23.3 The main entrance gate is a 2no. leaf metal gate, painted black. It has recently had its posts replaced (2025) and the gate hinges repaired. There is a similar gate towards the southern boundary which gives direct access to the rear of the building. *photo*

- 23.4 At the entrance gate, the tarmac of the footpath, and where it meets the concrete pathway to the Church, is patchy and broken up; there is evidence of some tarmac repair. The condition of this should be monitored as it could present as a trip hazard. *photo*  
3

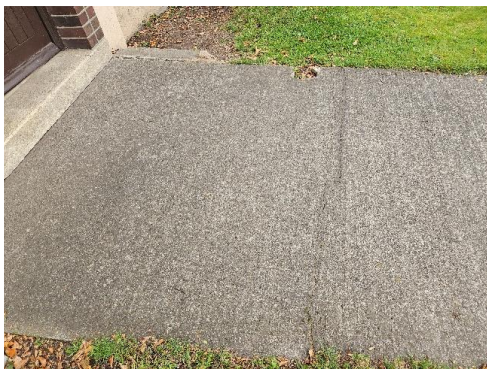
- 23.5 Cracking in the concrete pathway to the Church is to be monitored, as it could present as a trip hazard if the condition worsens. *photo*  
3
- 23.6 The northern boundary is defined by a low brick wall and timber outbuildings to the neighbouring property. The facing bricks and pointing are failing. It is likely that this is a Party Wall. It is recommended that the condition be brought to the neighbours' attention, so a plan for repair can be discussed. Repairs should be undertaken before the structural integrity of the wall is compromised. *photo*  
3

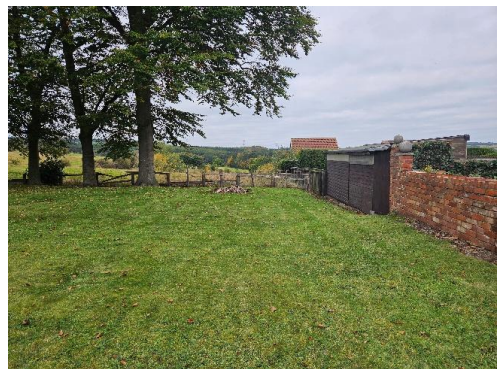
23.6  
23.7

- 23.7 The western boundary is defined by adhoc field fencing, mostly comprising timber and wire. It would be aesthetically beneficial if it was replaced but, again, this is likely to be a Party Fence; discussion with the adjacent landowner would be required. *photo*  
3

| xL) | The northern boundary is defined by a low brick wall and timber outbuildings to the neighbouring property. The facing bricks and pointing are failing. It is likely that this is a Party Wall. It is recommended that the condition be brought to the neighbours' | 23.6 |
