**Quinquennial Inspection Report  
Church of St Cuthbert, Redhouse, Sunderland  
North Wearside Parish  
Diocese of Durham**

10 June 2026

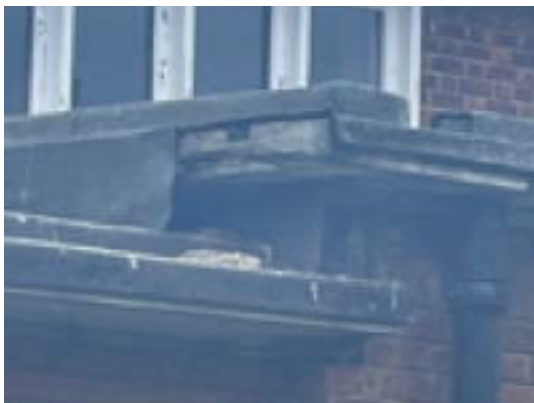
**Missing Felt and Spalled Concrete to Choir Vestry/Meeting Room Roof**

There are multiple areas of patching to the church copper felted roof in black felt. The ancillary flat roofs cannot be seen from ground level. The Hall roof is in reasonable condition with a single displaced slate to the east elevation.

Undertake full inspection of felted roofs and flashings by a reputable roofing company and implement recommendations. Cost Band 2– £2,000.00-£9,999.

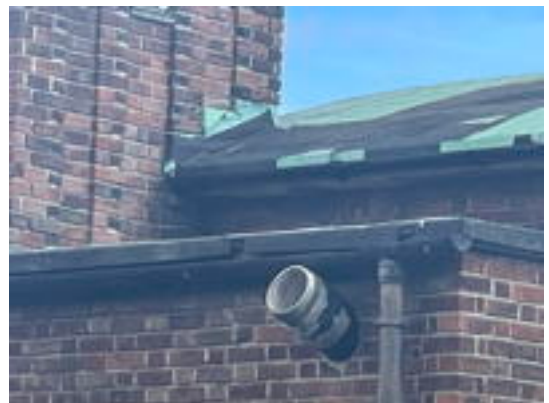
**Missing Felt to Organ Loft Roof**

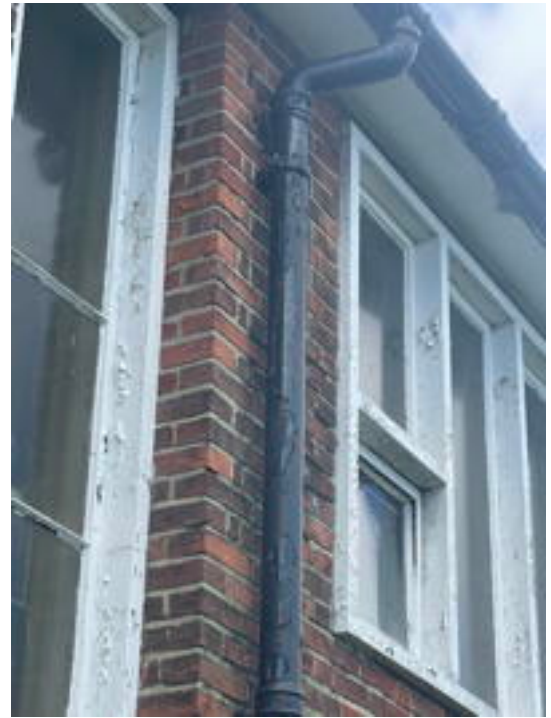
**North Elevation Ranwater Pipe**

It was not possible to tell if everything is fully watertight as it was dry at the time of the inspection. The north elevation gutter needs resealing. There may be an issue with the North Porch hopper head which show signs of leakage.

Attend to leaking sections of gutter and hopper head. Cost Band 1–£0.00-£1,999.

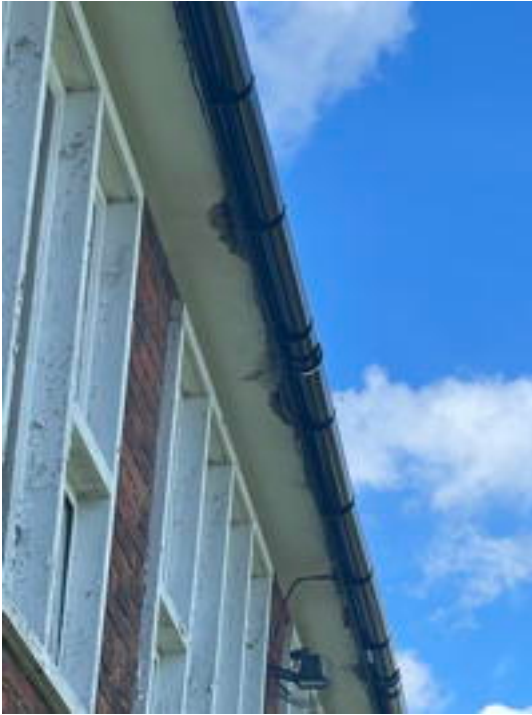
**North Elevation Spalling Concrete at Eaves**

Spirelet appears generally sound and in good condition when viewed from ground level. The tower capping has areas of spalling concrete which have worsened since the last quinquennial. Similarly, the church eaves and meeting room eaves. The timber eaves facias and verges to the hall and link lobby require redecoration.

Arrange specialist survey of spalling concrete eaves to church, tower and ancillary south roofs to advise on remedial works and future costs. Cost Band 1–£0.00-£1,999.

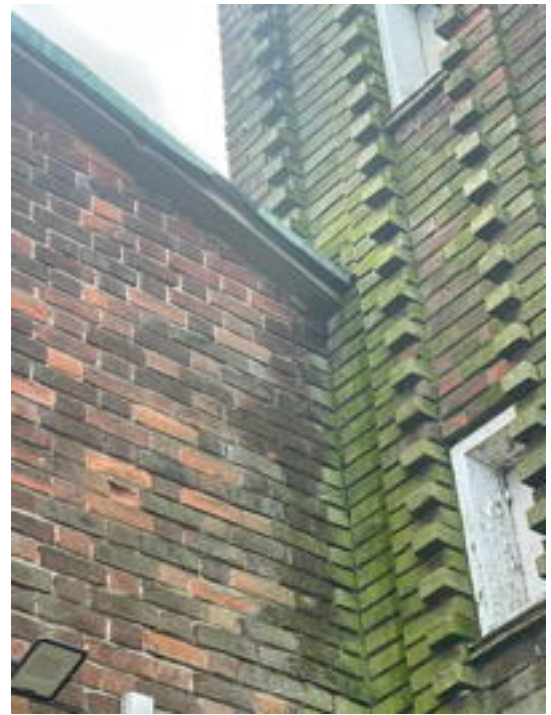
**West Elevation Spalling Concrete at Eaves**

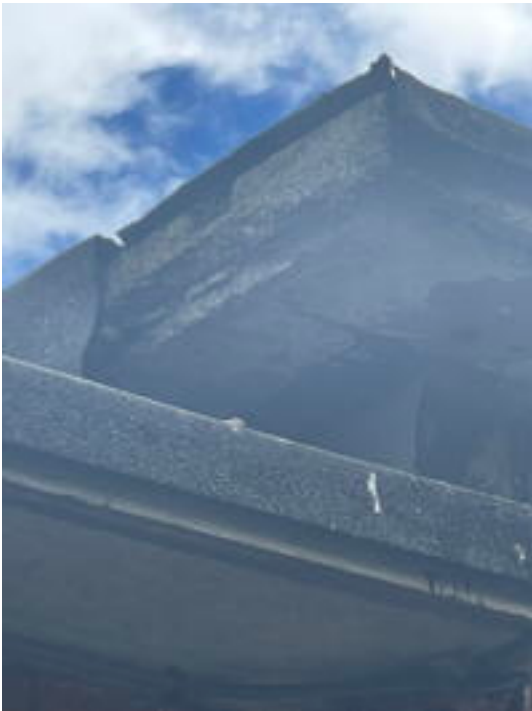
**Choir Vestry/ Meeting Room  
Spalling Concrete at South West  
Corner**

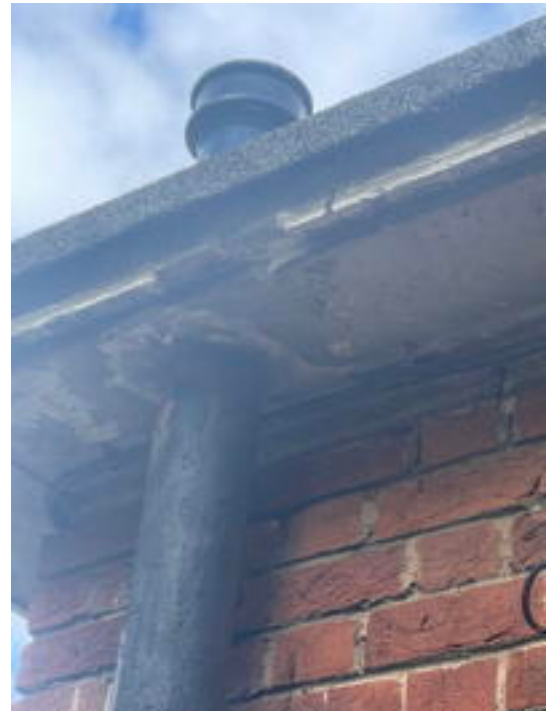
**Choir Vestry/ Meeting Room  
Spalling Concrete South Elevation**

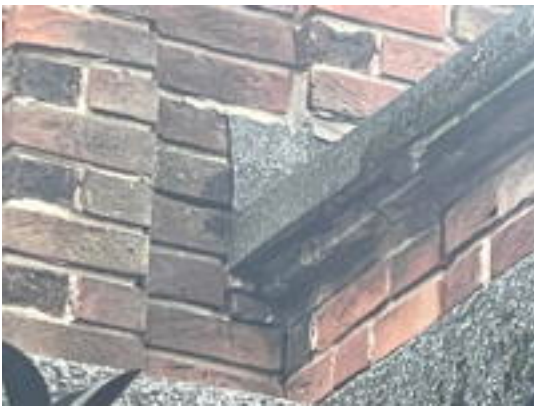
**Choir Vestry/ Meeting Room  
Spalling Concrete West Elevation**

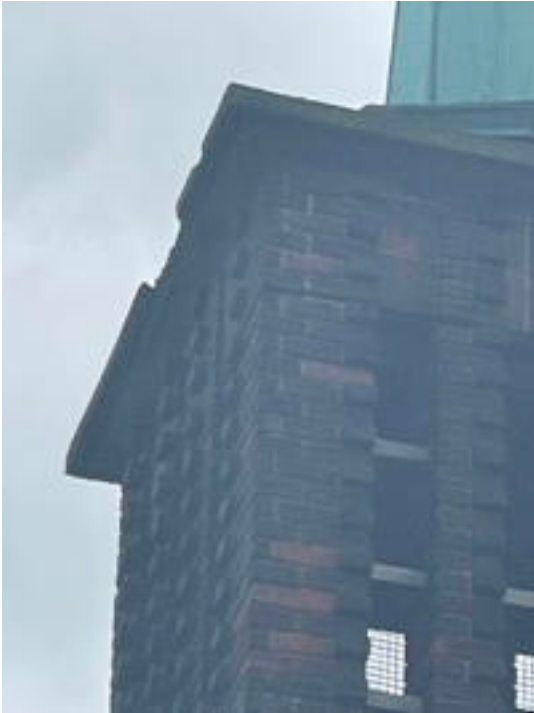
**Tower Eaves North Elevation  
Spalling Concrete**

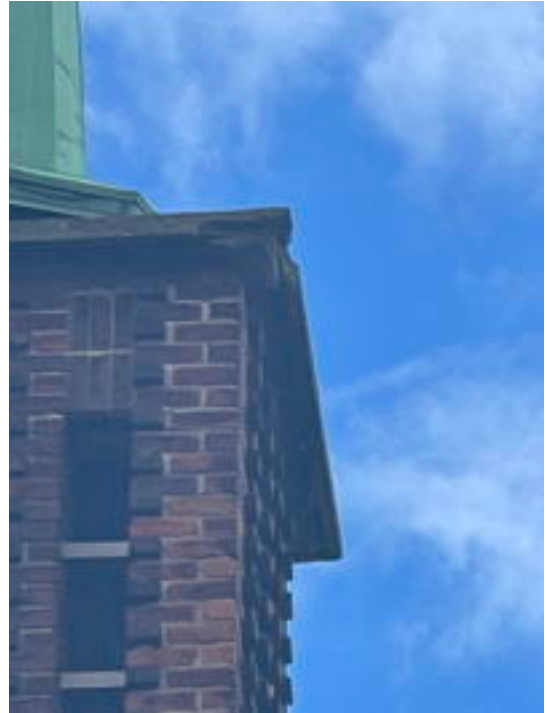
**Tower Eaves West Elevation Spalling  
Concrete**

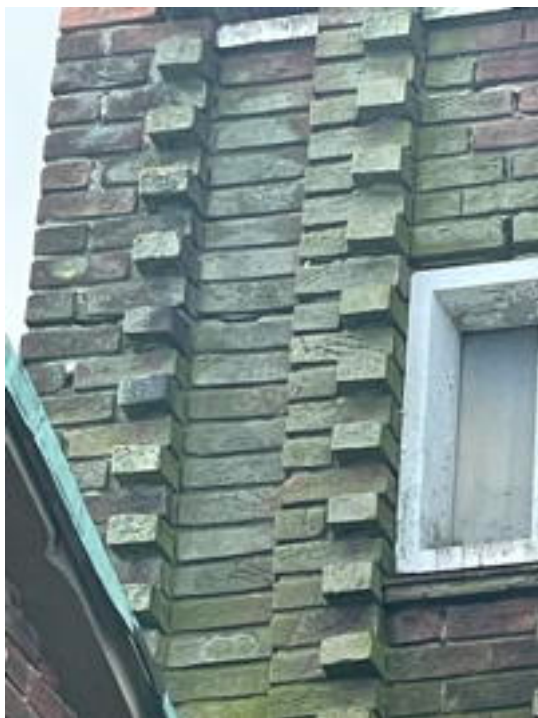
**Tower North Elevation Horizontal Cracking**

There is a horizontal crack in mortar joint to tower, north elevation east end at mid height.

Investigate horizontal crack to tower and generally survey with steeplejack and implement recommendations. Cost Band 2– £2,000.00-£9,999.

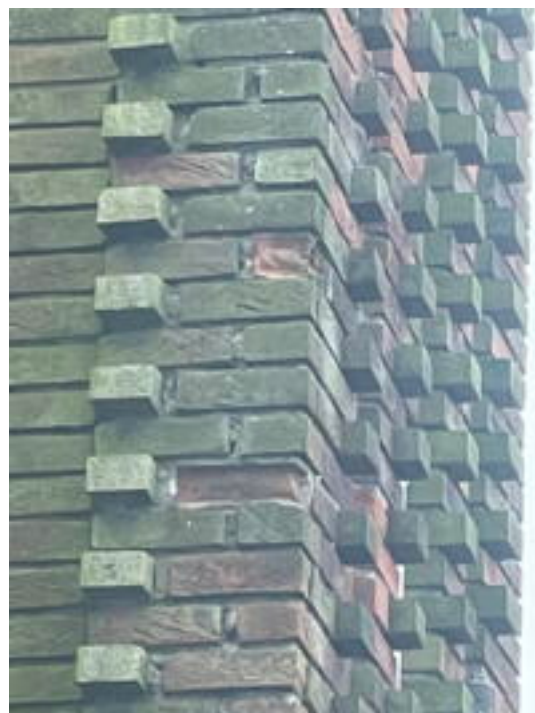
**Tower North West Corner Spalled Brickwork**

There are a few individual bricks that have spalled badly that should be cut out and replaced. Some areas of the church and the ancillary rooms that require repointing with lime mortar

Cut out badly spalled bricks, ie with more than 30% loss of surface depth, and replace with new bricks to match existing. Cost Band 2– £2,000.00-£9,999.

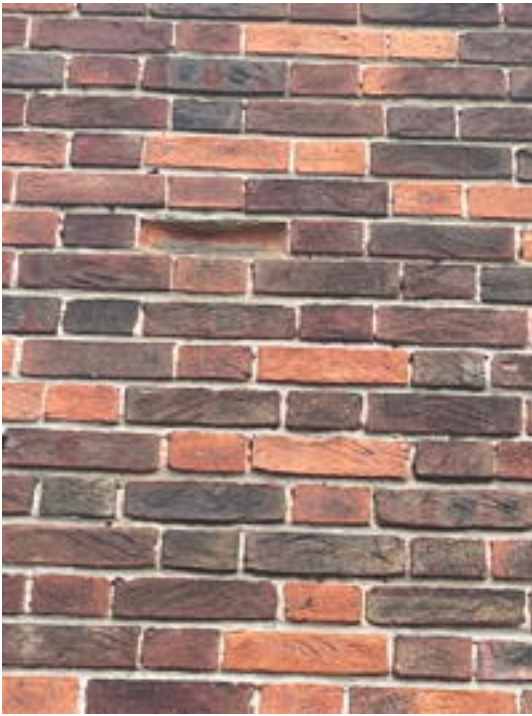
**West Elevation Spalled Brickwork**

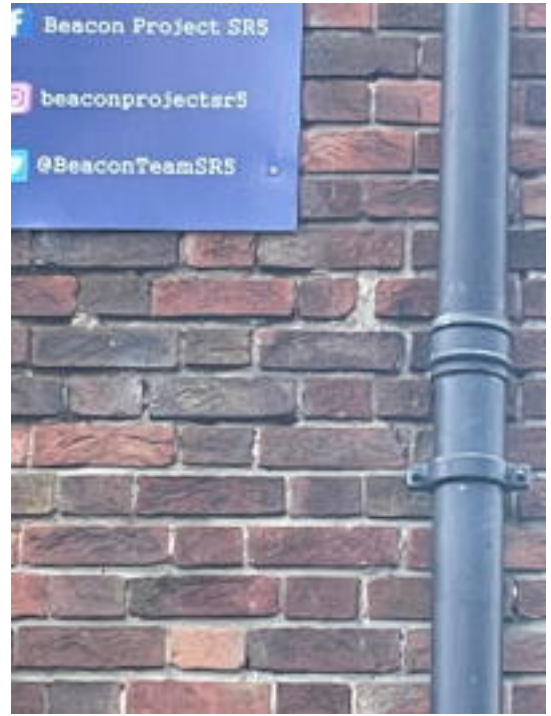
**North Elevation Inadequate Pointing**

Repoint areas of missing mortar with lime mortar. Cost Band 1–£0.00-£1,999.

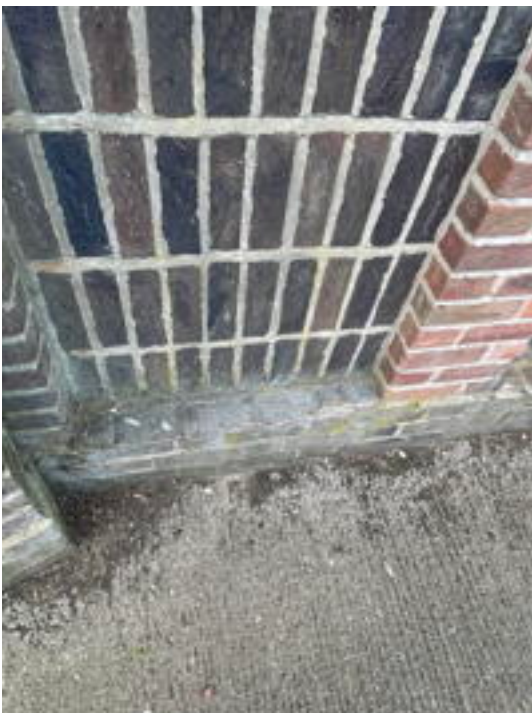
**Broken Creasing Tiles to Base of Sanctuary Brickwork**

Replace broken creasing tiles to base of sanctuary brickwork below windows north and south elevations. Cost Band 1–£0.00-£1,999.

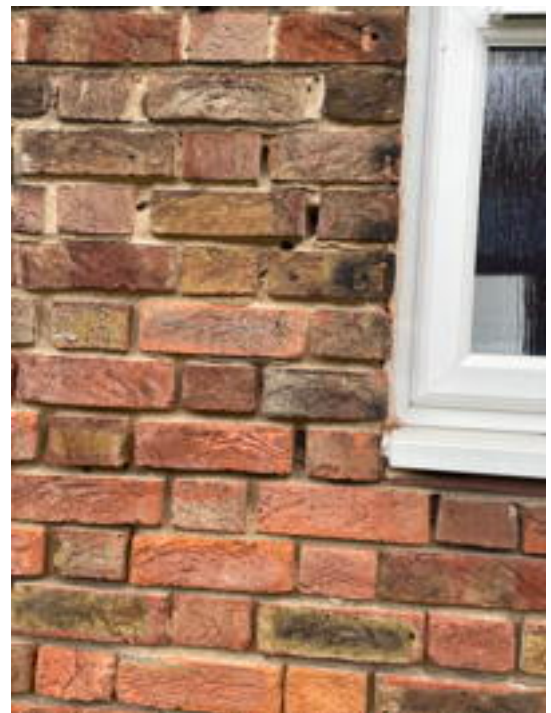
**Meeting Room/Choir Vestry South Elevation Inadequate Pointing**

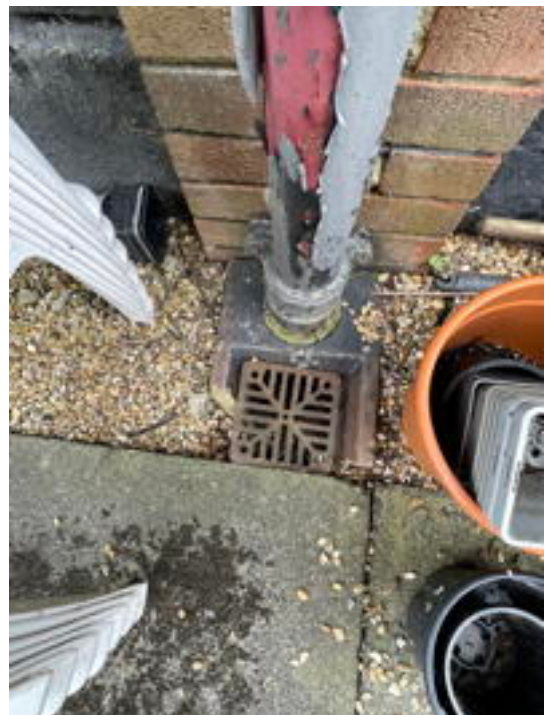
**Broken Gully**

Some gullies partly blocked and some partly broken. The west elevation inspection chamber is no longer obviously visible near in the vicinity of the newly landscaped orchard area.

Repair all broken gullies and locate west elevation inspection chamber in landscaping. Cost Band 1–£0.00-£1,999.

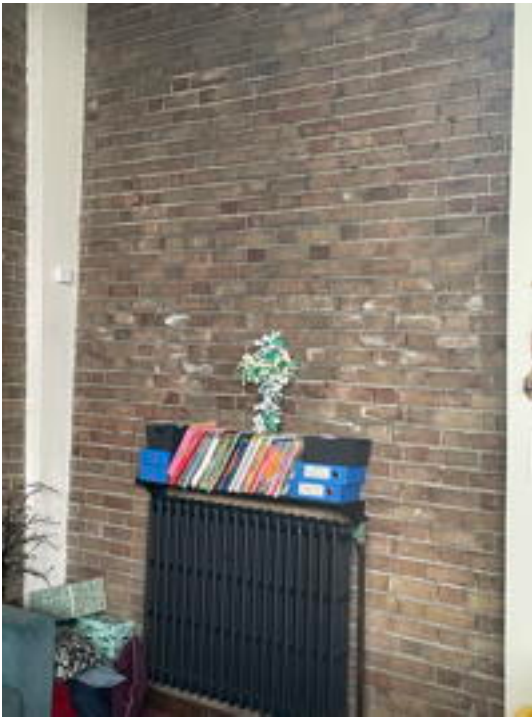
Some signs of salts to brickwork, notably north west corner and above north porch below previously broken gutters and where pointing has deteriorated. Missing pointing to west window, left hand side at low level, corresponds to some brick deterioration externally, and some staining below west window indicates leakage around glass. Minor cracking to brickwork to north porch doors left-hand side. Plasterwork is in satisfactory condition.

**Salts North West Corner**

Carry out brickwork repairs externally as section 9.4 and repoint at west window internally.

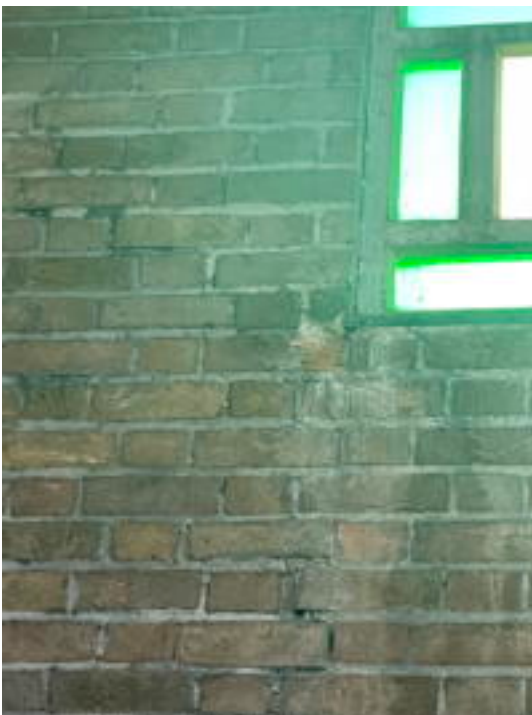
**Open joints and Staining to West Window**

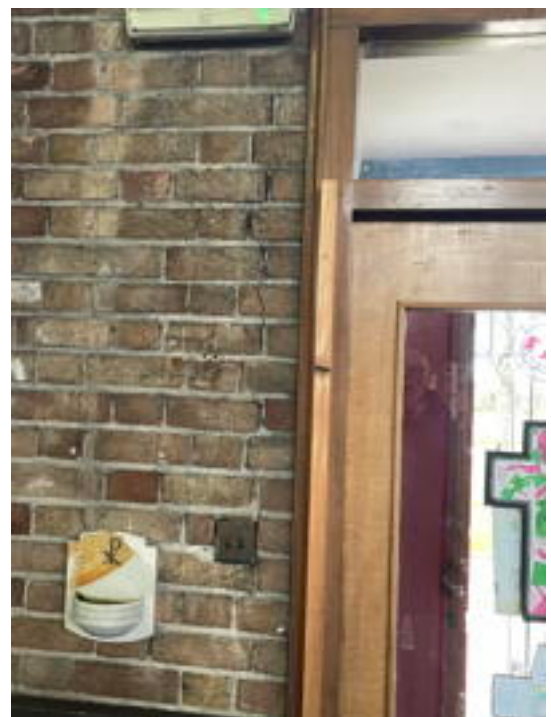
**Cracking at North Porch Doors Left Hand Side**

Monitor cracking at North Porch Doors Left Hand Side and report if it deteriorates. Cost Band 1–£0.00-£1,999.

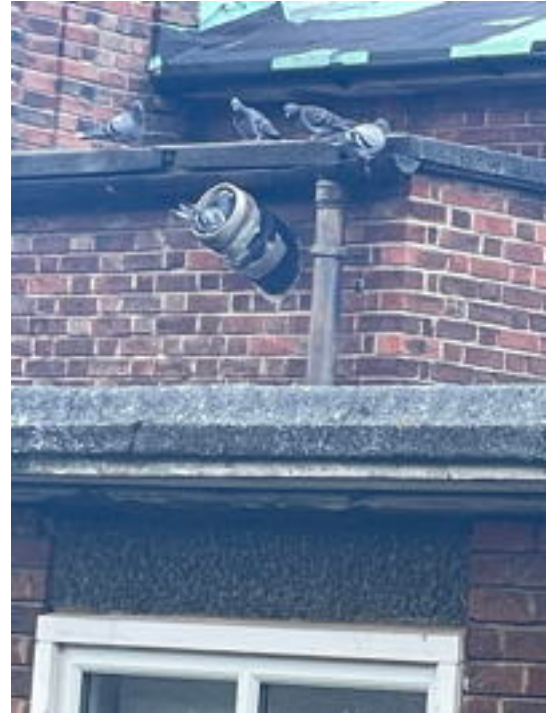
**Possible Pigeon Infestation**

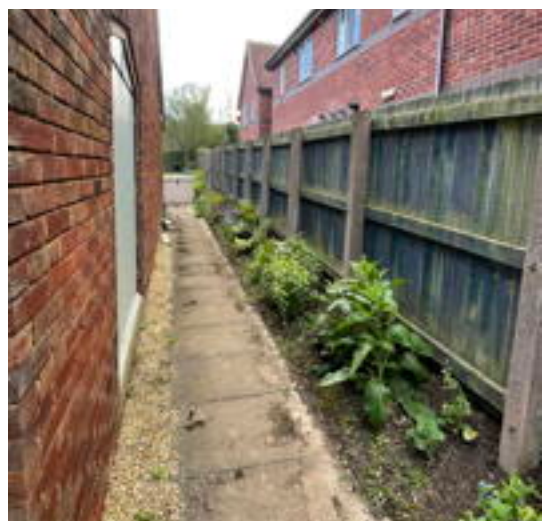
**South Boundary Fence**

All mostly in satisfactory condition. South boundary fence towards west end of site looking dilapidated

Consider replacement of South boundary fence towards west end of site. Cost Band 1-£0.00-£1,999.

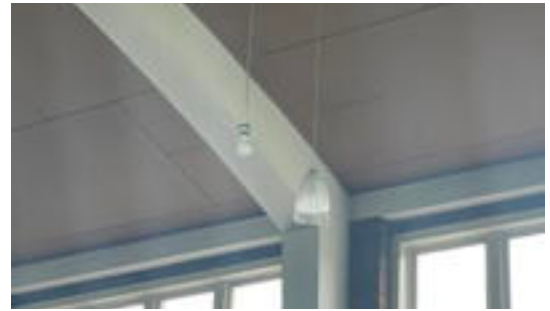
**Missing Shade**

There is no record of the fire detection system having been tested in the Log Book. There is one missing shade to the church lights

Replace missing shade to church lights.
