ROWLANDS GILL St BARNABAS
(22A)

QUINQUENNIAL REPORT

4 August 2023

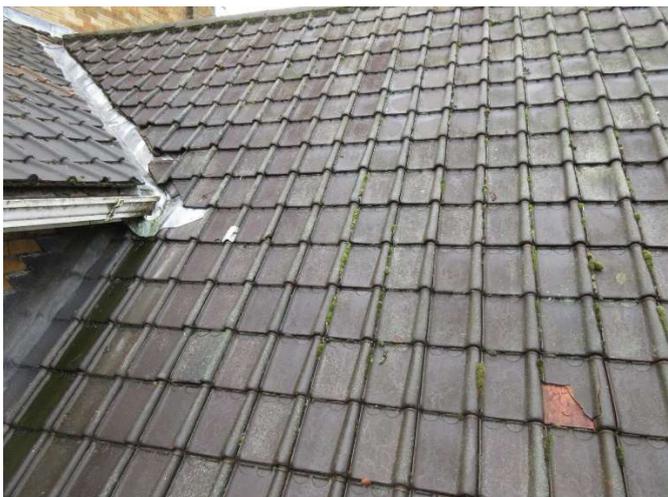
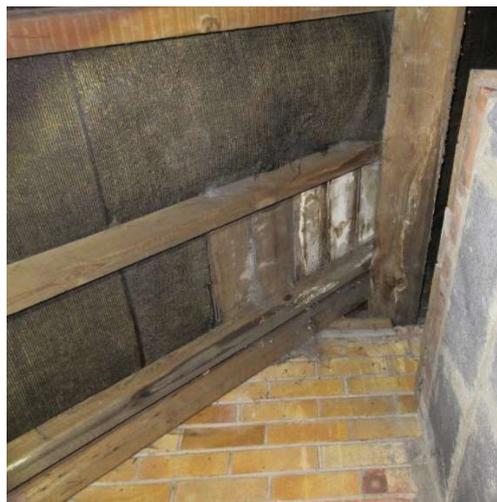
Vestry S side

21. On the E side some tiles are spalling including one on the Vestry S side.
One cut tile at the S Vestry valley has slipped out. Two flashband patches on the valley lead themselves appear cracked. Damp below suggests the valley now needs renewal.

| Renew Vestry lead valley and broken tile over upper Hall | 21, 24 |

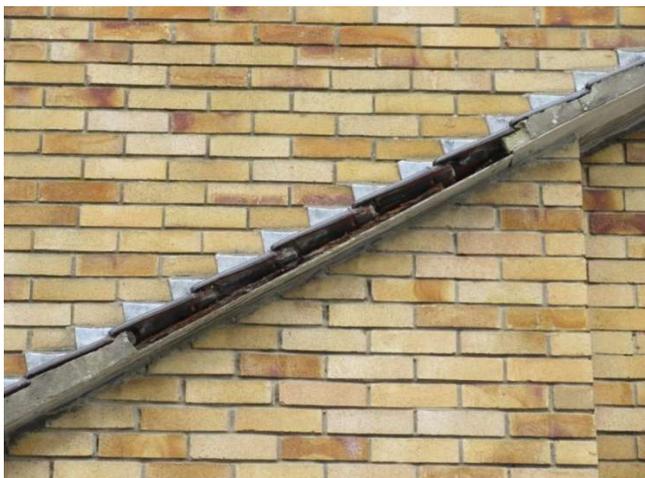
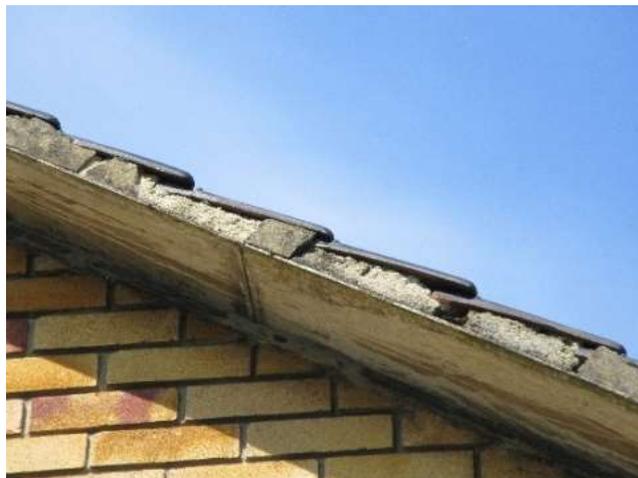
24. One W Hall tile has fallen out, leaving an open hole. Its broken bits lie on the dormer roof. The felt must be catching rain at present as no damp appears inside.
25. Lengths of mortar are missing from the verge at the S end of the Hall, exposing batten ends and loosening the undercloaks.

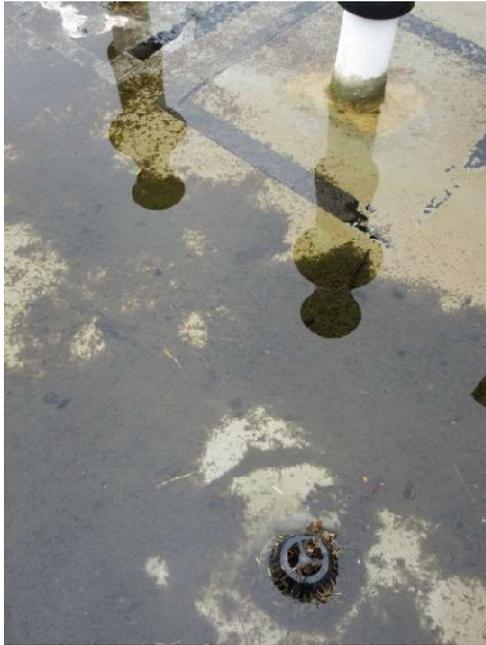
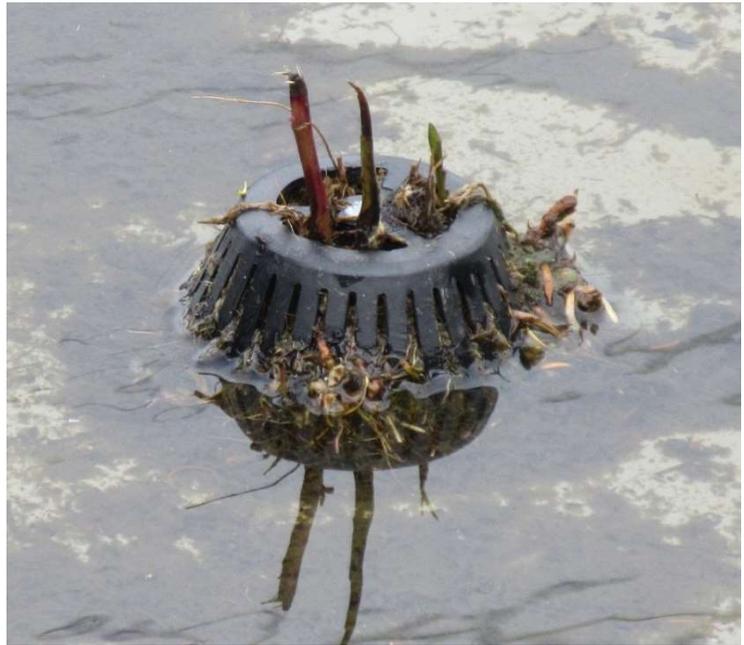
31. Deeply ponded over the boiler room around two disused tall metal flues with collars sealed down, because the outlet at that end is choked by growth inside its cage which could not be cleared at the inspection.

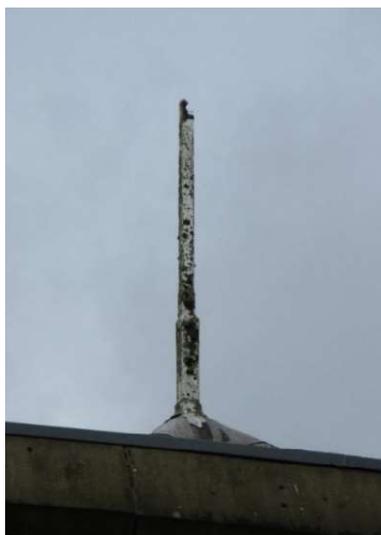
Former cross on Tower now rusting away

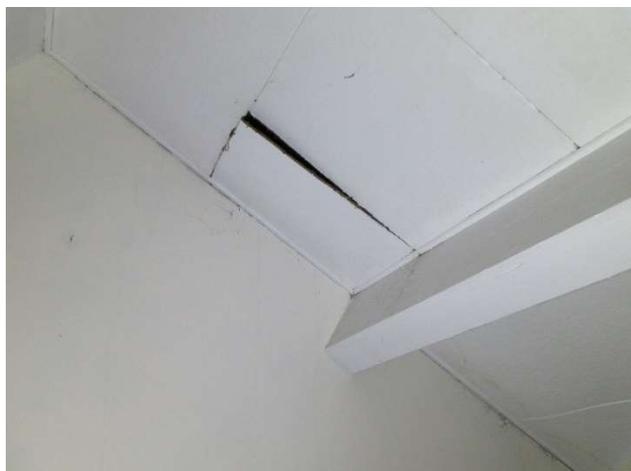
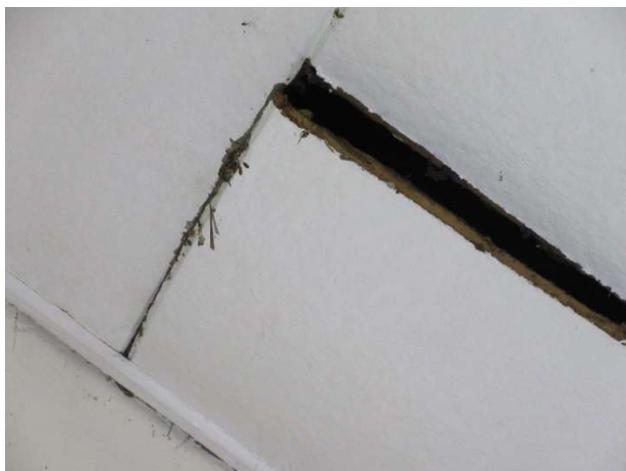
58. In **Nave** sloping painted large thin softboard tiles seem sound but two over pulpit and one close to the organ are coming loose. The softboard is nominal insulation only. In **Baptistry** sound flat painted plaster.

Tile loose near organ

| Refix loose ceiling tiles at Nave | 58 |

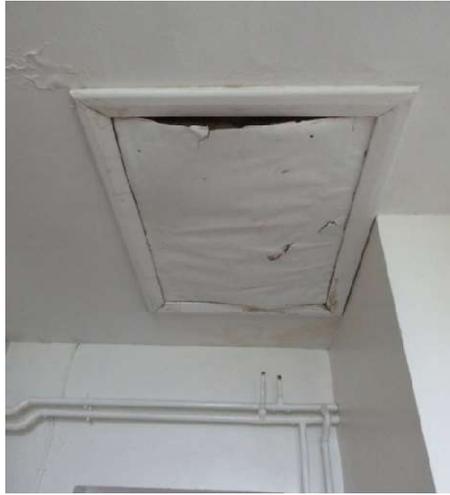
59. **Vestries** have plaster on softwood joists with thin insulation quilt over part only. Sound except hatch and adjacent plaster damaged by roof leak over.

Damaged hatch at Vestry

| Repair ceiling and hatch at Vestry | 59 |

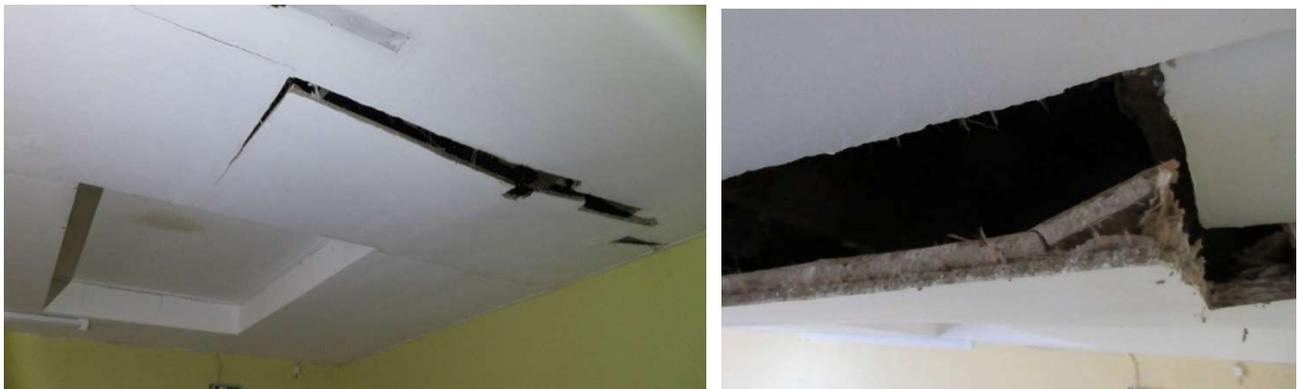
69. At the N end about 2m² of the ceiling under the flat roof has dropped exposing the ceiling as a skimmed double layer of plasterboard under joists and woodwool slabs.

| Repair ceiling at Upper Hall | 69 |

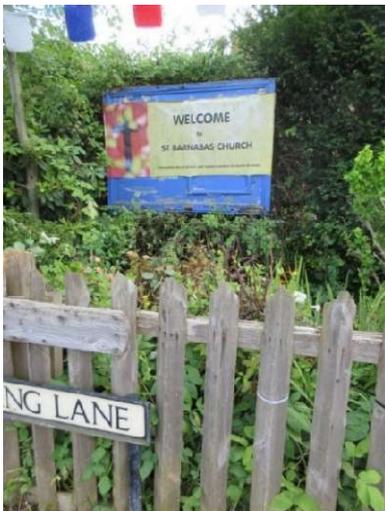
Decaying corner sign

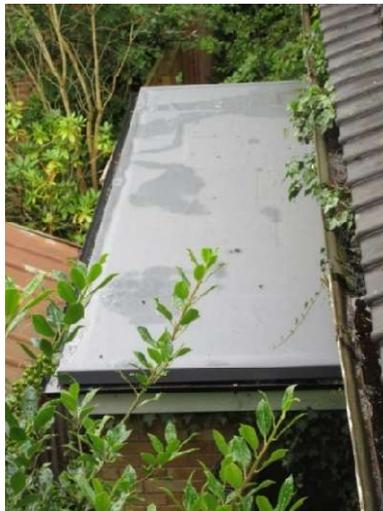
Ivy in gutter over Baptistry

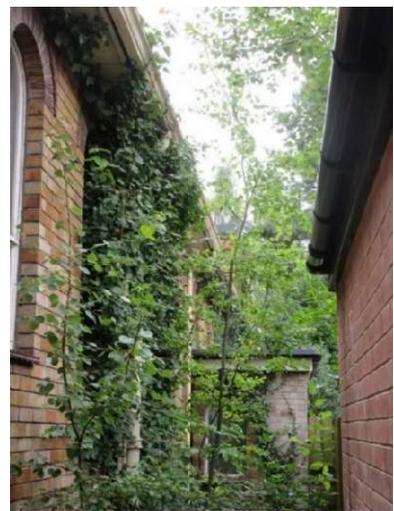
120. The whole hidden narrow W side land appears neglected. Ivy grows into the gutters and many self seed saplings are now large enough to appear in the church windows.
A tree branch from a neighbouring garden now grows over the flat roofed part of the Upper Hall.
All should be removed to prevent damage and allow access for maintenance.
Repeat every few years appears necessary.

Saplings in the strip of land at W

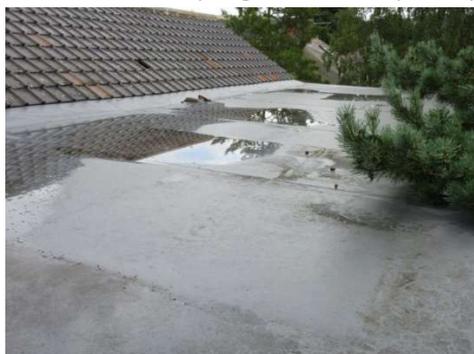
Branch over Upper Hall

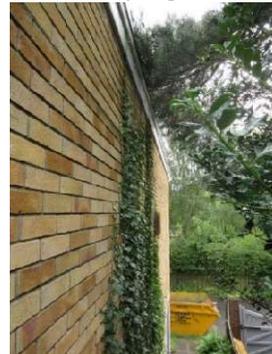
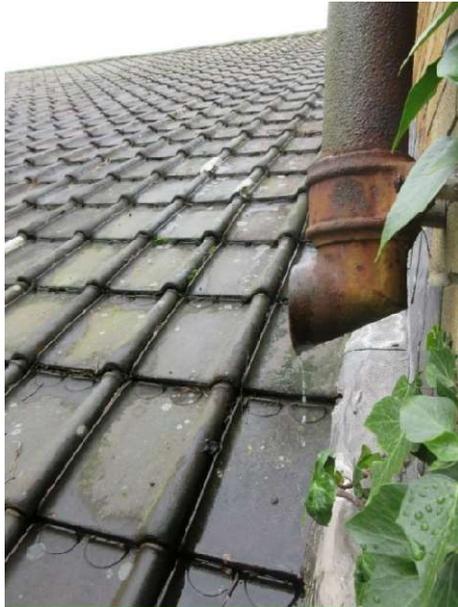
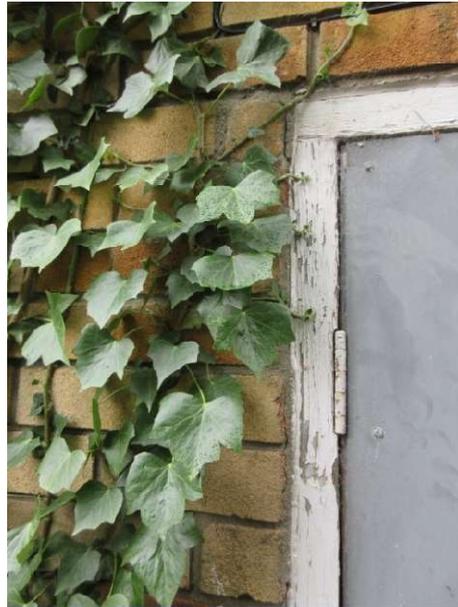
Ivy at Upper Hall

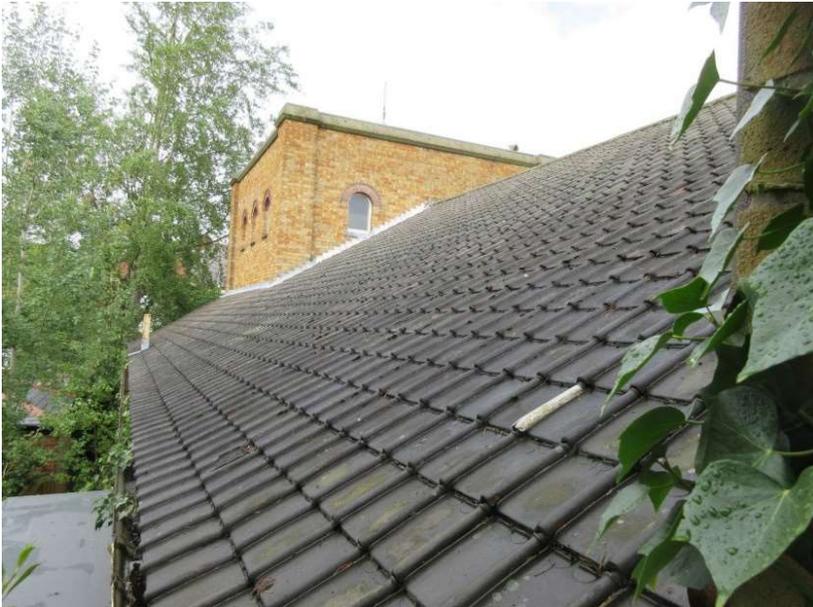
Ivy at W roof

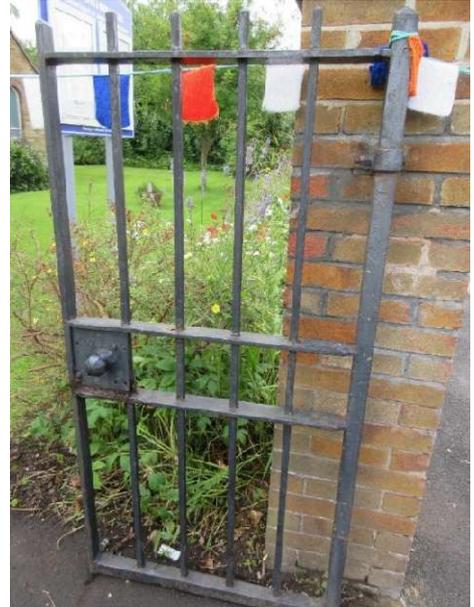
123. A pair of steel gates in brick piers with flat stone caps. One pier has been rebuilt, the other repointed leaving its gate dragging on the path. Both gates are rusting.

Rusting Gates
