## Church of St Mary the Virgin, Shincliffe

### Quinquennial Report

**11<sup>th</sup> May 2026**

**Sarah Harrison** RIBA

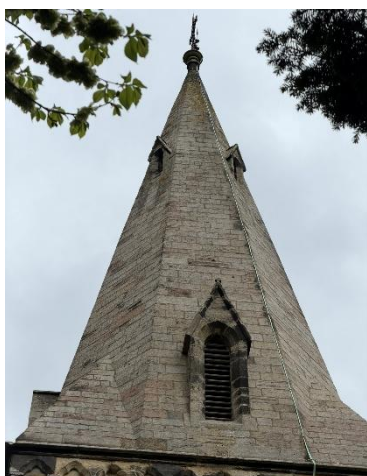
*Figure 1 - South Spire*

6.1.1 The 2021 Stone Technical inspection records the tower and spire as being in generally good condition, with only localised defects identified. Recommended works included minor lime mortar pointing repairs, treatment and selective replacement of timber louvres, repair of fissured masonry by cross-stitching, refixing of defective lead flashings, cleaning out internal bird debris and guano, and repainting/protection of the internal cross tree, kingpost, weathervane and lightning conductor components. The report also noted that some internal mortar appeared to be cementitious and should continue to be monitored at five-year intervals.

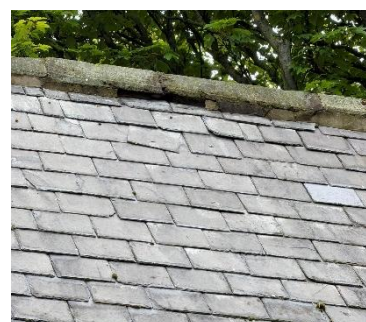
6.2.2 **Chancel South** – The ridge bedding has been patched in the past and it looks as though some of these areas are now starting to fall out. There are a number of slates slipping at the top and mid sections. The flashing to the Nave appears satisfactory, as does the flashing to the watertable which laps over the coping stones.

*Figure 2 - South Chancel Ridge*

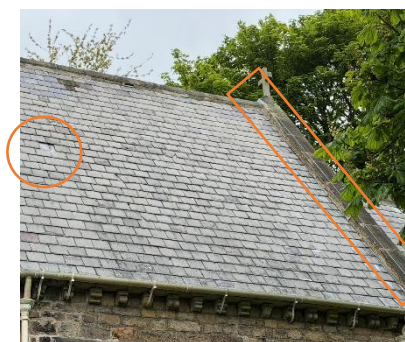
*Figure 3 - South Nave*

Overall the slating is fair, though there are two slates which have slipped and need relacing near the top and the tower, additionally there are some slates that have been replaced and are not a good match. The abutment to the tower is stepped flashing which looks to be satisfactory and the east side to the chancel arch has been re-made, with the lead removed from the top of the watertable.

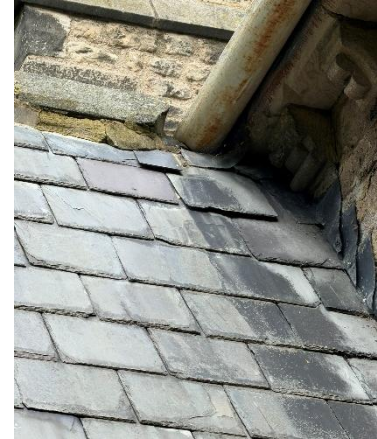
- 6.4.1 **East Side** - The ridge pointing has been patch repaired in places and is now failing, with one large section having come away and another area beginning to break up. There is an infill section in mortar abutting the south water table. The area beneath the gutter is questionable, with the ridge copings stopping short and a mortar/lead arrangement which would be best re-made in a more durable detail. The slating remains serviceable at present, although there are some contrasting replacement slates and a number of cracked, chipped or delaminating slates. The south abutment is formed in mortar and is cracking at the apex. The stepped lead flashing to the nave abutment appears sound. Localised repairs should be planned, including renewal of defective ridge pointing, isolated slate replacement, and re-making of the vulnerable mortar abutment and ridge/gutter junction.

*Figure 4 - Porch East ridge*

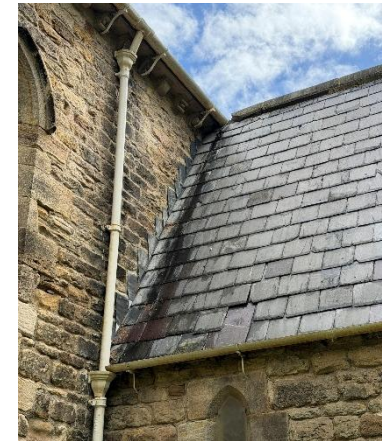
- 6.4.2 **West side** - Similar to the East, though the ridge has lost approximately half of its bedding on this side. The detail at the gutter shows signs of issues as on this, a relatively dry day, there is water running down the roof from this junction. There is one slate which has slipped and lies in the gutter.

*Figure 5 - Porch West*

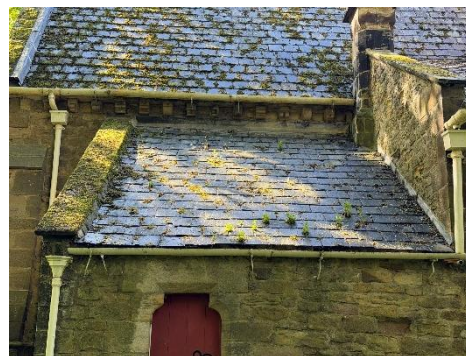
- 6.7.1 Ridge abutment to the chancel is in lead and appears ok. As per other northern slopes the slates are heavily covered with moss, and some plants are starting to take root, these should be removed now. The abutment to the organ loft is in lead and appears ok, though the detail of the flashing around the chimney should be checked, as the condition internally suggests some damp in this area. The abutment to the east is mortar flashing and difficult to assess as it is covered with moss, which should be cleaned off.

Figure 6 - Vestry

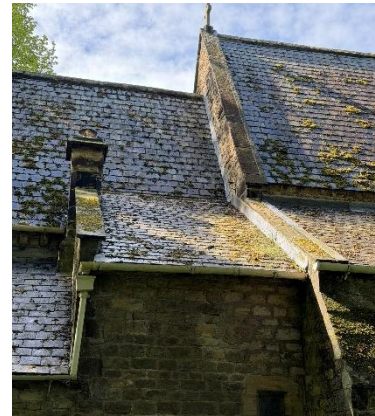
*Figure 7 – Organ gutter*

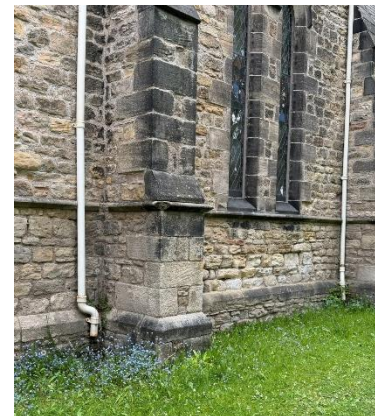
7.7 **Nave South** – Gutters discharge into pleasant octagonal hoppers and downpipes. Most of the downpipes stop short of the gullies, particularly noticeable to the middle where the rainwater looks to have stained the wall behind and the downpipes would benefit from extending closer to the gullies. There is vegetation growing in the west end of the gutter. Again some rusting beginning to show, particularly at joints.

*Figure 8 – South Nave RWP short*

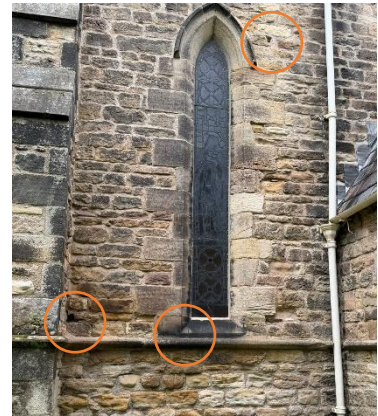
- 8.2.1 **East:** Fully re-pointed in lime. There is one eroded stone to the south side, though no action required yet.
- 8.2.2 **South Side:** The corbel course is generally satisfactory, although there is erosion behind at the west end, which would benefit from localised pointing. The walling is generally sound, but the lower levels show erosion due to long-term damp. There are some open joints to the west side, including two holes to the west of the porch, which should be filled. The west lancet also has a cracked cill.

*Figure 9 – South Nave*

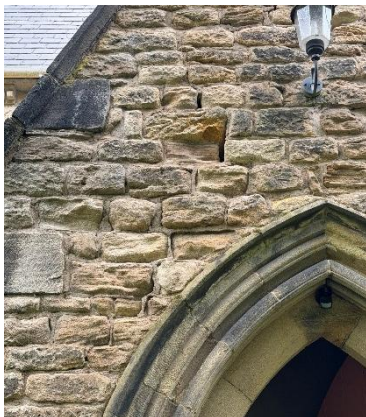
*Figure 10 – South Porch*

8.3.2 **South Side:** The condition appears to have worsened since the previous inspection. There is a slight crack to the west side above the arch, together with some very open joints, including at high level above the arch. These should be repointed within the next 12 months. It appears that a finial cross may have broken away, and reinstatement would be desirable if evidence of the original detail can be confirmed. The arch itself is eroded, and the shaft on the west side is wasting away, likely due to prolonged dampness. The east shaft has previously received a cementitious repair, which has not helped the condition of the masonry, although this side is less eroded. The eastern order of the arch is also eroding, possibly due to the quality or durability of the stone.

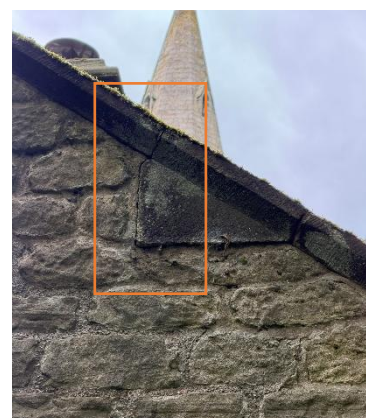
- 8.6.1 **North:** There are a few areas of severely eroded stones, but not yet requiring replacement, these should simply be monitored and assessed at the next QI.
- 8.6.2 **East:** The walling is generally sound, with some algae staining adjacent to the chancel, possibly associated with a rainwater issue, and this should be monitored. Centrally, at the mid-water table, there is a crack to the left-hand side of the triangular stone coping, which has not been noted previously, therefore there may be some active movement in this gable which should be monitored.

*Figure 11 – East Vestry cracking*

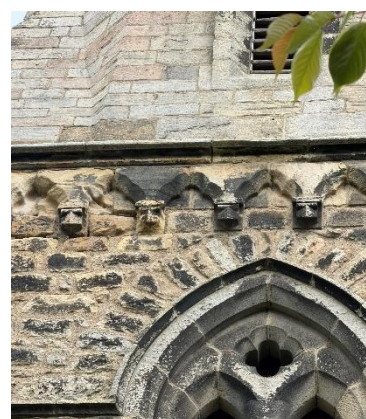
- 8.7.1 **Spire:** See Stone Technical Report and works carried out, no defects visible from ground level, some moss at the top.
- 8.7.2 **Third (Belfry) Stage:** Erosion to the Lombardy corbels and open joints below. Minor open joints to the string course above. Replacement circular mullion, timber louvres slight wear to the louvres but all appear intact. Rooks reported at the last QI and the PCC report that Jackdaws are currently nesting inside.

*Figure 12 – South Tower Third stage*

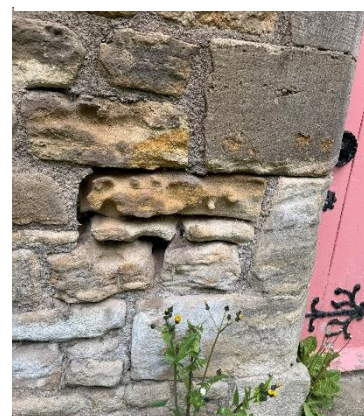
- 8.7.4 **First stage:** walling eroded slightly by the nave and severely to the left of the doorway, the mortar here has almost been lost to the full depth and needs two or three new stones indenting. There is another area of severe erosion to the SE buttress, and should be closely monitored for replacement. Crack to the left-hand shoulder of the doorway lintel, as reported previously. The pointing around the step should also be renewed once cleared of vegetation.

*Figure 13 – South Tower First stage*

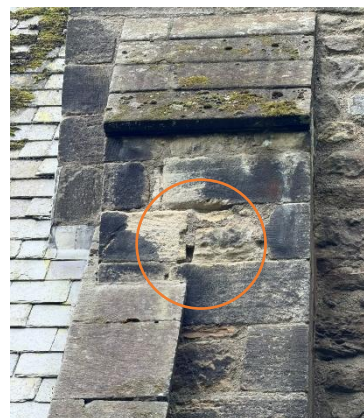
- 8.8.2 **Third Stage:** Slight erosion to the frieze and some holes just above the corbel on the S W corner, open joints between the corbels on the north side. The walling shows some erosion below the string course.
- 8.8.3 **Second Stage:** Walling is generally sound. Narrow lancet, leadwork is aging but no action is currently required.
- 8.8.4 **First Stage:** Walling is generally ok, apart from some erosion to either side of the base of the lancet. The lancet is clear glazed and ventilator looks rusted and fixed. The north buttress shows slight erosion to the stonework.

*Figure 14 – Northeast buttress*

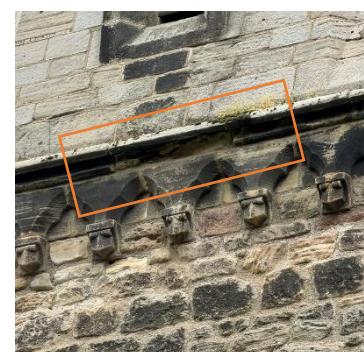
*Figure 15 – East Frieze mid-section*

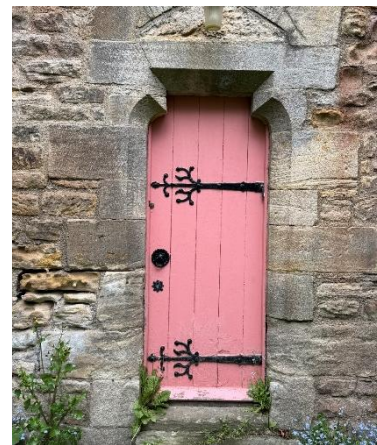
As per the vestry door. Decoration breaking down at the weather bar and around the lower decorative hinge, this will need sanding down prior to re-decoration.

*Figure 16 - Tower door*

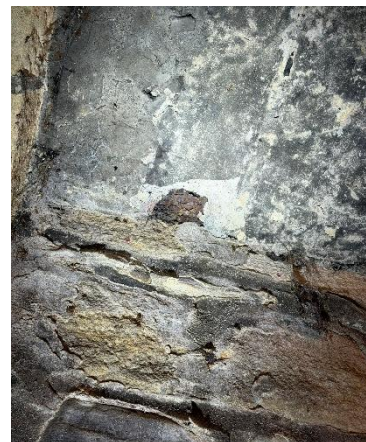
11.1 The concrete ceiling appears generally satisfactory, although there is one area of rusting where the concrete has spalled. The external section of roof appears to have a timber structure internally and seems dry enough at present.

*Figure 17 - Rust to ceiling*

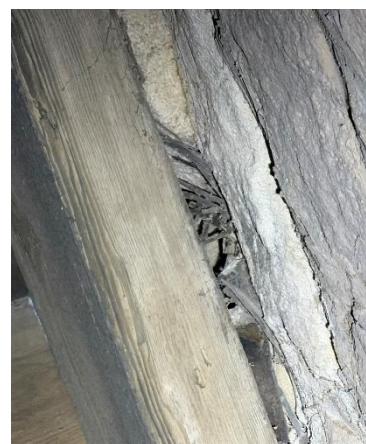
12.1.2 It is not known whether these recommendations were carried out. Jackdaws are reportedly nesting within the spire and belfry, suggesting that bird access may remain an issue. The interior of the spire should be inspected at regular intervals and, therefore, it would be a worthwhile improvement if safe and practical access could be made feasible.

*Figure 18 - gap in belfry ceiling boarding*

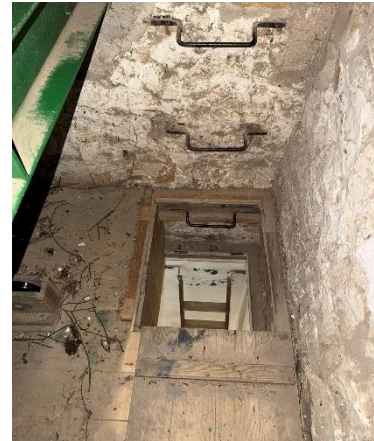
- 12.2.2 The floor is dry and lightly dusty, with the boarding appearing sound and in good order. There is currently bird nesting material across the floor and some material on the bells. The bell frame is painted steel and appears satisfactory. There are six bells, which appear to be Whitechapel bells, with a 1969 date visible on one bell.
- 12.2.3 The handholds at the top of the access ladder are coming away and the access arrangement requires improvement, with better grab rails and a more secure ladder arrangement. The walls have permanently fixed baffles with drop-down sound hoppers, which appear satisfactory, although they were not tested.

*Figure 19 - hand holds and bird material*

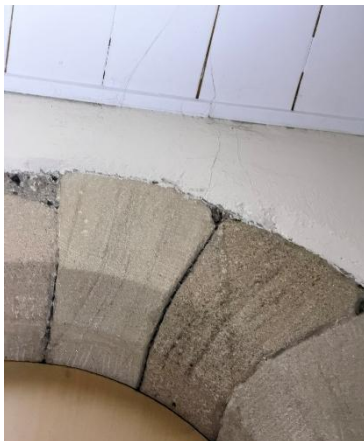
*Figure 20 - crack to circular window*

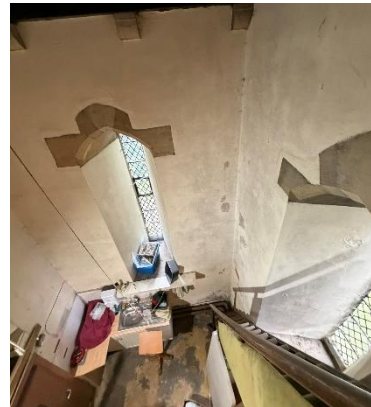
- 12.4.1 The open-joisted ceiling appears ok, apart from a hole over the stair, although this lies beneath the built-in box seat above. The walls are painted plaster and are generally serviceable, but the decoration is aged and peeling in places. The floor is stone paved, with some areas of lime mortar beginning to break up.
- 12.4.2 The north window has a slight crack at the arch, which was also reported in the previous QI, although not photographed. On the south side, the window continues up into the ringing room and appears satisfactory. The floor runs

*Figure 21 – general wall decoration*

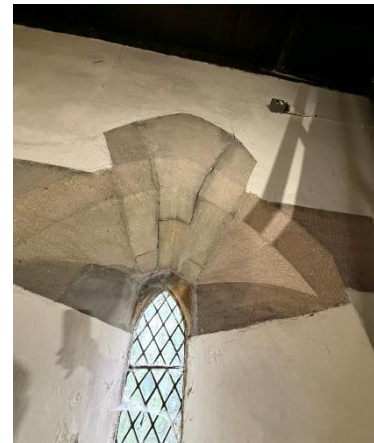
- 12.4.3 The arch to the nave appears sound. The west window has some cracking at the head, again previously reported as present but stable, and localised repointing would be beneficial. The glass is diaper leaded and appears to be in fair condition.

*Figure 22 - crack at head of west window*

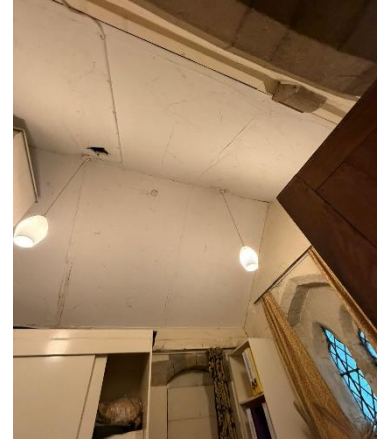
- 14.1 The **nave, chancel and aisle** ceilings are boarded.  
Comments on the condition of the visible roof timbers and finishes are included in the section above.
- 14.2 The **vestry** has a fibreboard-type ceiling with taped joints, some of which are coming away. There are also a couple of damaged areas, together with a hole and cracking at the edges. Overall, the ceiling is in poor condition and should be renewed.
- 14.3 **Organ Loft:** It was not possible to access the organ loft to inspect the ceiling fully. Polythene sheeting is present to the ceiling area, which limits visibility. A further inspection should be arranged, if possible, perhaps when the organ is next serviced.

Figure 26- Vestry ceiling

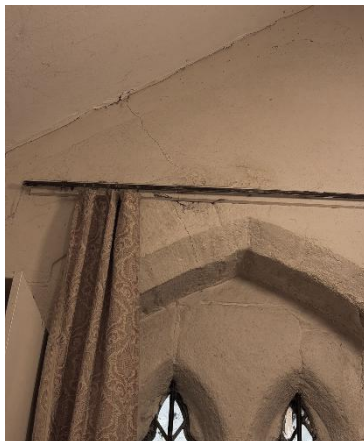
Figure 27 - Vestry crack

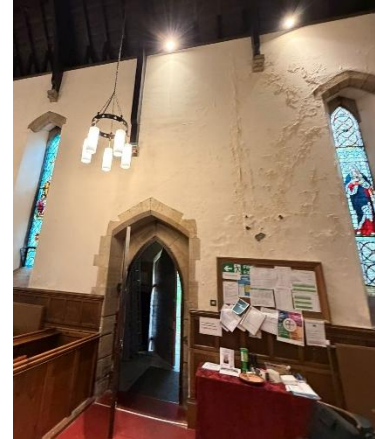
- 16.1.2 West side: To the right of the doorway there have been remedial gypsum plaster repairs. The finish is blistering and salts are coming through as it cant effectively dry out.

Figure 28 - West wall, near door

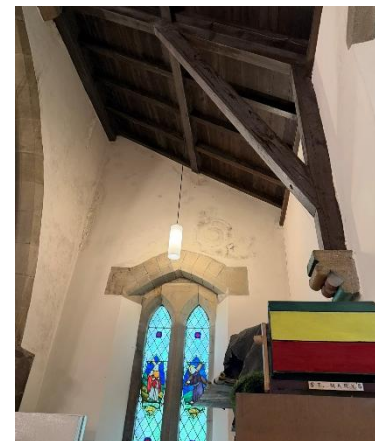
- 16.2.3 Above the Lady Chapel, adjacent to the organ loft, the west wall is now quite badly damaged. This is believed to be an ongoing issue which has not yet been resolved. Externally, as noted in Section 6.5.2, the water table has been identified as a possible cause and should be investigated further. A similar repair approach to the east end and chancel arch water tables may be required.

Figure 29 - N aisle, West wall

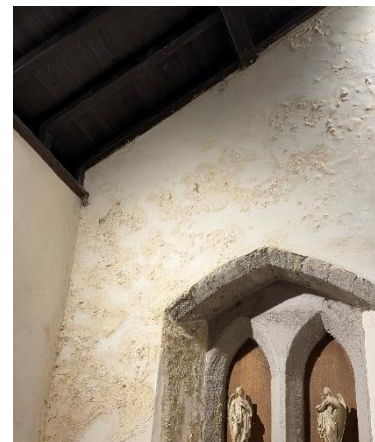
Figure 30 - Lady Chapel, east wall

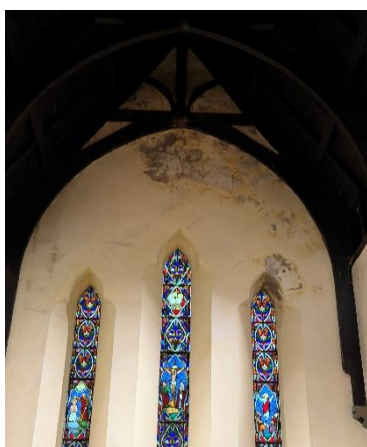
- 16.3.2 The area around the chancel arch was described as patchy in the previous QI, but now appears worse than shown in the previous report photographs. However, this may be because the area is now drying out, with the paint beginning to flake away as residual moisture escapes. This should continue to be monitored before any redecoration is carried out.

*Figure 31 - Chancel East*

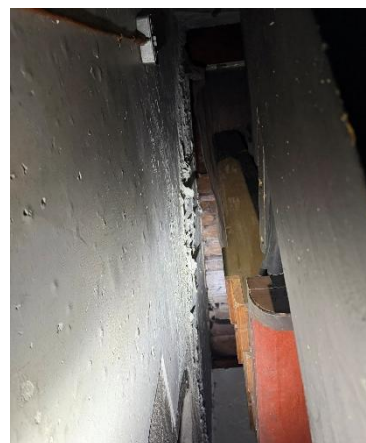
16.5 **Organ Loft:** It was not possible to inspect the organ loft properly, so the full condition could not be confirmed. The opposite side of the Lady Chapel wall is heavily affected by damp, with plaster coming away. This is generating dust and debris, and the organ should be protected until the issue has been resolved and the area made good. There is also dust present on the floor.

*Figure 32 - Organ chamber west*

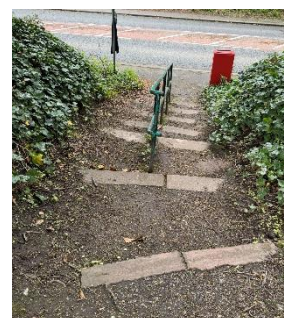
*Figure 36 - North steps*

29.5 The **northern boundary** is largely open to the highway with a 1-2m level difference and no edge protection, with mature trees, low hedging, fallen branches and redundant stones. Fallen material should be cleared. There are steps up from the pavement which are undulating and the central handrail requires decoration.

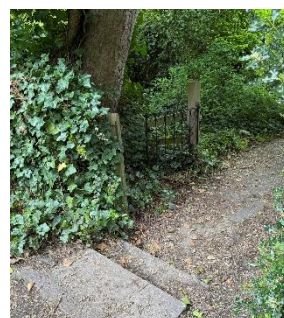
29.6 The **western boundary** includes an additional burial area projecting westwards, with a mixture of domestic fencing, hedges and stone walling. Some open joints remain to the stone walling and should be repointed in due course. Closer to the church, there is an additional gated entrance, though once again the gates are detached and the fence is falling over, this should be repaired.

*Figure 37 - West entrance gate*
