St. Oswald's Church, Shiney Row

Diocese of Durham
Archdeaconry of Sunderland
Deanery of Houghton-le-Spring

Quinquennial Inspection Report
February 2022

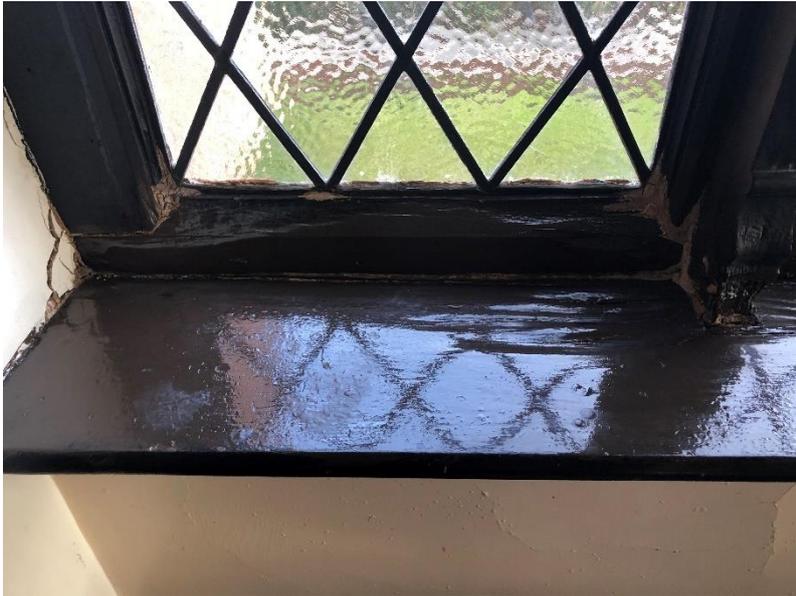
8.2	Vestry window 3-light and 1-light chancel window, opening lights at edges of second tier.
8.3	Hall and kitchen, white uPVC with night lights.
8.4	Internally some wood decay has affected window sills (nave east window nearest organ).

P1 (5806):
Wet rot to window frame and sill

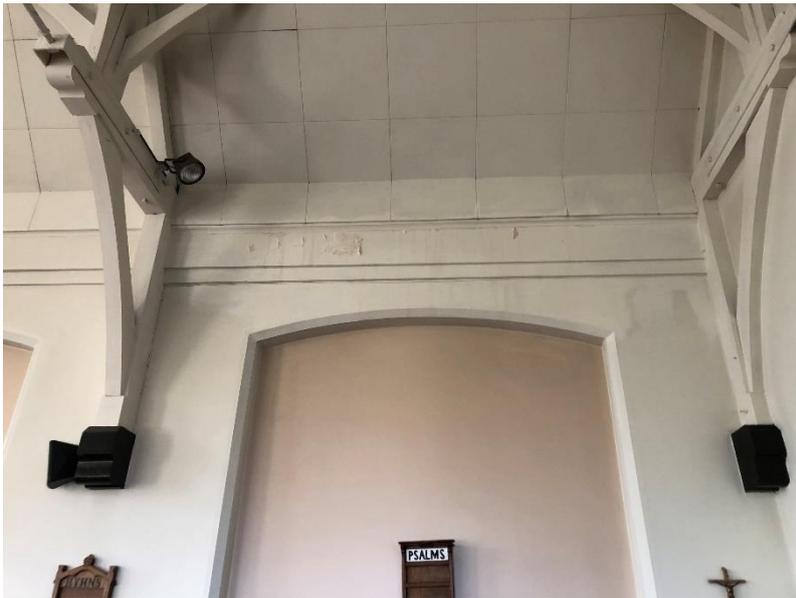
P2 (5818):
Eaves paint flaking (west/nave);
ceiling tiles composition TBC
(possible asbestos?)

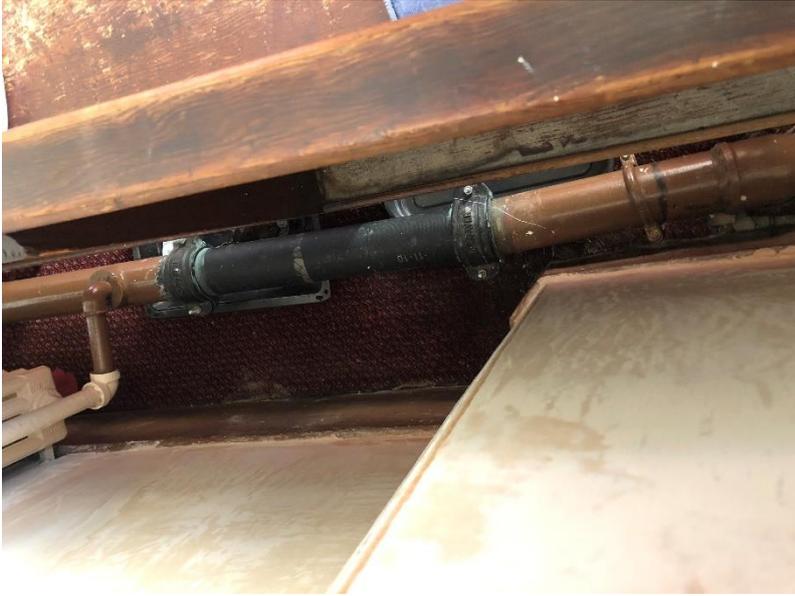
12.2	The electrical conduits serving the boiler at floor level are rusting and unsupported. This requires urgent attention.
12.3	Gas fired, low pressure hot water system serving large bore steel pipes and cast iron column radiators. There have been recent recurring leaks in the church pipework, and at least one current leak that requires attention. It may be advisable to budget for re-piping the system in the medium term.

P3 (5823):
Pipework repair

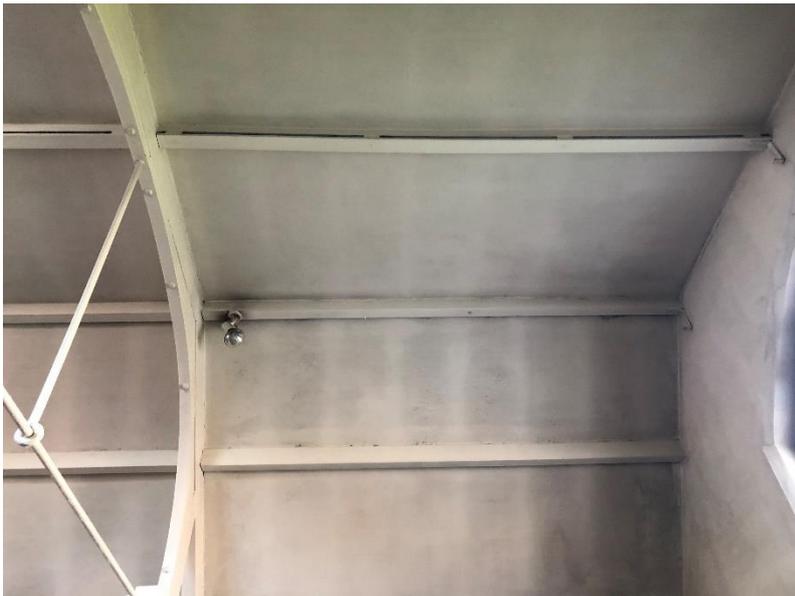
13.4	Light level is poor in church/hall lobby. Lighting elsewhere appears satisfactory but more energy efficient and accessible fittings in the church should be considered. High level nave recessed ceiling lighting may prove difficult to maintain and be less energy efficient than modern LED-type units.

P4 (5842):
Chancel ceiling, pattern staining;
lighting accessibility issues

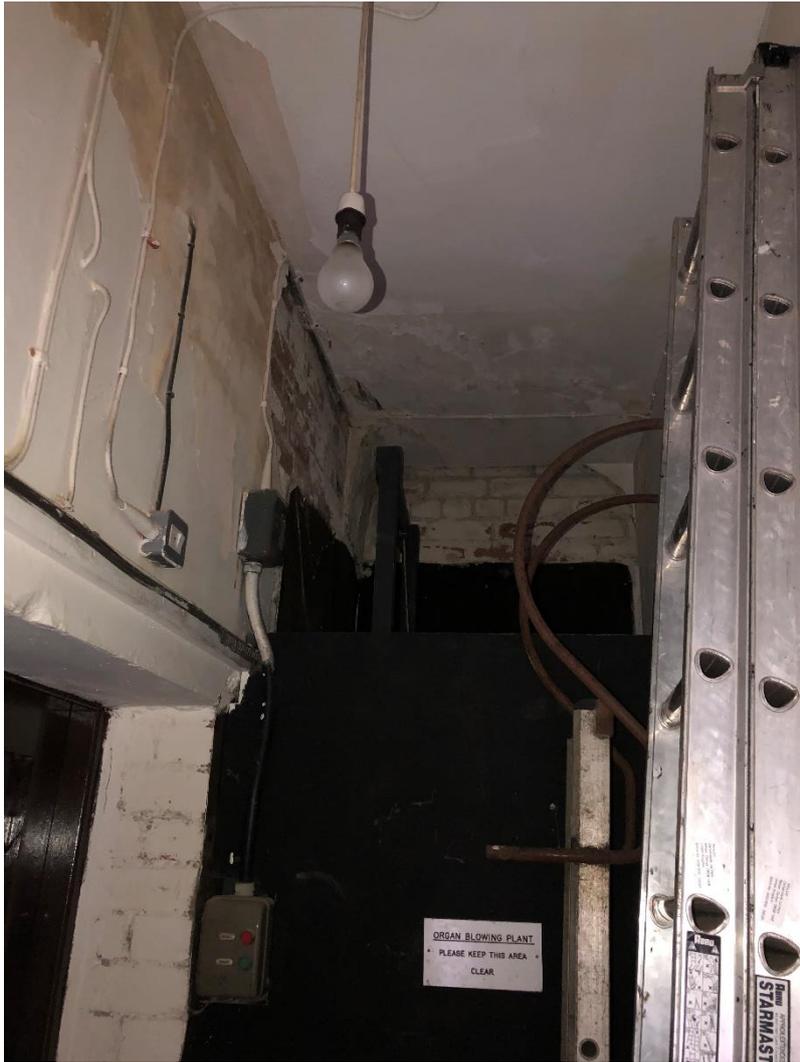
P5 (5848):
Vestry passage ceiling condition

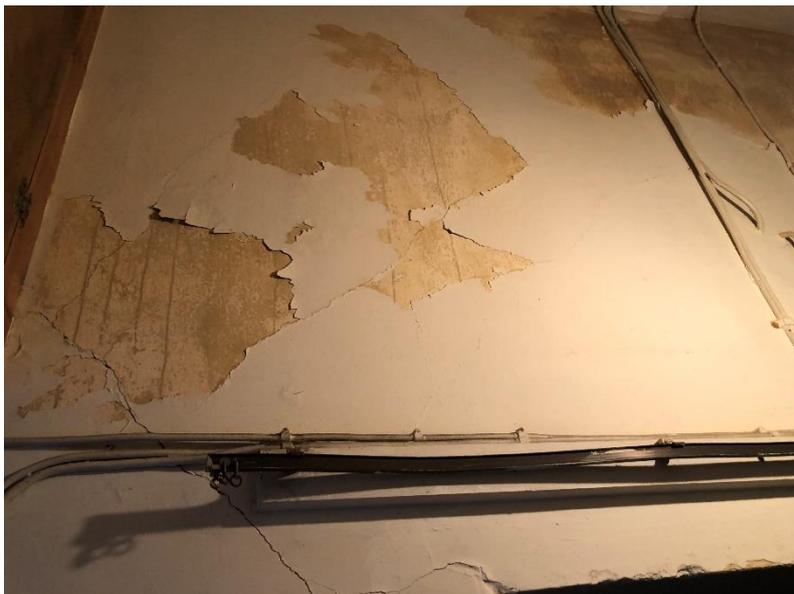
P6 (5851):
Vestry passage wall condition

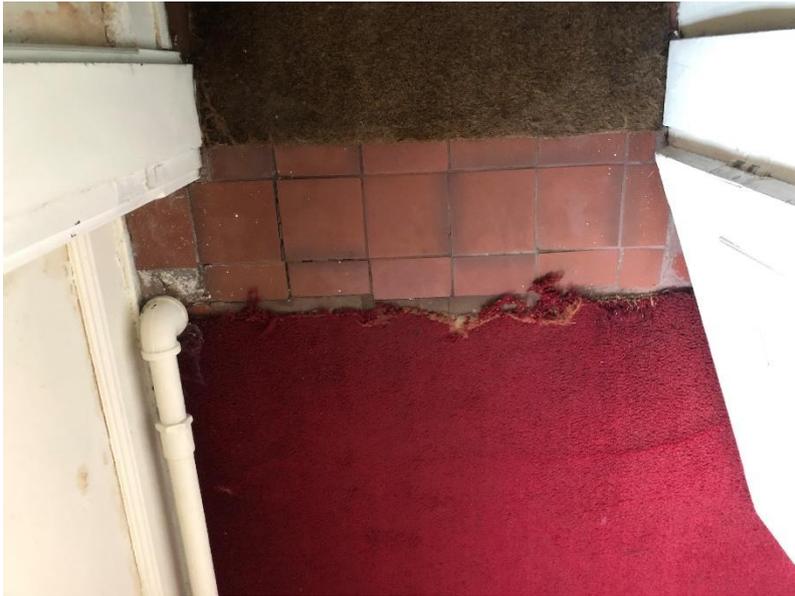
9.2	Vestry entrance has carpet over red clay tiles. Choir vestry has asphalt floor, with historic cracking.
9.3	Main hall has hardwood strip flooring in good condition.

P7 (5852):
Vestry carpet edge

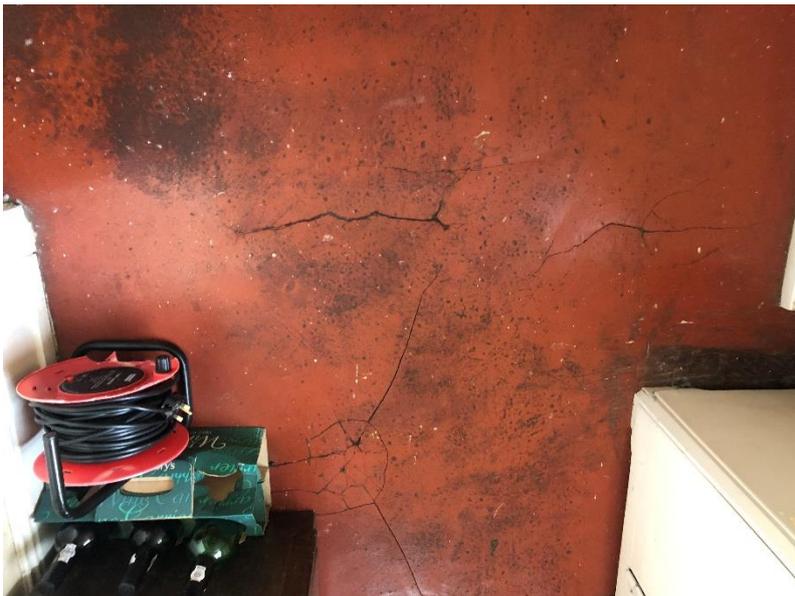
P8 (5856):
Vestry floor cracking

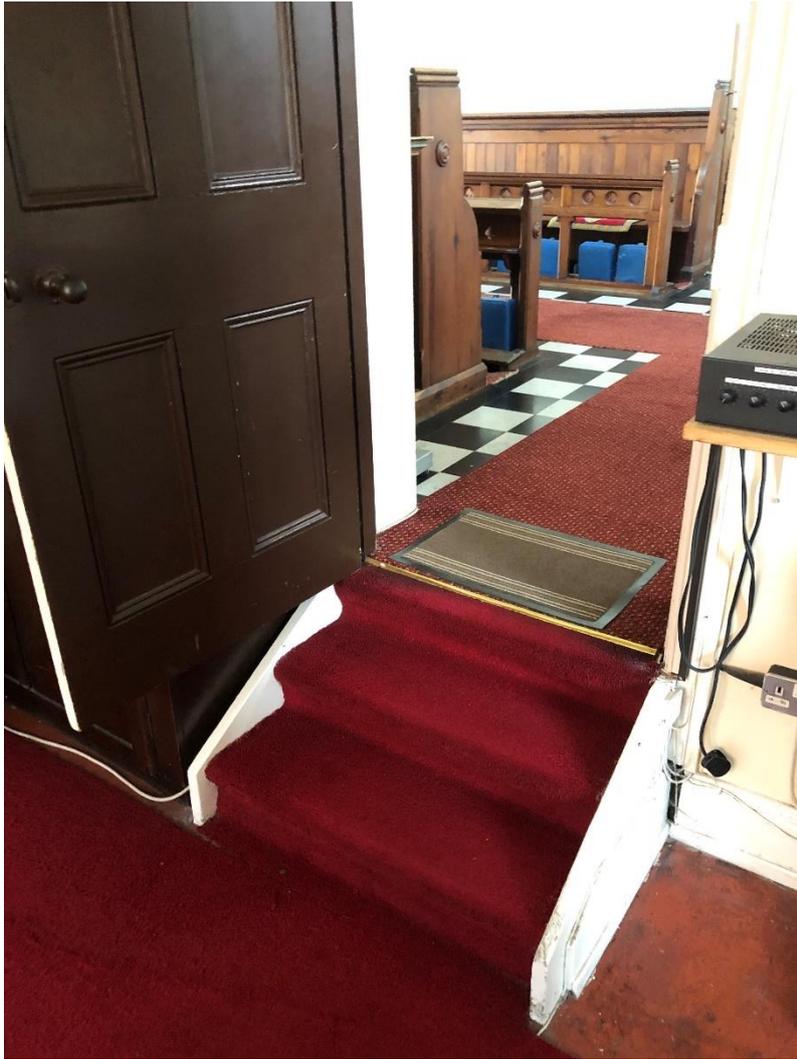
P9 (5861):
Vestry steps, lack of handrail

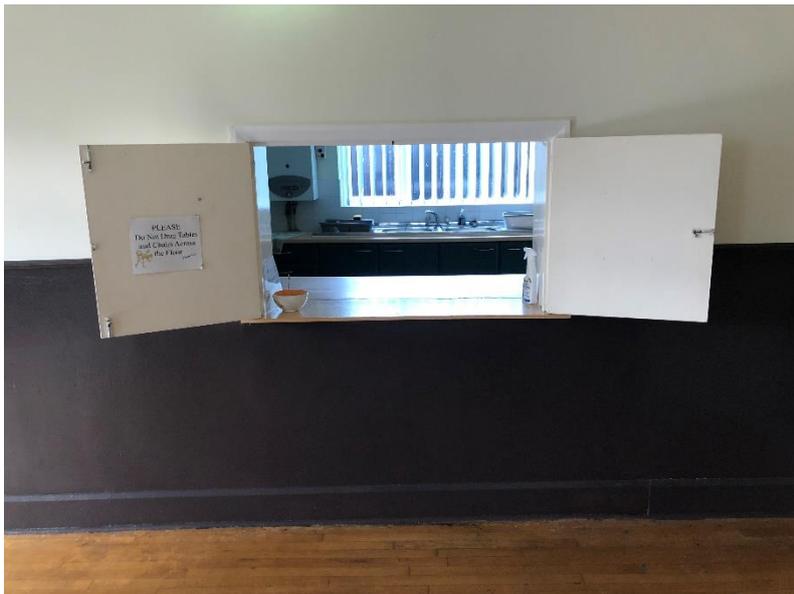
15.2	Kitchen servery hatch is not fire resistant and ideally should be upgraded. Gas cooker does not have emergency gas cut off valve.
15.3	Escape routes in the hall are clear and have illuminated signs.

P10 (5886):
Kitchen servery hatch (fire
resistance?)

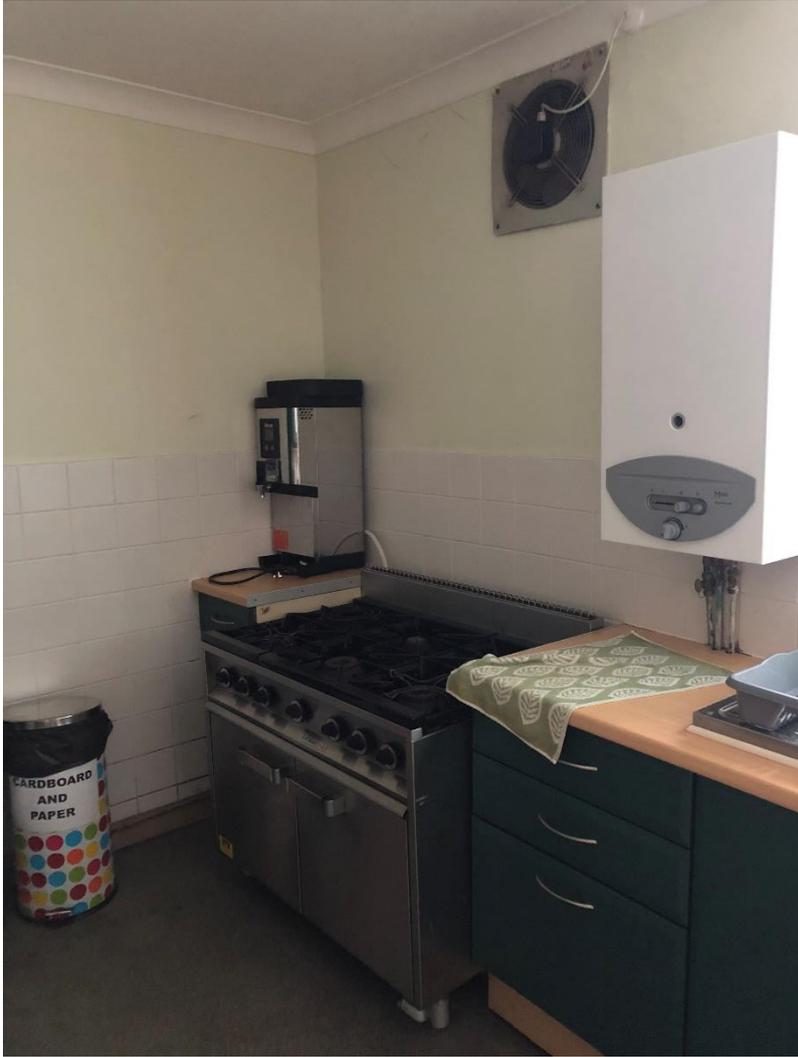
P11 (5887):
Emergency gas shut off/
fan isolator

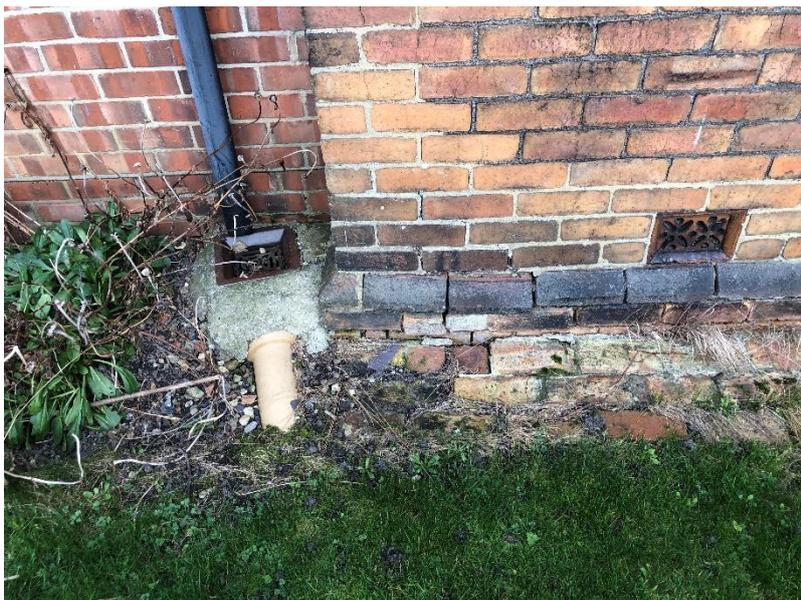
P12 (5958):
Plinth brickwork displacement
