July 2024: Closed church of South Hylton St Mary – Sink hole formation on north wall of church.

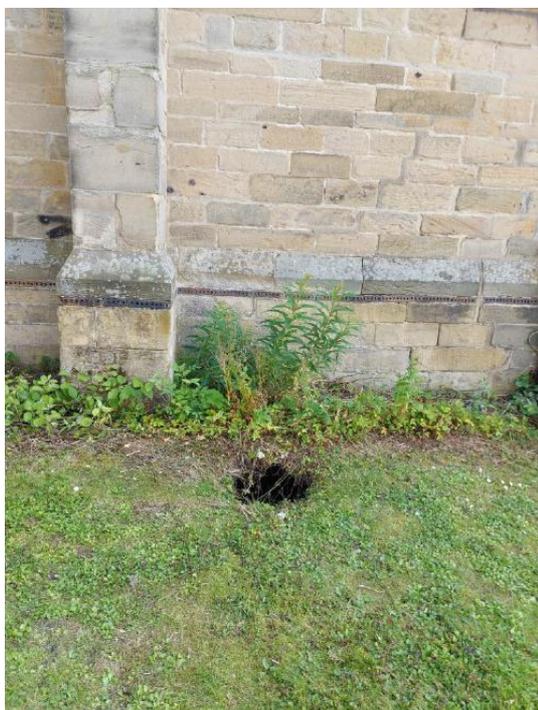
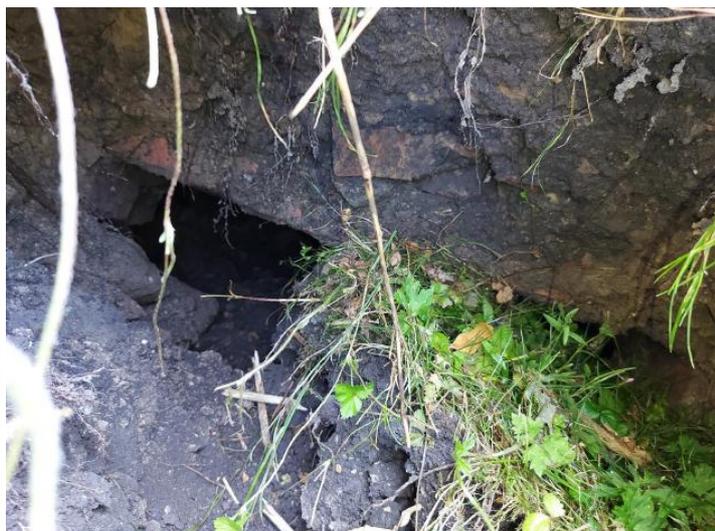
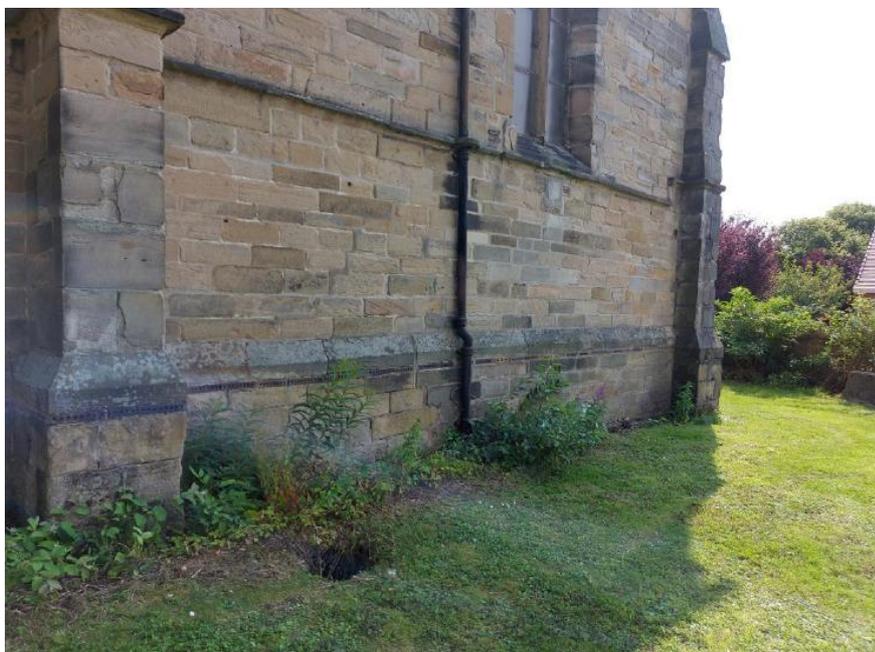
Hole measured approx. 600mm diameter at mouth opening, 2m deep diagonal direction below church north wall foundations, located on north side of church, 7m from the west gable end corner/buttress. Evidence of brick and ash fill.

Area cordoned off. Insurers and Coal Authority notified. See structural engineer's report.
