**Closed church of South Hylton St Mary: Schedule and Statements of Significance and Needs**  
**Faculty Petition OFS Application Ref: 2025-123170**  
**Ground investigations to churchyard and installation of new water pipe.**

**SCHEDULE OF WORKS OR PROPOSALS:**

- i) Investigations into soil, churchyard wall foundations and drainage in the closed churchyard, by Sunderland City Council, in response to formation of sinkhole and ground subsidence.
- ii) Laying of a replacement water pipe through the south and east parts of churchyard.

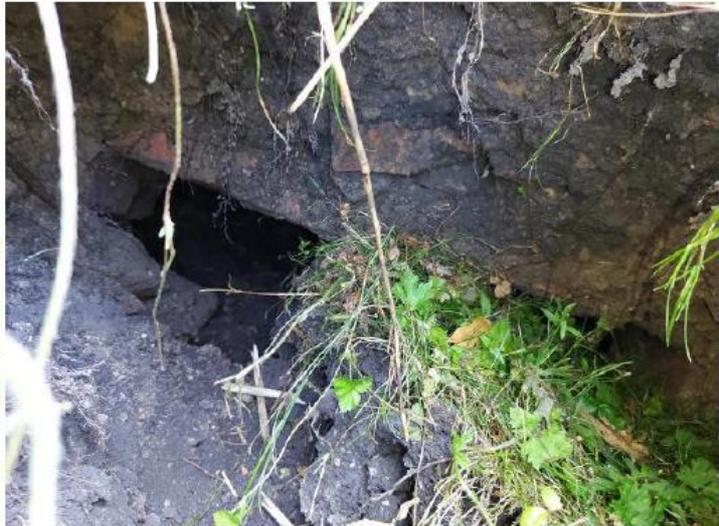
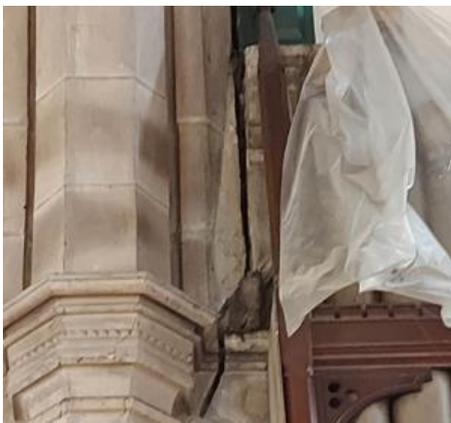
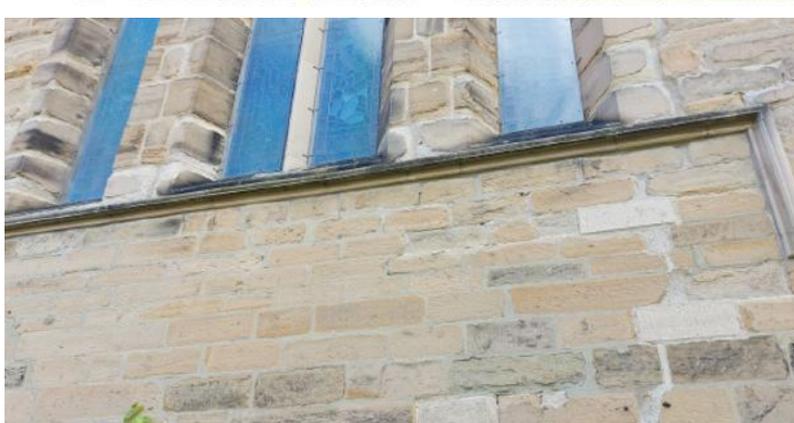
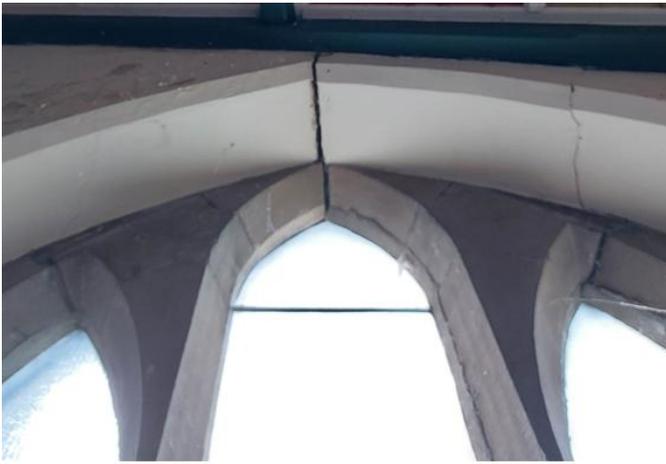
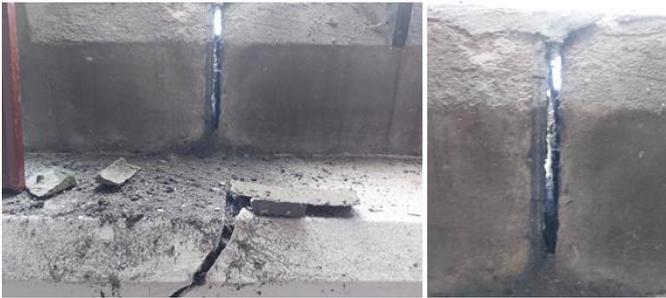
- 2m deep sink-hole formation below n. wall of church.
- Historic and continuing structural cracking and rotation of the chancel around the organ and chancel arches.
- Previous structural pinning and repair of w. end.

- Structural cracking of n. transept window apex, mullions and sill. Structural monitoring in place since 2023 and continue following pointing and packing of the cracks.

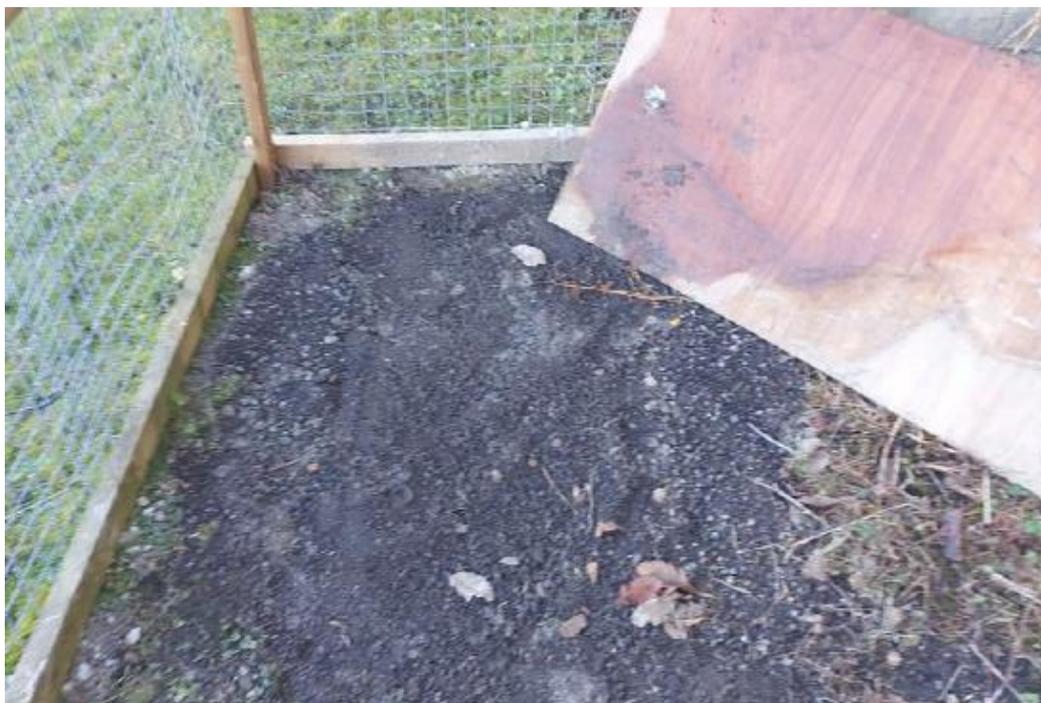
[Refer to photographs of sink hole attached.]

This petition confirms that the churchyard sink hole, which formed below the church building’s north wall (7m from west corner) in July 2024, was filled-in with a lean mix concrete, (a low-strength mix, consisting of 1 part cement to 7 parts aggregate and hand-vibrated to remove air pockets). This was to ensure the void provided with a non-structural fill and to prevent further loss of soil, further water ingress and an increased likelihood of further structural defect to the church structure. This was on the advice of Clach Conservation Structural Engineers following completion of their assessment and report.

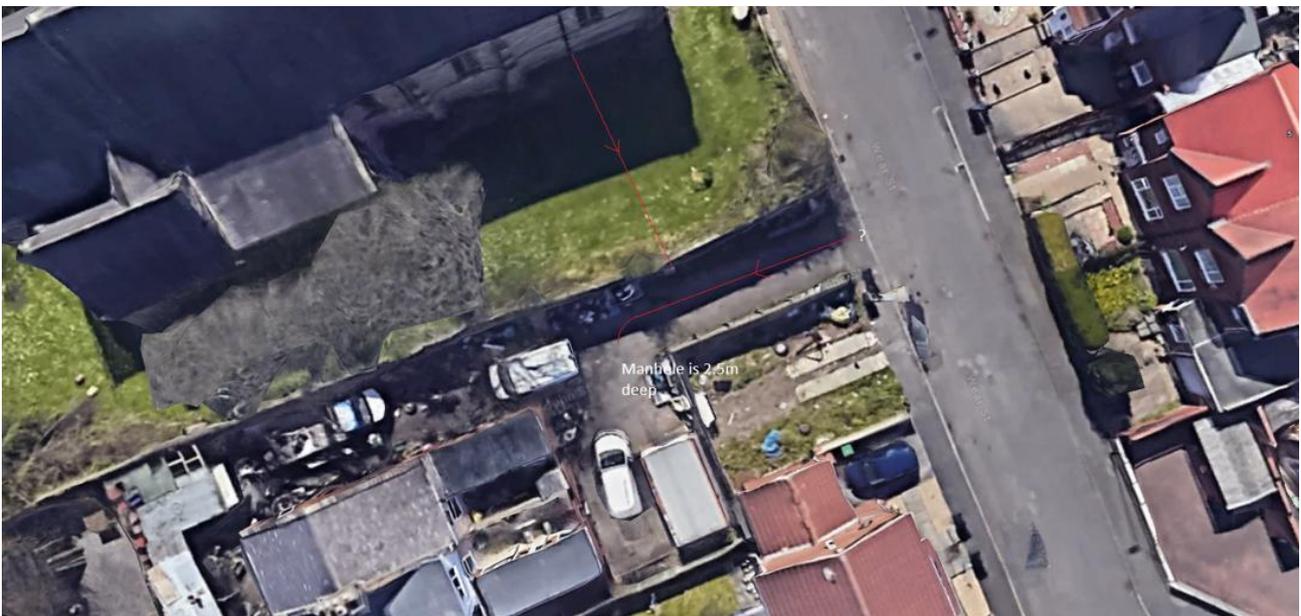
[Sunderland CC Initial Drain Survey Sketch]

However, initial drain survey undertaken by Sunderland City Council and DDBF has indicated at least one gully on the north side (west end) drains through the churchyard and north boundary retaining wall. (Red arrow superimposed on CH Fowler site plan and as indicated on Sunderland Council annotated aerial plan...)

The drain can be identified with cast iron outlet passing through the retaining wall onto the north side of John Street. The drain itself was found to be blocked with only a little water issuing from the pipe and the majority assumed to be “leaking from the pipe at one of the collars upstream” [Report by Sunderland City Council Service Delivery Manager (Drainage)].

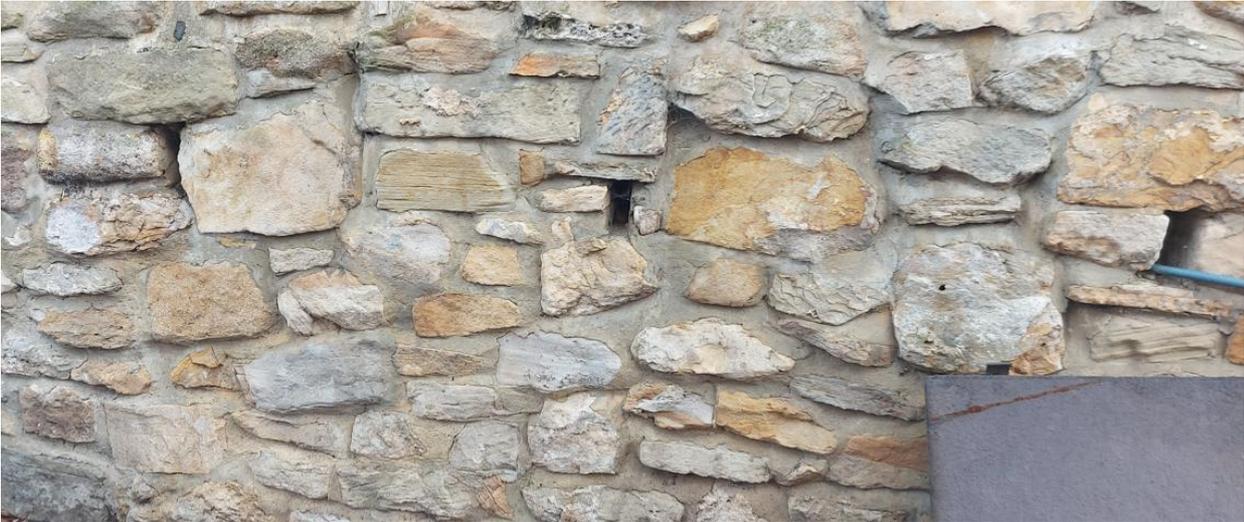
There are no other drainage outlets through the north retaining wall, leading to the assumption that, in addition to this defective drain, all other soakaway drains from the church building terminate within the churchyard boundary. Whilst ground water weepholes are located along the north retaining wall these are dry and do not appear to be providing any effective drainage to the retained churchyard burial ground.

Weep holes along north boundary wall on John Street historically dry, some with nesting birds.

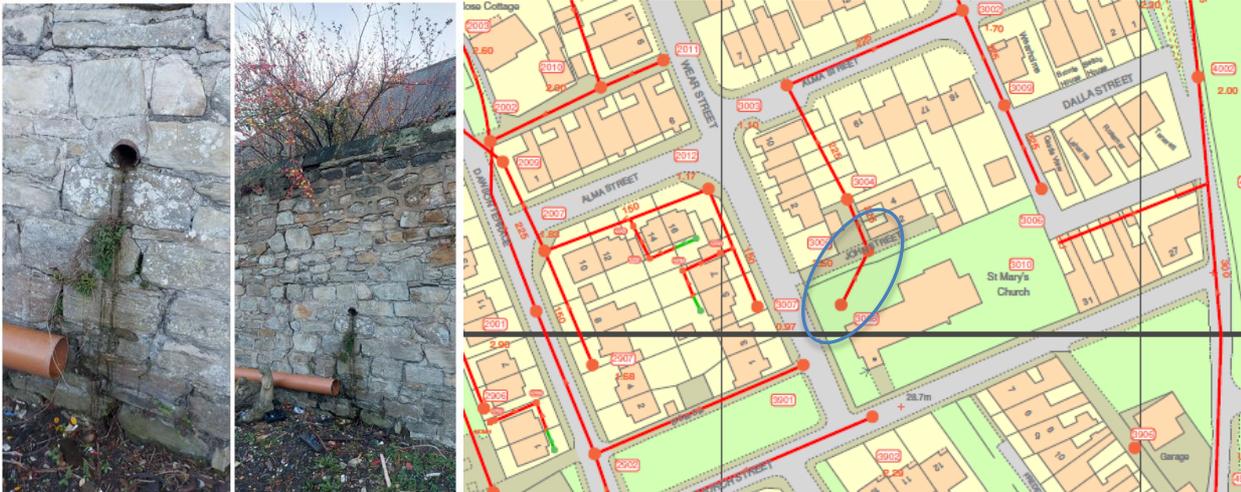
(left) Limited surface water draining from the church building western RWP gully through outlet in north wall.  
 (right) NWL drainage asset plan illustrating combined inspection chamber no.3008 in northwest area of churchyard.

Refer to *NWL drainage asset plan*. NWL suggest a combined sewer inspection chamber (no.3008) located within the churchyard burial ground, to the northwest of the church building. This chamber cannot be located by survey and does not appear to exist. Sunderland Council’s survey confirmed of this combined sewer: “The sewer does not seem to go under the church wall as plotted. It turns approx 90 degrees as shown” [Sunderland CC Initial Drain Survey Sketch]. For clarity, the combined sewer runs downstream, from west (Wear Street) along John Street to inspection chamber 3005 and then turns 90 degrees (to the north).

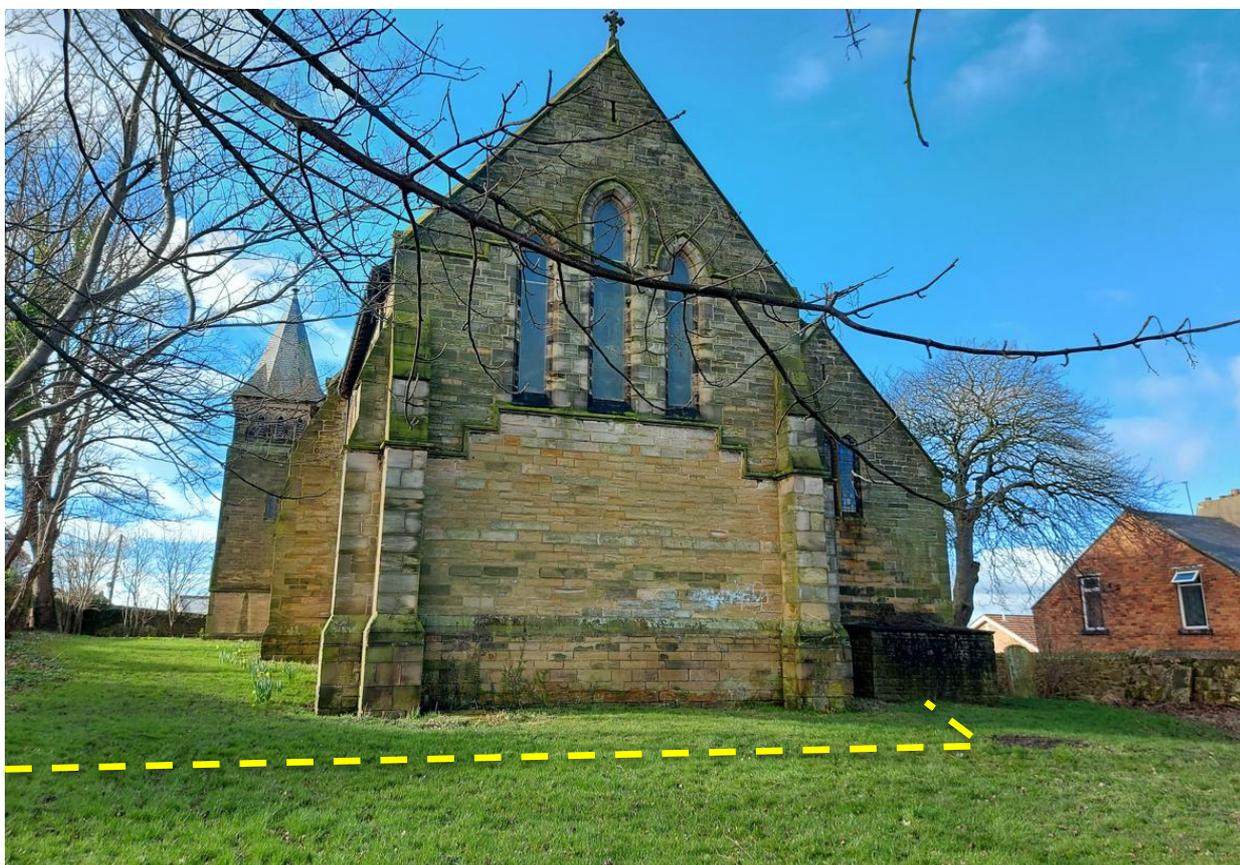
**Option 1 (not preferred by NWL)**  
From location of existing mains supply stop cock on Church Street.

**Proposal:** Two routes were identified for a new pipe passing through the churchyard. Whilst a new chamber with stopcock was fitted on the main supply entering the property in 2023 (Church Street – towards east end of churchyard), NWL surveyor was not satisfied with Option 1 which would involve entering below the south boundary stone wall, due to their concern for the stability of the wall and the proximity of mature trees.

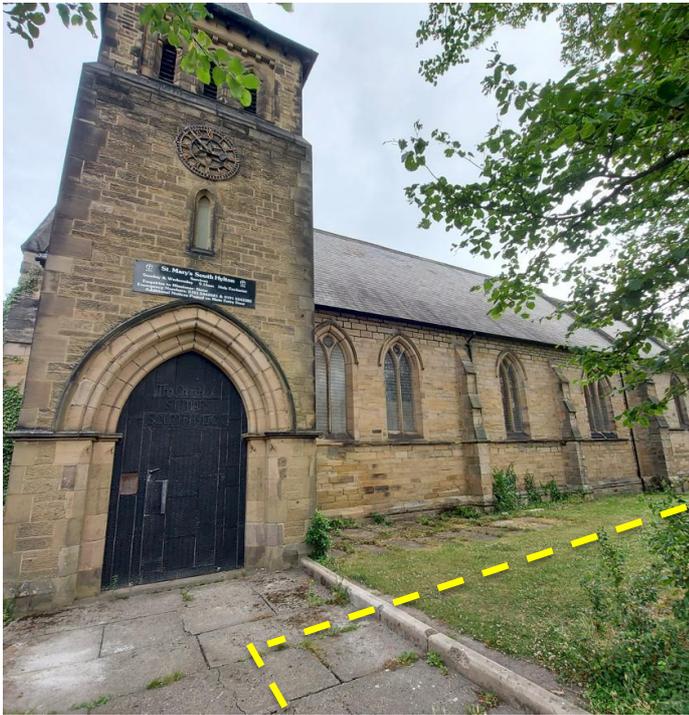
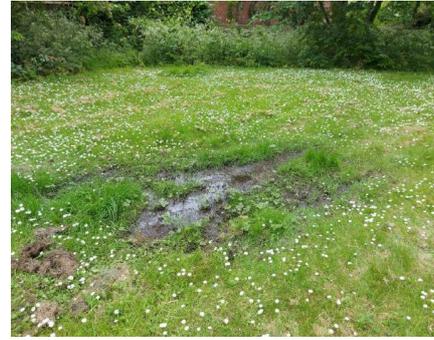
July 2023 mains water leak in the east end of the churchyard. The original lead supply pipe was turned off at the new chamber and stop-cock installed on Church Road.

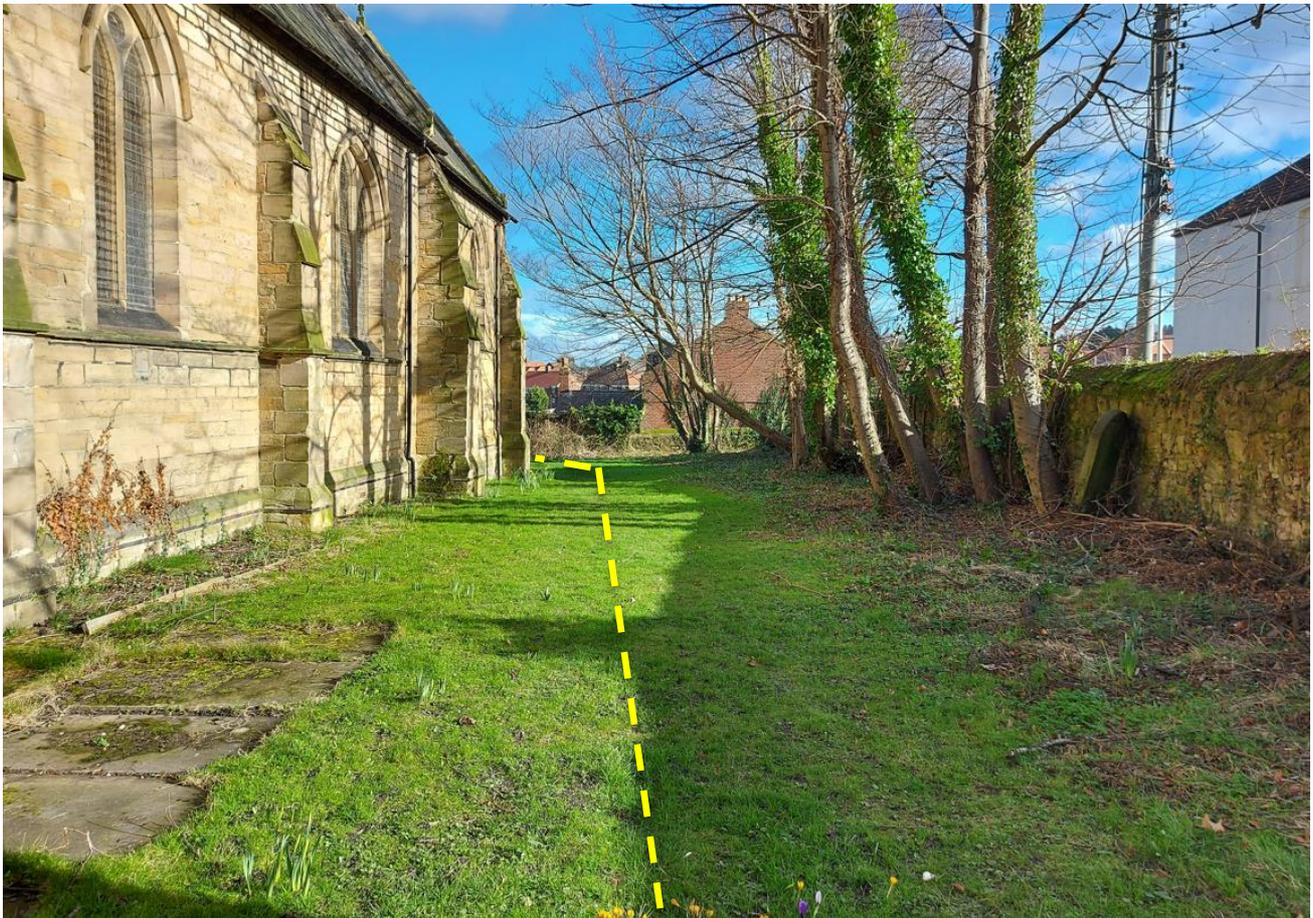
**Option 2 (NWL preferred and proposed route)**

Option 2 would take alternative site entry below churchyard path at the west, avoiding passage below the south boundary stone wall, but would ultimately follow a similar route to the cellar at the east end.

**NWL preference and proposal is for Option 2:** a new mains supply entering the property from Church Street at the west (footpath) end and then running east through the churchyard along the south side of the church building – avoiding burial slabs and gravestones. This despite the longer route and NWL being aware there are unmarked burials dating back to 1821 and the possibility of a hand excavation required.

Proposed depth of trench is 750mm. Whilst NWL stated preference for a grundomat mole between excavated pits. **The DAC advised it recommended Option 2 subject to the trench being excavated by hand.**
