St HILDA
SOUTH SHIELDS
(110)

QUINQUENNIAL REPORT
on the architect's inspection on

8 May 2024

IAN NESS
ARCHITECT
26 GROSVENOR PLACE NEWCASTLE upon TYNE NE2 2RE
tel & fax
0191 281 2559

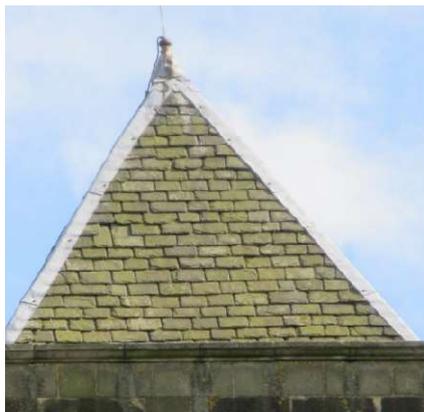
Slate missing from Tower N side

Have steeplejack repair Tower slate and prepare and paint Tower rainwater pipe	18, 42
Have steeplejack clear Tower gutter every two years	20
Clear all gutters, hoppers, pipes, gullies and boiler house steps once a year	31, 32, 34, 35, 37, 38, 40, 51

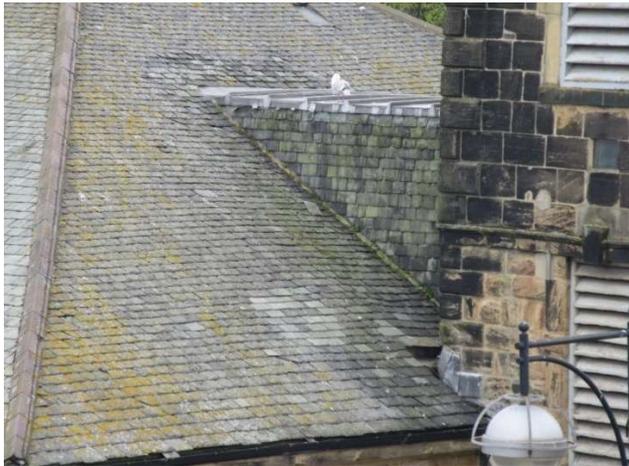
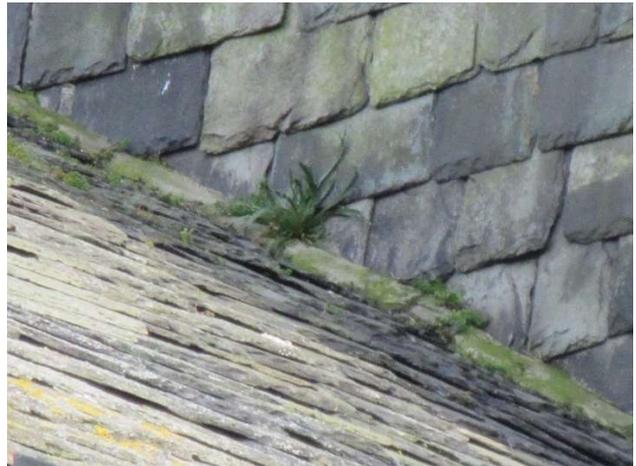
21. A tunnel between the W Tower and W hip has a flat lead roof and slate cheeks all seeming in good order except plants in a mortar fillet between the N cheek and the hip slates must mean the fillet is cracked and leaking. At S side no fillet, indicating concealed lead soakers.

plants in cracked mortar fillet N of the tunnel between Tower and Nave roof and a slipped slate lies on lower slates

Restart clock	16
Strip and remake mortar fillet at N side of slate tunnel from Tower	21
Repair slates at E hip, S Nave W end, W hip	22, 24, 25
Prepare and paint Song Room NW pipe	39
Re-align rainwater pipes at Song Room NE	39
Prepare and paint external joinery	65 – 68
Powder coat the mesh window protection, clean windows	99
Renew failed lamps	126

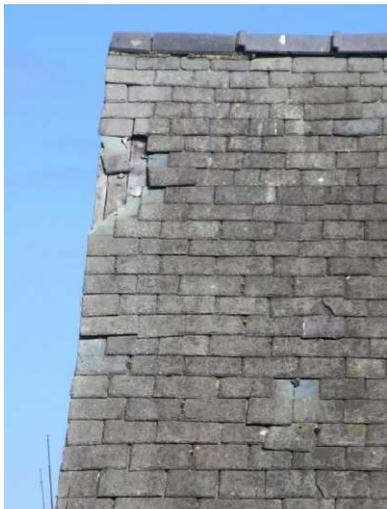
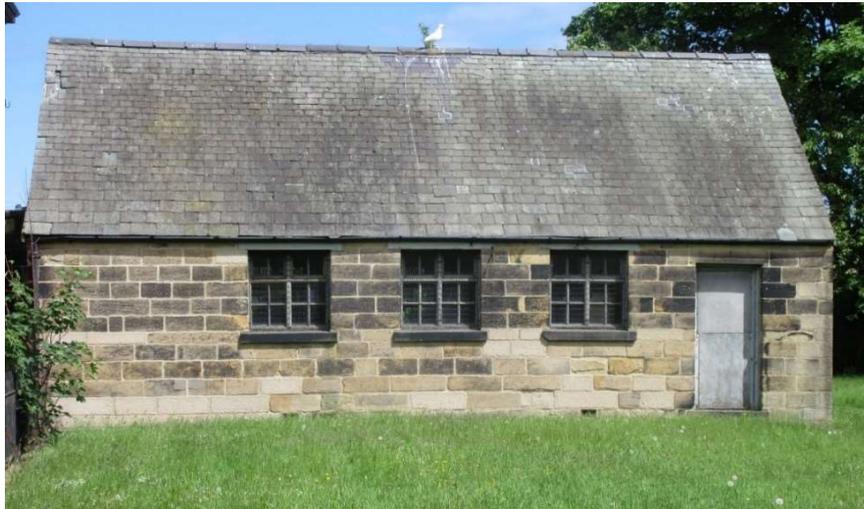
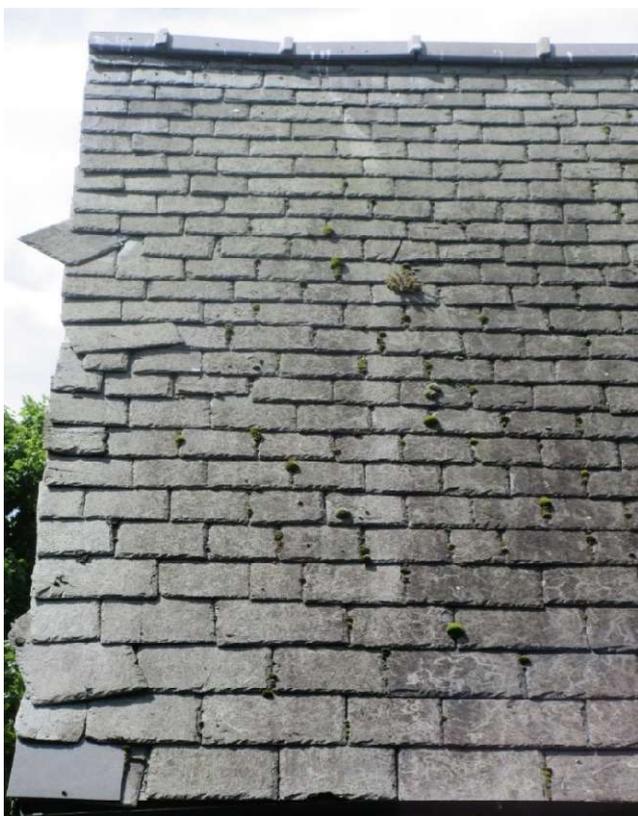
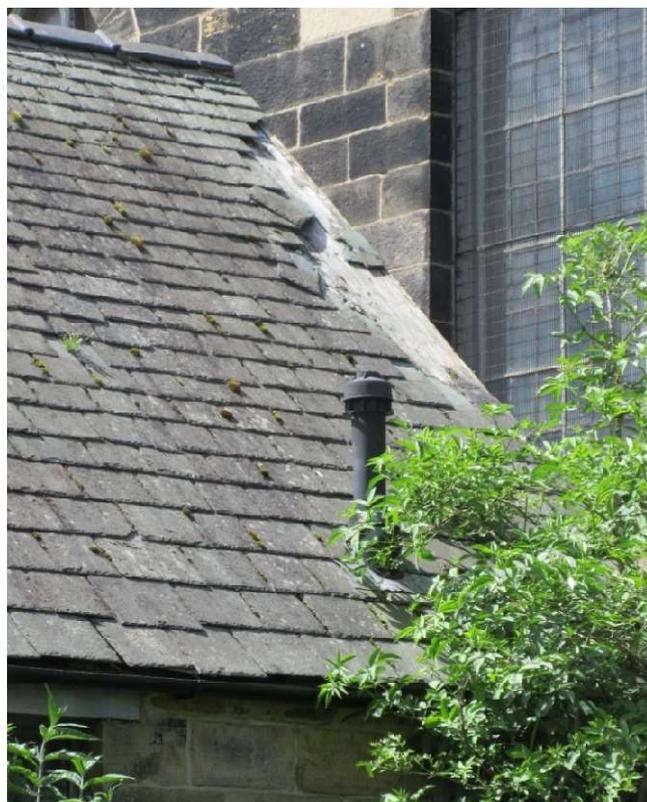
Song Room E side

26. Song Room diminishing westmorland slates on boards. Some welsh patching at ridge and N verge. Mostly fair but patches now completely missing at N ends of both sides (largest at the more obscure E side) suggesting vandalism while standing on the flat roofed link to church, At E four others slipping, one missing. At W two others slipped out, one slipping. Others held with wide beads of mastic (not a permanent repair).

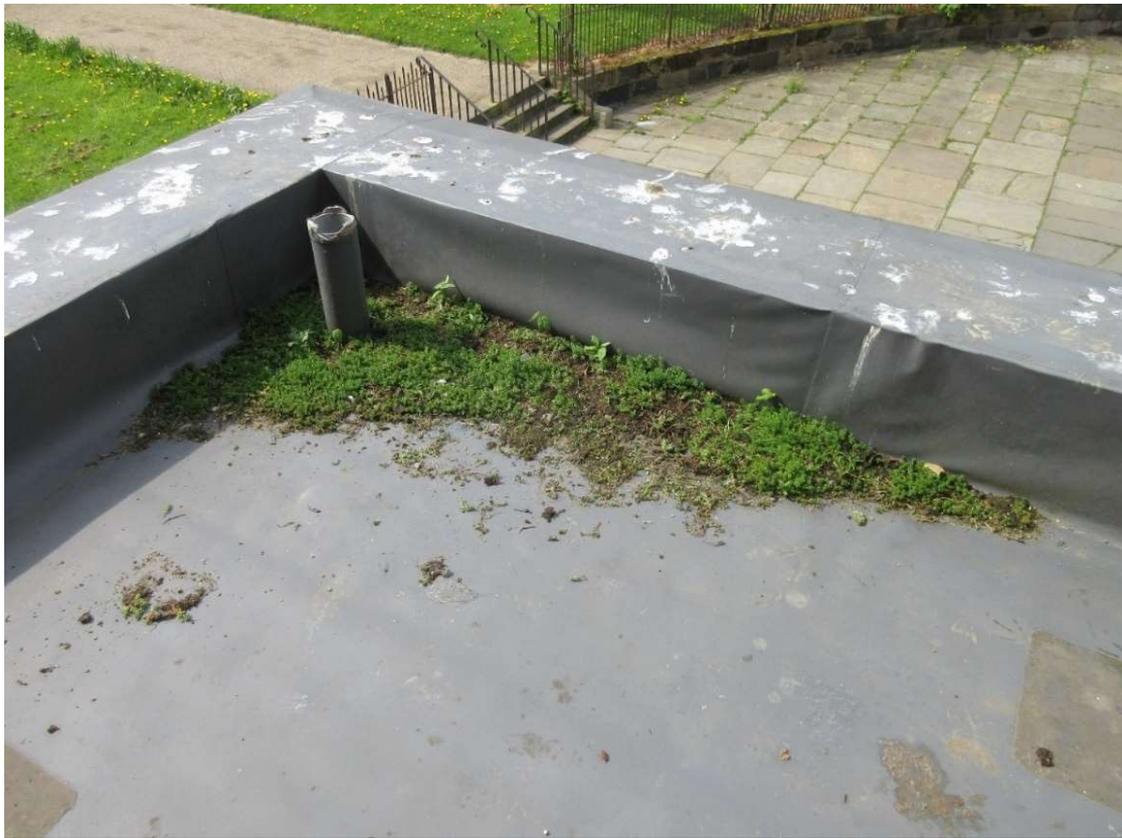
27. Porch link has shallow pitched green mineral felt with upstands turned into Nave and Song Room walls.
28. Vestry and Kitchen covered in flat Sarnafil pvc membrane with deep upstands carried over parapet copings and their cast stone cornices. Sumps with side outlets through the parapets. Both roofs have patches in a different material, seeming sound but with unknown life.
29. Kitchen upstands silicon pointing into church joints. Eight patches. Silt build up in corner and in the sump, below which the ceiling is damaged suggesting leakage.

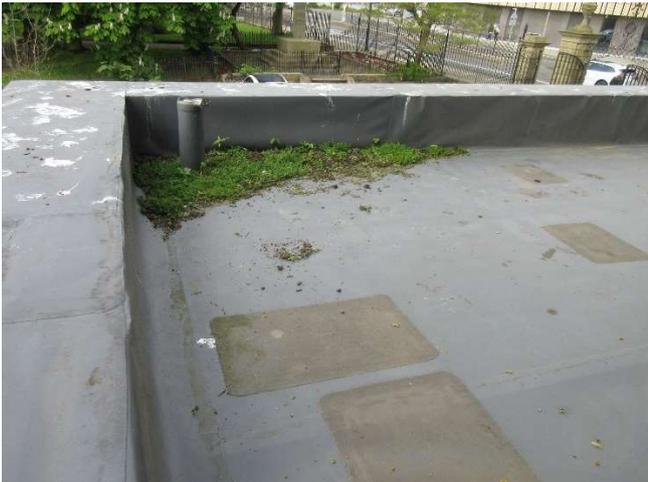
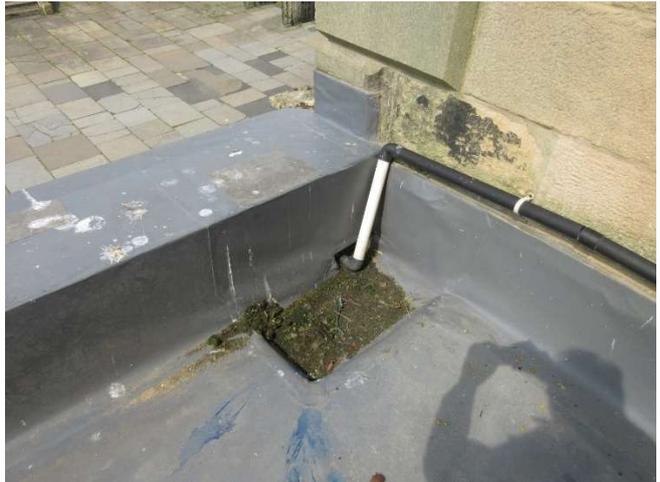
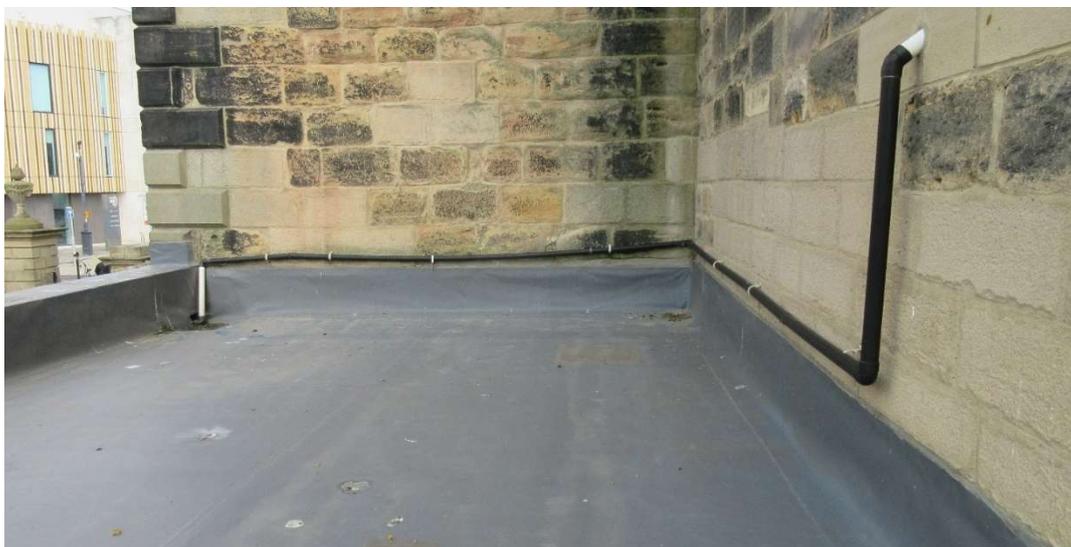
Kitchen roof with condensate drain from boilers now extended to outlet sump

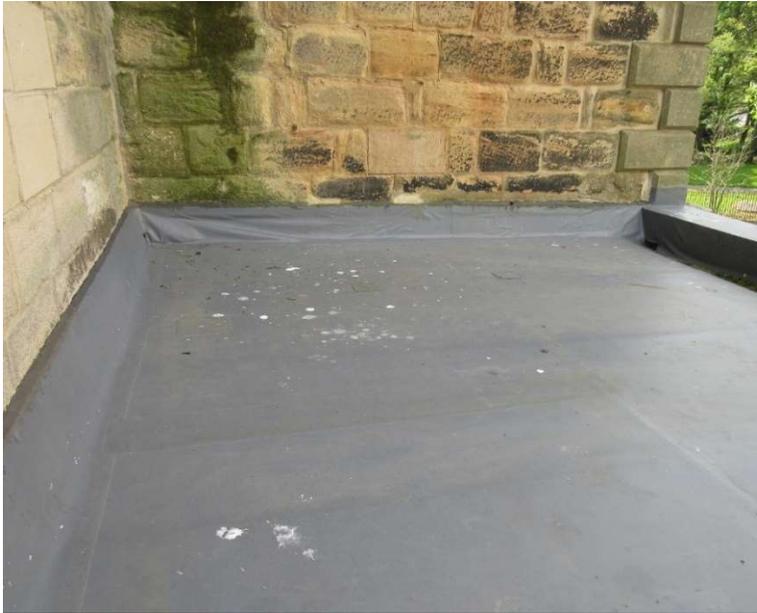
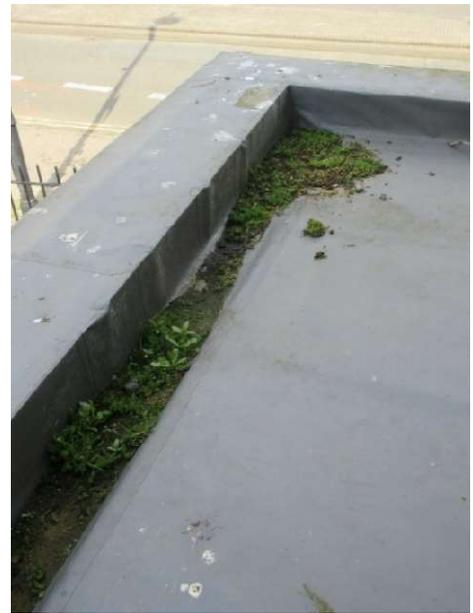
Vestry Roof

30. Vestry Sarnafil appears sound. Has been improved since last report with sealant fillets over the upstands. If there is any future leakage it may be better to change to the stronger upstand detail recommended by Sarnafil (metal strip with sloping silicon top bead) but note water running down the Vestry interior may bypass the roof through a void in the Tower wall during severe overflow from the Nave gutters (para 34) Seven patches (four Sarna, three substitute – well stuck but limited life). Silt and plants in the internal gutter.

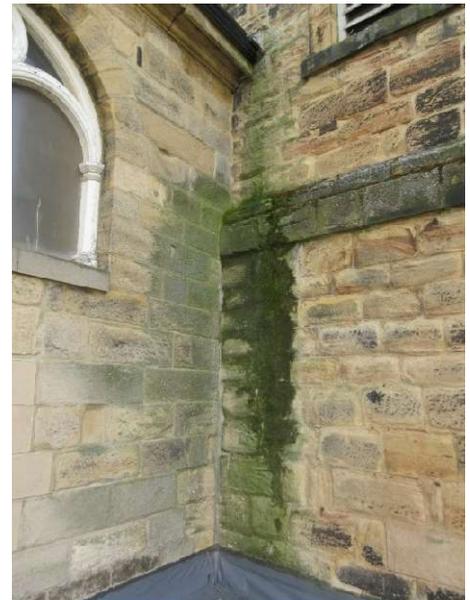
wall over Vestry remains wet

34. Water appears to run down the stone wall under the W end N gutter (over Vestry) which is green with damp. Reported runs on the Vestry wall below probably caused by storm water spills causing the green algae and bypassing the roof upstand through the wall. The secret gutter and cornice gutter above (appear clear now but have been blocked previously) need to be kept clear.

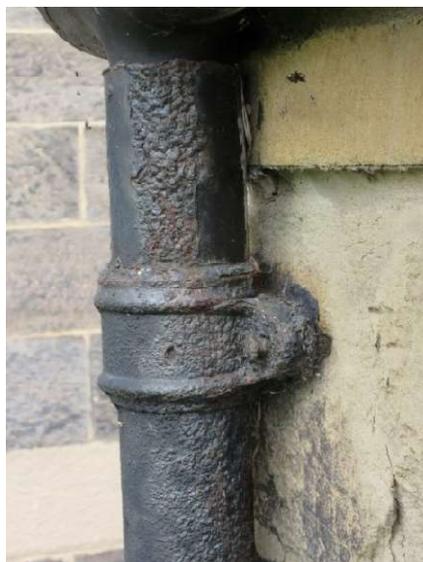
Song room NW

39. The Song Room has plastic half round gutters, old cast iron hoppers and one rusting pipe at NW. Other pipes plastic, including at the Porch link a pipe still so loose and misaligned that it appears to end in a hole in the stone wall. Now so overgrown by a shrub that difficult to see.

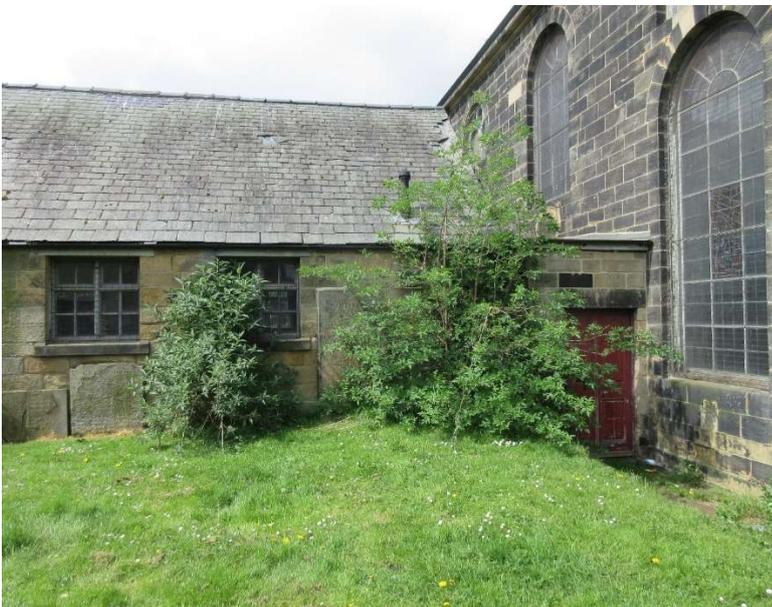
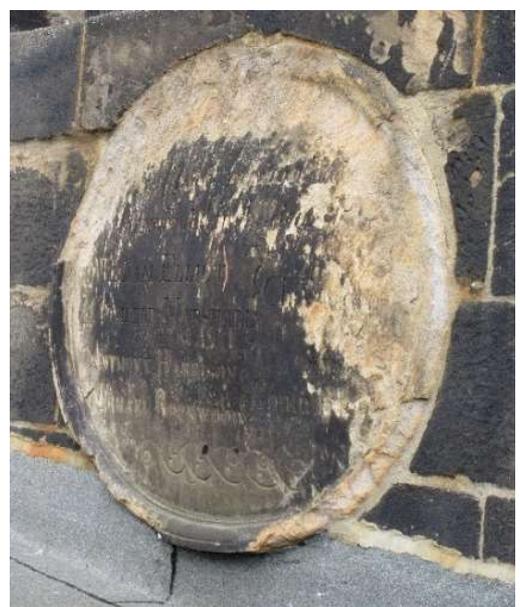
Hidden plaque over Song Room porch

- 46. A hidden oval tablet over the S Porch erodes from the edges.
- 47. The rendered Vestry, Kitchen and stair walls have tempted spray painters but are clear now. A large patch lost at S end exposes solid brickwork. At W open joints in the exposed brick below the render would be better pointed.

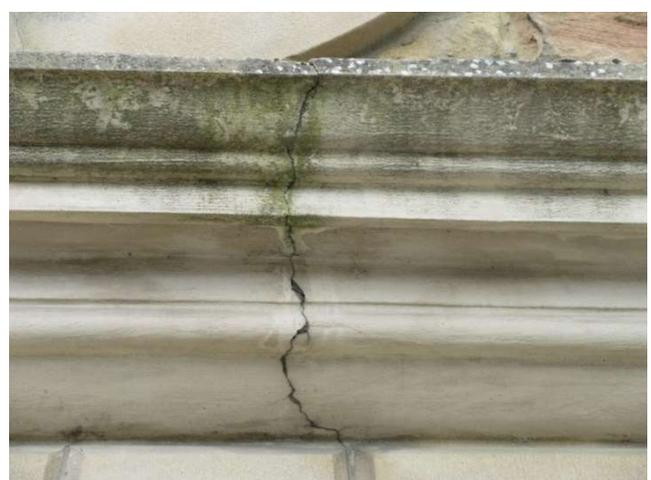
para 49

49. Where the Vestry/Kitchen cornice continues across the Tower ground floor it is not capped. Its sloping mortar top is mossy. The cornice has cracked slightly in two places, one extending down to a slightly cracked joint in the entry arch.

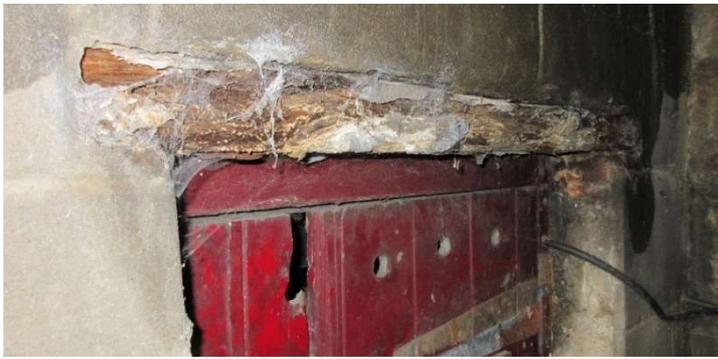
53. At one side a small Organ blower room has a flat roof with parapet above general paving level. After flood the door lintel, electrical switching and blower were replaced, the blower now raised on blockwork as a precaution. The lintel is decaying again. Both doors are pierced and air is drawn through into the Organ so the blower room is ventilated and said to be dry (no access 2024).

Decaying Lintel at Blower door

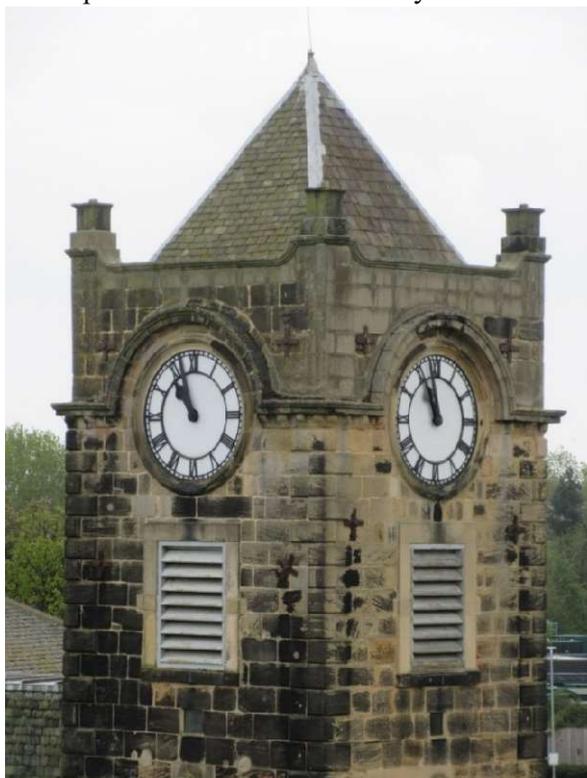
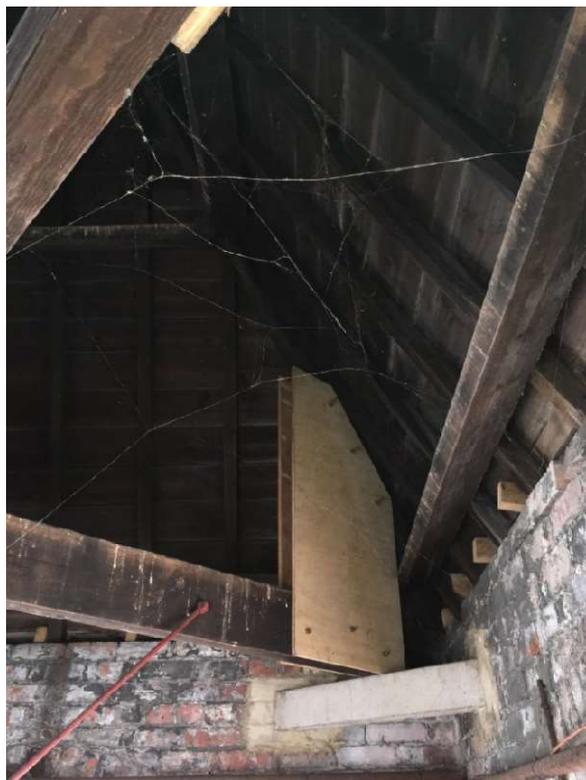
Tower roof timbers 2019 including 1999 repairs

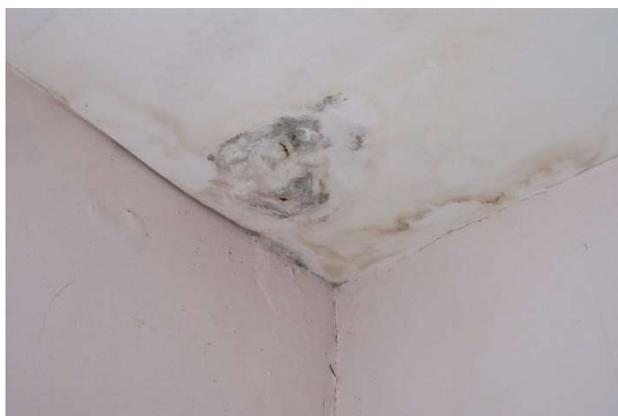
74. Song Room painted flat and sloping softboard without insulation quilt. Minor watermark by small hatch. Its lobby sound painted boards.
75. Plaster at the Kitchen and lowered accessible wc ceilings sound except water damage at Kitchen ceiling and wall in corner under the roof sump and outlet.

NW corner of Kitchen ceiling

Repair (and alter?) the E end margin, to prevent collapse and improve appearance	50 – 56
Renew or paint metal sign by N door	68
Repair plaster in corner of Kitchen	75
Clean off external stairs and landings, cover with asphalt with upstands to dry both wcs	76 - 78, 89, 90
Improve level access and appearance at main W entrance	134

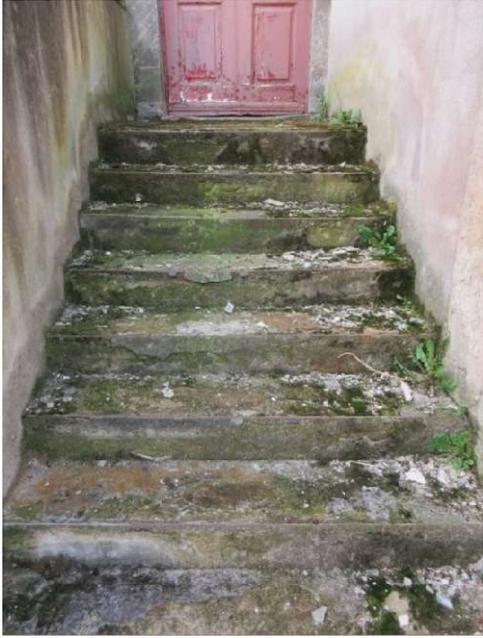
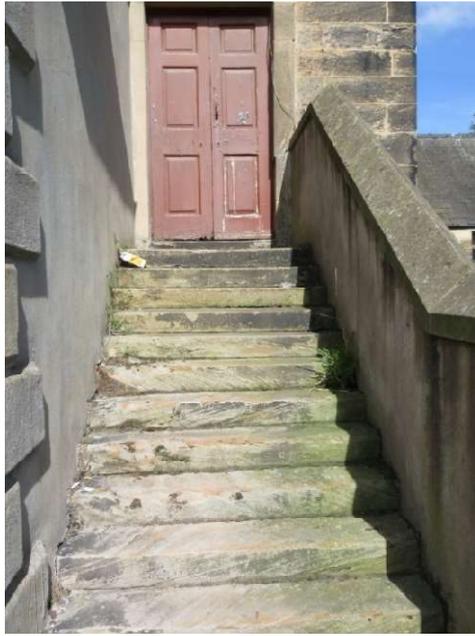
para 76

76. There are single wcs under both NW and SW external stone landings and stairs, which have no waterproofing. Cement skim on the NW stair is crumbling. The solid outer walls are rendered (part missing at S) but may have no dampproof courses preventing rising damp. Both wcs are damp.
77. The S wc has fully tiled walls and floor, beginning to loosen.

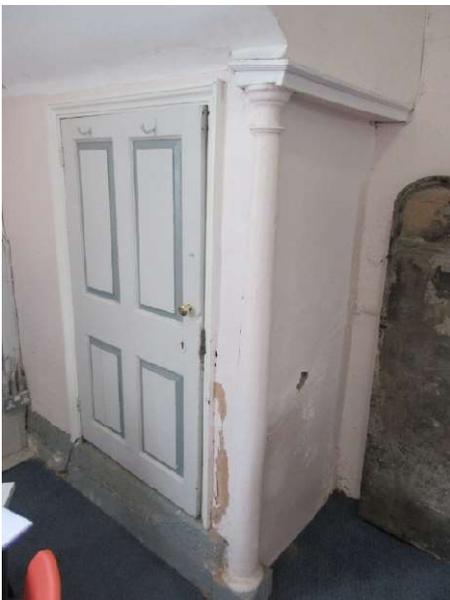
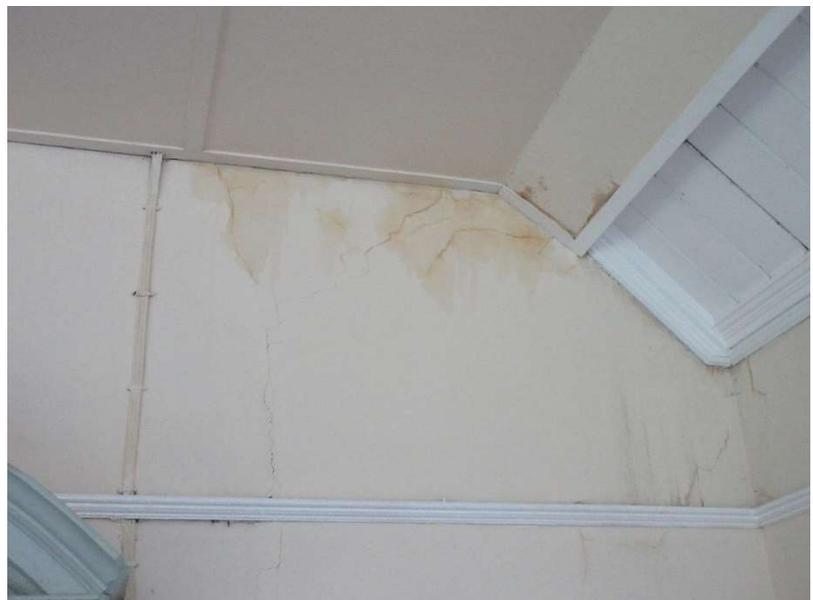
90. In the Vestry wc masonry paint all damaged by damp.
91. At Song Room NE corner top of wall and part of ceiling discoloured under the worst roof slate damage.

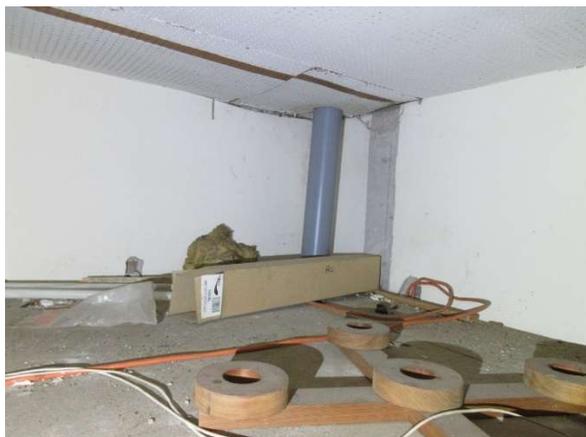
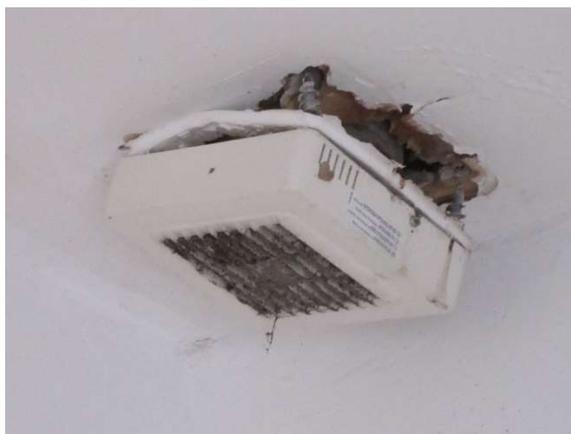
94. Access wc off the Kitchen has a ceiling extract fan ducted through a ceiling void and the flat roof, switched with PIR light without overrun timer. The fan has dropped from the ceiling but works. Cowl broken so fan exposed to rain down the duct pipe.

Vent pipe through void over wc off Kitchen and its dropped fan

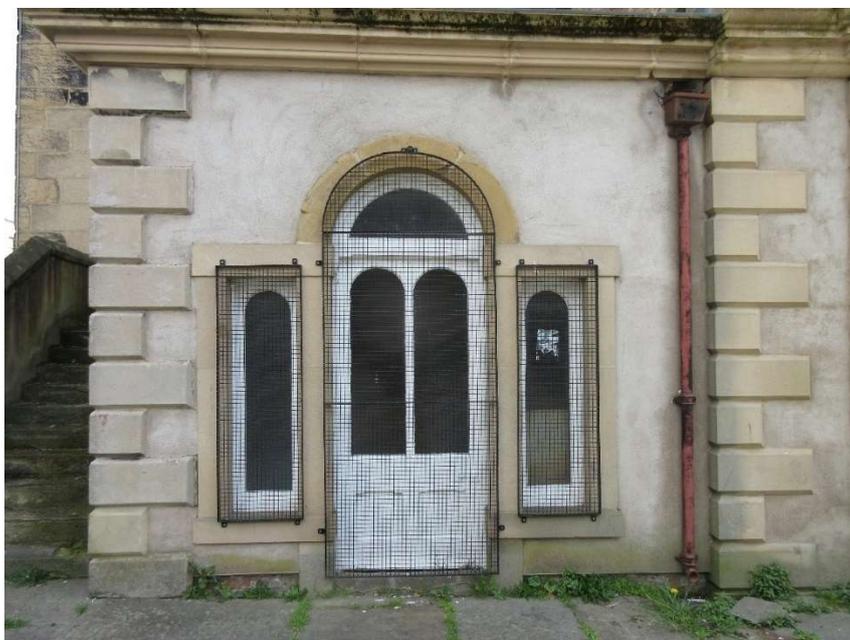
paras 98 and 100

99. Grey painted mesh at the Apse. Black painted mesh at Song Room and lower Nave windows. All have some rust. If the mesh is removed and powder coated it may last many years. The windows should be cleaned and painted at the same time.
100. Recent mesh added at Vestry and Kitchen (para 62).

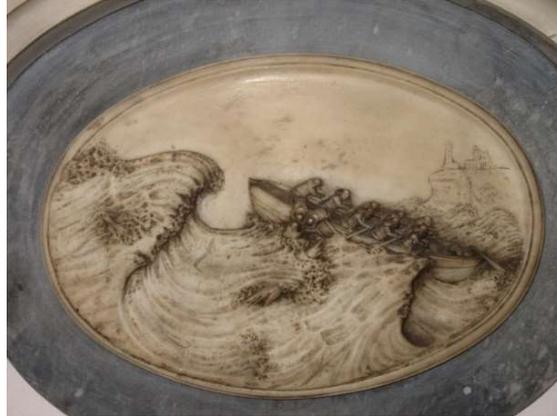
111. In Vestry wall monument part hidden by floor safe.
 In Kitchen large Pemberton monument in painted Doric aedicule.
 In Nave and Visitor Centre 14 marble classical wall plaques all good quality but dirty in places. Five more in Gallery of which four are very high quality and deserve care and publicity to visitors. At S one is patched after loss of some marble.
 The NE Gallery monument is poorer in design, large part missing and may be better removed than repaired.

Example of fine but dirty marble monument

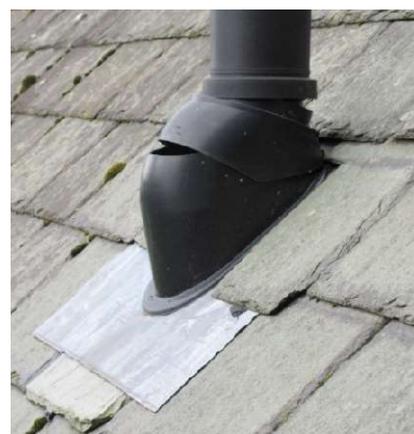
Combi flue at Song Room
