**Quinquennial Inspection Report  
Holy Trinity Church, Southwick, Sunderland  
Diocese of Durham**

David Jowett - Architect, BA, DipArch, RIBA  
25 Roseworth Avenue  
Gosforth  
Newcastle upon Tyne  
NE3 1NB  
Tel: 07788 710 204  
email: [david@davidjowett-architect.co.uk](mailto:david@davidjowett-architect.co.uk)

6 May 2026

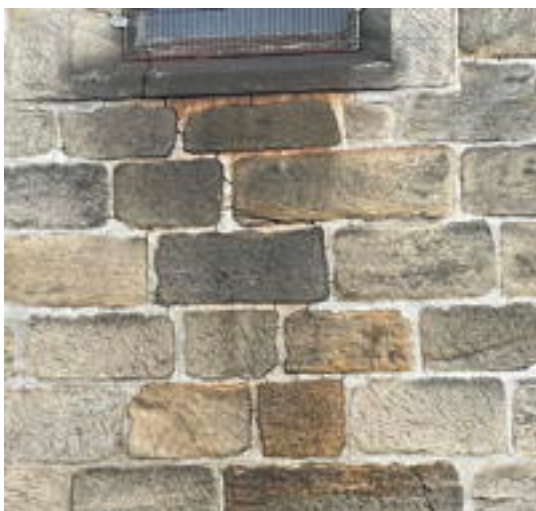
**West Elevation South End Cracking and Staining**

Overall condition of the nave north, south, and east walls is satisfactory. Nave west elevation, both north and south sides, has areas of loose mortar around the windows.

Arrange inspection with stonemason to advise on schedule of future stonework repairs and repointing in order of priority. Cost Band 1–£0.00-£1,999.

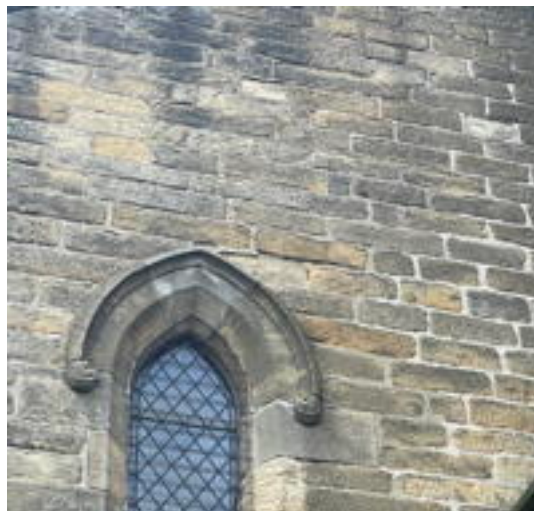
**West Elevation North End Eroding Stone and Cement Pointing**

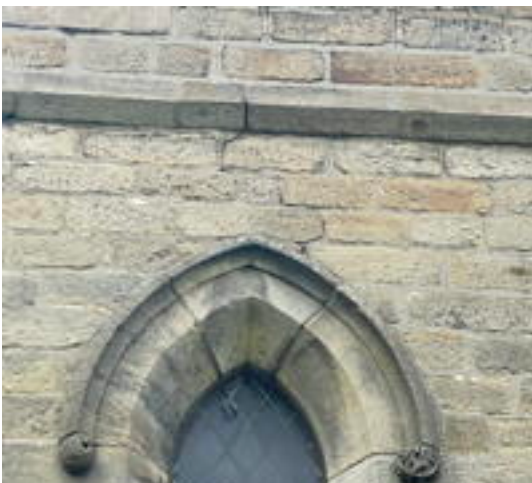
**North Elevation Cracking**

Vestry, north, north east and east elevations all have areas of decaying stonework.

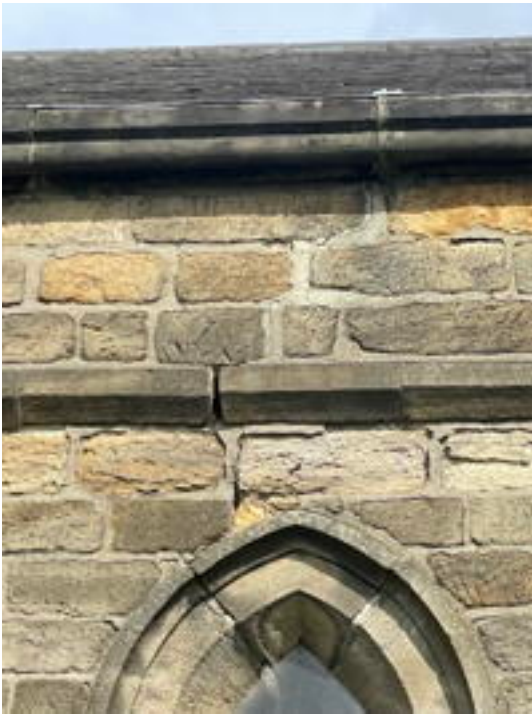
**Chancel South Elevation Open Joints and Eroding Stonework**

Chancel south elevation has open joints, decaying stonework and cement pointing at high level

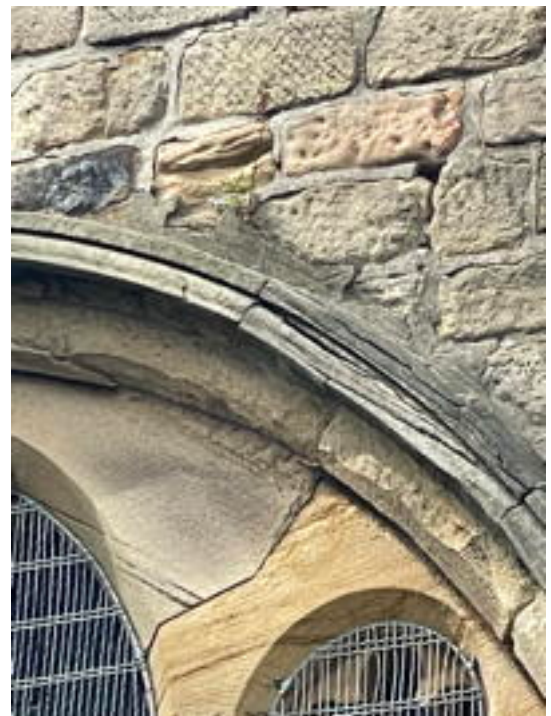
**Chancel East Elevation Open Joints and Eroding Stonework**

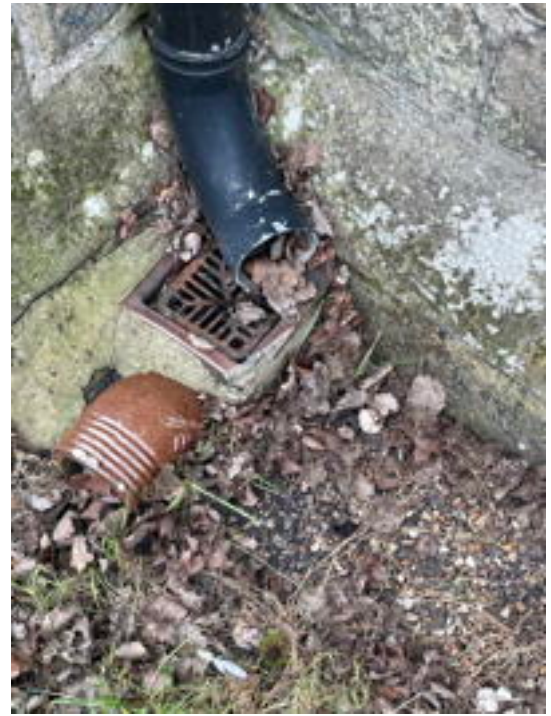
**Gully Not Connected to Drain**

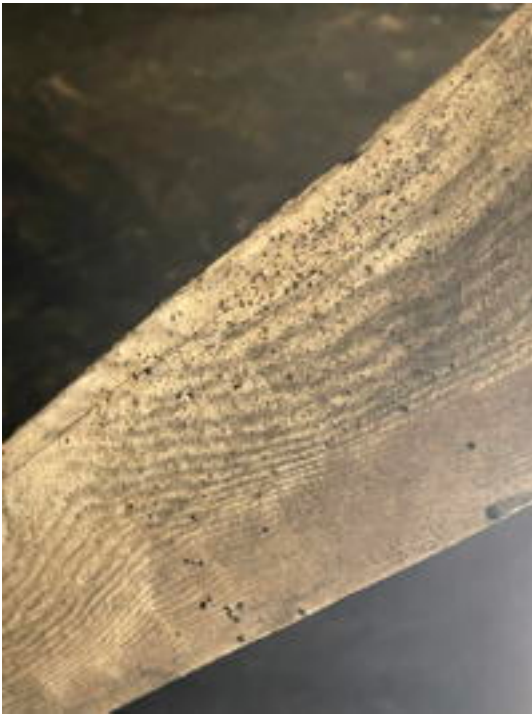
**Woodworm at Fourth Stage**

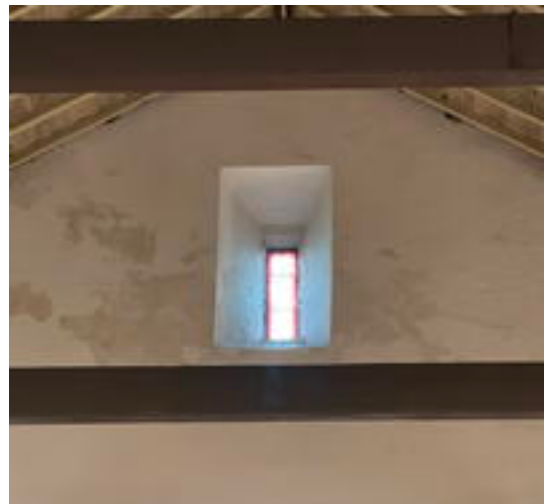
**Nave East Residual Damp**

All decorated since the last quinquennial with clay paint and looking very good. Residual damp still drying out following stonework repairs to the east end of the nave at high level, and can be expected to take a minimum of another 12 months, or considerably longer, before being fully dried out.

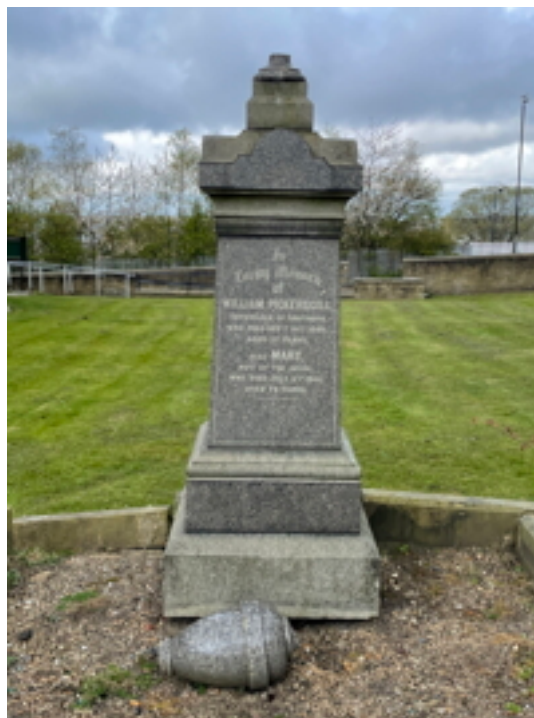
**Tombstone to Charles Pickersgill**

The top section of the tombstone has come dislodged and should be repaired.

Arrange repair of the tombstone with the Local Authority. Cost Band 1– £0.00-£1,999.

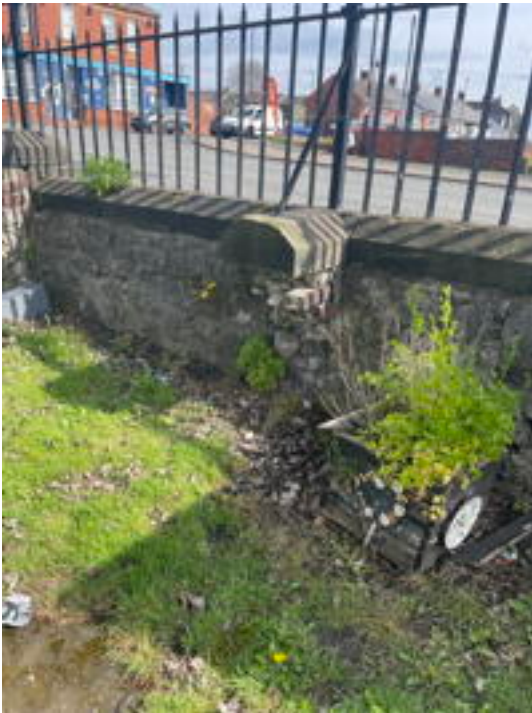
The stonework walls are in many areas suffering from lack of pointing, shrubs growing within walls and in one area, partial collapse. The east elevation railings are in need of decoration.

**Collapsed Buttress East Elevation**

Arrange repairs of boundary walls with the Local Authority. Cost Band 1– £0.00-£1,999.

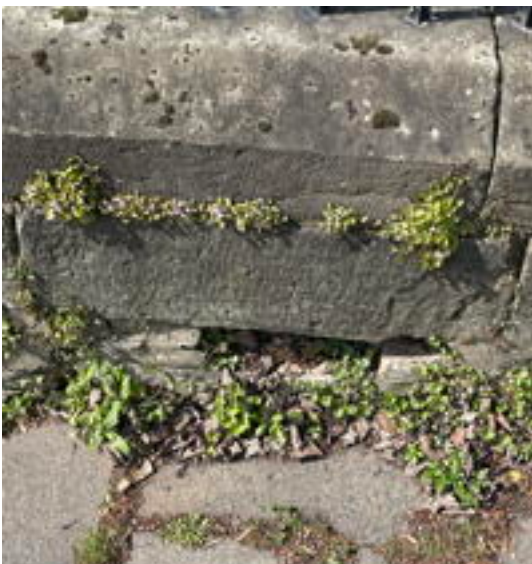
**East Elevation Wall Typical Missing Pointing Plant Growth**

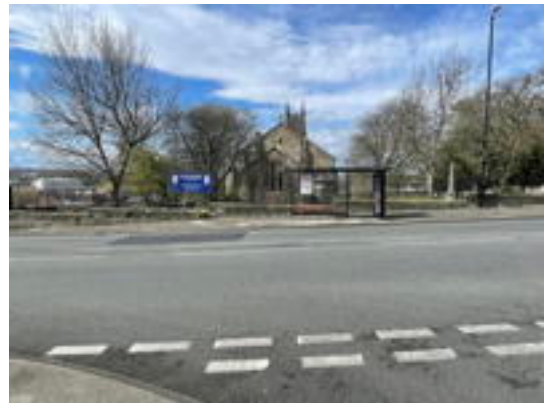
**East Elevation Wall Missing Pointing, Plant Growth and Rusting Railings**

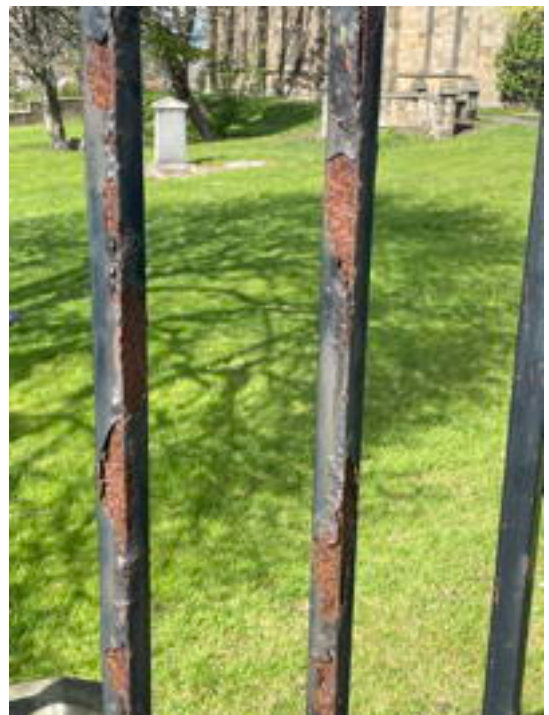
**East Elevation Typical Rusting Railings**

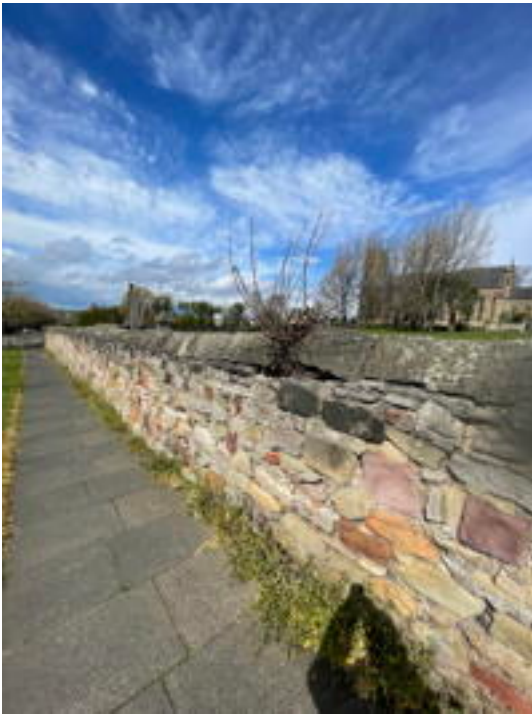
**South Elevation Shrub Growth**

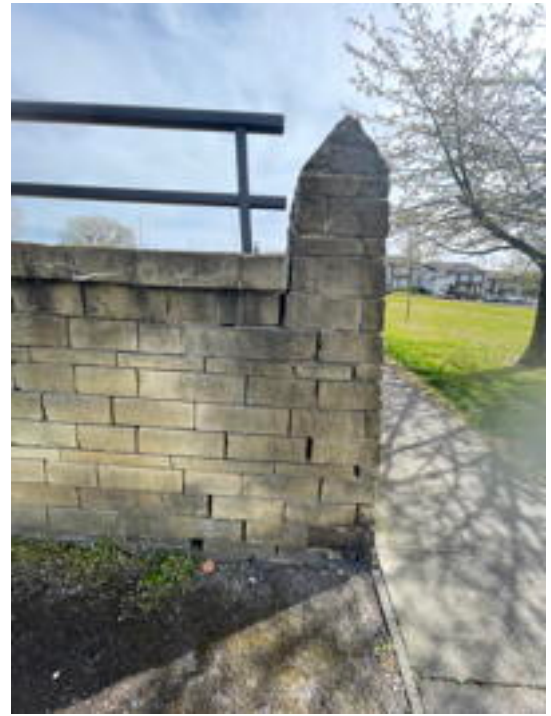
**South West Corner Movement**

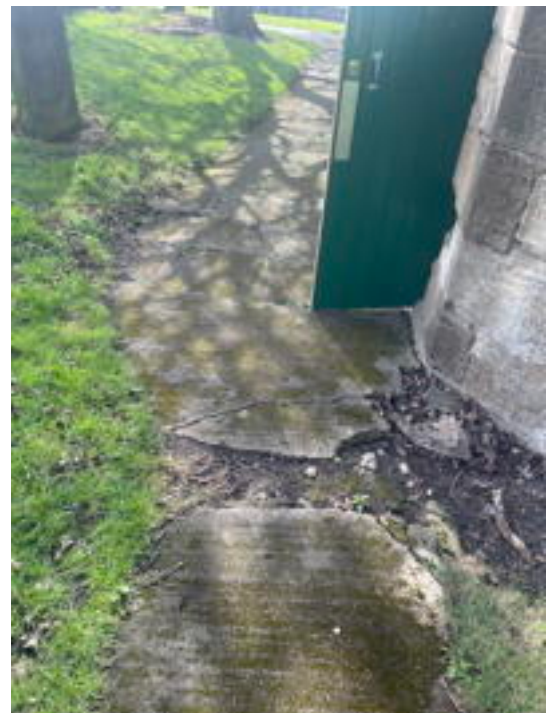
**Broken Pathway by Vestry Door**

Most is generally in satisfactory condition. The paving to the pathways, especially at the east boundary, has some uneven and broken flags that could cause a trip hazard and should be levelled. There is broken section of concrete pathway adjacent to the Vestry door.

Arrange repair of pathways with the Local Authority. Cost Band 1– £0.00-£1,999.

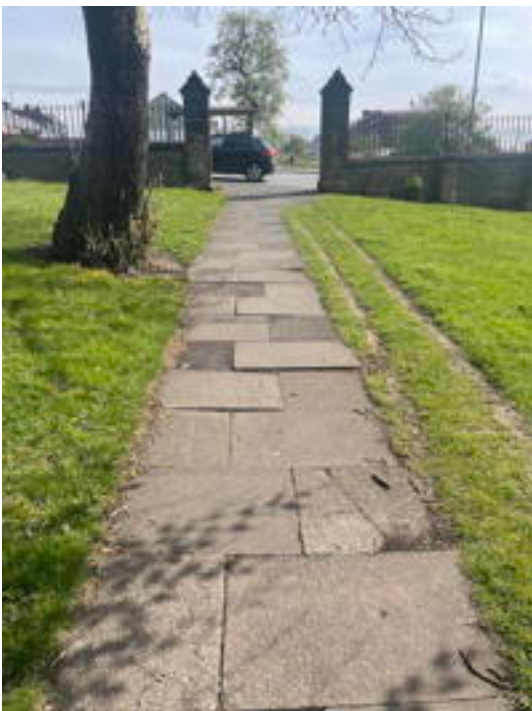
**East Boundary Pathway**
