Diocese of Durham

**St Mary, Staindrop**

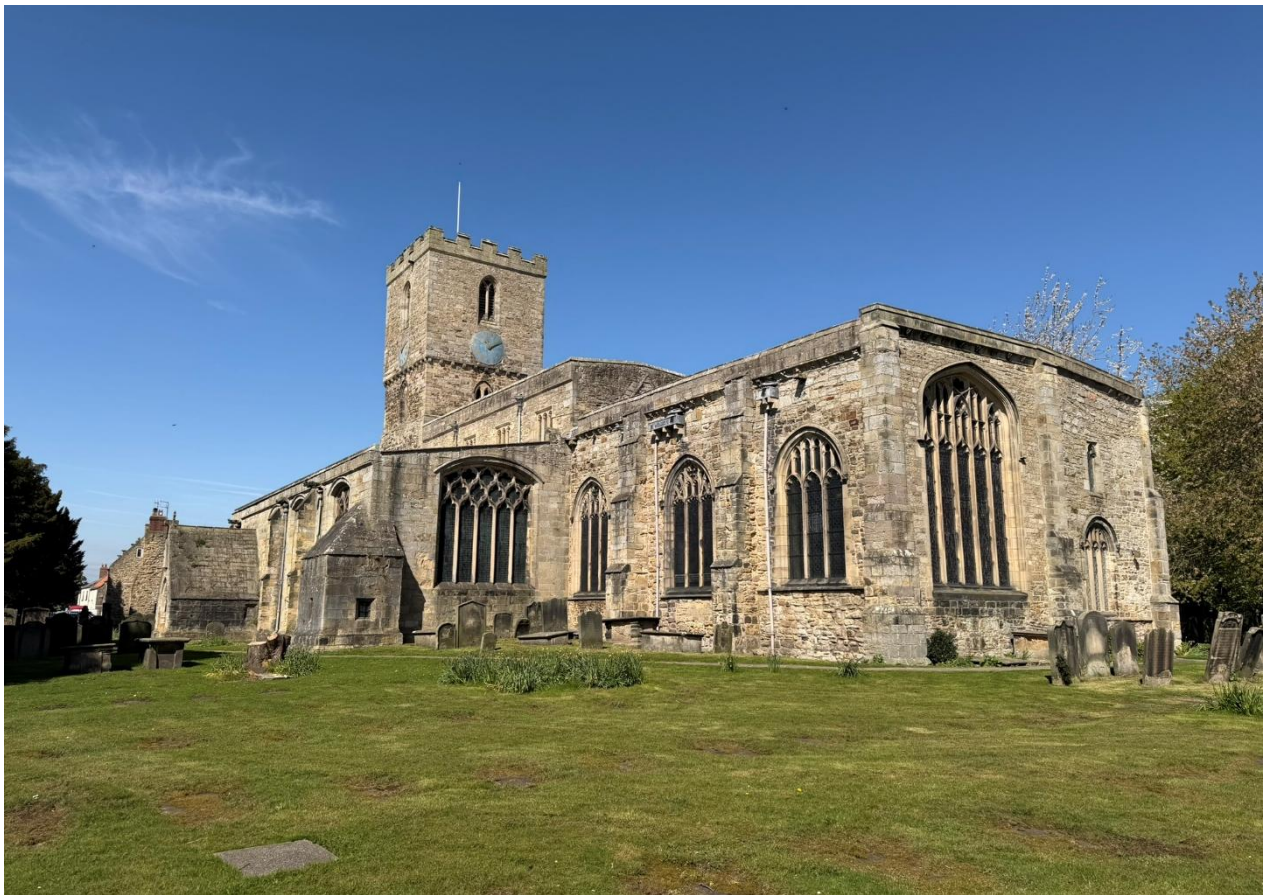
Incumbent – Revd Canon Eileen Harrop

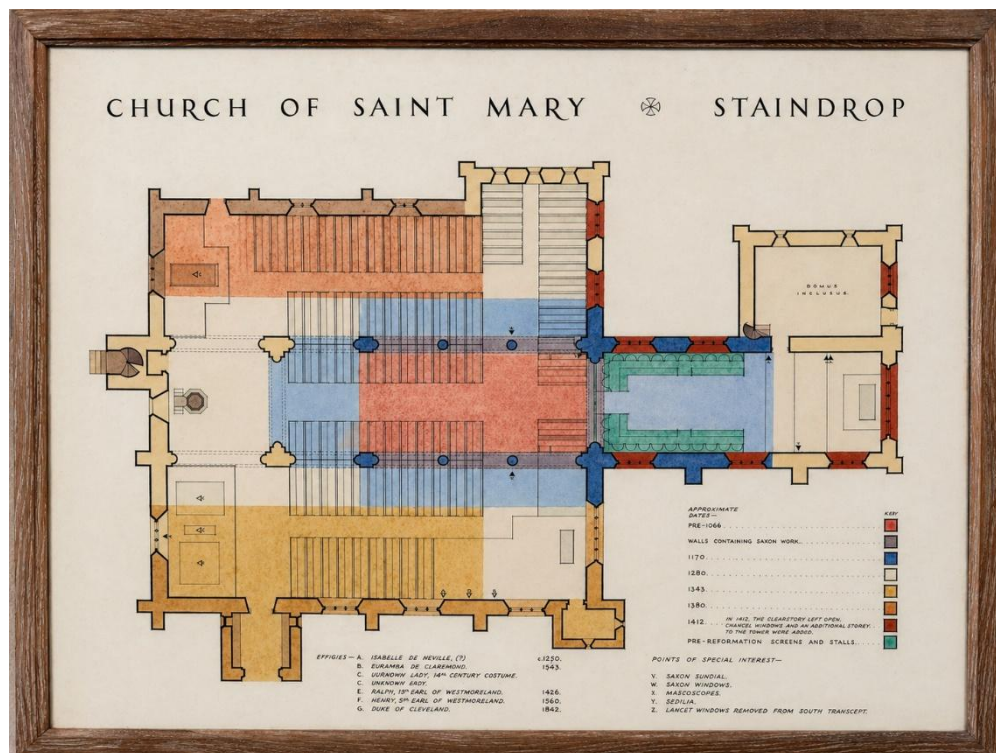
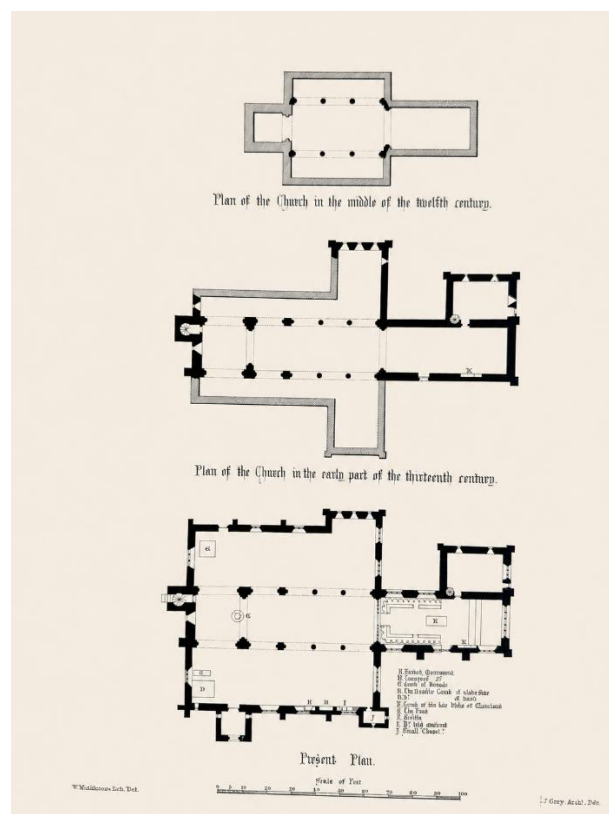
### 1.5 Plans of the church (displayed within the church - NTS)

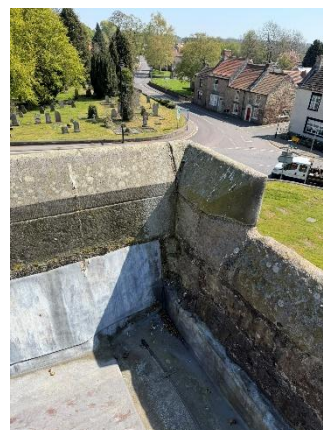
*Figure 1 - loose parapet SE*

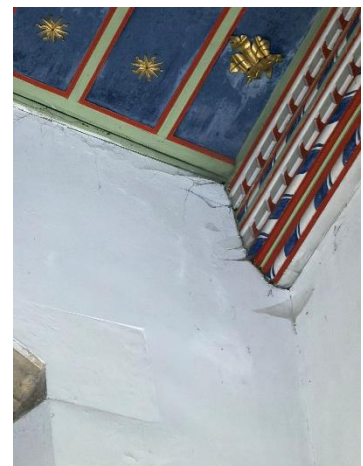
*Figure 3 - SE ceiling*

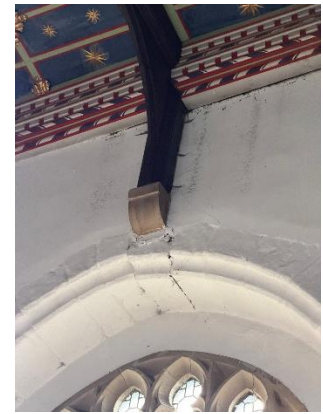
*Figure 4 - Item 2.7.2*

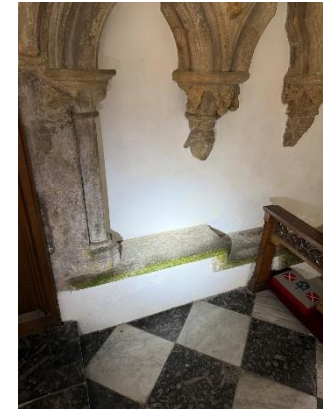
*Figure 5 - Sedilia algae growth*

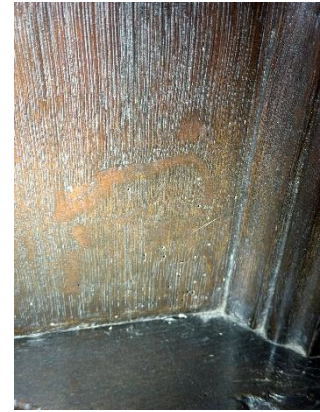
*Figure 7 - Woodworm in stalls*

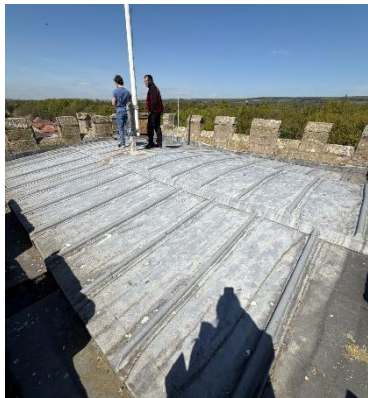
*Figure 8- View from SE corner*

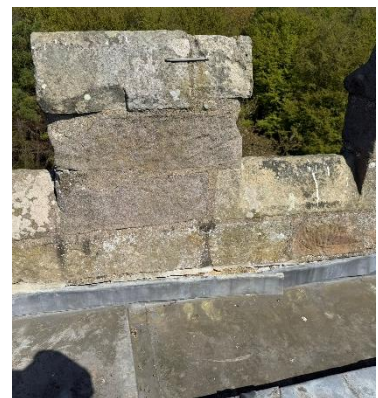
*Figure 10 – Lead flashing failure*

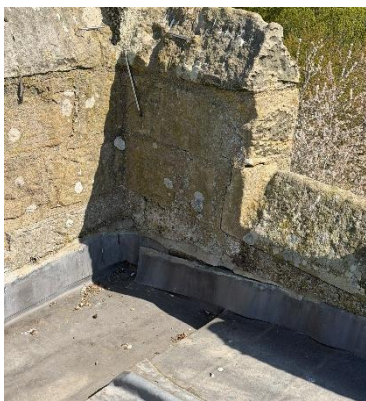
*Figure 11 – lead flashing failure*

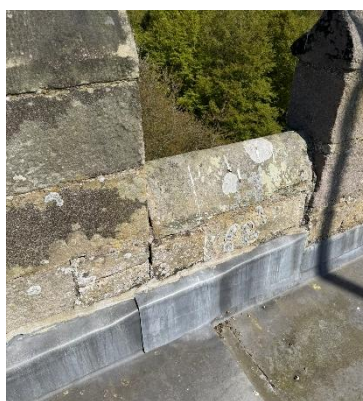
*Figure 12 – Open joints to parapet*

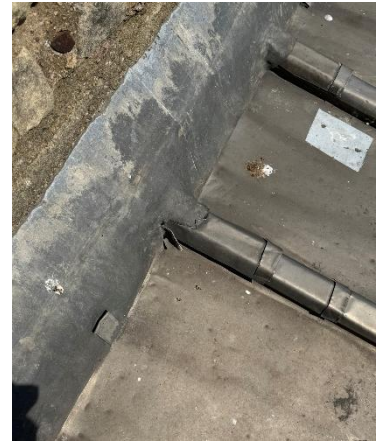
*Figure 14 - South roof, item 3.2.1*

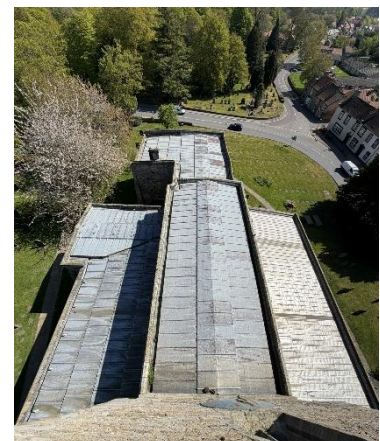
*Figure 17 - Roofs from tower*

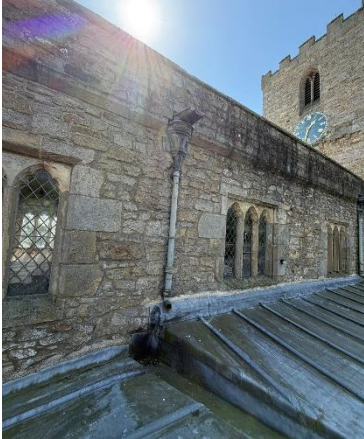
*Figure 19 – N Aisle w/ Nave outlet*

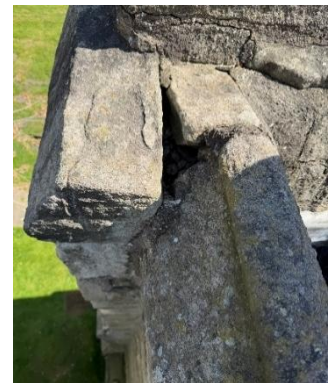
*Figure 20 - Open joint to northeast corner*

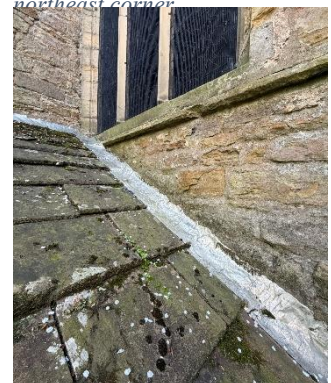
*Figure 21 - Boiler roof failing flashband*

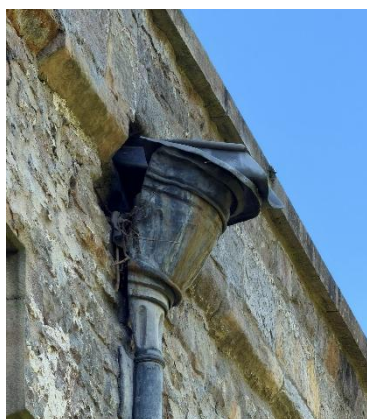
*Figure 22 – N Aisle hopper*

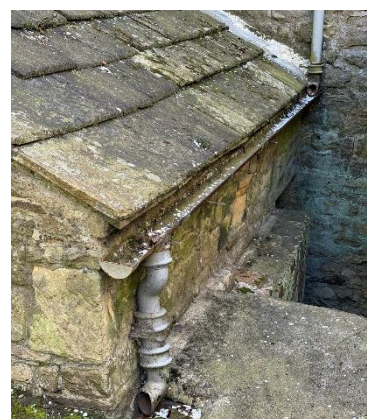
*Figure 23 – Boiler house gutter*

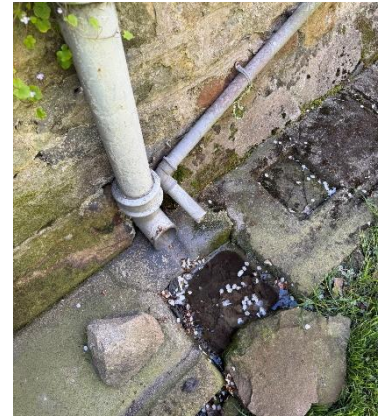
*Figure 24 - Concrete apron w/ blocked gulley at N Transept*

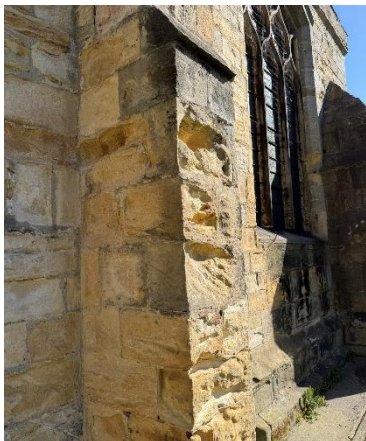
*Figure 25 - South Buttress erosion*

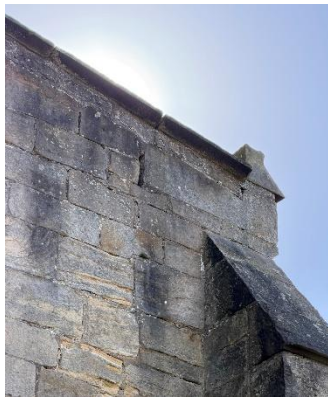
*Figure 26 - W end S Aisle open joint*

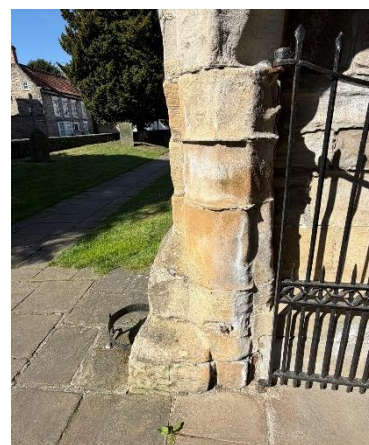
*Figure 27 - S Porch erosion*

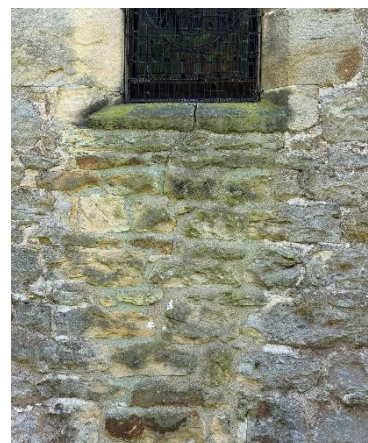
*Figure 28 - N transept N crack*

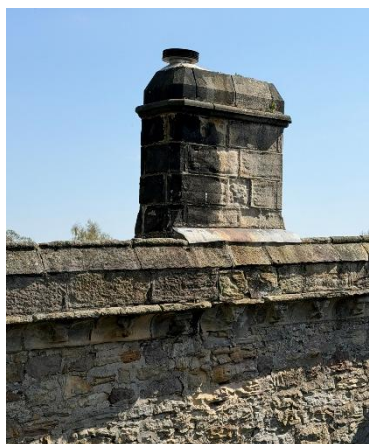
*Figure 29 - W Vesty chimney*

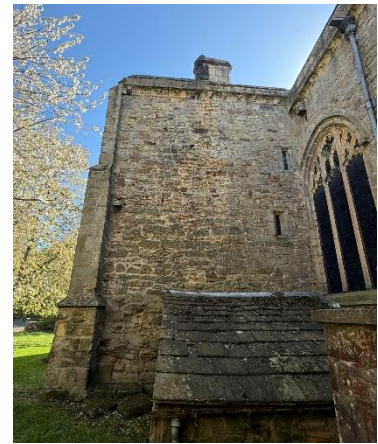
*Figure 30 - Vestry W wall erosion*

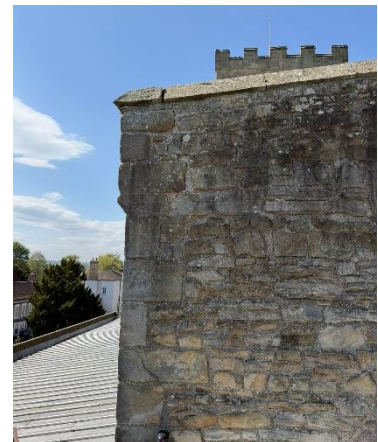
*Figure 31 - Clerestory E wall*

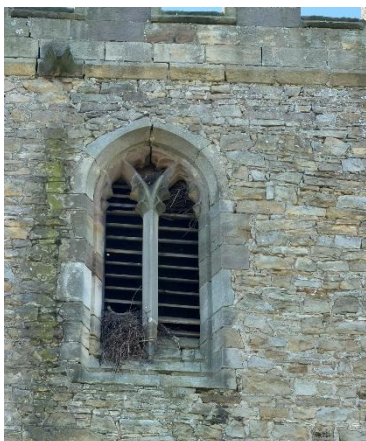
*Figure 32 - N Belfry opening*

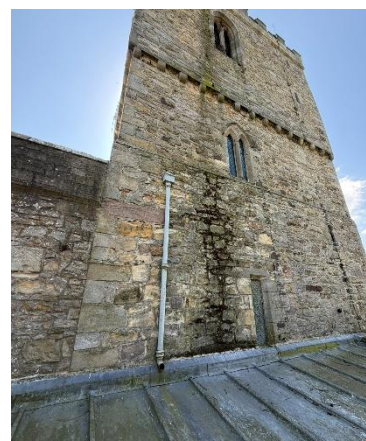
*Figure 34 - Staining from overflow*

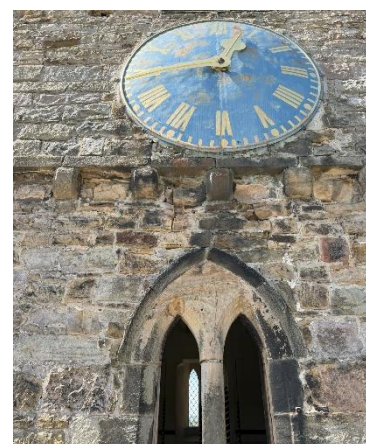
*Figure 35 - E voiding under clock*

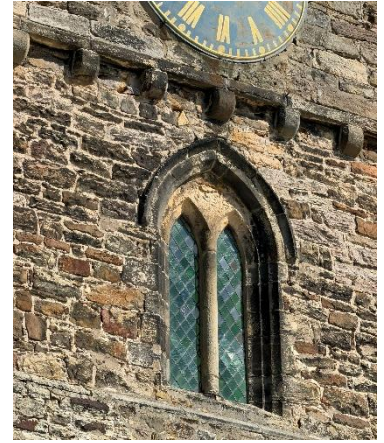
Figure 36 – S erosion over lacets

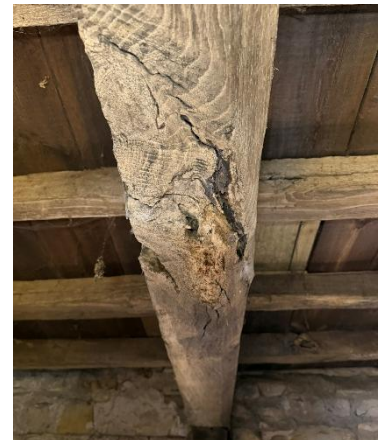
Figure 37 - Split beam

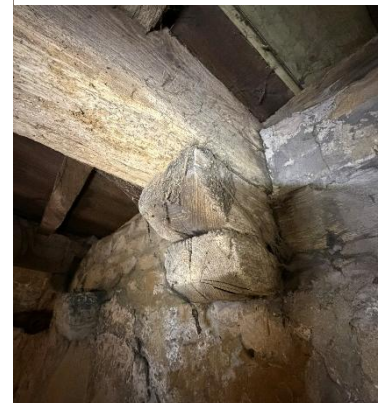
Figure 38 - damp and woodworm

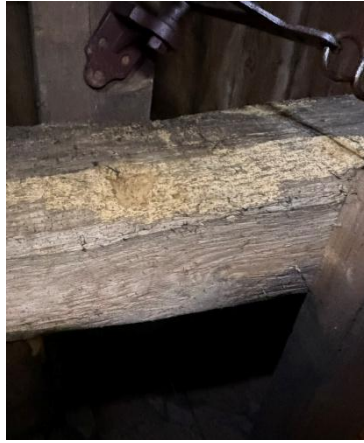
*Figure 40 - woodworm damage*

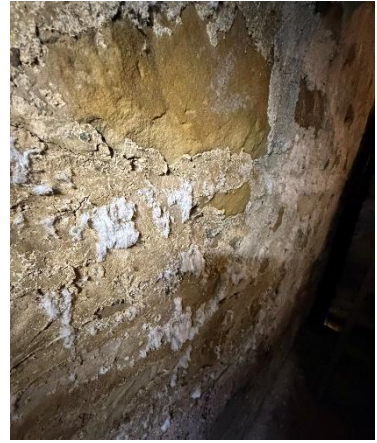
*Figure 41 - salts on wall*

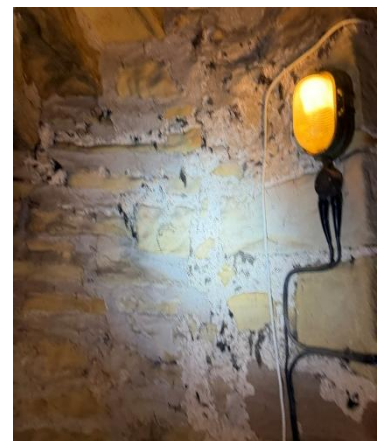
*Figure 42 - Plaster to stair*

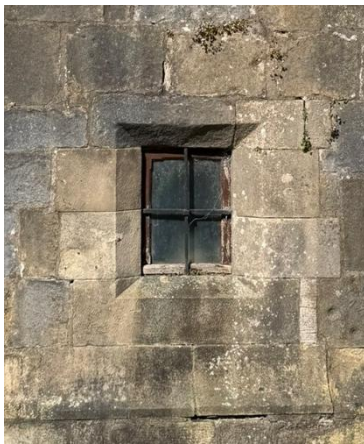
*Figure 43 - Flower roof window*

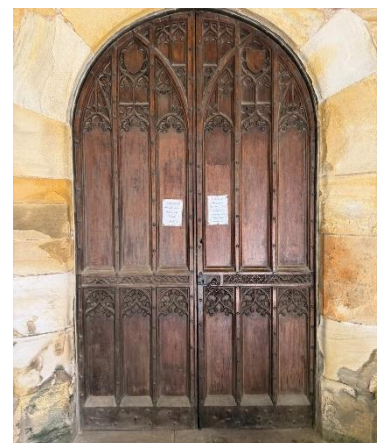
*Figure 44 - Entrance doors*

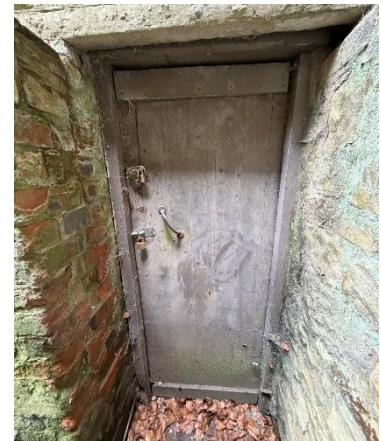
*Figure 45 - Boiler room door*

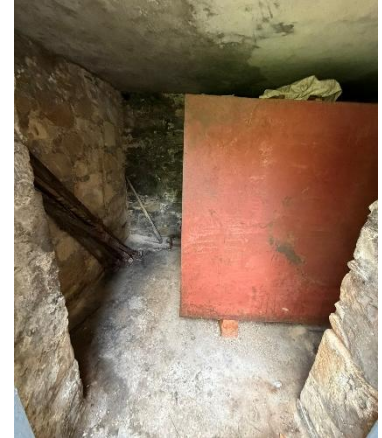
*Figure 47 - oil tank*

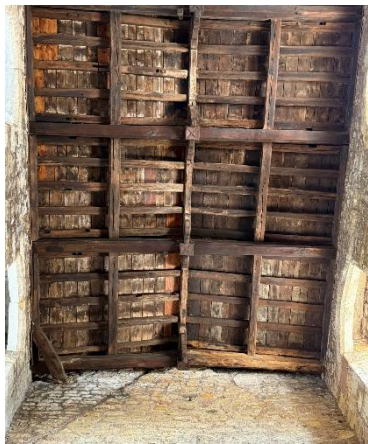
Figure 49 - Nave roof overall

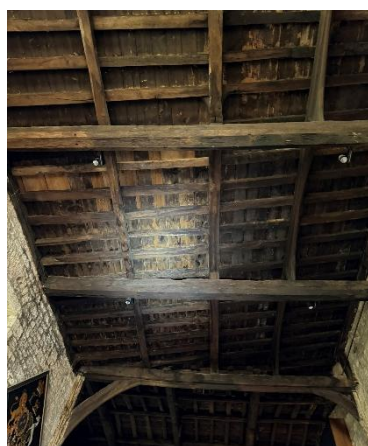
**10.3.4** Faults in the leadwork above appeared to correspond with areas of internal staining, and repair of the leadwork was recommended to allow future monitoring. White lead dust staining remains visible near the north wall and should be treated with caution. Refer to the July 2024 site visit report for further detail.

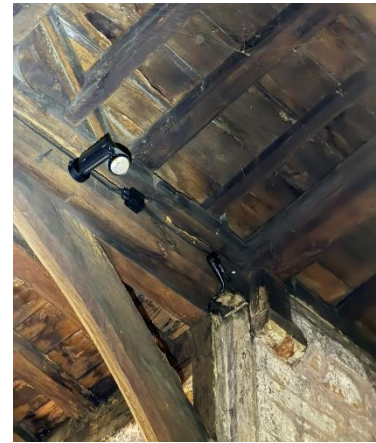
*Figure 52 - Corbel at N Transept*

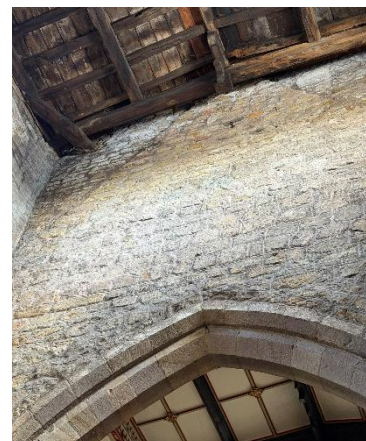
*Figure 54 - High level efflorescence*

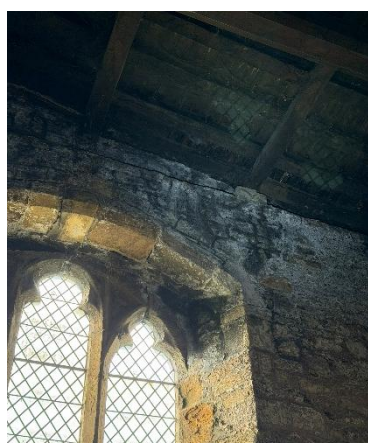
*Figure 55 - W window with leak*

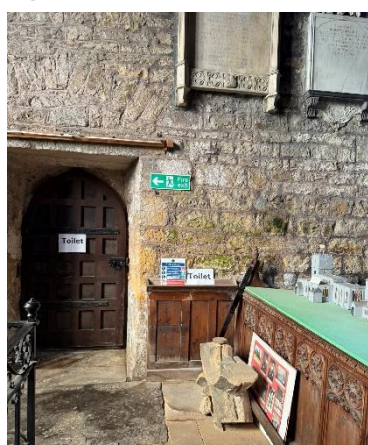
*Figure 56 - Algae build up at N Door*

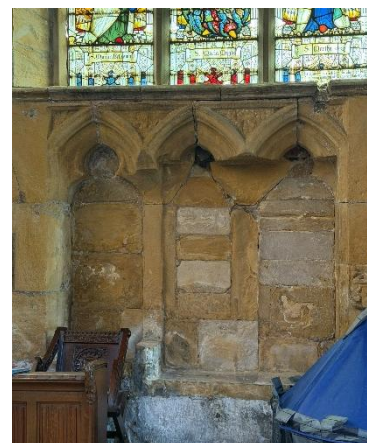
*Figure 57 – S Aisle Sedilia*

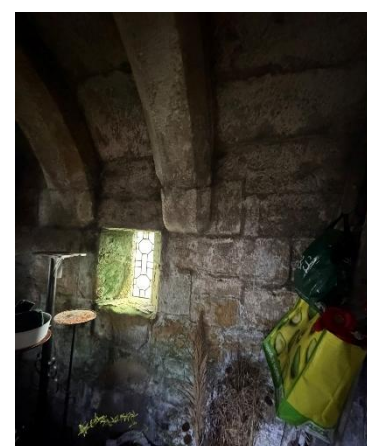
*Figure 58 - Flower room*

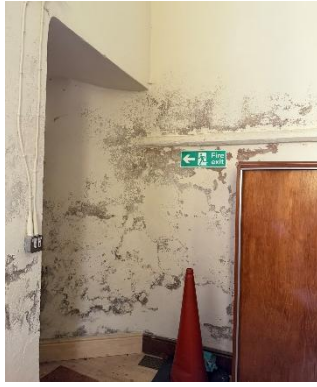
Figure 59 - Vestry Plaster

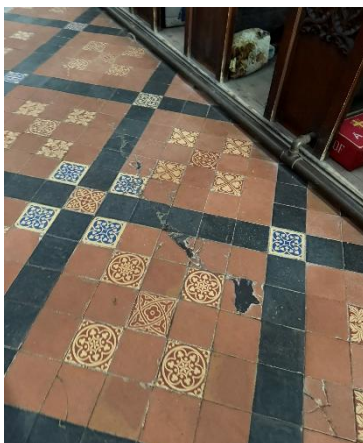
Figure 60 - Nave Aisle

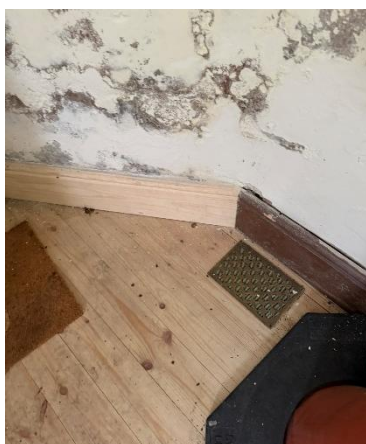
*Figure 61 - Vestry floor repair*

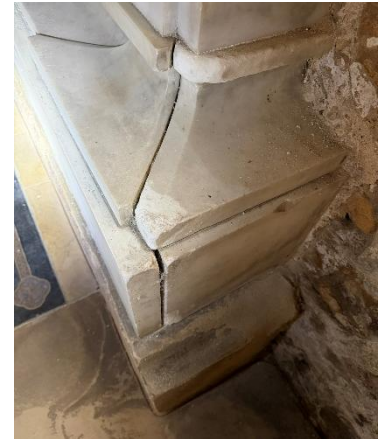
*Figure 62 - opening joint to monument*

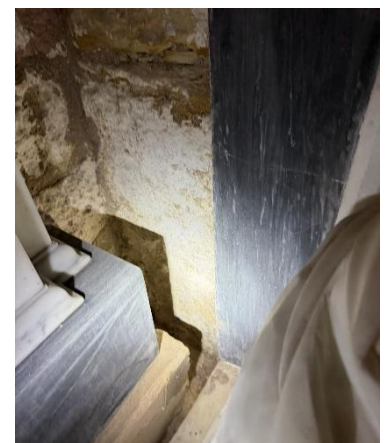
*Figure 63 - Damp in NW corner*

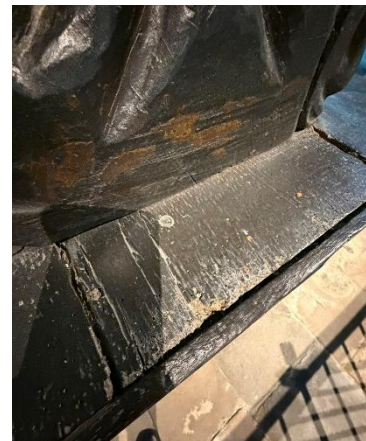
*Figure 64 - Damage to SW monument*
