Care of Churches and Ecclesiastical Jurisdiction Measure 1991 – Quinquennial Inspection
ST JOHN THE BAPTIST CHURCH, DURHAM ROAD, STOCKTON-ON-TESS, TS19 0DZ

Diocese: Durham
Archdeaconry: Auckland
Church Code: 613 324

Date of Inspection: 26th July 2024
Inspection undertaken by: Jamie Holden RIBA RIAS AABC
Previously Inspection: 2019 by Ian Ness

Studio Tamacoco Architects

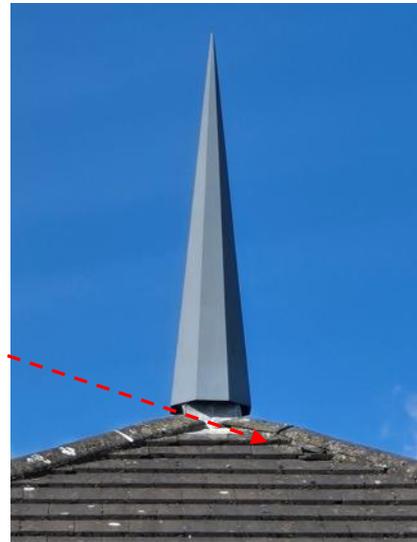
2.1.4

- 2.1.1 The building has a pyramidal roof with interlocking concrete tiles that cover the main hall/ worship space which extends at a shallower pitch to the north and east side where the side chapel, kitchen, entrance lobby and ancillary accommodation are located.
- 2.1.2 The roof appears to be entirely weathertight and the tiles are in reasonable condition. However, the mortar used to bed the 'hip-tiles' has cracked and is loose in several areas. An experienced roofer should be appointed to check the mortar bedding to all four hips with any loose material raked out and repointed. It is noted that the lower section of the SW hip has already been repointed. **4**
- 2.1.3 Where the roof extends on the east side of the building there is a pointed verge. The mortar is cracked and loose and also needs to be raked out and repointed. **4**

b) Open jointed ridge tile and cracked mortar

Roofing - At present the roof appears to be weathertight however the more to pointing which beds the hip tiles and seals the verges is cracked, loose and falling out in places. The PCC should arrange for a roofer to check all the pointing to the hips and verges and carry out the necessary repairs.

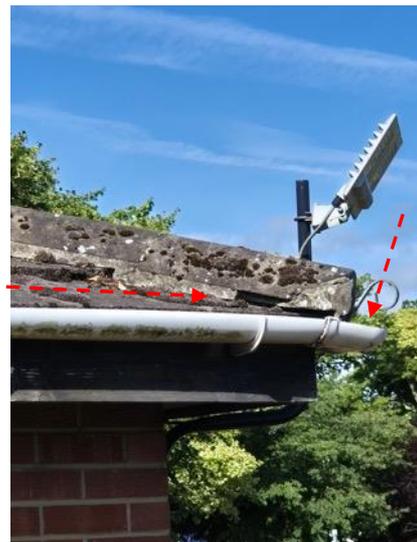
2.1.5

b) Cracked bedding mortar ought to be repaired and gutter levelled at the corner.

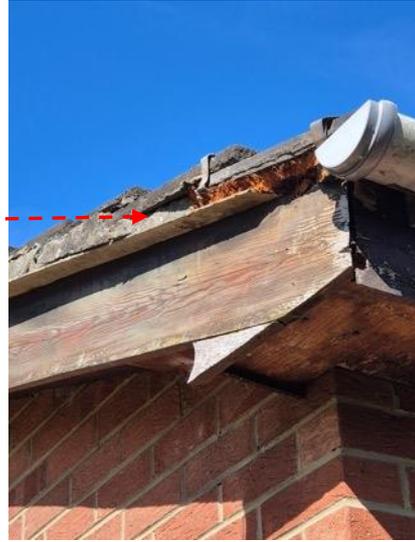
2.1.6

b) Mortar point to the verge is breaking down. Loose mortar to be removed and the verge repointed.

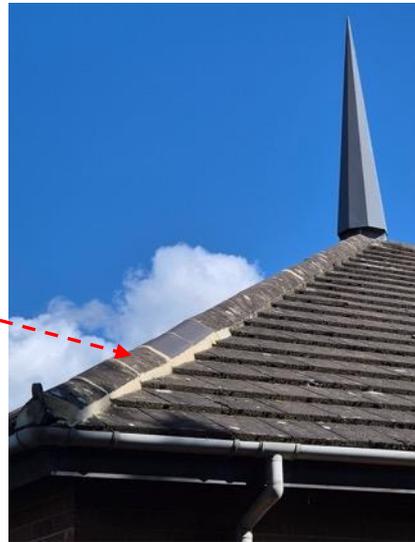
2.1.7

b) Recent repointing to the hip-tiles carried out in early 2024. Two of the tiles appear to have been replaced.

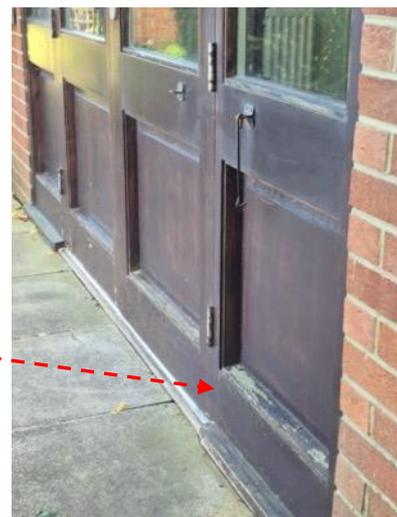
- 3.1.3 All windows and doors are double-glazed with painted timber frames. The decoration is breaking down on the more exposed parts of the window joinery i.e. transoms, horizontal beading and cills.

b) Weathered ledges

- 3.1.4 Most of the windows and doors would benefit from being redecorated, however, the windows in the south and west elevations seem to be more heavily weathered than the others and would be considered a priority that ought to be dealt with within the next 12 months. **2**

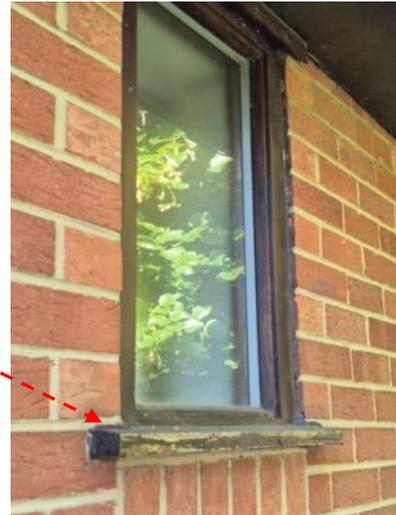
3.1.10

b) Typical example of weathered cills requiring redecoration.

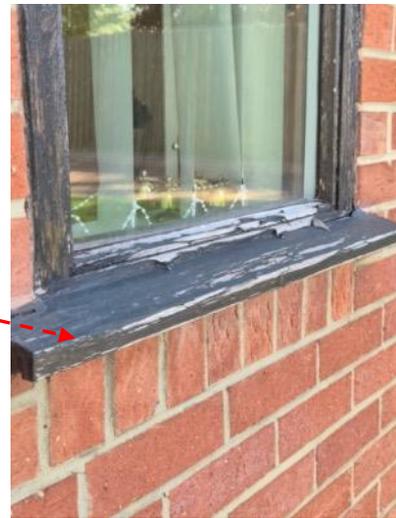
3.1.11

b) Decoration to the horizontal window beads and cills is starting to breakdown.

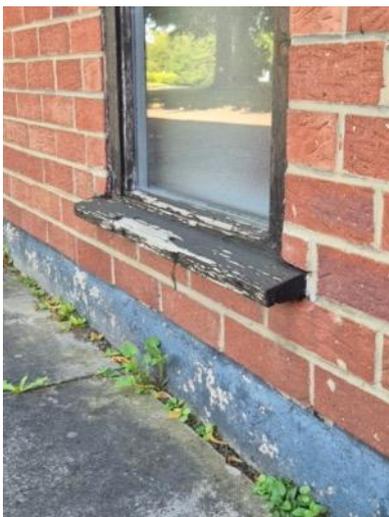
3.1.12

- 3.1.5 The cills to the three tall windows in the centre of the west elevation are loose. It is noted that they have been screwed to the frame through the nosing and need to be re-fixed and filled to ensure there are no gaps between the joinery where water will collect. **2**

a) The cills to the windows in the west elevation are loose and require redecoration.

3.1.4	Rectorate windows	n/a	£ 1,500
3.1.5	Cill repairs to 3no. windows in the west elevation	n/a	£ 500
3.1.6	Replace window mastic	n/a	£ inc. above
		<u>Sub-total</u>	<u>£ 2,000</u>

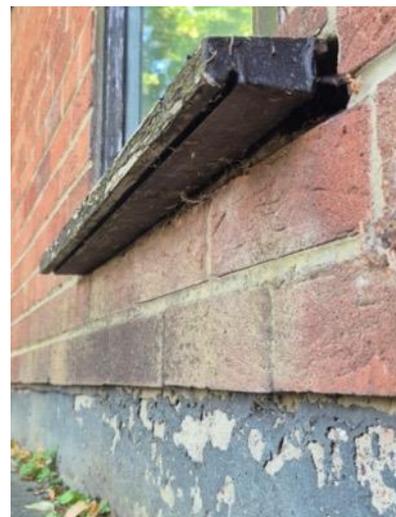
- 3.1.6 The windows are sealed within the masonry opening by a mastic bead. The mastic is becoming brittle, it has shrunk and cracked in places. Where this has occurred the old mastic needs to be removed and replaced. This applies to the windows in the west elevation specifically but they all should be examined carefully to ensure they are sealed. **2**

b) Cills are not adequately sealed.

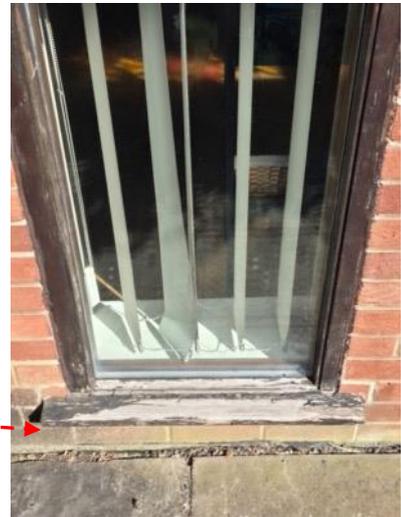
3.1.14

b) Redecorate cills.

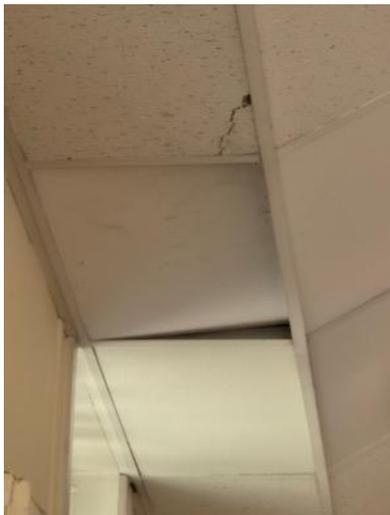
4.2.9

- 4.2.4 Ceiling - The pyramidal form of the main roof is expressed internally and is underdrawn with the same suspended metal framed grid and ceiling panels as found in the lobby. The ceiling is looking a bit aged with a few areas of impact damage but all perfectly serviceable.

a) Minor damage to some ceiling tiles

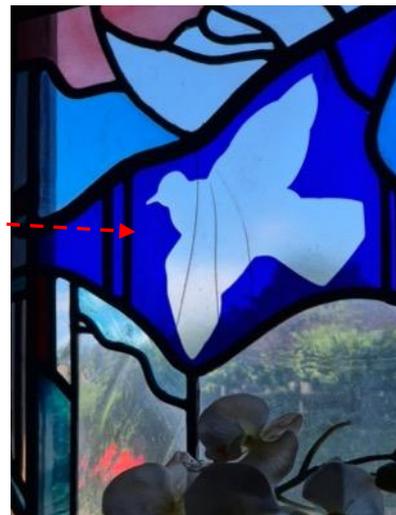
4.3.7

- 4.3.1 The side Chapel is a simple rectangular room with three stained glass windows in the east wall. The central panel has some minor fractures in the glazing but remains weather-tight.
- 4.3.2 Chairs are arranged against the walls with a simple altar table is positioned at the south end.
- 4.3.3 Floor - The chapel retains what is understood to be the original hardwood block flooring in good order.
- 4.3.4 Walls - The walls feature the same panel lining as found elsewhere in the building. The walls are painted and presentable.
- 4.3.5 Ceiling - The same suspended ceiling as used elsewhere can be found in the chapel with three surface-mounted ceiling lights. All in reasonable order.

b) Minor fractures but appears weathertight

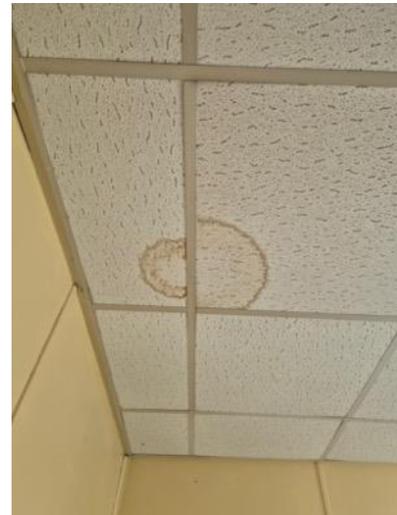
4.4.5

4.4.2 The walls and ceiling have the same panelled lining and metal framed grid as elsewhere in the building. There is what appears to be moisture staining to the ceiling. This has not worsened in recent years and is considered historic.

b) Staining to the ceiling is thought to be historic.

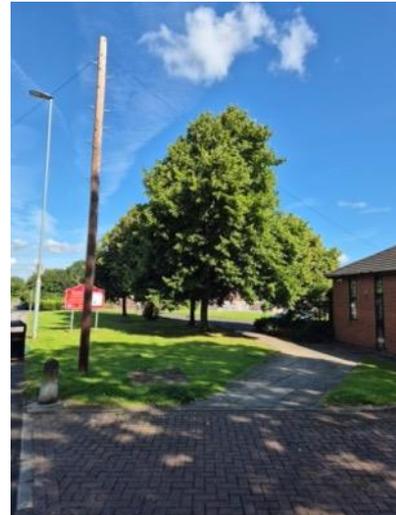
5.1.8

- 5.1.2 There is public access for pedestrians across the site from Durham Road to St Crispin Court. The footpaths are laid with concrete paving slabs which have become uneven due in part, but not entirely to the presence of the 4no. large trees to the west. There are also a few crack slabs, all of which create potential trip hazards in a number of areas.

b) Large trees to the west of the site have caused some of the footpath paving to become dislodged.

1.16	Consider remedies for the uneven footpaths (as noted in Section 5.0) and review the Equality Act 2010 and consider accessibility/ access audit.	n/a	£ 0

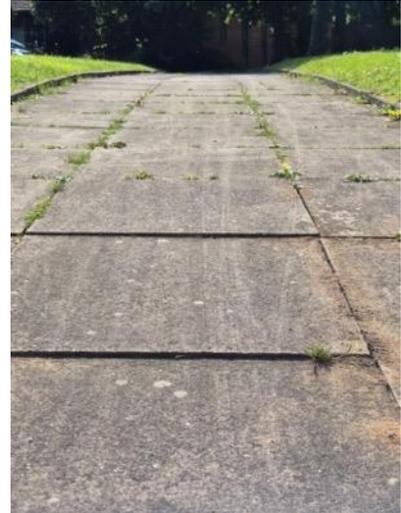
5.1.9

b) Flag stones are becoming open jointed and uneven

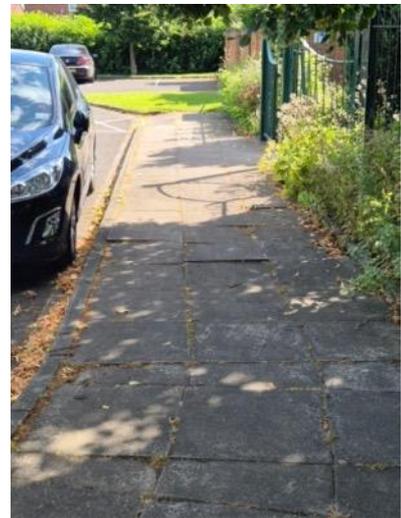
5.1.10

The paving slabs on the approach to the building are uneven and it is understood that a remedy is being investigated.

b) Footpath at the entrance to the church has a dropped kerb but the paving is cracked and uneven

Accessibility - The PCC has already identified the trip hazard caused by uneven paving slabs immediately outside the entrance to the church and in some areas of the other footpaths within the site and is taking action to find a remedy.

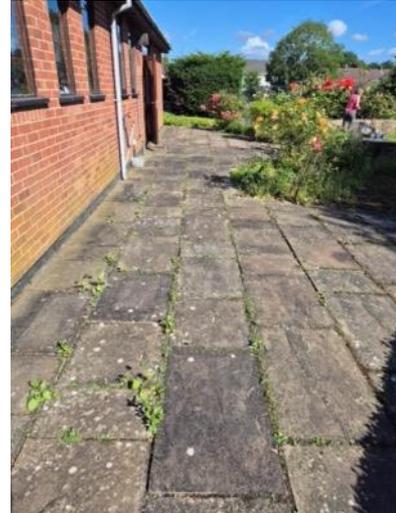
5.1.12

b) Open jointed patio needs regular weeding.

- 5.1.7 Repointing the paving would prevent any vegetation from taking root, however, the growth is periodically weeded out and generally kept in check. Like the rest of the garden, the paving is well cared for by volunteers.
