QUINQUENNIAL INSPECTION REPORT
Of
**THE MINSTER CHURCH OF SAINT MICHAEL AND ALL ANGELS AND SAINT BENEDICT BISCOP,
SUNDERLAND**

SUNDERLAND MINSTER

QUINQUENNIAL INSPECTION AND REPORT July 2024
David Beaumont BA (Hons) Grad Dip, RIBA, AABC

REPORT ON THE 2024 QUINQUENNIAL INSPECTION

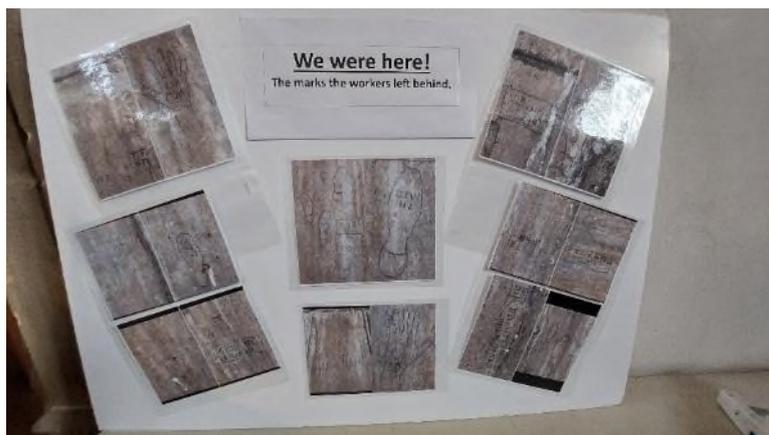
The old leadwork is holding up and it is a gull residence. Dead one present at inspection. Leadwork has valuable historic graffiti and mustn't be lost when the day comes to replace the lead

Loose side flashing

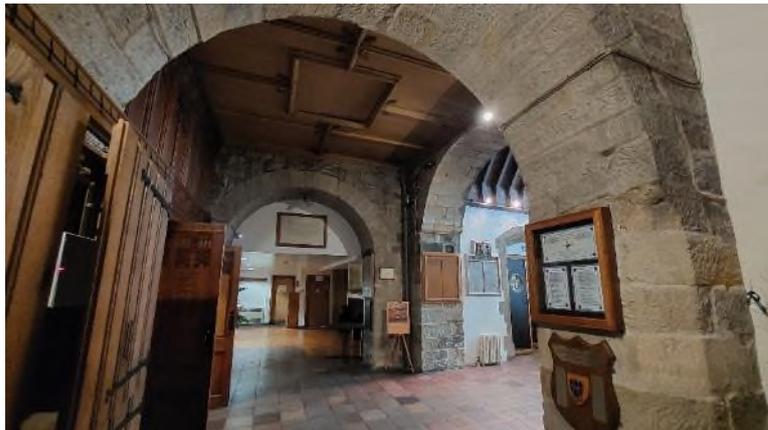
Base of Tower:

Stable and cracking is the same as the last QI: West 3mm, N 2mm at keystone. Slight amount of pointing fallen out of the southern arch but no action required.
Memorial panelling in good condition.

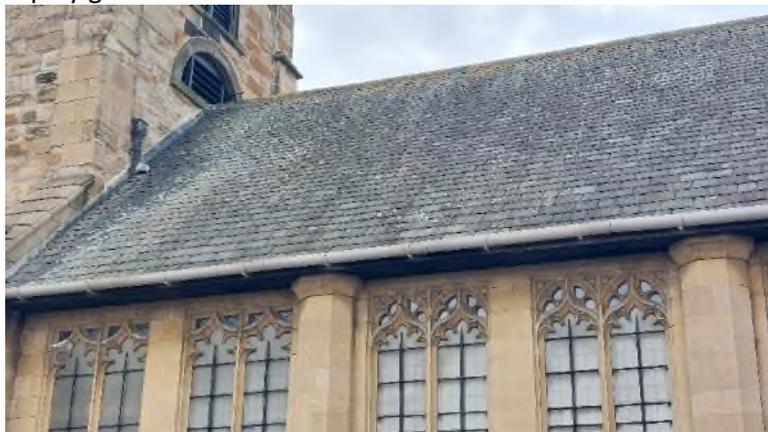
- **Nave:** Repairs carried out in 2015 as part of South aisle works. South Side Some ridge pointing loose and slating looks ok. One slip by gutter outlet

Recommendation: none

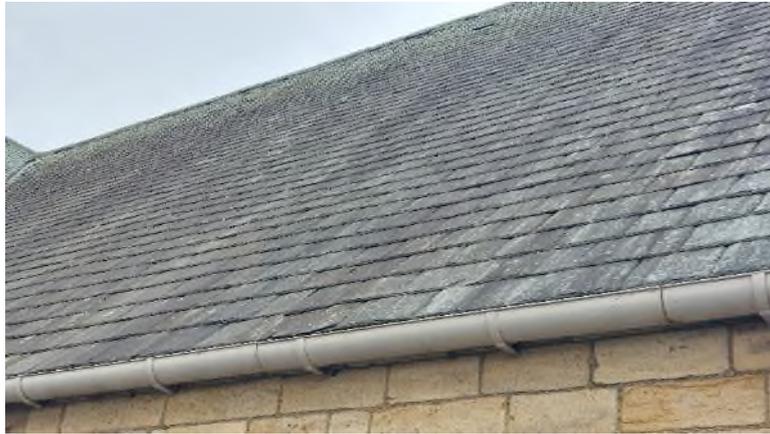
West side – ridge pointing loose, slipped slate

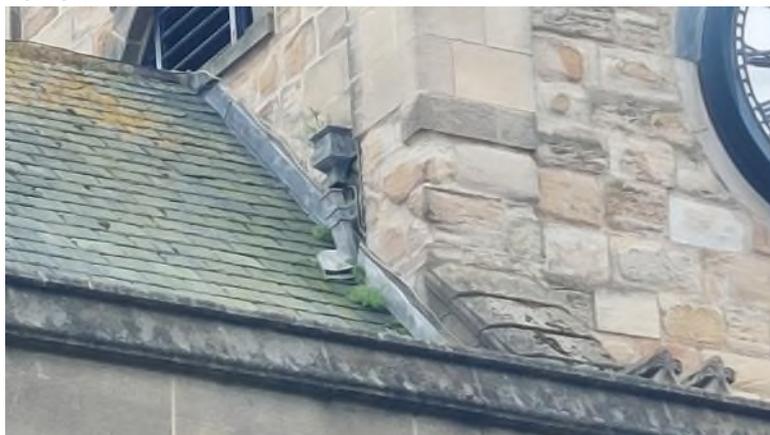
Tower:

A big issue at the north side tower is the tower pipe which discharges onto the nave roof. Its shoe over the nave roof is dislodged and not running correctly and may cause leaks inside. The s side should also be checked as there is staining to roof boarding in the same position. Above these positions the pipes are internal with bends and it would be wise to check that they are not blocked.

The n side downpipe has a dislodged shoe as it terminates on the nave roof. Which needs refixing. No signs of internal water penetration.

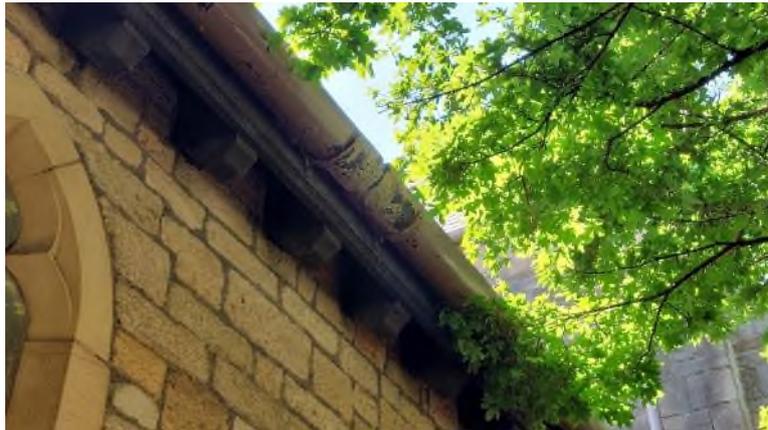
B Choir Vestry :

South Side – A mixture of old and new half round gutters. The decoration is coming away as is the joint between them. Rusted out at the back. Anti-climb paint on the upper part of the downpipe appears ok. The bottom part of the downpipe's decoration is coming away and it's a little bit high for the gulley but it will do, the gulley has leaves in it.

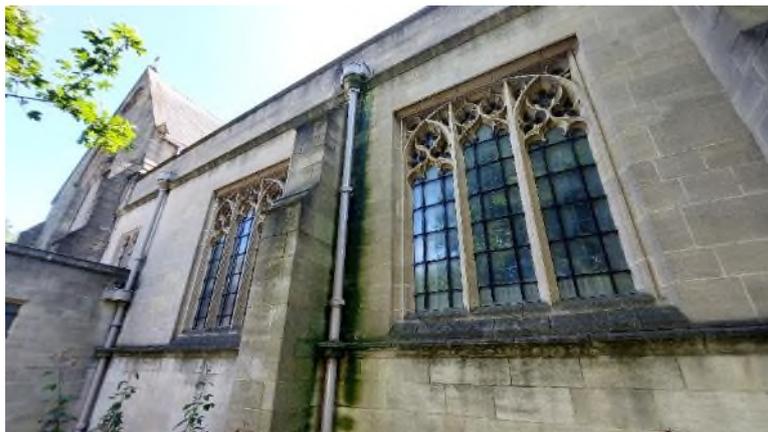
M North Aisle:

Three downpipes with ornamental hopper heads (hoppers repainted in 2018) and anti-climb paint is wearing away a bit at the upper levels. The remainder of the pipes coming down to the ground look sound, Middle pipe blocked at inspection (and cleared) .These all discharge to gulley's that should be checked to be clear of blockages

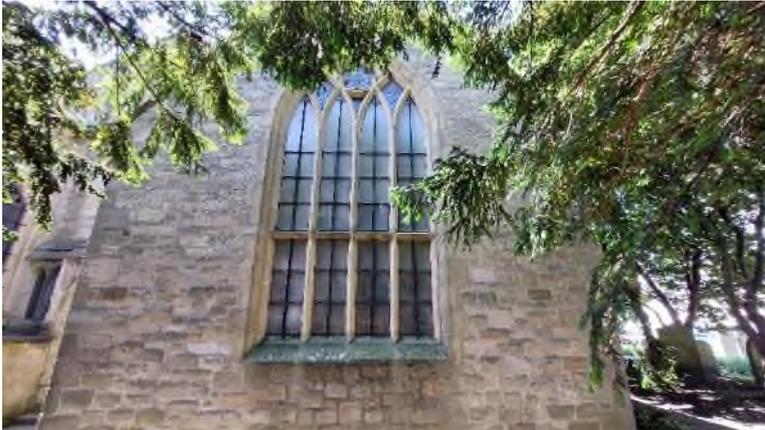
East Side –

Water table appears ok. The walling is sound, has a four light window with a horizontal transom, the transoms are ok. The ashlar arch to the north side slightly eroded but no action required. Glass is covered with dirty polycarbonate and slightly rusting ferramenta.

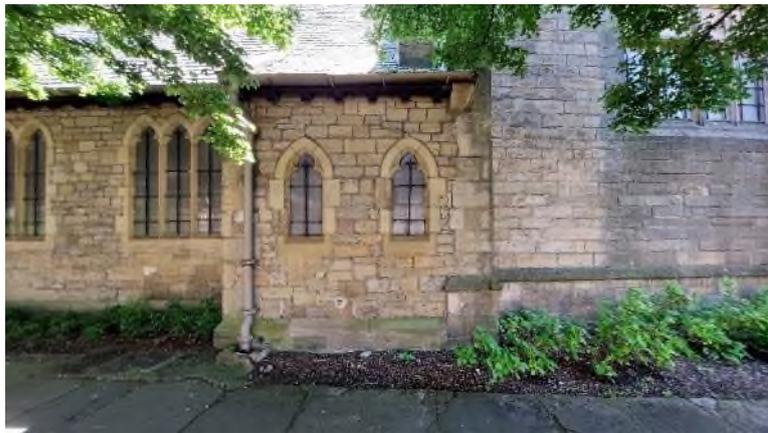
D Choir Vestry Servery

East Side –
Slight cracking at the kneeler stone with open joints at the head that should be attended to in the next 5 years.

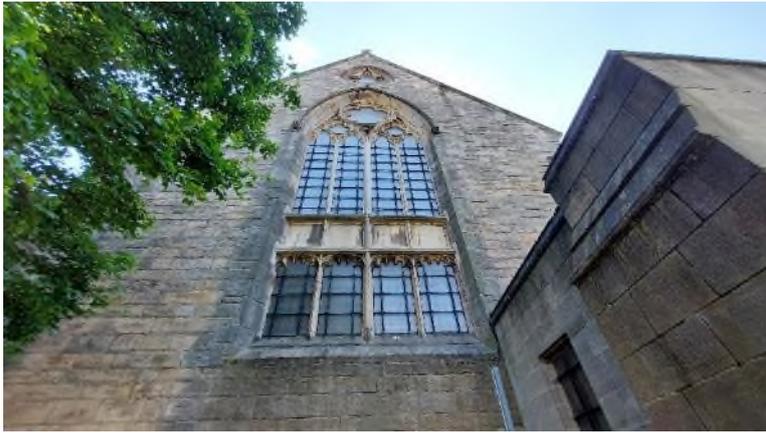
North Side –

Water table is ok, the walling generally is fine, and there are a few stones that have eroded but not problematic, probably best if they were infilled with lime mortar though it's expensive to get the scaffold up just for that. Some open joints on the plinth capping.

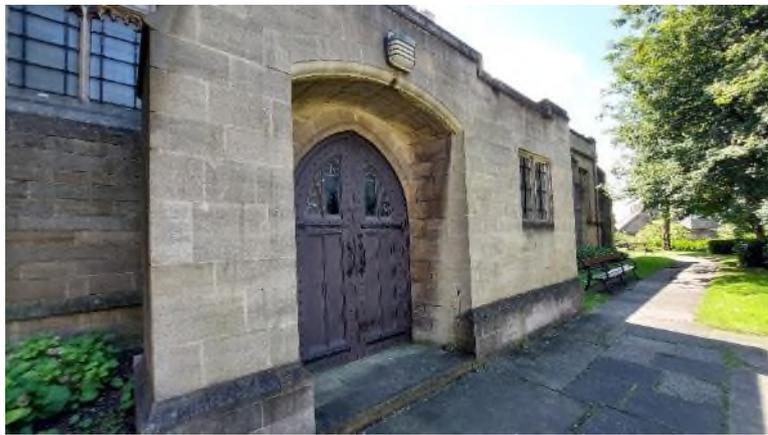
East Side – Open joints to the upper parts, particularly at the buttress edges. Polycarbonate over glazing with rusting ferramenta. Slight open joints at the junction to the transept showing minor differential settlement.

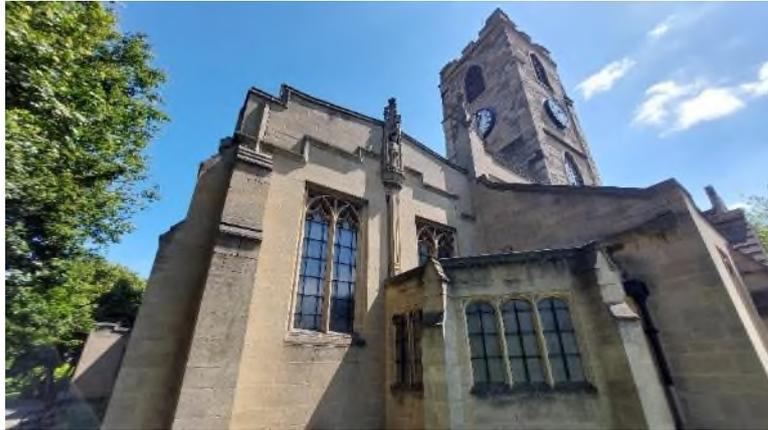
West Side –

Open joints to the raking parapet repaired in 2018 at high level. Walling is good, the pinnacle and statue appear in good condition, crack to the s lintel seen before and unchanged. There has been graffiti scratched on the surface of the stonework and probably needs to have CCTV around this corner.

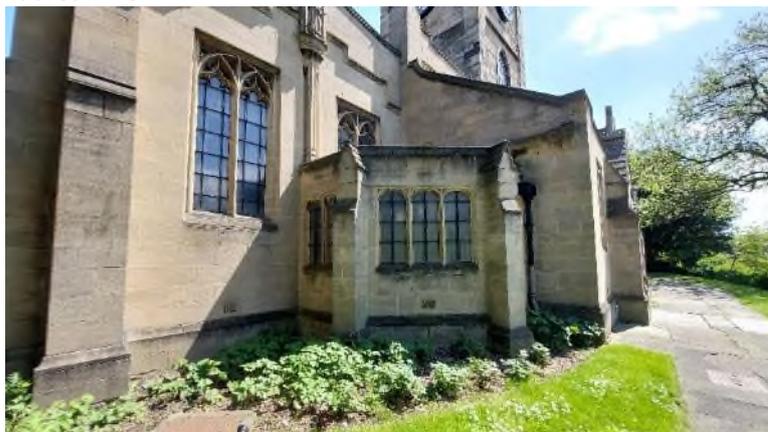
D **Ladies W.C.:**

Open joints to the parapet top and the buttress on the north west elevation. Three sets of windows with rusting ferramenta and polycarbonate that is dirty.

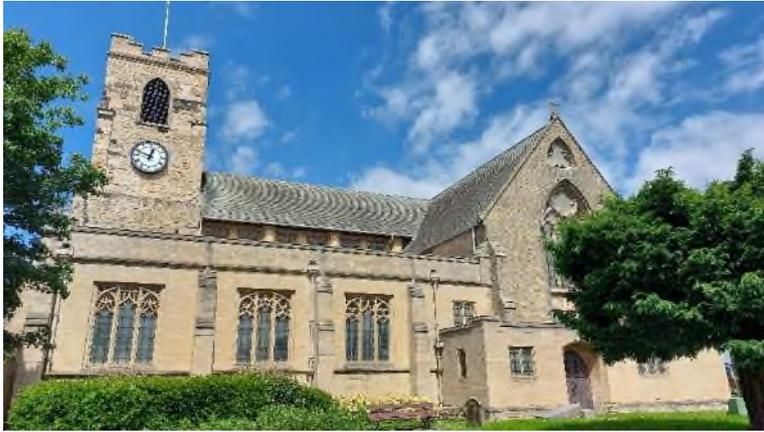
D South Aisle:

West Face –
Repointed as a result of the 2015 work and in good condition, the cills to the kitchen window are slightly open jointed. The plinth below is in sandstone and is eroding.

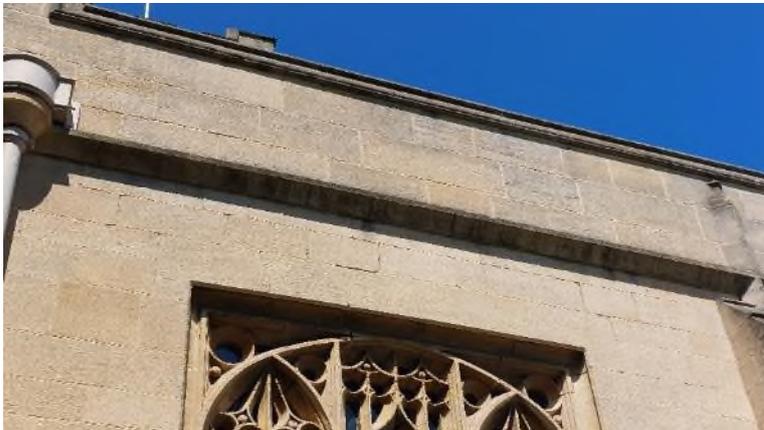
South Side –

Parapet repointed in 2015. There are some open joints above the window heads and at the buttresses. The plinth is sandstone and eroding. The windows are the same as the north side, here the polycarbonate has been cleaned but the ferramenta is rusting slightly.

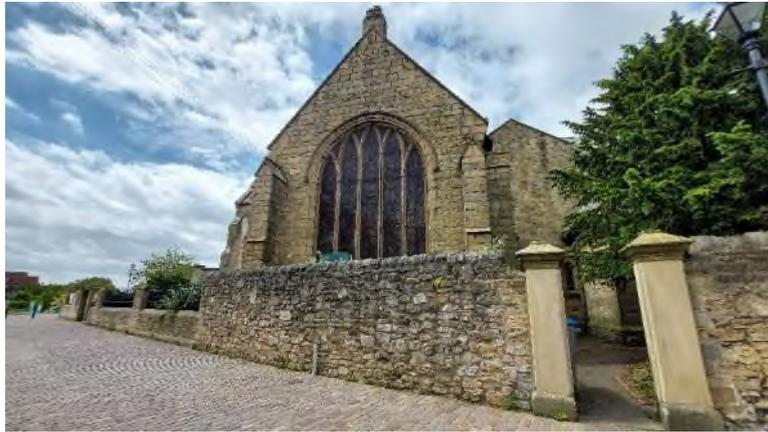
Northern Side – Mixed sandstone and concretionary limestone (showing coralline concretions) masonry wall in fair condition, repointed the previously reported cracking. New gate piers that are chipped by SCC bin collection skips. Door permanently removed (and on top of the boiler room) to stop loitering.

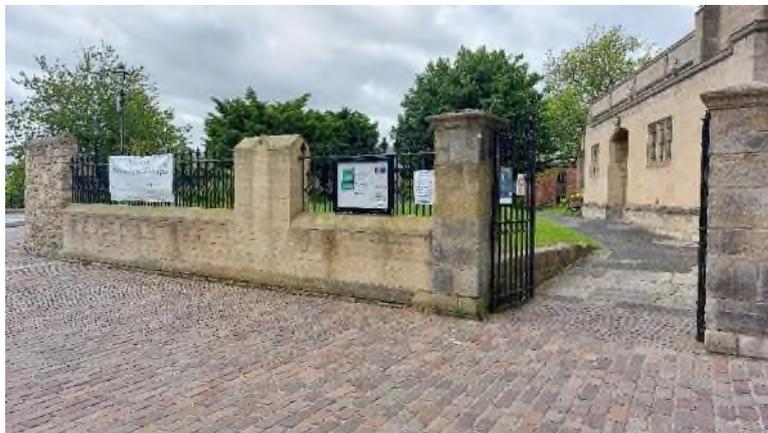
The secondary half of the boundary comprises a low sandstone wall with metal railings. This had multiple open joints in the stonework which have been repointed and railing redecorated and to the south, replaced in Victorian pattern.

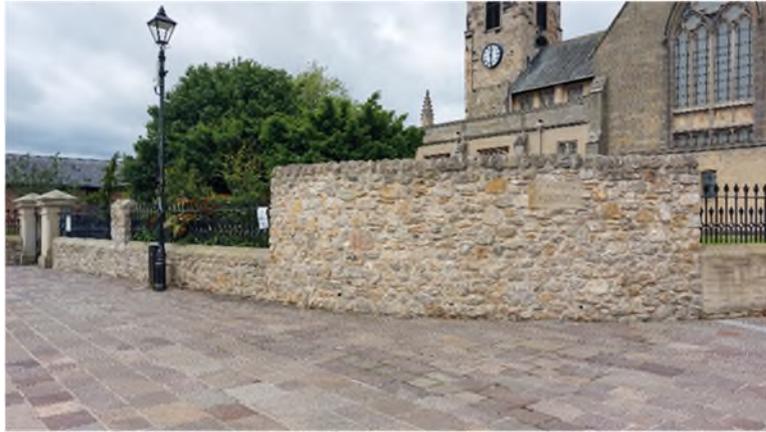
- **South east facet:**

This is a high wall on the facet on the angle of the road which may well have been installed at the time of the Caroe works, it had a large crack down the middle of it and has been repointed in lime.

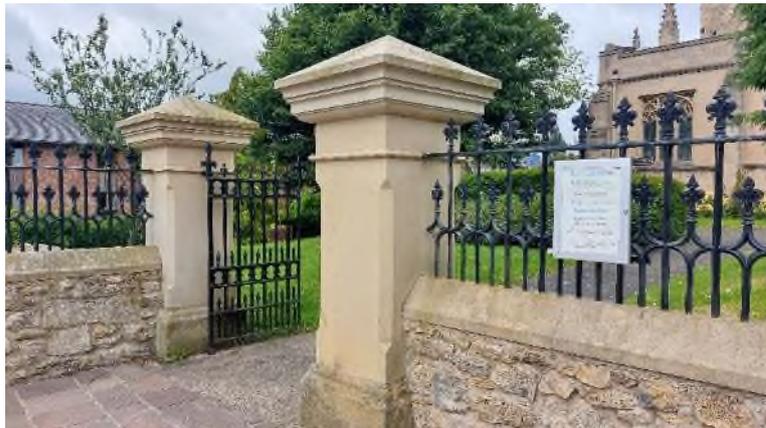
The twin gates have been redecorated but have no ironmongery or restraint. The sandstone pier caps have been replaced. There is rusting metal still in the piers which should have been removed. This entrance no longer makes sense- it was for when the church was accessed at the west end and so to use it makes for a dog leg path within and an indirect approach from The Green.

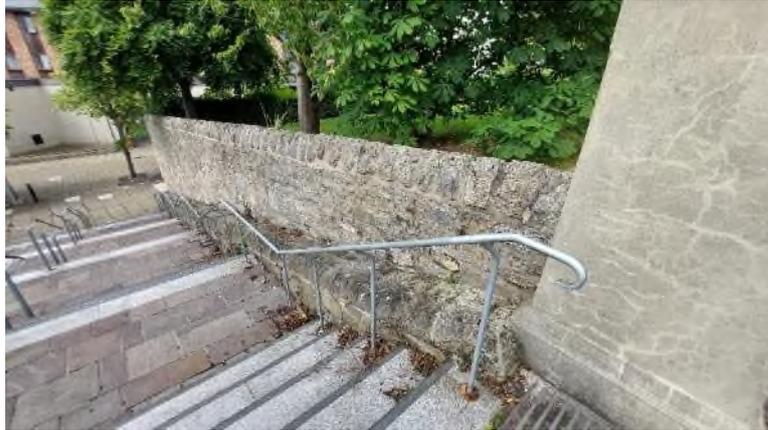
Stairs down to western side: Walling here is in good condition. But the baluster supports are rusting. Some crazing on the cement render on the pier.

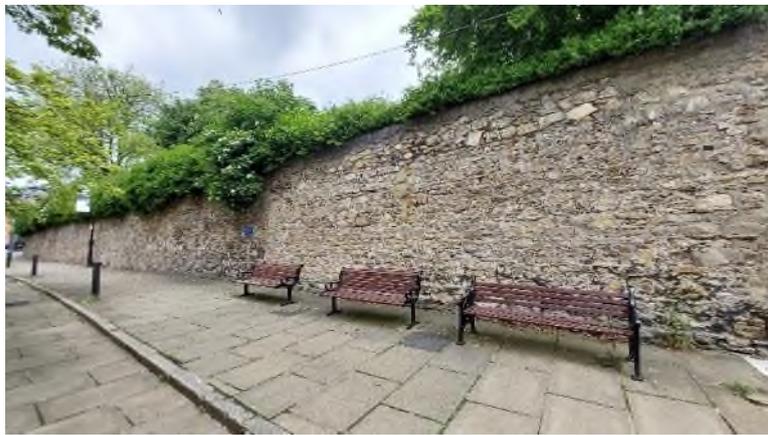
The west high retaining wall wasn't part of the repair works. It has three major vertical cracks that have been noted in past reports.

This features a substantial and high retaining wall, retaining the burial ground. Towards the southern end there is a large crack by the memorial 'Hind Street burial ground' sign, doesn't appear to be worse than last time but there are multiple open joints on the wall and some poor historic repairs to it.

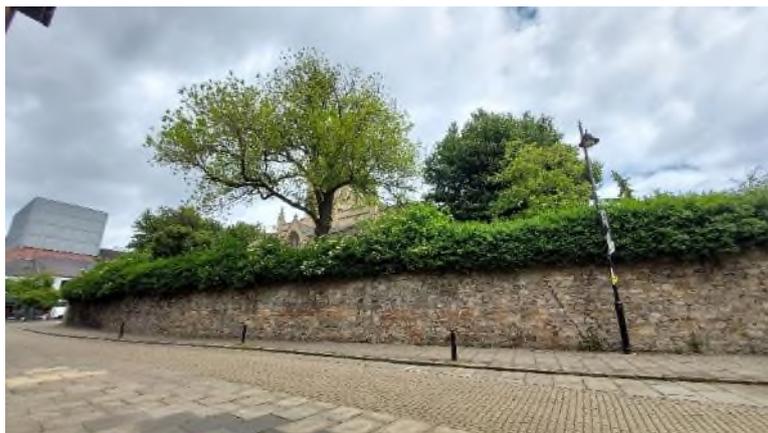
Some of the bushes are growing over the edge, there is one sapling growing at the coping, a lot of ivy has grown over it in the past that, has been cleared off.

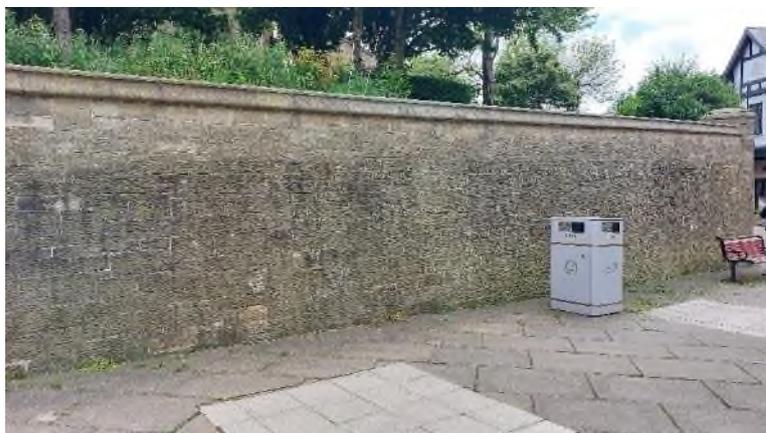
At the very end of the wall it looks to have been rebuilt when the church was. Some cracking.

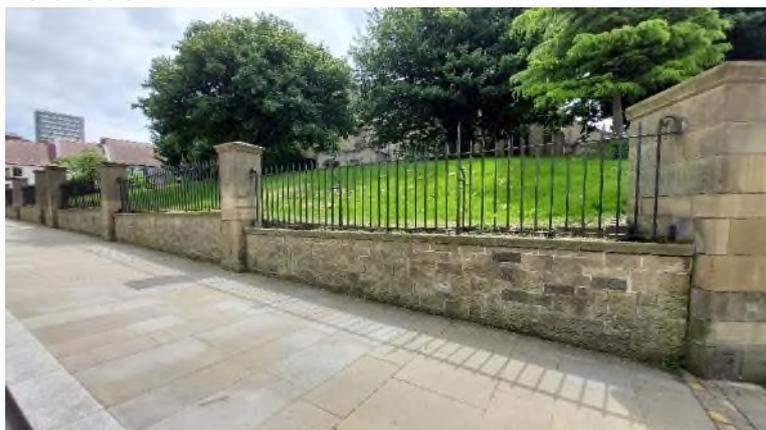
North Side:

The wall here comprises of low level wall with stone copings supporting an ornamental metal balustrade of good quality. Balustrade is rusting but it is not breaking the joints in the stone pillars. The wall itself has been repointed in cement in the past and would be better in lime if funds allow. The very edge of the

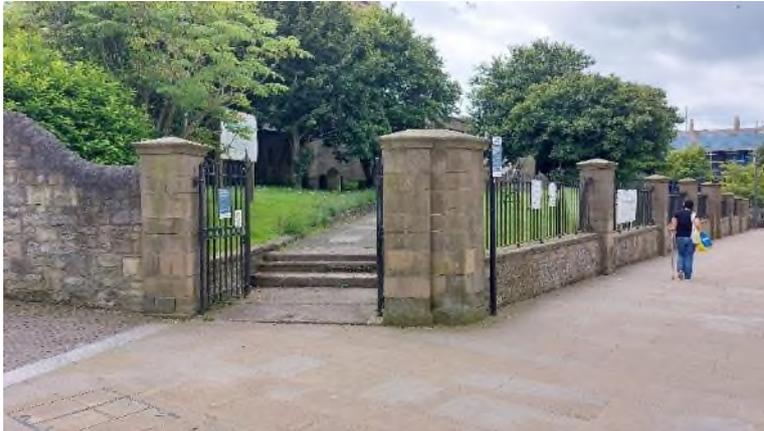
Pair of ashlar stone piers supporting a pair of metal gates, which operate ok but are unable to be kept fixed in a closed position, some rust .

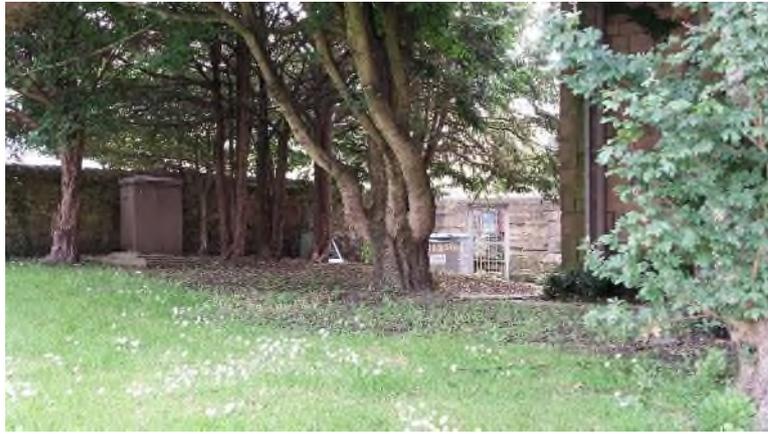
These trees need to be kept in check particularly at the north east part of the site as they shield intruders.

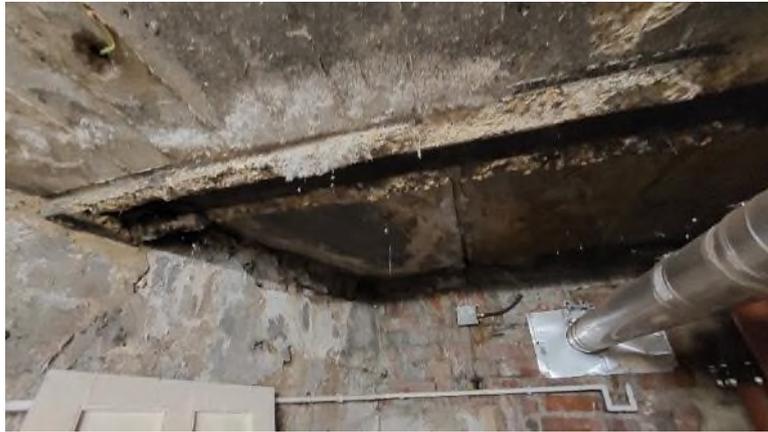
The steel beam continues to rust though it doesn't look as if action is needed yet. Generally the walls are fairly old and of their time. Boiler installation of Remeha Quinton Pro double boilers with Grundfos pump and boiler control system. Some lumber to clear out. Steps are slippery with leaves and rain runs down them. Door replaced by metal gate with temporary screening to hide boiler. Sump pump reported as working. Gas meter cpd on roof.

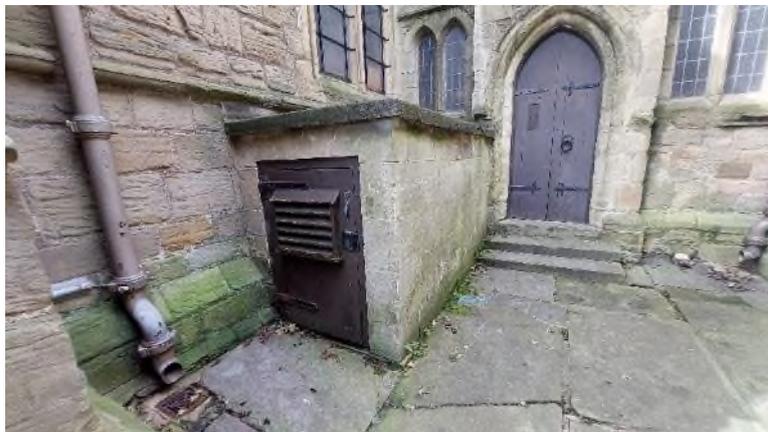
Not able to inspect inside but advised that the door still jams and has rusty hinges.

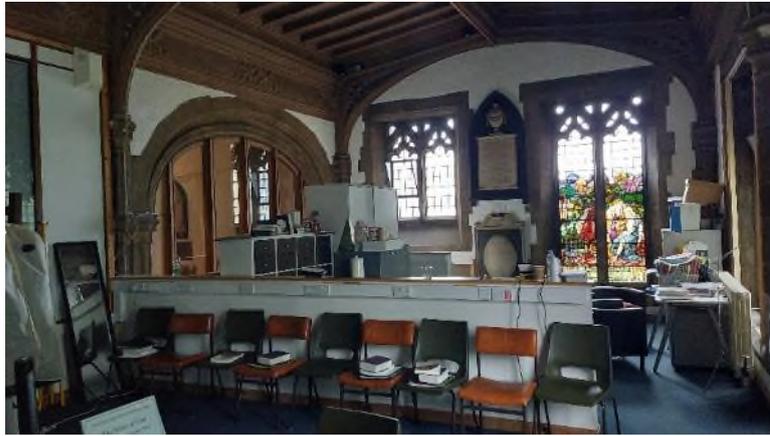
Historic staining to the ceiling at lower reaches dues to water leakage from roof, which was repaired in 2018. Walls are ok, floor has modern carpet. There is one crack on the west wall below one of the windows, approximately 2mm and is the same as last two QI reports. Floor still squeaks slightly. Modern lighting was replaced with spots as part of the 2018 repairs. Fine pictorial glass.

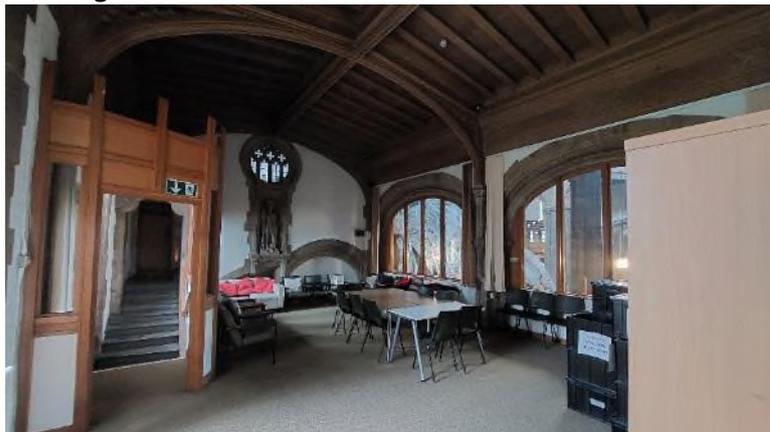
Some historic staining on the roof boarding at the lower reaches but not as significant as the western end. Redecorated since last QI. Floor creaks as the meeting room 1. New carpet but opportunity to stop floor squeaks missed.

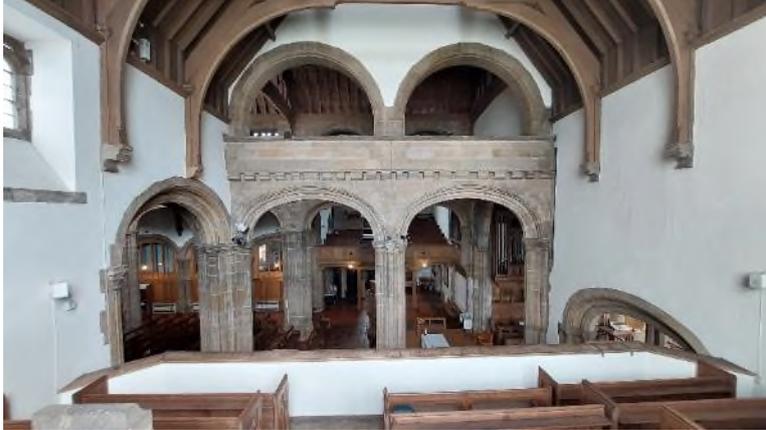
Slight cracking to the bracing of the roof trusses towards the nave seen at last two QIs
The door to the stairs and the door catches on the floor and there is no handle. The glass is bowed at the entrance doors as elsewhere.

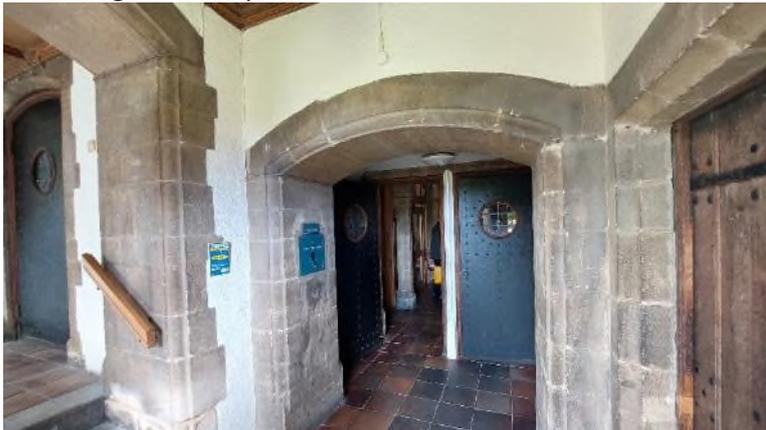
Entrance porch ok, The pair of double doors are leather covered and they could do with easing as they are catching slightly and the door latch needs oiling and easing.

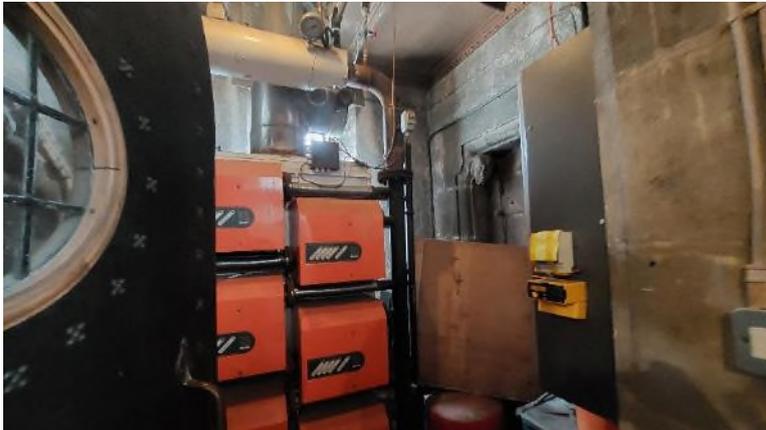
Some historic water staining on the ceiling, noted on the last two QIs, but it would be prudent to have a close look at the flat roof material. Eastern wall features an early remnant doorway. Ideal Concorde Super S4 Module 50 boiler.

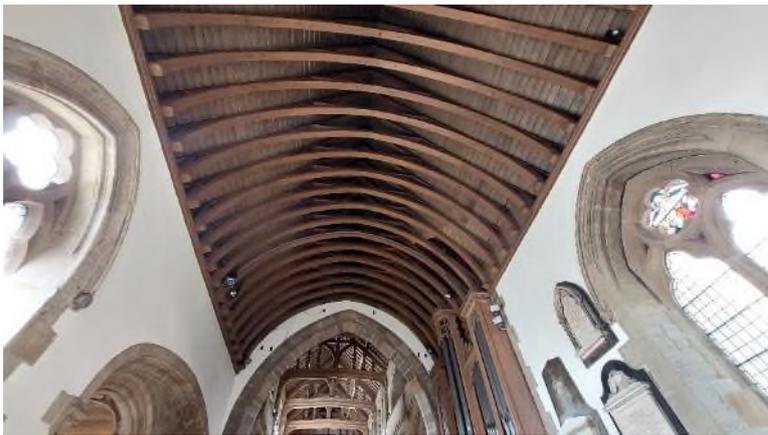
- Boarded ceiling looks ok, walls are all in fair condition, slight open joints at the top of the eastern window

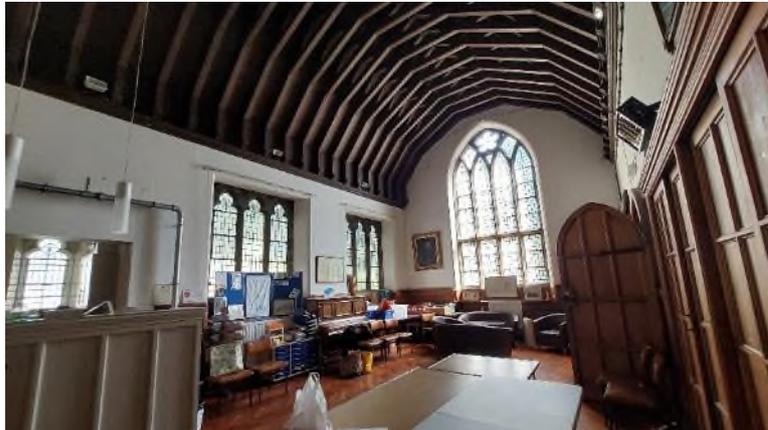
Ceiling appears in good condition as are the walls, albeit they look a little outdated and could do with some decoration. Plenty of cobwebs behind the polycarbonate window protection. The panelling is fine. The herringbone flooring is looking a little scuffed.

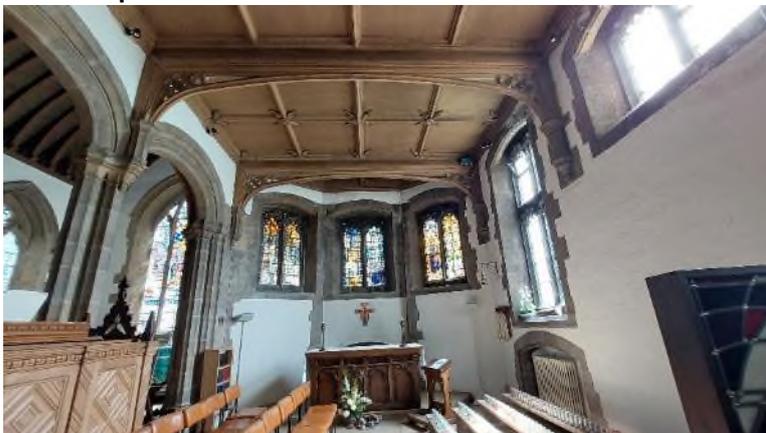
No real change here from the last QI report. The flat ceiling is unblemished. The walls have some lead sulphate marking particularly to the south side at the lintels. The walls are in good condition and there is no cracking to the arches that look onto the chancel and to the south inner aisle. Flooring is a mixture of herringbone and floor slabs.

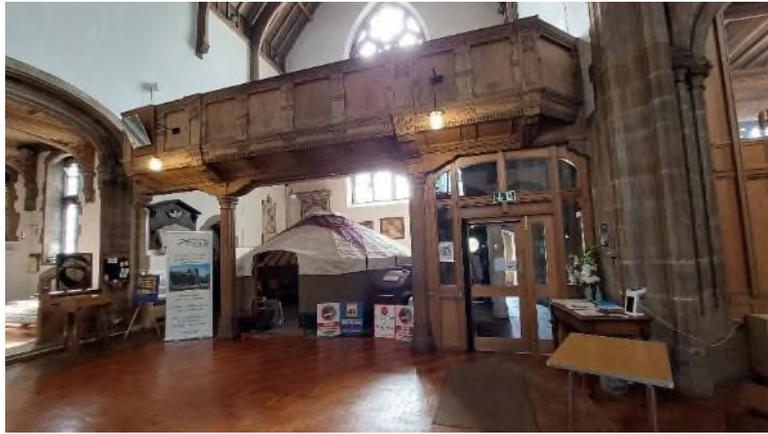
This contains the yurt and it rather fills the space but it is a successful addition to the Minster. Trip at the doorway. Shrinkage to W capital gallery column. Separate electric heater. This is a possible fire risk in a flammable structure that could imperil the building. The same thoughts go with candles if they are used and so a management system needs to be in place to reduce risk.

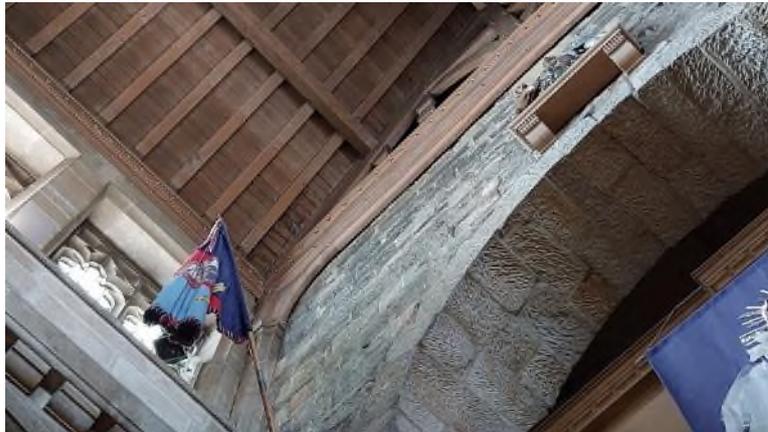
But there is an area of marking on the south side at the west end (it might have been missed in previous inspections). It corresponds to the tower downpipe position that is causing problems at the north. Is this similarly affected?

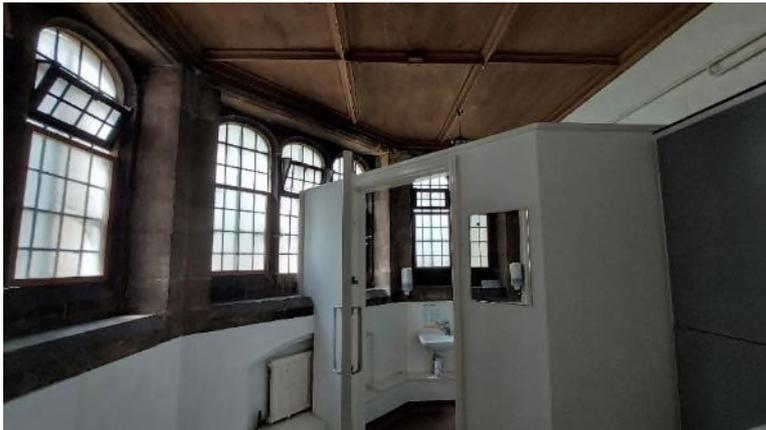
Recently remodelled and appearing satisfactory, the windows are as the previous QI, in that they are obscure, still dirty and the ventilators looks as though they may not be working.

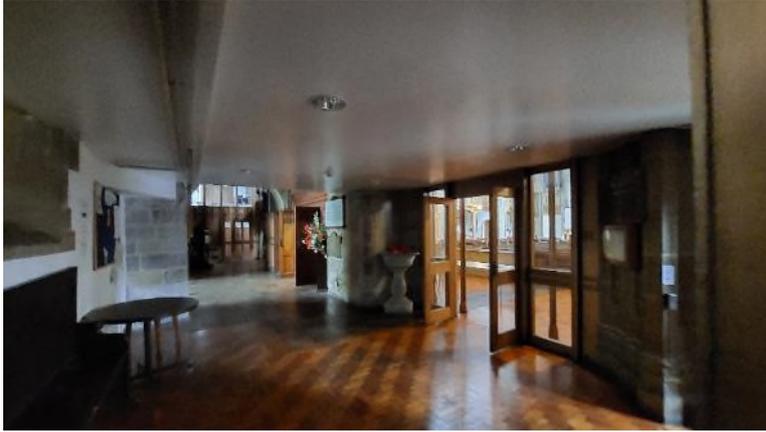
The office is formed above this and it has a low plasterboard ceiling with inset lights in good condition. The walls are mostly enclosed by glazed screens, doors to café etc. Continuation of nave flooring. This space contains the redundant oval font which is cracked in the bowl and pedestal.

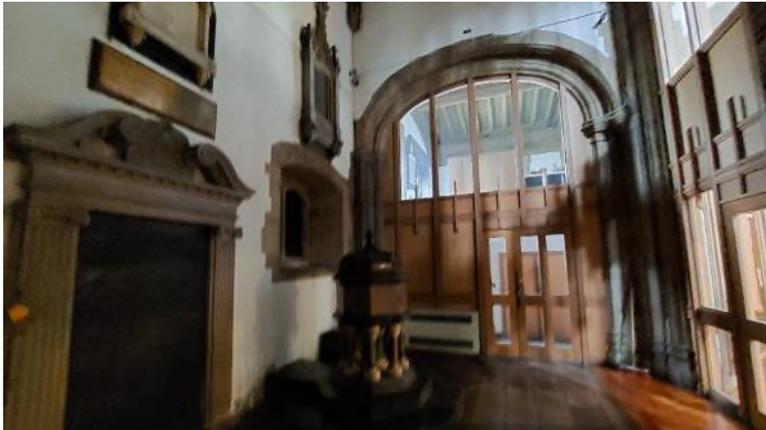
Double height space to open boarded ceiling which has slight historic water marking. Walls are mostly arches and glazed in on two sides which appear ok, the arch to the tower has approximately 1mm crack in one of the keystone joints as last QI.

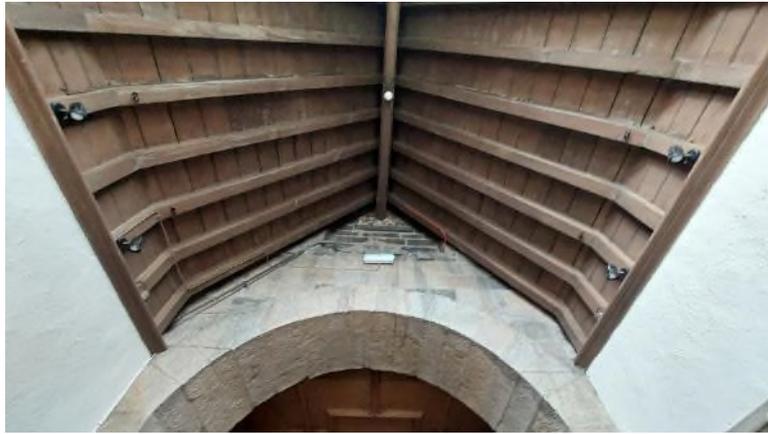
Ridged open boarded roof with ridge beam that goes into the old porch, partially enclosed by the tower with rather rough brickwork, that is inset between a larger opening, there is also some cable about and pipework. Old water marks on there and there is also a 1mm crack to the arch. No change since last two QIs

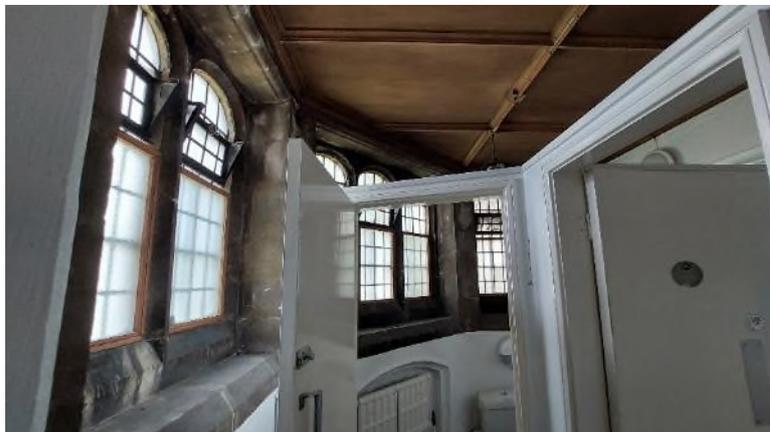
Ceiling is open boarded, some slight water marking but ok, the windows and stonework are rather grey and water stained but acceptable. The windows are secondary glazed with timber like the gents. The cubicle and fittings are rather old fashioned and were planned for updating in 2018 but funds were not available. The western wall at low level by the radiator had damp due to a now unblocked gully outside.

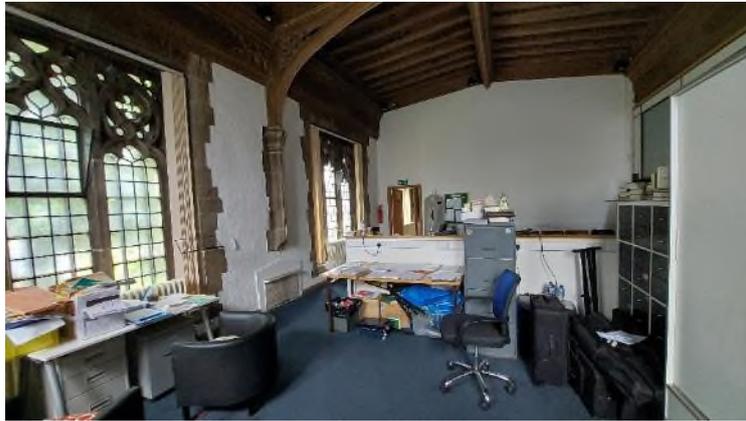
This is formed on top of the kitchen. The roof is open boarded and has historic water staining that has also gone down the walls in places. The south entablature has been cleaned as a result of the 2015 south aisle works. The roof joinery at the western end over the kitchen by the two windows and above it is quite badly marked and could do with being refurbished when funds allow.

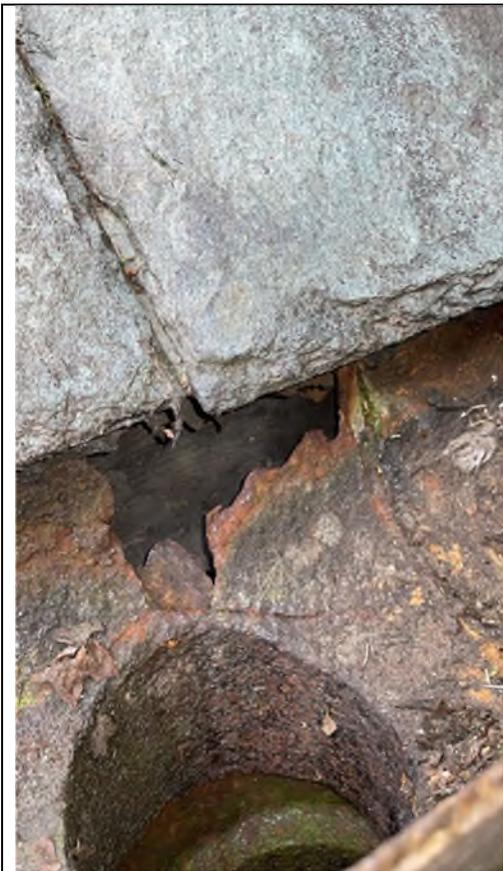
Broken Joint on chancel

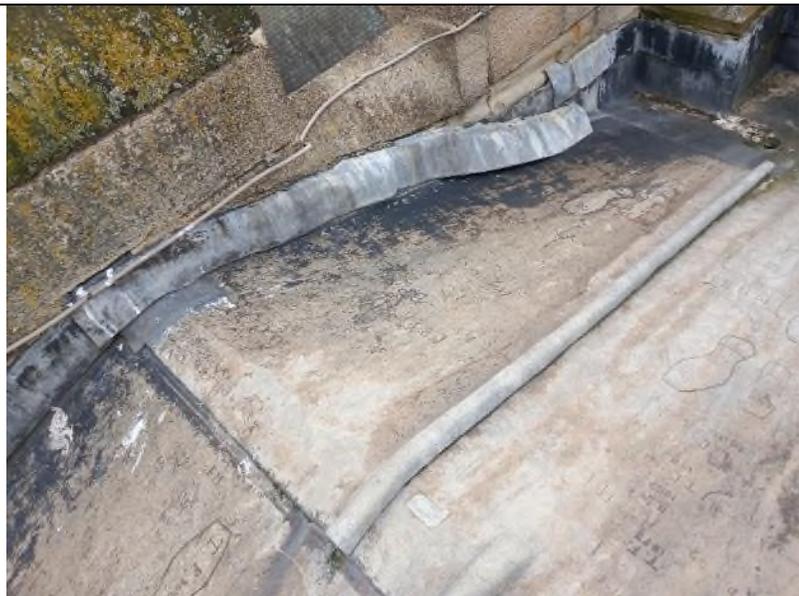
Tower flashing loose
