**QUINQUENNIAL INSPECTION REPORT  
OF**

**TRIMDON GRANGE, ST. ALBARN**

**QUINQUENNIAL INSPECTION AND REPORT**

**February 2025**

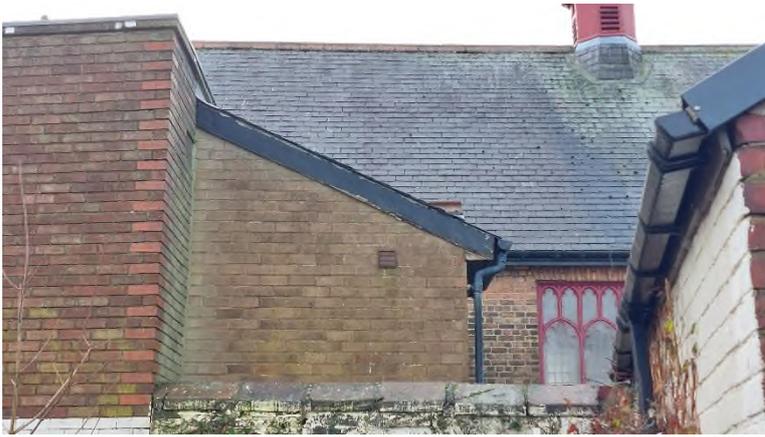
**Nave:**

**North side** – OK. Pointed verge no lead flashings. Some moss building up and green around the fleche, not wholly visible, there has been a couple of patch repairs that are lifting slightly, this roof is all the same slate colour unlike the opposite side.

**South side** – This roof has two colour bands picked out in purple slate and there are a few chipped and broken and missing slates in both the overall area and in the colour band, I wonder if this is the original slating and that the north side has been re-done?

**Recommendation:** consider reslate of south nave in say 20 years

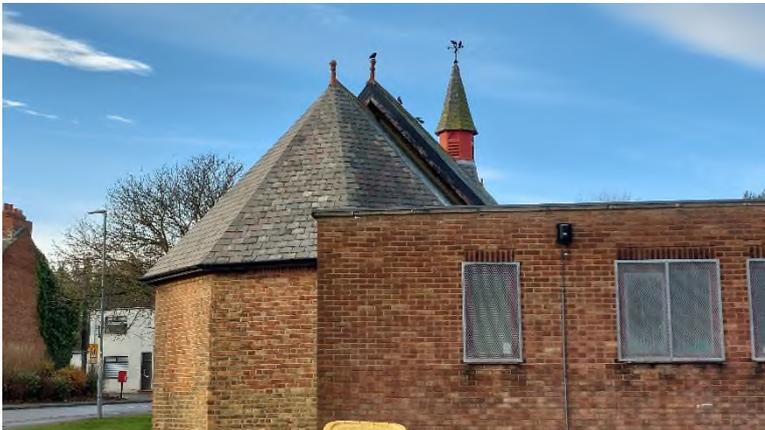
**Chancel:**

**North side** – Octagonal hipped ends with cut mitres. The abutment to the nave gable has some loose and cracked slating. Probably caused when accessing the roof to steel flashings. The chancel abutment flashing to the nave gable looks to be just mortar, I don't know that there is any lead behind it.

**East end** – This has been patched in different coloured slating, some purple some grey and it looks sound enough, I think.

**South side** – The cut mitre looks a bit poor halfway up and to its left-hand side is a missing slate.

**Recommendation:** repair mitre and missing slates

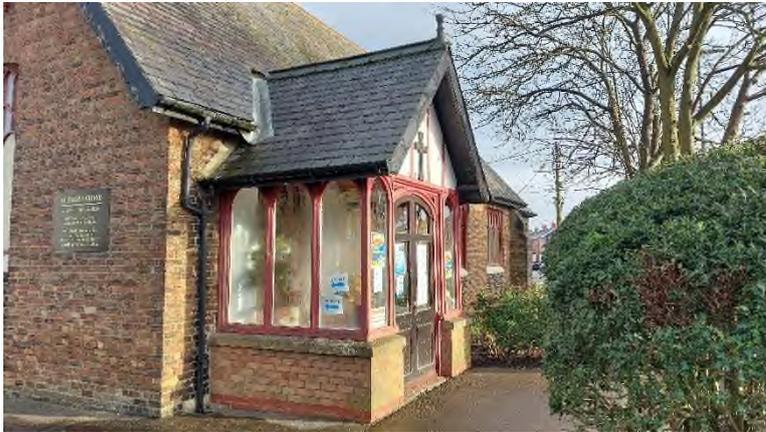
- **Porch:**

Same style as the nave, except the ridge tiles are grey. Slating both sides are ok. The mortar abutment flashings are sand cement covering the lead work to discourage thieves.

**Recommendation:** none

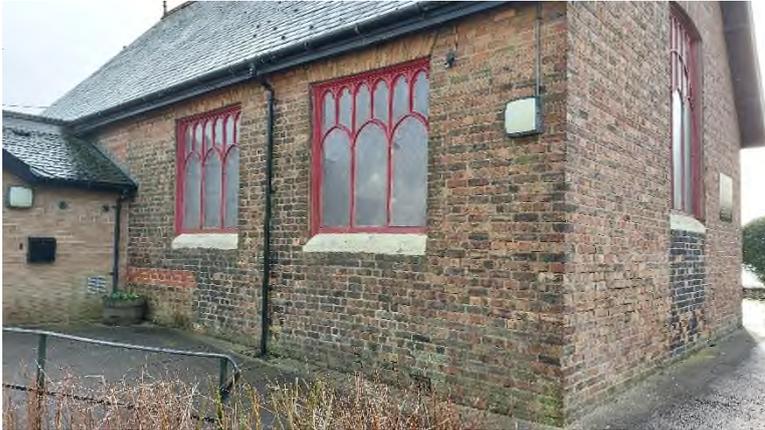
#### **North side –**

This is a small part that is left over from being enclosed by the hall, brickwork a bit patched, cement pointed, some open joints, some bricks losing their face but in fair condition.

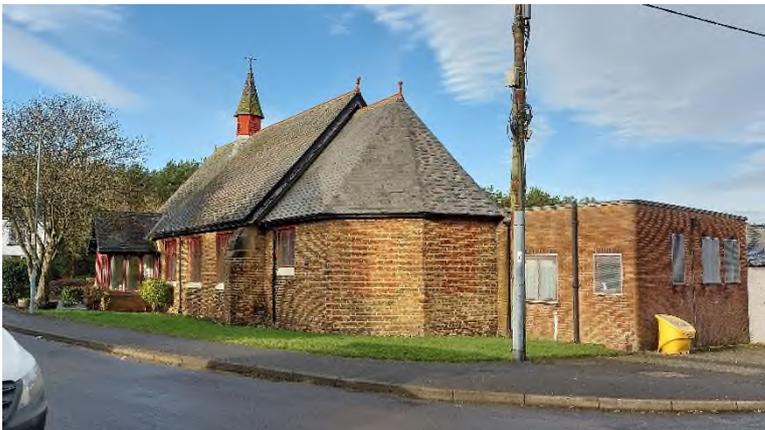
#### **Chancel –**

**South side –** Same erosion. The window head is soldier courses unlike the flat arches elsewhere, open joint at the angle change.

**East side** – Two windows blocked in with none-matching bricks, some open joints but generally sound.

**Recommendation:** none

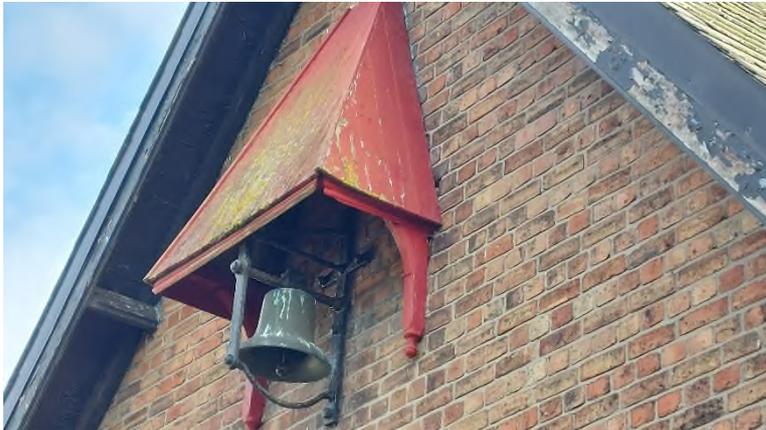
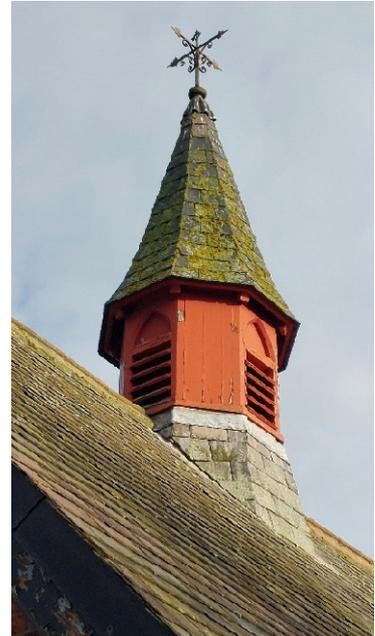
**M** Timber fleche with octagonal spire, roof slated and rather green, topped with lead finial supporting a cross like weather vane.

The louvered belfry part doesn't have a bell and I think was only ever designed as a ventilator, decoration is breaking down, some cracking at the joints of panels but looks sound enough, under that the leadwork apron is ok and the slate skirt look ok too. The church advise that the Fleche was informally looked at during the last five years. It would be good to put on record the inspection findings. Timber fleches are notorious for hiding their structural defects (if there are any) behind the panelling.

**Bells** – There is a bell housed at the west gable at the apex, it has a ringing mechanism inside the church, and it sounds ok. It is a chiming bell, it would be worthwhile just checking if the axel is oiled and greased satisfactorily. It has a timber hood see later section in the external iron and wood for comments on it.

**Recommendation:** check over bell mechanism

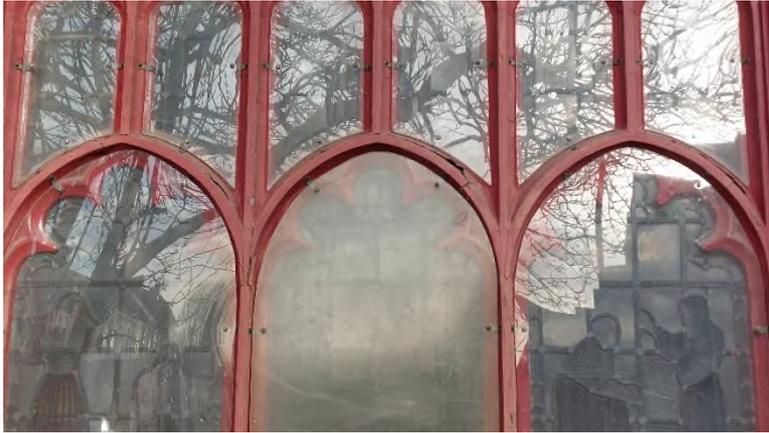
The windows are principally three light lancets with dual clerestory lights above in obscure leaded glazing in timber frames, whose decoration is breaking down a bit. The frames are covered in polycarbonate which is looking rather grey now and there is quite a bit of dirt trapped behind them.

**Porch** – Some rot beginning to occur at corner post and part moulding missing at the right-hand side of the door arch.

**Recommendation:** repair and redecorate windows, clean glass and protection

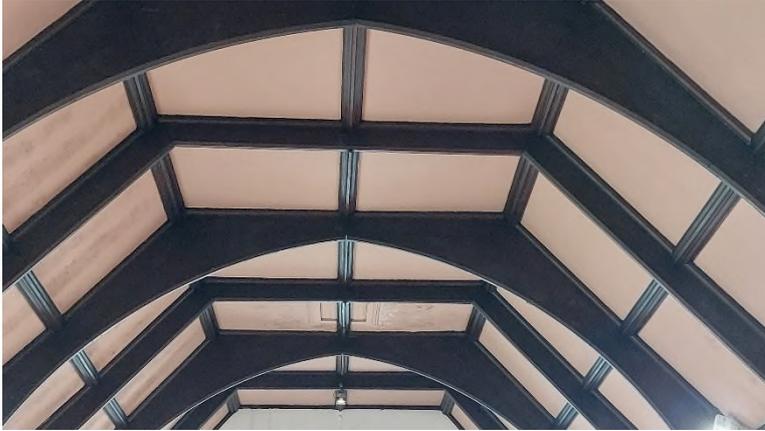
#### - **Nave:**

Three principal trusses with bladed rafters, four secondary rafters into wall head. The principals are extended down into stone corbels, all of that looks ok, there is no evidence of shrinkage or movement.

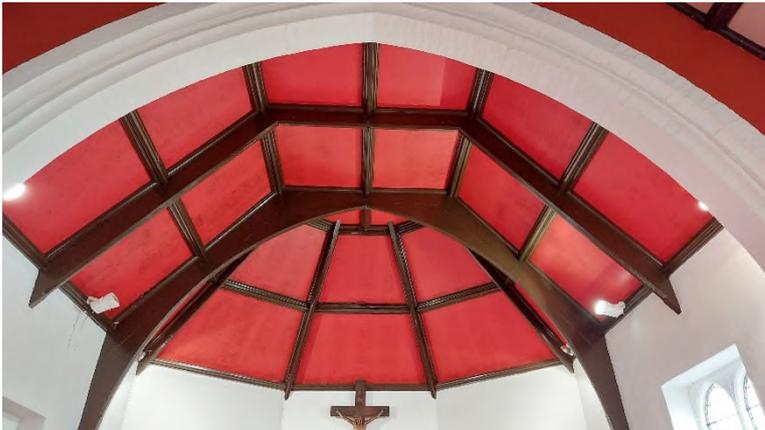
#### **Chancel:**

Same design as nave, one of each looks ok, apsidal end with secondary rafters into wall head looks ok with exposed purlins.

**Recommendation:** none

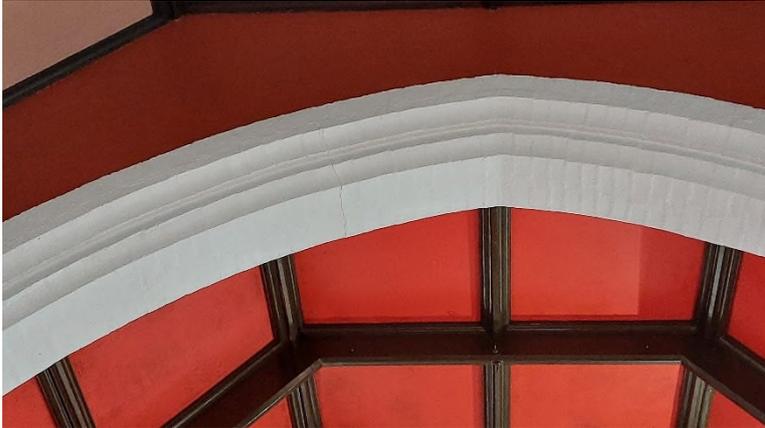
- **Chancel Arch:**

There is a crack to the chancel arch on the north side just below the apex, this hasn't been mentioned in the previous QI but it looks historical to me, viewed from within the chancel there is a zigzag crack running up to the roof and this suggests that this might be settlement that has been induced by the addition of the church hall buildings disturbing the ground, but it isn't anything to be concerned about presently. There is also a crack at the entrance lintel of the south porch at the nave wall, this does not look to be causing any difficulty. The previous QI did pick up that there was cracking to the window cills which wasn't so evident on this inspection. There is some more concerning cracking at the east end of the church hall which has zigzag cracking to the mortar joint above the kitchen window to the north side as it abuts the neighbour outbuilding, the window lintels to the two windows might be suspect, are they dropping? There seems to be some movement at the horizontal joints where a lintel would bear but I think it is just keeping an eye on it and repointing might be wise and using that as a crack monitor.

Brick chancel arch painted, there is a crack to the north side close to the apex at a joint, but it looks historical, it does extend up the wall within the chancel, is it likely to be induced by the church hall additions?

**Recommendation:** none

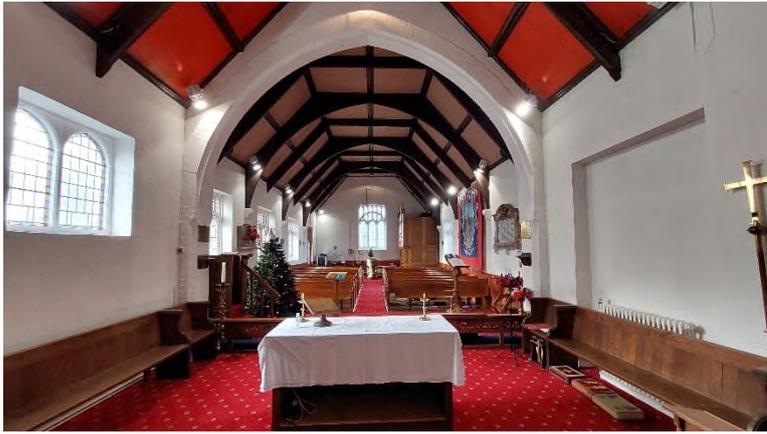
The walls to the nave and chancel are plastered and decorated, the decoration is good, there is one area in the nave close to the organ where the decoration is breaking down above the dado and damp is coming up above the dado in the north west corner by the side of the organ.

There is an area of remedial plaster in the chancel at the south side close to the arch. The decoration to the walls is generally good and to the nave ceiling but the chancel ceiling decoration is poor this is probably due to with a lack insulation and it's the passage of dirt through the fabric that has made it stained.

**Recommendation:** redecorate chancel ceiling

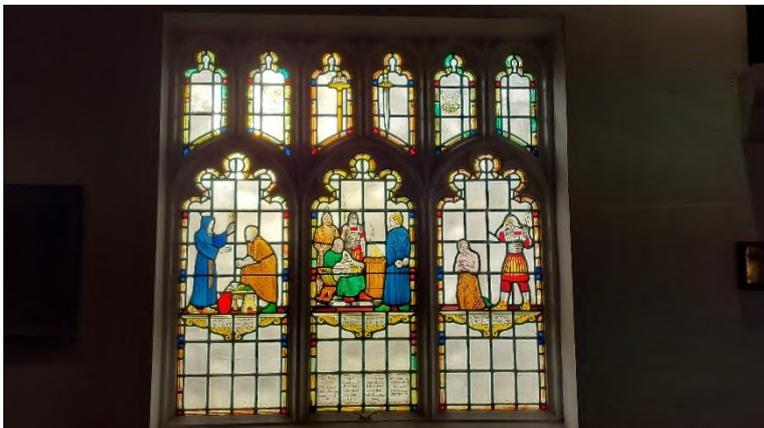
7.5.7 GLAZING

Most of the glass is obscure leaded with coloured margins, it does look a bit dirty on the polycarbonate, quite a lot of condensation on the glass. One pictorial window on the south side to the Bradley family, the condition is good.

**Recommendation:** clean glass

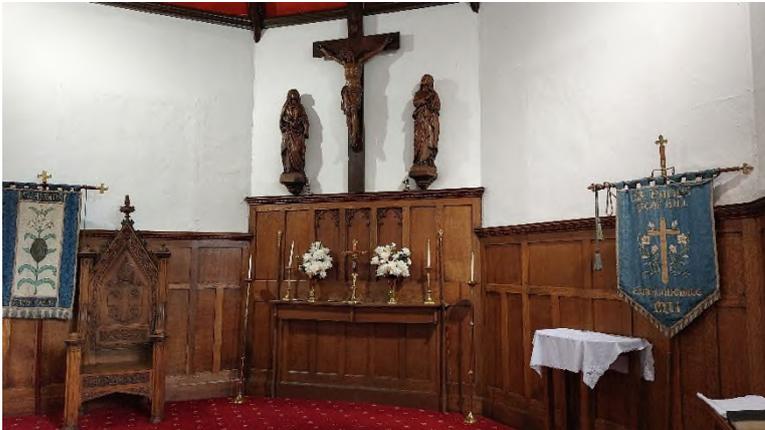
- **Reredos:**

Oak panelled reredos with mid rail shelf sagging slightly with three tracery panels, the rest blank, to its outer edges the panelling is extended around the apsidal end to form a dado type panelling and all of that looks good.

**Recommendation:** none

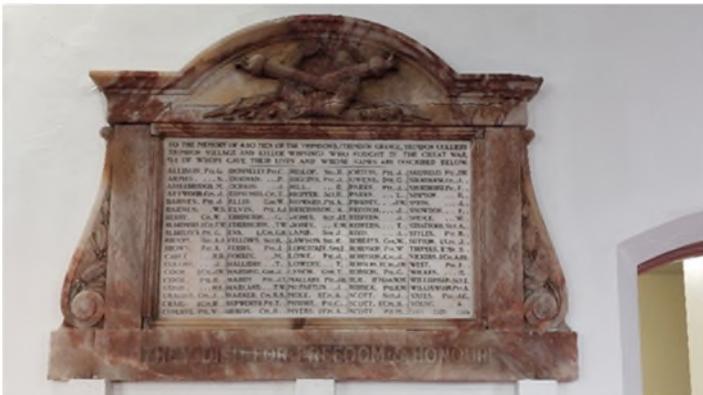
- E **Monuments:**

Two War Memorials, the First World War is in marble its top is cracking and is looking slightly disjointed on the left-hand side. Second World War tablet is good. Alongside is a Miners' banner

**Recommendation:** establish repair needs of WWII memorial

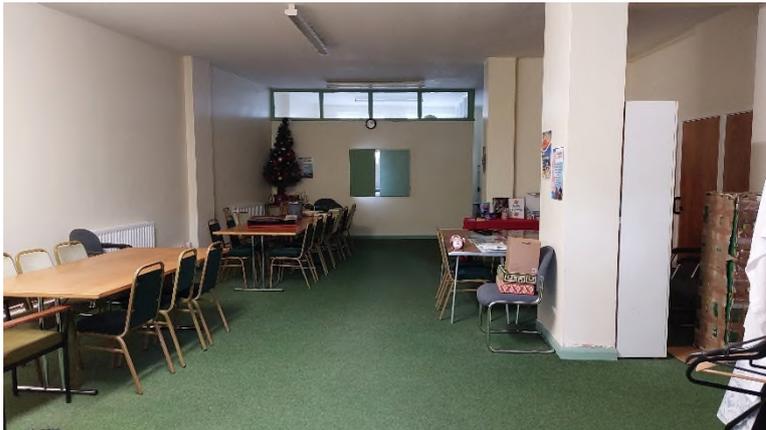
**E Church Hall –**

Large space providing room for communal activities with table and chairs. Ceiling undulating slightly, it looks like it has been patched over in the past, perhaps there has been a leak. There is some slight bubbling, and the patching is quite poor, but it is serviceable. The walls are plastered, and the decoration is ok. The floor is solid with serviceable Flotex type carpet.

**Recommendation:** consider cupboards

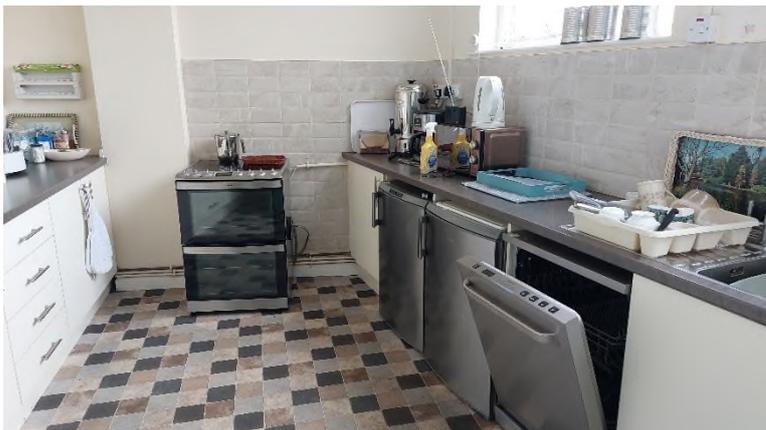
**- Kitchen –**

Catering standard. Ceiling and wall decoration is ok, floor is good, contains good appliances, there are windows on the east made of obscure glazing they are not easy to open as they are rather high and is painted up now, condensation on the glass, high level borrowed light windows look ok. Is extract fan adequate?

**Recommendation:** consider improved ventilation

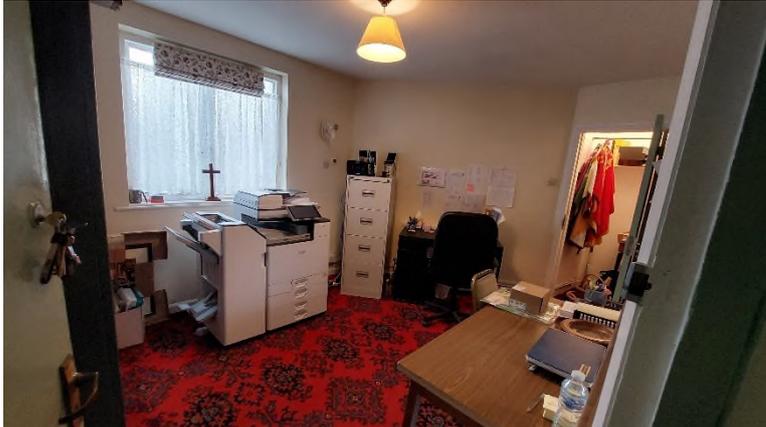
- **Vicar's Vestry –**

Ceiling and walls plastered, and decoration is ok. Carpeted floor ok. Not too full of things and reasonably furnished, it has a store cupboard to the side and that looks ok. Some condensation on the window.

**Recommendation:** none

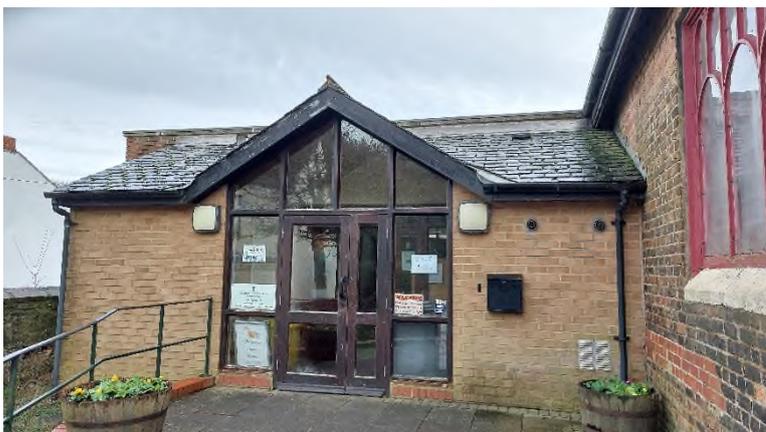
**Porch** - Has a slated roof with some mould on it, there is a water discharge that comes off the flat roof at the northern side of the

entrance and peculiarly it is running though we haven't had any rain. Is there a burst pipe on the hall roof?

**Recommendation:** check hall roof condition, porch roof water, porch rwp loose and gully needs repair, repair ramp edge brickwork, repair rotten windows, check kitchen outside wall east end cracking at lintels,

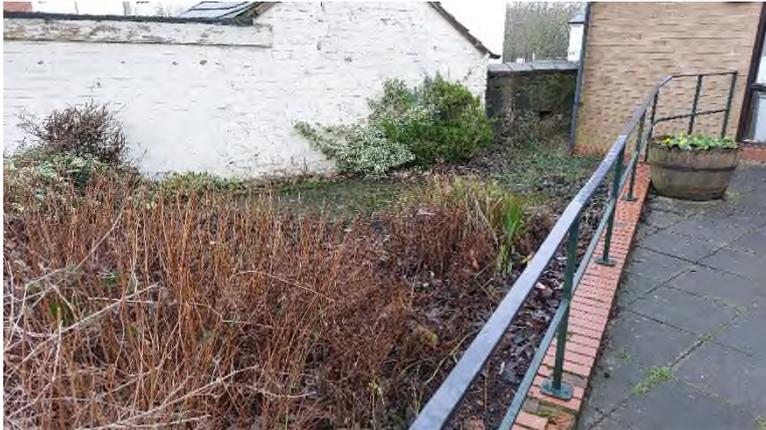
There is a small area of stone wall onto the neighbouring property with a big hole in it and a couple of cracks and it looks as if it has the potential to collapse because the ground is higher on this point, the rear doesn't look so bad but it would be wise to take a closer look without the ivy on it. The porch roof drain that is taking the flat roof its downpipe is loose and is discharging into a gulley that has lost its grid.

Some brickwork breaking up at the ramps edging.

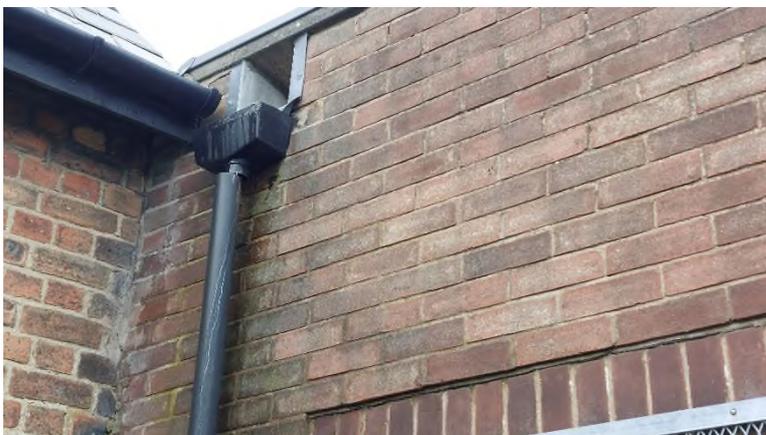
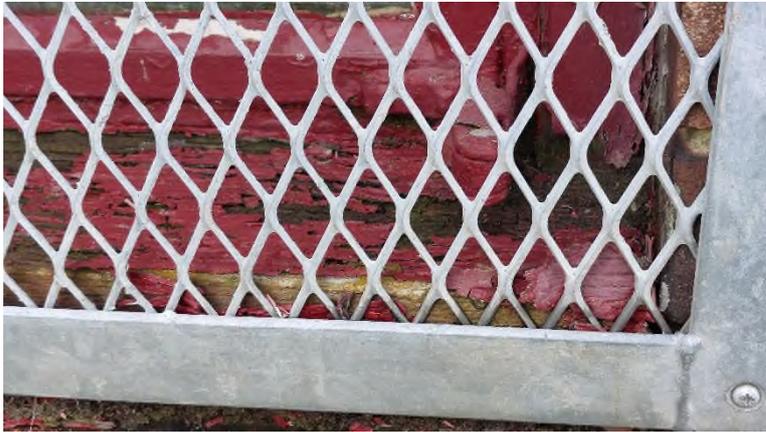
#### **South elevation –**

The downpipe to the hopper head is disconnected and is greening up the wall and I wonder if the gulley is also blocked, this wall has metal mesh security to the windows and the windows behind are timber and the decoration has broken down the cills look as if they are rotten.

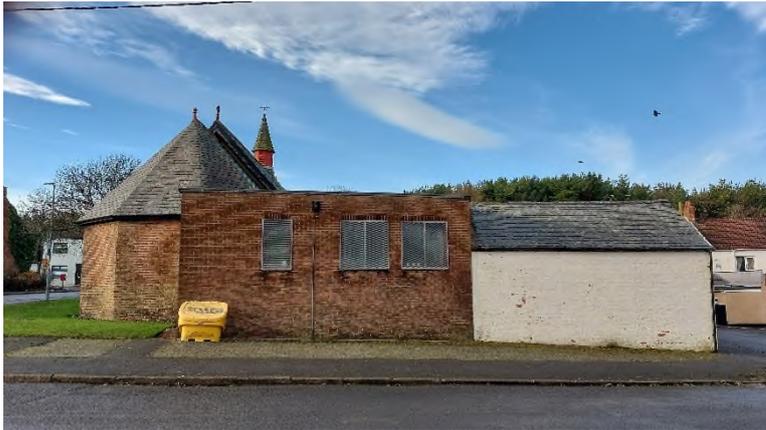
**East elevation –**

The wall has some diagonal settlement cracking at the northern end where the joints have opened up below the wall head coping, it maybe that the lintels aren't doing their job very well.

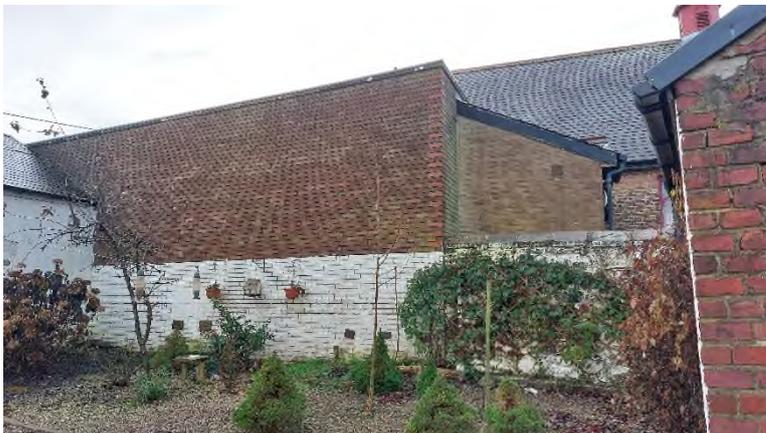
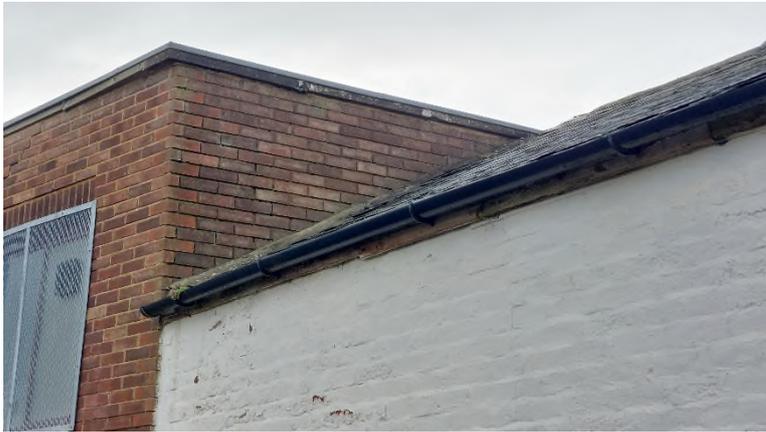
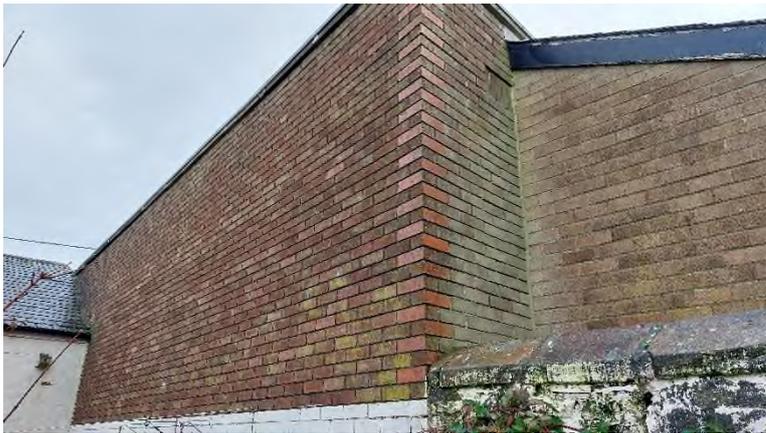
**North elevation –**

The spandrel panel above the white neighbour outbuilding has lost all of its pointing. Save this work up until there's more to do elsewhere.

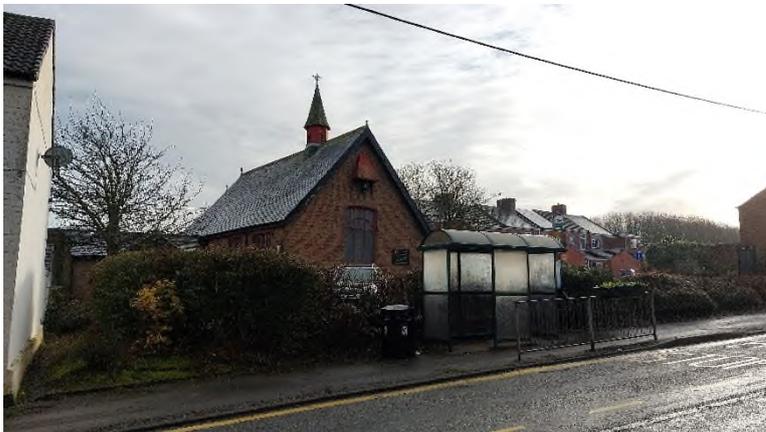
**West Boundary –**

Low hedging onto highway enclosing carpark area, the tarmac is beginning to be eroded a bit now.

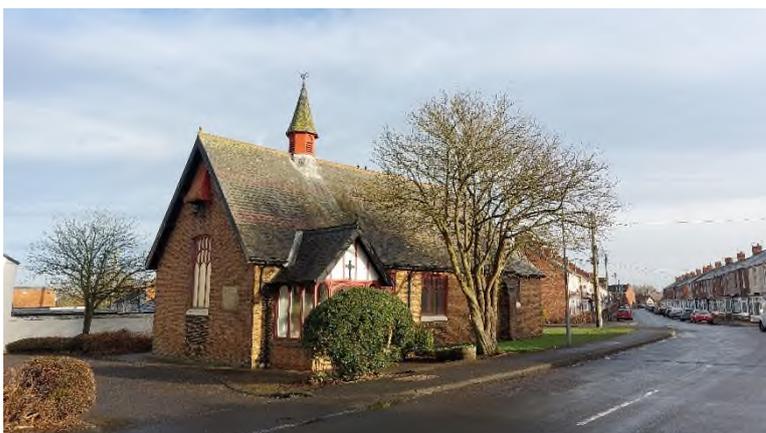
**South Boundary –**

- **Trees:** One mature tree which is close to the south porch and footpath, which is beginning to encroach on the footpath lamppost and has the potential to threaten the porch and catch the nave and as the trunk is a multiple split trunk there could be a possible collapse and so it would be wise to understand the condition of the tree and perhaps reduce its crown and might Highway's lend a hand here as it can affect the footpath.

Mostly open to the footpath, grass, one tree which has been pruned I wonder if there is rot at the stump, multiple stems I wonder if that is going to spread and also it is starting to enclose the streetlight it would be worthwhile understanding what the

condition of that is. Pin kerb around it next to the tarmac pavements is breaking up a little, small planting bed at the foot.

**Recommendation:** check south boundary tree condition
