**Quinquennial Inspection Report  
St Alban's Church, Windy Nook, Gateshead  
Deanery of Gateshead  
Archdeaconry of Sunderland  
Diocese of Durham**

David Jowett - Architect, BA, DipArch, RIBA  
25 Roseworth Avenue  
Gosforth  
Newcastle upon Tyne  
NE3 1NB  
Tel: 07788 710 204  
email: [david@davidjowett-architect.co.uk](mailto:david@davidjowett-architect.co.uk)

2 May 2026

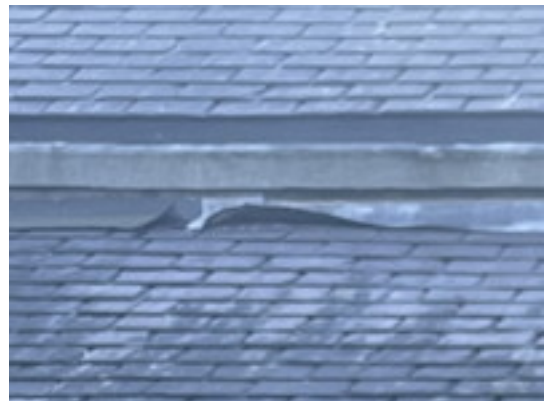
**Broken Slates South Nave Roof**

Several chipped slates, 3no to the south Nave Roof. Two sections of synthetic lead-free flashing have come loose from the nave roof north-west gable and need to be secured immediately. Ridge pointing is missing to the chancel and to the nave south roof and west roof.

Replace all chipped slates, secure loose flashing and make good pointing to ridges. Cost Band 1–£0.00-£1,999.

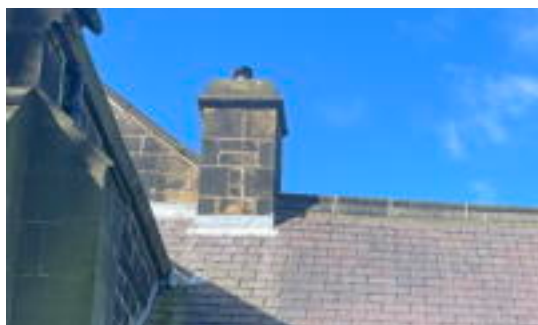
**Loose Parapet Flashing Nave West End South Elevation**

Finials, Bellcote and Chimney all appear generally sound and in good condition when viewed from ground level. Loose flashing to nave west end south elevation parapet.

Secure loose flashing. Cost Band 1–£0.00-£1,999.

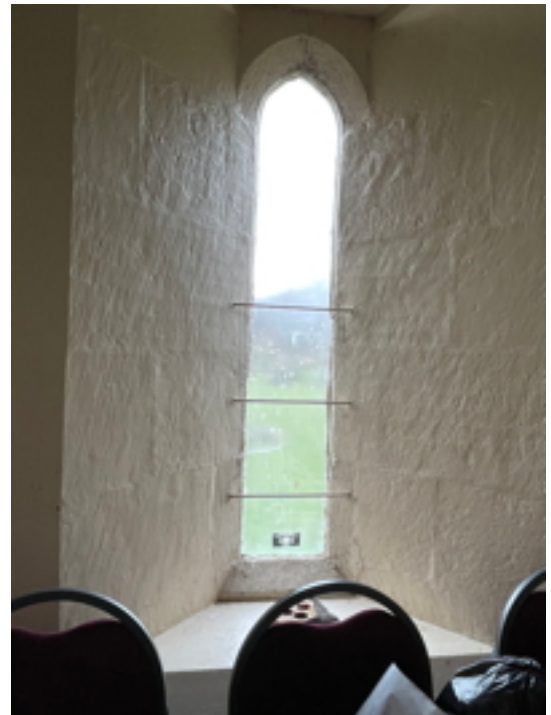
**Window 20 North Aisle, west wall temporarily glazed in polycarbonate**

Window 20 should ideally be replaced

Replace cracked quarries and replace 2no windows. Cost Band 2– £2,000.00-£9,999.

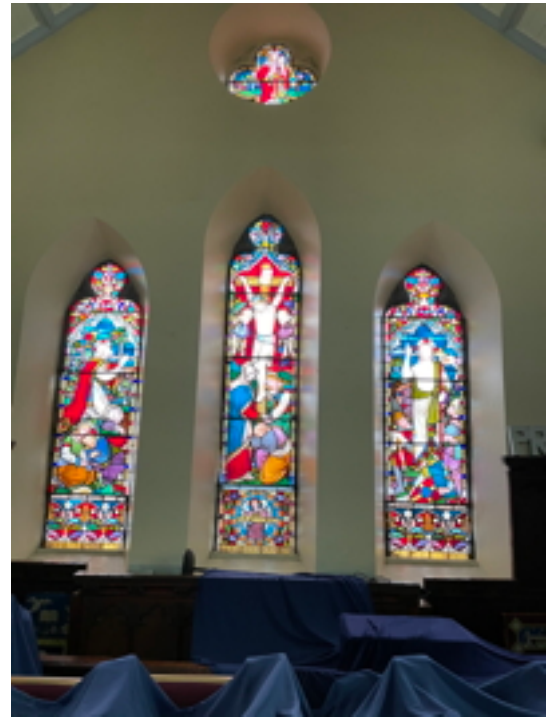
**Windows 7, 8, 9 and 10. W7-9 Three stained glass lancets. W10 Quatrefoil window above. Stained glass is possibly reused as the fit to stonework openings is poor. Saddle bars are rusting. Some distortion.**

Windows 7 to 10 saddle bars are rusting. Some distortion, repairs may be required soon.

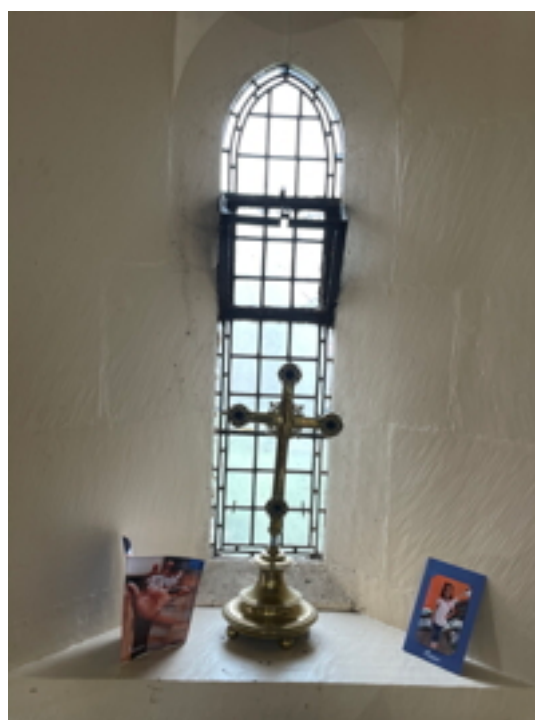
**Window 16 North Aisle, single lancet, plain.**

W16 has two cracked quarries.

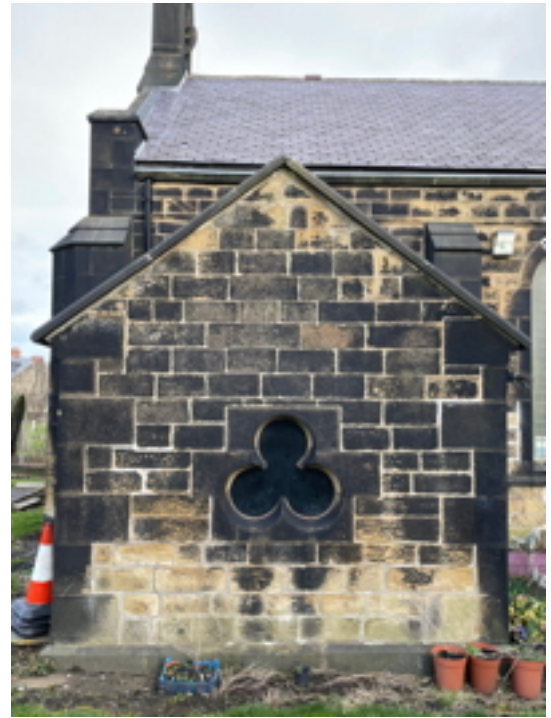
**Window 24 South Porch, trefoil  
window infilled with plywood**

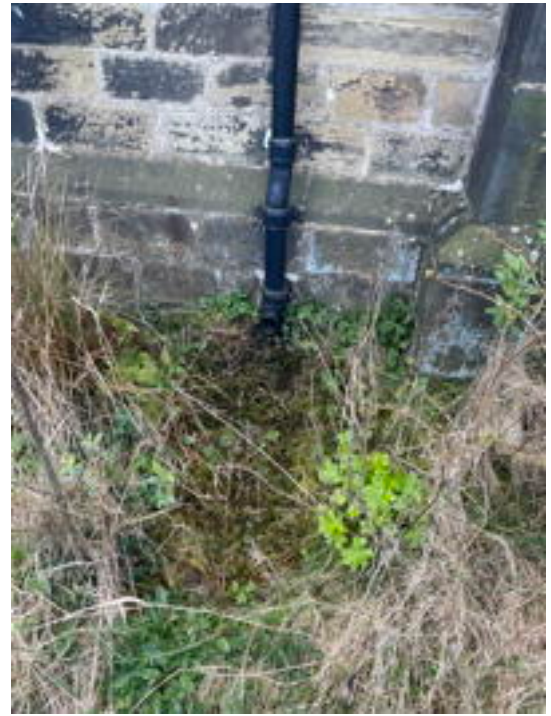
**Overgrown Run-Off**

Some run-offs obstructed and overgrown. One gully is missing.

Remove obstructions and clear overgrowth to run-offs to let water drain to grassed areas and replace missing gully Cost Band 1-£0.00-£1,999.

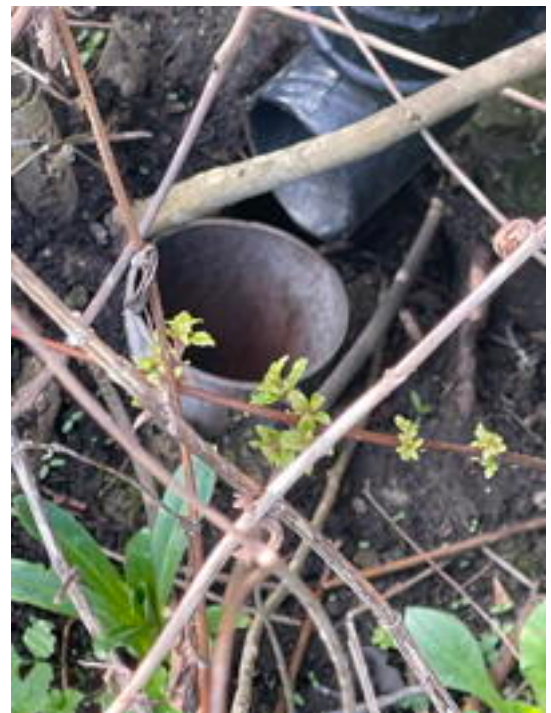
**Missing Gully**

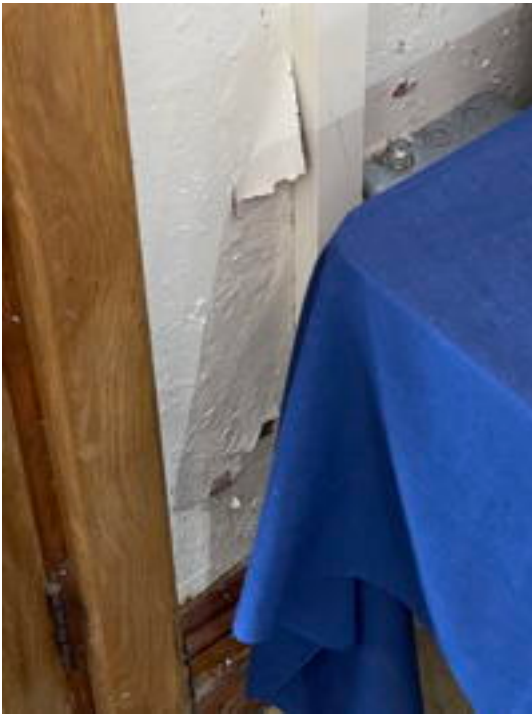
All is generally in satisfactory condition. Peeling paint to RHS of door to the Entrance Lobby. Cracking at high level to north aisle, east end. Some minor cracking at eaves level

**Peeling Paint at Porch Door**

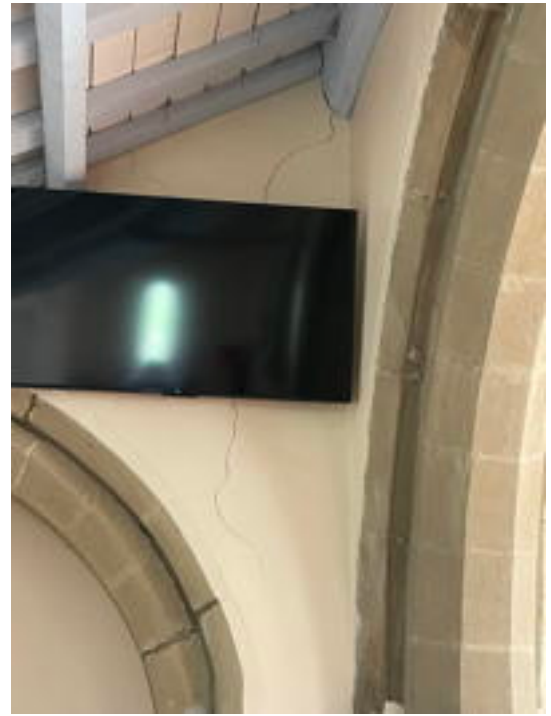
**Cracking North Aisle East End**

Monitor cracking for signs of further movement. Cost Band 1-£0.00-£1,999.

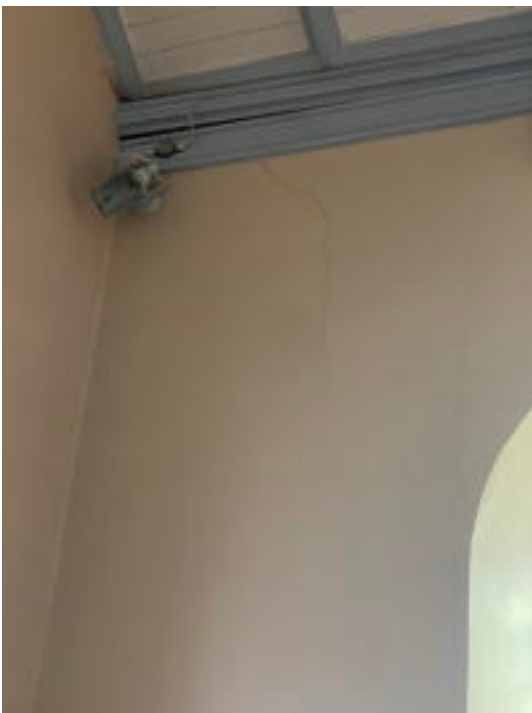
**Cracking at Eaves**

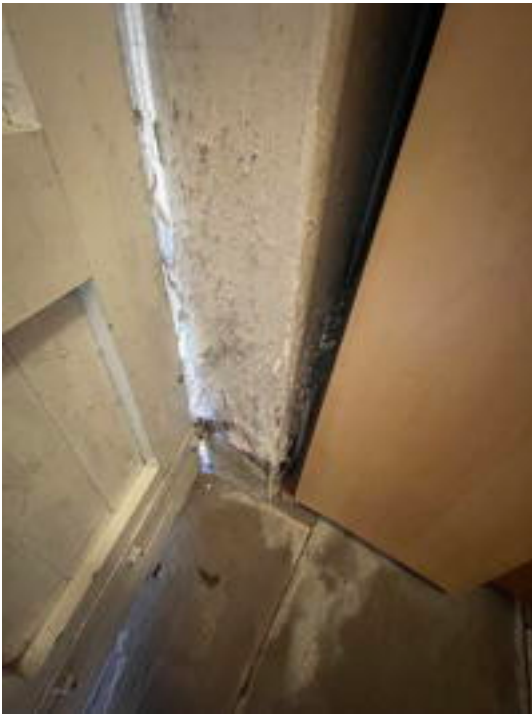
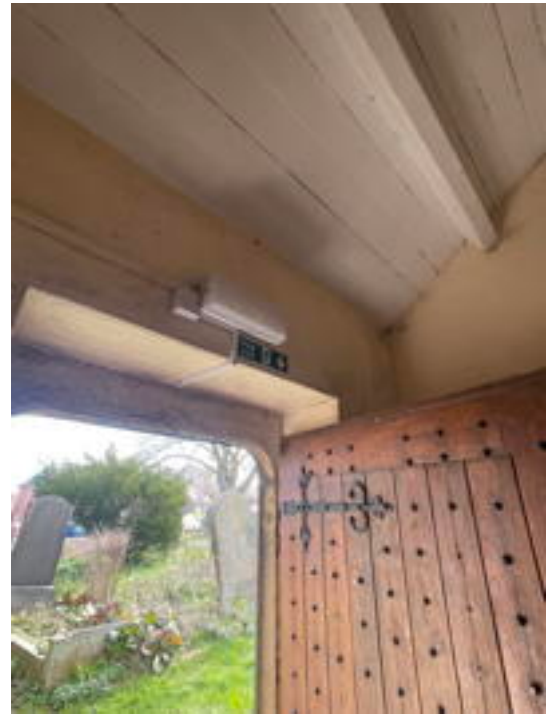
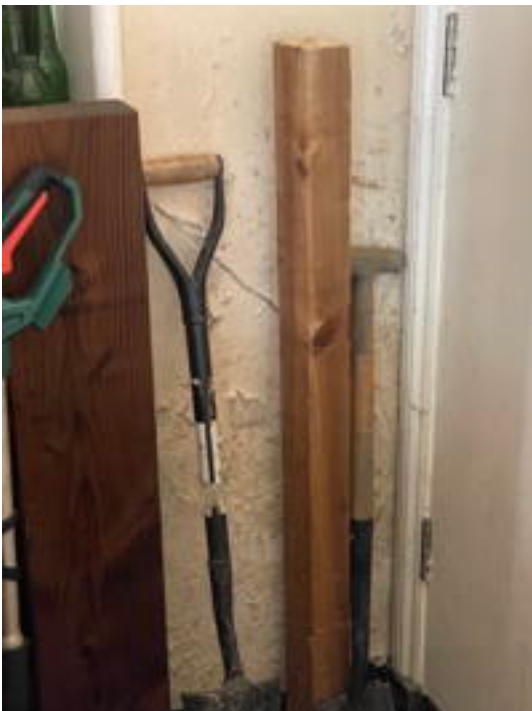
Decoration deteriorating further and was poor at last quinquennial a. Efflorescence at low level on walls and mould around the door. Numerous stored materials could compromise the emergency escape route. The porch floor requires some pointing of joints.

**Deteriorating Paintwork Door RHS**

**Deteriorating Paintwork Door Head**

**Deteriorating Paintwork South Wall**

Remove pots from walls externally as above. Locally brush down and decorate peeling sections of paintwork, and treat mouldy sections with an appropriate fungicidal solution and redecorate. A better solution would be to remove gloss paint and apply a new clay paint finish. Cost Band 1–£0.00-£1,999.

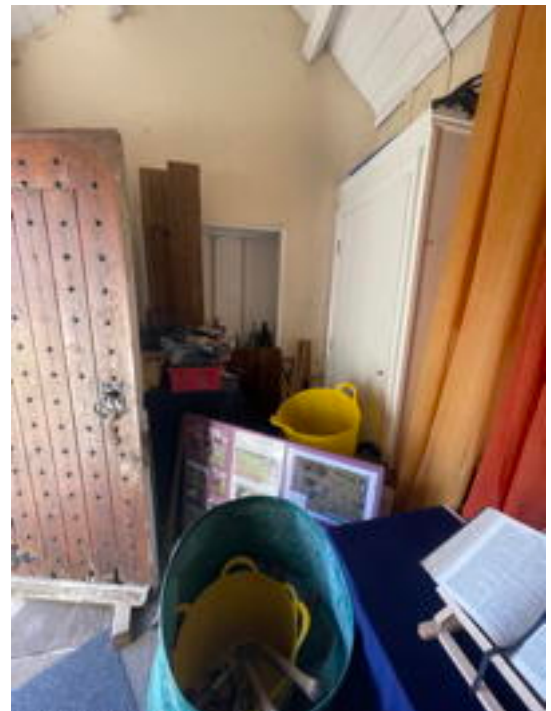
**Stored Materials**

Consider alternative storage for stored material. Cost Band 1–£0.00-£1,999.

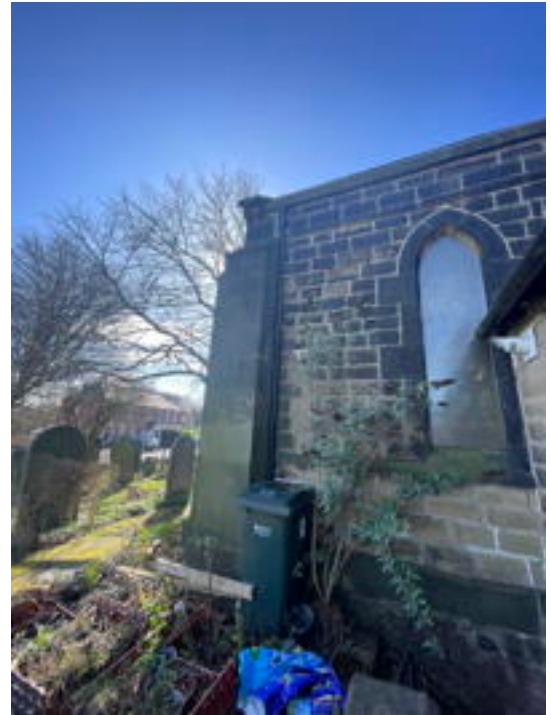
**Buddleia**

The trees generally all appear to be in satisfactory condition. However, the buddleia and other seedlings should be fully removed before they cause damage to the church structure. The trees should all be inspected by a qualified tree surgeon every five years and pruned in accordance with their recommendations.
