Quinquennial Inspection Report

St Mary and St Stephen Wolsingham

For
St Mary and St Stephen PCC
July 2024

QUINQUENNIAL REPORT 2024

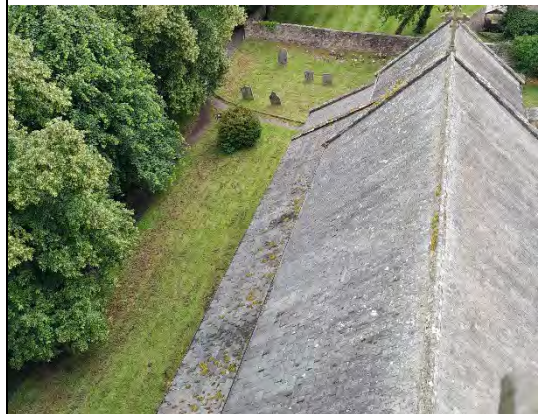
No.	Description	Recommended Action	Cat.	Photograph
EXTERIOR				
1.0.0	Roof coverings			
Westmoreland slates in diminishing courses to pitched roofs. Stone ridges. Lead and mortar flashings. Lead finish to tower roof with some neoprene joints.				
1.1.0	Nave			
1.1.1	Ridge: gaps to pointing to ridge stones.	Point up ridge stones.	2

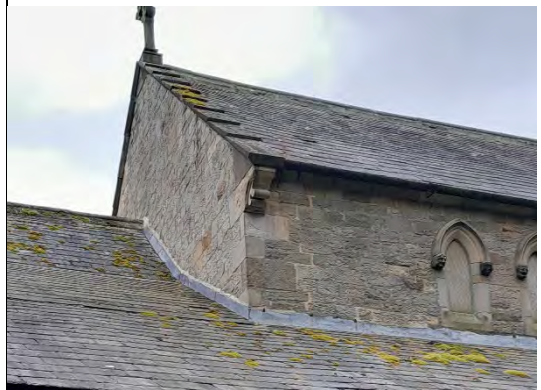
1.1.2	North roof: there are around a dozen cracked and/or slipped slates. Slating otherwise appears sound.	Re-fix slipped and replace cracked slates.	1

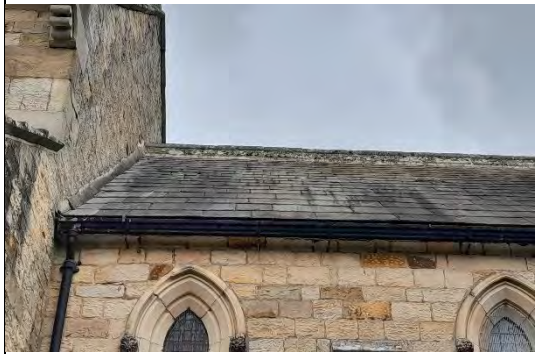
1.1.3	South roof: there are around half a dozen cracked slates and several slipped slates. Slating otherwise appears sound.	Re-fix slipped and replace cracked slates.	1

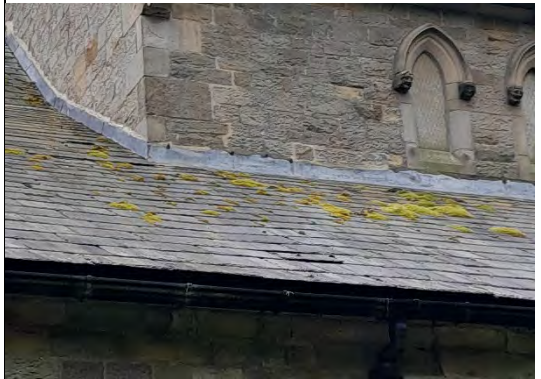
1.2.0	Aisles			
1.2.1	North: a mismatched slate has been used to carry out a repair. Slating otherwise appears sound.	Replace slate with slate graded to suit coursing.	3

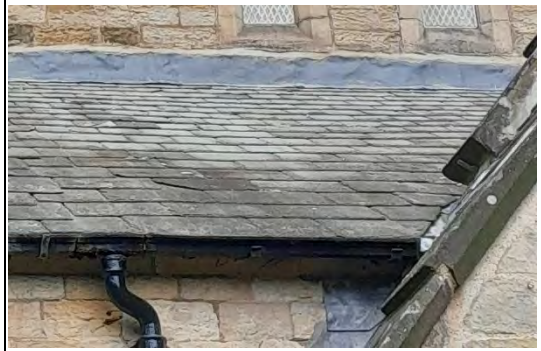
1.2.2	South: there are around half a dozen cracked slates. Slating otherwise appears sound.	Replace cracked slates.	1

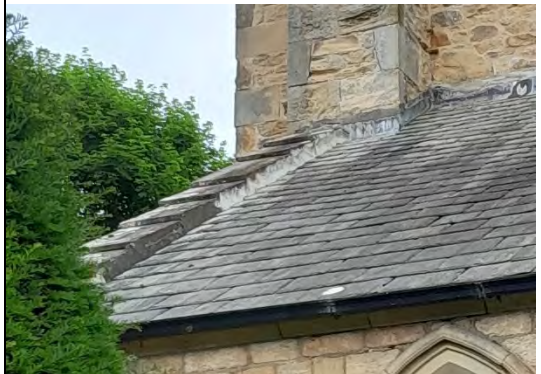
1.2.3	South: the mortar fillet to the west water table abutment appears to have been partly renewed recently. It does not appear in keeping with other mortar fillets.	Replace mortar fillet with mortar to match existing.	5

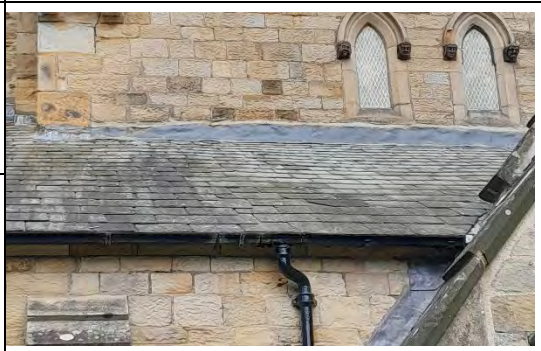
1.2.4	South: the slate coursing is mis-matched to the west of the porch. It is assumed re-slating took place at different times for these areas.	Re-slate, reinstating continuous courses.	5

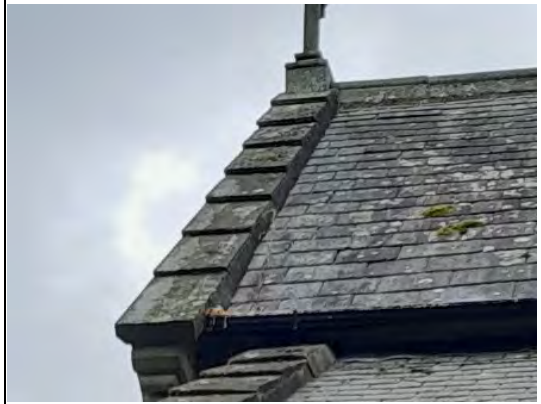
1.3.2	North roof: Mortar fillet to water table to east has loose mortar. Slating generally appears sound. Lead flashing to nave abutment.	Renew the mortar fillet to the water table.	2

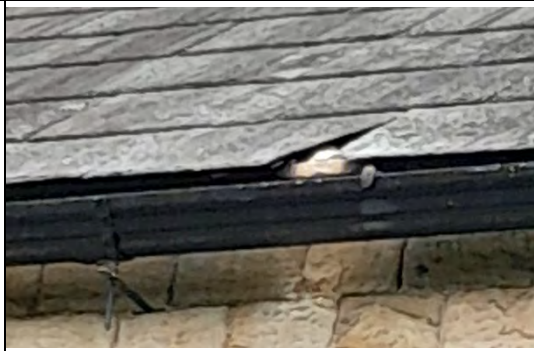
1.3.3	South roof: there are around half a dozen cracked and/or slipped slates, including a large broken eaves slate. Slating otherwise appears sound.	Re-fix slipped and replace cracked slates.	1

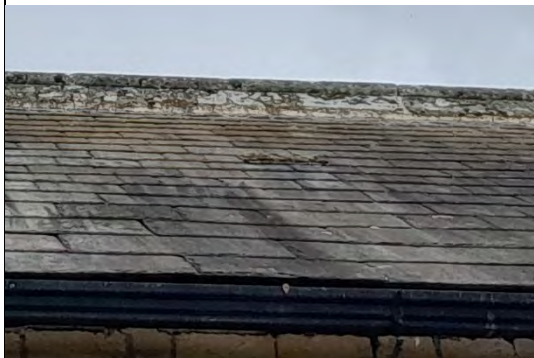
1.3.4	South roof: there is a single slate with a moss-like covering.	Investigate moss on single slate.	4

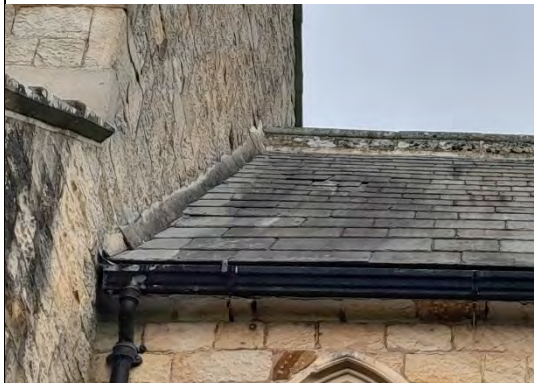
1.3.5	South roof: the west abutment with the nave wall has a mortar fillet. The lower section has broken away. It appears lead soakers are in place but no lead flashing. This is in the location of historic dampness internally.	Investigate extent of leadwork. Repair mortar fillet. Replace mortar fillet with lead flashing, ensuring lead soakers are in place.	1 4

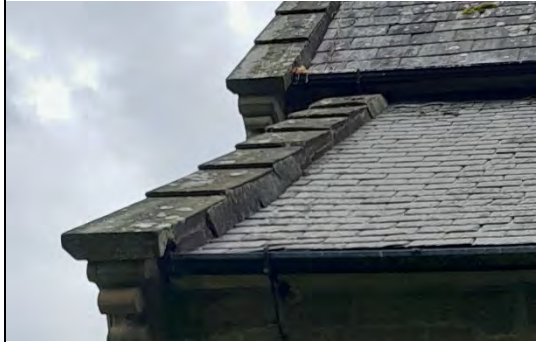
1.4.2	Mortar fillet to water table to east has loose and missing mortar.	Renew the mortar fillet to the water table.	1

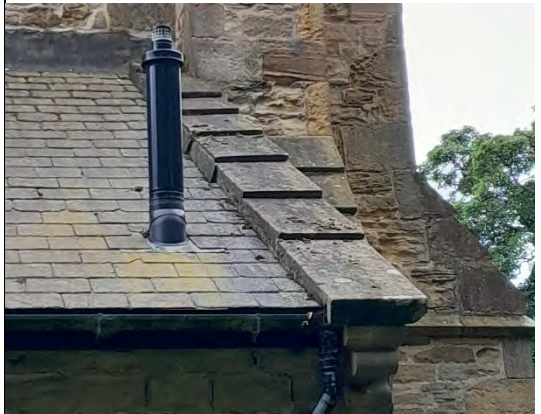
1.5.0	Choir Vestry (New Boiler Room)			
1.5.1	Mortar fillet to water table to west has loose and missing mortar.	Renew the mortar fillet to the water table.	1

1.5.1	Renew the mortar fillet to the water table to the west of the choir vestry roof.	£300
1.7.1	Identify and rake out areas of loose pointing to tower roof lead flashing. Refit lead flashing. Point up.	£250

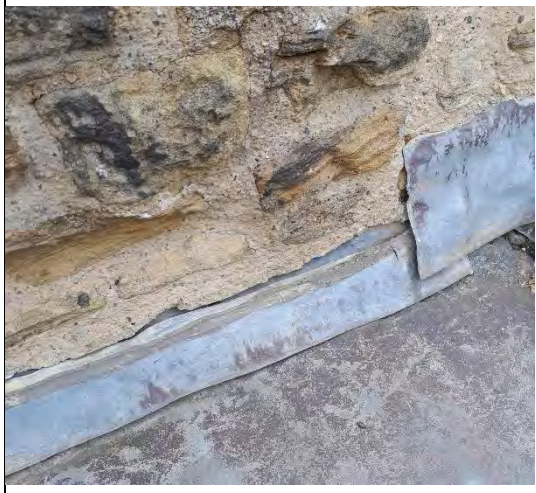
1.7.0	Tower			
1.7.1	Lead finish to roof generally appears sound. Perimeter lead cover flashing is loose in places with areas of loose pointing to the flashing.	Identify and rake out areas of loose pointing. Refit lead flashing. Point up.	2

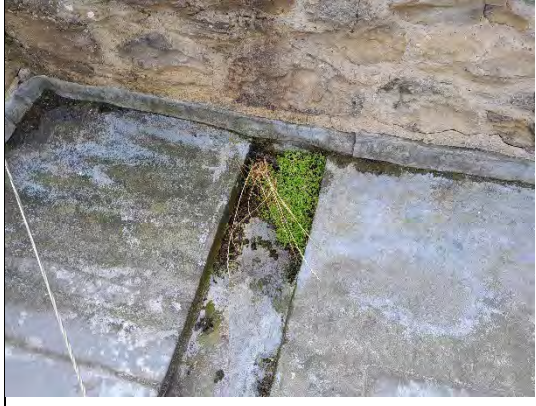
1.7.2	There is debris and vegetation collecting in the gutter channels.	Clear the debris and vegetation from the gutter channels.	M

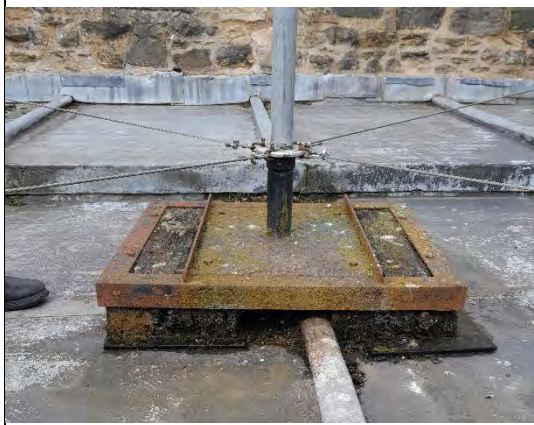
1.7.3	The flagpole is fixed in position with tension cables enabling no penetration of the roof covering. The pole sits in a steel cradle bedded on timber blocks on rubber matting. The steel cradle is showing signs of corrosion. The timber blocks are showing signs of decay.	<p>The steel cradle should be rubbed down and painted to prevent further corrosion.</p> <p>The condition of the timber blocks should be monitored and replaced if found to no longer be sound.</p>	<p>4</p> <p>4</p>

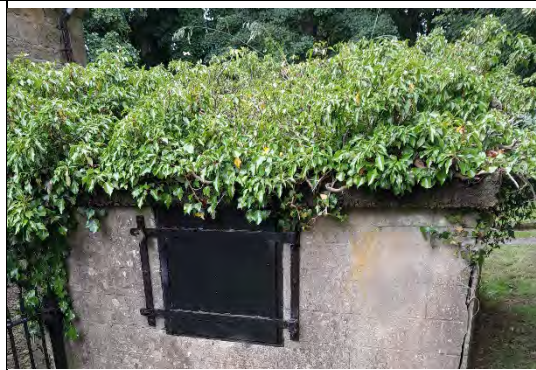
1.9.0	Tank Building			
1.9.1	Rendered brick walls with damaged render in places. In situ concrete roof. Extensive ivy growth.	<p>Remove ivy. Assess condition of concrete slab.</p> <p>Repair slab and render as necessary.</p>	<p>M</p> <p>5</p>

1.9.2	It is assumed the building is redundant, housing the oil tank for now-replaced oil-fired heating system.	Consider demolishing the building instead of repairing.	5

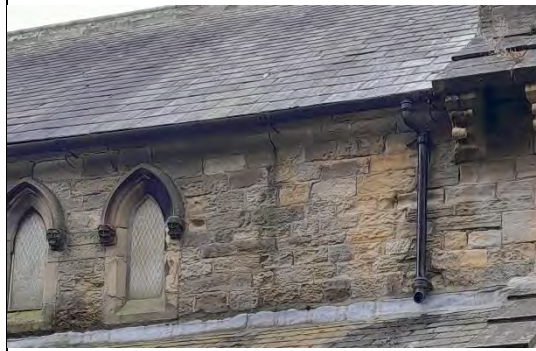
2.0.0	Rainwater goods and external pipes			
A variety of materials: lead, cast iron, plastic and aluminium.				
2.1.0	Nave			
2.1.1	North: half round cast iron gutter. Signs of weeping joints. Some signs of corrosion/cracking at western end. Partially blocked with debris/vegetation at eastern end. Cast iron downpipe with swan neck to western end discharges onto south aisle roof with shoe.	Unblock gutter. Inspect gutter. Rub down and redecorate corroded areas. Seal gutter joints. Replace cracked sections of gutter.	M 2 4

2.1.1	Inspect north nave gutter. Rub down and redecorate corroded areas. Seal gutter joints.	£500
2.2.1	Seal gutter joints to north aisle gutter.	£200
2.2.4	Inspect south aisle gutters and re-seal joints as necessary.	£200

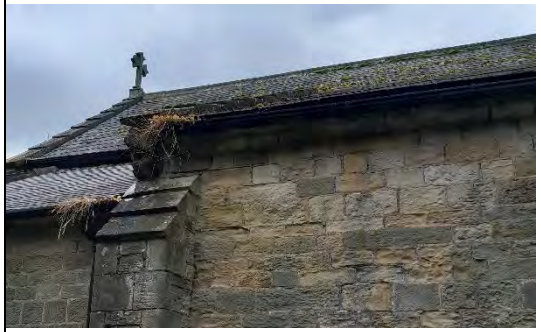
2.2.0	Aisles			
2.2.1	North: the plastic ogee profile gutters are partially blocked with debris and vegetation. There appear to be leaking joints with evidence of dampness on the walls below in these areas.	Unblock gutters. Seal gutter joints. Replace plastic with cast iron.	M 2 5

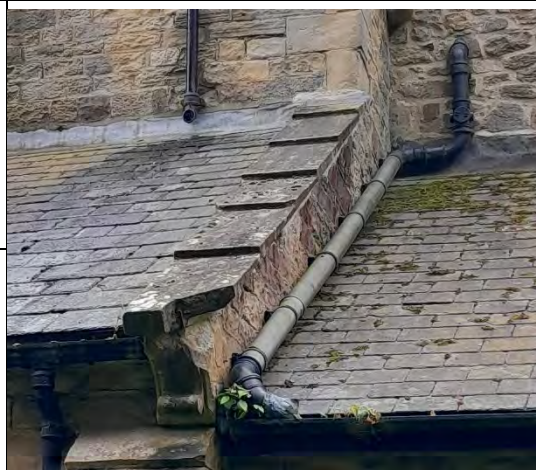
2.5.2	There is a plastic pipe connected to the cast iron tower rainwater pipe. The 90 degree bend to the end has a temporary spout fitted to the end which discharges direct into the choir vestry gutter.	Replace the spout with new cast iron section.	4

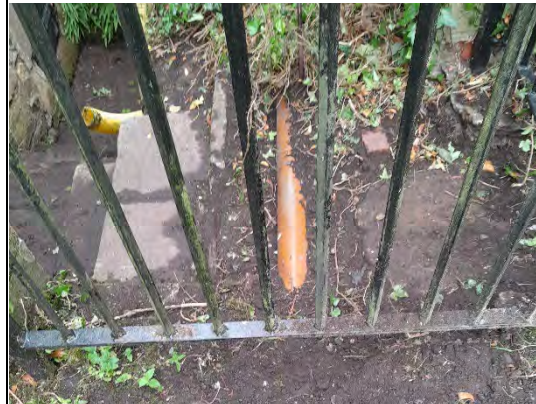
2.5.3	The plastic gutter is blocked with debris and vegetation.	Unblock gutter.	M	
2.6.0 Boiler Room (Basement)				
2.6.1	There is an exposed plastic drainage pipe at the head of the external boiler room steps.	Protect pipe from damage by either burying at a suitable depth below ground (connections allowing) or bridging over.	4

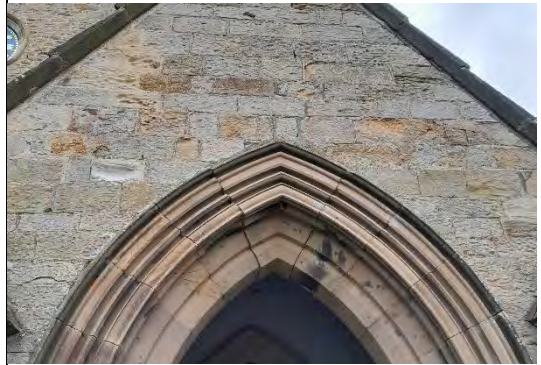
3.0.0	Walls			
Main church body of coursed squared sandstone with ashlar plinth and dressings. The tower is formed of sandstone rubble with dressed stone quoins.				
3.1.0	Porch			
3.1.1	The keystone above the entrance arch has dropped with minor cracking to masonry joints visible above.	Point up cracks and monitor.	2

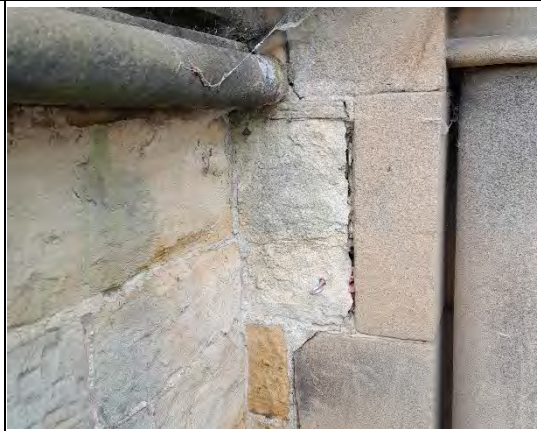
3.1.2	There are areas of missing pointing to the front buttresses at the joints, possibly due to movement.	Point up the open joints.	4

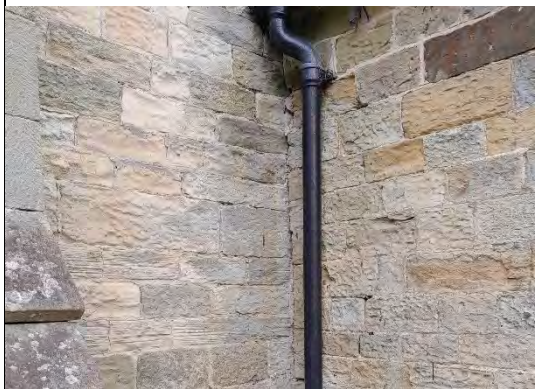
3.1.6	The butt joint to the main church body on the west side has loose and missing mortar.	Point up the gap.	4

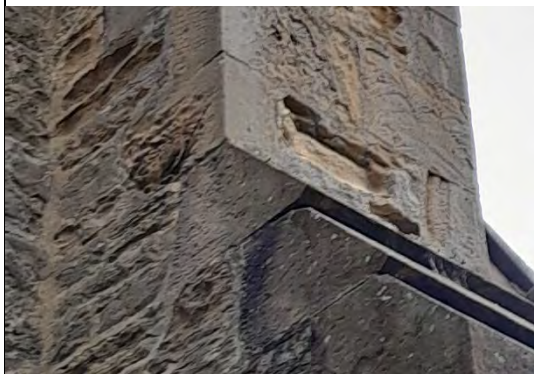
3.2.6	North-west: there is vegetation growth on the corner between buttresses.	Remove the vegetation. Investigate if open joints are behind the vegetation. Repoint the open joints if found.	M 2

3.2.4	Rake out and point up the open joints to the western wall base to the tower with lime mortar.	£100
3.2.6	Investigate if open joints are behind the vegetation to the north-west corner of the tower between buttresses. Repoint the open joints if found.	£50

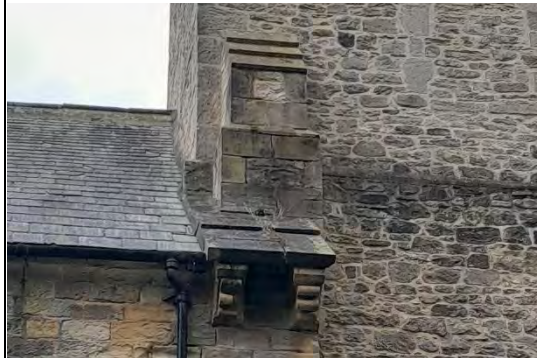
3.3.0	Aisles			
3.3.1	North: the corner of the bottom water table/corbel/kneeler stone to the west has broken.	Replace water table/corbel/kneeler stone.	4

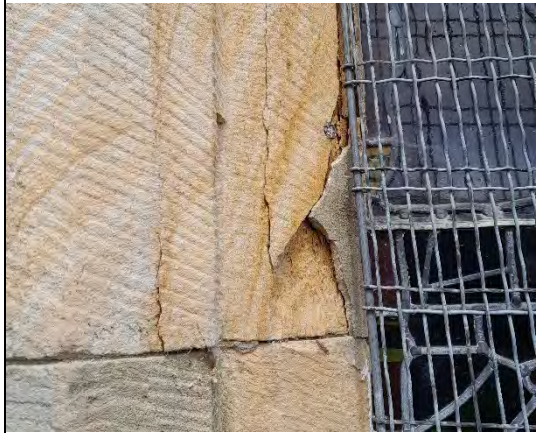
3.3.8	South: the lower left stone to the buttress to the east of the porch has shifted out.	Point up stone in shifted position.	3

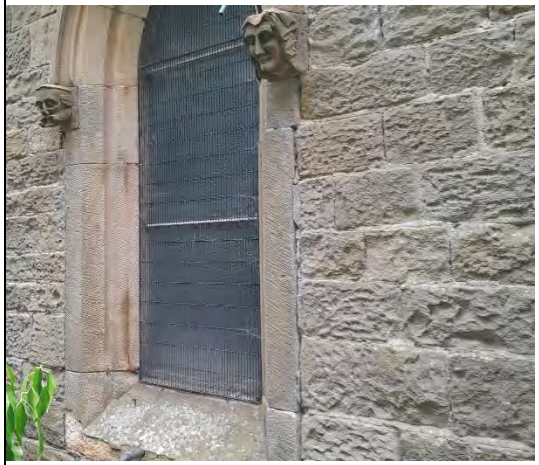
3.6.3	North: the masonry to the west of the window has minor cracking along the mortar joints.	Rake out and point up the crack.	2

3.6.3	Rake out and point up the crack to the north wall of the choir vestry west of the window.	£100
3.6.4	Rake out and point up the crack and areas of open joints generally to the west wall of the choir vestry.	£150

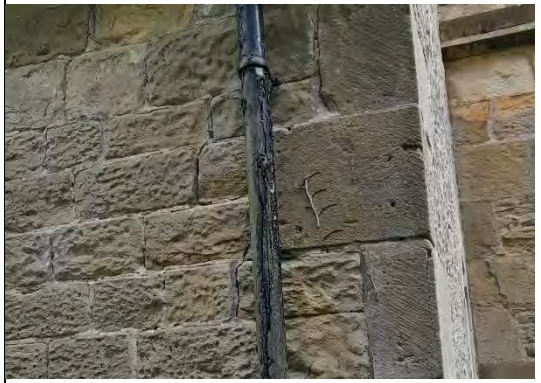
3.6.4	West: the walling to the north appears to show signs of minor movement with cracks at the upper level. There are areas of open joints to the wall more generally.	Rake out and point up the crack and areas of open joints generally.	2

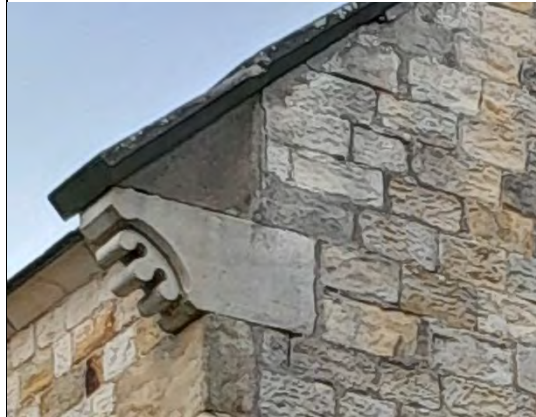
3.7.0	Nave			
3.7.1	East: there appears to be historic movement of the south kneeler/corbel with surrounding movement cracks to the joints which have been pointed up previously. Some joints have opened up again/anew.	Rake out and point up open joints. Monitor.	2 M

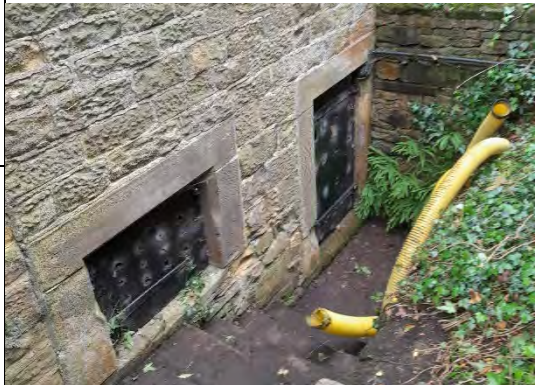
5.2.2	Timber boarded battened hatch door with band hinges. Holes formed in door, assumed for ventilation but now rotting.	Consider replacement of hatch door.	5

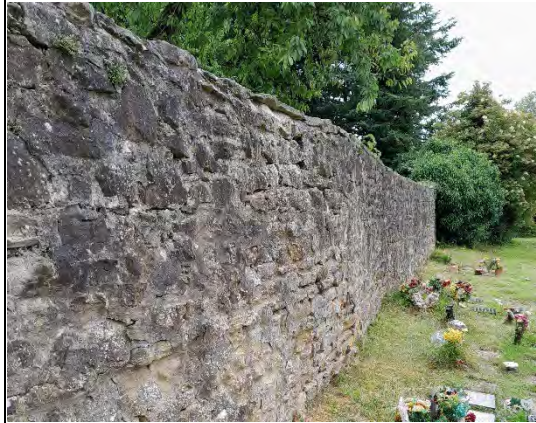
6.2.2	North return stone wall: there are cracks and bulged to the wall in the location of trees behind. It assumed that tree growth has led to the cracks.	Monitor for further wall movement. Consider pointing up the cracks to consolidate the wall.	M 4

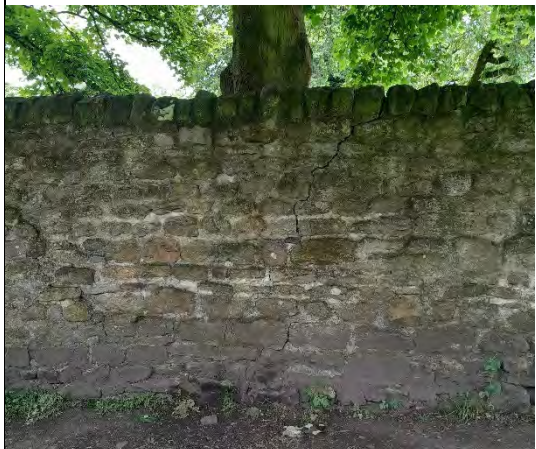
6.2.3	North wall: there are a number of capping stones which have dislodged.	Re-bed capping stones.	3

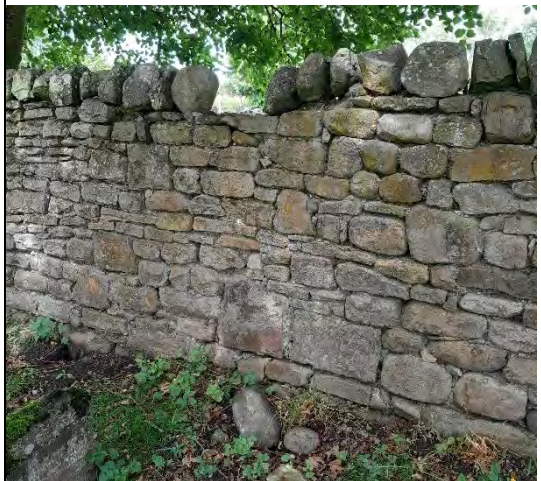
6.2.4	East stone wall to new graveyard: the capping stones are loose and poorly laid.	Re-bed capping stones.	3

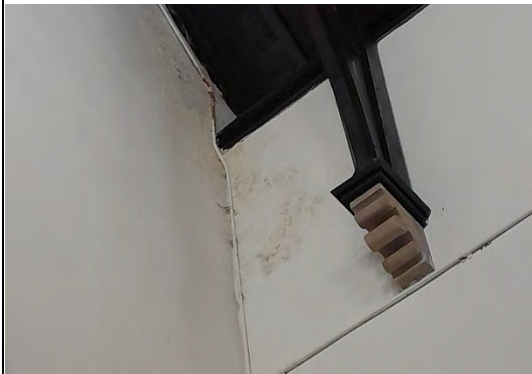
8.2.0	Aisles			
8.2.1	South: there is dampness to the eastern wall at high level. The damaged plasterwork noted in the previous QI report has been repaired. The dampness does not appear to be causing damage to the plasterwork currently.	Monitor.	M

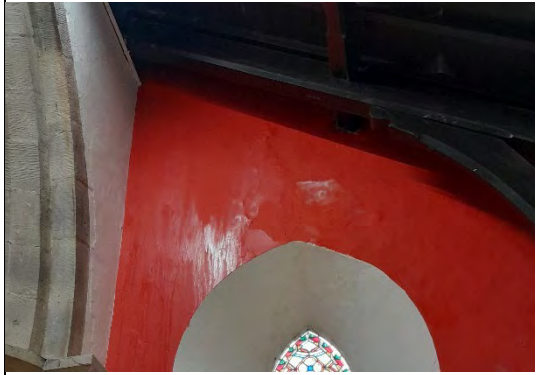
8.2.2	South: there is a damp patch to the south wall. There is no obvious sign of the source although there are areas of open joints around the windows and at low level on the south wall.	Monitor for drying out. Redecorate with appropriate breathable paint when dry.	4

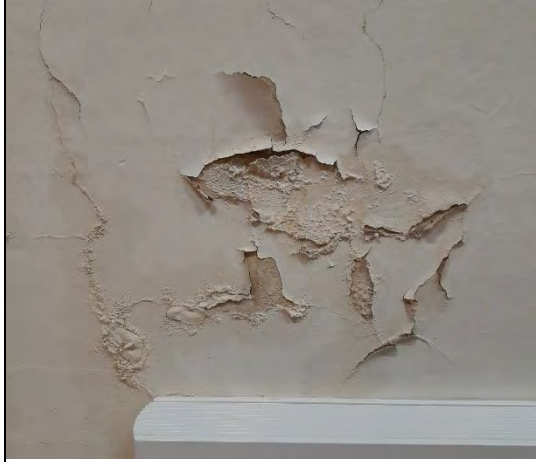
8.2.3	North: north-western corner has an area of rough plasterwork. This area was noted in the previous QI report. It is probable that this is a painted repair of previous dampness which has dried out, rather than a full plaster repair.	Monitor for new signs of dampness.	M

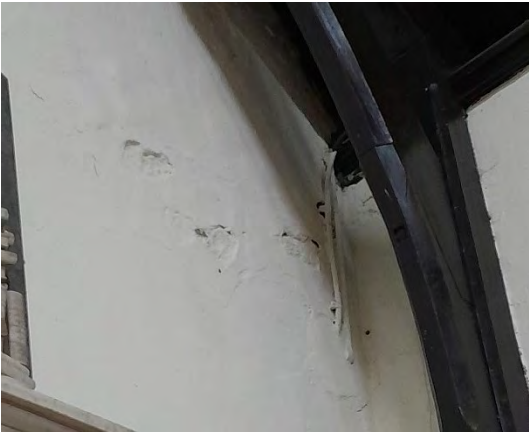
8.2.4	North: flaking paint which is taking a thin layer of plaster with it. Blocked gutters to the north may be causing dampness to the walls. It is possible non-breathable emulsion paint on lime plaster or application at an unsuitable temperature has exacerbated the problem. As this section is above a new radiator, the improved heating system may have contributed to the peeling paint.	Rub down flaking paint and redecorate with appropriate paint in suitable conditions.	4

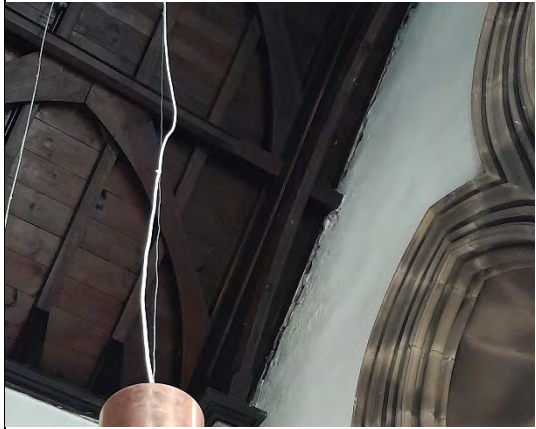
8.3.2	There is water staining on the stone arch adjoining the nave. This is possibly a historic leak that has been fixed although is in the location of the damaged mortar fillet (item 1.3.5).	None.	N/A

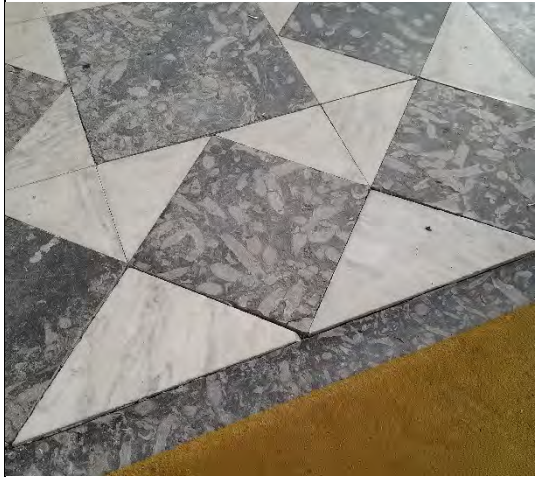
9.2.0	Chancel			
9.2.1	The raised area and steps are laid with a pattern of Frosterley marble and white marble. Some slabs are loose and there are areas of missing grouting.	Re-bed and grout loose stones.	2

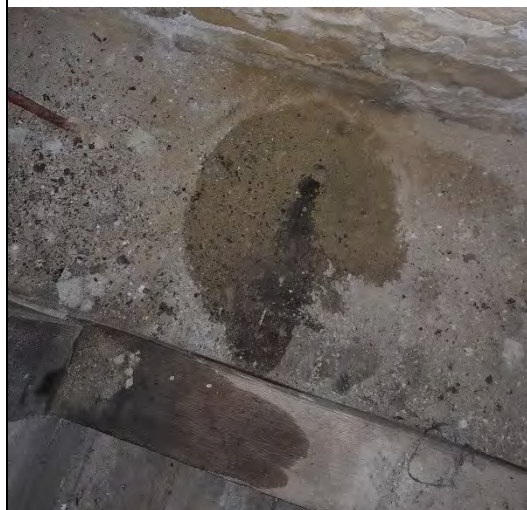
9.4.0	Tower			
9.4.1	Bell chamber floor: the floorboards are worn but serviceable. There is a damp patch between the pipe and flue. The water source is not immediately apparent.	Investigate source of dampness and monitor.	M

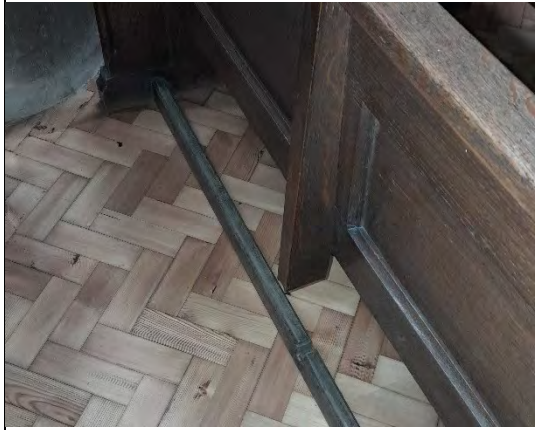
11.0.1	Pews: oak and generally in good condition. A number of pews are missing legs, feet or book rests.	Assess whether missing elements of pews affect their strength or stability. Repair as necessary.	4

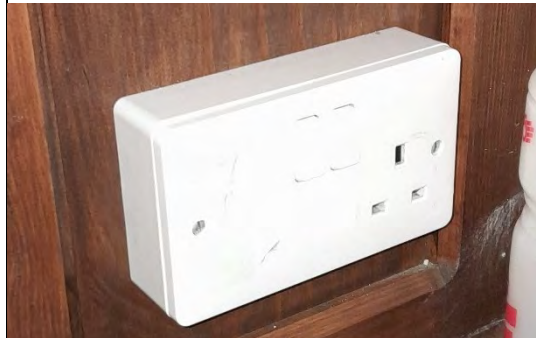
12.0.0	Electrical Installation			
The electrical installation was tested in June 2023 and required remedial actions carried out. Regular maintenance checks are documented.				
12.0.1	There is a taped-up socket in the kitchen.	Consult electrician to ascertain if a safety hazard. Replace/repair socket based on recommendations.	1
