**Closed church** of Darlington St John: Schedule and Statement of Significance and Needs

Faculty Petition OFS Application Ref: 2025-122719

Removal and disposal of bells, organ, furniture and fixtures.

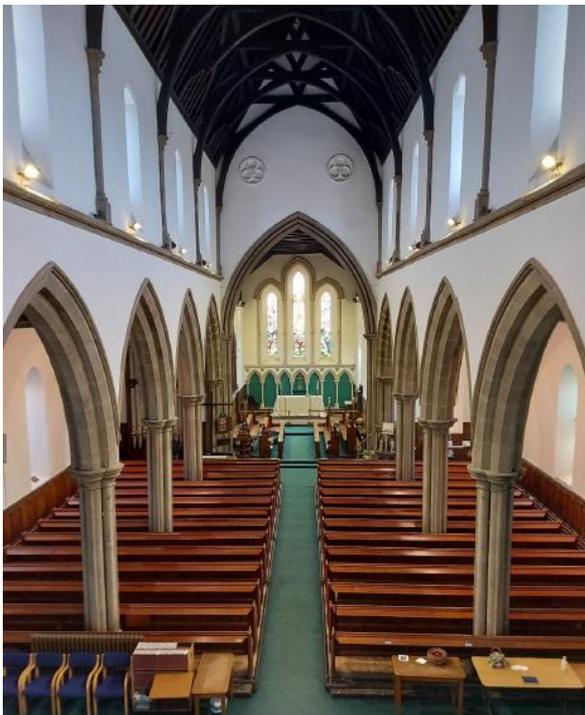
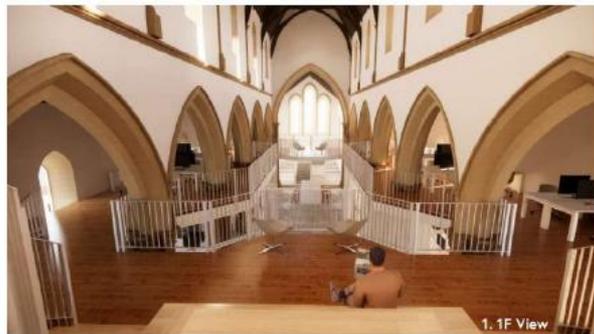
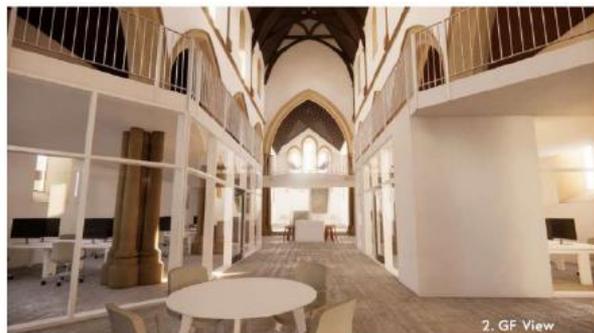
Drawings courtesy of  
ELG Heritage and  
Corstorphine & Wright  
Architects

To allow the building to be put to office use, the Commissioners must first undertake a public consultation process and ensure all necessary planning permissions and listed building consents are secured. Disposal of the church organ, peal of eight church bells and nave and chancel fixtures/furniture forms appropriate, practical and necessary preparation for putting the former church to this proposed new use. This is for space-use requirements and in part for access and maintenance purposes. None are suitable for retention but some can be used or accommodated elsewhere. Cessation of the property for use as a place of worship has arguably diminished the heritage values expressed in the original relationship between *design* and *use*. However, the sympathetic approach and open-plan office design aim to retain its ecclesiastical character.

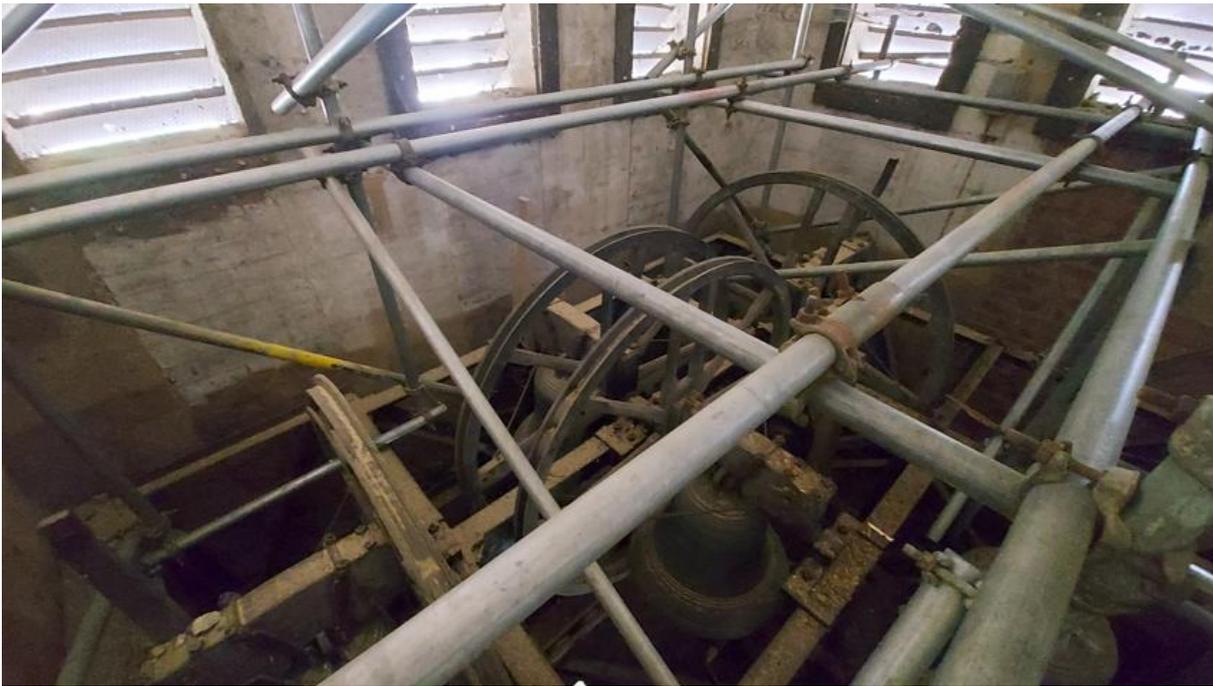
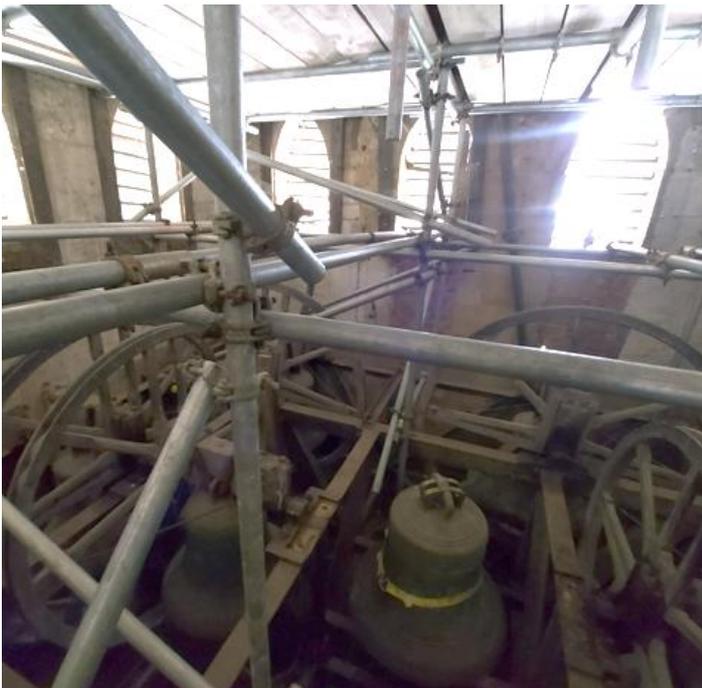
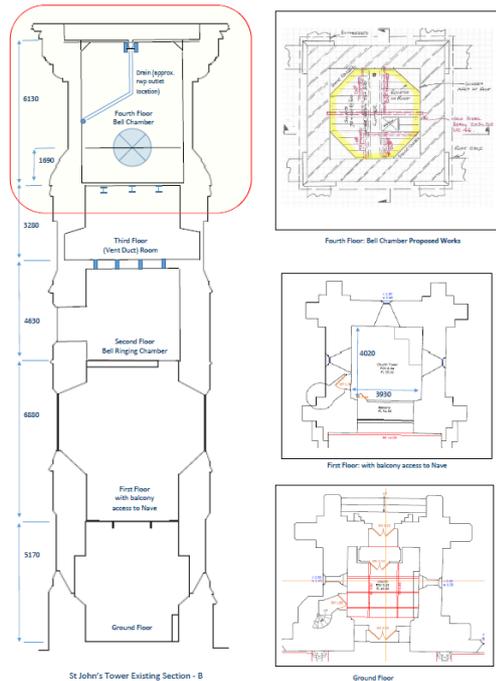
The bell chamber currently houses a peal of eight bells on a steel bellframe.

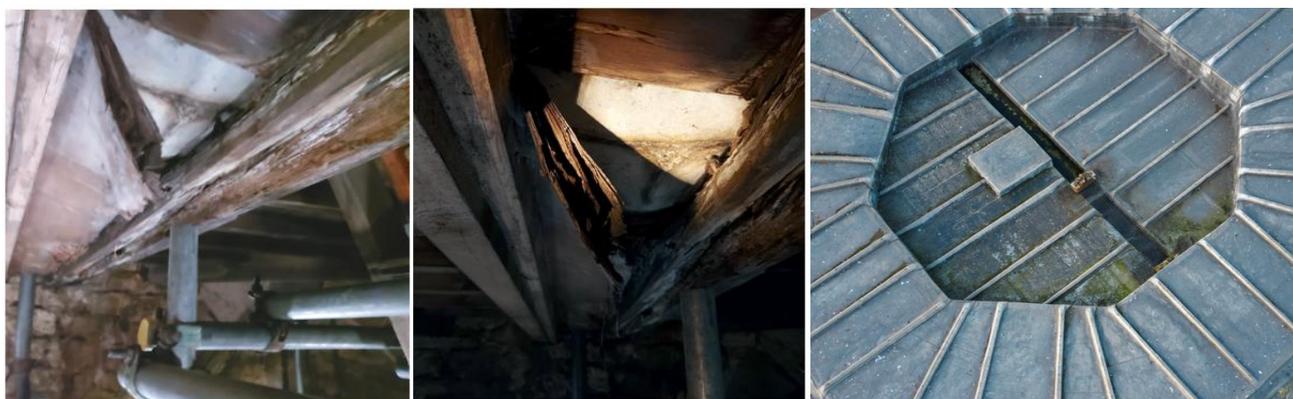
Since prior to closure for worship in 2023, the unoccupied building has suffered some critical fabric issues including failure of the tower roof gutter, following years of rain water ingress, causing saturation of the four internal tower floors and bellframe. As a consequence of the sustained water ingress the tower floors, hatches, stairs and ladder access were in critical condition, unsafe to use, and the roof at risk of collapse. (Refer to [Appendix C](#)). The headstock to the tenor bell was also found to be rotten and at risk of failure, requiring the tenor bell to be dismantled and fixed in stationary position to the bellframe.

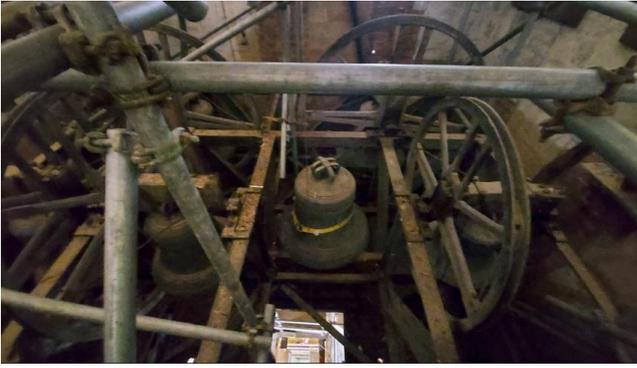
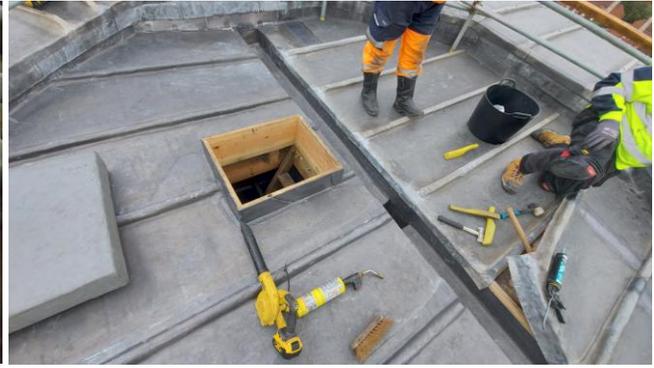
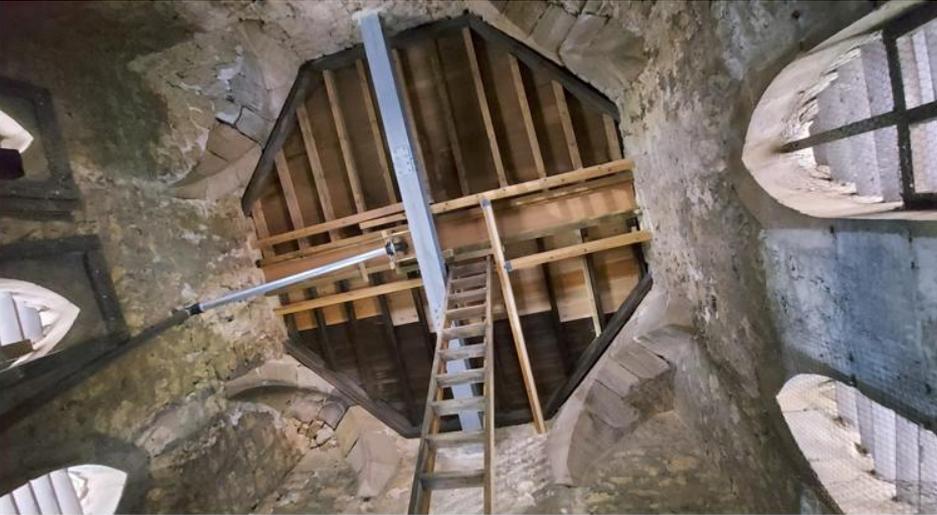
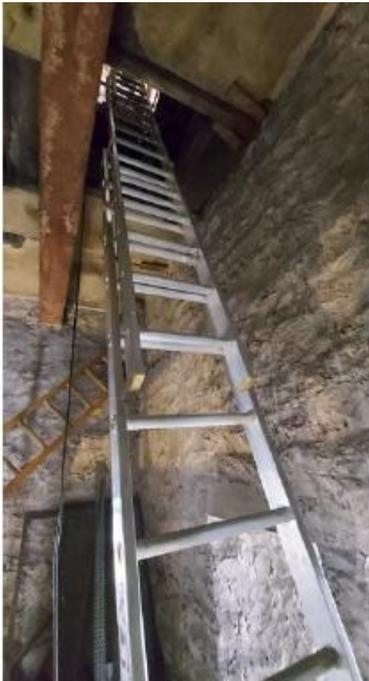
In 2025, with listed building consent and grant of faculty, the Diocese undertook a phased programme of repairs, totalling £75K. Initially, the internal floors of the tower were strengthened, and safe temporary access provided up through the tower and its bellframe, to offer an inspection deck to the tower roof. Structural repairs followed with insertion of a structural steel roof beam, replacement timber roof trimmers, a reformed box gutter and drainage outlet and like-for-like replacement of Victorian lead roof coverings. The work was complex, costly and painstaking due to safety risks, the poor internal environmental conditions and the difficulty of navigating the bellframe and its eight bells, wheels and working mechanisms. Despite the building being closed and in a mothballed condition whilst awaiting being put to a new use, the Diocese decided to look beyond temporary holding repairs, believing the extent of this conservation work would help to ensure the long-term preservation of the tower and the church's fabric for future generations.

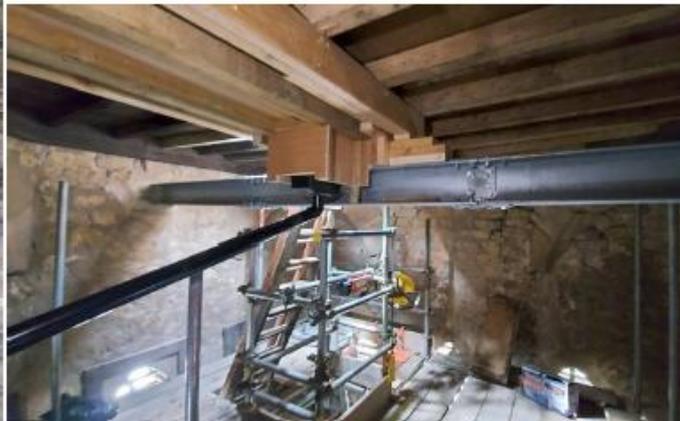
Despite the repairs, current access up to the underside of the tower roof hatch, for inspection and maintenance purposes remains poor and unsafe. The restricted apertures through the metal bellframe, bells and mechanisms and its suspended floor structure, do not readily allow for installation of improved safe access, e.g. cage ladder, up to roof level.

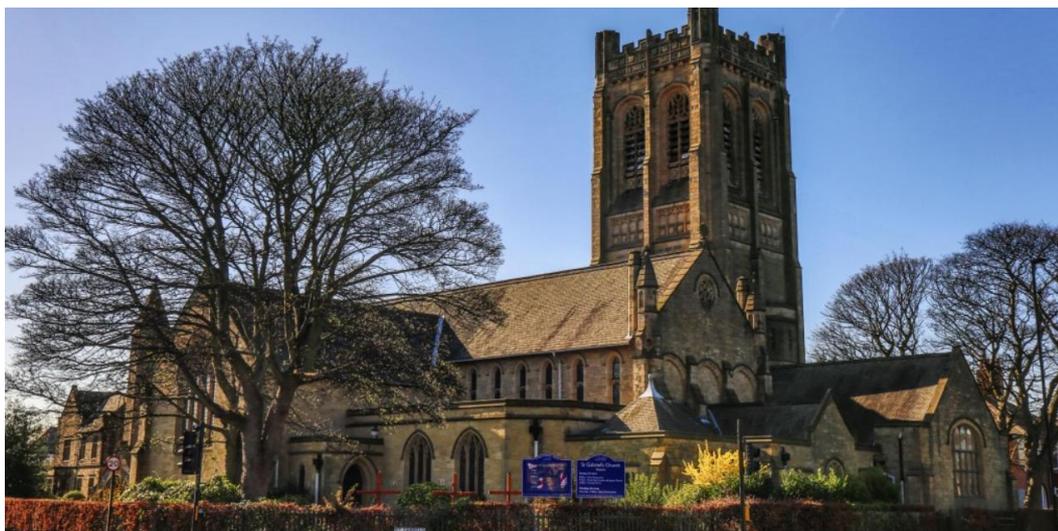
**Sale to Keltek Trust and proposed donation to Newcastle St Gabriel's Church, Heaton: Bell Project**

The Parish of Newcastle St Gabriel is undertaking a bells project to introduce twelve bells into the bell tower of the grade II church in Heaton, to form one of the largest peals of bells of any parish church in the dioceses of Newcastle and Durham. It is hoped the church will provide a regional centre for bell ringing and training, with a particular outreach towards students, to keep and grow the tradition and practice of bell-ringing in the northeast. Having sourced eight bells from St Mary's church, Aberavon, Wales, the parish must raise funds for a further four. The entire project is estimated to carry a cost averaging £12.5K per bell. Following agreement with the Keltek Trust and Mr Jim Crowther, Durham Diocese proposes to offer the 5<sup>th</sup> bell from St John's, or a minimum of 6 hundredweight in metal, as a donation to this project. The remainder would be purchased by Keltek Trust and Mr Crowther as acquisitions for re-use in regional church bell projects.

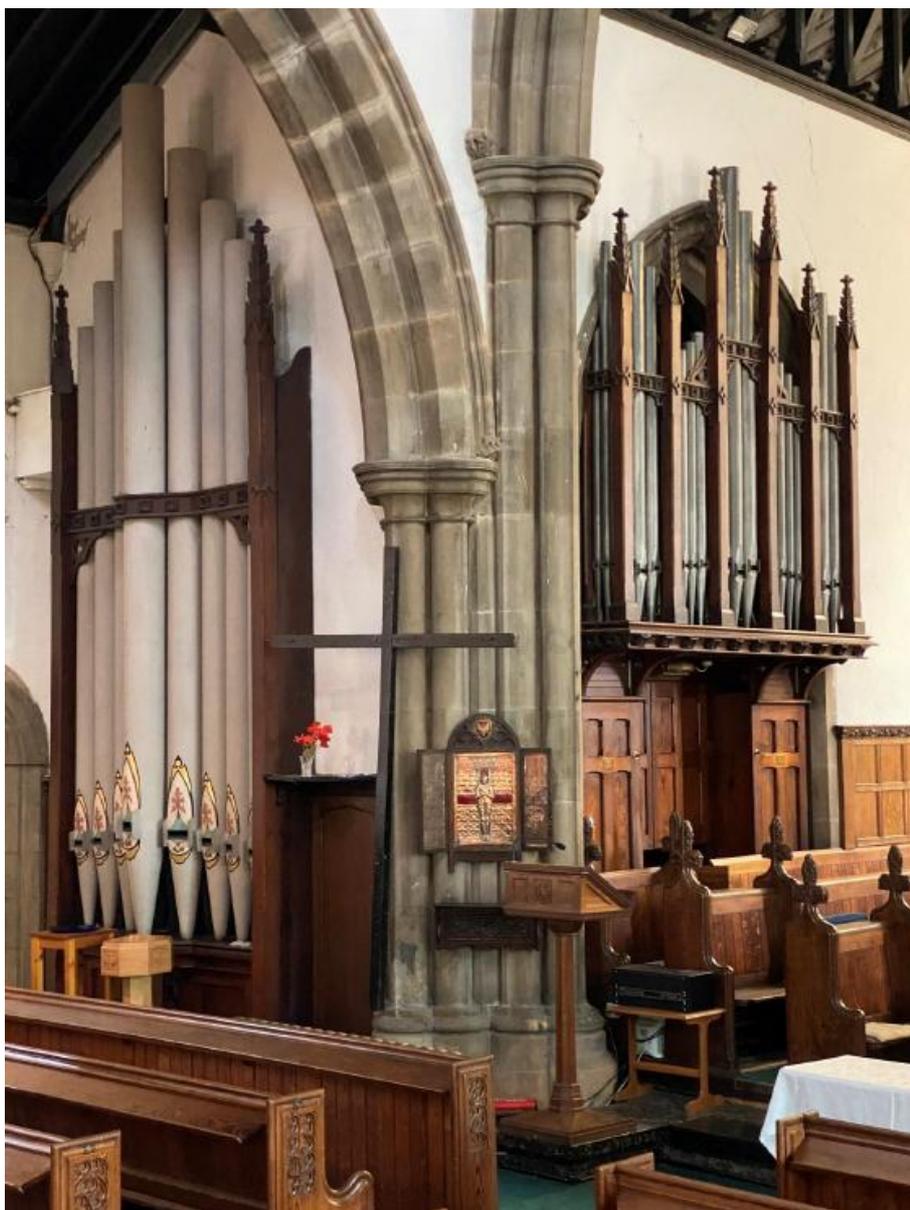
CBC Report: “The most significant items are all of a later vintage. Firstly, the organ, by H S Vincent & Co of Sunderland, was installed c1888. It has a handsome pipe rack style case which displays to the chancel and to the N aisle. It is listed grade II\* in the BIOS historic organ listing scheme.”

The H.S.Vincent organ has a BIOS Historic Organ Grade II\*Certificate. Described by the late Mr Richard Hird (former Diocesan Organs Advisor) as “a ‘grand’ organ: an early example of builder H.S.Vincent's work, built in 1890 when he was aged 29. The organ was restored and slightly modified by H.E.Prested of Durham in 1970, and has been maintained in very good order latterly by Brian Brighton.” (Refer to [Appendix E.](#))

Replacing the original 1865 organ by James Nicholson of Newcastle, which had been located in the west gallery, the present organ by H.S. Vincent & Co. of Sunderland was given its opening recital by Philip Armes (organist of Durham Cathedral) on 18<sup>th</sup> September 1890. The Vincent organ is not only an instrument of high quality, its large bulk is tightly recessed into the pit of the north organ chamber. It has been maintained well and kept in good condition but, despite the Diocese arranging for occasional playing during the closure period, the cold and damp environment of the redundant church is causing gradual deterioration and its further retention there will eventually lead to significant mechanical problems, the loss of its rich and bright timbre and the need for retuning, if not major restoration in the long term.

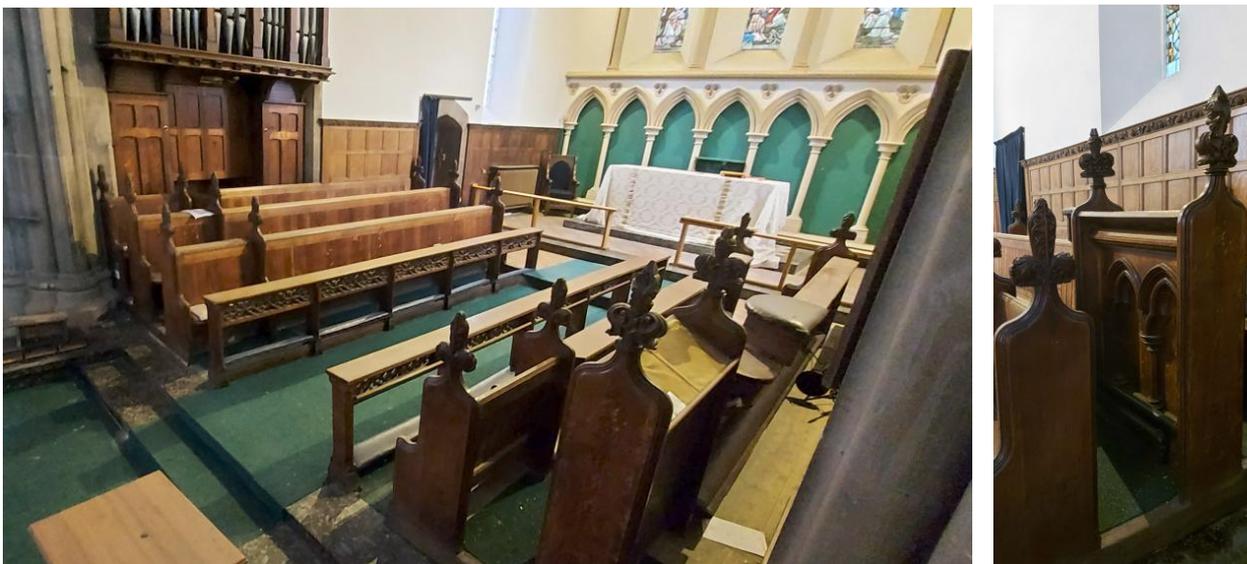
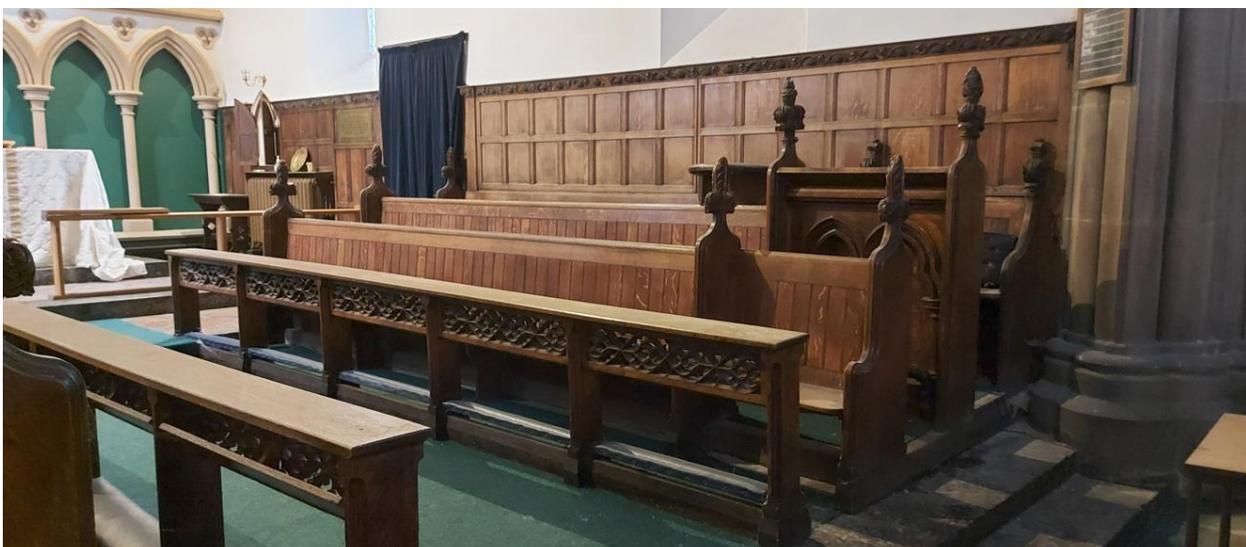
The Chancel stalls and the wall panelling in the church are made of oak. They are of low to moderate significance. There is no proposal to remove the wall panelling in the aisles or chancel.

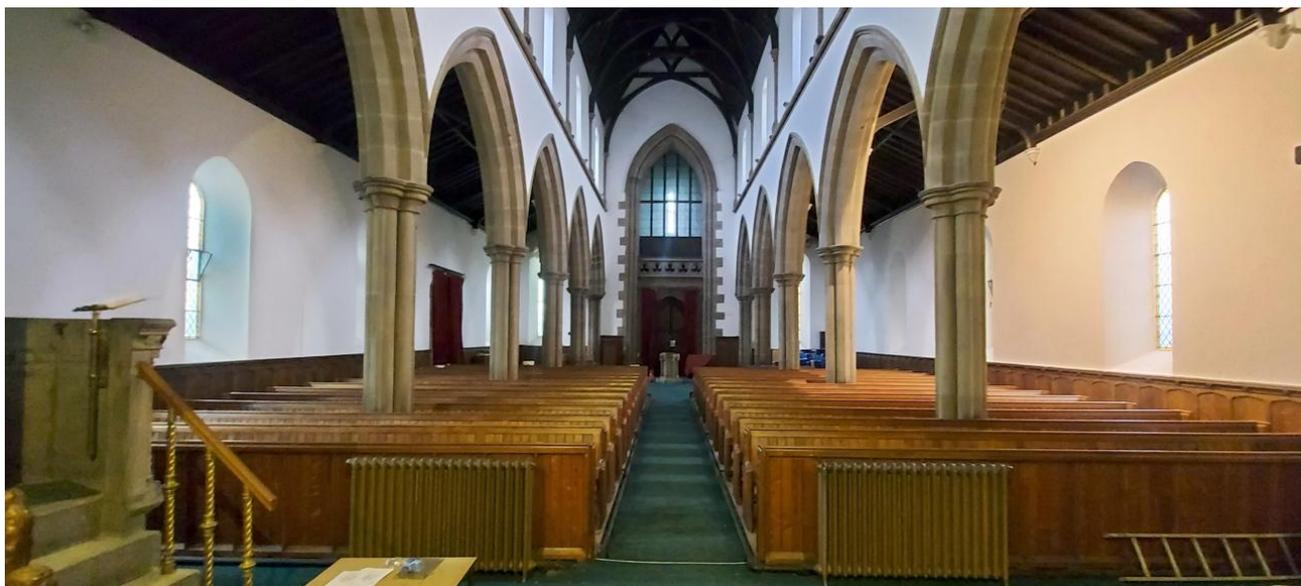
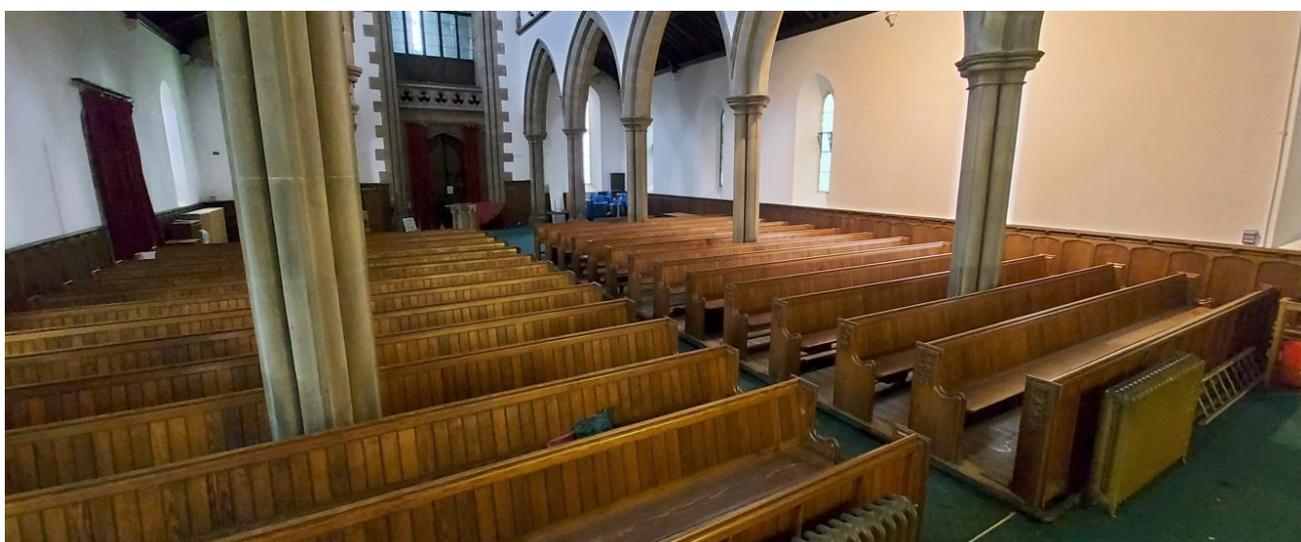
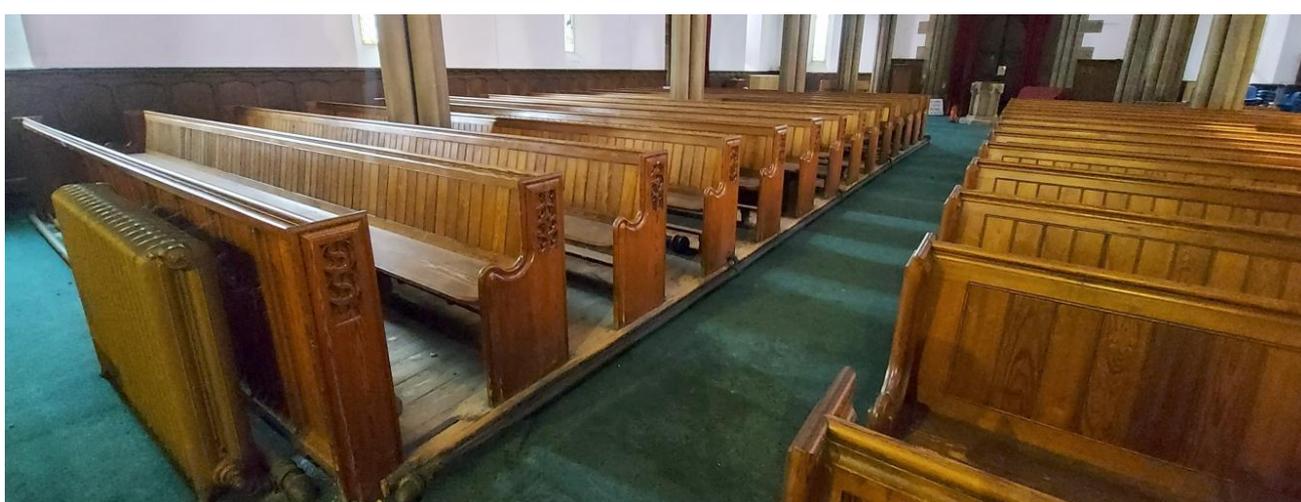
The Nave pews on each side of the central aisle are long and extend continuously into the north and south aisles. The pews and frontals are fixed and made of pitch pine and stained. They are of low significance.

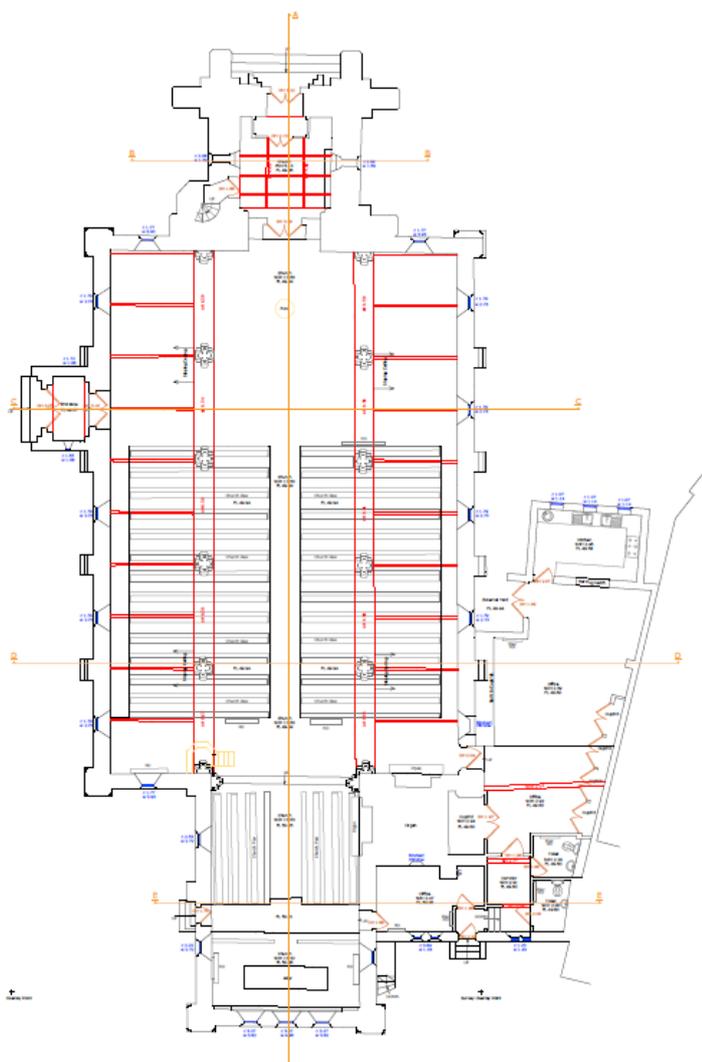
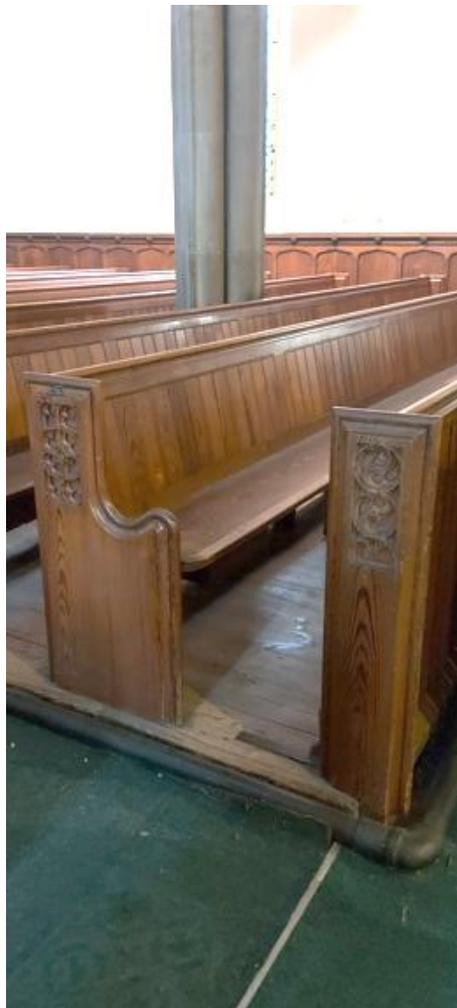
To accommodate six of the nave columns the existing pews are built and carved to fit around the masonry. Many contain duct holes for the large diameter church heating pipes which pass through and a number of the pews have pipes fitted to the underside of the seats in an early form of pew heating. To accommodate removal and preparation for sale on the commercial market these pews will need substantial work and reducing in length.

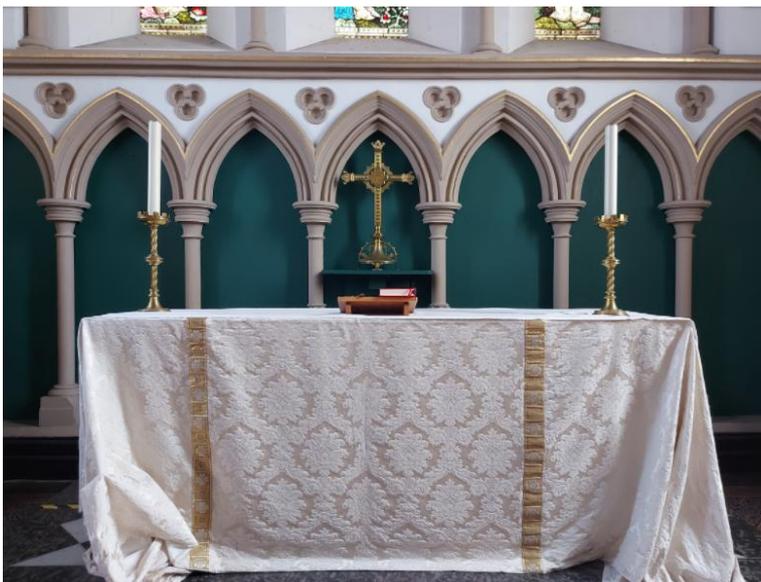
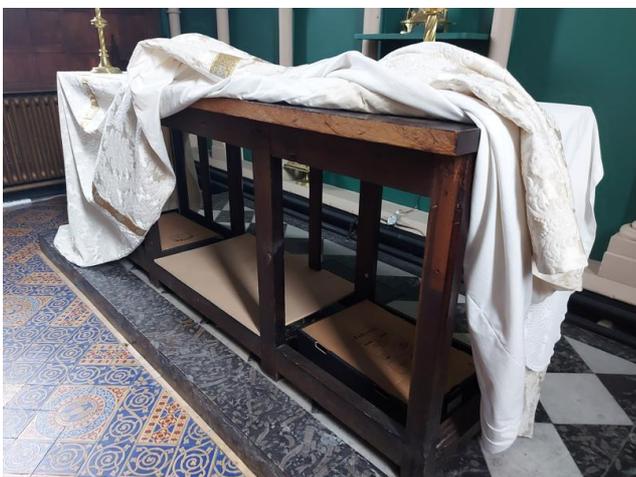
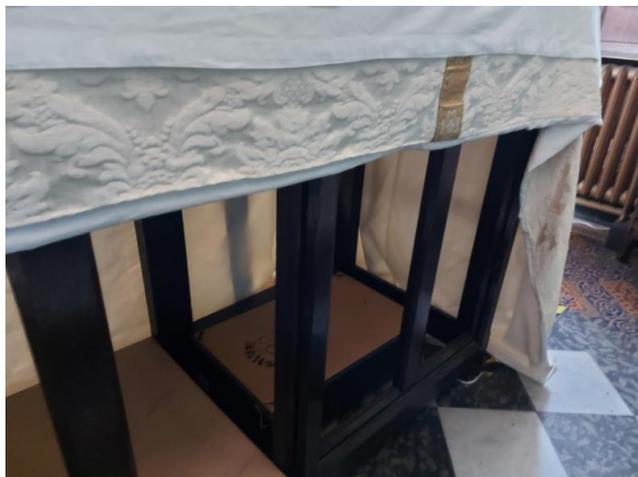
The altar cannot remain in situ under the proposed new use. Prior to a Commissioners’ pastoral disposal scheme being made and brought into effect, it is proposed to be removed under faculty. Given that there is no request to provide a new home for the altar in another church, it is proposed the altar table is destroyed. The table is made of a simple timber frame. The CBC report states: “The church is not richly furnished. Most items are relatively plain. Few are definitively part of the original fit-out, as it appears that the congregational and choir seating may be somewhat later. The altar and font reliably date from the original furnishing. Both have suffered damage.”
