Diocese of Durham

## Belmont, St. Mary Magdalene

### Quinquennial Report

**25<sup>th</sup> March 2025**

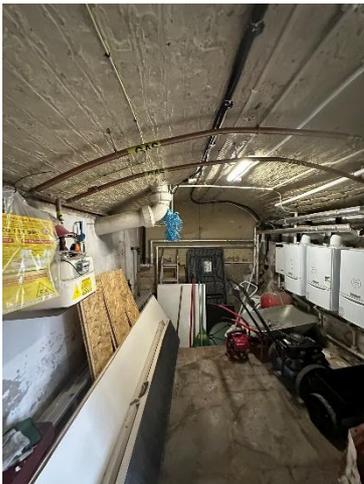
Figure 15 – Boiler room 3No boilers

12.4 **General** – The room is dry and contains the three Vaillant boilers expansion vessel and pump, also houses the distribution board. A door leads to the blower room and there is some bits of lumber that could do with being cleared away..

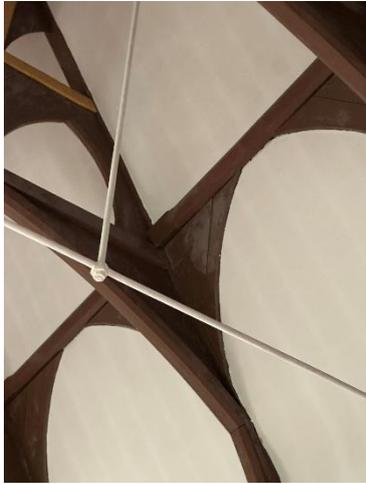
Figure 18 – Nave

13.1 **Nave** - Seven bay trussed ceiling with tie rods, the common rafters are underdrawn with boarding. The lower part of the ceiling showing ghosts of rafters behind, indicating heat loss through ceiling. Slight hairline cracking to some of the surface suggesting it might be plaster and lath. Decoration is looking dated, there is also some bloom on the painted timber work and mildew on the blade of the truss. The tie rods all appear ok.

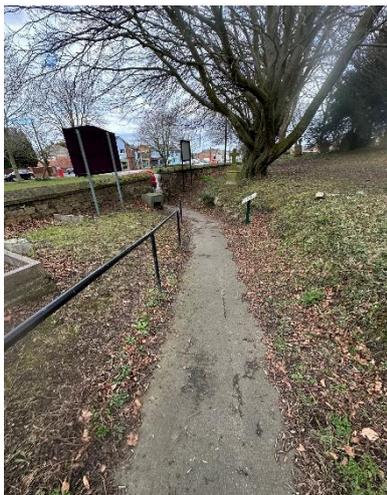
Figure 24 - Access from North

- 28.7 **Northside:** On the outside facing eastern wall by the War Memorial there is a hole and a chipped coping. Some open joints to the coping. Metal gate on its hinges but rusting and trapped by the raised level of the tarmac.
