## St Andrew, Southchurch, Bishop Aukland

### Quinquennial Report

On the architect's inspection of

**23<sup>rd</sup> April 2025**

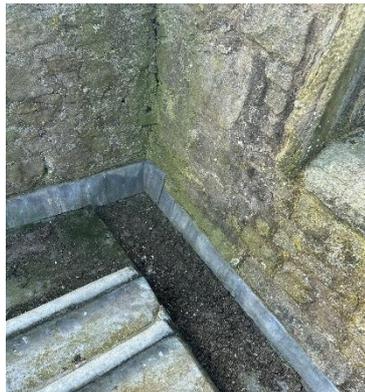
- 6.1 **The tower:** Lead roof covering and gutters, generally the main roof falls to the east and west, in 9 bays with central cover bays. All of the lead roof and gutters were replaced by Norman and Underwood in 1991. Minor repairs and new gutter bottoms were also installed at the same time.
- 6.1.1 Lead lined gutters fall to outlets on the north and west sides. The lead above the outlet to the west side has an area of flashing which is separated from the wall, following the crack to pointing noted in the last QI completely breaking away. The gutter has a little build-up of silt to the northeast corner.

*Figure 2- Step in E side from above*

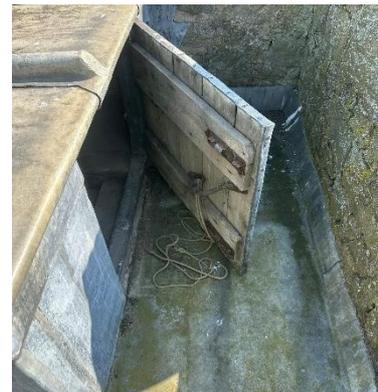
*Figure 3 - SW corner*

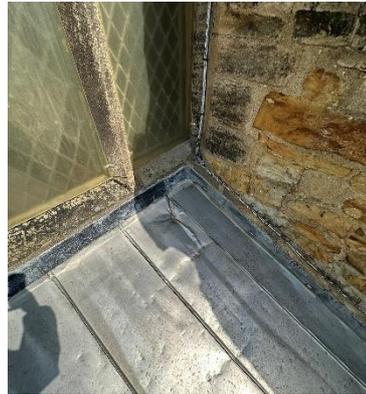
Figure 5 – Dent in S Aisle steel

6.2 **South Aisle Roof:** The roof has a stainless steel sheet covering with standing seams and extends over to the south vestry. It is generally in good condition except for a few dents and patches, there is a significant dent adjacent to the transept. There are 9 no. patches to the stainless steel in total.

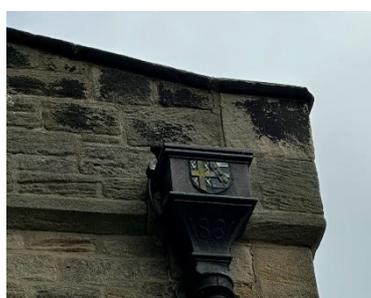
Figure 12 – SW corner

8.1.1 Squared rubble stonework, the majority of which is in fair condition but an area of 1m<sup>2</sup> above the lancet window has eroded and it will require replacement in due course, in the meantime re-point open joints in a soft lime mortar. There is some mild erosion to 2m<sup>2</sup> of the stonework at low level adjacent to the tower, again would benefit from small areas of re-pointing.

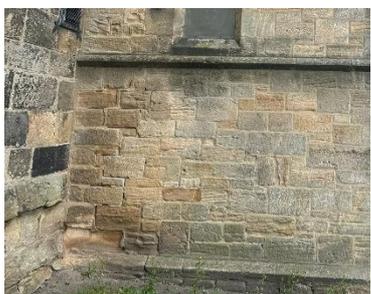
Figure 13 – West cill and erosion

8.1.2 One lancet window in fair condition, there is a crack to the cill, which appears to progress to the string course below, this should be monitored and should be pointed to prevent water ingress here.

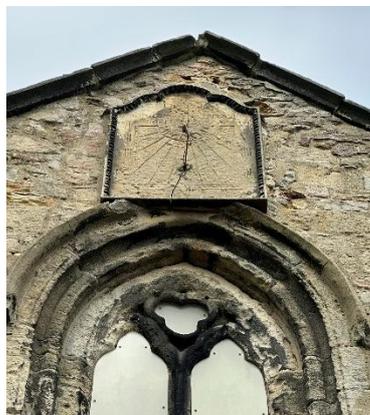
Figure 15 – Sundial

- The sundial face is eroded badly; there is now a crack that runs all the way through the stone, this should be immediately checked at closer proximity to ensure its stability, following this a scheme of how best to conserve the sundial should be arranged.

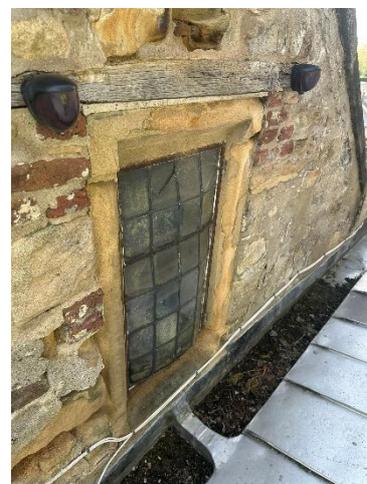
Figure 16 – N Porch

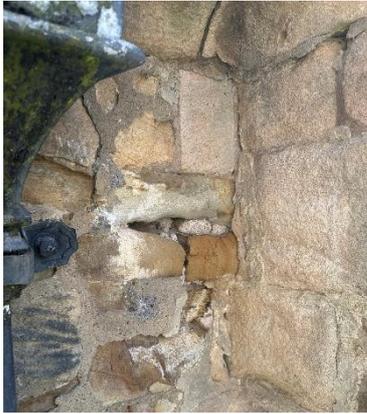
Figure 17 – Above S Aisle

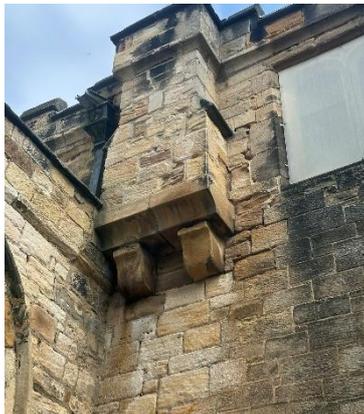
Figure 18 – Near chimney

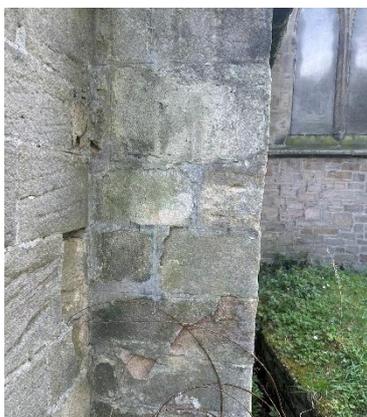
Figure 28 – NW Butress

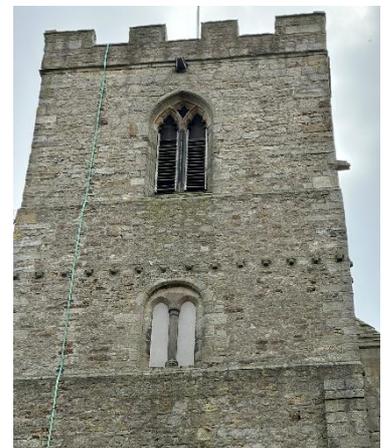
*Figure 30 - east tower and clock & louvres*

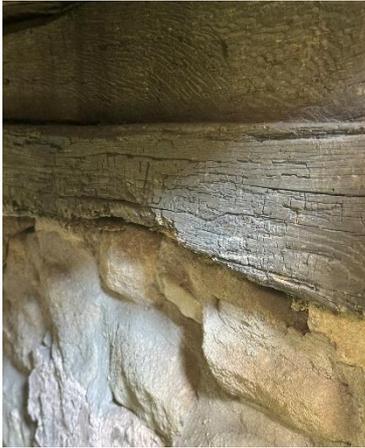
Figure 34 - timber to east

- 10.1.6 The timber around the base of the hatch is also rotten in places and would benefit from repairs when improvements are made to the access.
- 10.1.7 The rubble walls of the interior are in fair condition. Several areas below wallplate level and around the louvred openings were re-pointed in 1991, which looks to be in a cementitious mix, one of the areas to the east looks to have broken up again since then.

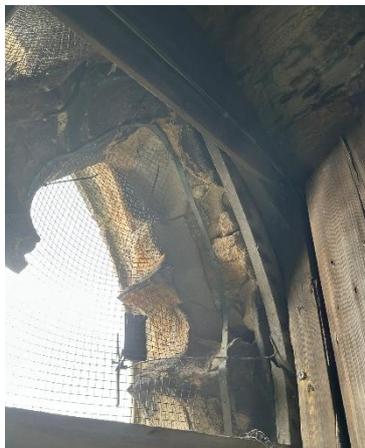
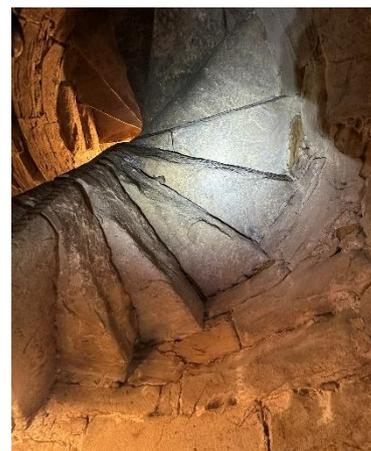
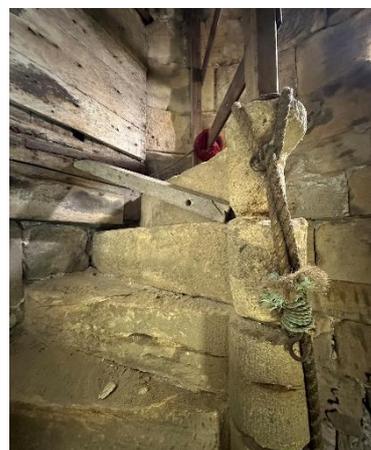
Figure 35 - belfry tracery

- South – 3No louvres missing
- West – ok
- East – Louvres are ok, however there is erosion to the stone reveal on the left-hand side
- North – 3No. louvres missing, one slipped, some pitting to stonework reveals, one of the shutters is permanently open due to the speaker position.
- The tracery and reveals of all of the windows need to be addressed with localised repairs and replacement stones as many are in poor condition.

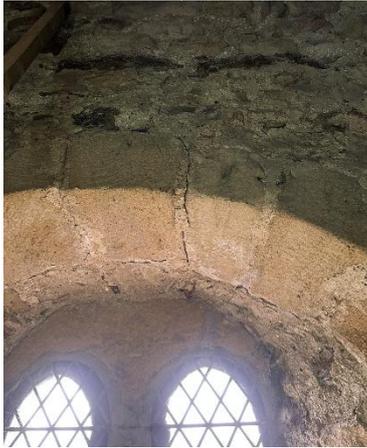
Figure 38 - S keystone

10.3.4 The walls are rubble and generally in good condition. The keystone to the southern window has dropped by approximately 3-4 mm, no further movement from that noted prior.

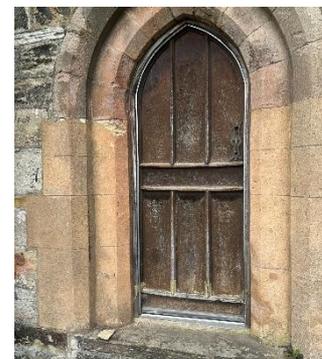
*Figure 40 – chancel door*

11.2 The door to the chancel is a historic timber door with an arched head. The weather mould is screwed on badly, the raised pieces are loose and broken towards the base, poor mastic sealant to edges.

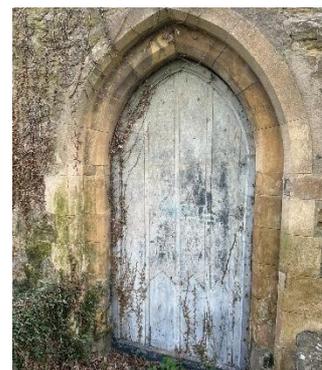
11.6 The north doorway that appears to be an ancient battened and boarded door. This has been repaired in its bottom section, probably in Victorian times

*Figure 41 – northern door*

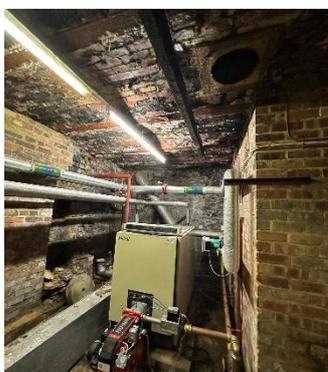
*Figure 42 – boiler room*

12.1 The boiler room is a subterranean space, located between the porch and south transept. Accessed via a pair of heavy steel hinged trap doors. These metal doors sit on a steel frame off a small concrete kerb. The doors are extremely heavy and would benefit from a hydraulic opener, in addition, all of the ironwork needs regular painting, and the locks need regular oiling.

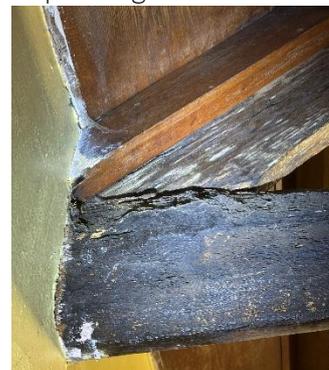
15.3 There is a white powdery substance on some of the timbers in various locations. White powder on timbers could indicate a few things, including fungal growth, insect activity, or chemical residue

Figure 46 – northern door

from wood treatment. There are no other signs indicating dry rot and therefore it is thought to be another residue, the PCC should confirm if this timber has been treated.

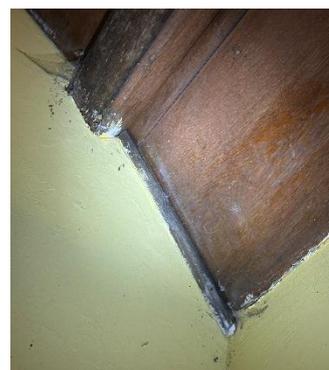
Figure 47 – northern door

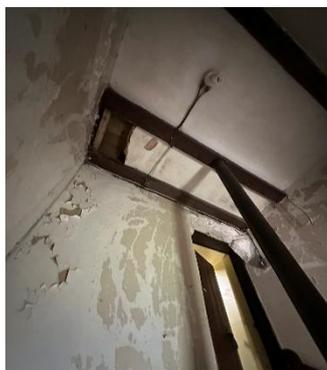
Figure 48 – stair ceiling

15.8.1 The ceiling is plastered and painted, with a large missing section, reportedly affected by damp, but the roof above doesn't appear to have any obvious defects – is this recent? The ceiling is additionally propped with a post from the spiral centre which is loose, this may be a covering over a metal prop.

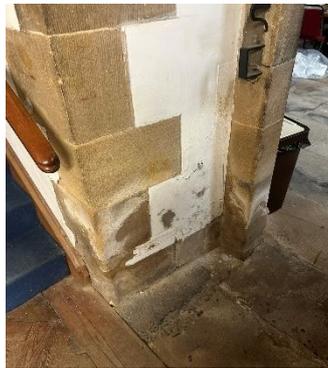
Figure 51 – damp at door

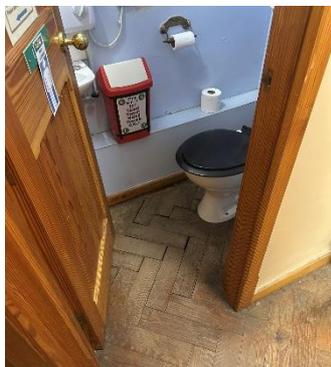
Figure 53 – WC floor

17.3 As with the kitchen, the WC's have a wood block floor, there are many blocks which are loose, especially in the smaller cubicle, and these require leveling and re-fixing.

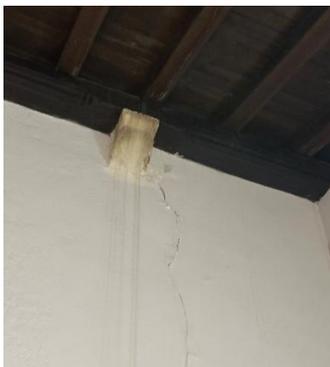
Figure 54 – E Corbel

18.3 The **walls** are mostly plastered, with exposed stone at the window reveals. Previously noted signs of damp in the south-west corner now appear less concerning. However, there is visible water staining on the east wall and beneath the corbels, suggesting an ongoing issue, likely related to the deteriorated condition of the external walls above. There is a crack by the easternmost corbel which may be due to the damp condition of the wall causing the plaster to lift, rather than structural movement. A few cobwebs between the wall and ceiling junction would benefit from being cleaned.

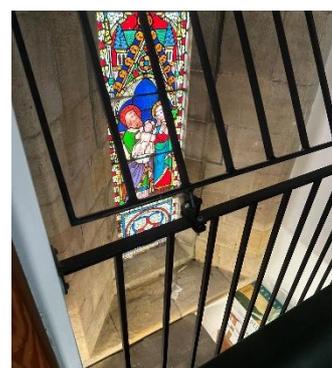
18.6 There are metal rails at the window recesses for safety reasons, but these do not provide any acoustic or fire protection meaning the space would require improvements to be used for anything other than storage. This should be noted in the Churches risk assessments.

Figure 56 – rails to windows

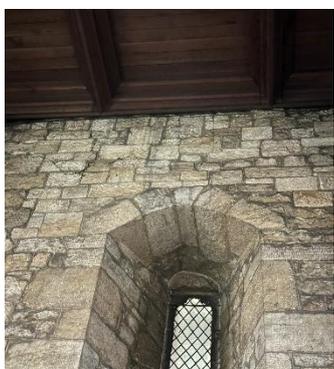
Figure 57 –V. Vestry south wall

19.4 On the south wall there is a crack below first floor level. This seems to be of longstanding as it has been noted at previous inspection but the new inspector will note any progression in this quinquennium. The historic crack at the cill is evident, as per the opposite side (choir vestry). There is a little water staining on the south wall below the floor level, it is unknown if this is current and should be monitored, although re-pointing the externals above this, where noted in section 9.1.4 may assist.

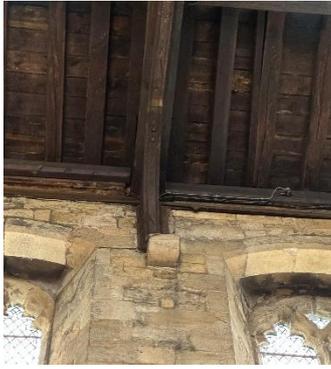
20.3 Additional timbers have been introduced to reinforce the structure in the second bay from the chancel and in the third bay from the west, indicating past efforts to bolster the structure. The beams also do not sit centrally on the corbels, thought to be due to historic movement. Although the roof was inspected during previous re-covering works many years

Figure 61 – corbel alignment

ago, no recent close inspection has taken place. A close inspection is now recommended, as it is increasingly difficult to assess the condition from ground level, especially given the extent of surface staining and areas of lighter boarding. Due to the lack of photographs included in the last report, it is not possible to comment on whether the condition remains unchanged since the last inspection.

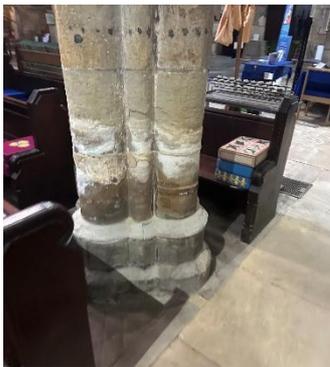
Figure 62 – Arcade column bases

20.8 Damp continues to affect all the arcade columns, producing visible salt deposits above floor level. Despite this, the arcade walls appear sound. However, there are minor vertical cracks above the first and second columns from the west on the north side, and above the third column from the west on the south side, as reported previously. These should be reviewed further and monitored for any progression, as no comparison is currently available. The pier on the south side (second from the chancel wall) leans westward, while its opposite on the north side leans eastward.

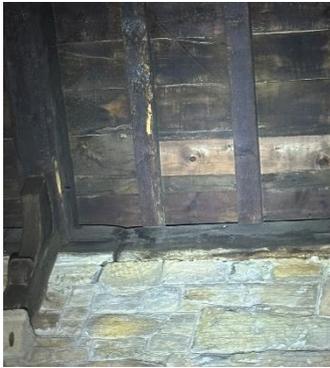
Figure 64 – mid S Aisle ceiling

21.2 The **roof structure** and ceiling are similar in construction to the Nave, consisting of substantial oak elements. White patches visible on the boarding and timbers are likely the result of historic water ingress, however adjacent to the south transept, the ends of some ceiling boards show signs of potential rot, this could be caused by the flashings and wall condition above. Additionally, as it has now been many years since the last close inspection, access for a detailed high-level assessment is required. Ground-level observation makes it difficult to properly evaluate the condition, particularly given the extent of staining including some areas which appear to have active ingress (above easternmost memorial plaque).

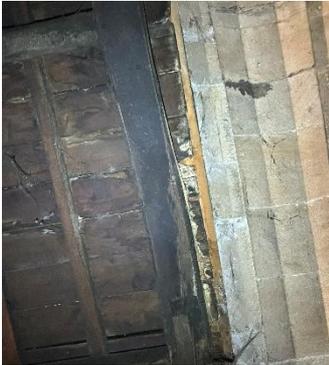
Figure 67 – east end ceiling

22.2 As with the South Aisle, there is visible discolouration to some of the ceiling boards at **roof level**, suggesting either historic moisture ingress or surface deterioration. Additionally, there is a line of white staining above the door, appears as if it could be to a previous fixture here, but cause not known. To the western end, adjacent to the tower what looks to be an active damp patch with some signs of fungal growth, also the case to the western arcade side, therefore these areas would also benefit from a close visual inspection, similar to other areas of the church, as the condition and causation cannot be fully assessed from ground level.

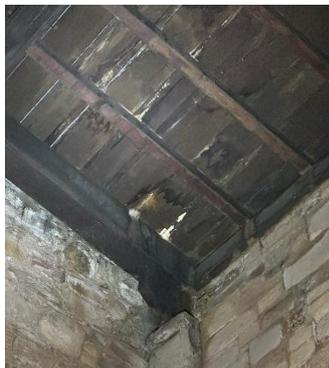
Figure 68 – West end ceiling

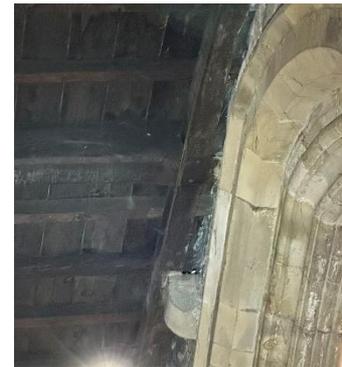
22.3 Of structural concern is the wall plate along the arcade wall, which has shifted outward considerably over time and is now only marginally retained on the corbels. The main roof beams in this area appear to have pulled away from the wall by approximately 50 mm. A close-quarters inspection is strongly recommended, involving a structural engineer, to assess any ongoing movement, risks or bracing required.

Figure 69 – Arcade wall plate

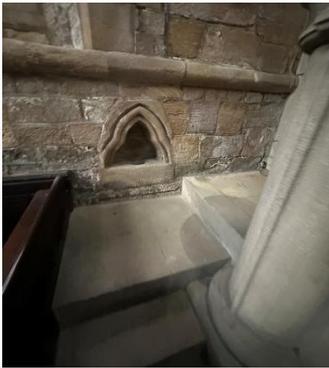
Figure 74 – piscina

24.4 Just behind the pulpit, a trefoil-headed piscina is present and appears to be affected by damp, as with the wider walling in this area. This appears to be penetrating damp from poor external pointing and overflowing rainwater goods.

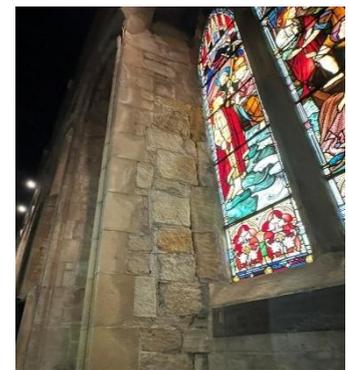
24.3 The **walls** are generally in good condition, although the pointing is quite angular and raised in profile. On the east wall at high level, between the beam corbels, there is a two-light window with surrounding stonework that still appears slightly damp at the head. Below this, two lancet windows—possibly original but with later architrave mouldings—are in good condition overall. The southern lancet shows spalling at the crown. On the northern side, the reveal is eroded.

Figure 77 – southern window reveal

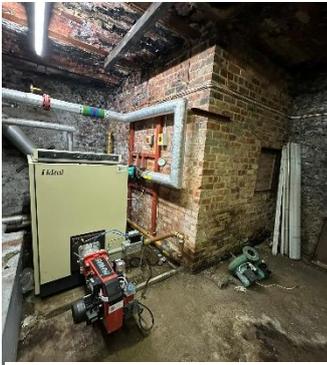
Figure 79 – boiler with new pump

27.1 The heating source is by Ideal Harrier GT boiler within the subterranean boiler house fed via large cast iron pipe sections. The main boiler is old and has seen many replacements, including recently the pump. The majority of pipes internally have now also been replaced with small bore sections and covered in with MDF boxings. The original cast iron sections and the pine casings have been removed, and new panel radiators have been installed. They are white and in stark contrast with the rest of the interior.

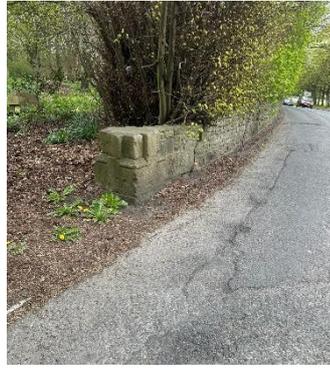
Figure 83 – W boundary E yard

34.6.4 **West boundary (Auckland Rd):** Stone retaining wall with iron railings — several missing or displaced. Stone copings require pointing or re-setting; slight outward lean in places. Tree growth near the former gate (north end) is disturbing masonry and should be removed.
