St Peter, Bishopton

Quinquennial Report

18th January 2024

HARRISON ARCHITECTS STUDIO LTD

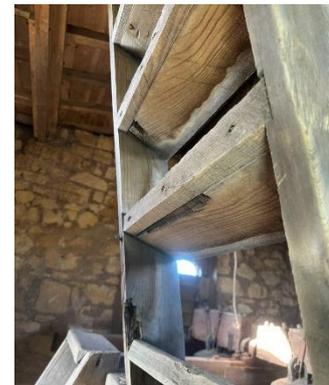
Figure 12a – Belfry Ladder

9.3.2 **Walls** – Random rubble, some open joints, particularly at high level. Cracks in the South East and to a lesser extent, South West corners as noted in the last inspection report, only the southeast was pictured, which shows little to no progression as far as I can see. A crack radiates from the top of the western lancet, not noted in the last report. These need to be pointed as soon as possible to allow any movement to be monitored. The sandstone quatrefoil belfry louvres are in very poor condition, these appear to have deteriorated since the last inspection, many louvres are dislodged. The tracery is also in need of repair, many cracks with some areas at risk of falling. There is external expanded metal mesh sheeting that looks in acceptable condition but should not be relied on to stop falling stone. The louvres and tracery need repairs urgently.

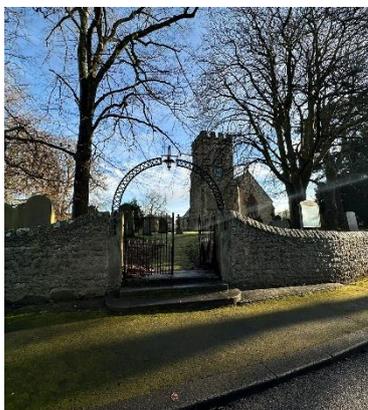
Figure 31- Main gate access

27.1 Wheelchair access: There is ramped access footpath, albeit steep from two entrance gates. There are three steps up from the pavement at the northwest access, and this is directly onto a highway. The south access is to a footpath which would seem like a more logical location to have (temporary) ramped access as this would not lead onto a highway, however there is no dropped kerb here so this would need to be requested from the council. The path may also need to be widened to its original width, and cleared of shrub overgrowth. There is also a step up into the porch which is managed by a temporary aluminium ramp.

seats) and determine what improvements can be made within the restrictions of the building. It may be possible to re-lay the step into the porch at an angle.
