## QUINQUENNIAL REPORT

*For the Parish Church of*  
Church of the Holy Spirit, Crawcrook

***Report Date: 14<sup>th</sup> July 2026***

Inspecting Architect:  
Becky Smith BA(Hons), MArch, ARB, RIBA

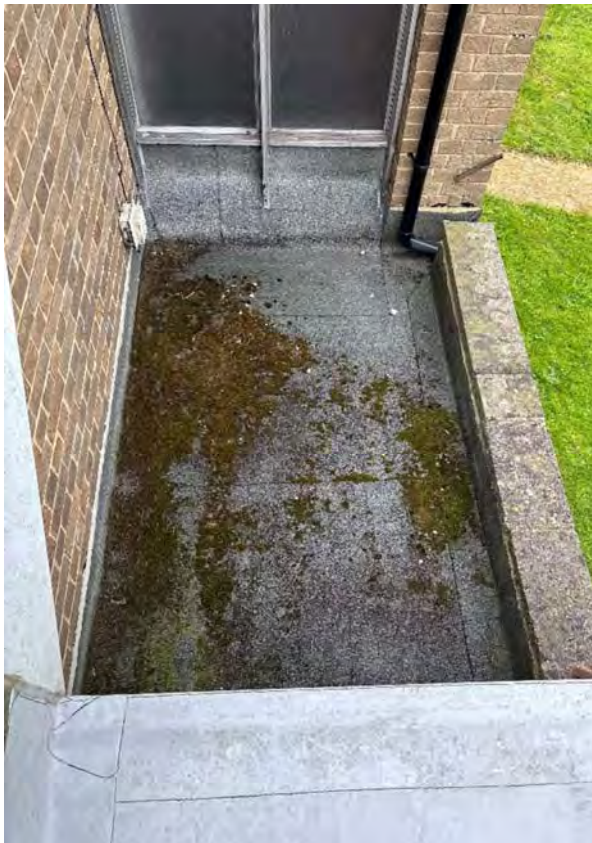
Moss growth to Boiler House Roof

| Category Scale | Area | Works Summary | Cost Band |
|---|---|---|---|
| 2-3 | Roof | Undertake repairs to slipped / missing roof slates to both roof slopes. Fix felt covering to chimney and undertake visual inspection whilst repairing. Removal of moss and debris to boiler house roof and inspect. | 1-2 |

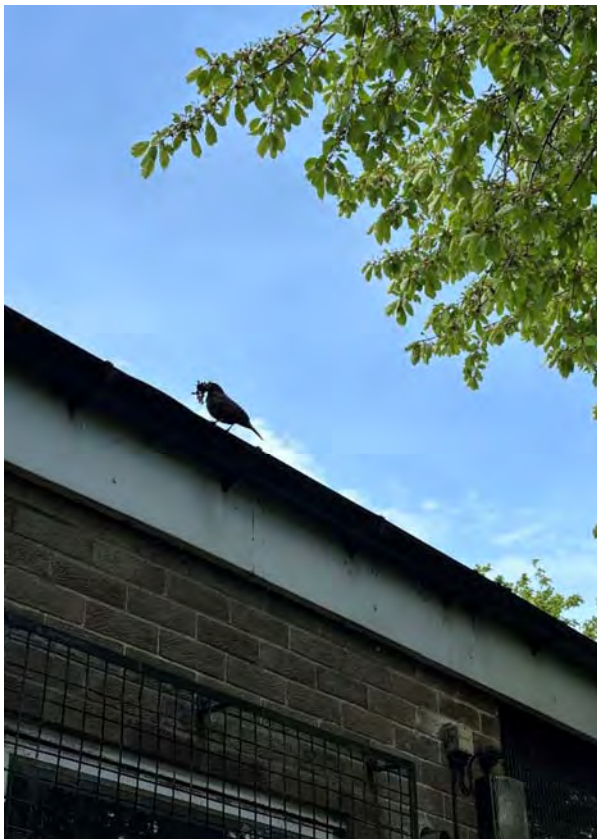
Birds gathering nesting materials from gutters – require clearing.

| Category Scale | Area | Works Summary | Cost Band |
|---|---|---|---|
| M/2/3 | Gutters | Clear all vegetation and debris from gutters. North Elevation downpipe to be connected to functional drainage outlet. Remove all loose, flaking paint and rust to rainwater goods to church and repaint. | 2 |

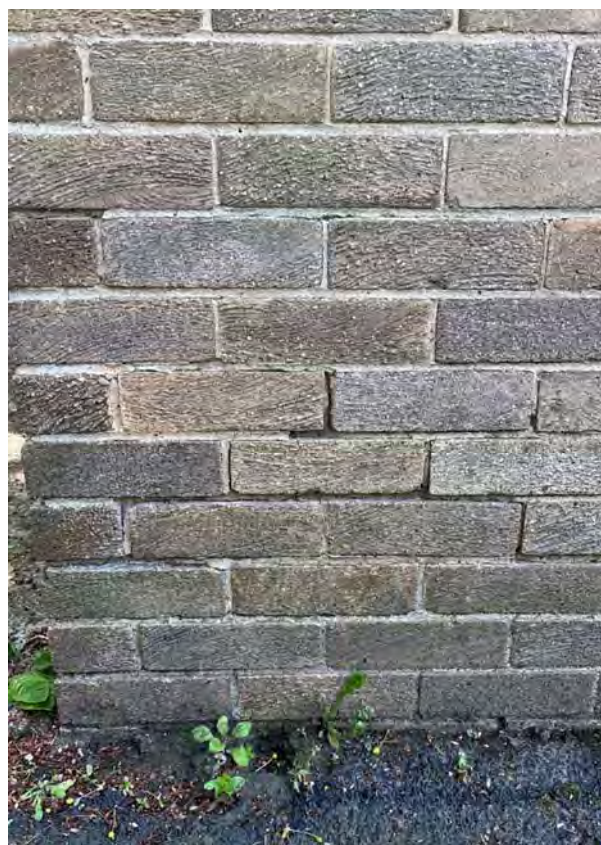
Area of loss of pointing to lower left wall

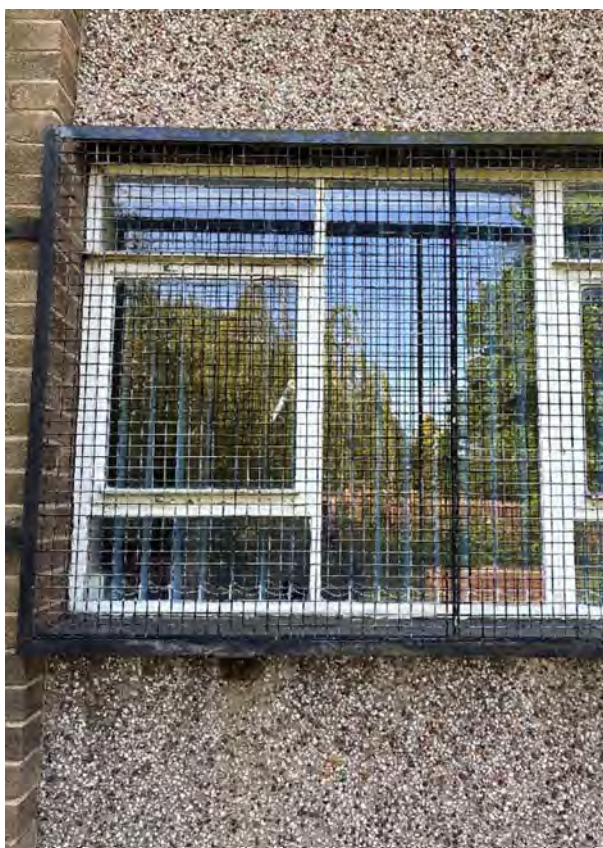
Metal covering to window

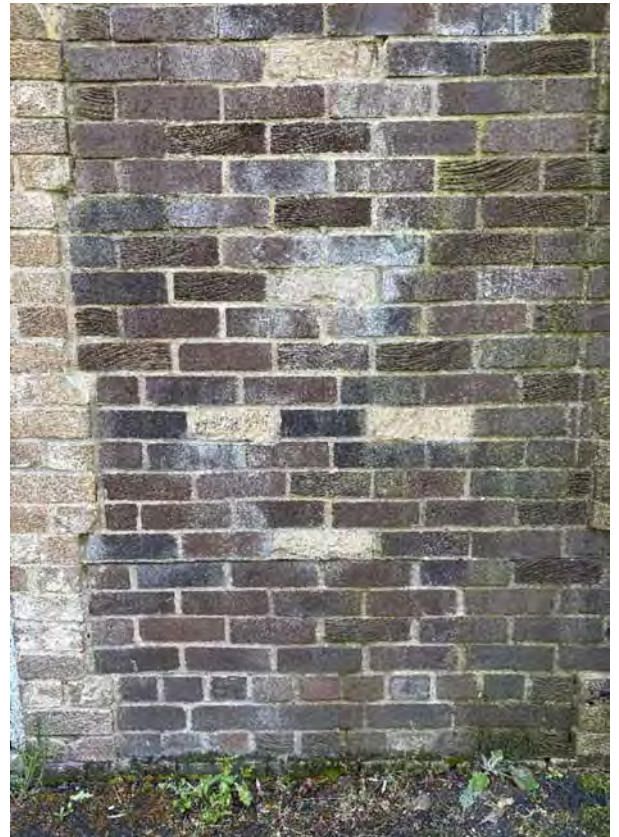
Efflorescence visible on this section of the elevation.

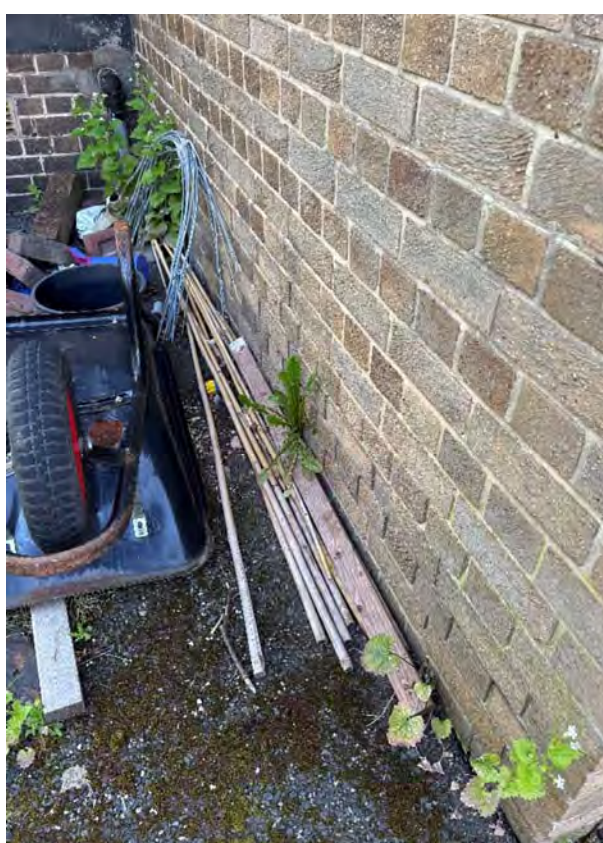
Items stored in front of elevation.

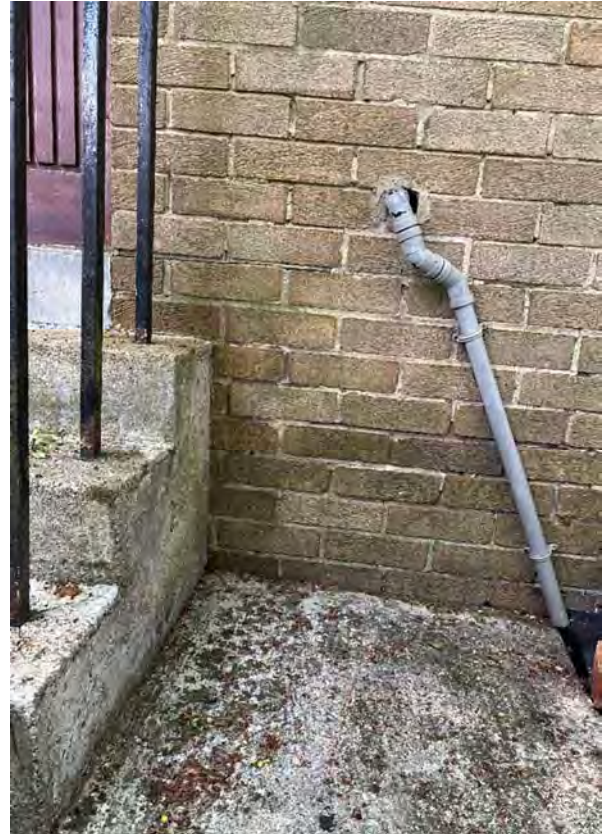
Example area where loss of pointing occurs around pipe

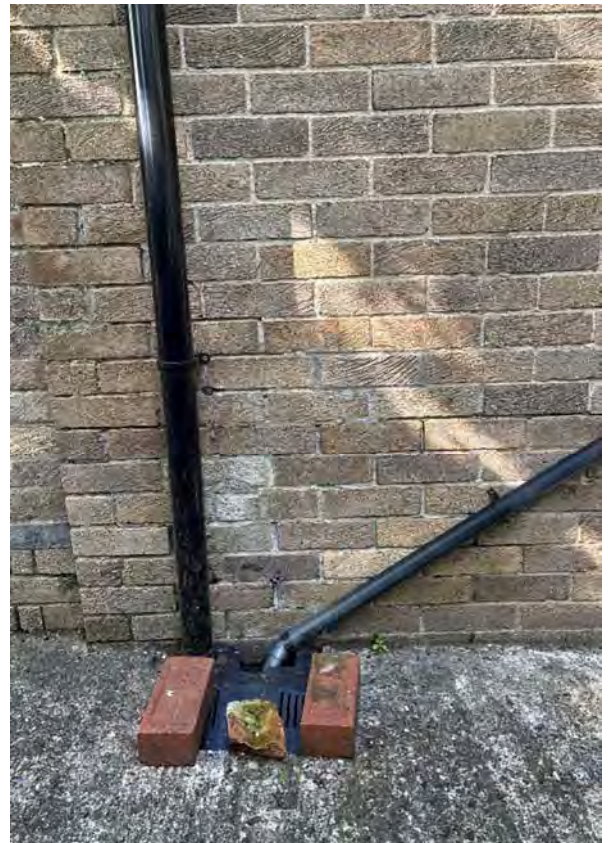
Example area of loss of pointing around pipes

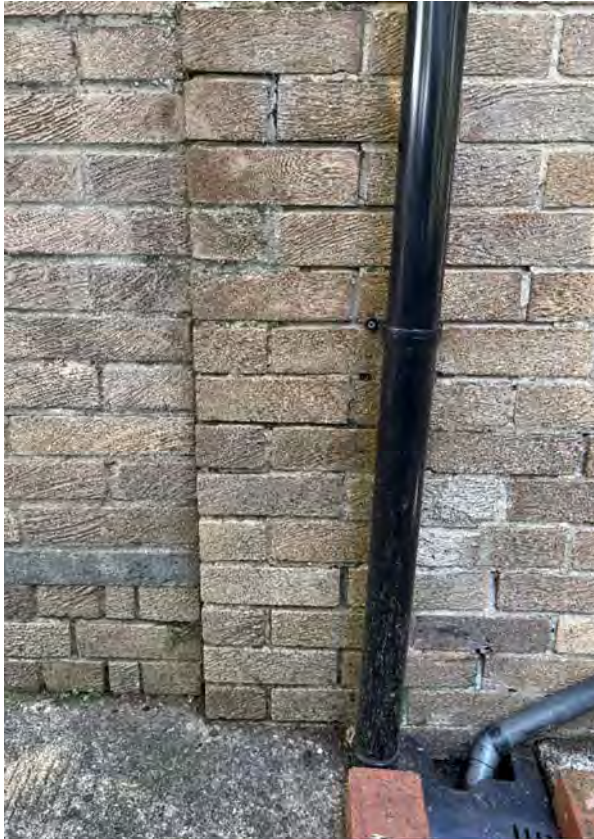
Example area of loss of pointing around downpipe.

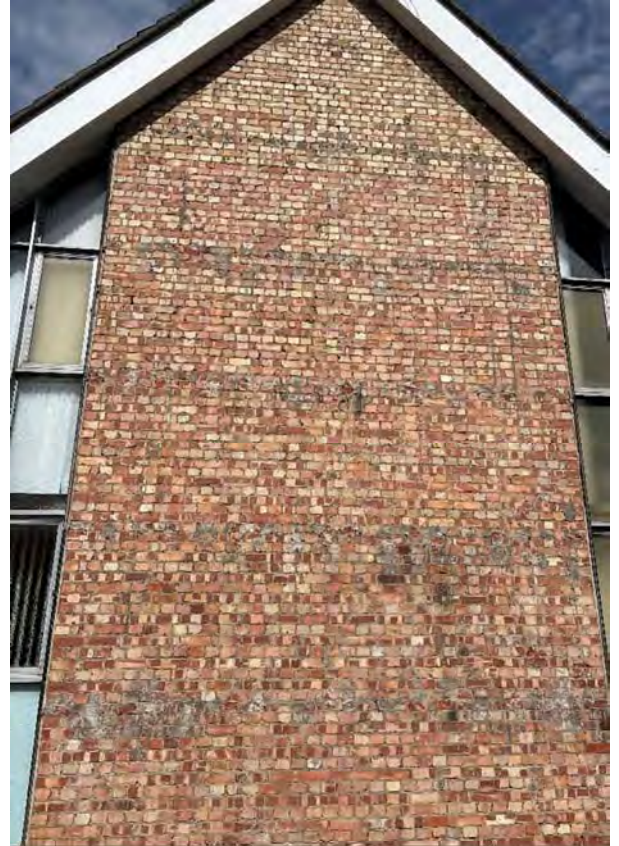
Area of exposed brickwork where slates previously were.

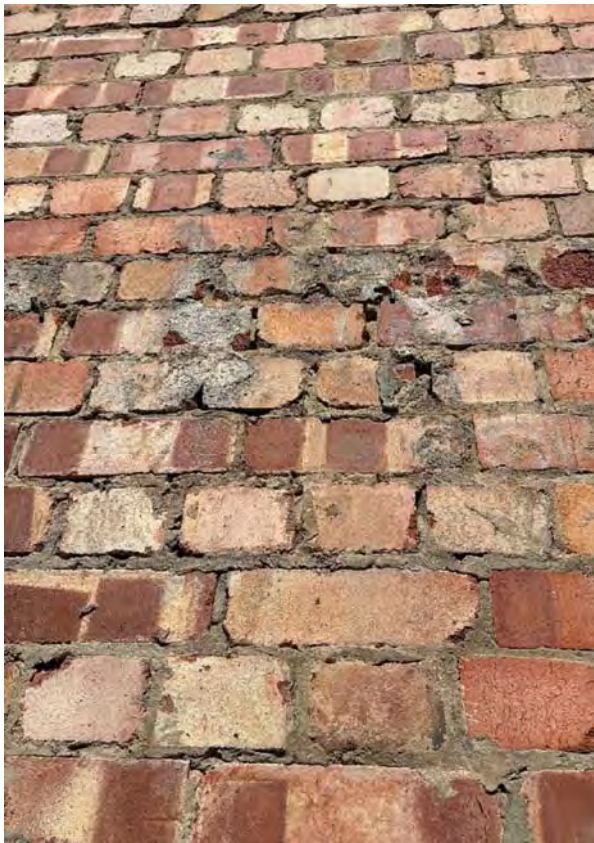
Example quality of brickwork

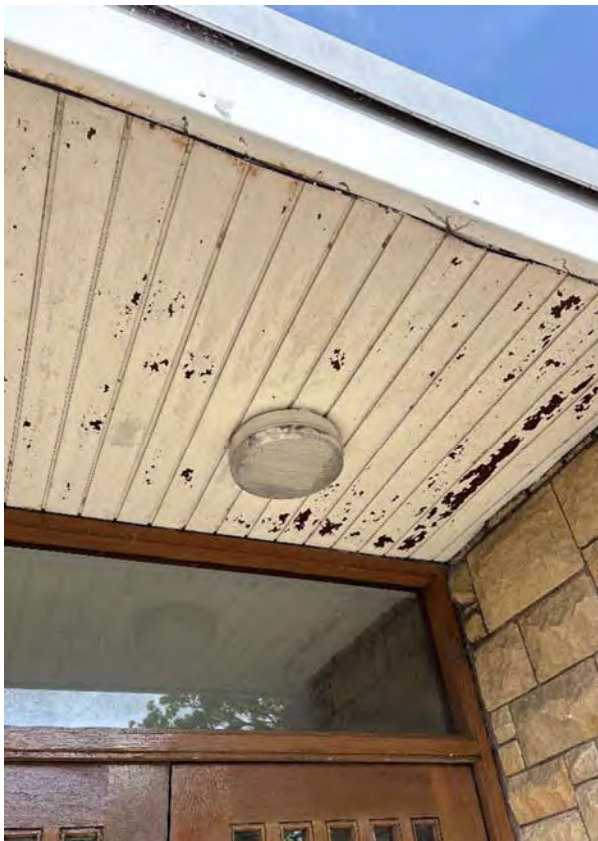
Loss of paint to ceiling area of entrance.

| Category Scale | Area | Works Summary | Cost Band |
|---|---|---|---|
| 3 | S. Elev | Investigate whether water ingress to roof area and repairs to underside ceiling finish. | 1/2 |

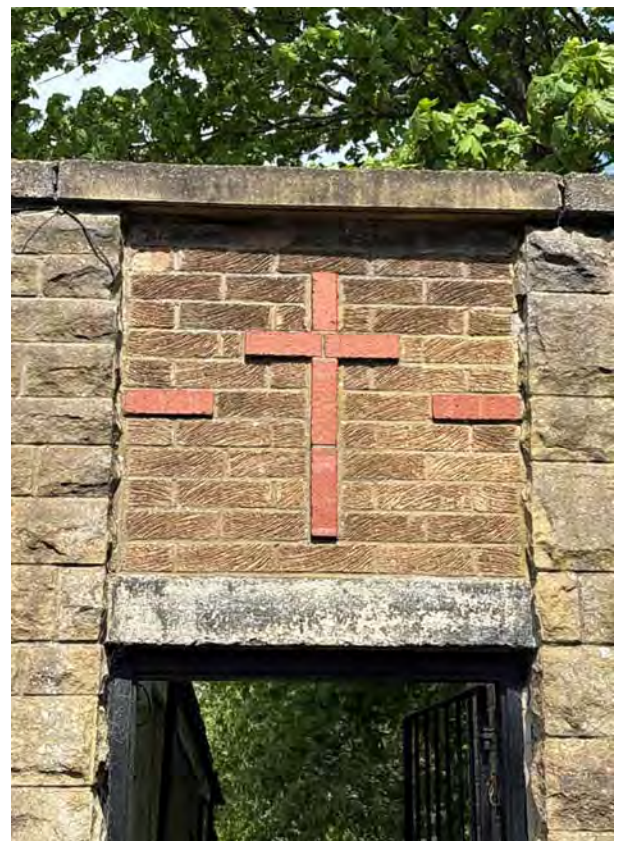
Loss of pointing to coping stones and between stone and brick connection.

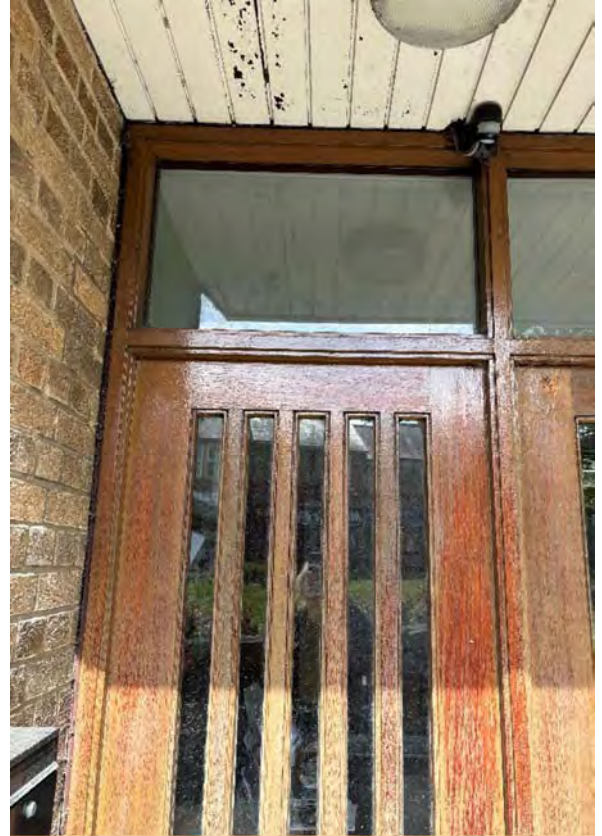
Loss of finish to doors

| Category Scale | Area | Works Summary | Cost Band |
|---|---|---|---|
| 3 | Doors | Entrance Doors: If not replaced as part of new elevation scheme repair door frames and repoint.<br>Boiler House: Repair doors and install mesh for bird and insect prevention.<br>East Door: Repair and treat security mesh. | 2 |

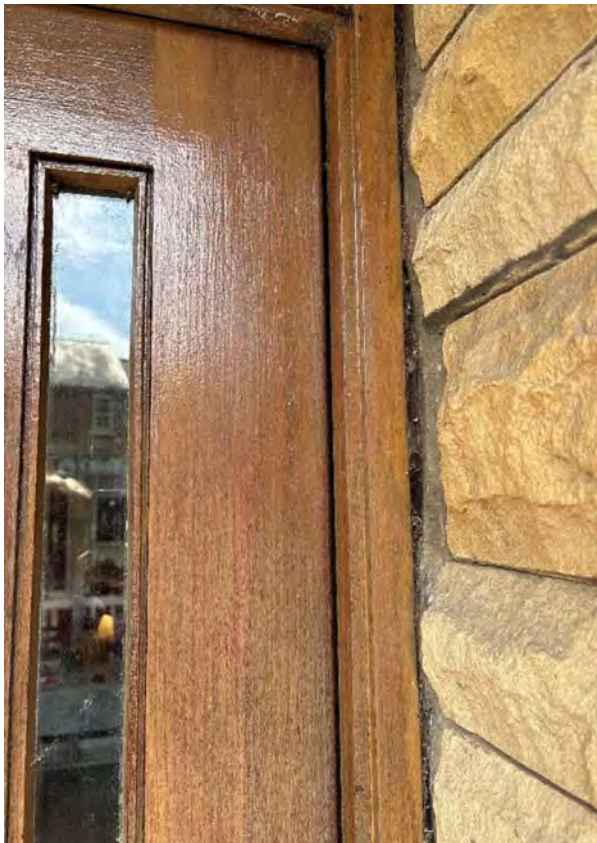
Loss of seal around door edge

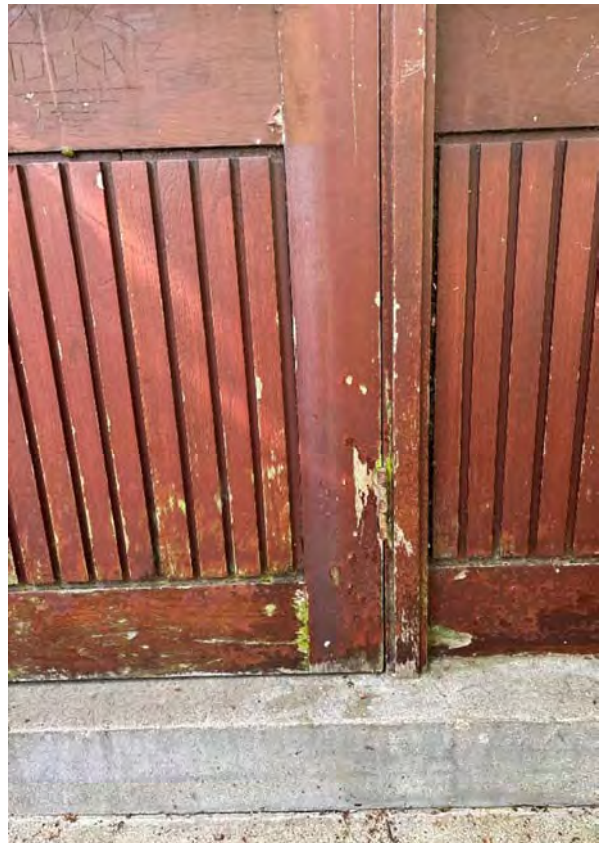
Area of flaking paint to doors

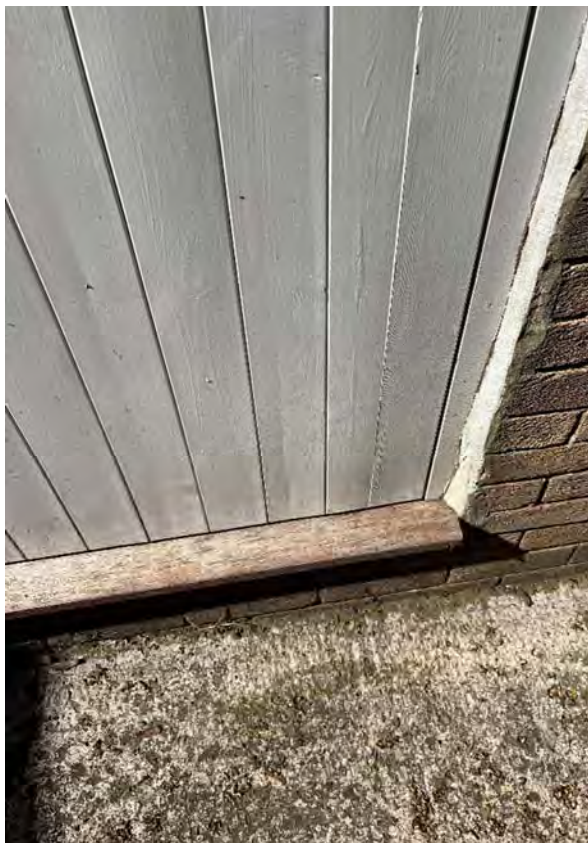
Flaking paint to door threshold

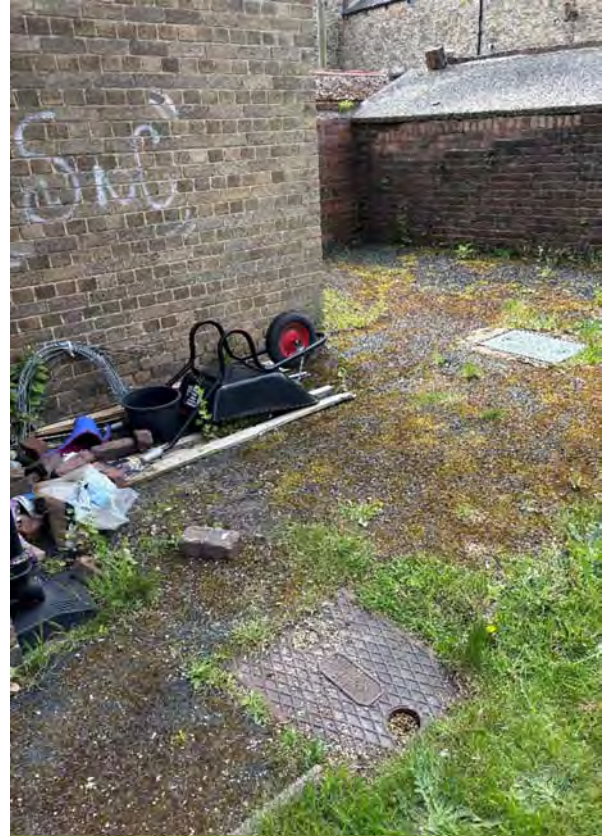
Moss / Weed growth to paved area surrounding church.

| Category Scale | Area | Works Summary | Cost Band |
|---|---|---|---|
| M-3 | External | Cut back vegetation and remove weed growth. Patch repairs to front entrance pot holes. | 1 |

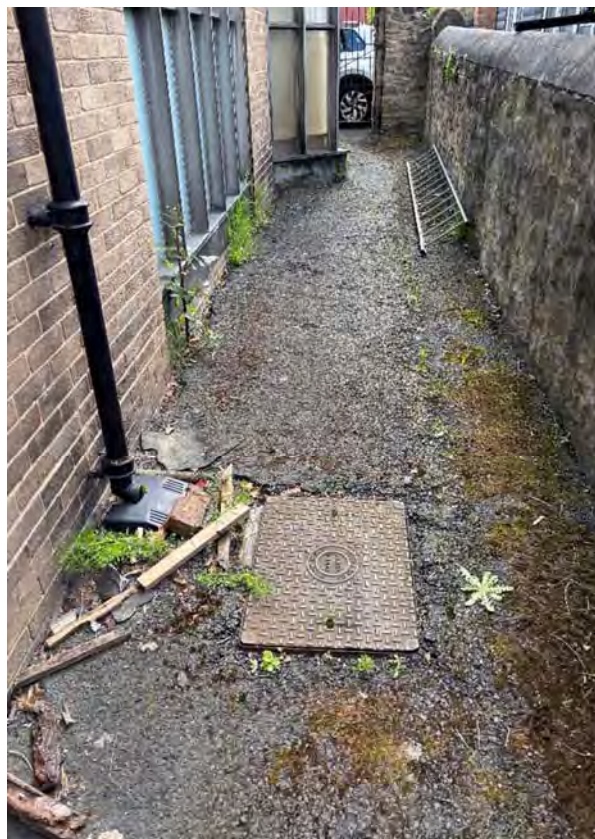
Rubbish and debris to be cleaned from rear churchyard/garden.

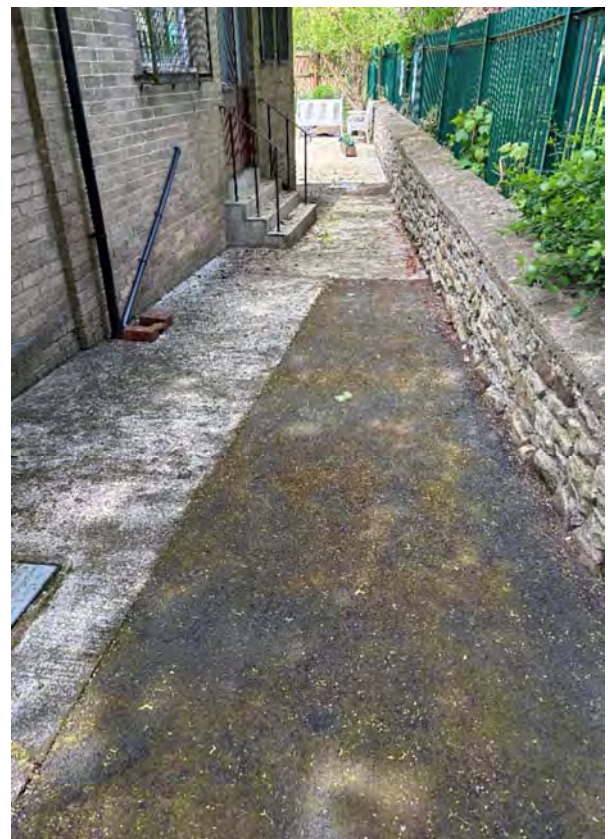
Changes to floor finish around garden creating some uneven surface finishes.

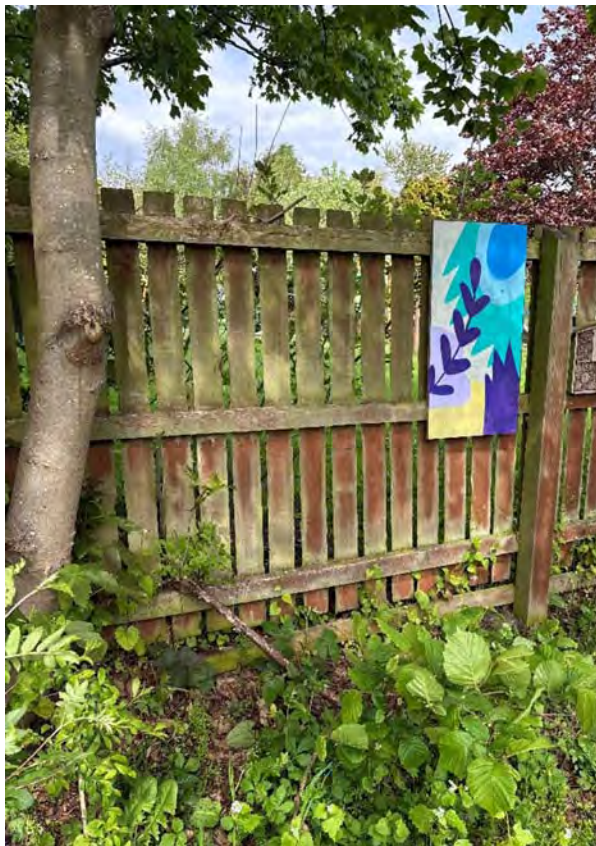
Significant weathering to fence posts and panels

| Category Scale | Area | Works Summary | Cost Band |
|---|---|---|---|
| 1-2 | Boundary Walls | Clear out debris to boundary wall to public pavement and undertake repairs to surrounding stones and wall. Plan for a repair and repointing / painting programme to all stone, brick and timber boundary walls. | 3 |

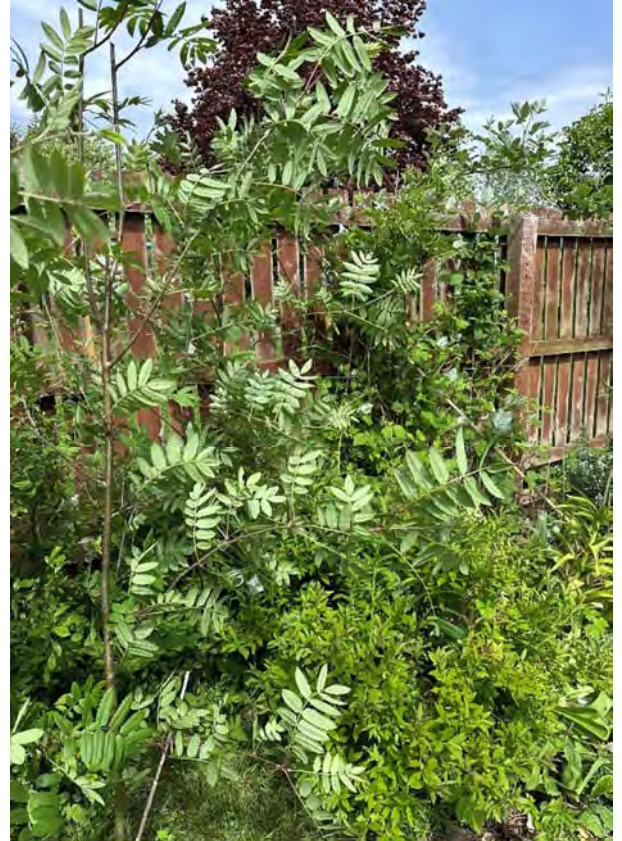
Overgrowth of vegetation to rear boundary

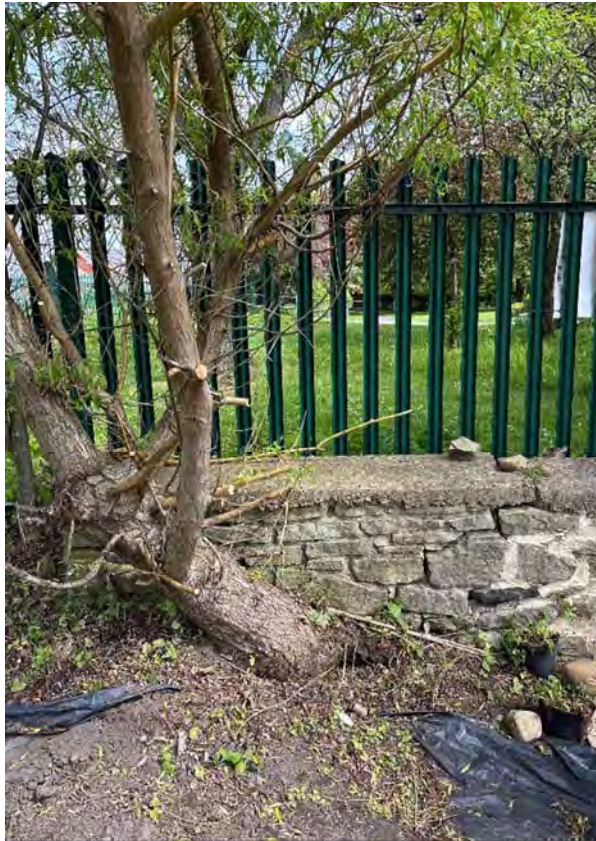
Tree roots impacting on stone boundary wall.

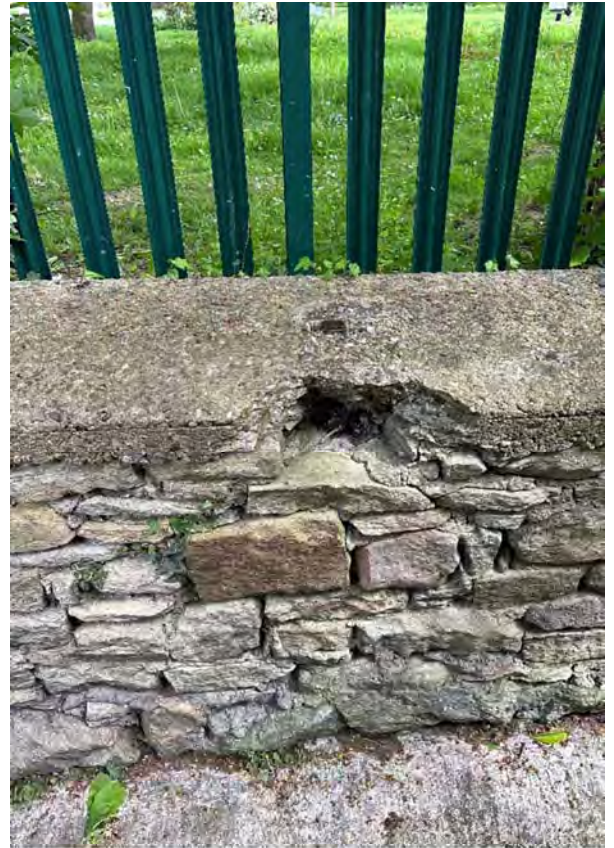
Example of loss of stone from iron fixing (occurs across whole wall)

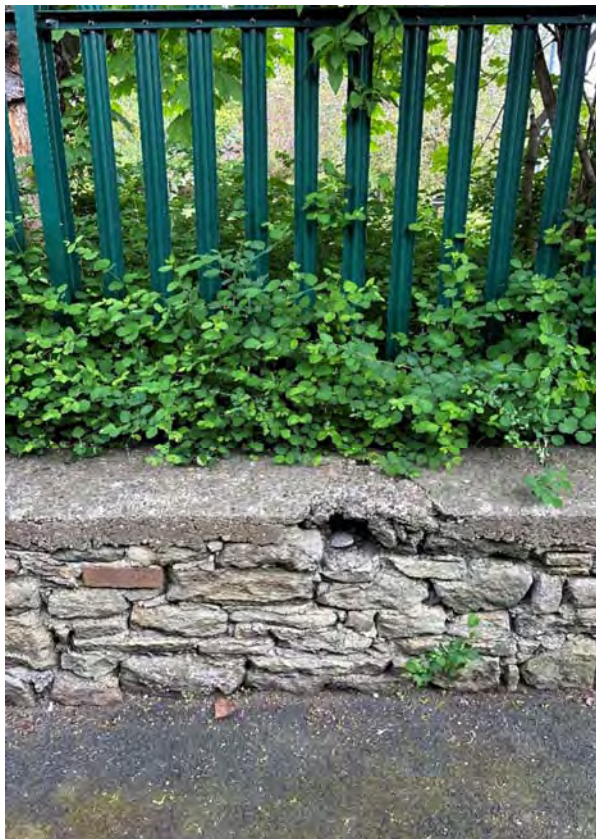
Example of loss of stone from iron fixing (occurs across whole wall)

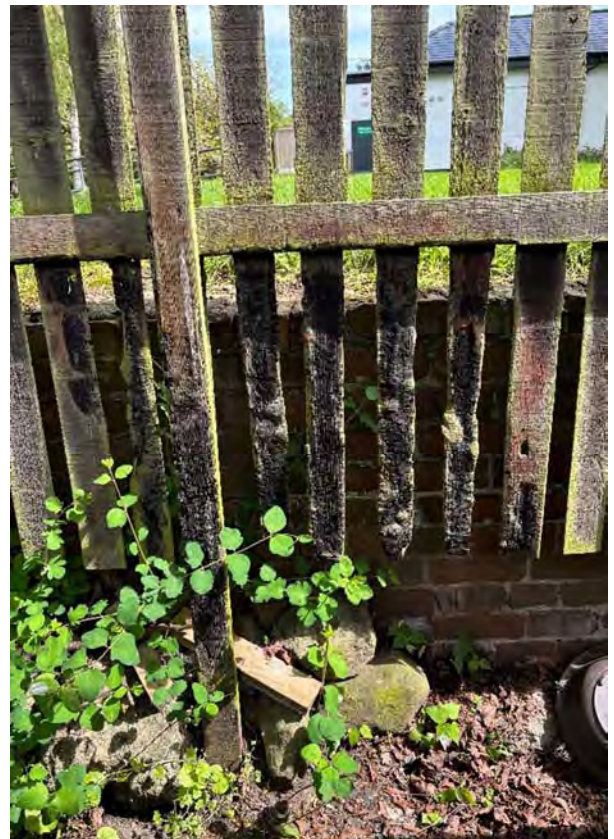
Rotten sections of timber fence.

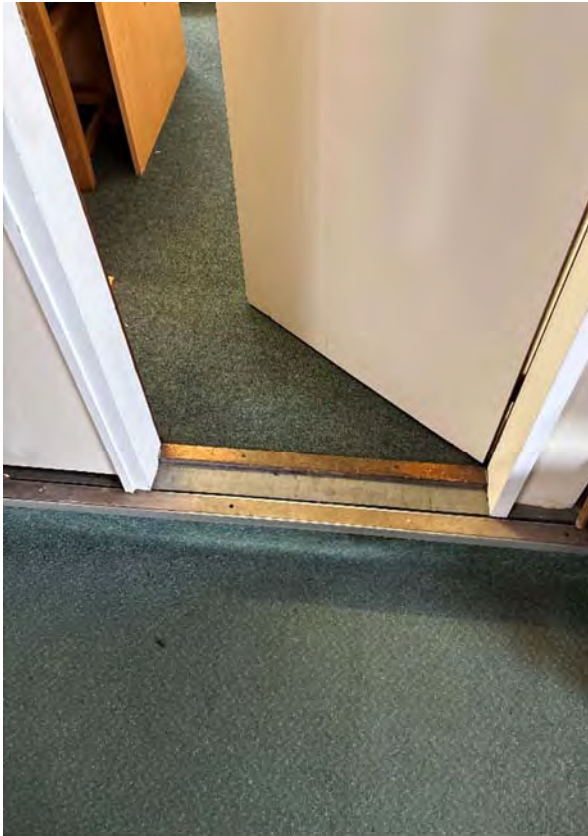
Threshold step into office. Should be clearer to prevent trips.

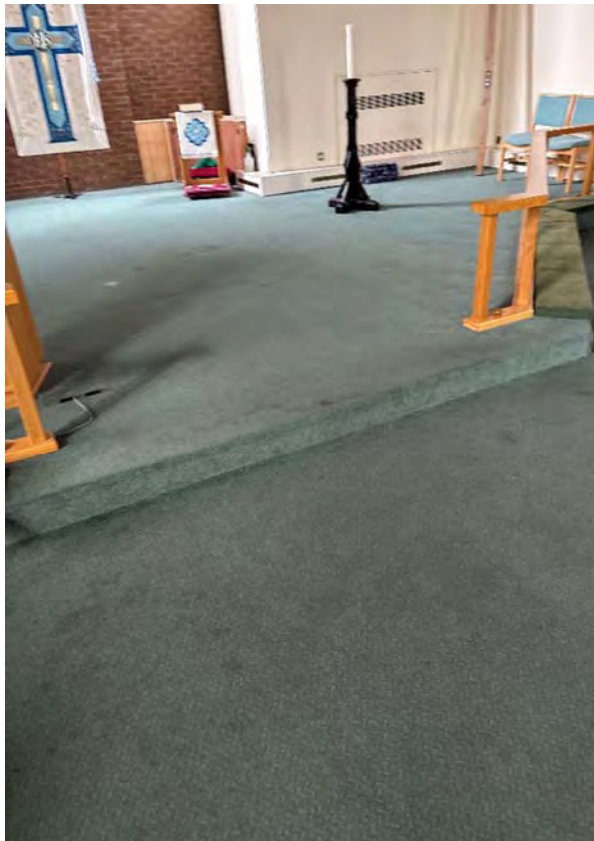
Step up should be identified more clearly to prevent trips.

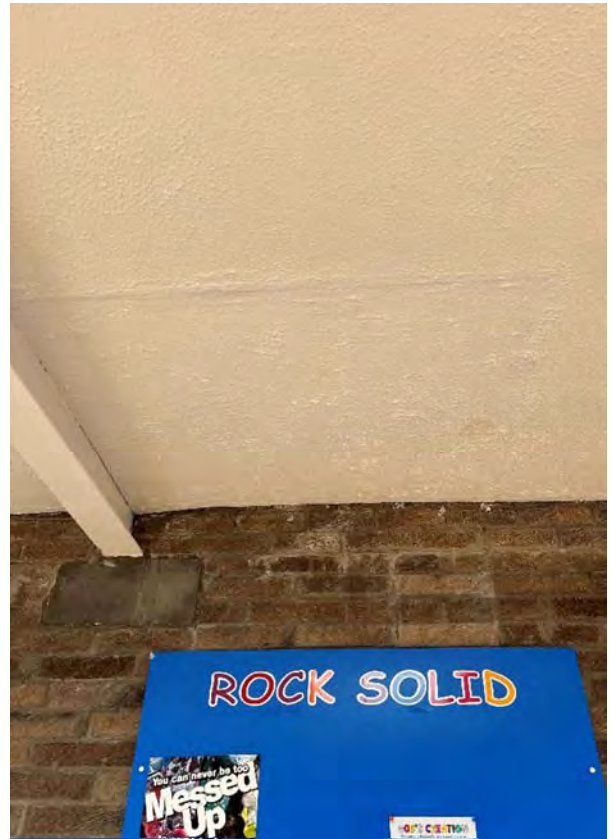
Example of uneven finishes to textured ceiling surface.

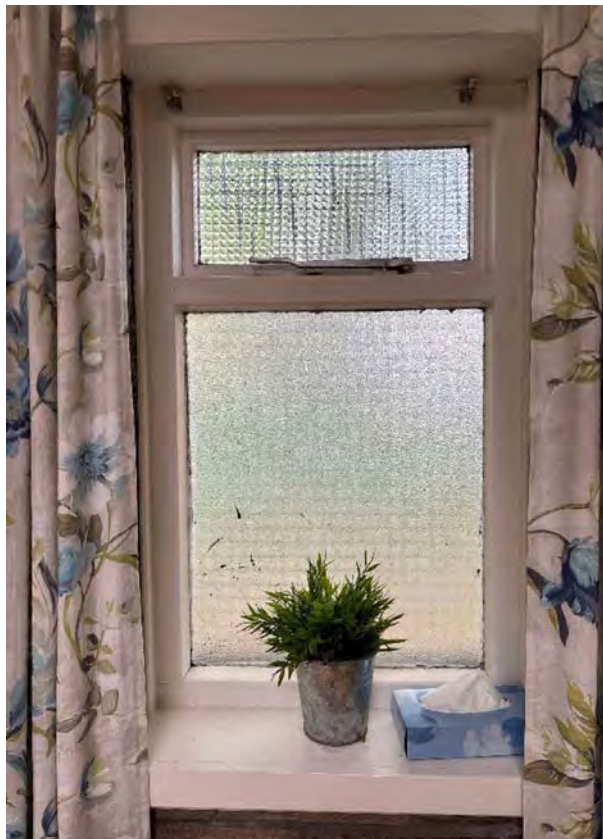
Dirt / paint markings to frames.

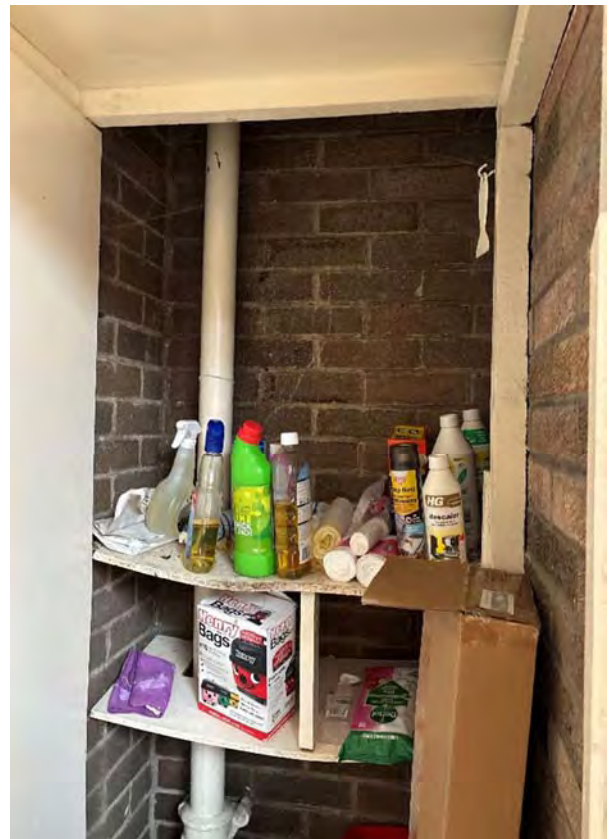
Storage cupboard shelving warping

| Category Scale | Area | Works Summary | Cost Band |
|---|---|---|---|
| 2 | Internal Cupboards | Remove heavy items, remove shelving and install heavy duty replacements. | 1 |

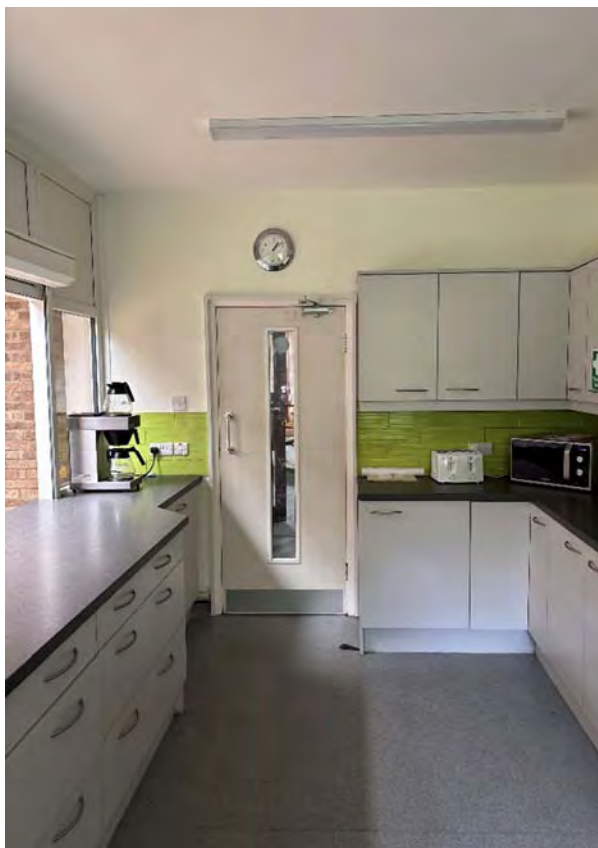
Door Stop use visible to fire door.
