St Oswald, Durham

QUINQUENNIAL INSPECTION REPORT 2023

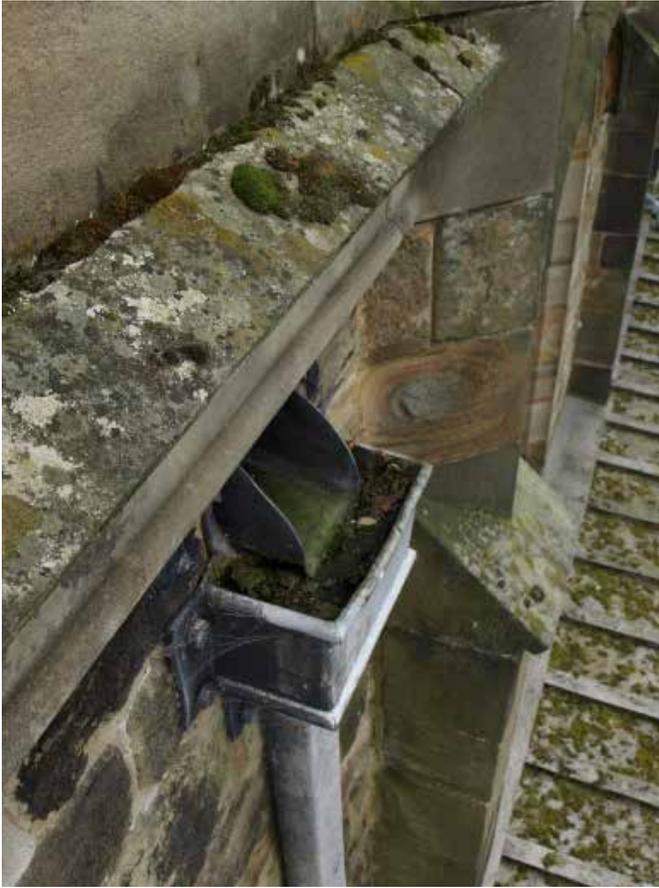
3.02.02	Nave north rainwater pipes	Lead rectangular section pipes with hoppers.	Good condition, but one hopper blocked with debris.	Clean out hoppers and pipes periodically, ideally every 6 months & monitor for any blockage or leaks.	A

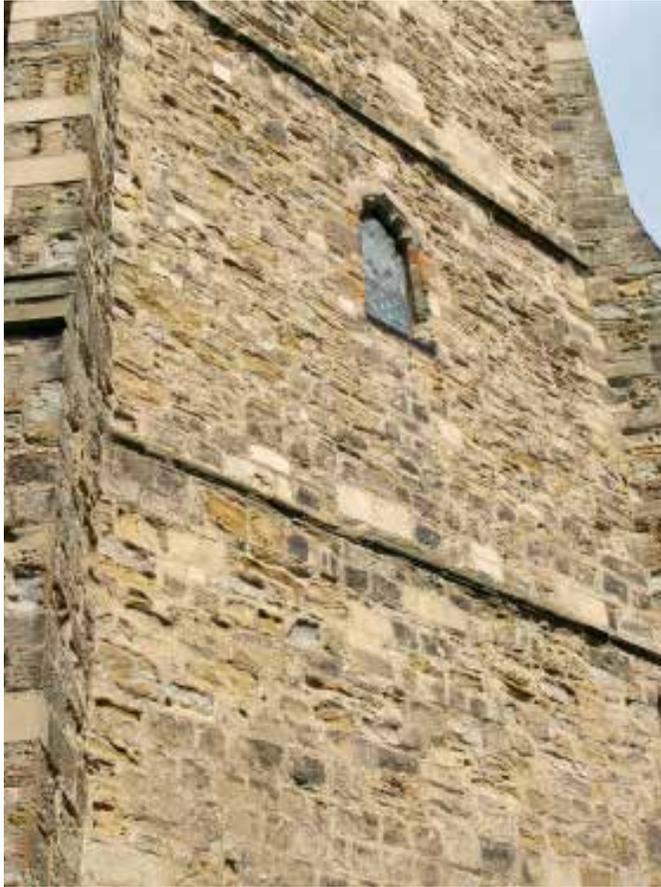
4.01.26	Tower external south elevation, openings	Cusped window opening in the new bell ringing stage and at low level one opening to the tower stairwell.	Cusped window opening, masonry localised re-pointing. Leaded glazing panel condition fair, though the panel has been cut back and the bottom half re-leaded, presumably following failure. Upper panel the lead is warping. Lower stairwell window has been blocked up.	Localised re-pointing in with phased re-pointing works. Cusped window localised re-pointing and minor masonry repair to deteriorated stonework at jamb. Repair to glazed leaded window pane panel.	C

4)	3.05.01 4.01.20 4.01.22 4.01.23 4.01.24 4.01.25 4.01.26 4.01.27	Tower, external east elevation masonry: re-pointing including parapet, pinnacles and main walling stone, including localised stone repairs. Tower north elevation masonry: re-pointing including parapet, pinnacles and main walling stone, including localised stone repairs. Add lead caps to deteriorated string courses to aid water shedding. North elevation openings: localised re-pointing. Second stage window: repair glazing, localised re-pointing, particularly around historic stonework. West & south elevation masonry & openings: re-pointing including parapet, pinnacles and main walling stone, including localised stone repairs. Add lead caps to deteriorated string courses to aid water shedding. To the cusped window, localised re-pointing and consolidation of cill. To small stairwell windows, consolidation of stone replacement of cill of upper window. Principal west window: re-point open joints to hood mould, minor masonry repairs to window tracery and base of jambs.	70,000

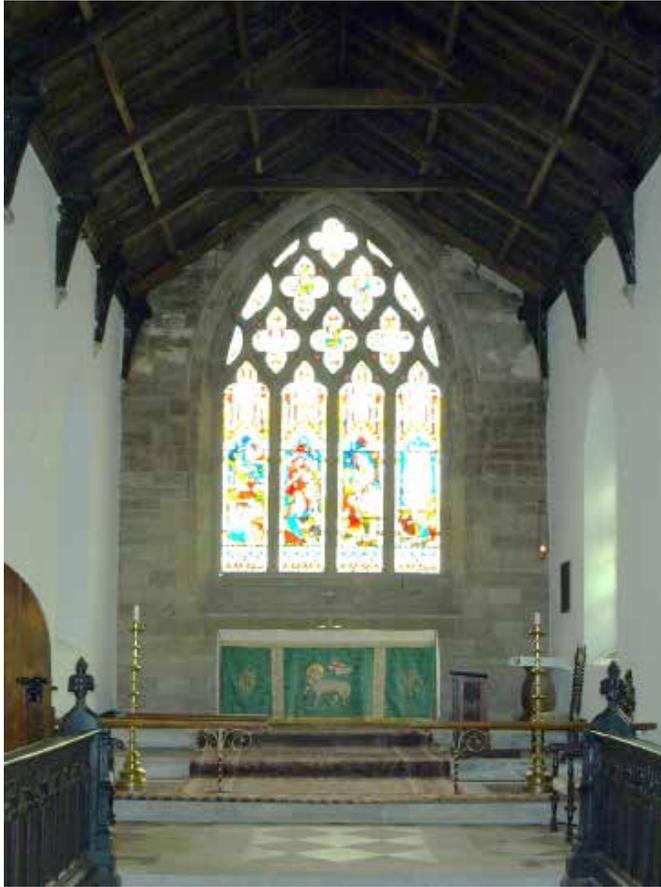
REF.	LOCATION / ITEM	DESCRIPTION	CONDITION/DEFECTS	RECOMMENDATIONS	PRIORITY
4.04 ROOF STRUCTURES & CEILINGS					
4.04.01	Chancel roof structure	Open timber roof structure consisting of 8 no. collared trusses supported on wall plates and stone and timber corbels with boarding over. The trusses carry purlins which in turn support the common rafters. This ceiling has had a considerable amount of repair. The two bays to the west end of the chancel have had all new rafters and purlins and the truss at the chancel arch and the next truss along have been replaced with new oak. To the remaining trusses plated repairs have been made to the joints. There is foiled insulation visible through the gaps in the boarding in a number of places, suggesting that this roof is insulated above the boarding.	Appears to be good condition following repairs.	None.

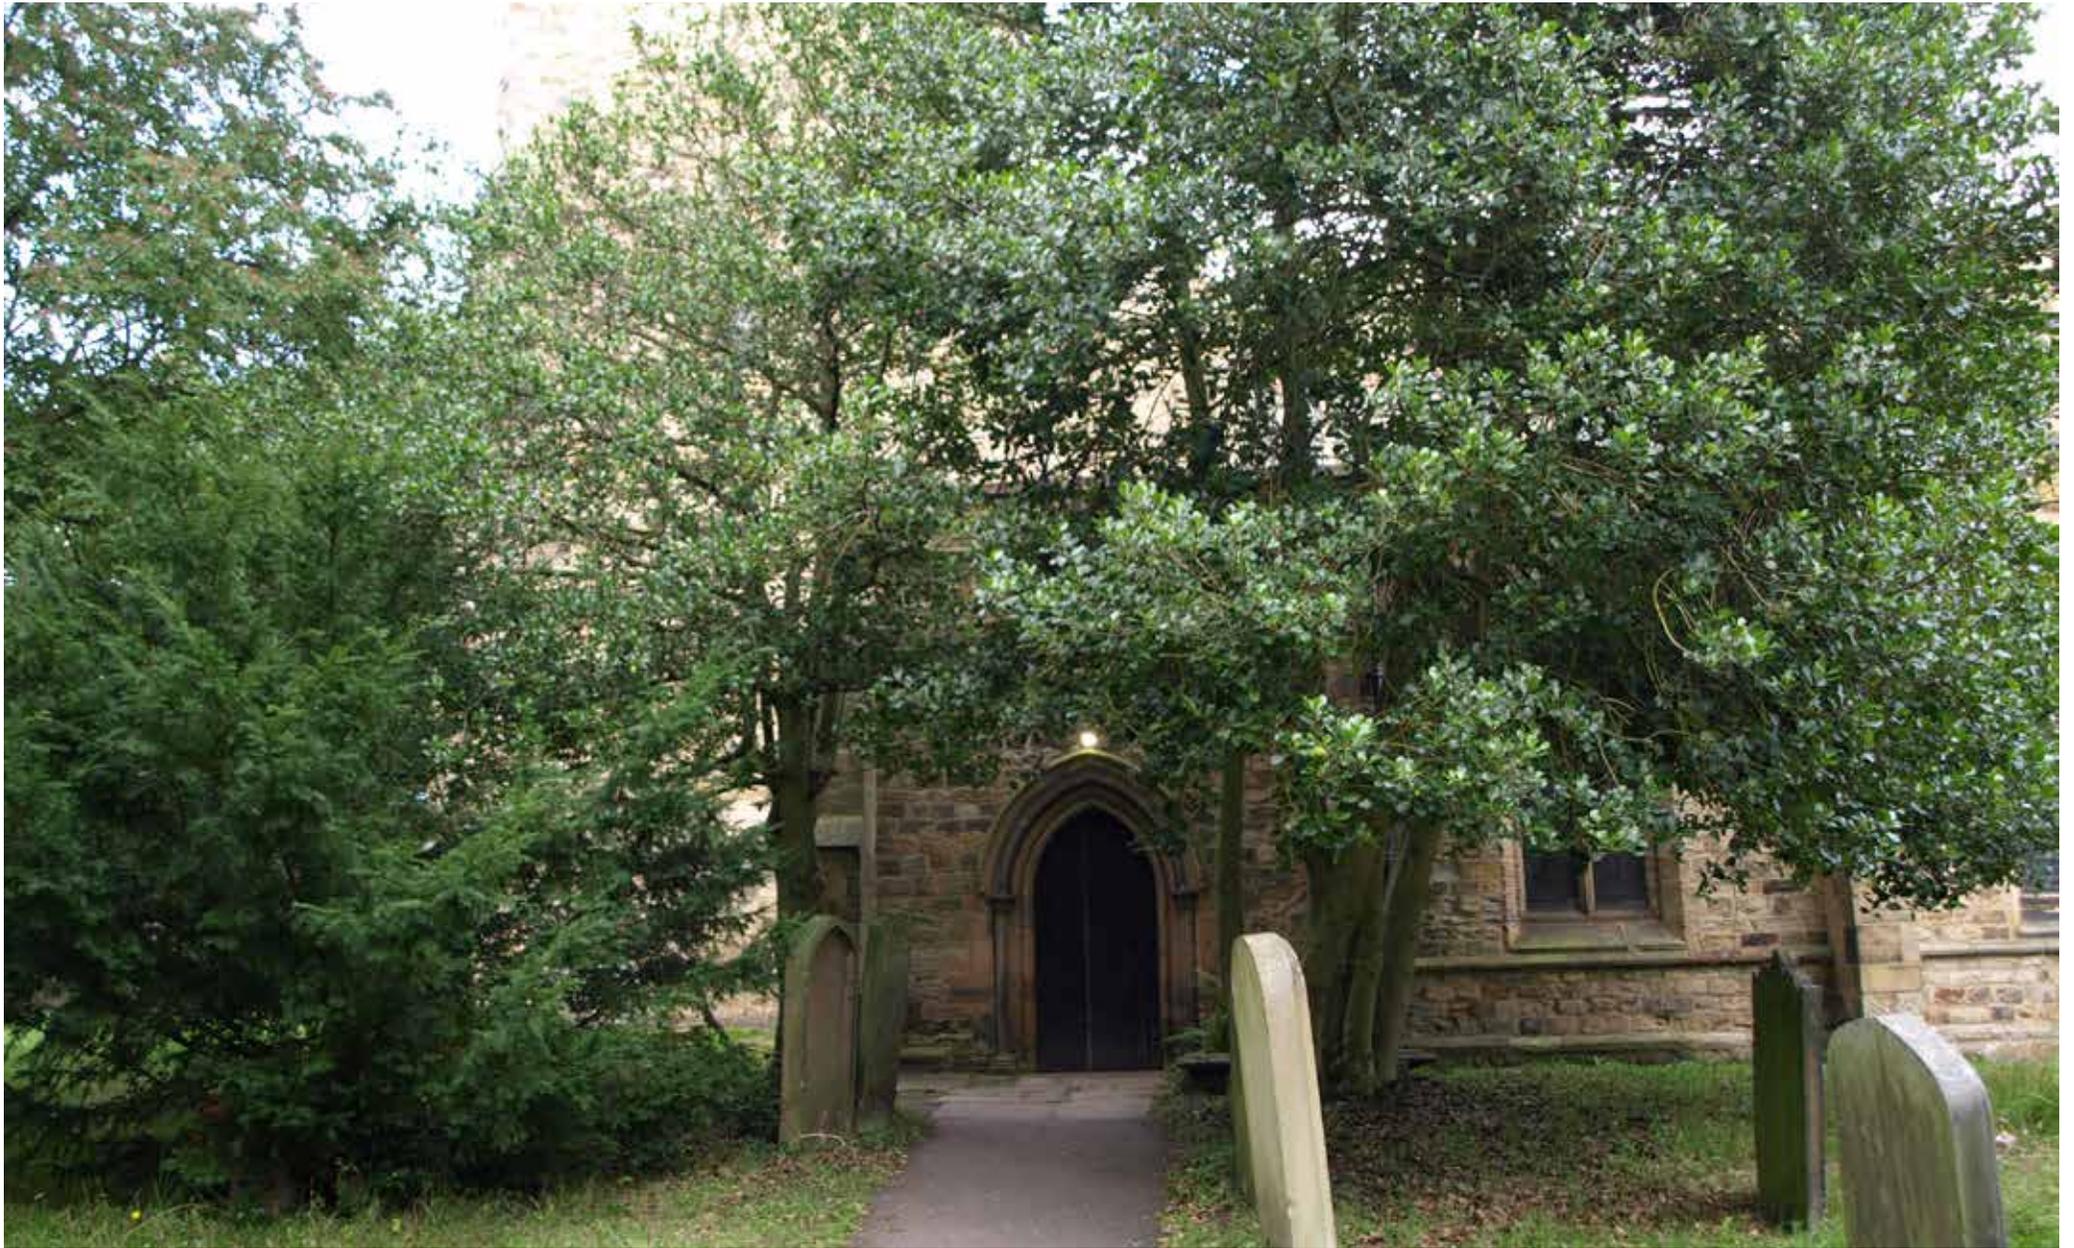
REF.	LOCATION / ITEM	DESCRIPTION	CONDITION/DEFECTS	RECOMMENDATIONS	PRIORITY
6.05	Trees & shrubs	A Tree Report was obtained in 2021.	A 're-wilded' site may be an appropriate backdrop for a Grade II* listed formal public building, but the church should not be screened by foreground trees or lost within encroaching vegetation.	Removal of encroaching trees near the building should be pursued, and the removal of trees which block views of the church from the road is recommended to give due prominence to the church building. The hollies by the Porch are particularly inappropriate and should be removed. Essentially all trees taht are within falling distance of the church should be removed.	B
