# QUINQUENNIAL INSPECTION REPORT - MARCH 2026

## THE PARISH CHURCH OF **SAINT MICHAEL AND ALL ANGELS**

FRONT STREET, ESH, CO. DURHAM, DH7 9QY

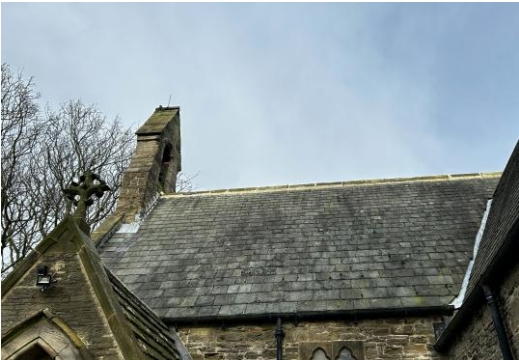
### Southern Pitch of the Nave / Chancel Roof

| | <b>Condition</b> <ul style="list-style-type: none"> <li>Some minor delamination of slates, but generally in sound condition.</li> <li>Extensive moss was removed during the 2024 roof works, however there is a small area of moss growth present.</li> <li>Flashings in sound condition.</li> <li>Ridge tiles have been re-bedded and a number were replaced where required during the 2024 roof works. Ridge tiles and bedding remain sound.</li> </ul> | |

| | <b>Repair Needs</b> <ul style="list-style-type: none"> <li>Monitor moss growth.</li> </ul> | M |

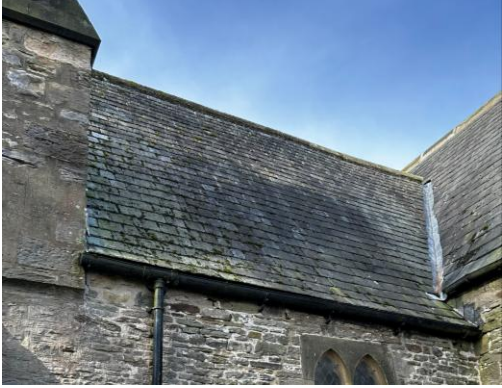
## Transept Roof

| | <b>Condition</b> <ul style="list-style-type: none"> <li>• Some minor delamination of slates, but generally in sound condition.</li> <li>• Flashings in sound condition</li> <li>• Flashings behind the chimney are not visible from the ground, but appear to extend an appropriate height.</li> <li>• Ridge tiles are soundly bedded and pointing is complete.</li> <li>• Moss growth, was removed in 2024 roof works, there is some remnants remaining or regrowing.</li> </ul> | |

| | <b>Repair Needs</b> <ul style="list-style-type: none"> <li>• Monitor moss growth.</li> </ul> | M |

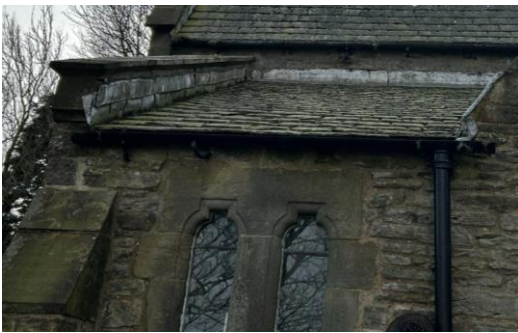
## Vestry Roof

| | <b>Condition</b> <ul style="list-style-type: none"> <li>• Slates generally in sound condition.</li> <li>• Flashing appear sound.</li> </ul> | |

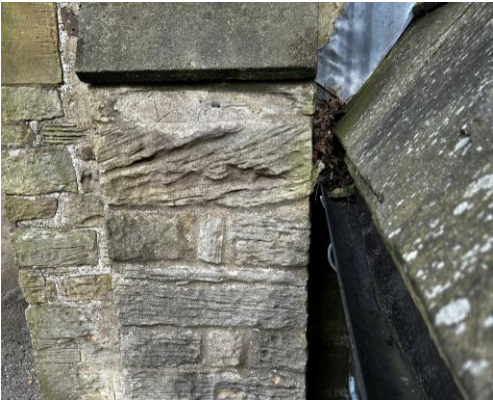
- Generally, the rainwater goods are in sound condition. It should be noted that this inspection was made on a dry day, so the opportunities for checking for leaks were greatly reduced.

- There is some leaf debris backed up in the gutter between the Porch roof and the western buttress.
- The clay pipe from the gully on the West side of the Transept appears to be broken.

- The gully on the South side of the Chancel has broken. It appears to be discharging normally.
- The gully on the East side of the Transept appears to be full of soil debris. This will limit its ability to function correctly.

- The gutter on the South side of the Chancel has been repaired, possibly a weld/solder. The repair is functioning.
- The downpipe on the North side of the Chancel offsets at the plinth. Previously blockages have been reported. Due to the dry weather, it has not been possible to say if this is still an issue.

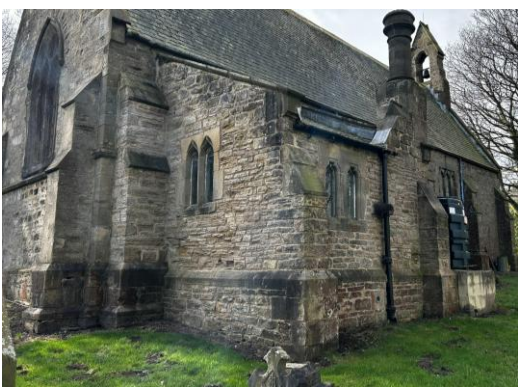
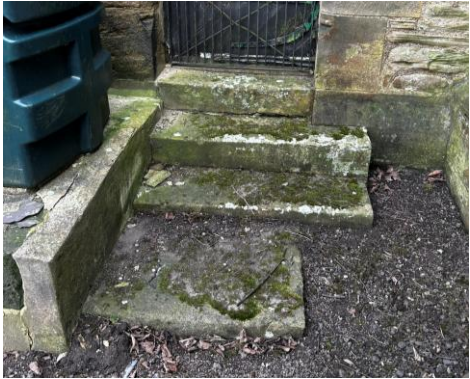
### Vestry Walls

| | <p><b>Condition</b></p> <ul style="list-style-type: none"> <li>• Walling is generally sound, although with some pronounced weathering to isolated stones, as elsewhere.</li> <li>• Pointing appears sound, although it is not clear whether it is lime or cement.</li> <li>• The oil tank plinth is unsympathetic to the church and would benefit from being faced with stone or screened from view.</li> <li>• There is some dampness to the west side wall behind the oil tank and around the vestry door.</li> <li>• The stone steps up to the vestry door are covered in moss.</li> </ul> | |

| | <p><b>Repair Needs</b></p> <ul style="list-style-type: none"> <li>• Face the oil tank plinth with stone, or screen it.</li> <li>• Remove moss from stone steps</li> </ul> | <p>E<br/>M</p> |

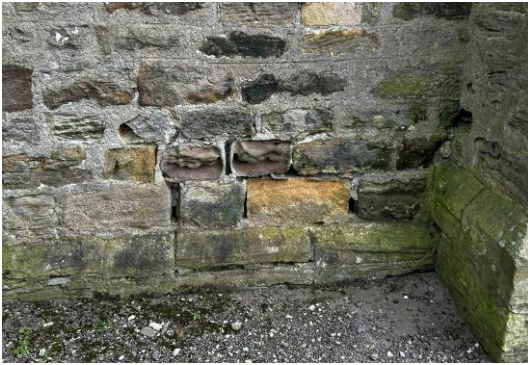
### West Gable of the Nave

| | <p><b>Condition</b></p> <ul style="list-style-type: none"> <li>The walling is sound, but there is considerable weathering of the surface, resulting in pitting and hollowing of the stone face. This stone loss is pronounced in some places, notably the head of the arch over the window and an area to the right of this. There are a couple of stones at knee level which are also weathering poorly. See photo.</li> <li>This is being exacerbated by the hard cement pointing which has been applied at some point in the past. Removal of the pointing will cause further</li> </ul> | |

| | <p>damage to the stone face so it should be left to weather away. Isolated stone replacements will be required at some point in the future.</p> <ul style="list-style-type: none"> <li>The long crack in the walling running from the window head upwards for about six feet does not appear to have propagated further since the last report. However this should continue to be monitored.</li> <li>The cables and lightning cable attached the elevation appear soundly fixed.</li> </ul> | |

| | <p><b>Repair Needs</b></p> <ul style="list-style-type: none"> <li>Carry out isolated areas of repointing, using lime mortar.</li> <li>Monitor the cracking in the wall above the window head.</li> </ul> | <p>D</p> <p>M</p> |

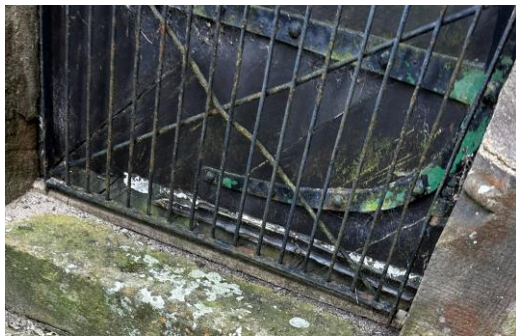
- The exterior door to the vestry (D2) is in sound condition. There is pronounced weathering to the stone arch, particularly around the keystone, although no remedial action is needed now. There is an outer iron security gate which doesn't latch to the stonework and so moves freely. The timber door has preservative woodstain which is failing at the base of the door and it would benefit from replacement. The weatherbar at the base of the door has completely come away and needs to be replaced.

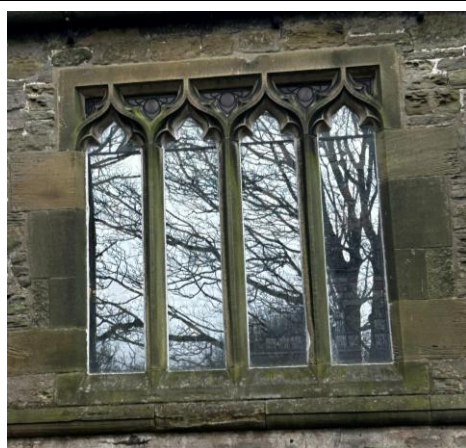
W5

- The south window (W5) in the Chancel is in sound condition. A wide 4 bay stained glass window of the Four Evangelists, it has secondary glazing externally, putty fixed to the stone. There is some slight weathering to the exterior stone mullions. Internally, a cement mortar repair above the sill is causing delamination in the stone.

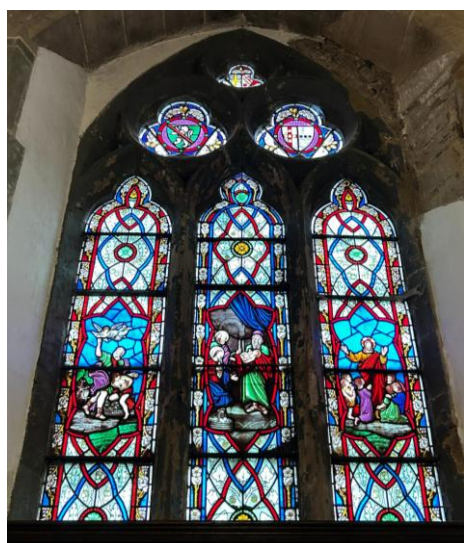
W6

- The east window (W6) in the Chancel is in sound condition. It is a tall tripartite window with three trefoil panes above. Externally, the window has unsightly metal mesh guarding which is rusting and staining the stonework beneath. The mesh is distorted and is pulling away from the wall in a couple of locations. It needs replacing, preferably with polycarbonate. The stone mullions behind appear to be weathering, although it's hard to see clearly behind the mesh. Internally, the stone is delaminating in places, due to historic dampness in this area.

| <p>W9</p> | <p><b>Repair Needs</b></p> <ul style="list-style-type: none"> <li>The east window (W6) in the Chancel should have its guarding replaced, preferably with polycarbonate.</li> <li>The lintel over the east window (W7) in the Vestry should be monitored for movement.</li> <li>Fit polycarbonate protection to the easternmost window (W9) to the north wall of the Nave.</li> <li>The west window (W11) in the Nave should have its guarding replaced, preferably with polycarbonate. The stone surround and tracery should be repointed with lime mortar to protect it from further displacement and weathering.</li> <li>The mortar joints to the stone surrounds of W9 &amp; W10 should be repointed with lime mortar.</li> <li>The putty around the glazing to windows W7 &amp; W8 should be replaced.</li> </ul> | <p>E</p> <p>M</p> <p>E</p> <p>E</p> <p>D</p> <p>D</p> |

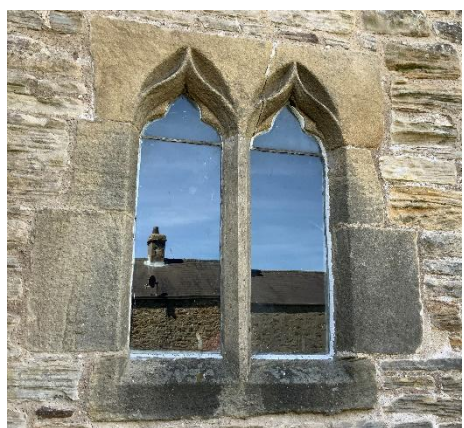
W7

- The east window (W7) into the Vestry is reasonable condition. A two-part plain-glazed window, the stone lintel has a pronounced crack at the head. The crack has been pointed in the past, suggesting it's not recent. There is a sizeable pit on the right hand side of the stone mullion, and a hairline fracture running up its centre. This doesn't seem to have worsened since the last inspection, but should be monitored for further cracking and/or movement. The putty around the glazing is cracking and will need replacing, but not imminently.

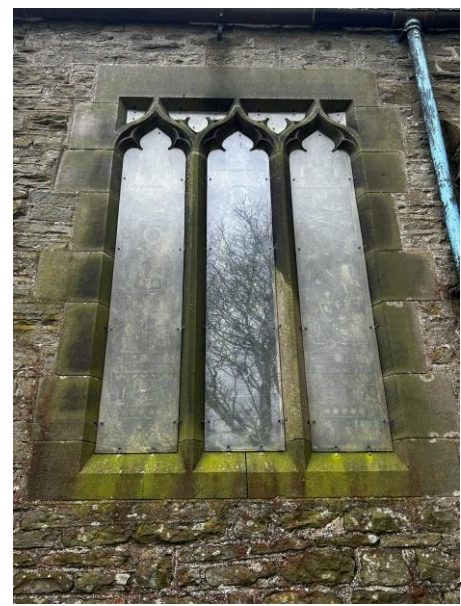
- The westernmost window (W10) to the north wall of the Nave is in sound condition. A three part window with stained glass. The stone surround is in good condition, however there is some green algae staining to the sill and the mortar joints are weathering. There is polycarbonate protection.

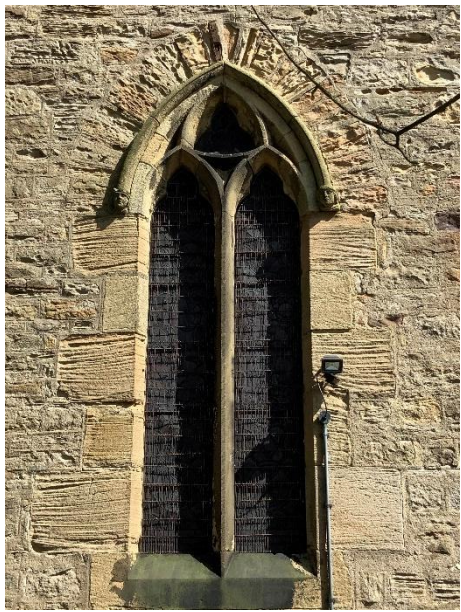
| <p>W11</p> | | |

- The west window (W11) in the Nave is a large bipartite window with trefoil above. The stone surround is weathering poorly at the head, particularly around the keystones, and the pointing has weathered out of the stone tracery. There is staining to the sill. There has been some displacement in the stonework here, and there is a crack running through the wall vertically from the right-hand side of the arch, suggesting historic movement. The metal mesh over the window is rusting and staining the sill and wall beneath. The guarding offers little protection to the stained glass.

| <p>W8</p> | <p>This should be replaced, preferably with polycarbonate.</p> <ul style="list-style-type: none"> <li>Internally, there is some minor damage to the stained glass of W11. A small piece of glass is missing from the right-hand panel, and there is some distortion and minor cracking.</li> </ul> | |

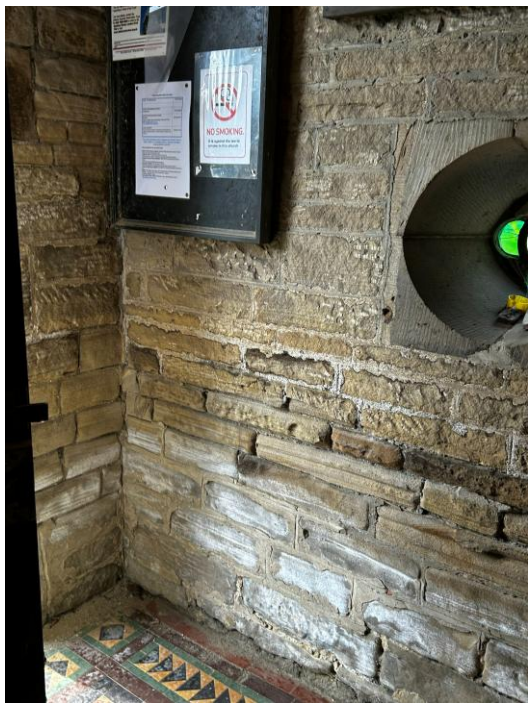
### 11.3 INTERNAL WALLS

| | <p><b>Condition</b></p> <ul style="list-style-type: none"> <li>The porch walls are in fair condition, although there is some presence of dampness in the lower parts, and some areas of missing mortar which will be attributed to the dampness. On the west wall, the stone is suffering from erosion and is now set back</li> </ul> | |

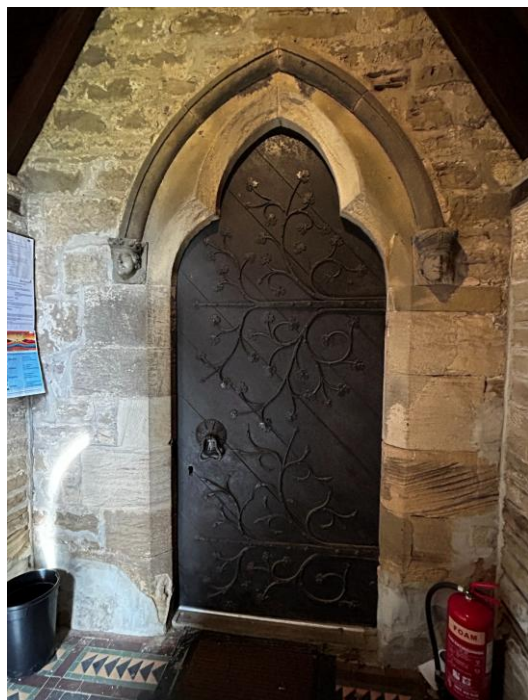
- Porch door D3 is in good condition, and ironmongery appears in working order, although the rim lock is unused.
- Vestry door D4 is in good condition and ironmongery appears to be in working order.

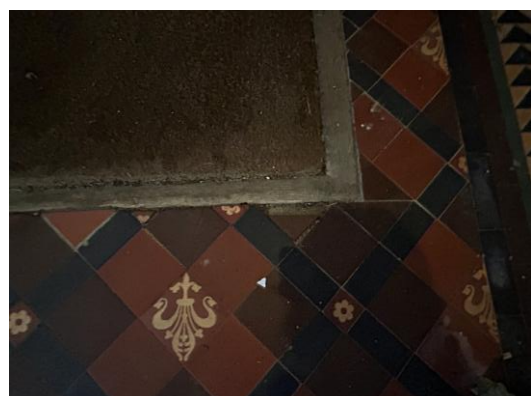
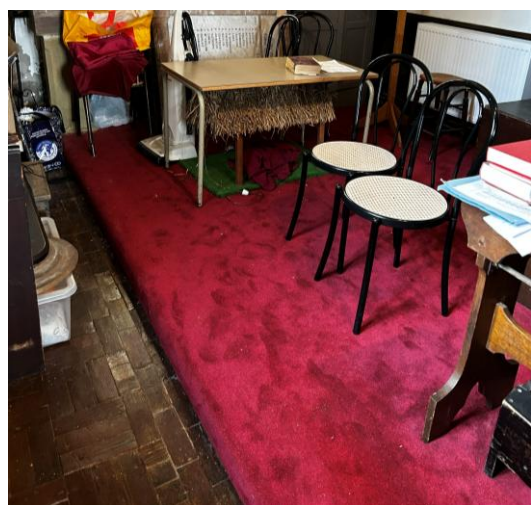
| | <p><b>Condition</b></p> <ul style="list-style-type: none"> <li>The tiled floor in the Porch is generally sound, although there is a loose triangular tile around the inset entrance matting.</li> <li>The raised timber flooring appears to be solid.</li> <li>The woodblock flooring in the Nave is very uneven, but not exceptionally so for a building of this age. The finish is wearing and it would benefit from being sanded back and re-varnished. The carpet runner is in good condition.</li> <li>The basement chamber access hatch is covered with carpet, however Rev Peers removed the carpet and opened the hatch for inspection. The hatch opens adequately and a supporting structure has been built below to support the hatch.</li> <li>The raised floor of the Chancel was covered by carpet and could not be inspected fully, but it appeared to be sound. The carpet is in good condition.</li> <li>The timber floor in the Vestry was covered by carpet and could not be inspected fully, but it appeared to be sound. The carpet was in good condition.</li> </ul> | |

| | <p><b>Repair Needs</b></p> <ul style="list-style-type: none"> <li>Refix the loose floor tile in the porch.</li> </ul> | C |

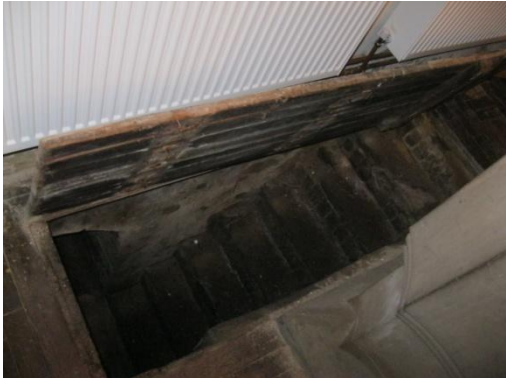
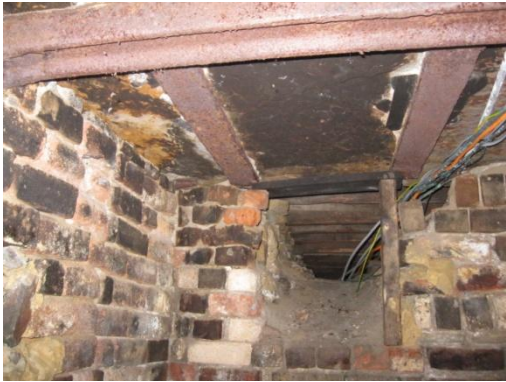
| | <p><b>Condition</b></p> <ul style="list-style-type: none"> <li>• The author did not access the basement. The notes and photos below are from the last report. It is noted in the next section that a lack of ventilation in the chamber is probably partly responsible for damage to the base of the font.</li> <li>• The masonry of the coal chamber and heating chamber would benefit from some repointing, particularly in the area under the nave where bricks have come loose. This will consolidate the structure.</li> <li>• The heating chamber does not appear to have much by way of ventilation, leading to potentially damaging conditions for the iron and timber. This was noted in previous reports. However, the conditions in the floor void do not appear to be causing imminent risk of rot.</li> <li>• The timber stored in this area, as noted in previous reports, appears to have been removed, as advised.</li> <li>• There is some severe corrosion to some steel beams which should be treated with rust inhibitor.</li> </ul> | |

| Category | Comment | Budget Cost |
|---|---|---|
| | <ul style="list-style-type: none"> <li>Repoint the brick and stone walls and piers of the heating chamber to consolidate the masonry.</li> <li>Treat ironwork in the basement heating chamber with a rust inhibitor where possible.</li> <li>The mortar joints to the stone surrounds of W9 &amp; W10 should be repointed with lime mortar.</li> <li>The putty around the glazing to windows W7 &amp; W8 should be replaced.</li> </ul> | |

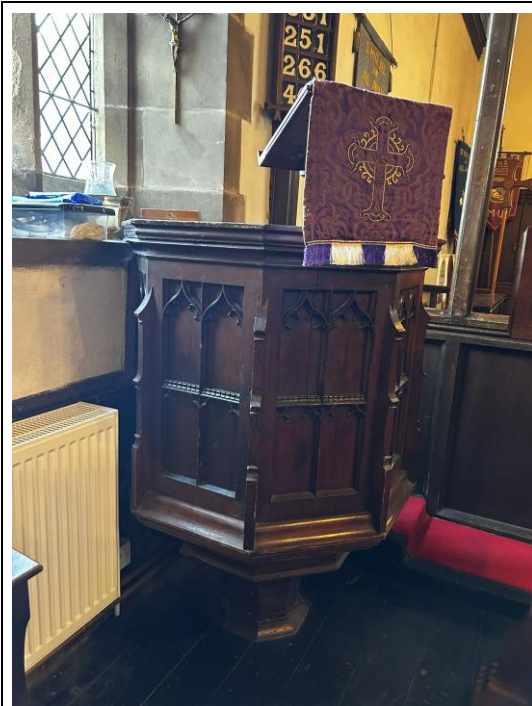
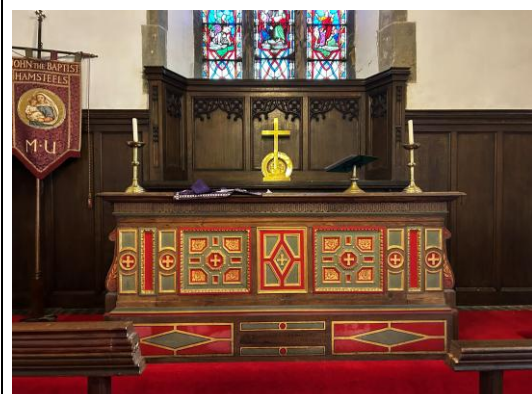
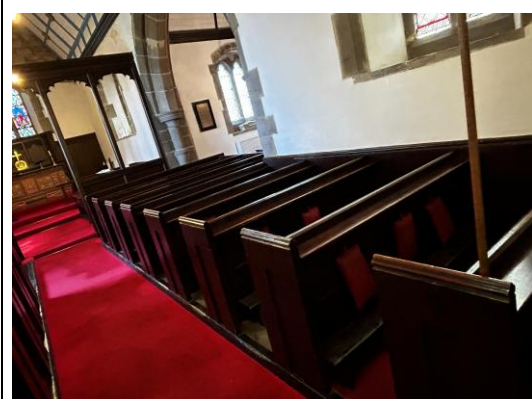
- The bell rope sash is missing, following discussion with Rev. Peers this broke while the bell was being rung, as a result of damp causing the rope to rot.
- Evidence of damp in the base of the font was reported in earlier report from 2014. There are large areas of delamination. This is rising damp coming up from the heating chamber below, another reason to ensure there is adequate ventilation in the chamber.
- The pews are generally in sound condition and are stable.
- The pulpit is sound and secure, and in a reasonable state of decoration.
- The lectern is sound and secure.
- The choir stall pews are in reasonable condition.
- The altar is stable.
- The wash basin in the Vestry is secure, and in working order. It does not appear to be plumbed in to a foul water drainage system, so only soap should be used here. The condensate pipe from the boiler has been connected to the waste pipe.

- Replace the bell rope.
- Remove carpet to basement trapdoor and address ventilation.
- Monitor delamination of stonework to base of the font.

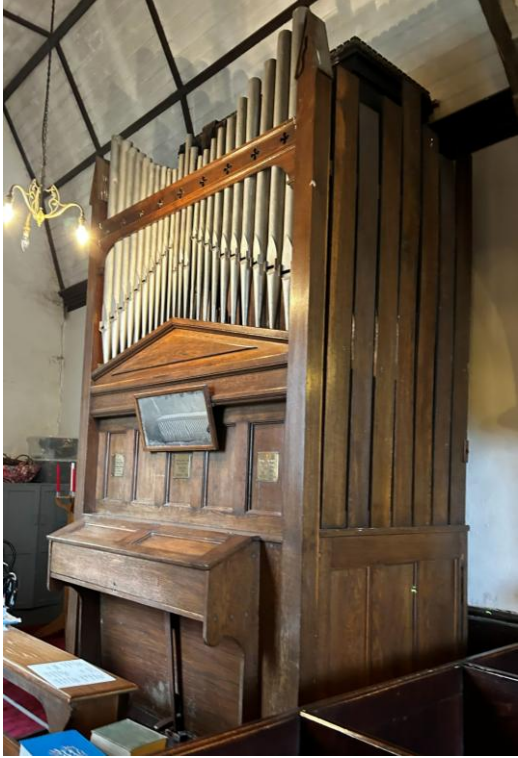
| | <p><b>Description</b></p> <ul style="list-style-type: none"><li>• The organ, by Nelson &amp; Co. of Durham, is located in the Transept.</li></ul> <p><b>Condition</b></p> <ul style="list-style-type: none"><li>• The organ has been tuned regularly.</li><li>• Note from previous report: Rev. Peers has advised that the organ has had several repairs in recent years and that it doesn't stay in tune for long.</li></ul> <p><b>Repair Needs</b></p> <ul style="list-style-type: none"><li>• A specialist should be engaged to repair the organ.</li></ul> | <p>E</p> |

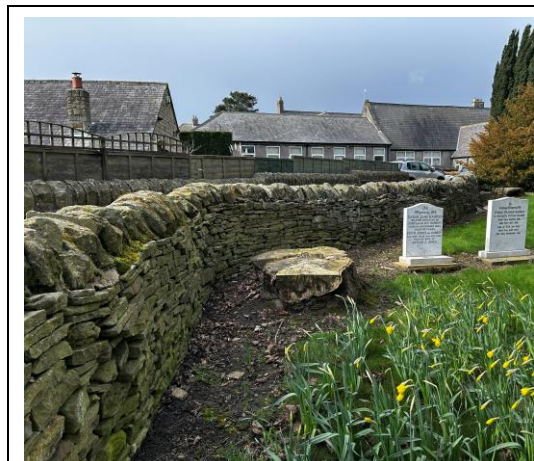
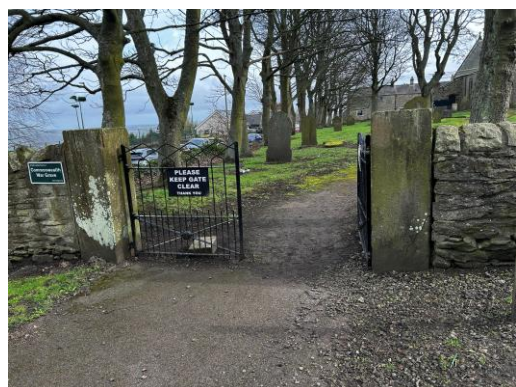
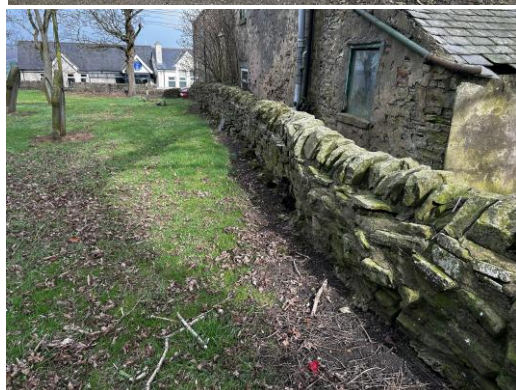
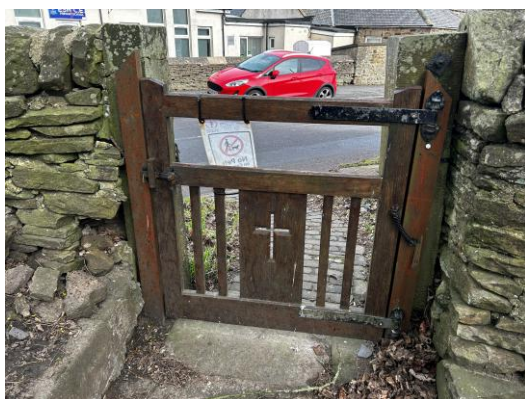
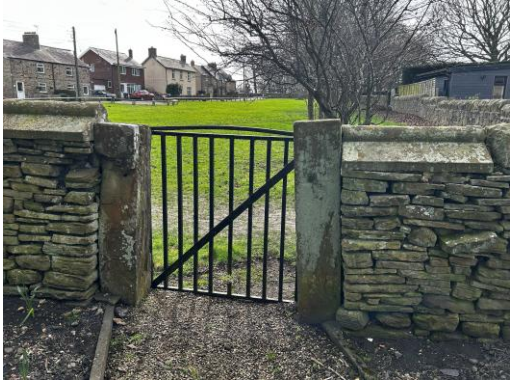
- The iron gates to the vehicular entrance are in good condition and have been repainted since the last inspection.
- The timber pedestrian gate is in good condition. The stone pier to the left-hand side of the gate, when looking from the inside, has fractured at the top, although it appears to be stable.

- The steel gate to the village green is in reasonable condition, although there is noticeable delamination of the stone gate posts.

| | <ul style="list-style-type: none"> <li>• Monitor the rubble stone retaining wall to the Northern boundary and report any further movement.</li> <li>• Monitor the stone gate post to the village green gate, and the pedestrian gate to the north, for further degradation.</li> </ul> | <p>M</p> <p>M</p> |

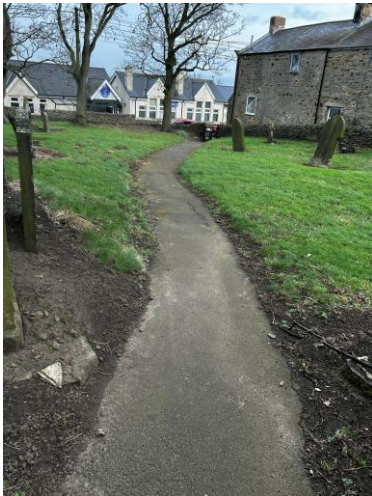
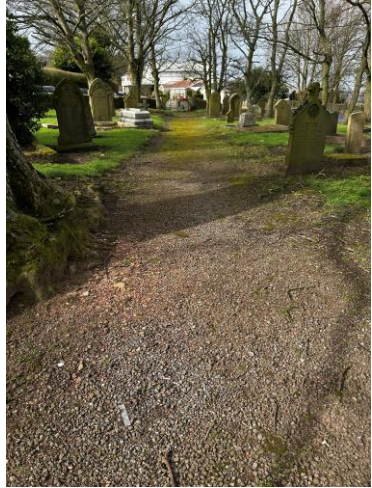
| | <p><b>Condition</b></p> <ul style="list-style-type: none"> <li>• All paths and hard standings are in serviceable condition.</li> </ul> | |

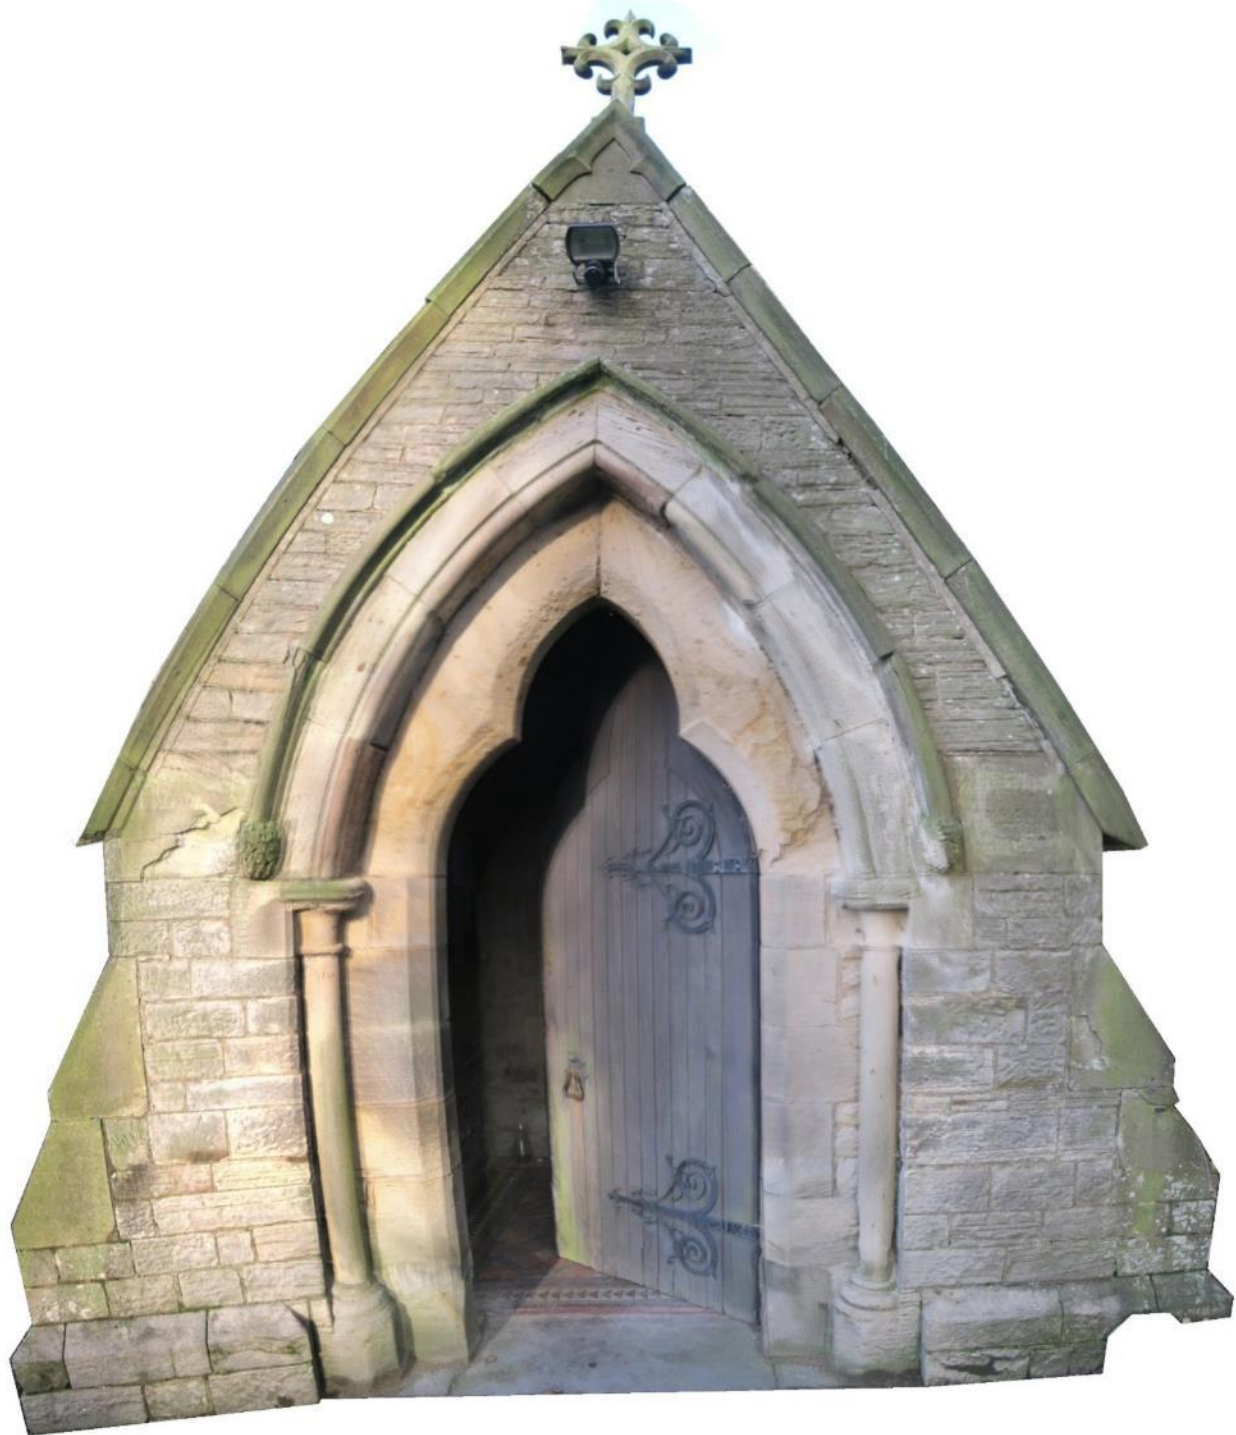
**18. COMPOSITE PHOTO OF PORCH GABLE AND REPAIR QUOTE**

The photo below records the current state of the Porch Gable in December 2014. The photograph has not been rectified, so can't be scaled from.

The photograph below was taken during this inspection in March 2026, and is included as a comparison to the 2014 photograph. The condition has worsened considerably, with much edges, features and stone facing.
