**QUINQUENNIAL INSPECTION REPORT
OF
GRANGETOWN, SUNDERLAND, ST. AIDAN**

**DIOCESE OF DURHAM
ARCHDEACONRY OF SUNDERLAND
DEANERY OF WEARMOUTH**

QUINQUENNIAL INSPECTION AND REPORT

JUNE 2025

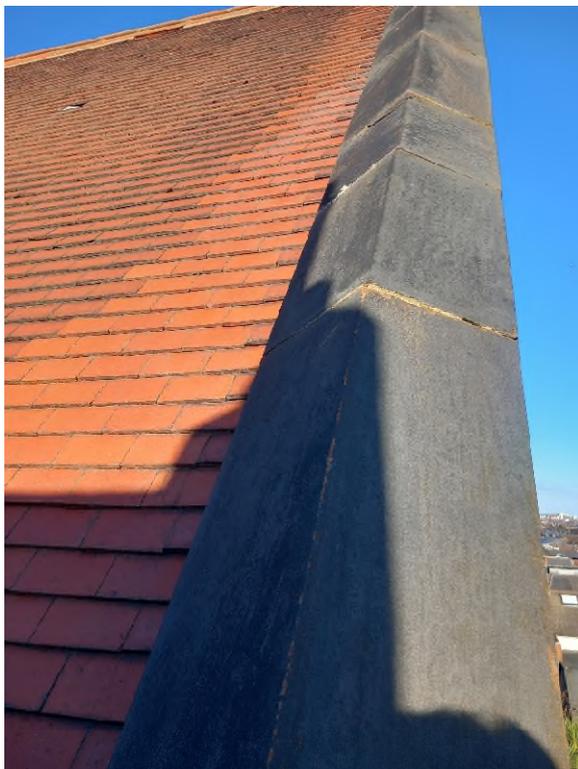
The type of underfelt and lath used on the north Aisle implies that this roof might have been retiled within the last 30 or so years. There are patches of the roofs on other areas where tiles of different types are evident, implying that these roofs might also have been retiled.

In any event, the tiling generally seems to be in fair condition, although a small number of individual tiles are missing, slipped or broken over all roof slopes.

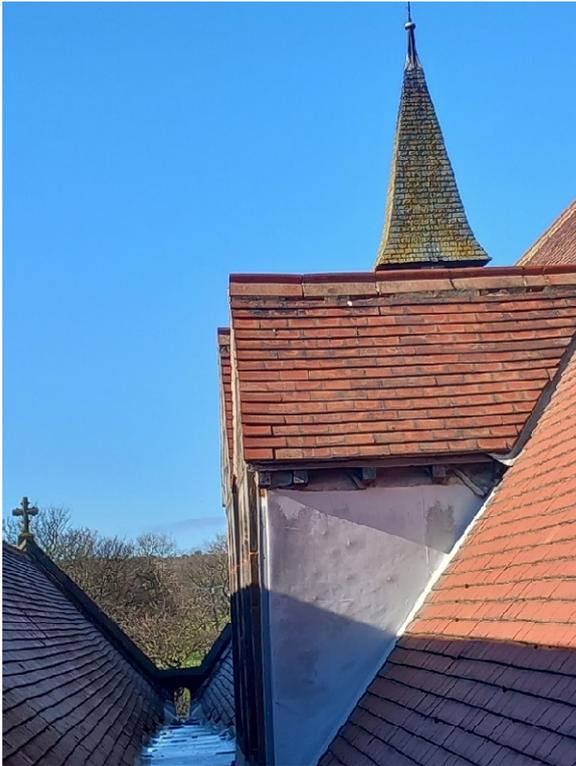
Ridge tiles are clay, and all seem to be in place. There are sections of the ridge pointing which are missing on all roofs, but there seems to be no roof leaks which are evident as a consequence.

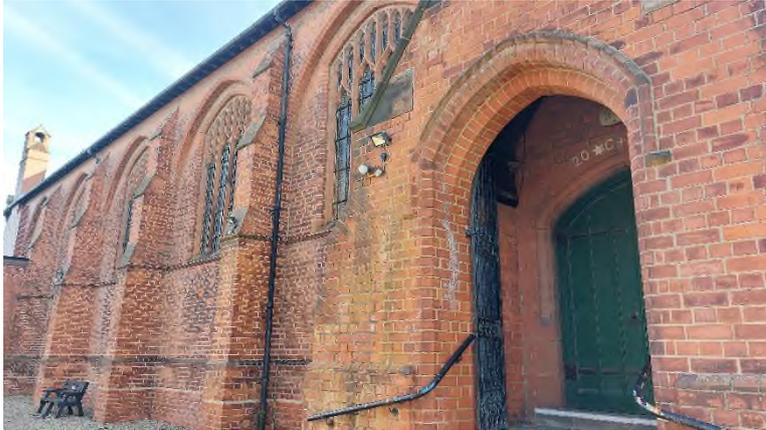
North Aisle:

Four bays original and the fifth eastern bay is in newer masonry, and this has a chimney above it, it looks ok. On this elevation is the north porch and the brickwork is ok apart from some slight eroded joints and some poor repointing in black cement and the buttresses are all right, some water staining on the eastern side of the door entrance and also at high level at the spandrel of the gable possibly coming from open joints in the watertable. The flashing to the roof look ok.

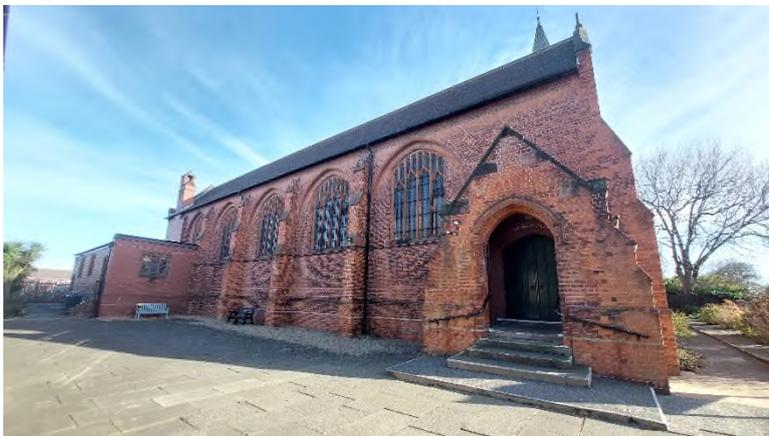
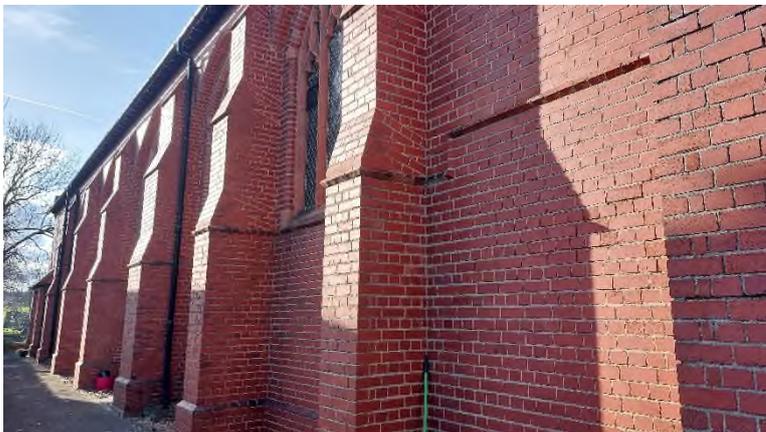
South Elevation:

South Aisle: Seven bays with a buttress either side of each window all the masonry looks very fresh, as do the bricks.

Recommendation: none

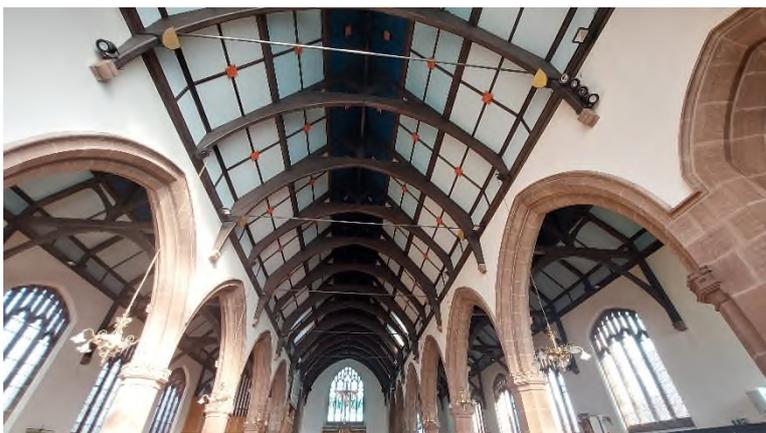
7.5.1 ROOF TIMBERS

Arched trusses with high level collars and wall posts to stone corbels in both nave and chancel, at that junction is a doubling up of the trusses to create the impression of a chancel arch. No obvious signs of movement, iron tie rods within the nave only. Supporting exposed purlins and decorative timbers forming

panels within the trusses with bosses at their junction but these may well be just decorative rather than structural elements it's hard to be sure, rafters above this and sarking boards on top of the rafters reports a previous QI. The valleys bear onto the arcade arches and these are enclosed by boarding and concealed. So no leaks to valleys are easily caught. Vley leak at north aisle/ nave at west end.

Recommendation: none

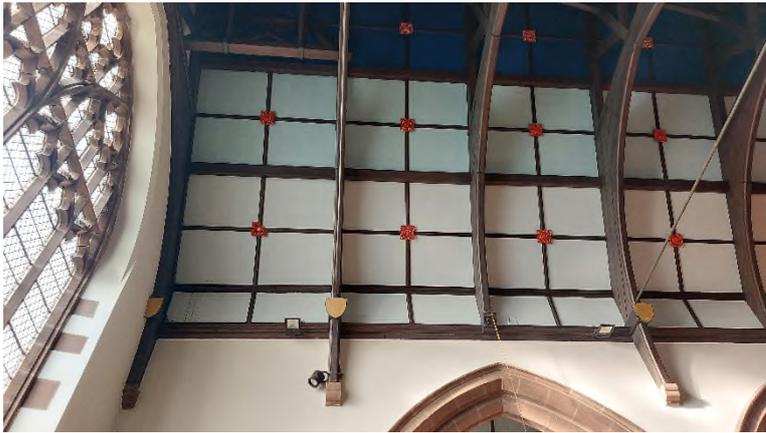
Within the nave it appears to be plaster ceilings and it maybe that that the sarking boarding gaps are grinning through slightly and they seem to follow the profile of the roof.

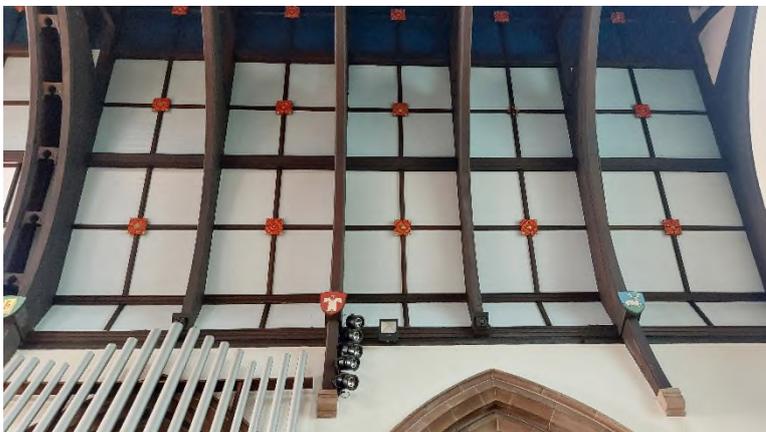
Where as within the chancel, the ceiling appears to be supported on rafters as you can see the ghost lines of them and also boarding lines and makes one wonder if there is simply just a paper over the surface, it is hard to tell. And all are painted.

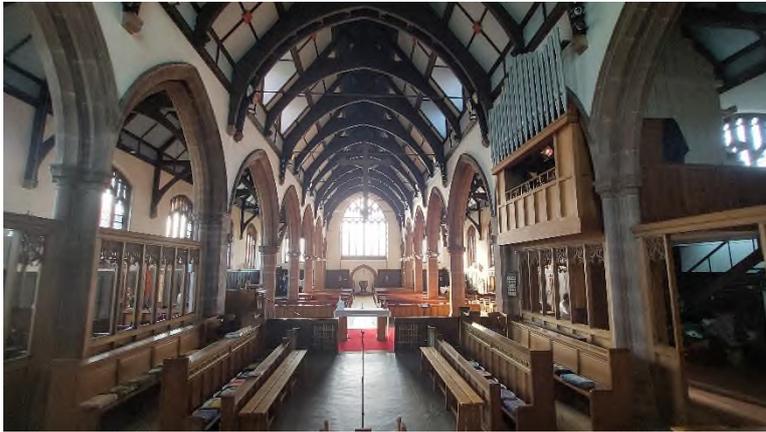
The chancel arcade is much lighter with narrower arches and circular columns with delicate moulded heads and bases. The plastered spandrels all appear sound apart from some slight water marking.

There is some water marking on the nave, north aisle to nave junction at the west end from recent leaking valley gutter.

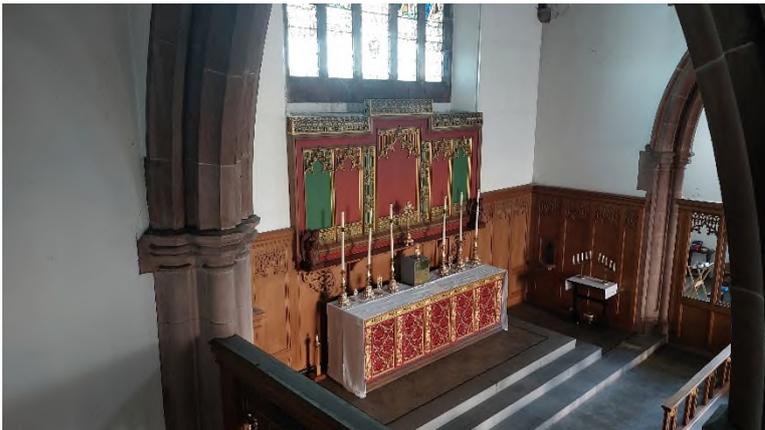
High quality oak screens at chancel and under the organ which has some perpendicular tracery above it and continued as blind tracery on the chancel wall.

Boarding below the eaves of the organ is plain and appears more recent.

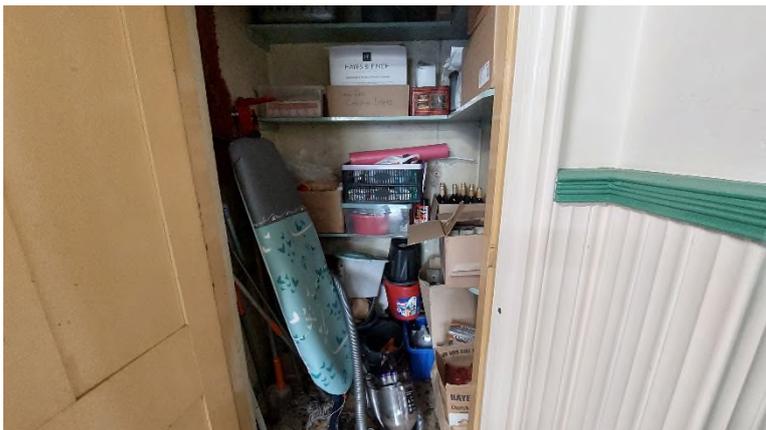
Painted fluted dado panelling at vestry, with vent holes top and bottom.

Recommendation: repair and ease porch doors
