Quinquennial Inspection Report

Church of St John the Evangelist Greenside, Tyne and Wear

Date of inspection: 19th August 2024; weather conditions – cloudy with sunny intervals

Date of report: 31st August 2024

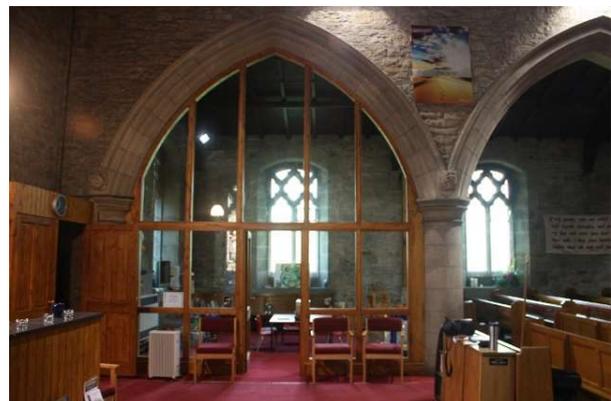
Enclosed bay of North Aisle containing Creche

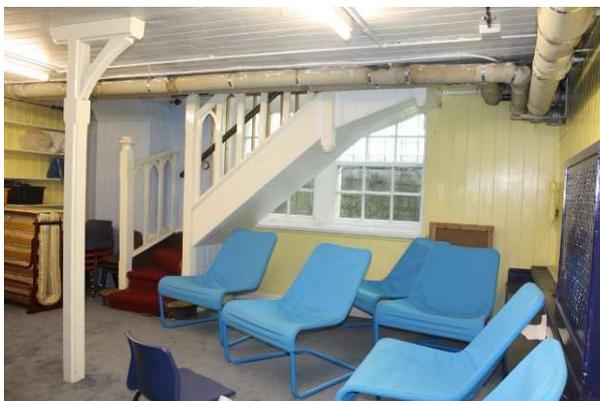
Basement Meeting Room

There are strong vapours in the Basement Meeting Room. These may be resulting from a petrol leak in the adjacent Boiler Room and/ or dampness in the walls and floor. Investigation is needed. Opening the casement windows will help dissipate the smell, reduce the dampness and improve air quality.
