**QUINQUENNIAL REPORT on the  
THE CHURCH OF ST THOMAS**

**HARELAW**

**Inspected by Bryony Roff BSc. BArch. MA, RIBA, AABC**

Date of inspection and weather conditions: 1<sup>st</sup> April 2026    Weather was cool and overcast, becoming sunnier later  
Date of report: 12<sup>th</sup> August 2026  
Date of previous report: January 2020

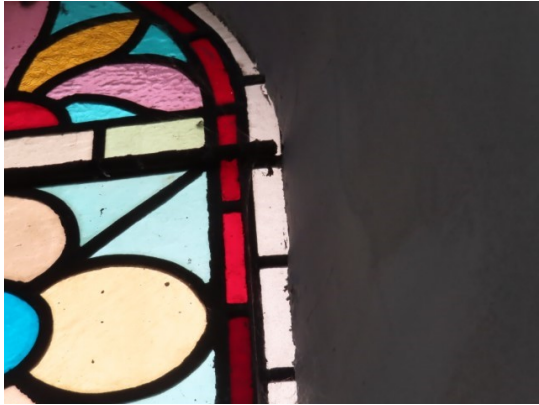
Saddlebar to Sii not fixed into the wall

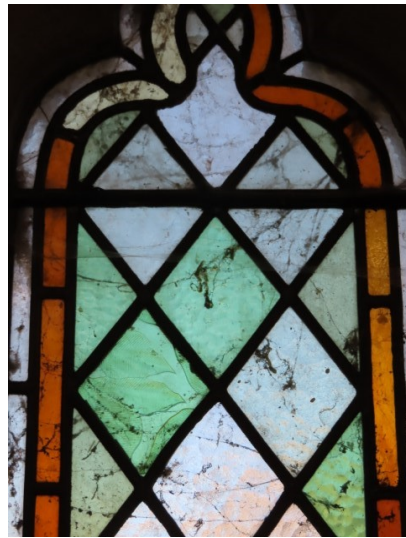
Debris behind window visible internally

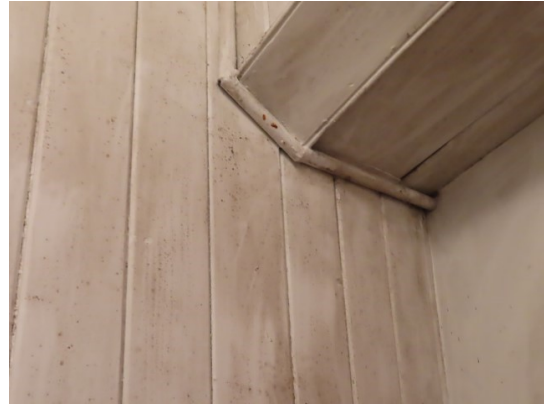
Mildew growth to the timber

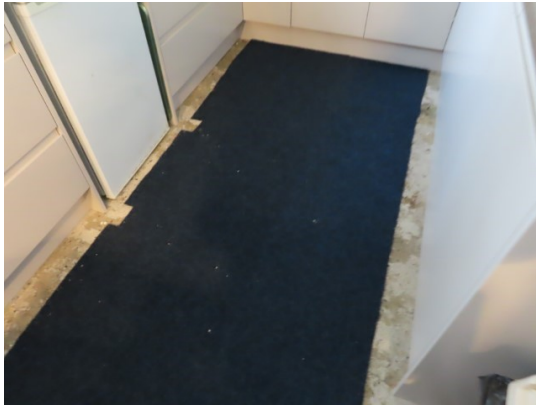
Floor covering in the kitchen is undersized
