**QUINQUENNIAL INSPECTION REPORT  
OF  
ST. MARY, BLACKHILLS ROAD, HORDEN, SR8 4LJ**

**DIOCESE OF DURHAM, ARCHDEACONRY OF SUNDERLAND, DEANERY OF EASINGTON**

**DATE October 2025**

**David Beaumont BA (Hons) Grad Dip, RIBA, AABC**

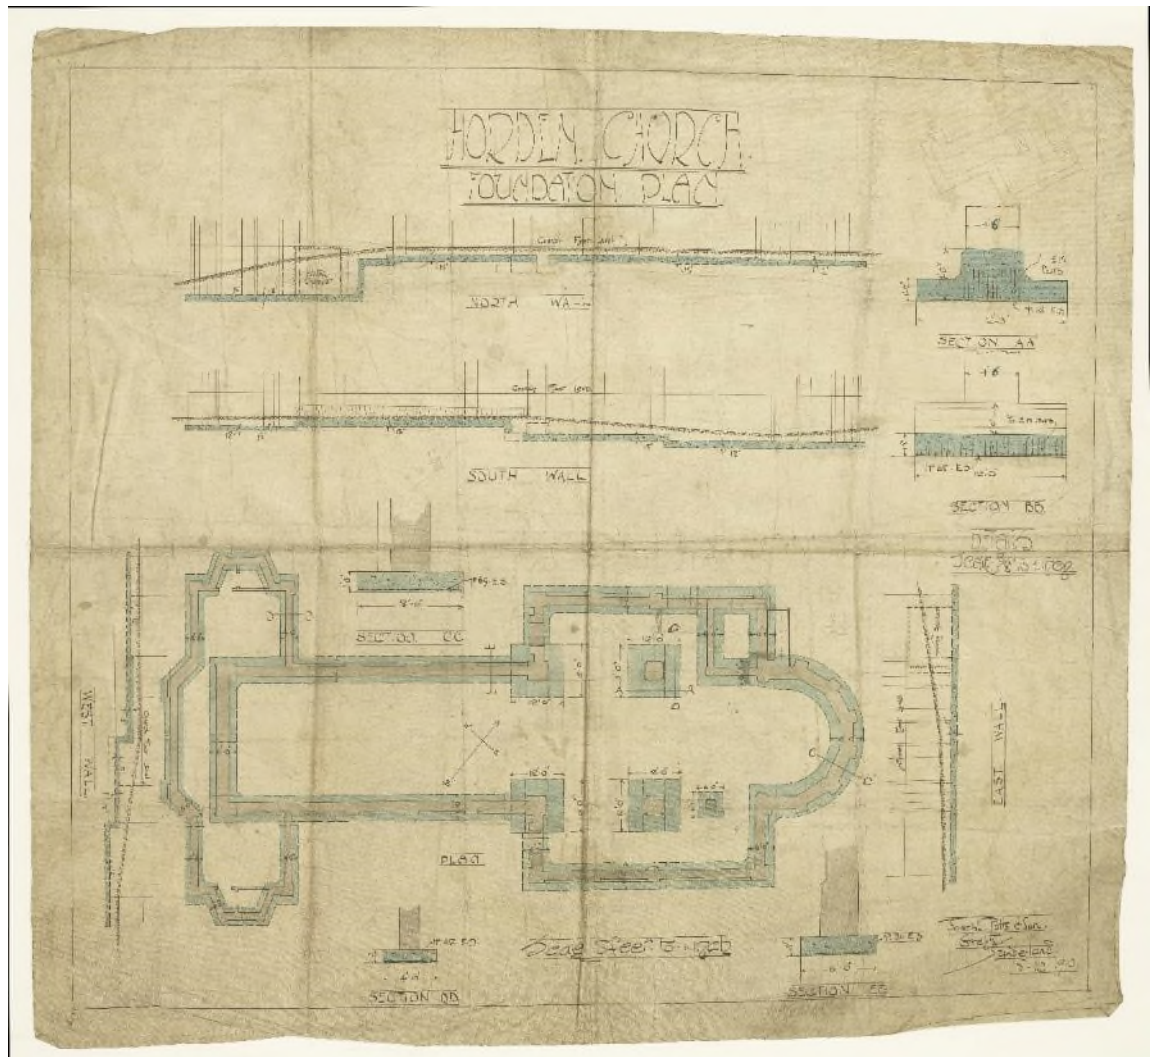
There is very little discernible movement inside the church the only evidence of structural movement is on the S side where the ground is falling away, at the S W vestry and the S E chapel, the vestry is the worst of the two where there is opening up of the jointing between the stonework, some of the stones themselves are cracked and there doesn't appear to be any other remedy other than to repoint them and then monitor possibly future cracking. There are open joints to the tower at the South East corner, adjoining the Lady Chapel where the arch has deflected slightly. There is no change to the joint gaps at this inspection so I think I can say that this is now historic and that ground movement is not active.

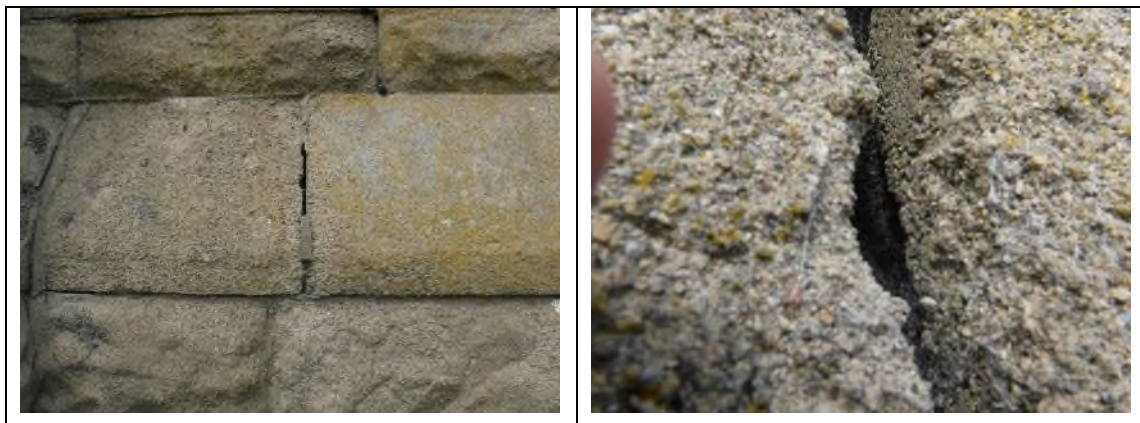
There is a greater area of open joints due to erosion and movement at the sloping units at the tower, under the clerestory windows, where their cills are made of stacked sloping units and there is a major salting inside from water penetration.

There's a question mark over how corners are formed - with an adequate bond or butted together? It also seems that the major pointing failure is on the sloping units and it may be these that need more attention than the general walling.

An investigation into the cast stone construction is to be undertaken to help inform future repairs. There will also be a need to understand how to repair eroding stones or whether they are replaced and if so, with what. So they need to be chemically analysed so that the composition of aggregate and binder is understood.

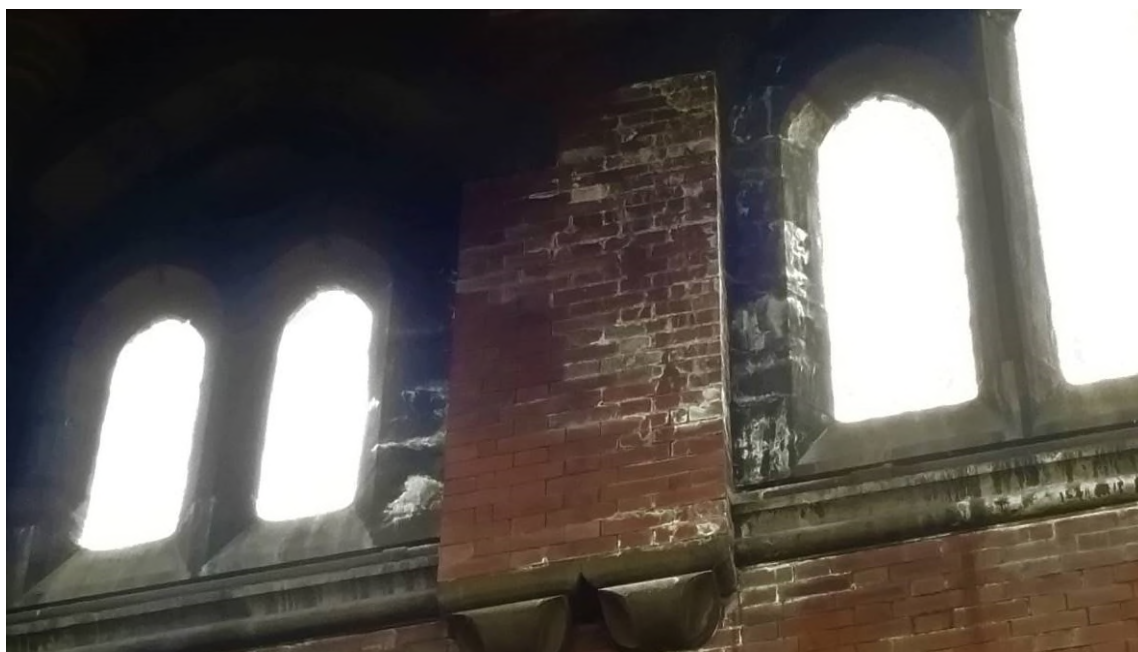
The windows and door jambs have cast stone dressings of multiple small units. It is likely that moisture is tracking right the way through them. Investigation of the wall construction at a window opening would also be worthwhile.

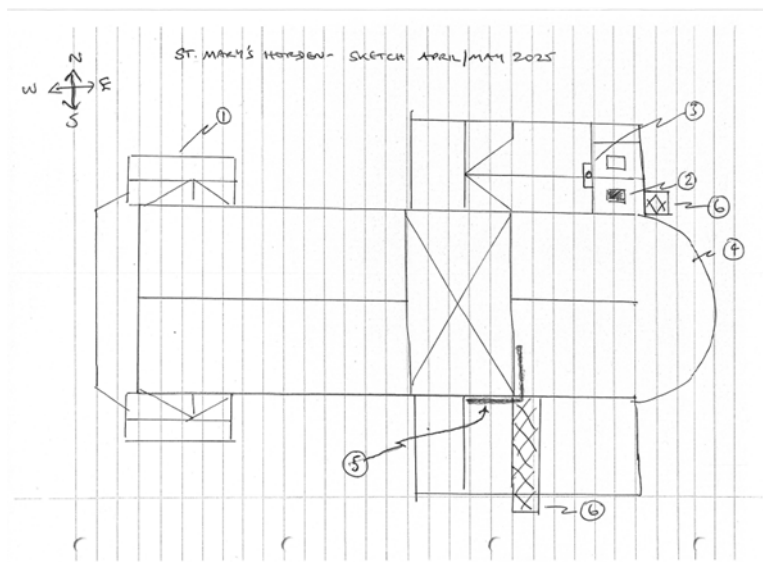
*The sketch plan indicates where the main items of work were carried out at St Mary's, notated as follows -*

*Item 1 - redressing of Masterform.*

*Gutter cleaning was carried out in all accessible areas (ie not including the Tower), and slates were refixed where possible, particularly on the south Transept east face, and south-west Chancel. We attempted to get to where a slate is missing near the ridge on the south slope of the Nave, but decided that it was unsafe to do so without more access equipment.*

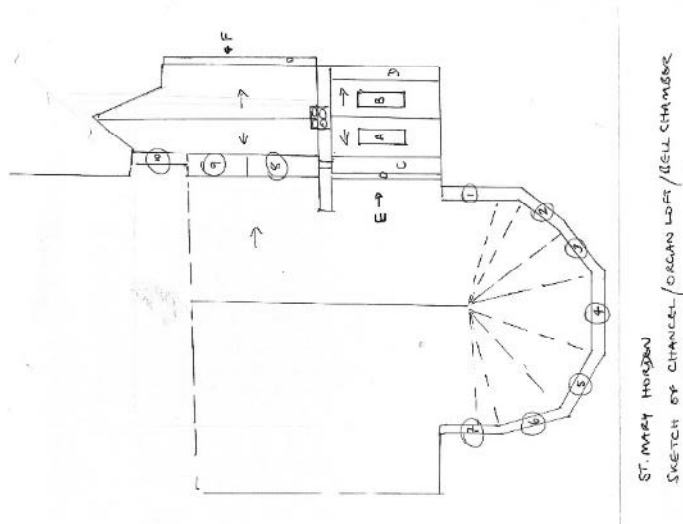
After the inspection at the end of June there was lead theft and water ingress into the organ chamber. The scope of repairs is being developed with the agreement of loss adjusters as shown below:

- *A. Remedials after vandalism, using lead -*
- *New lead in areas 4, 5, 8, 9 (in two bays).*
- *Refix flashings where possible, or renew if necessary, in bays 1, 3 to 9 inc, 10.*
- *New dormer cheek at west side of A.*
- *In-situ repair of gutter lining at E, as well as renewal of downpipe, and repair/replacement of flashing at east end.*
- *In addition, all necessary removal and refixing/replacement of slating to accommodate the above works.*
- *Provision of access scaffolding at the north east corner of the Church, as well as guardrail installation at the east of the Chancel.*

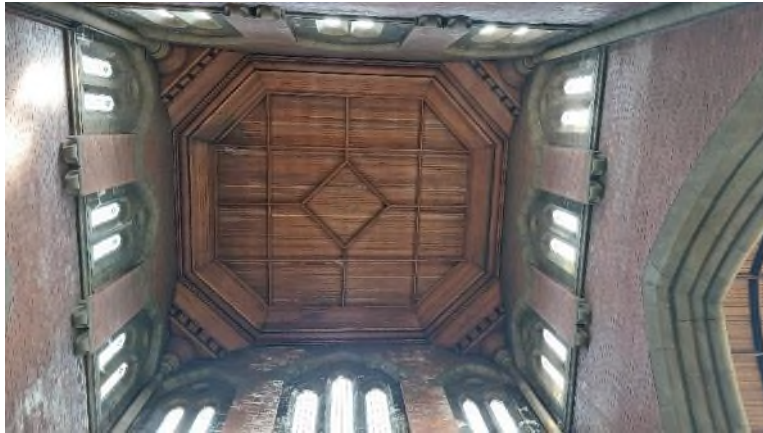
The ceiling has no change white marking within the centre square suggesting that there might be some previous water ingress there (it's not on the line of a hip).

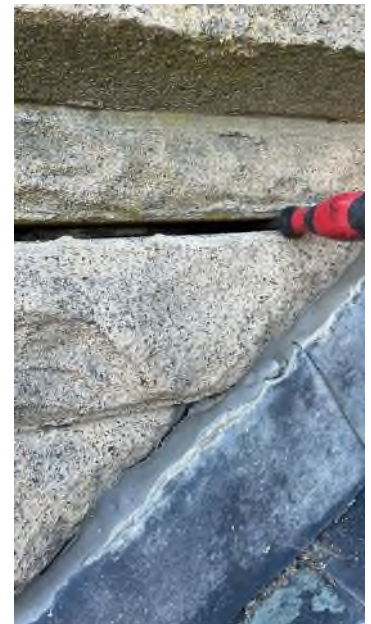
Open joints due to minor movement

Open joints

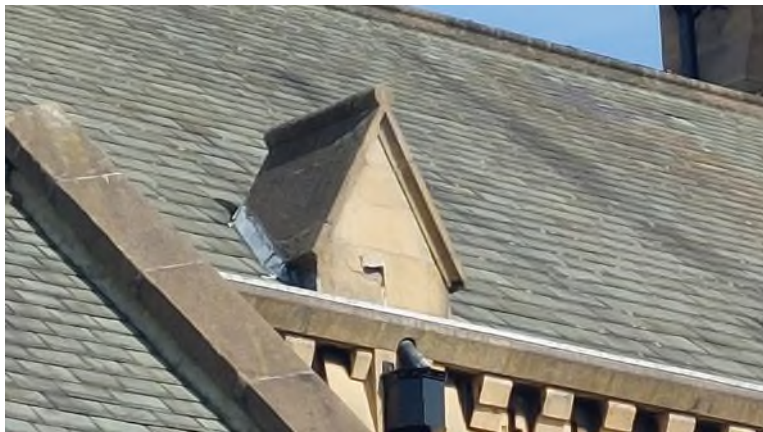
Original Westmoreland slating on all of the hipped roofs with mineral felt on the flat roof.

The tower is a hipped structure with cut hips and this has been repaired by Andrew Gibson in 2020 but there are still areas coming apart.

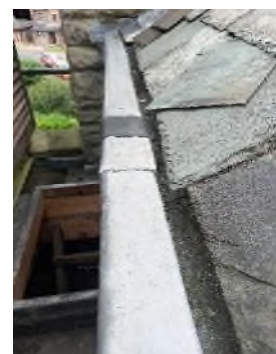
Damaged gutter

*The reslating of the Organ Chamber roof would entail using the best of the existing slates, made out with matching slates from our stocks, fixed with copper nails to treated battens, Roofshield VPM and counterbattens laid over the existing roof boards. New lead would be provided to the cornice gutter at the north, and where flashings and soakers were not replaced in last year's works. Slating would be renewed up to the valley gutters over the north Transept, but the existing valley lead would be left in situ (unless you decide otherwise). The cost of this would be £10,915.00 plus VAT.'*

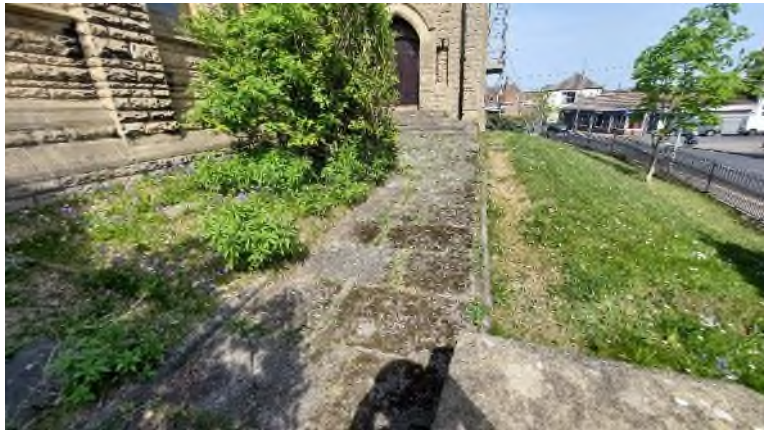
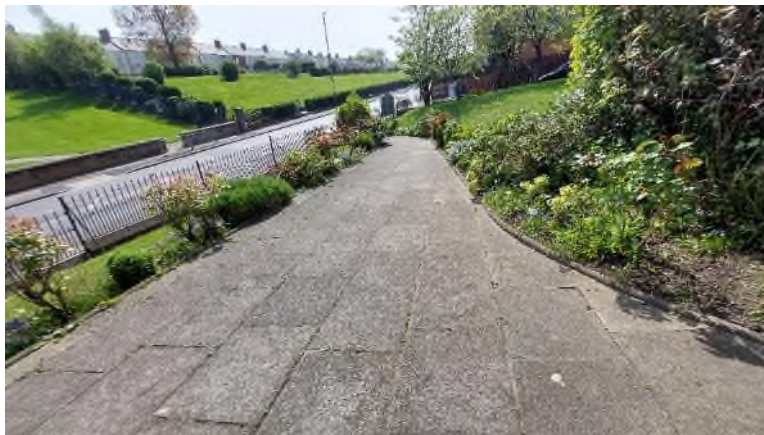
The paths have been swept up at the foot of the nave on the N and S side and the gulleys cleared out. Some paving is uneven.

The south transept entrance steps are managed better and the whole south side shrubbery is under better control. The north area is grass leading to the Hall

**Recommendation:** none

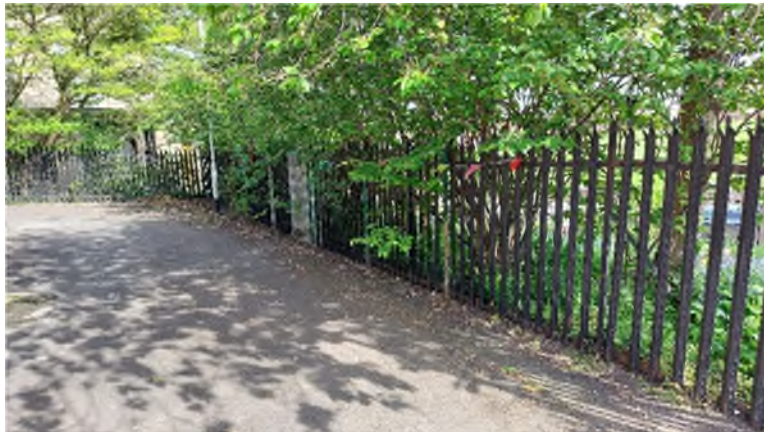
Metal fencing, ok. Part Hall and rendered wall. All ok.

**Recommendation:** none

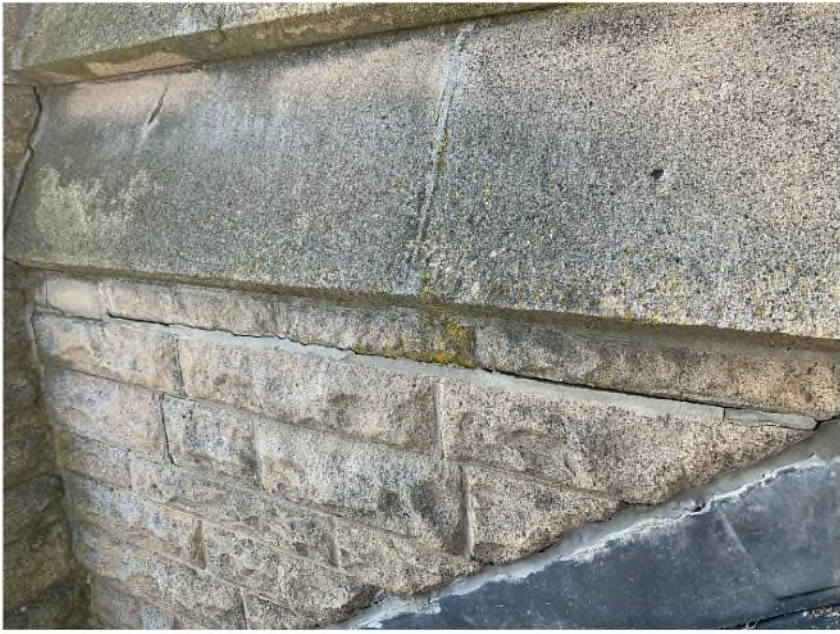
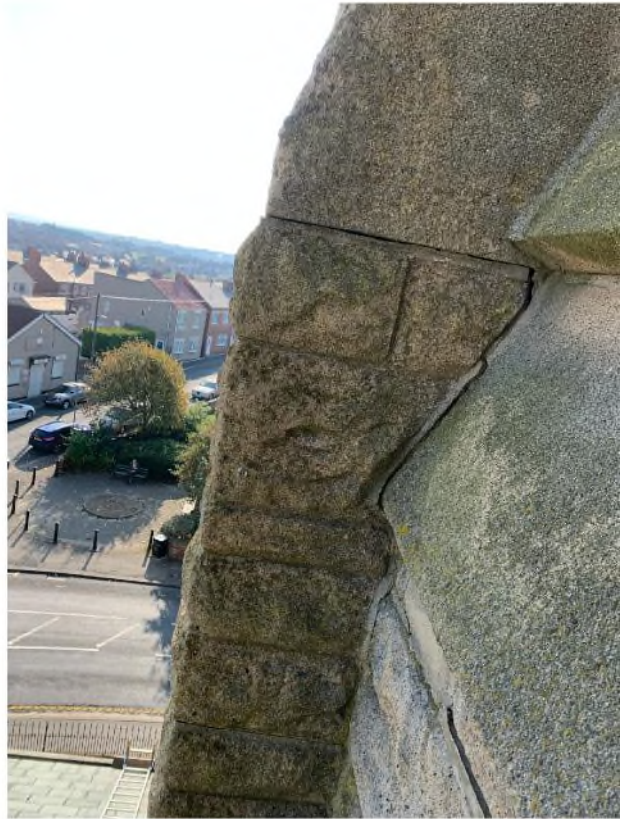
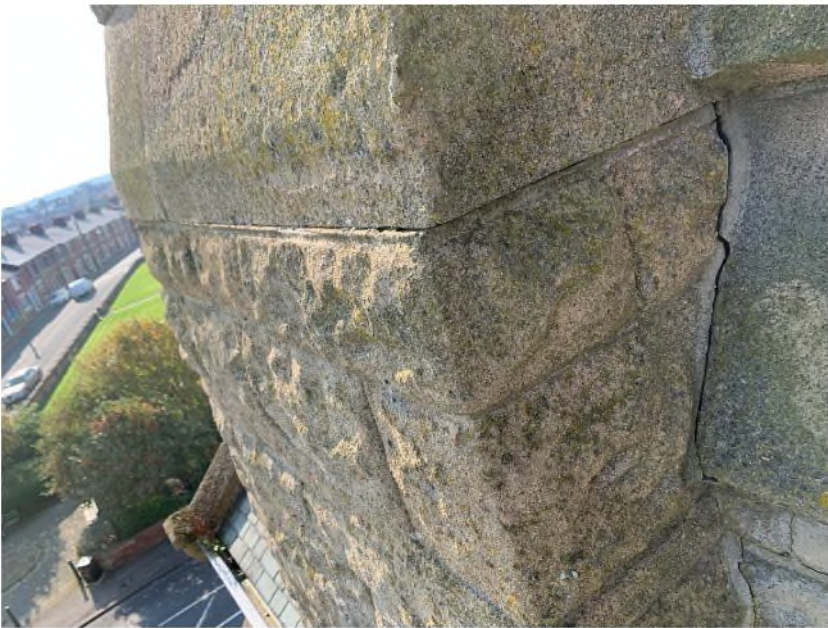
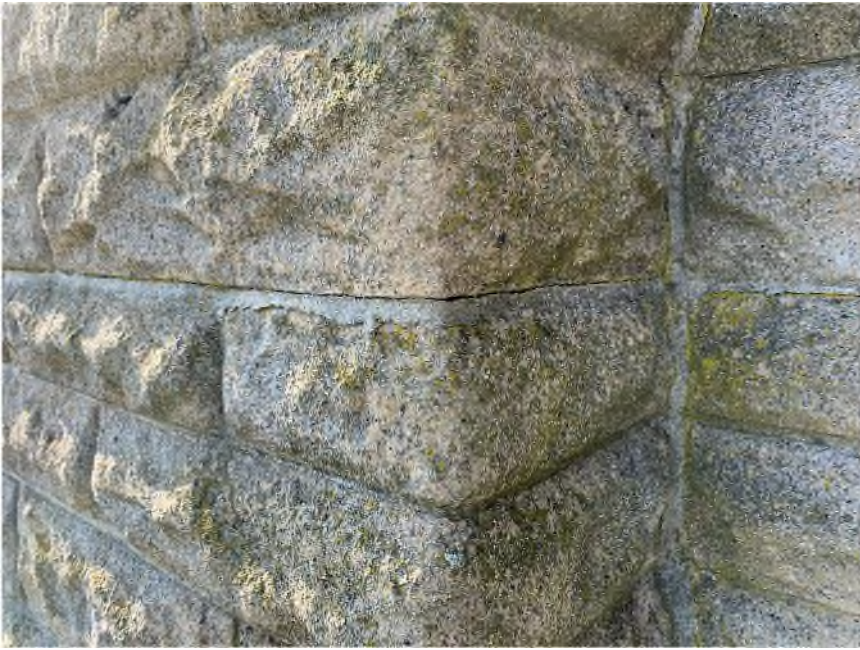
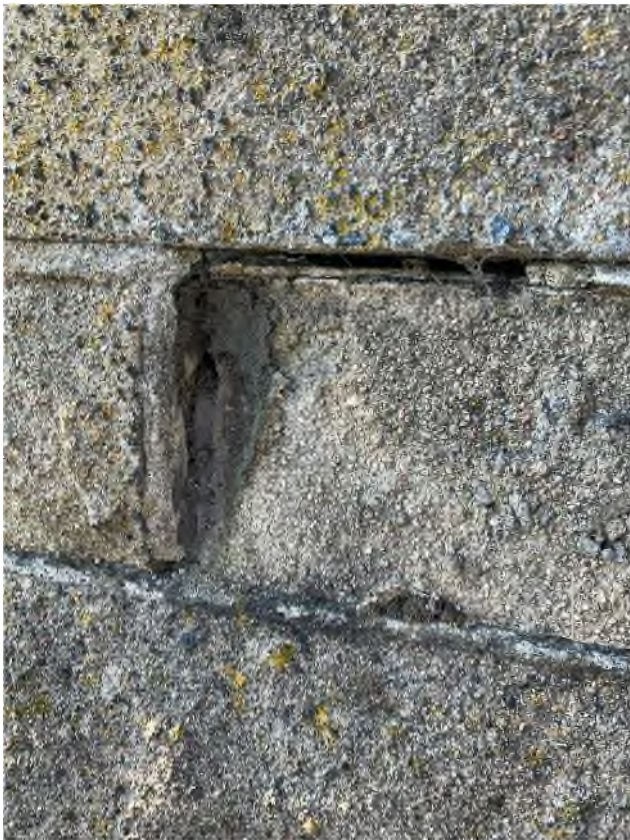
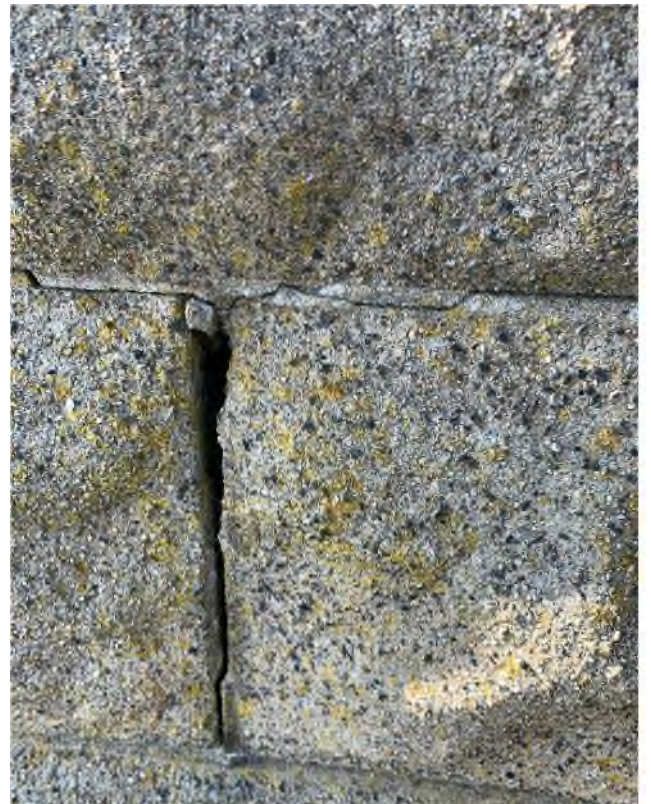
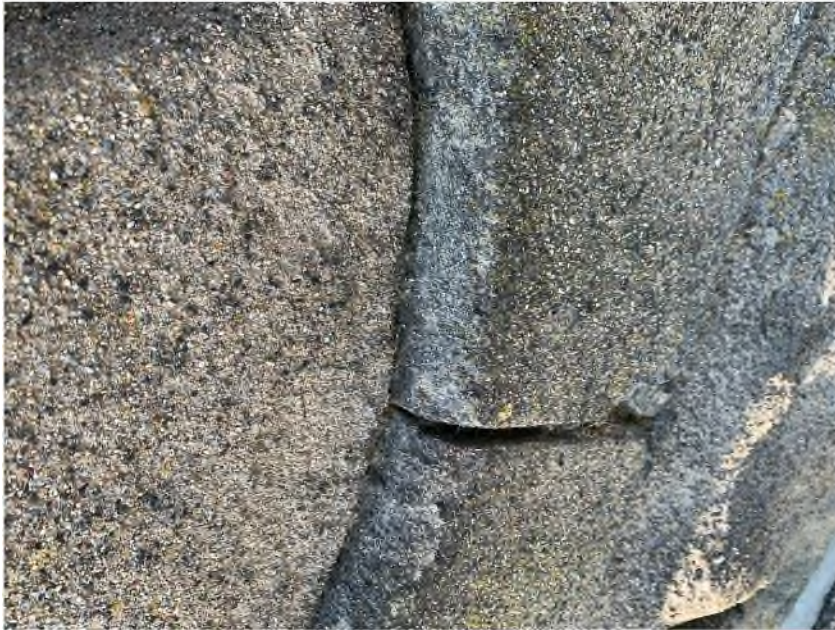
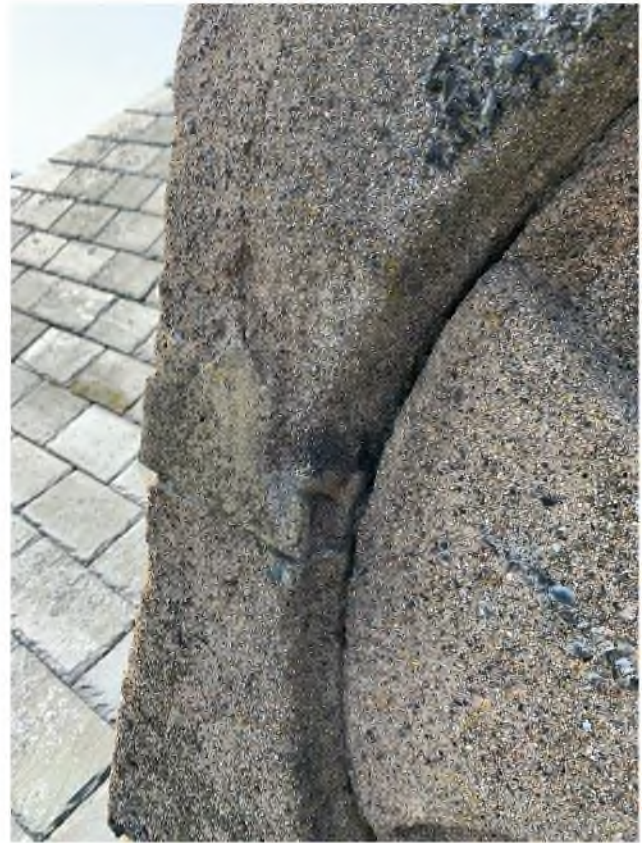
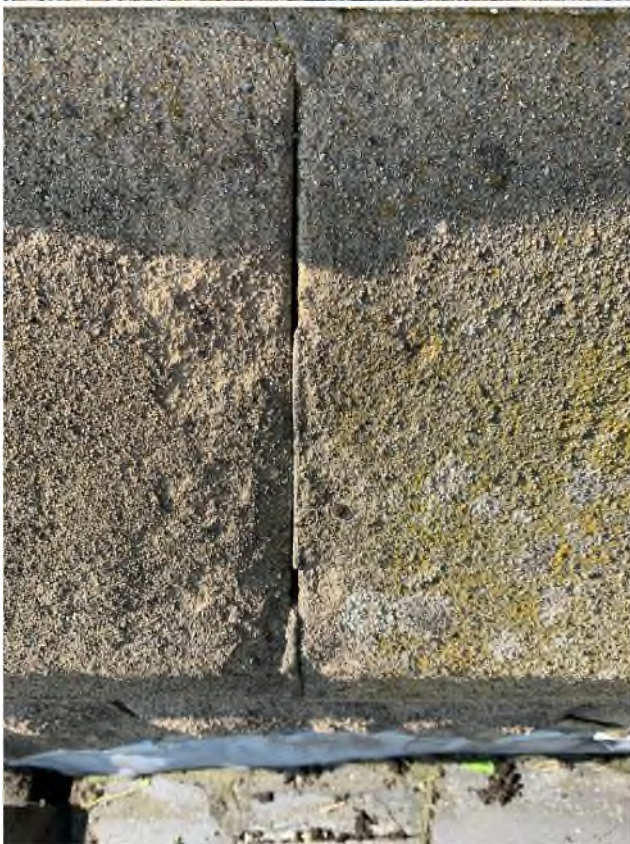
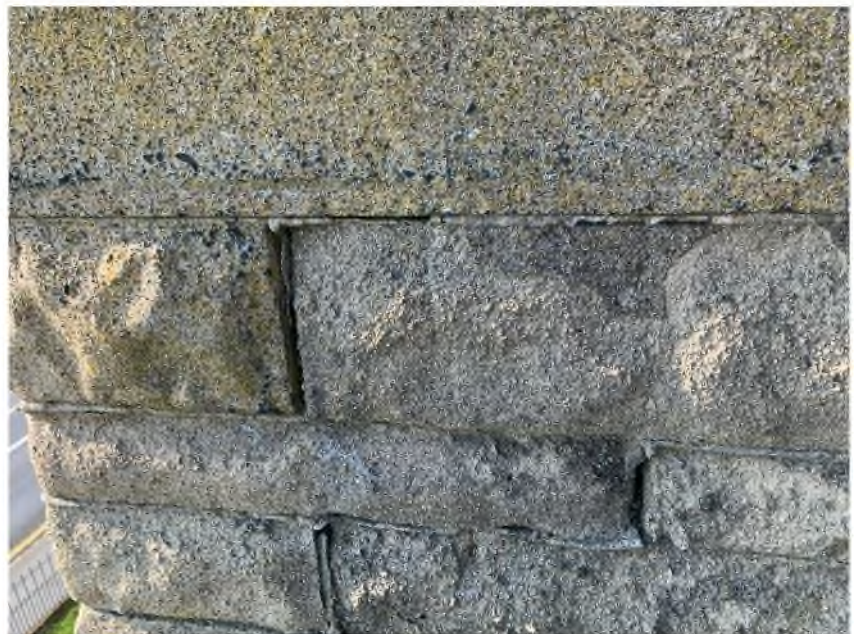
- 1.1 Open joints are evident throughout.
- 1.2 Some light cracking is evident to a number of concrete blocks.
- 1.3 Most mortar joints to lead flashings are cracked and beginning to fail.
- 1.4 A large section of lead has been stolen from the East face of tower at ridge height.
- 1.5 A large section of flashing has been stolen from the east face of tower.
- 1.6 A large crack is evident to the East face of tower.
- 1.7 The South buttress to the East face of tower has several large cracks with some movement evident.
- 1.8 A concrete block is failing to the East face of tower.
- 1.9 A section of flashing to tower top valley has failed (valley was cleared of debris during inspection).

- 2.1 Patch point open joints as necessary.
- 2.2 Pin cracks to concrete blocks.
- 2.3 Cut out and repoint failing mortar joints to flashings.
- 2.4 Remove/replace, vandalized/stolen sections of lead.
- 2.5 Remove/replace, vandalized/stolen sections of lead flashing.
- 2.6 Fit Helibar to cracks in East face of tower.
- 2.7 Refit concrete block to East face.
- 2.4 Replace failed section of flashing to tower top valley.
