Confidential to:

**IRJ/EC/S2046/Quin**

## 1. PREMISES IDENTIFICATION

- 1.1. The property is a Grade II listed, mid-19<sup>th</sup> century parish church occupying a large churchyard to the south of Front Street (B6279) in the centre of the village.

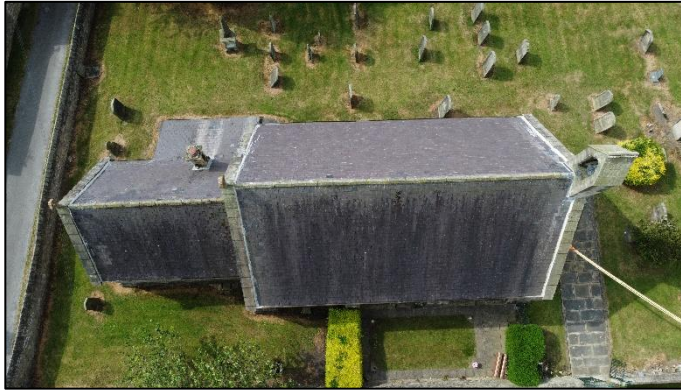
**Photograph 2**

- 5.1.2. The roofs are covered with Welsh slate and have mortar bedded and pointed, angular stone ridges.
- 5.1.3. There are stone copings to the gables of the main roof over the nave and chancel.
- 5.1.4. Numerous slates have been replaced or re-fixed.
- 5.1.5. There are isolated missing/broken slates and where slates have been replaced, some of these are to a poor standard. A general overhaul is required to replace defective and poorly re-fitted slates to a poor standard.

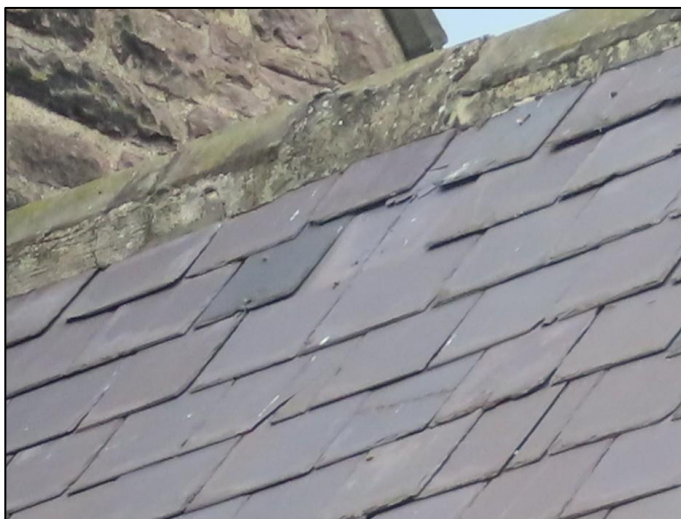
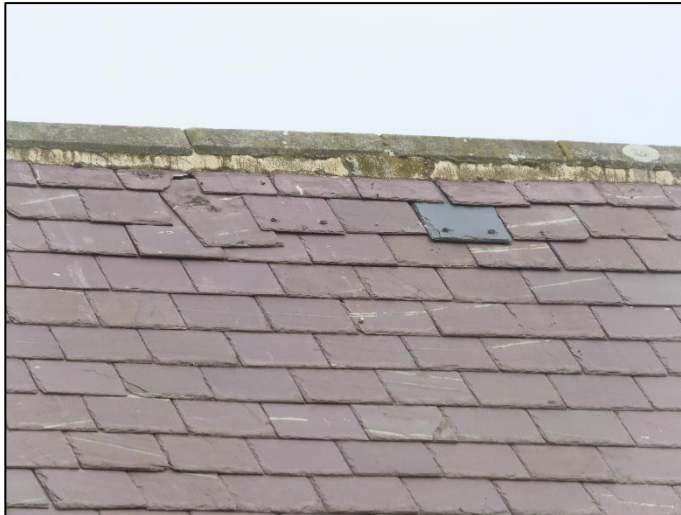
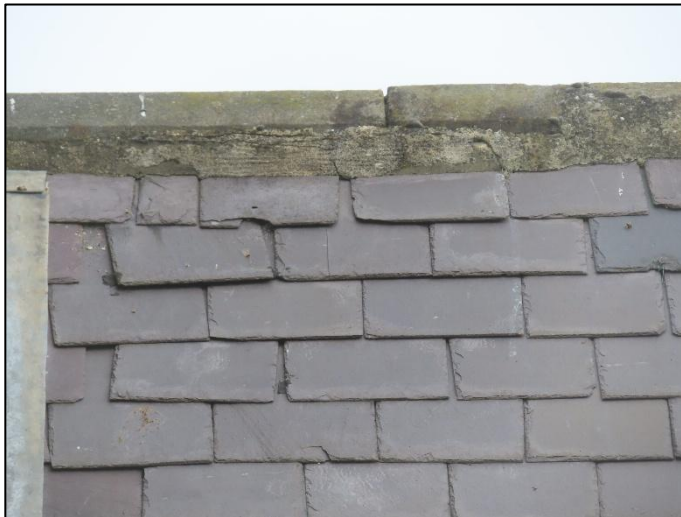
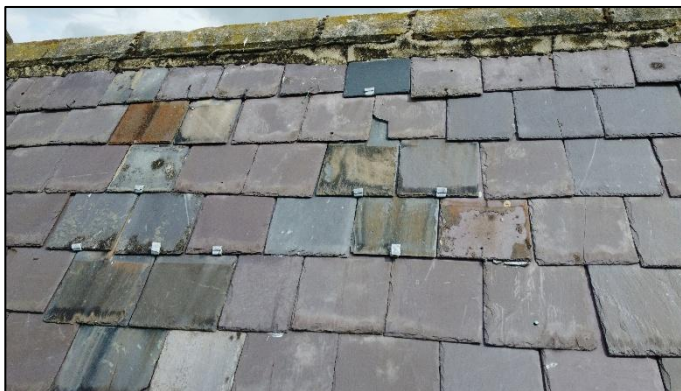
- 5.1.6. Mortar filleting to the copings has been undertaken to a poor standard I anticipate to have been during unsuitable weather conditions and is consequently breaking down, requiring replacement.

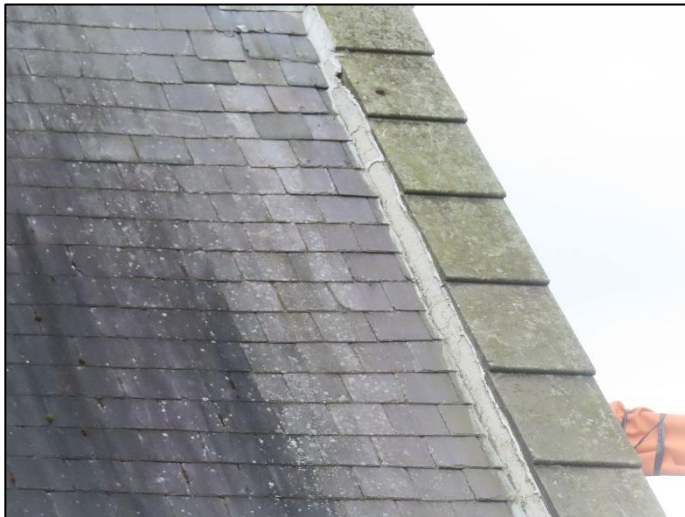
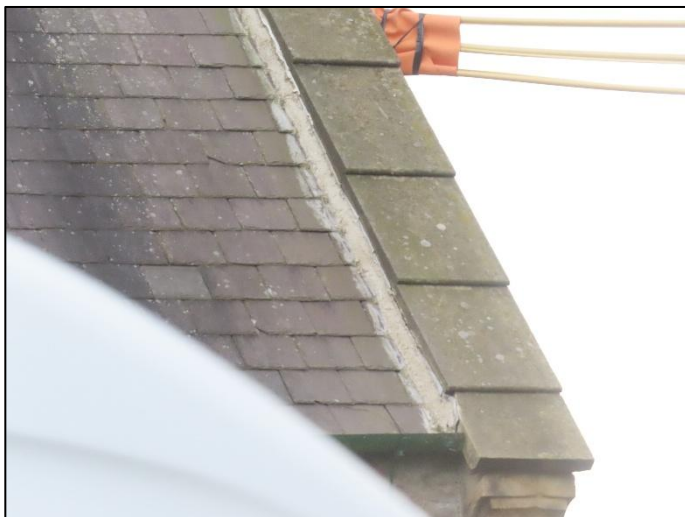
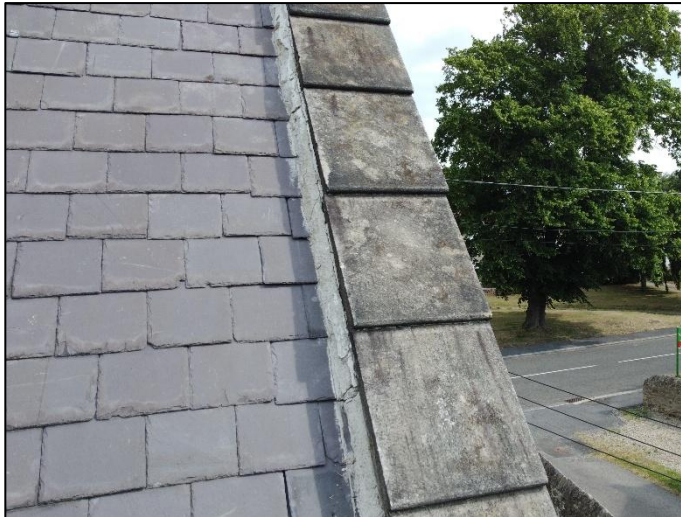
- 5.1.7. Pointing to the ridges is becoming cracked and loose to some areas, requiring replacement.

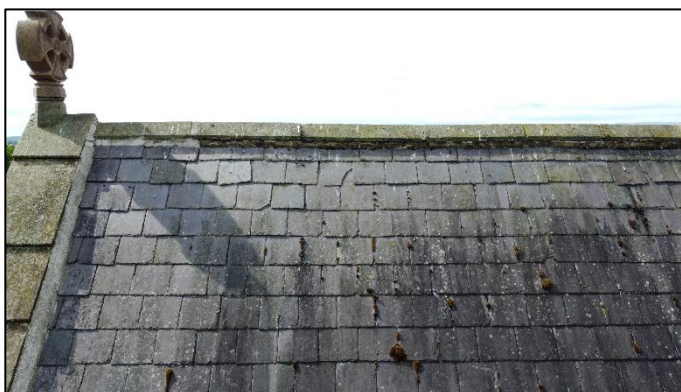
**Photograph 12**

- 5.1.8. At the abutment of the chancel roof with the nave, there are lead flashings which are in reasonable condition for their age.

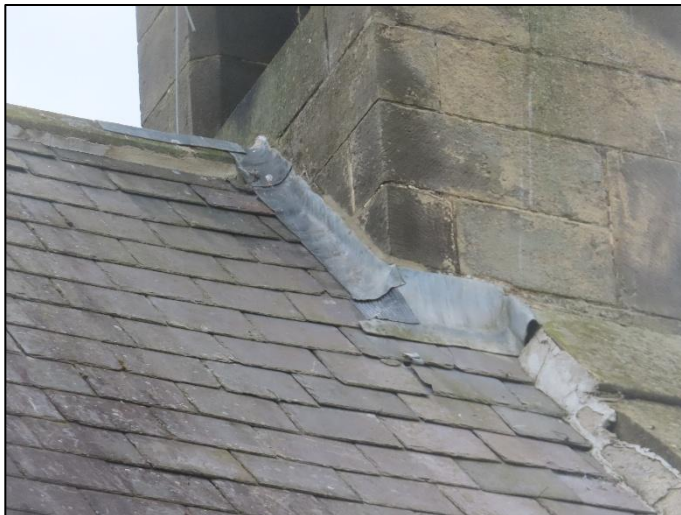
**Photograph 14**

- 5.1.10. The lead is dressed over the copings to both the north and south slopes, but which has become distorted and potentially could allow driving rainwater penetration, requiring re-dressing.
- 5.1.11. To the south slope, a new flashing has been fitted more recently.

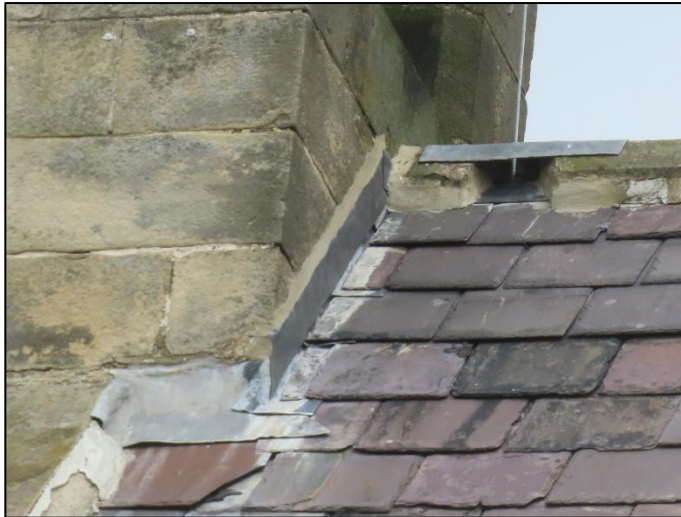
**Photograph 15**

- 5.1.12. To the vestry roof abutment, there is mortar filleting, some of which has been repaired.

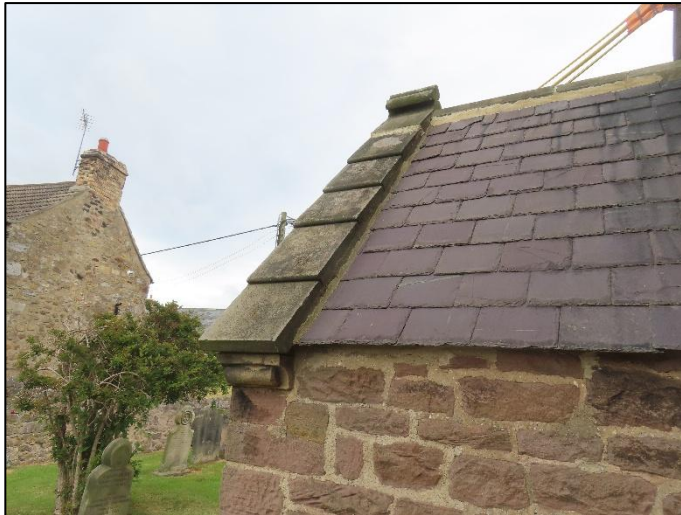
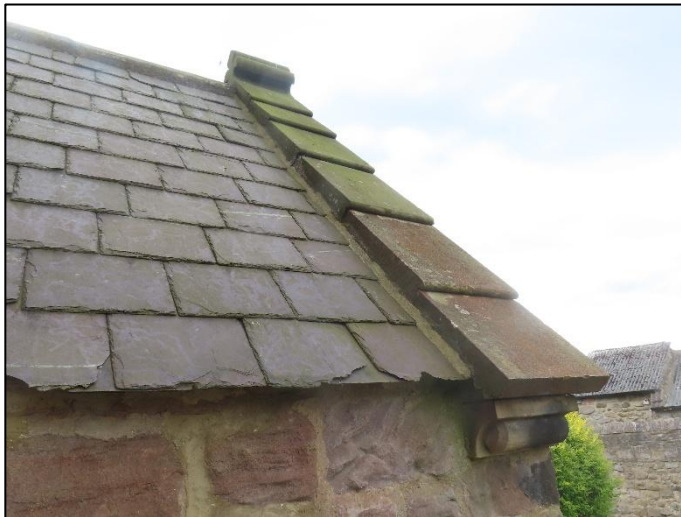
- 5.1.17. However, a small area on the south slope is cracked and loose requiring replacement.

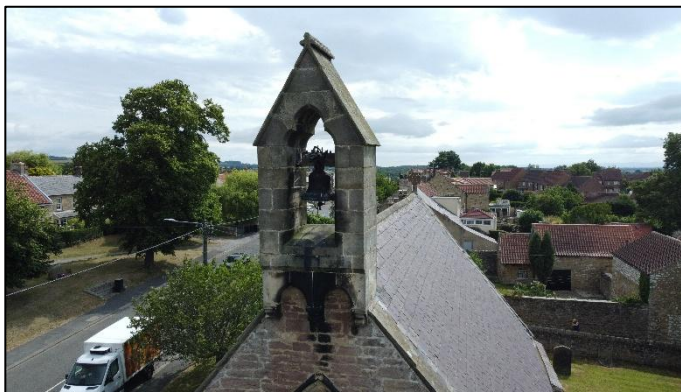
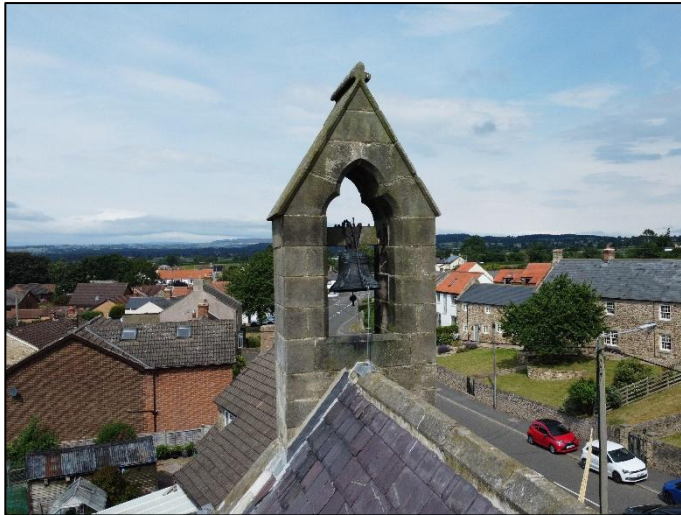
- 5.3.6. There are no rainwater goods to the porch.
- 5.4. **Tower, Spire Bells and Frames**
  - 5.4.1. There is no tower or spire however there is a bell cote with a single bell, timber headstock.
  - 5.4.2. The bell cote is of ashlar stone construction and seen to be in reasonably good condition.

- 5.4.3. I understand that a recent inspection of the bell has been undertaken while scaffold was up for maintenance works and the bell and stock considered to be in reasonably good condition.

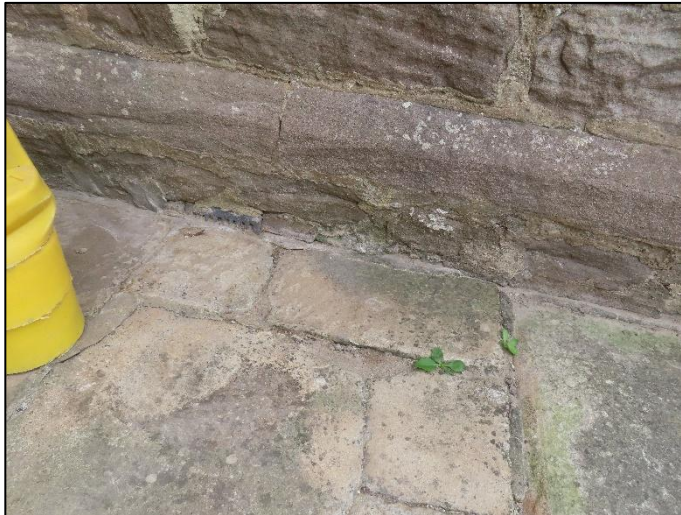
**Photograph 29**

- 5.5.6. To the chancel, the top has been moved and there are leaves in the well, requiring cleaning out.

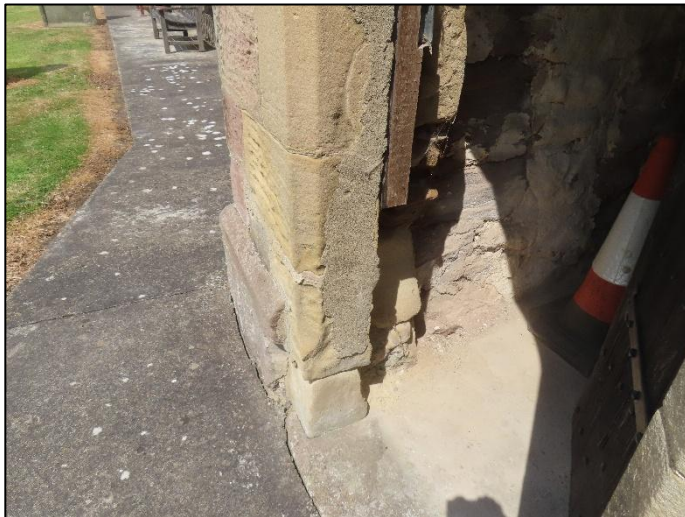
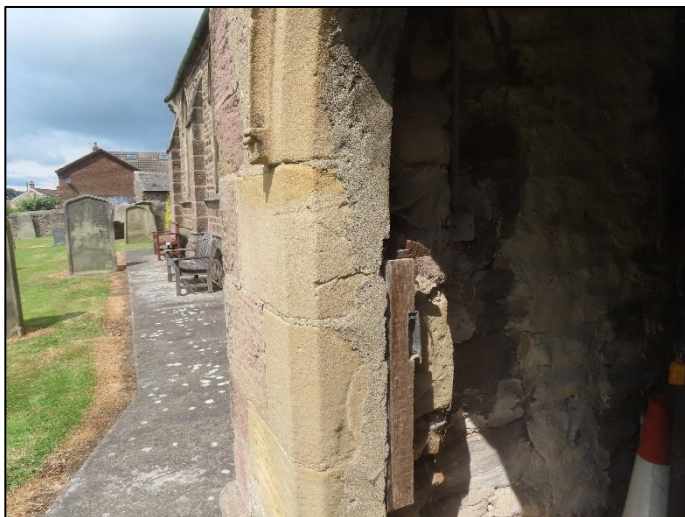
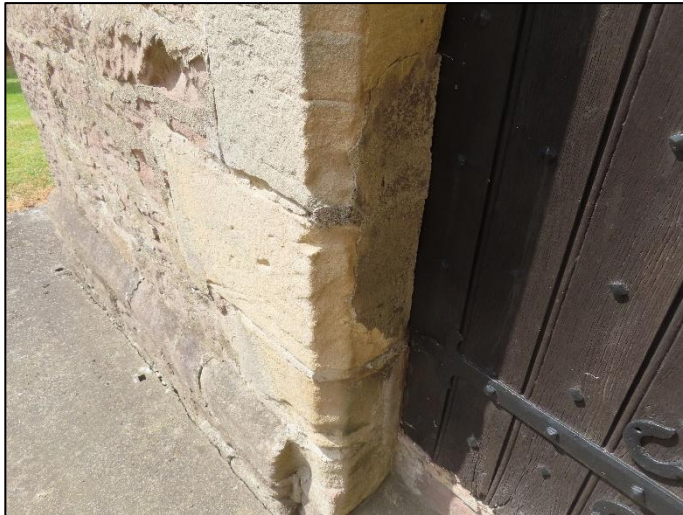
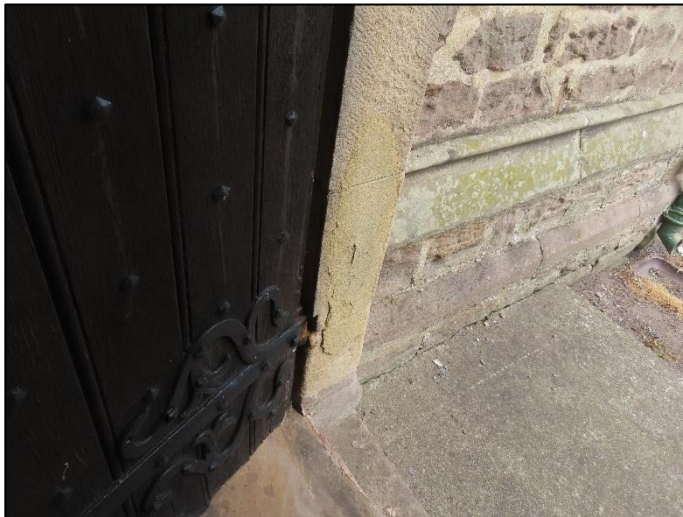
- 5.5.17. There are areas of significant erosion of stonework evident which are to a degree exacerbated by previous cement mortar pointing and to these areas in particular, the cement mortar should be removed and replaced with lime mortar.

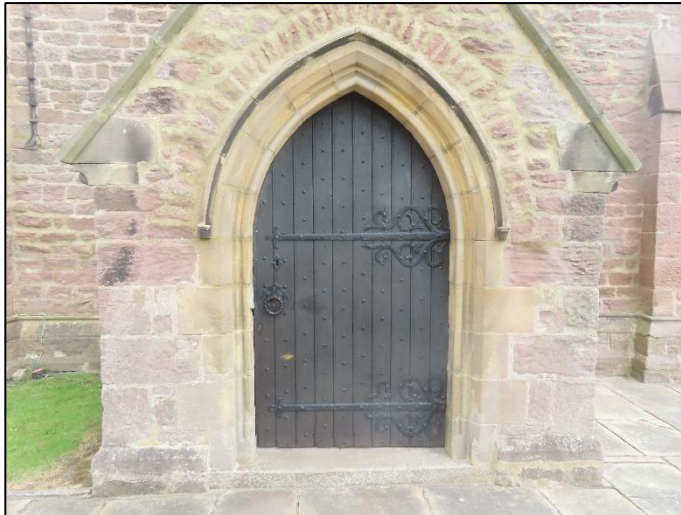
**Photograph 55**

- 5.6.2. There is an iron ring pull which is significantly worn but still operational.

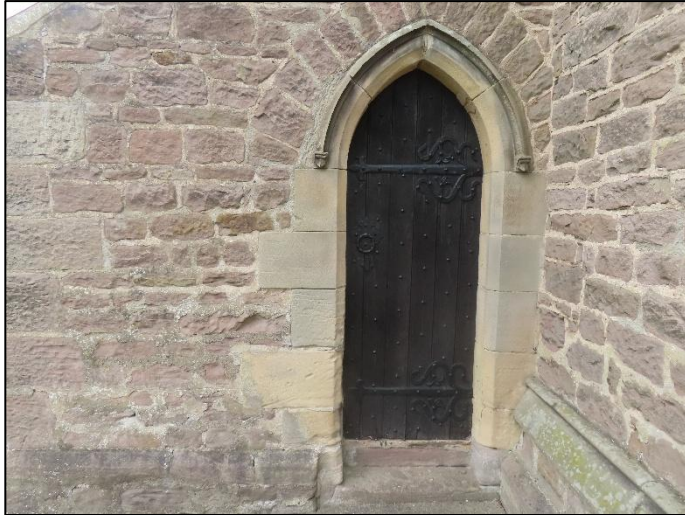
**Photograph 57**

- 5.6.3. General age-related weathering is evident to lower sections in particular but of a relatively minor nature.
- 5.6.4. The vestry and boiler room doors are of very similar nature but narrow.

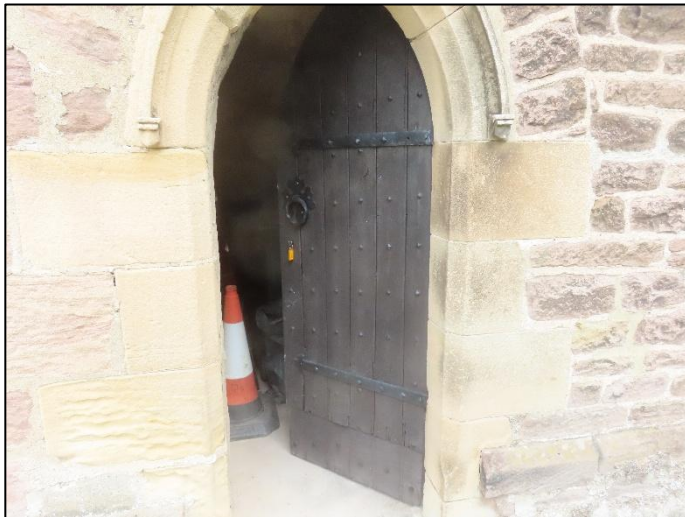
**Photograph 58**

5.6.5. The vestry has a weathered lower face.

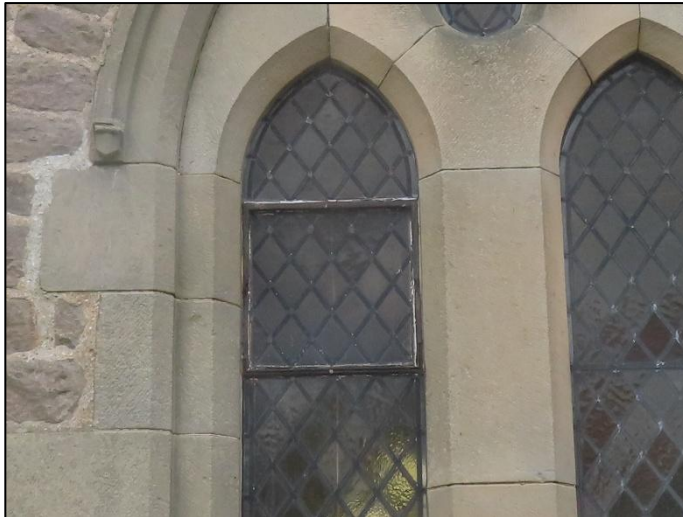
**Photograph 61**

- 5.6.14. To the south-east window, there is an opening vent which is distorted and the metalwork corroding, requiring cleaning down and re-decoration.

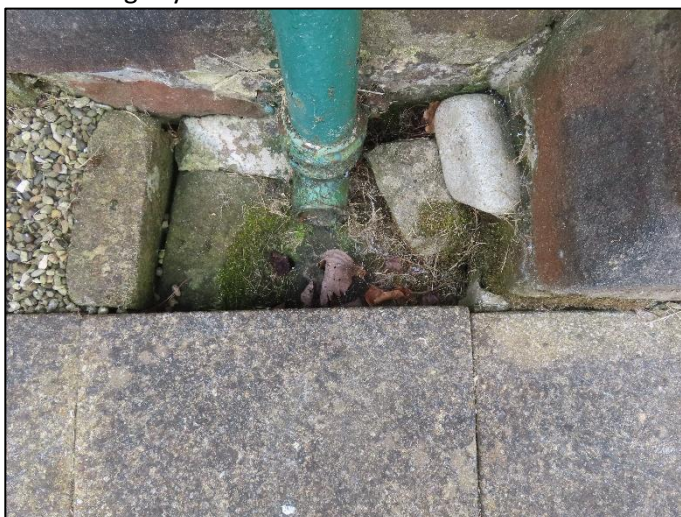
**Photograph 64**

- 5.7.1. The rainwater downpipes discharge over clay gulley tops to the south side and stone dishes to the north side.
- 5.7.2. I understand that during periods of rainfall, pools of water develop and it is believed that there is no drainage system however I suspect that the area beneath the dish top gullies is blocked and these should be lifted and cleaned out which would also confirm whether or not there is a drainage system beneath.

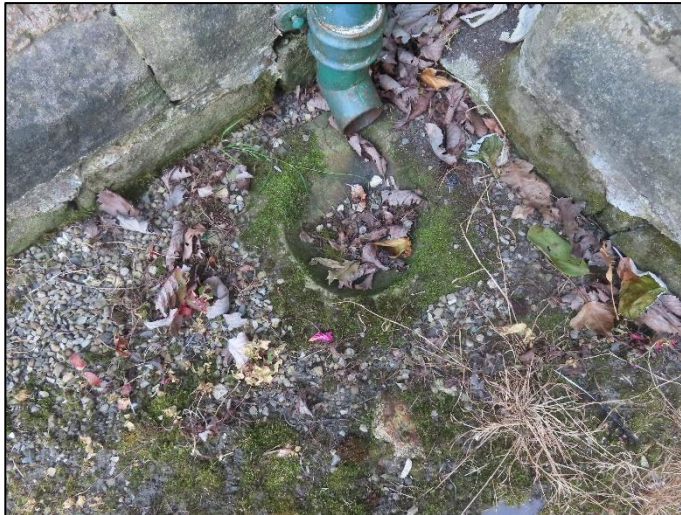
**Photograph 65**

- 5.7.3. The gulley to the south side of the chancel requires cleaning out.

- 8.1.1. Replace missing and loose roof slates.
- 8.1.2. Clean out gullies.

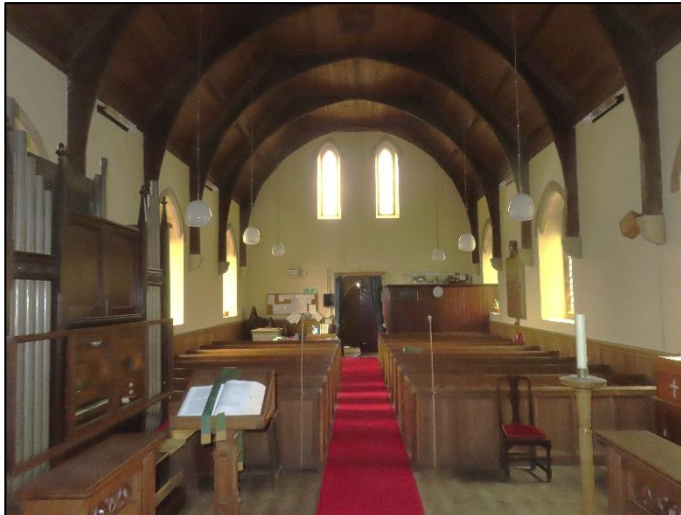
**Photograph 67**

- 5.9.1. The nave roof is supported on 6.No narrow, pine, collar trusses with extended legs and curved spandrels which support at least two rows of purlins to each roof slope but only one of which is visible due to a ceiling and small apex void which is not accessible by using surveyors' ladders.

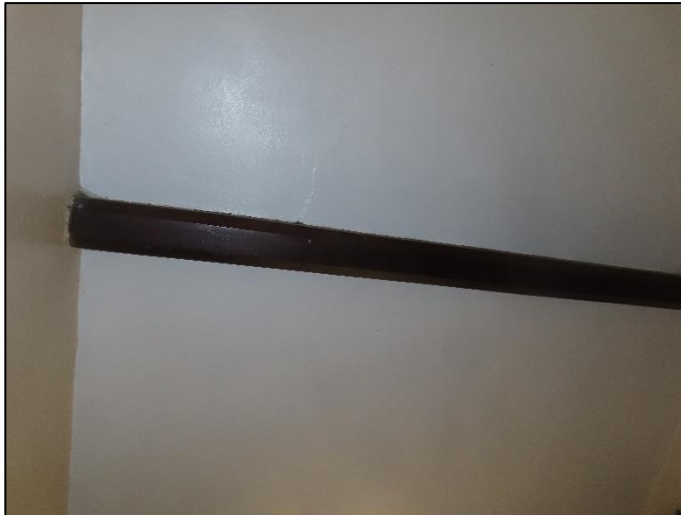
**Photograph 69**

- 5.9.8. The purlin is noted to be free from any active woodworm infestation or decay and there is no evidence of any water ingress.
- 5.9.9. To the boiler room, the roof is partially visible through a hole in the ceiling. The structure comprises a single purlin supporting common rafters and which as far as can be ascertained, appears free from any active woodworm infestation or decay.

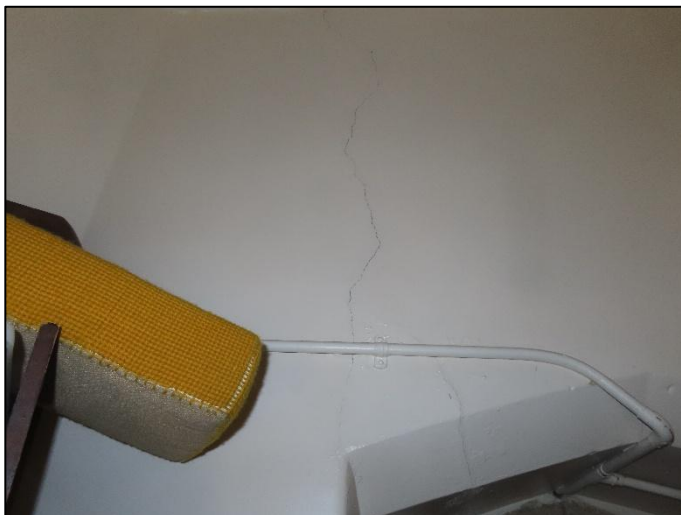
**Photograph 74**

- 5.11.6. There is blistering and deterioration of paintwork and plaster at lower level to each side of the external door and south wall which I would recommend is patch repaired with lime plaster. Any decorative finish should be vapour permeable.

8.4.6. Replace defective plaster to vestry walls.

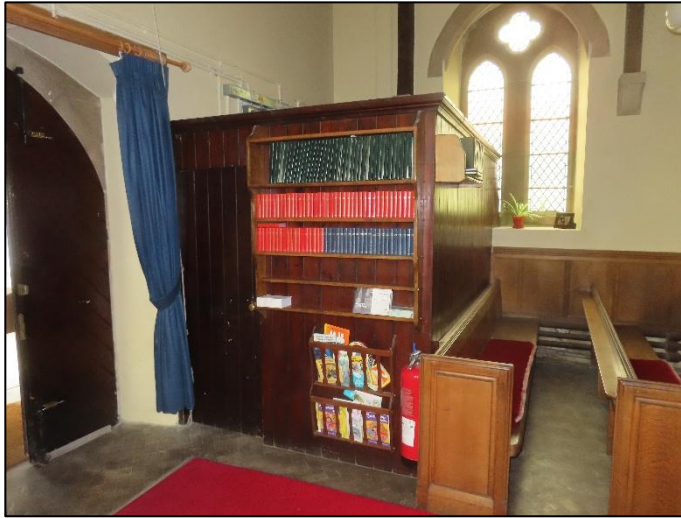
**Photograph 78**

- 5.11.7. There is a vertical boarded timber partition to the north-west corner of the nave with vertical, timber boarded door which is in reasonably good condition.

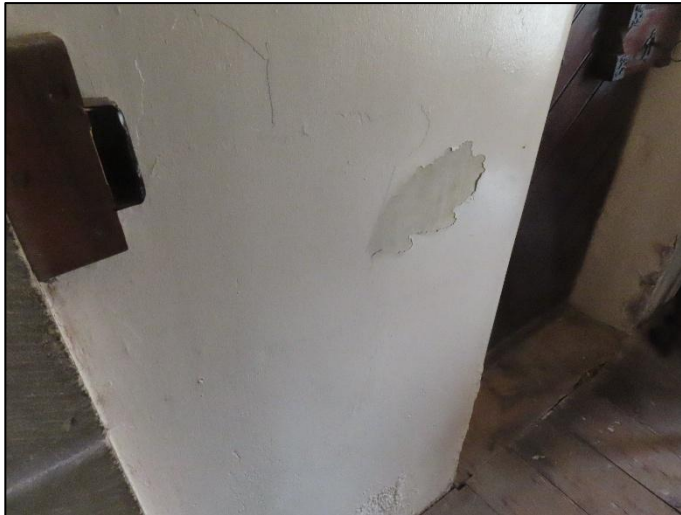
**Photograph 84**

- 5.15.1. The church has recently undergone complete redecoration of the walls to the nave and chancel.
- 5.15.2. Within the vestry, there is blistering and peeling paintwork as previously reported.

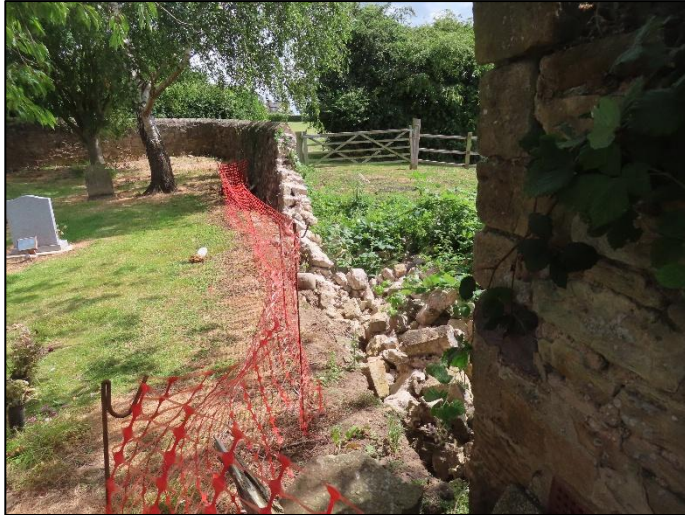
**Photograph 87**

- 5.28.1. The perimeter of the churchyard has mortar stone-built boundary walls which is in reasonable condition to the front and east-sides. To the west side, there are several bulges and areas of leaning together however ivy growth has prevented a full examination.
- 5.28.2. To the south, the boundary is formed partly by a neighbouring building which is in a state of collapse.
- 5.28.3. Part of the wall to the east side of the building has been undermined and collapsed and I understand is under negotiations for re-building.

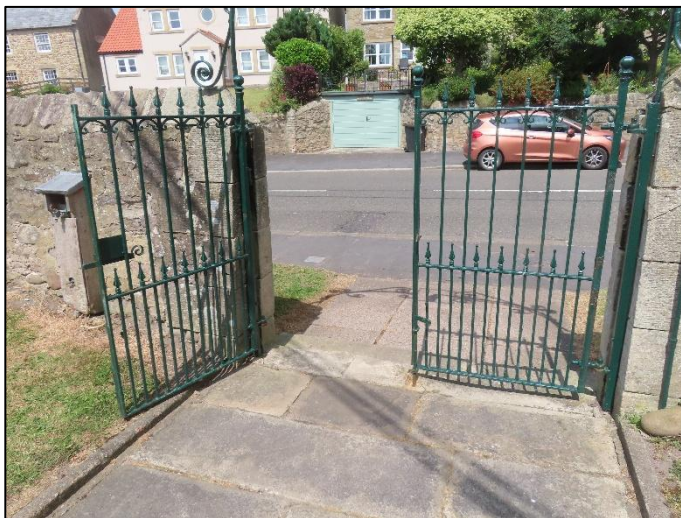
**Photograph 91**

- 5.28.8. Although the gates have been recently decorated, preparation has not been properly undertaken, and areas of corrosion are again visible.
